DATA BOOK

Lower Chase River Dam

CITY OF NANAIMO

EBA ENGINEERING LTD.

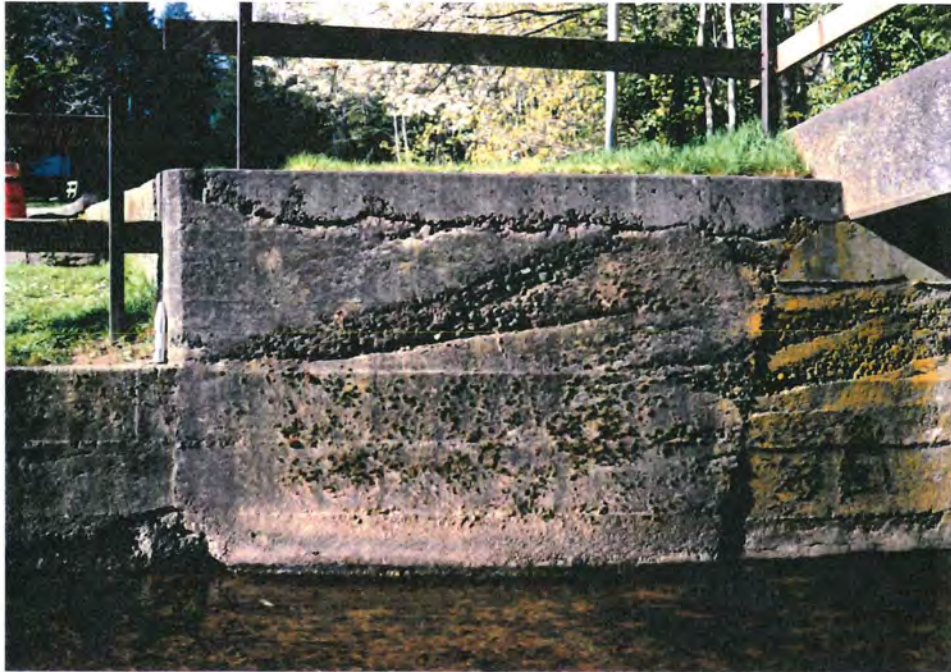
OLD CONCRETE ABUTMENT UPSTREAM OF FOOTBRIDGE AT SPILLWAY

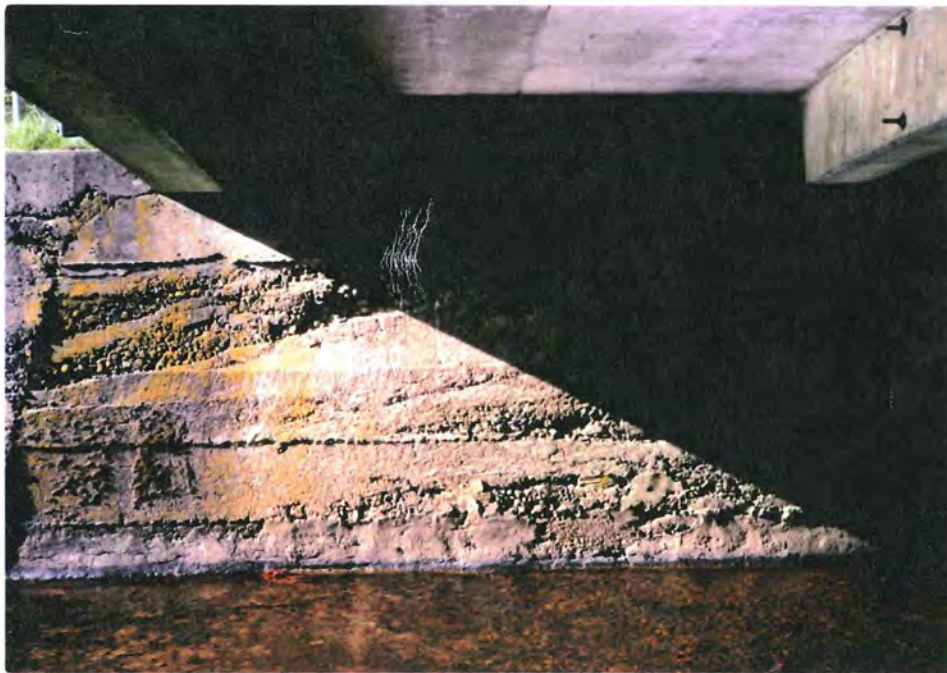
**OLD CONCRETE SPALLING AND SEGREGATED BENEATH
FOOTBRIDGE AT SPILLWAY**

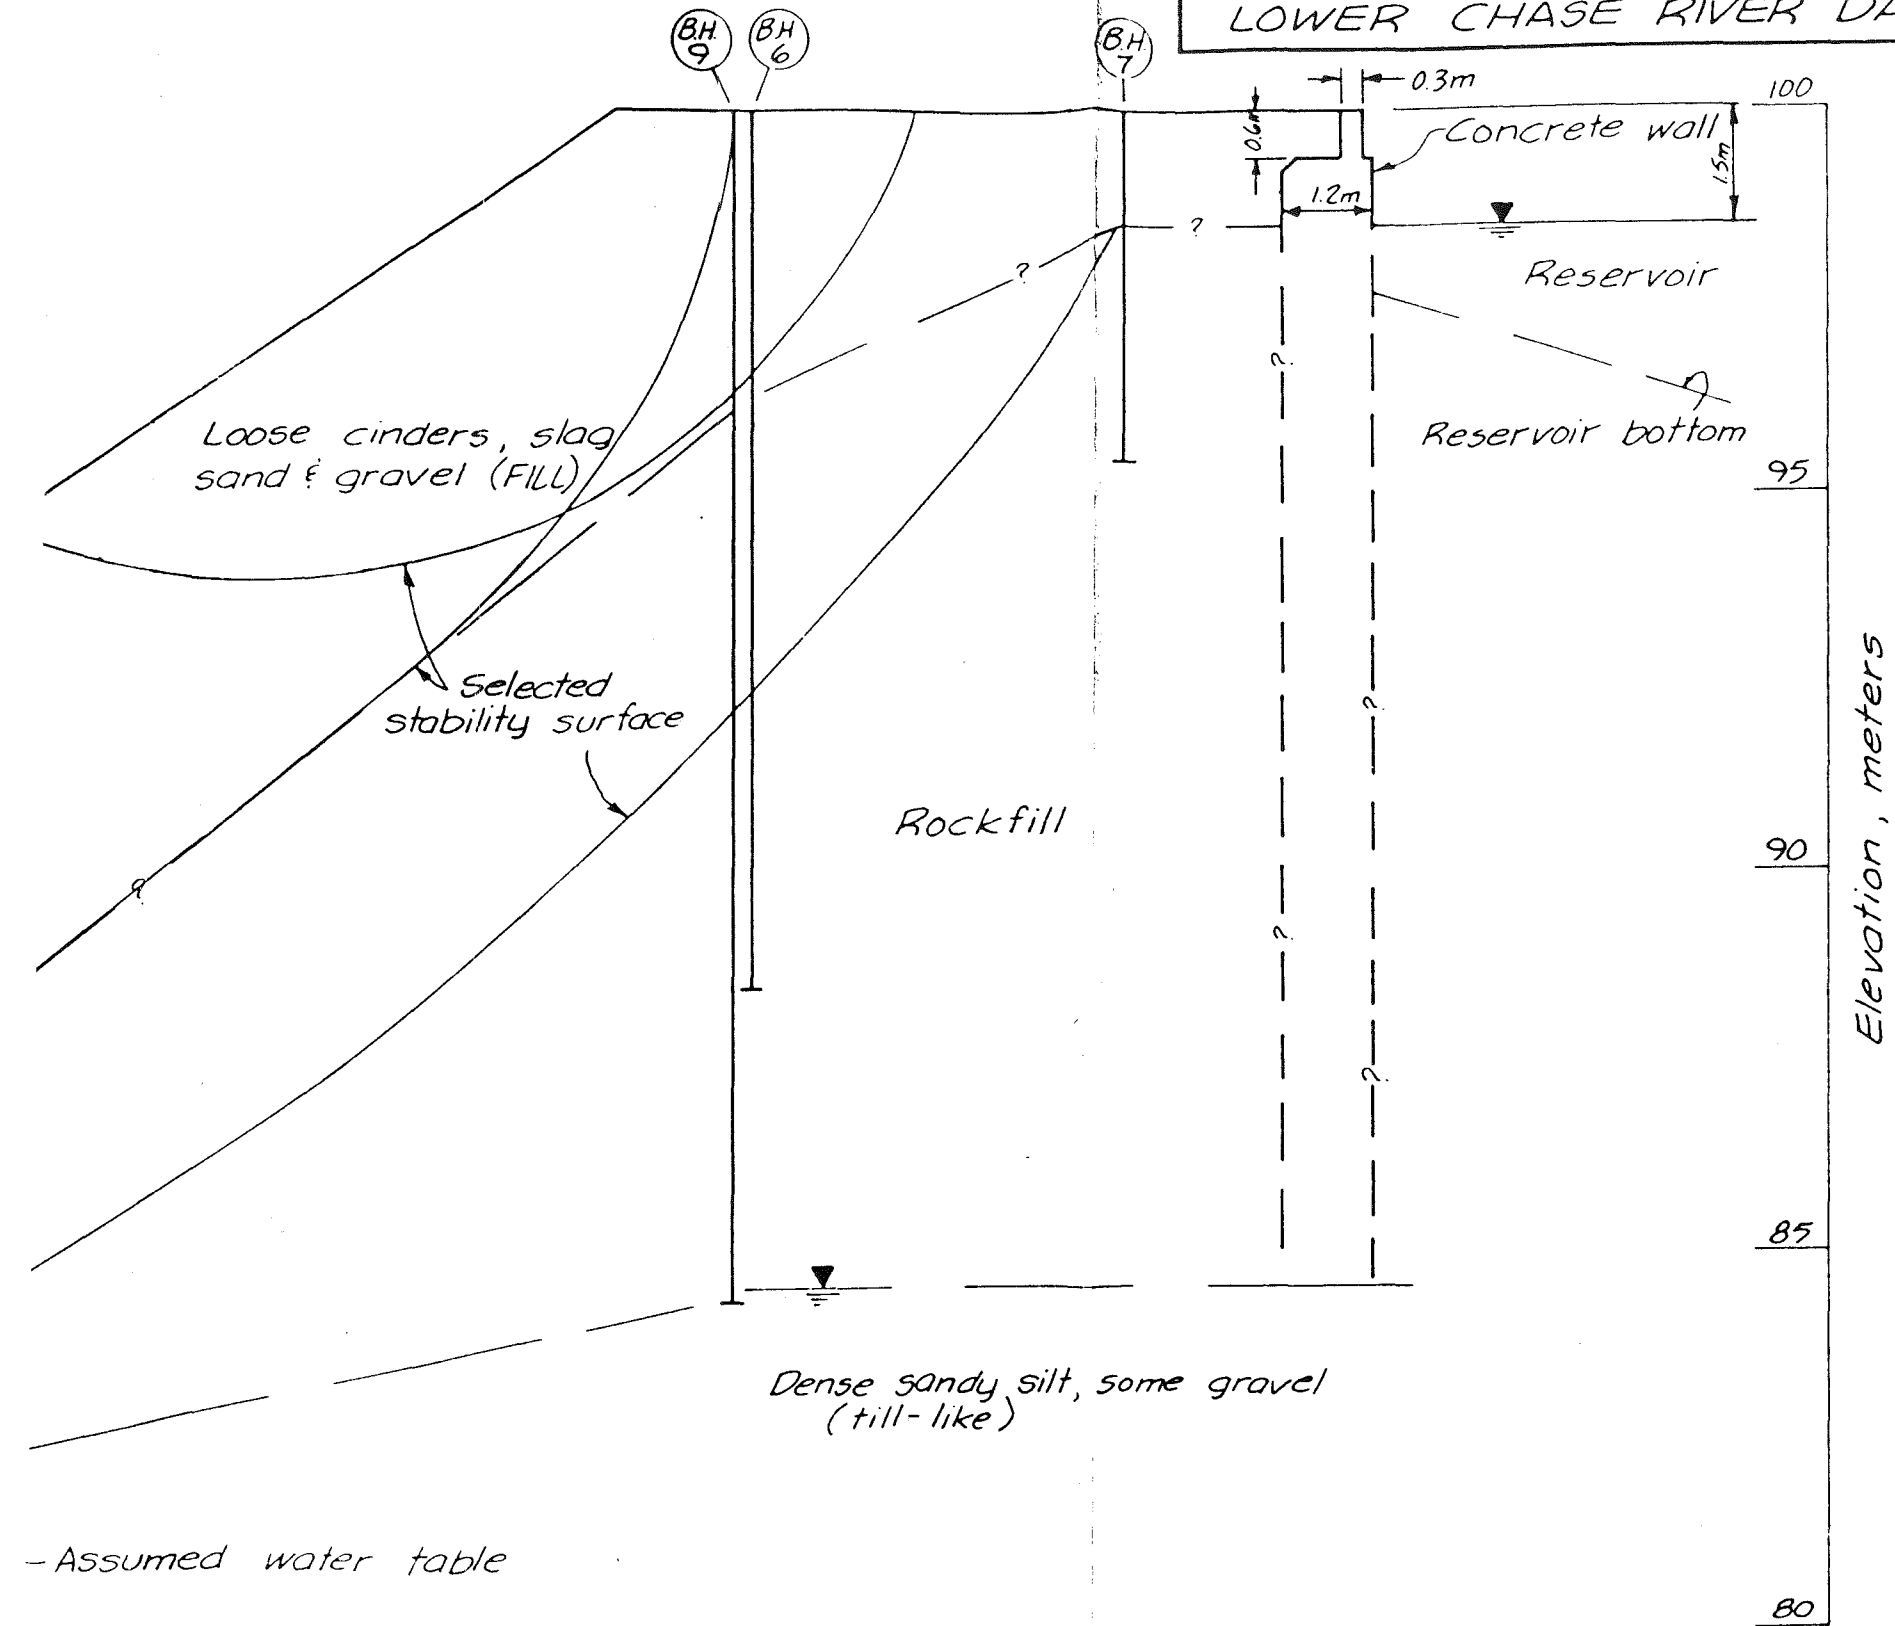
Figure 8

An inferred section through the dam is shown in Figure 8. Based on the results of the field work the dam appears to have been constructed with a concrete core wall with rockfill end dumped on either side of the wall to provide structural support. Fill consisting of slag, cinders, sand and gravel has been end dumped on the downstream side of the original dam cross-section to form the existing downstream slope of the dam. The results of the field investigation indicate the fill is very loose to loose. The results of the drilling through the rockfill indicates that some voids exist in the rockfill. These voids are up to 0.3 m size.

Our analyses indicate that the downstream slope of the Westwood Lake and Middle Chase River Dams generally have a factor of safety above 1.5 but range from 1.4 to 1.7 against a deep seated overall failure. The downstream slope of the Lower Chase River dam has the lowest computed factor of safety against a deep seated failure since the failure surface examined was mainly through the loose slag fill. A factor of safety of 1.2

was calculated for the rockfill, assuming that the loose slag fill did not exist. This is a very conservative assumption as the overall stability does include the effect of the slag fill. The factor of safety, considering the total dam section, is 1.4.

INFERRED SECTION THROUGH
LOWER CHASE RIVER DAM

that due to the location and presence of a residential development downstream, the factor of safety should be upgraded to a minimum of 1.5 against rotational failure. In order to achieve this, fill should be placed against the downstream slope. It is considered desirable to decrease the overall slope of the downstream face from its present inclination of 1.6 horizontal to 1 vertical to a slope of 2 horizontal to 1 vertical. Alternatively, a weight berm may be used to achieve the same end. The dimensions of the berm have not been determined at this time as further study would be required. A preliminary estimate indicates a berm 11 m high, from the valley bottom up the existing downstream slope, with a top width of 5 m, would be sufficient to provide the desired increase in stability. The downstream slope of the berm would be constructed at 2 horizontal to 1 vertical. This berm would be constructed with a clean pit run sand and gravel with a designed toe drain along the valley bottom to collect any seepage which may enter the berm.
