Nanaimo Fire Station 1

Business Case Analysis : Renovation vs Replacement - April 25, 2017

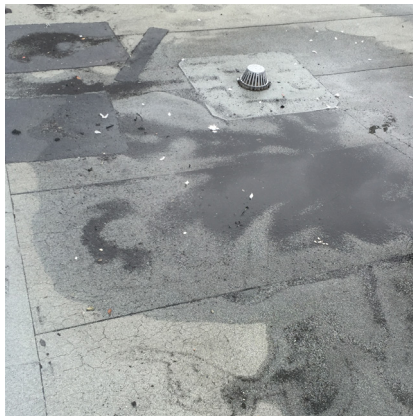
1

1. Existing roofing needs urgent replacement.
2. Existing gear room is not large enough.
3. Degraded concrete at hose tower.
4. Gear stored in apparatus bay environment

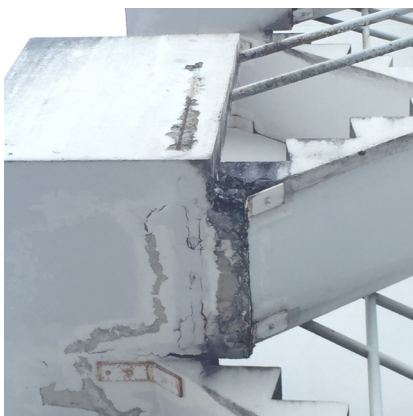
3

- The hose tower structure and concrete facing needs repair to fix spalling and exposed reinforcement.

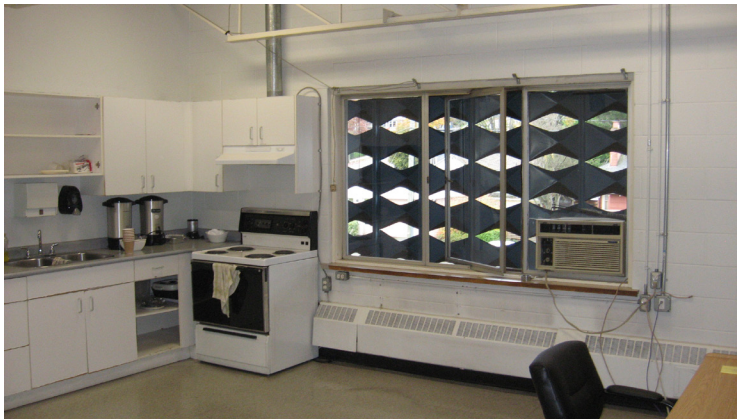
1

Additionally, the building is currently ventilated through a combination of operable windows, window air conditioners and a heat pump serving the dispatch area. This does not meet the requirements for healthy ventilation included in the current building code which would require a forced air ventilation system for all spaces.

1. Existing ventilation system does not meet code requirements.
2. Boiler needs replacement.
3. Existing piping and valves need replacement.

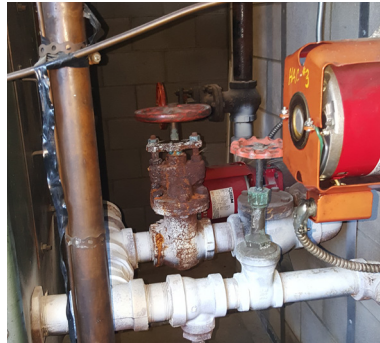
3

Several items were identified as needing urgent replacement including the existing boiler, heating system and most of the existing supply, drainage and storm water piping.

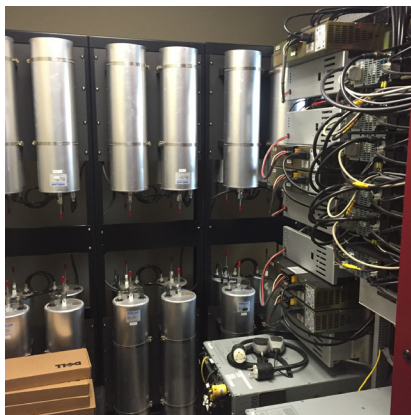
1

1. Radio equipment in existing radio room.
2. City of Nanaimo backup server in existing IT room.
3. Hazardous materials are present within the building.
4. Existing electrical service is ageing and has no spare capacity

Electrical service to the backup server and radio equipment located within the building was observed to have some deficiencies including the absence of redundant uninterrupted power supply (UPS) backup and surge suppression. These deficiencies pose the risk of potential failure and damage to data equipment and electronics.

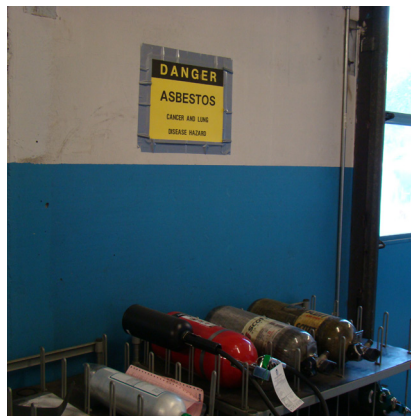
3

Several building elements were found to contain asbestos, lead, Polychlorinated Biphenyls (PCBs) and Silica. While the presence of these materials was not deemed to pose any immediate health risks to the occupants of the building, demolition and disposal of these materials will need to be done in accordance with relevant standards.

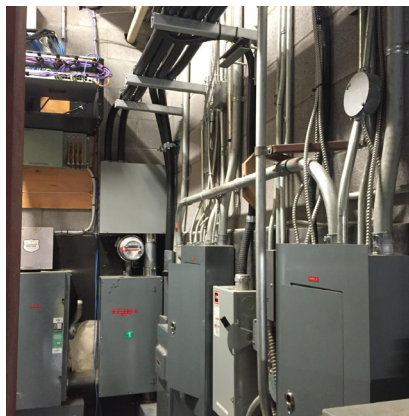
4

Several items were identified as needing urgent replacement including the panels and cables. Failure of any of these elements is anticipated to leave parts of the building without power till new equipment can be installed. The electrical system also does not have any spare capacity and it is recommended to not add any new loads to the building prior to upgrades.

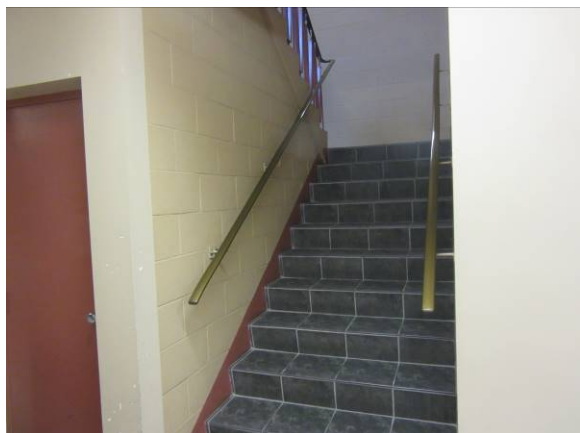
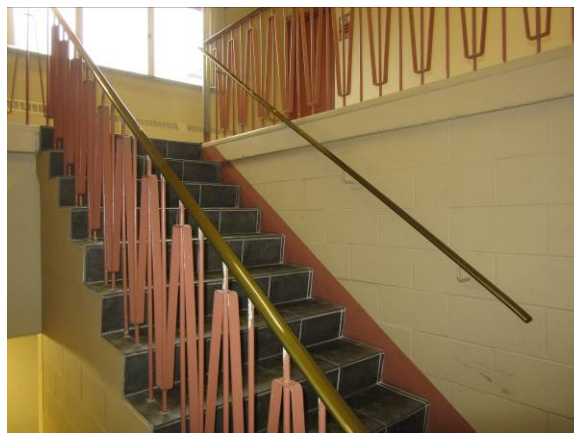
For this project, width, headroom and slip resistance appear to comply with the requirements of Articles 3.4.6.5 and 3.4.6.6 at the existing open stair. Handrails are noncompliant with regard to continuity and extensions and the stairs are without the required tactile warnings and contrasting markings at treads.

Photo 1: Open Stair

Photo 2: Open Stair

Thus, at the open stair, we recommend:

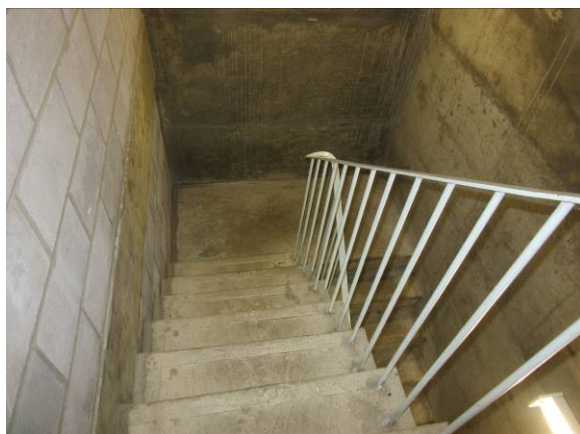
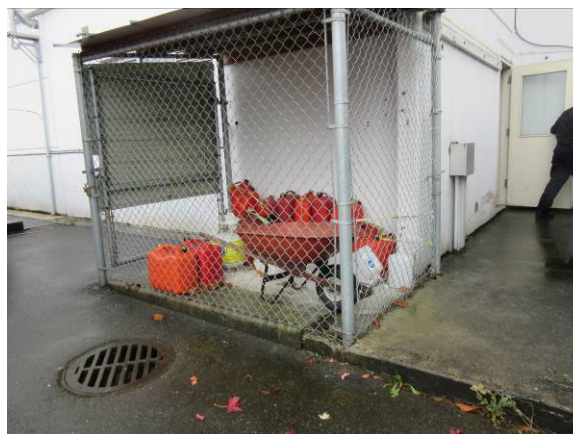
The second storey exit is in an obscure area, unmarked, poorly lit and the exit door does not fully open as it hits the guard on the landing. The stair discharges outdoors behind the building's diesel generator and adjacent an enclosure used to store portable fuel containers. The stair is 914mm wide and rise and run are 216mm and 250mm respectively and guard height is less than the heights described in the Building Code; 920mm at stairs and 1070mm at landings.

Photo 3: Second Storey Exit

Photo 4: Second Storey Exit

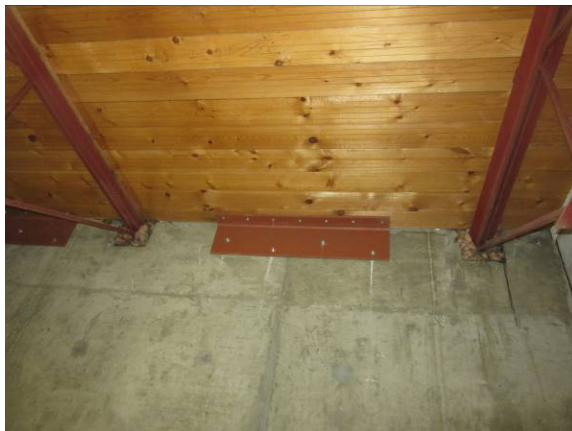
The fire separation between the second storey exit and the hose tower includes penetration by flanges of steel joists. The annular spaces are packed with mineral wool. Installation of a listed firestop system that includes caulking or other means of smoke seal is recommended.

Photo 5: Penetration of Fire Separations between Second Storey Exit and Hose Tower

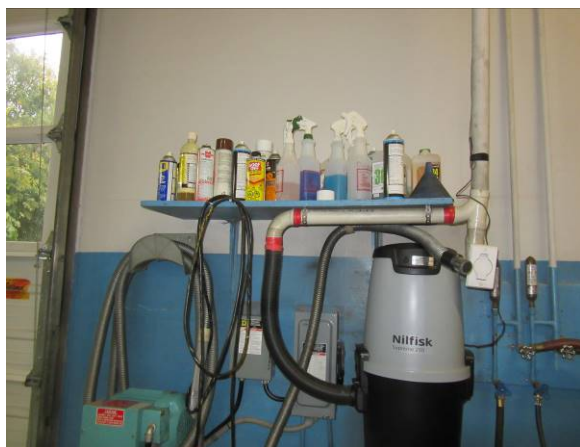
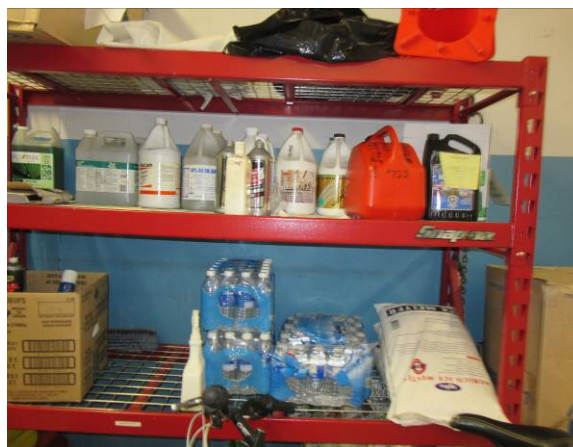
Sentence 3.3.1.21.(1) prescribes a 1h fire resistance rating at janitors' rooms on the basis that cleaning supplies may include dangerous goods such as bleach, ammonia or solvents, in small quantities. The building includes multiple storage rooms at both storeys that contain items that should be stored in a janitors' room. We recommend consolidating the storage of cleaning supplies into one or two dedicated janitor's rooms enclosed by fire separation and equipped with self-closing doors having a $\frac{3}{4}$ h fire protection rating.

Photo 6: Storage of Cleaning Supplies

Photo 7: Storage of Cleaning Supplies

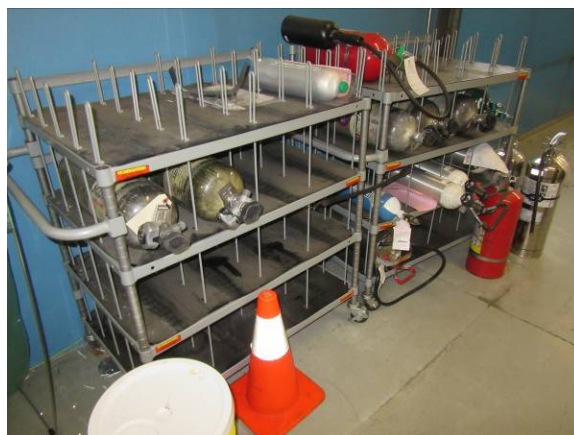
The building contains stored cylinders of compressed medical gases; oxygen (O₂) and nitrous oxide (N₂O). O₂ and N₂O are (primary) Class 2.2 non-toxic, non-flammable gasses and (subsidiary) Class 5.1 oxidizing agents; this means that while they are not flammable they will, by yielding oxygen, contribute to combustion of other materials.

Photo 8: Oxygen Cylinders in Apparatus Bay

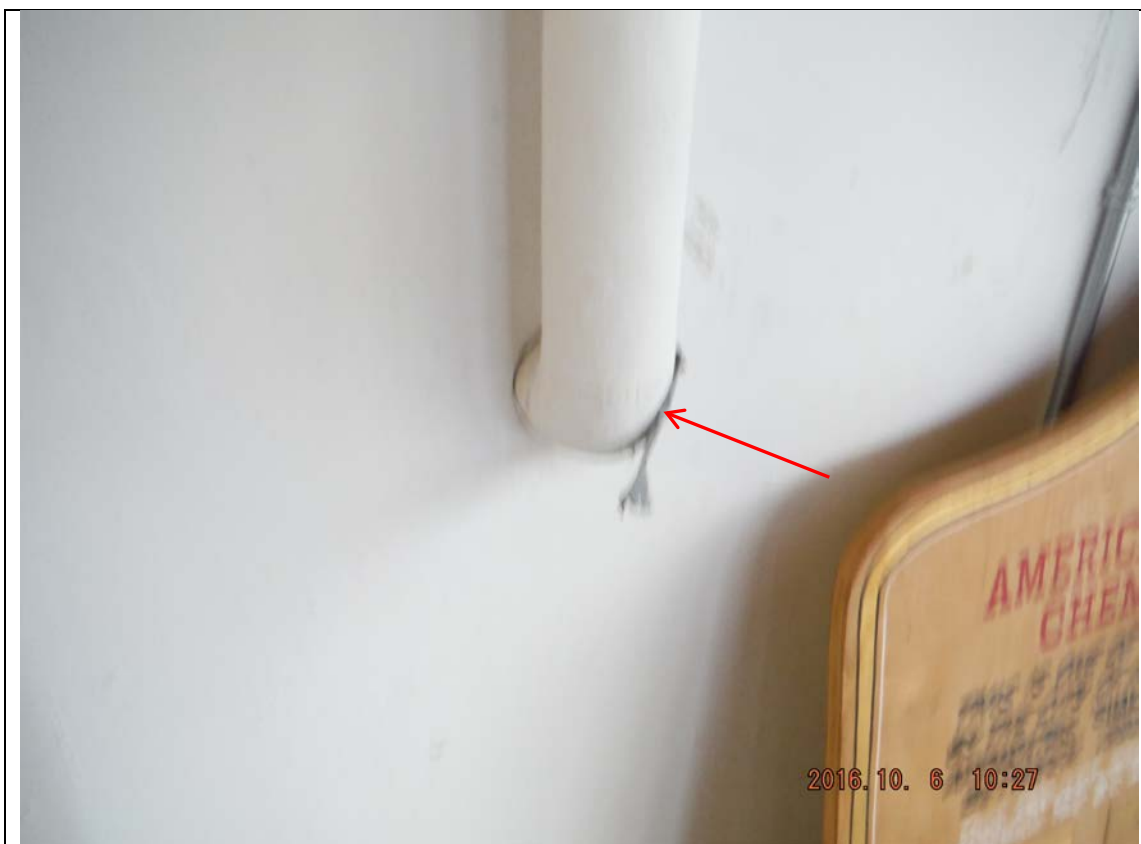
Photo 1	Date: Oct 06, 2016	Location: 1 st floor display room
Description: Sample 01 – Pipe elbow

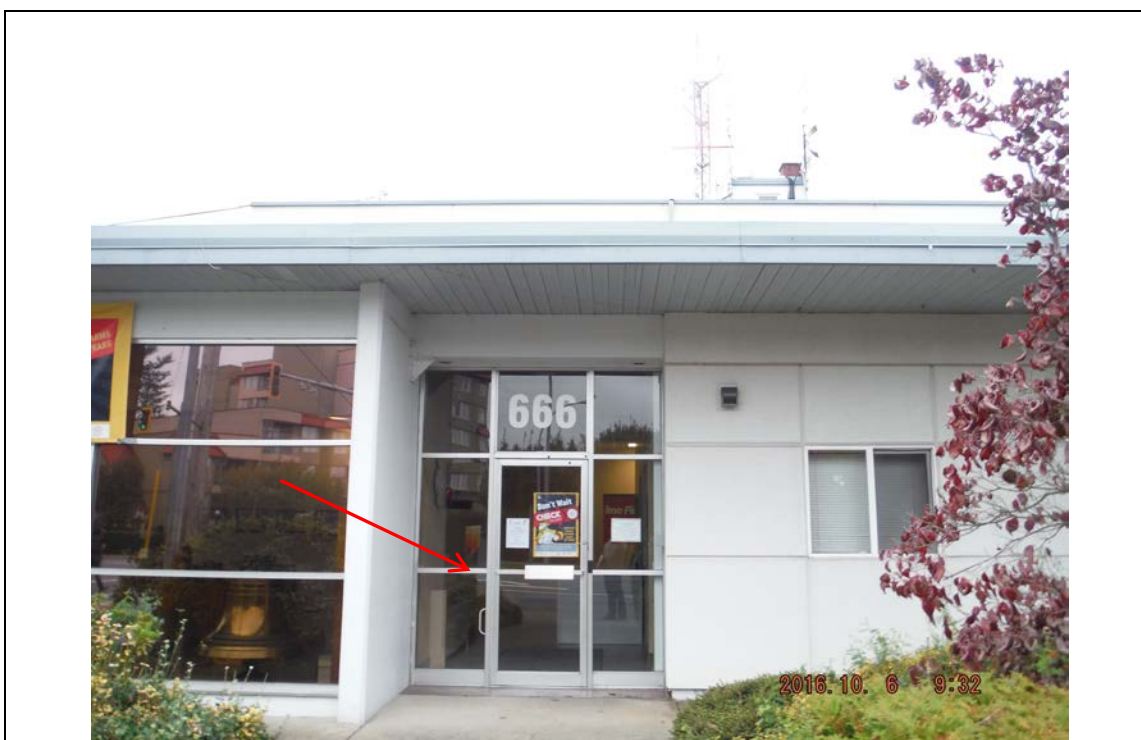
Photo 2	Date: Oct 6, 2016	Location: Main entry door
Description: Sample 03 - Butyl tape around the edges of the window

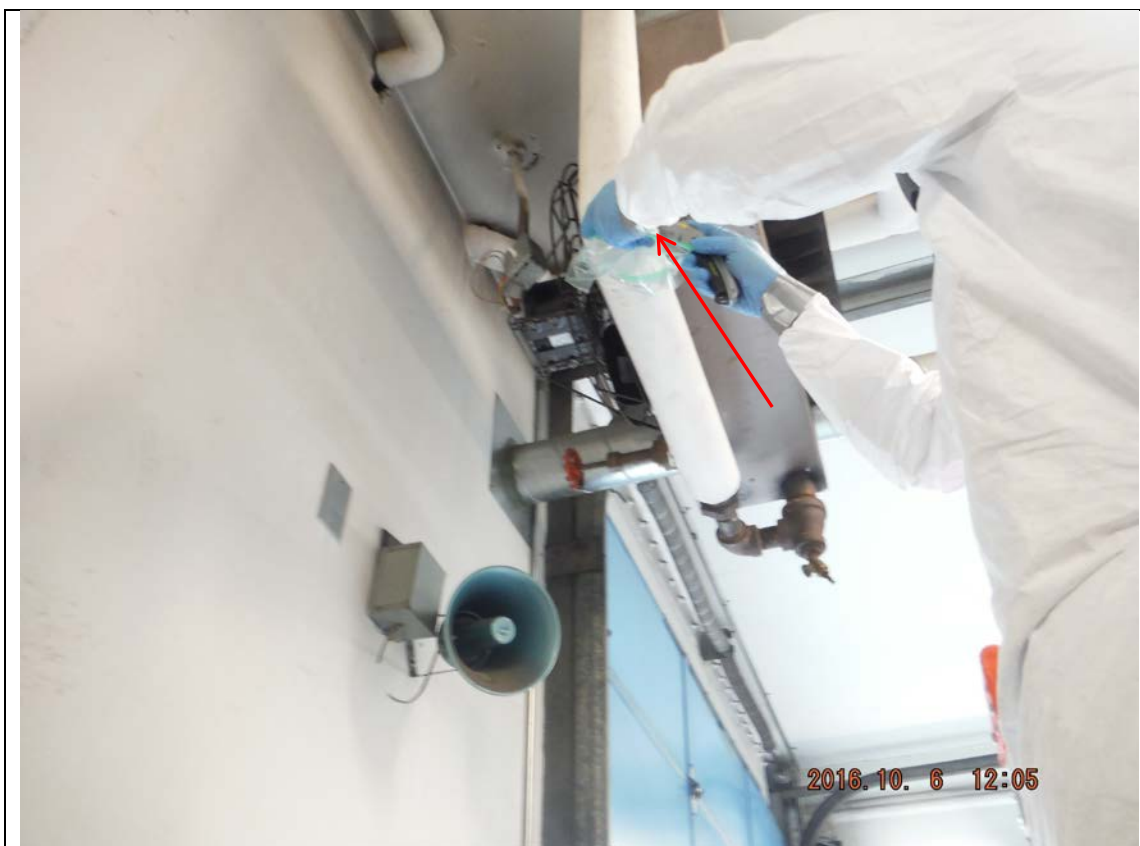
Photo 3 | **Date:** Oct 6, 2016 | **Location:** East truck bay

Description: Sample 15 – Radiator pipe elbow

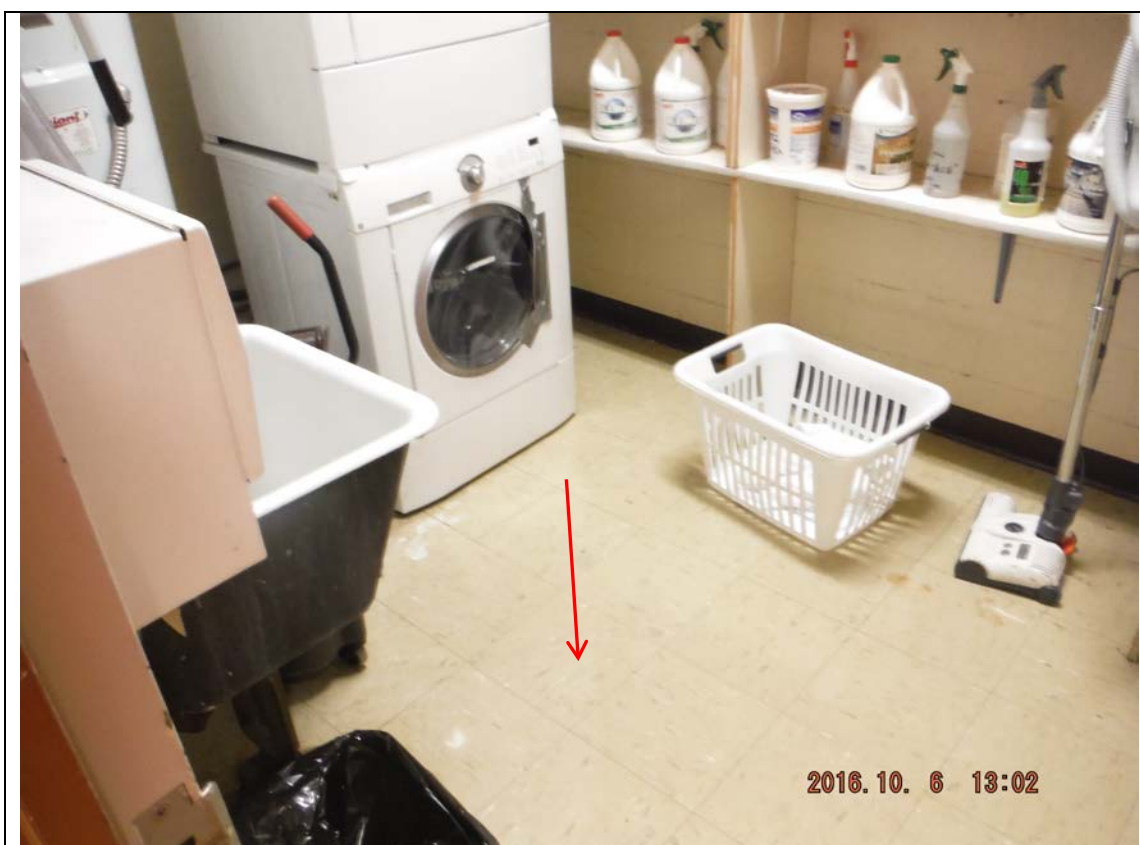
Photo 4 | **Date:** Oct 6, 2016 | **Location:** Janitor's closet

Description: Sample 22 – 12"x12" vinyl floor tile
