**Risk Assessment of Two Black Cottonwoods  
at Georgia Avenue at the south east corner of 577 6<sup>th</sup> Street**

# Risk Assessment of Two Black Cottonwoods at Georgia Avenue at the south east corner of 577 6<sup>th</sup> Street.

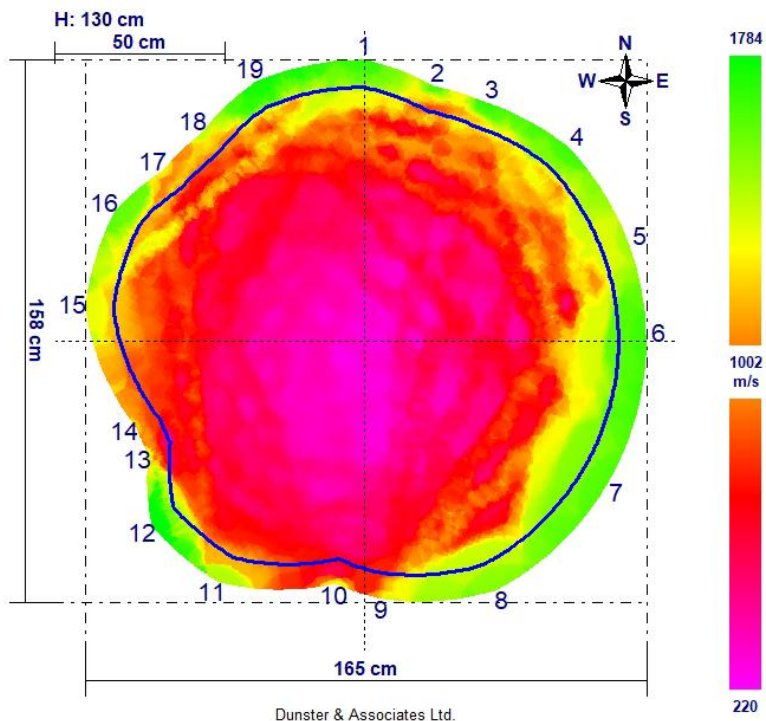
Figure 3. Tomogram of tree # 1.

Nineteen sensors were used to gain an image. Figure 3 shows the resulting tomogram. The low velocity data (purple) represents areas of decayed or missing wood (possibly hollow). The high velocity data (green) represents solid wood in good condition.

The tree trunk has very extensive decay across the entire trunk. In this test I have set the shell wall thickness line (the blue line on the tomogram) to 10%. Strength loss calculations in the Arbotom software suggest that there is an average 48% loss of strength in the trunk when the wind was blowing from the south west to the north east. The Resistograph7 tests confirm that there is only 11 centimetres of solid wood at sensor 16 and 20 centimetres at sensor 7.

- 3 Consider creating wildlife trees. This only applies to tree # 1. Because both trees are in a riparian area I expect that removal will require use of a crane to avoid dropping materials into the river. To convert tree# 1 into a good wildlife tree remove the crown and retain a trunk about 10 metres high. Jag up the top cut surface of the trunk. That would leave a large standing column of wood. To add an extra degree of safety I would attach steel cables to the trunk at a point several metres below the top. Those cables would be attached to the ground downstream on either side of the bank and would act to prevent a collapse of the trunk onto the bridge. The tree trunk would then become an excellent habitat for owls, woodpeckers and other bird life. Tree # 2 leans too far and is not suitable for a wildlife tree.

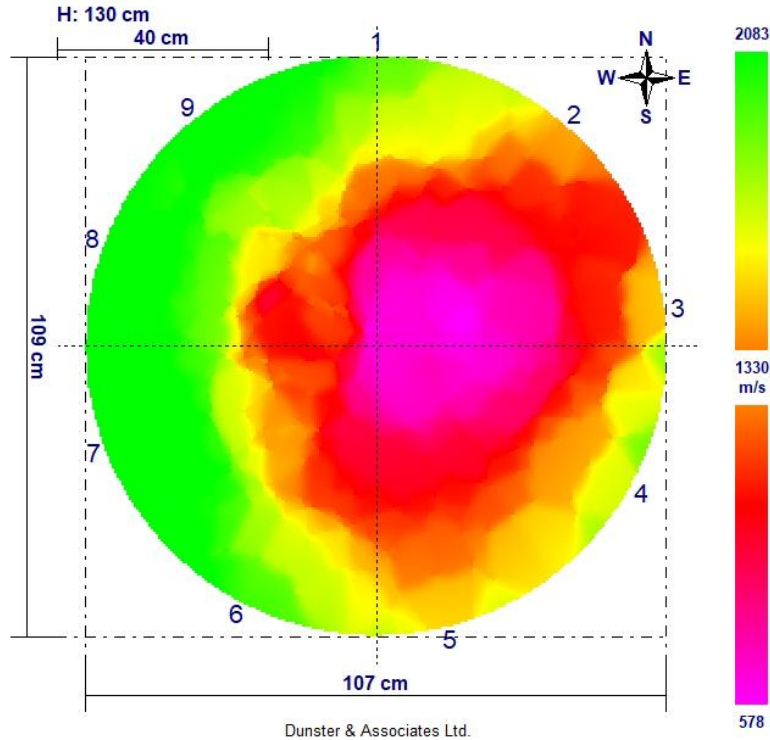
Figure 6. Tomogram of Tree # 2.

Nine sensors were used to gain an image. Figure 6 shows the resulting tomogram. The low velocity data (purple) represents areas of decayed or missing wood (possibly hollow). The high velocity data (green) represents solid wood in good condition.

There is an offcentre column of decay extending towards the east side. The tree leans southwest so the decay area is more on the tension side of the structure. Strength loss calculations in the Arbotom software suggest that there is a average 27% loss of strength in the trunk when the wind was blowing from the north east to the south west. The Resistograph7 tests confirm that there is only 7 centimetres of solid wood at sensor 3. On the tension side at sensor 7 there is about 45 centimetres of sound wood.

Both trees have columns of decay in their trunks. Both trees are rated as a high risk once construction starts and the bridge is completed. Tree # 2 should be removed in its entirety. Tree # 1 could be retained as a wildlife tree.
