2023 Formal Annual Dam Inspections – Recreational Dams

Final Report

H366322-0000-220-230-0005

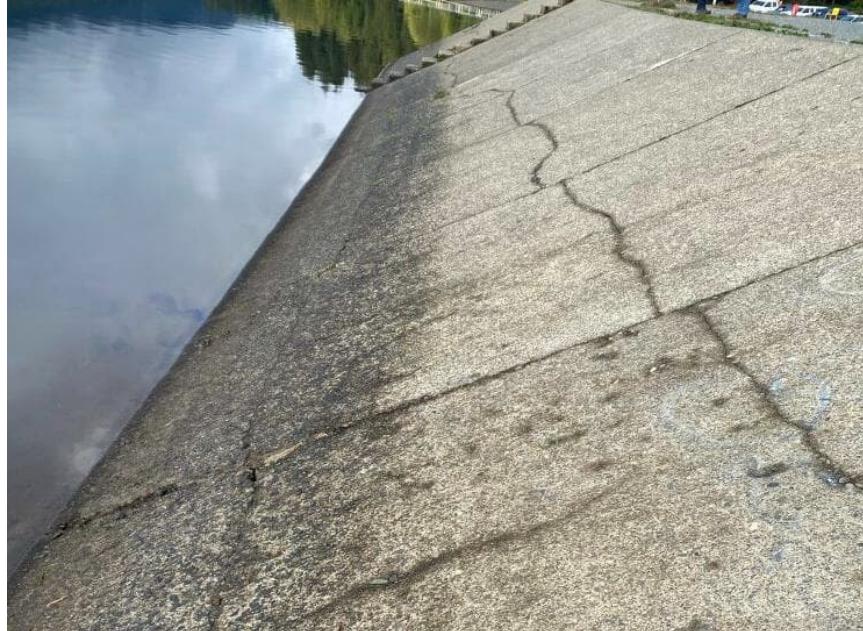
WWL 3: Upstream Concrete Face of Main Dam with Horizontal Cracking

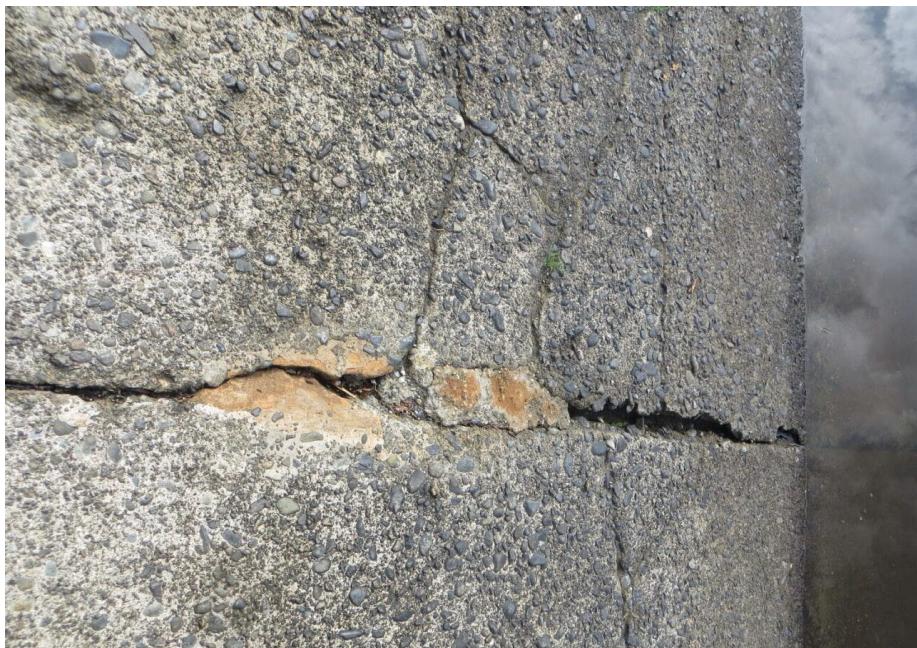
- The upstream face of the dam that is comprised of concrete panels was in fair condition. Some concrete cracking and spalling were observed near concrete panel joints and along the waterline (**Photograph WWL 4**). Some localized grouting repairs were performed, but these repairs have not remained intact in most cases. The concrete panels are not relied upon for impoundment; therefore, repairs are considered a maintenance item and should be undertaken if erosion of the slope occurs.

WWL 4: Upstream Concrete Face of Main Dam with Joint Deterioration and Cracking

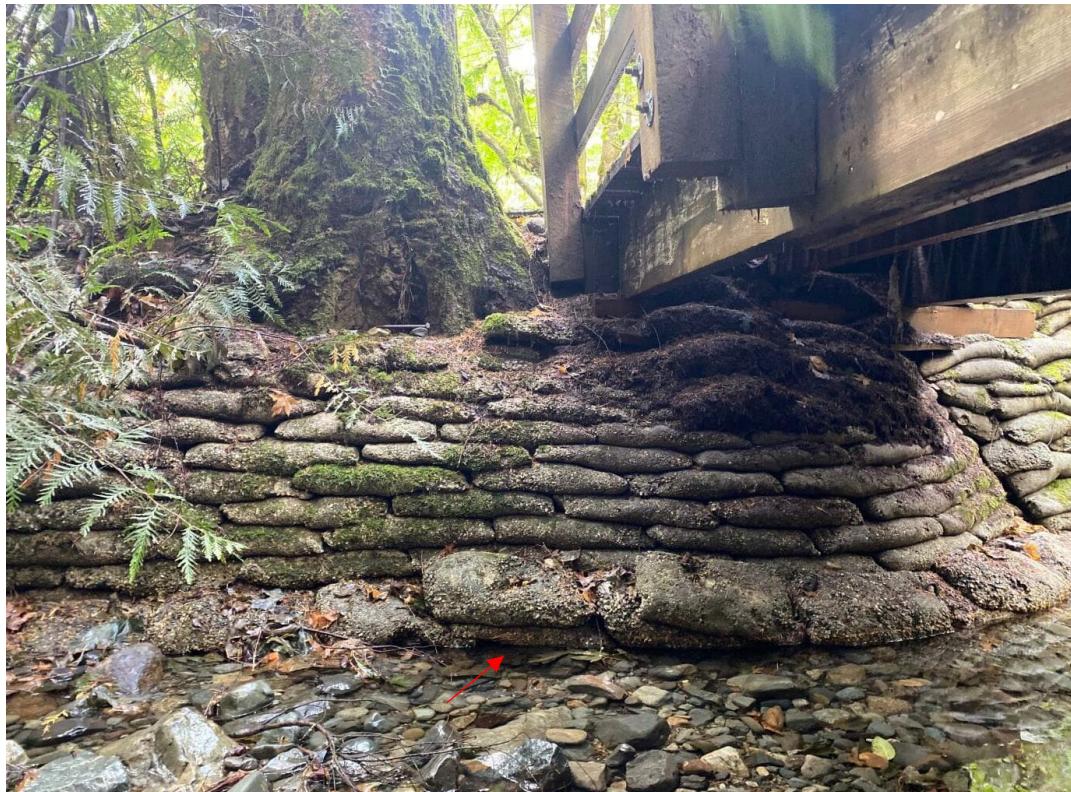
WWL 16: Erosion Damage on Downstream Right Abutment of Bridge (Inlet Channel)

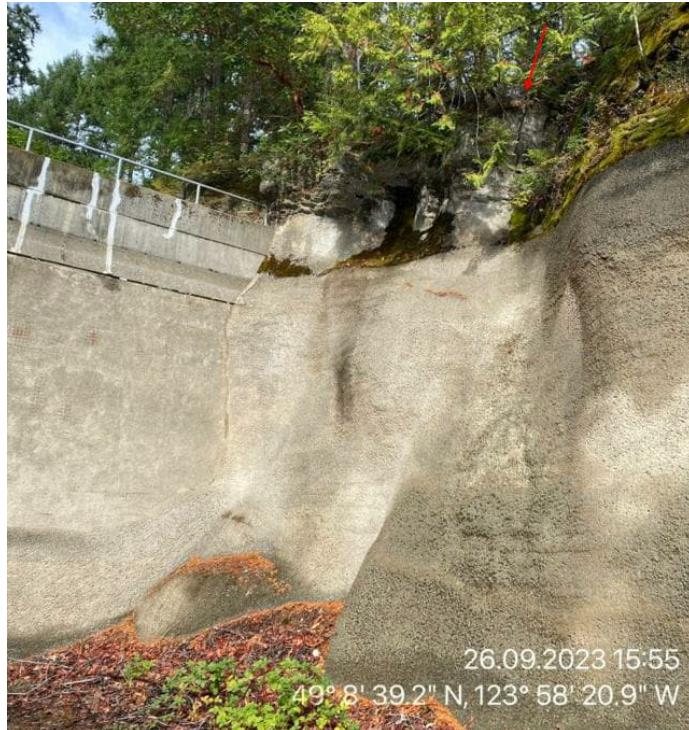
R01 8: Right Abutment Upstream of the Dam; Crack in the Bedrock above the Shotcrete Wall

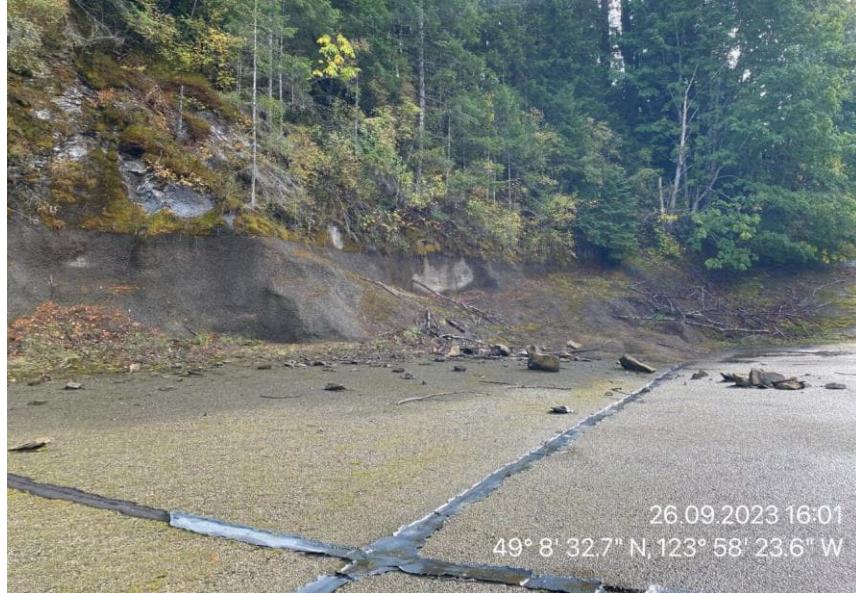
R01 12: Right South End of the Reservoir where Rockslide Debris was Observed

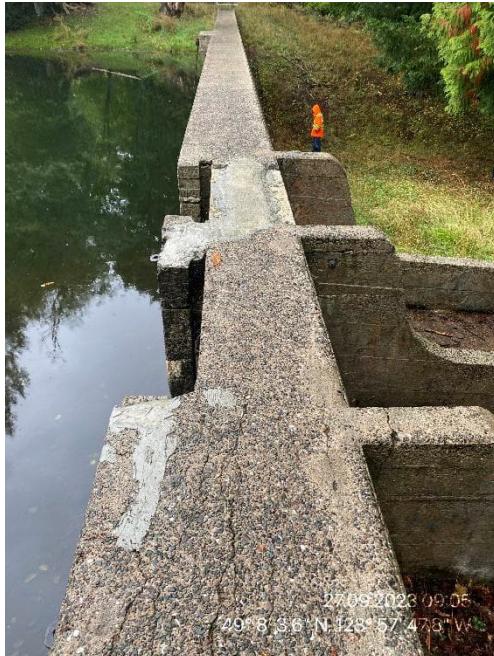
HAW 4: Concrete Deterioration of the Top of the Spillway Bridge

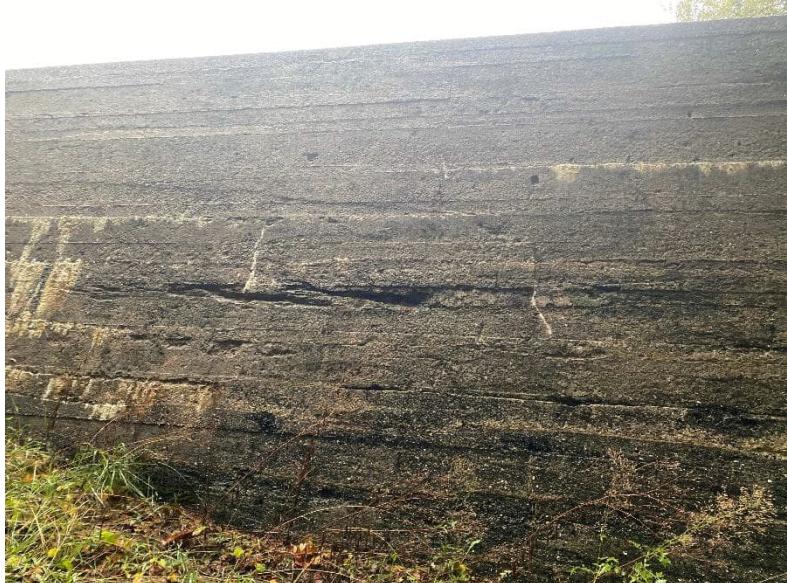
HAW 8: Concrete Deterioration at Downstream Face of the Dam

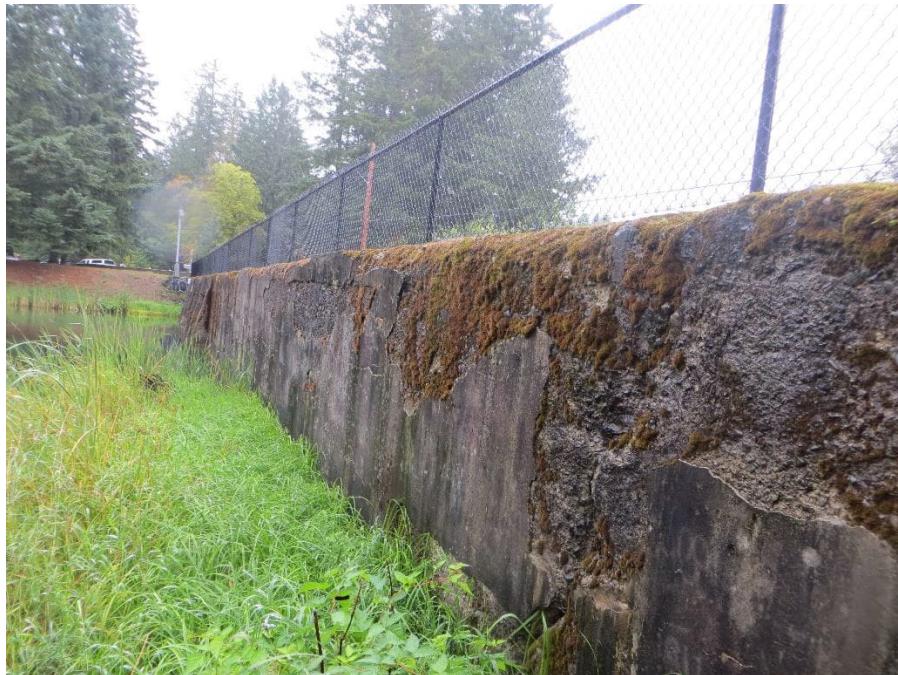
UCR 3: Concrete Deterioration at Right Side of Buttress Wall of the Dam

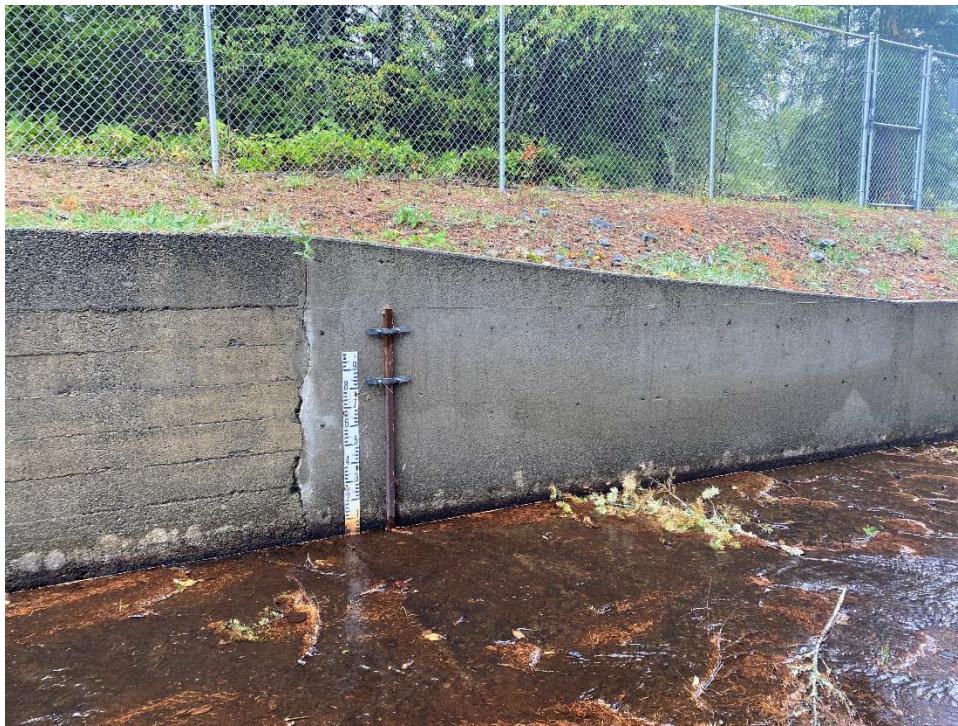
UCR 6: Left Spillway Chute Wall with Crack at Water Gauge

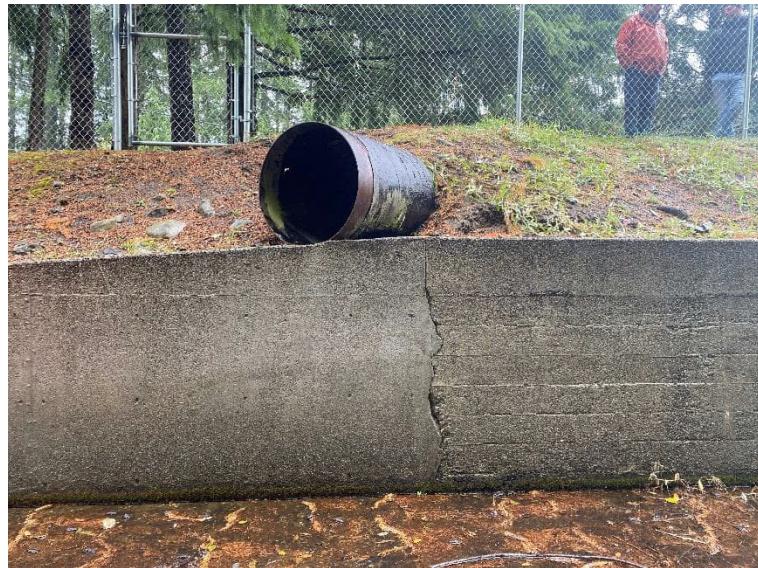
UCR 7: Right Spillway Chute Wall with Crack at Drainage Pipe

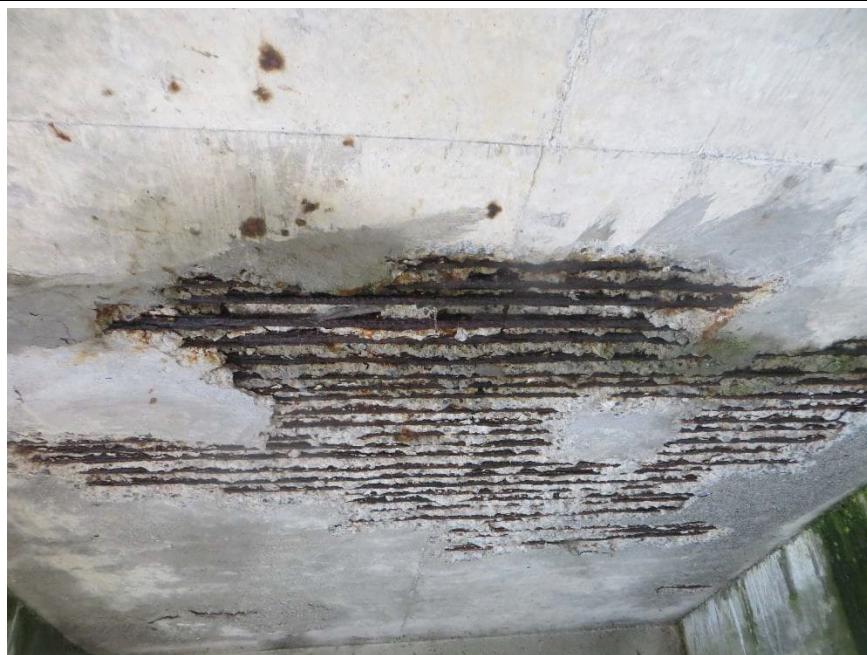
MCR 4: Concrete Deterioration with Exposed Reinforcing Bars Underside of the Spillway Bridge Deck (Left Bay)

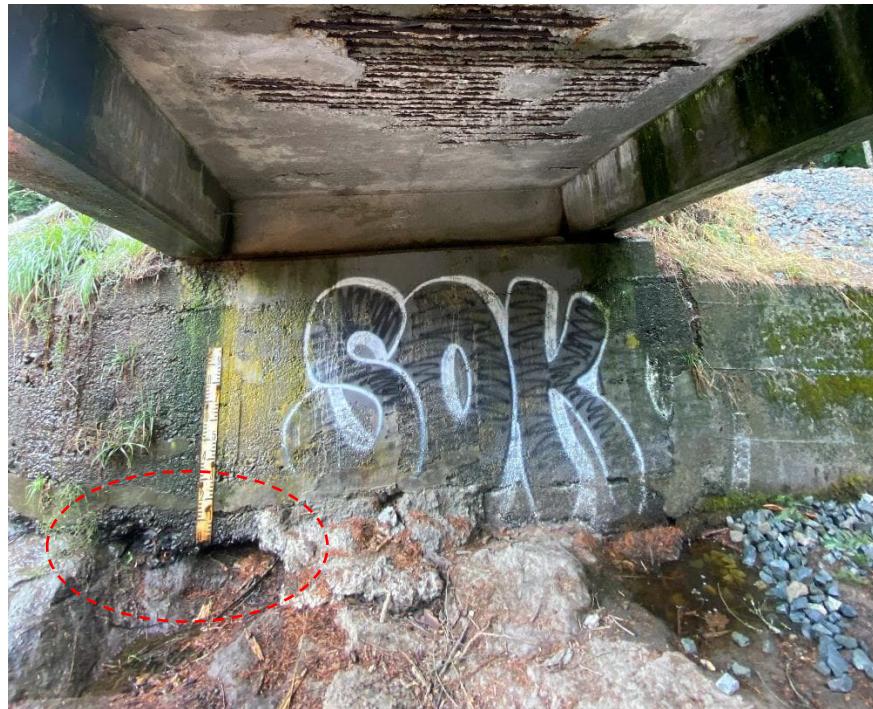
MCR 5: Concrete Erosion at Contact with Rock at Left Abutment of the Spillway Bridge Deck (Left Bay)

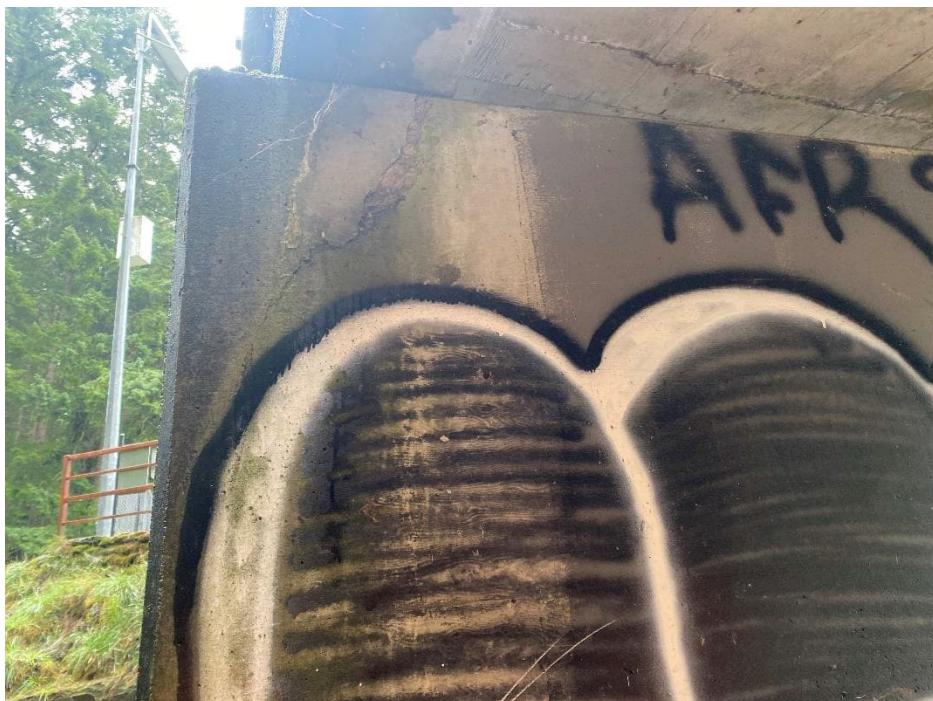
MCR 18: Concrete Crack at Top Corner of Centre Spillway Pier

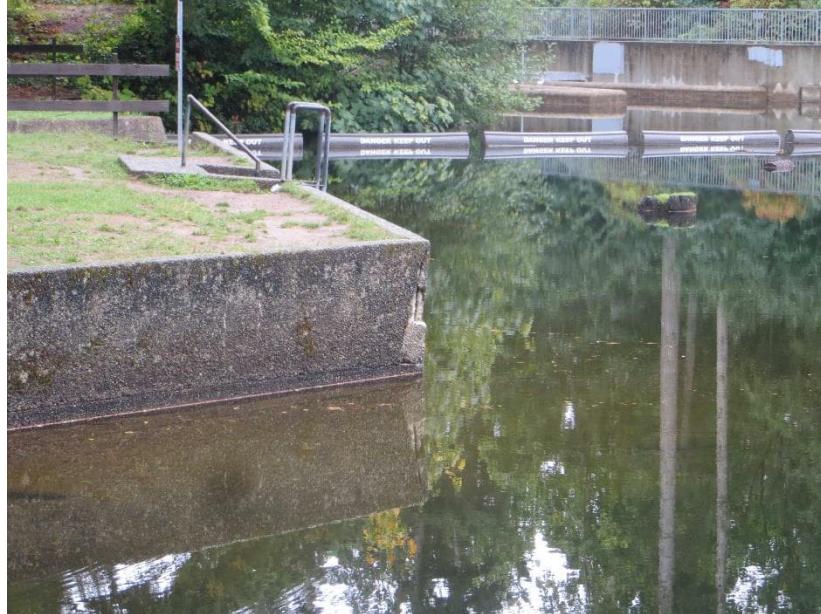
LCR 7: Upstream Retaining Wall for Reservoir Access with Spalling Visible

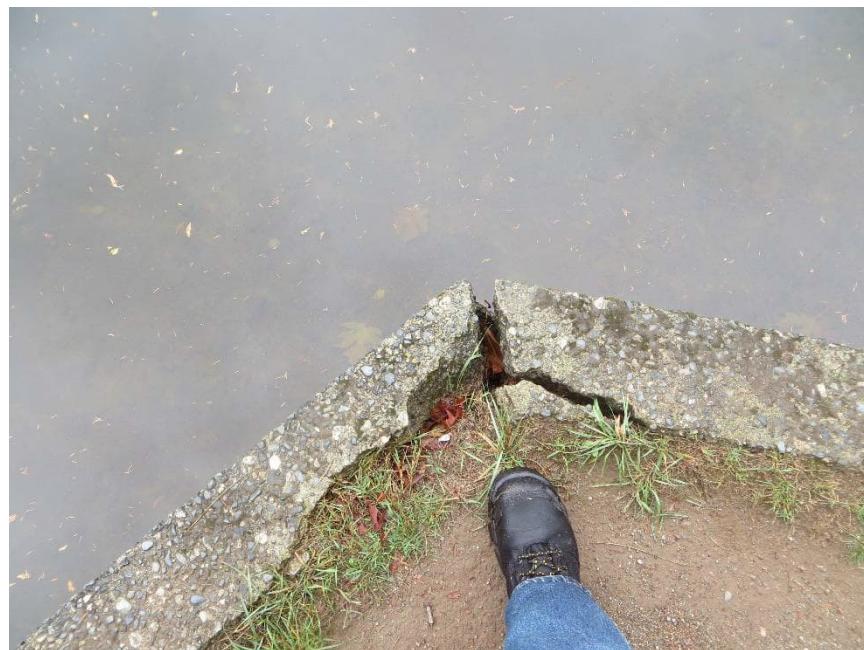
LCR 8: Cracks at Upstream Lower Wall Corner

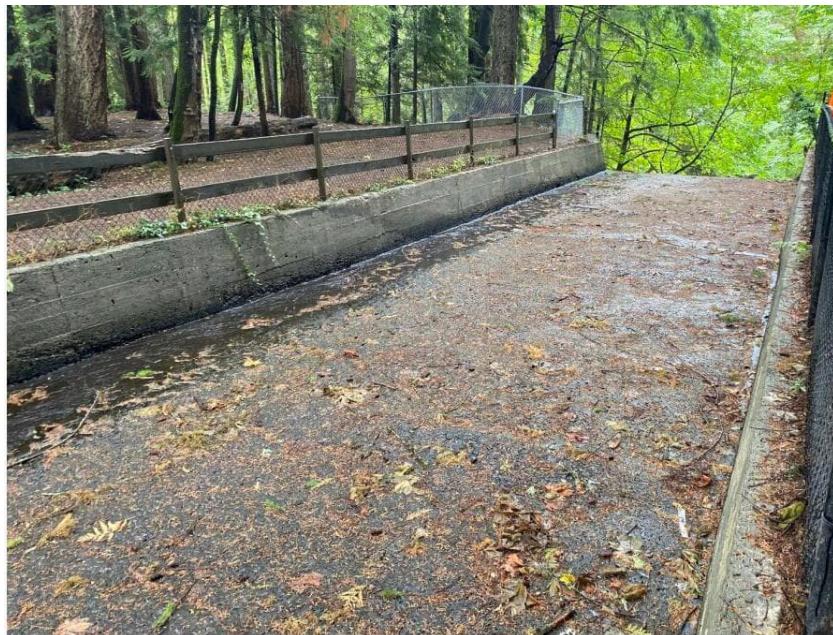
LCR 10: Repair at the Base of Spillway Chute Left Wall

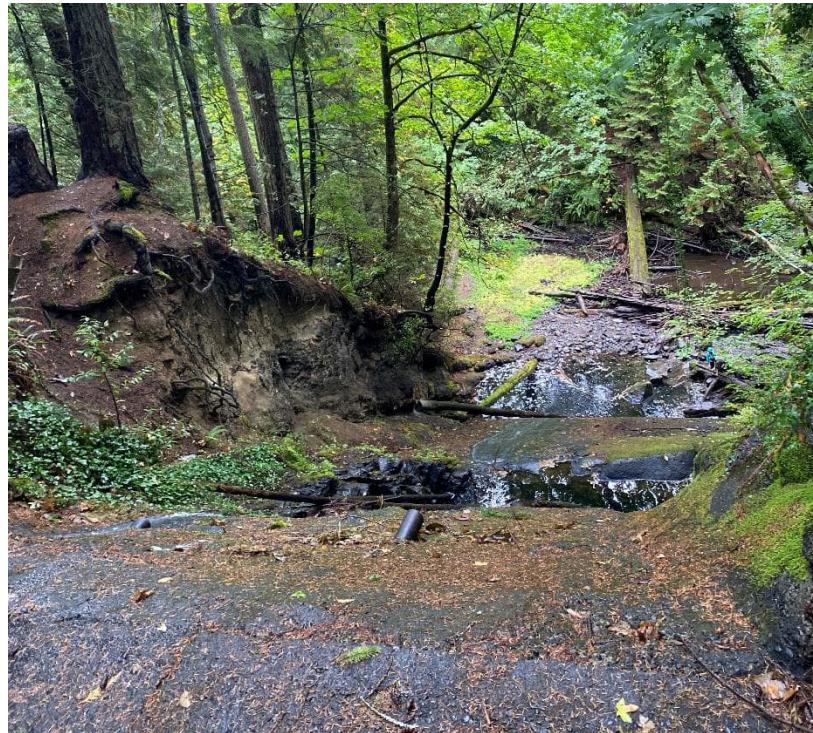
LCR 12: Scoured Rock Channel filled with Debris Downstream of Main Spillway Chute Slab

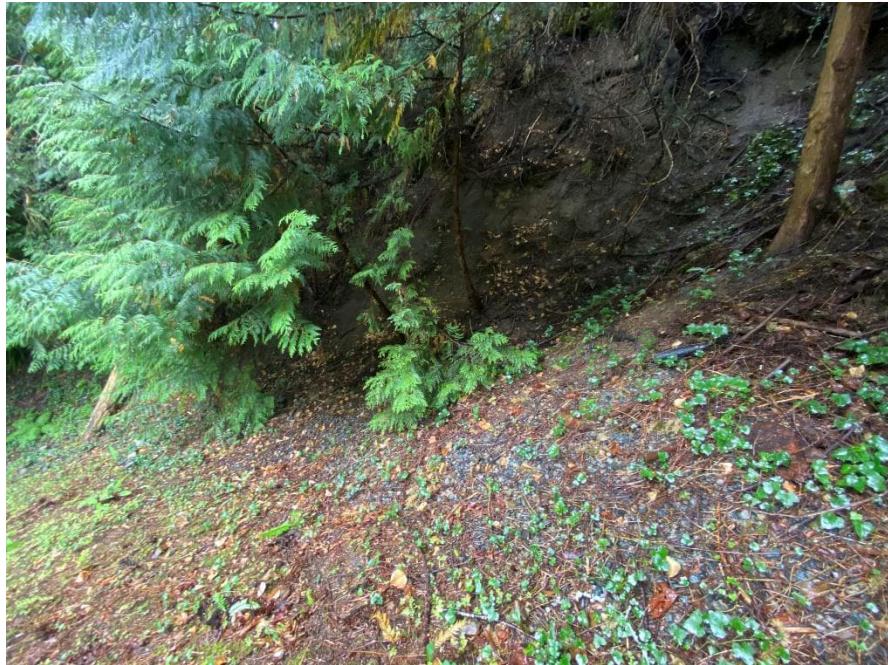
LCR 17: Large Trees at Right Abutment (Downstream)

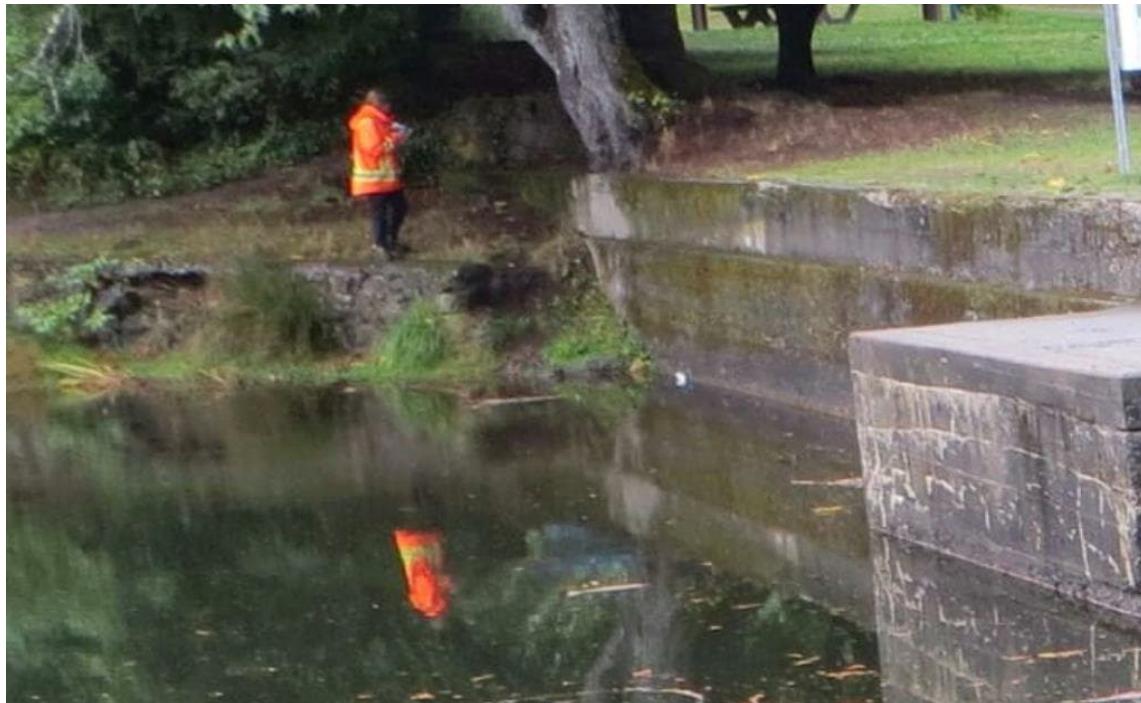
LCR 23: Erosion at Upstream Rock Retaining Rock

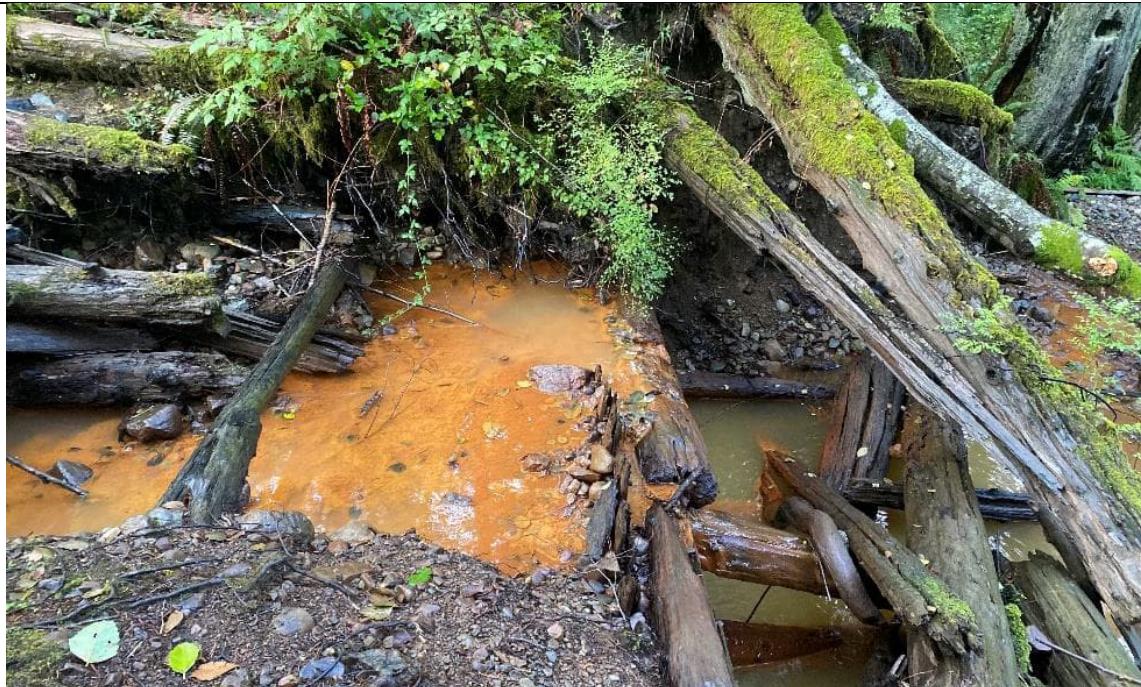
WCL 1: Left Abutment of Dam Showing High Degree of Deterioration

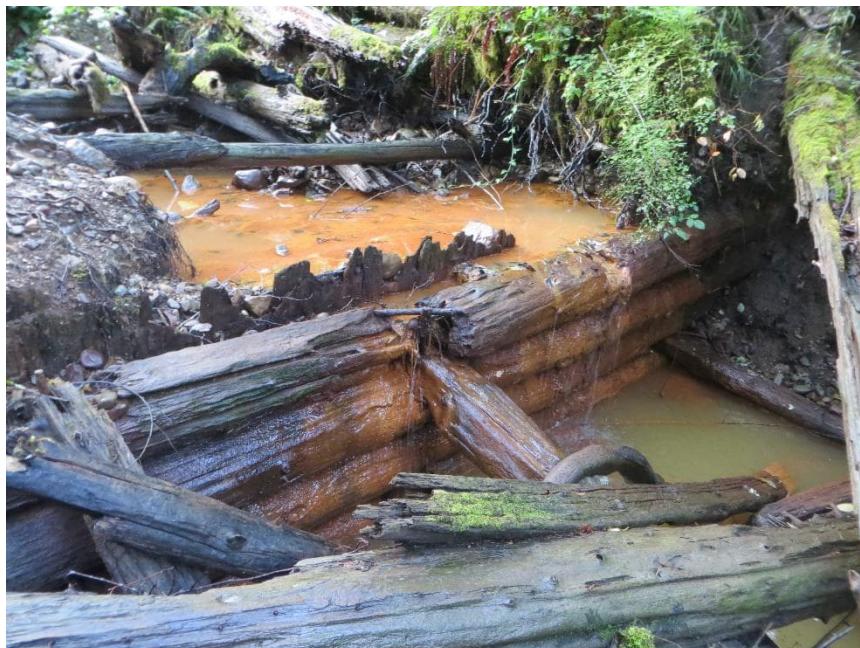
WCL 3: Dam Showing High Degree of Deterioration

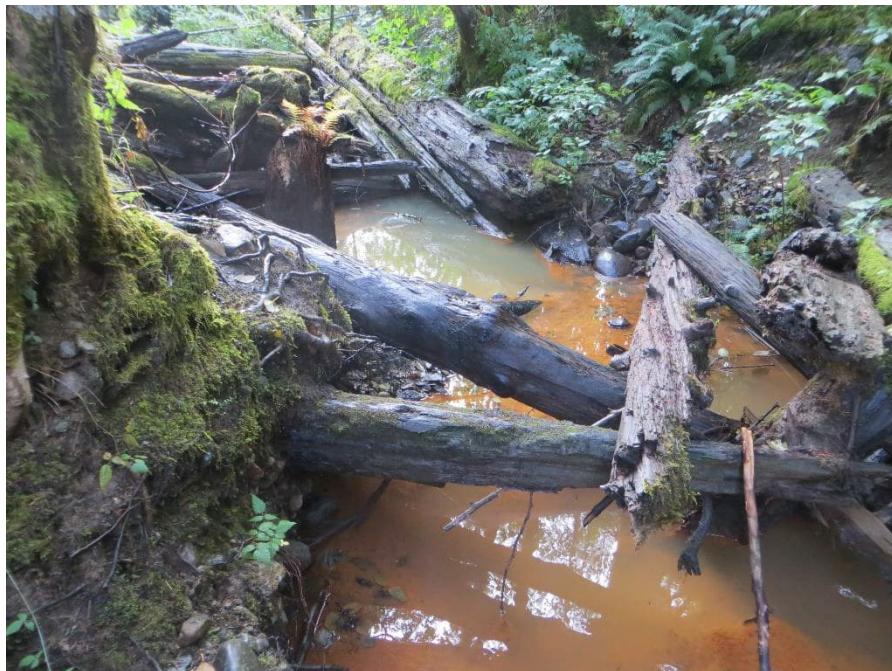
WCL 5: Inlet Channel Upstream of the Dam Showing Significant Erosion
