2023 Formal Annual Dam Inspections – Water Supply Dams

Final Report

H366322-0000-220-230-0004

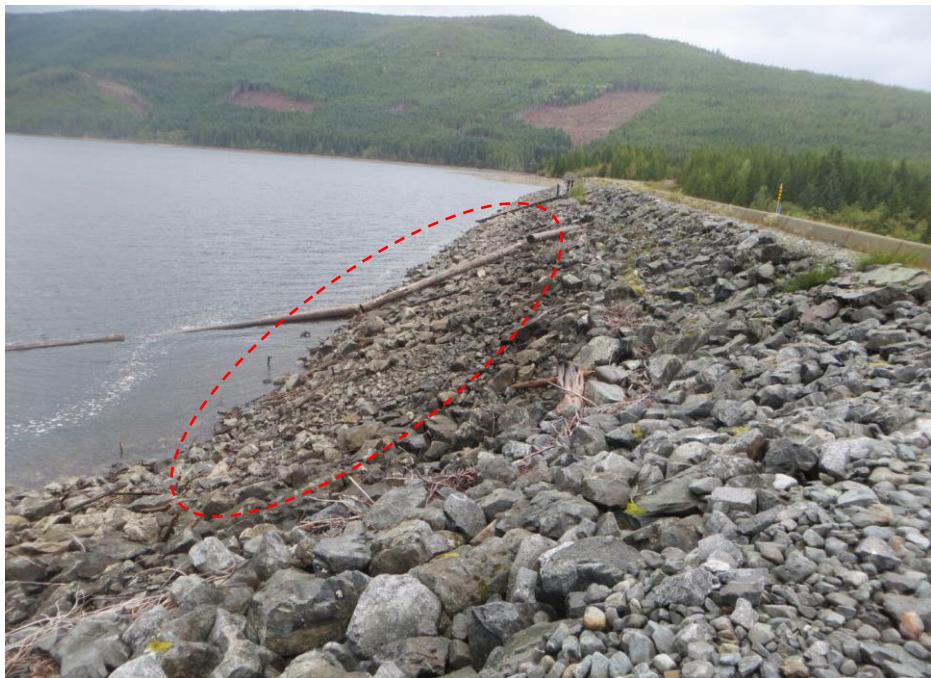
(Photograph JCR 35). Some areas at the bottom of the exposed riprap were found to be mainly comprised of smaller rock particles **(Photograph JCR 1).** The riprap thickness varies from approximately 0.3 m thick. Riprap diameter ranges between 0.1 m to 1.5 m with a mean size of approximately 0.5 m. Zones of low coverage and lack of interlocking were specifically observed left of piezometer SP12. Zones of low coverage and smaller rock size should be monitored, and consideration given to rehabilitate the riprap protection in those areas.

JCR 1: Upstream Face of the Dam, with Smaller Size Rock Particles along the Reservoir

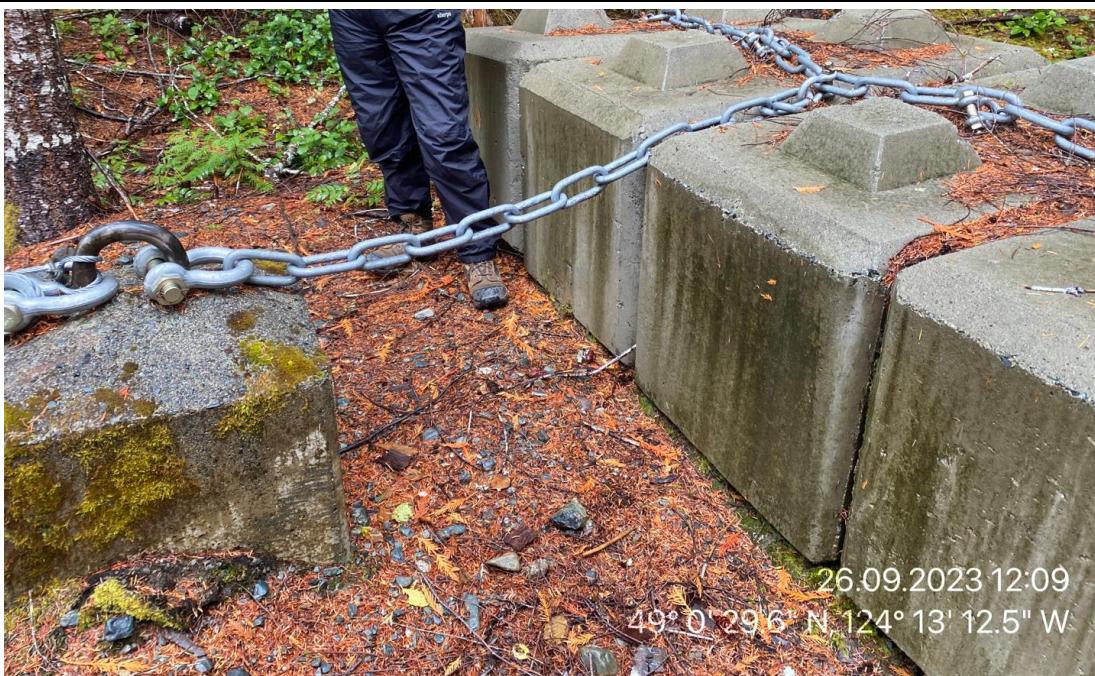
of anchors were observed to be connected together with chains but the connection was not currently taut (**Photograph JCR 2**), which will result in loading (and ultimately the movement) of the old smaller concrete block prior to the new larger concrete lock blocks being engaged.

JCR 2: Log Boom at Right Anchors

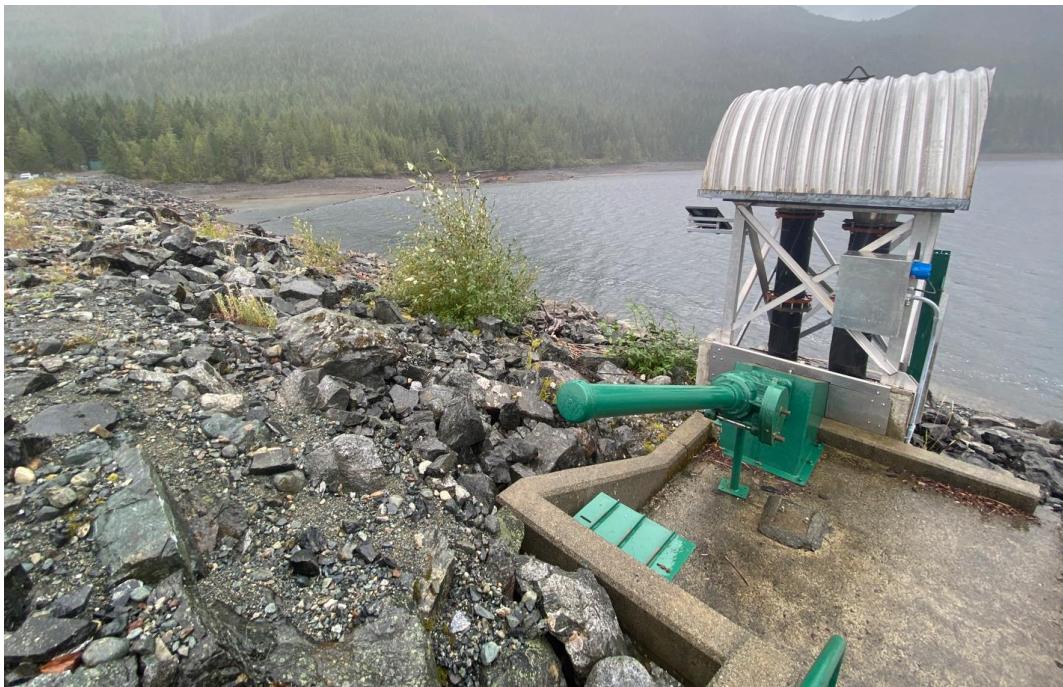
JCR 6: LLO Intake Gate at Upstream Face

- Minor vegetation growth was noted in the freeboard zone **(Photographs JCR 6, JCR 34 and JCR 35).** It is recommended that vegetation be cleared (including roots) and voids backfilled to mitigate potential riprap dislodgement due to vegetation growth and improve visibility of the upstream face for inspections.
- Wood debris deposition was noted on the upstream face which is removed and burned by City staff as part of the annual maintenance program. This annual maintenance was performed in the fall following the site visit when the fire danger rating is low.

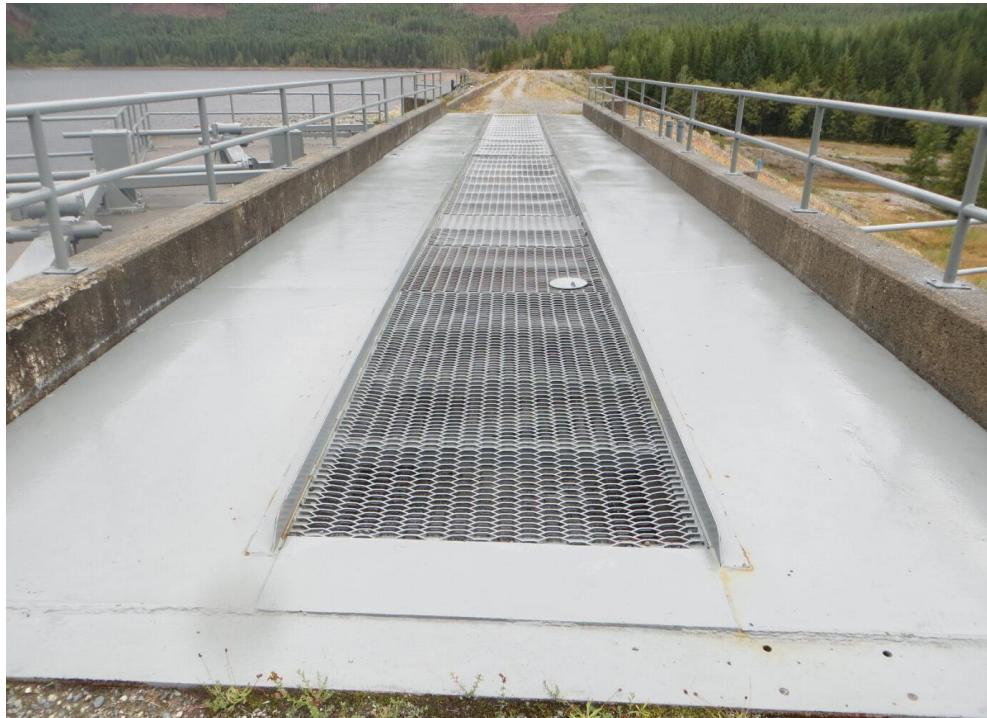
- The steel grating panels in spillway deck were observed to be in fair condition and steel angles were installed along both sides of the grating to prevent vehicles from driving over the grating since these grating panels were likely not designed for vehicle loading (**Photograph JCR 7**). All steel members and grating panels on the spillway deck were repainted recently.

JCR 7: Steel Grating and Angles on Spillway Deck to Prevent Wheel Loading on Grating

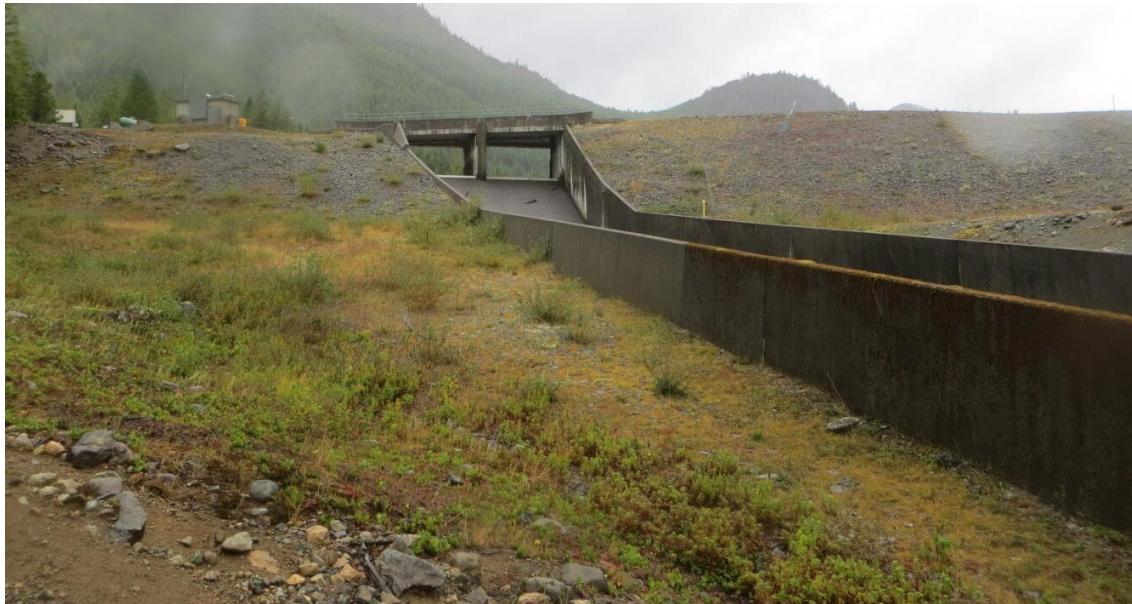
JCR 10: Vegetation near to Right Wall of Spillway Chute

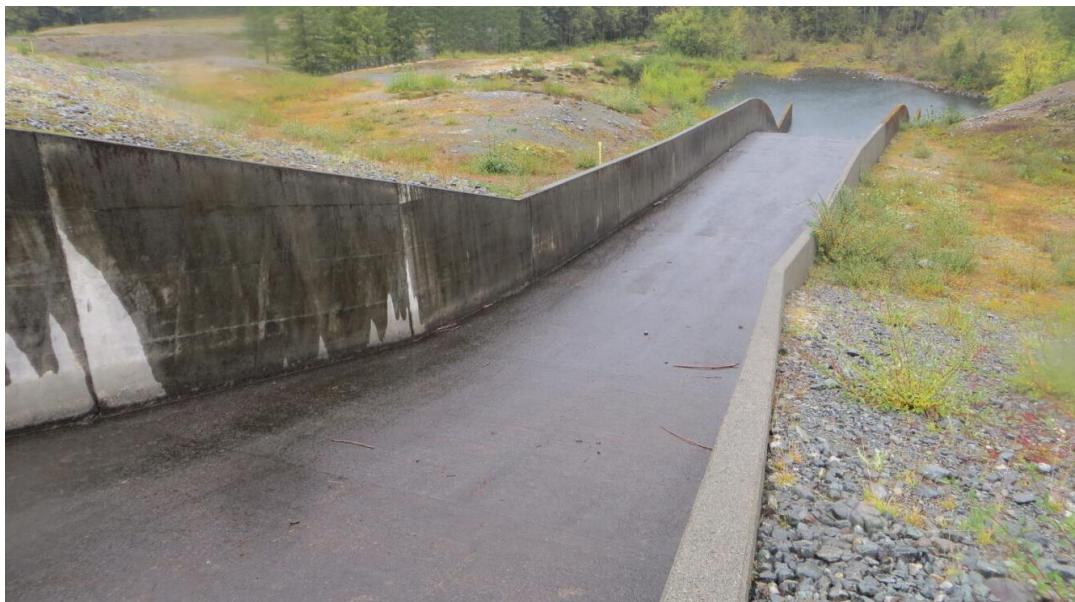
- The main spillway structure was generally observed to be in fair condition and no major changes in condition were observed since the 2022 FADI. Small pieces of debris were observed inside the spillway chute at the time of the inspection (**Photographs JCR 12 to JCR 15**).

- Areas of spalling were observed at the construction joints along the spillway slab (**Photograph JCR 12**). Spalls up to 100 mm wide were observed. Calcite staining was noted at many of the construction joints along both the spillway slab and walls, which could be an indication of past seepage through the joints. Sign of seepage could not be observed due to rainfall during the inspection but some seepage was observed along the slab at the downstream construction joints in 2022 FADI. It is recommended that the areas around the construction joints continue to be monitored to detect any additional concrete deterioration or seepage over time.

JCR 12: Spillway Structure Chute (looking Downstream)

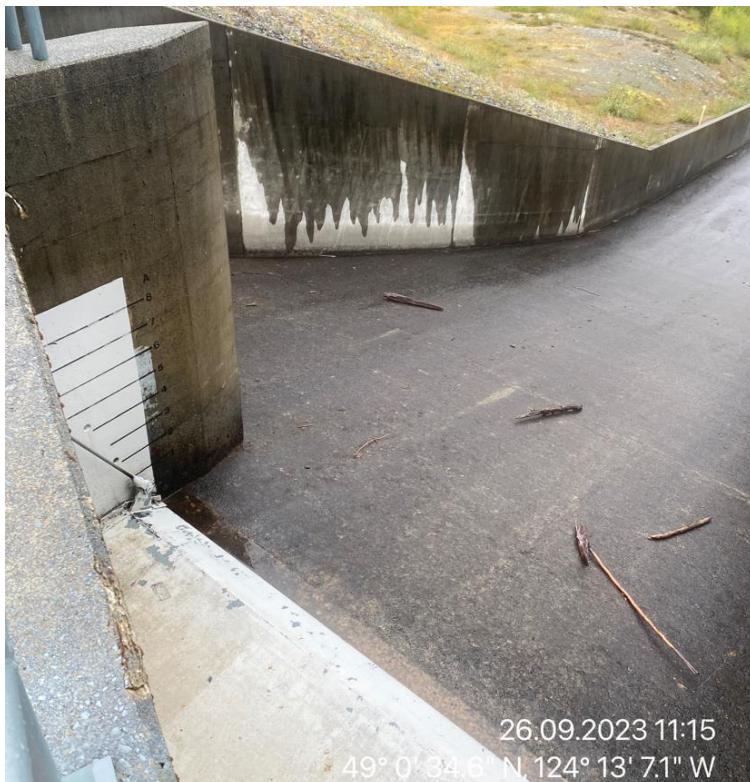
JCR 13: Small Debris Inside Spillway Structure Chute (Looking Downstream)

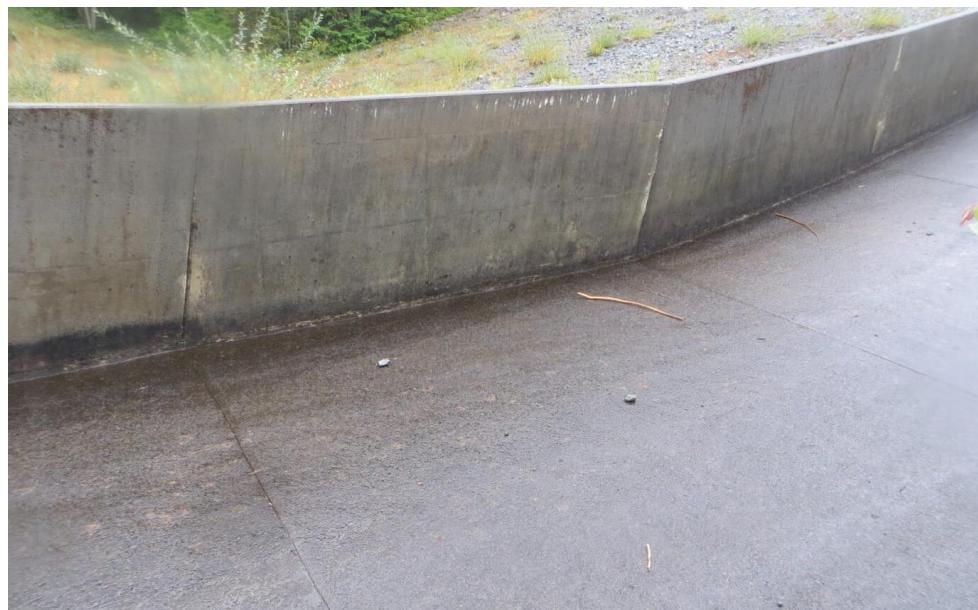
JCR 14: Construction Joints in Spillway Structure Chute

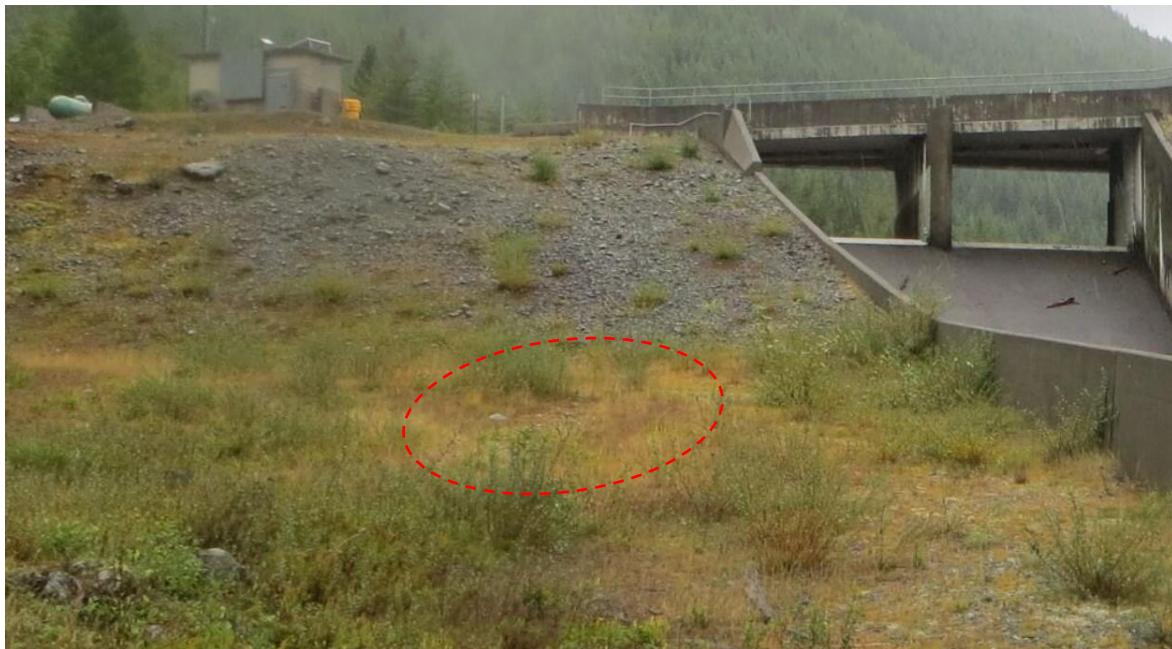
JCR 32: Sign of Seepage on Downstream Face Near the Right Abutment

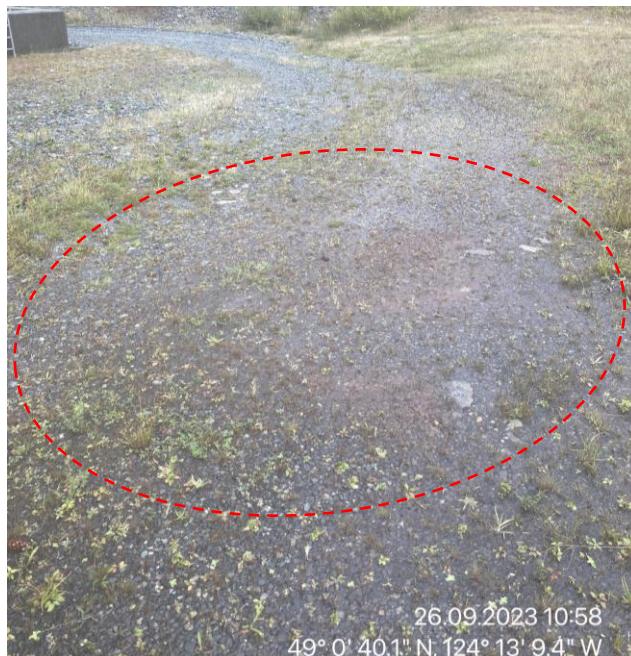
- As described in the 2020 FADI report, a wet spot approximately 1 m in diameter was observed on the lower access road just upstream of Weir E (see location marked on **Figure B2 in Appendix B**). During the 2023 inspection, this area was observed to be wet due to the rain and have a light rust discolouration, but no ponding was observed (**Photograph JCR 33**). Going forward, this area should be closely monitored at the same time as data is collected at Weir E. If active seepage is observed and if the seepage is cloudy, and/or if earth material starts to bulge in this location, dam safety personnel should be notified immediately.

JCR 33: Previously Observed Wet Spot on the Lower Access Road Upstream of Weir E

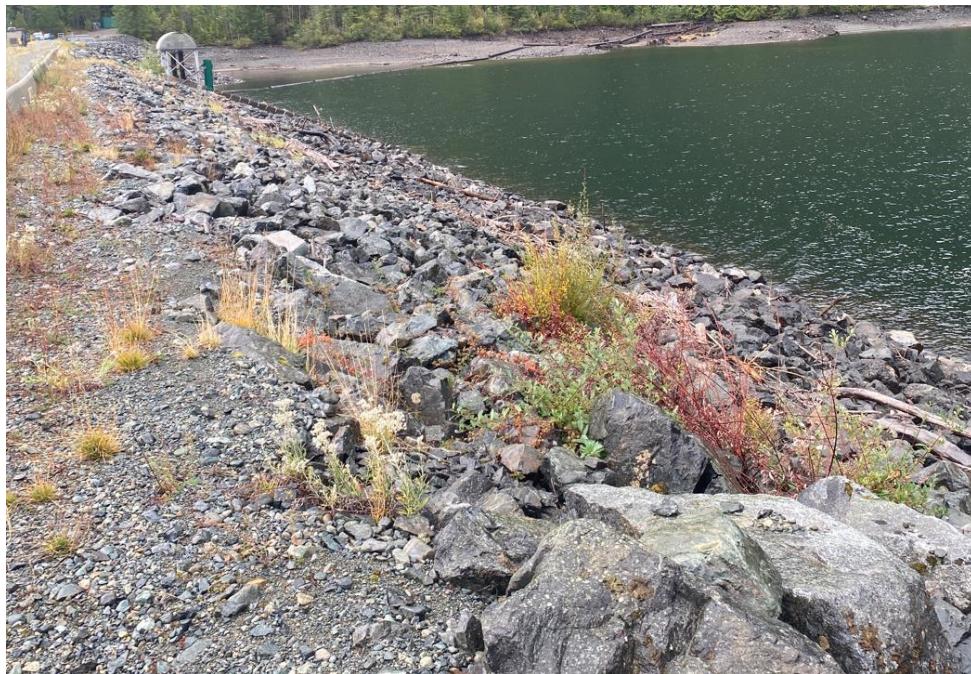
JCR 34: Good Condition Riprap with Average Interlock Observed on Upstream Face of Dam (Looking towards the Right Abutment)

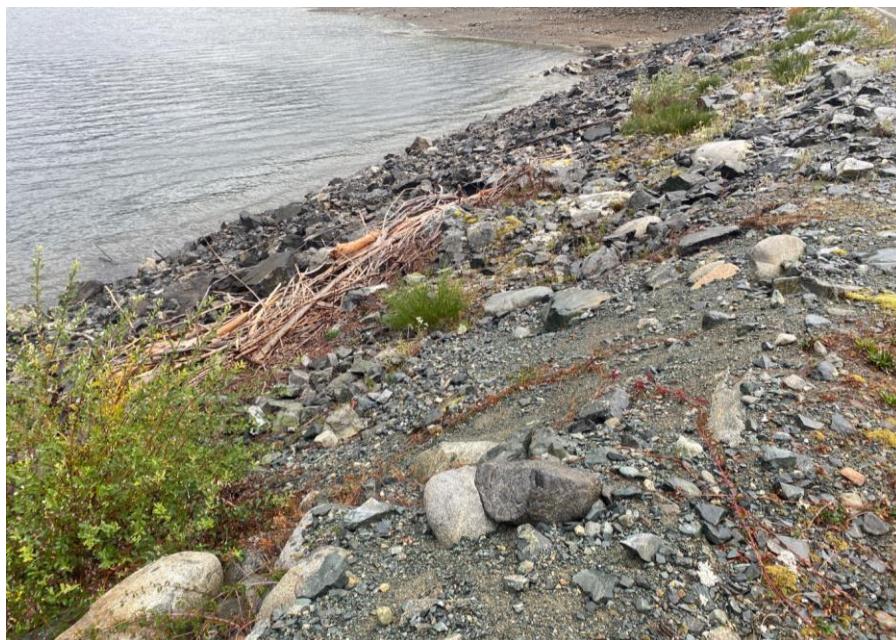
- There was no sign of cracking or slope instability along the upstream slope of the dam during the inspection.
- The upstream slopes showed no sign of erosion or beaching. No settlements or depressions of concern were noted (**Photograph JCR 1**).
- Riprap on the upstream face was only inspected above the waterline which corresponded to a larger area than in previous inspections due to the lower reservoir level. Riprap coverage appeared continuous apart from select zones of low coverage, smaller size rock particles (compared to the mean size), and lack of strong particle interlocking

JCR 35: Poor Quality Riprap Left of Piezometer SP12

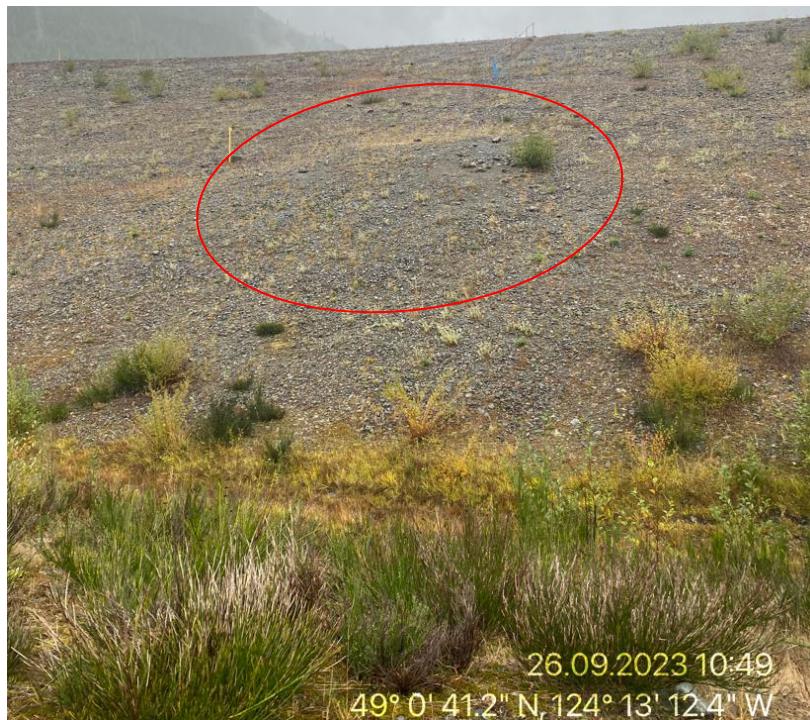
JCR 37: Bulge on Downstream Face (Looking from Downstream Toe)

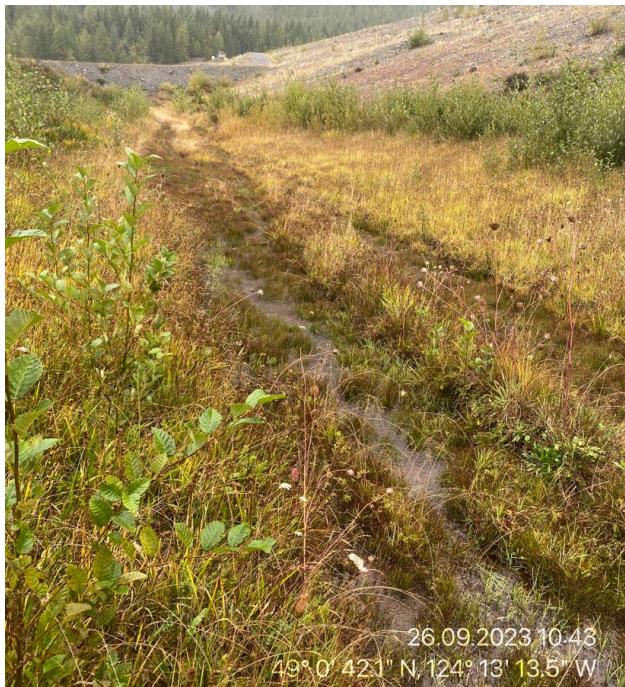
JCR 38: Downstream Toe with Ruts and Seepage

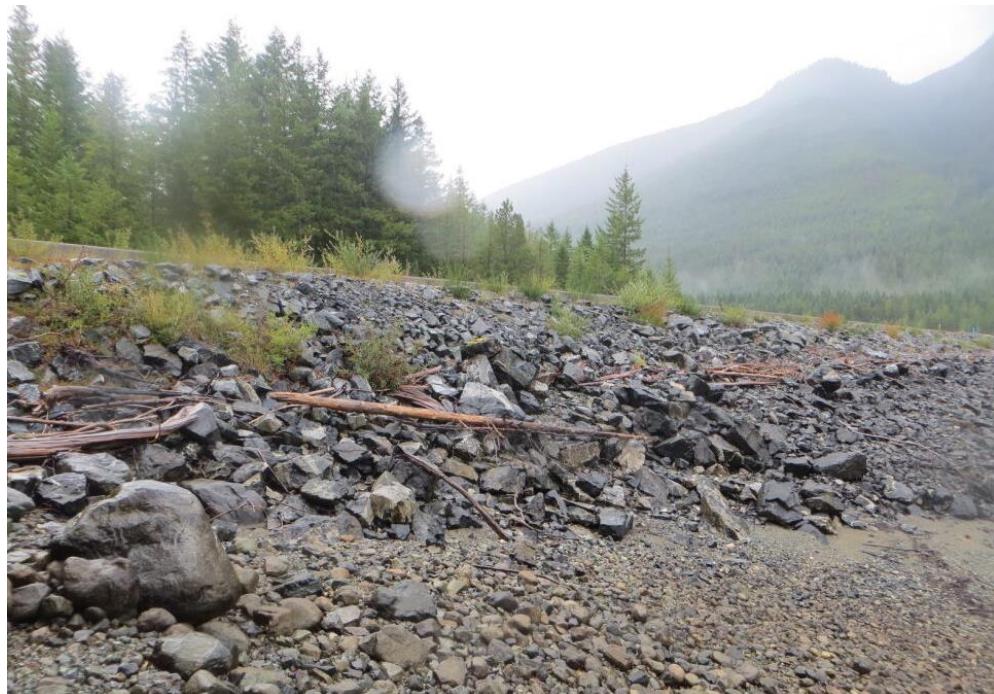
JCR 39: Over-steepened Section in the Upstream Riprap at the left Abutment

- The upstream face of the left abutment steepens to approximately 1H:1V over a 15 m length. It is recommended that the City monitor this over-steepened section, conduct a survey of the area, and compare to past year's survey to determine if movement is advancing. As described in the 2022 FADI, high water levels have eroded soil cover where the riprap meets the abutment at shoreline. This has created erosional scour approximately 0.3 m to 0.5 m high **(Photograph JCR 39).** During the 2023 FADI, this scour was observed to have similar dimensions. This should be monitored, and consideration given to placement of rockfill and riprap to mitigate erosion if conditions worsen.

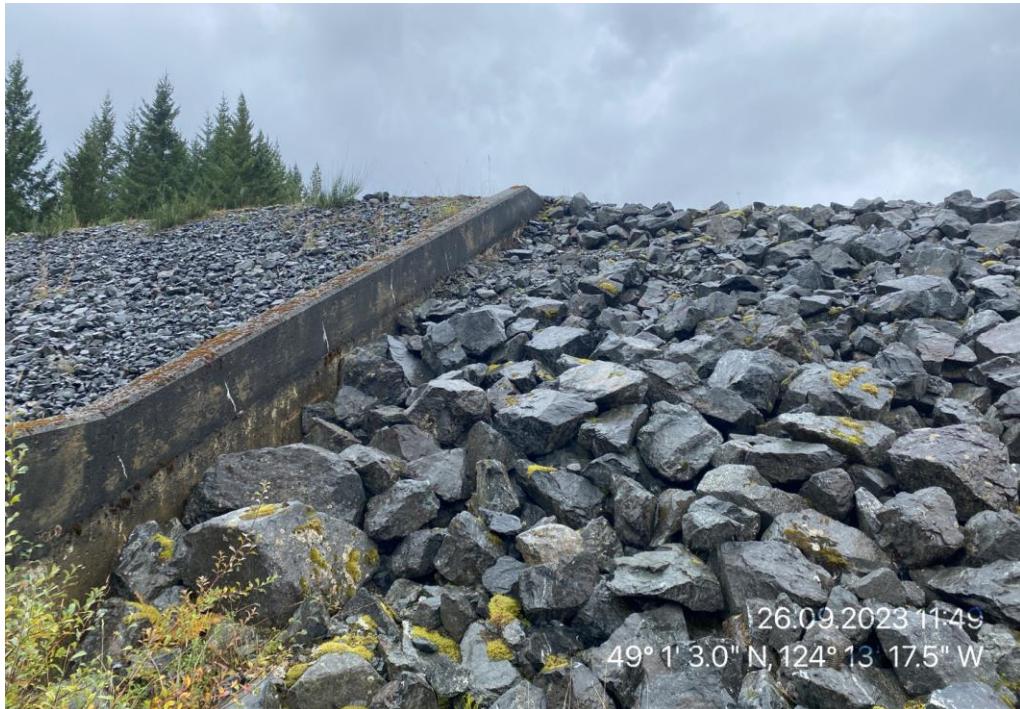
JCR 42: Auxiliary Spillway and Downstream Face of Dam, zone with sparse riprap

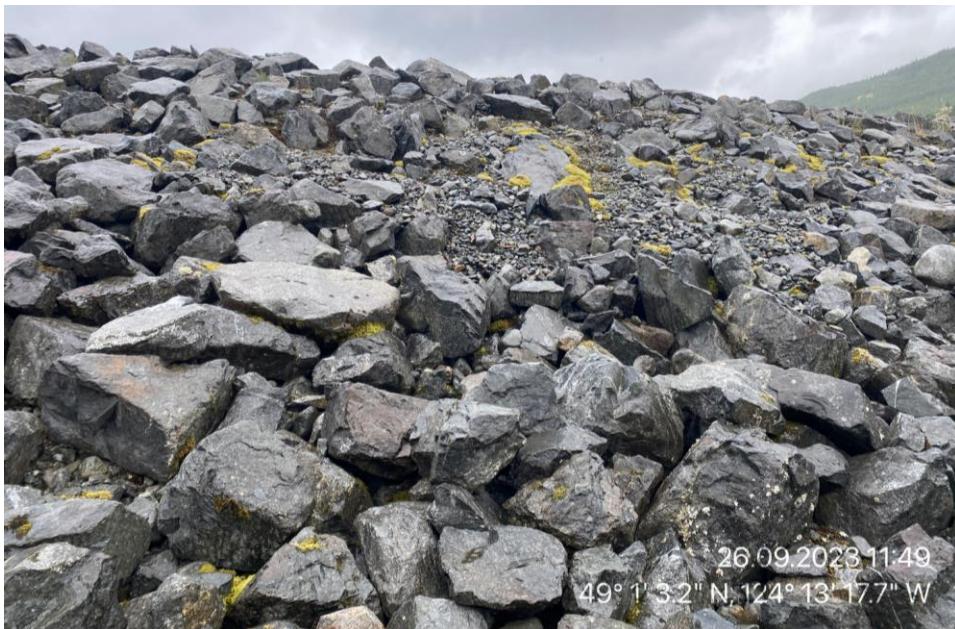
JCR 43: Auxiliary Spillway and Downstream Face of Dam, zone with sparse riprap

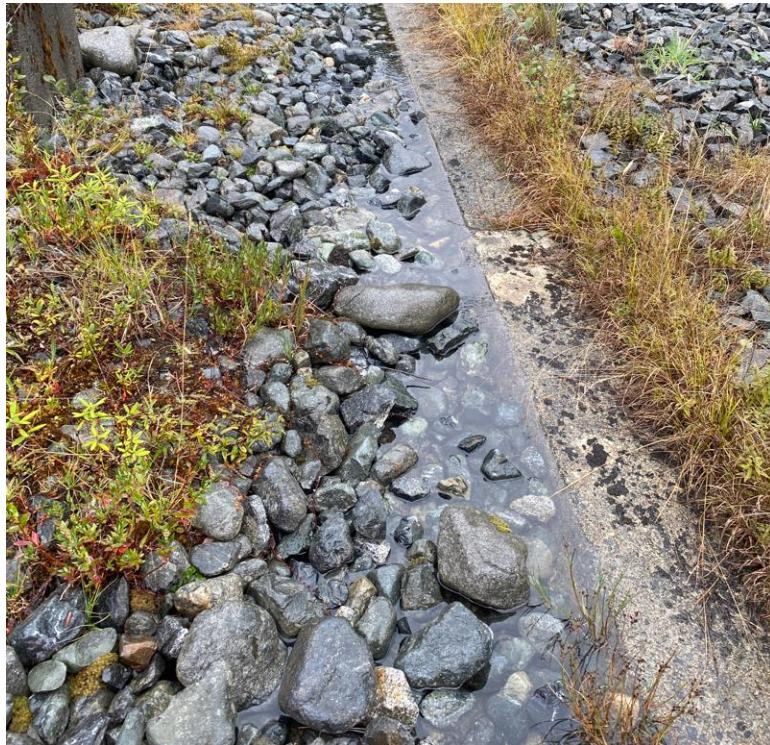
JCR 44: Seepage at Downstream Toe of Auxiliary Spillway

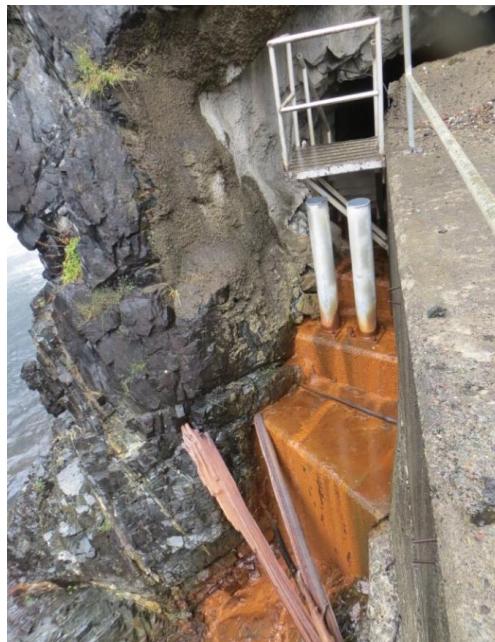
SFK 10: Tunnel Weir Seepage

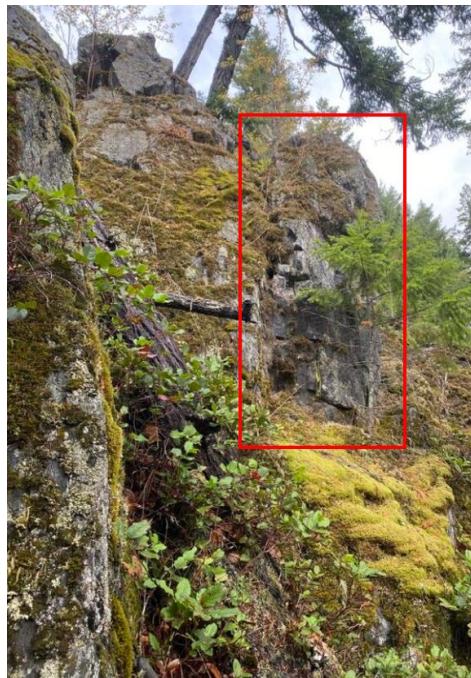
SFK 14: Potential Rock Block Instability Located Upstream of Left Abutment

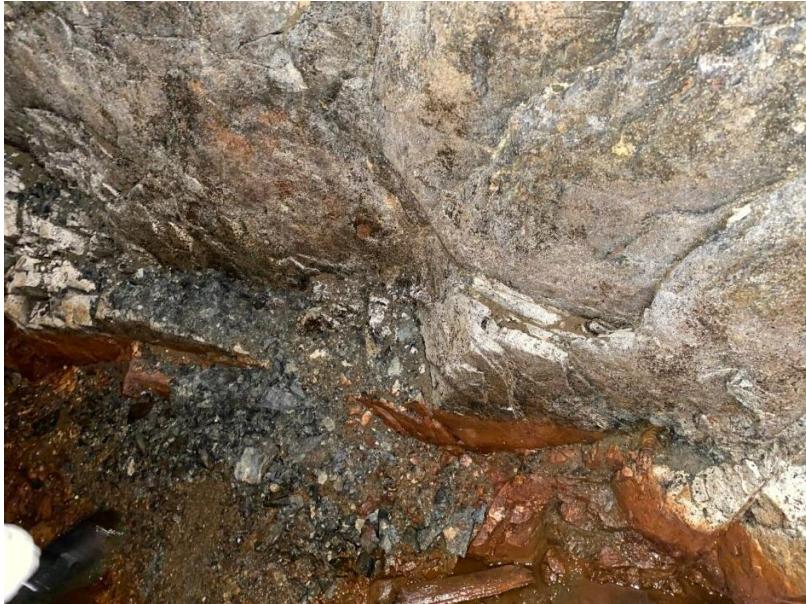
SFK 15: Loose Rocks Observed at the Toe of the Left Wall of the Supply Tunnel, where Local Shear Clay-filled Discontinuity is Found
