2025 Formal Annual Dam Inspections – Water Supply Dams

Final Report

H366322-0000-220-230-0007

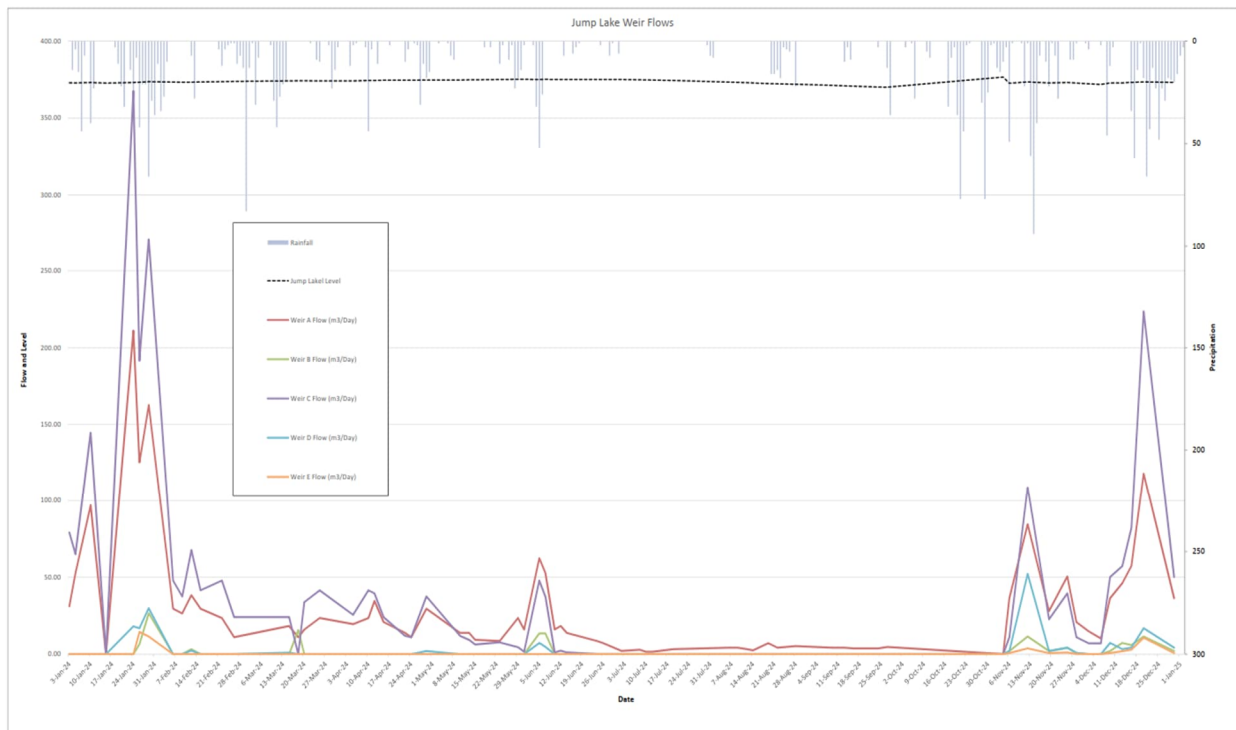
Figure 3-1: Jump Lake Weir Flows

As part of the routine inspections, the seepage elevation over the ‘V’ notch weirs are recorded by measuring the flow elevation above the base of the ‘V’ notch. This data is plotted on graphs to help identify trends. See shown in **Figure 3-1**, the weir flows are well correlated to the precipitation and there is no concern with any of the trends.

Due to the low flow at the weirs, the drawdown is expected to be minimal and the seepage measurements at the weirs are effective at identifying trends.

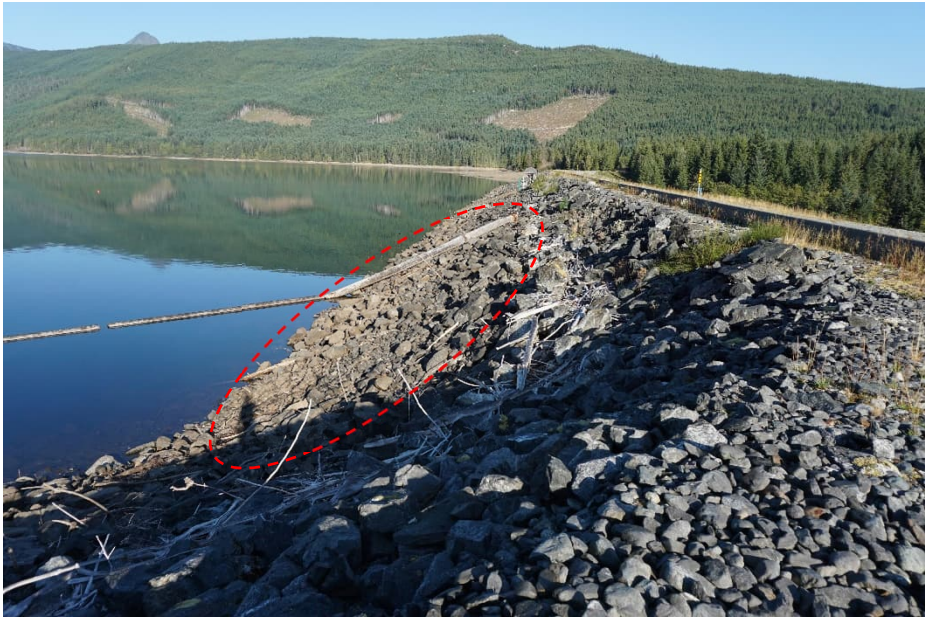
- There was no sign of cracking or slope instability along the upstream slope of the dam during the inspection.
- The upstream slopes showed no sign of erosion or beaching. No settlements or depressions of concern were noted (**Photograph JCR 1**).

JCR 1: Upstream Face of the Dam, with Smaller Size Rock Particles along the Reservoir

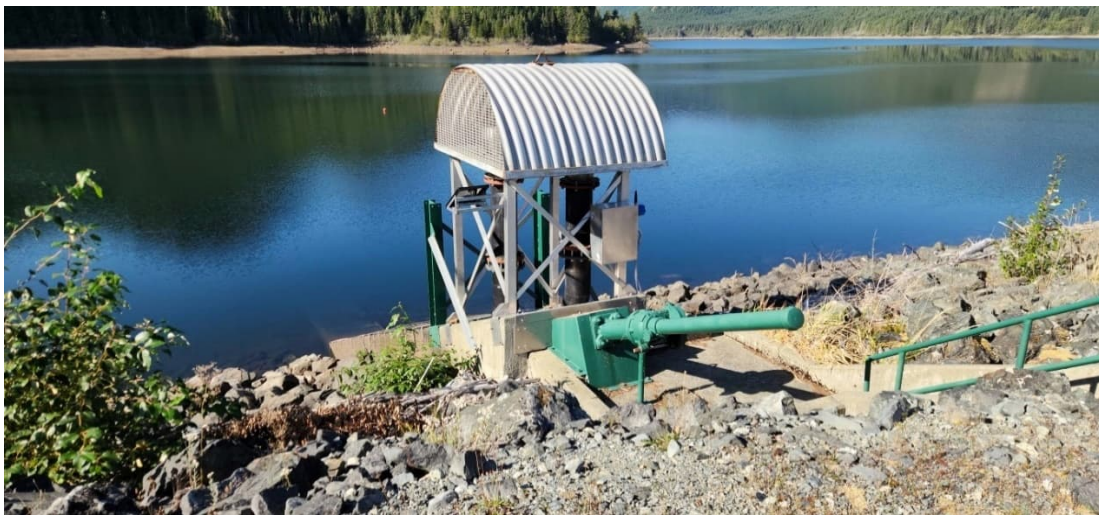
- Minor vegetation growth and accumulation of woody debris was noted in the freeboard zone (**Photographs JCR 6** and **JCR 30**). It is recommended that vegetation be cleared (including roots) and voids backfilled to mitigate potential riprap dislodgement due to vegetation growth and improve visibility of the upstream face for inspections.

JCR 6: LLO Intake Gate at Upstream Face

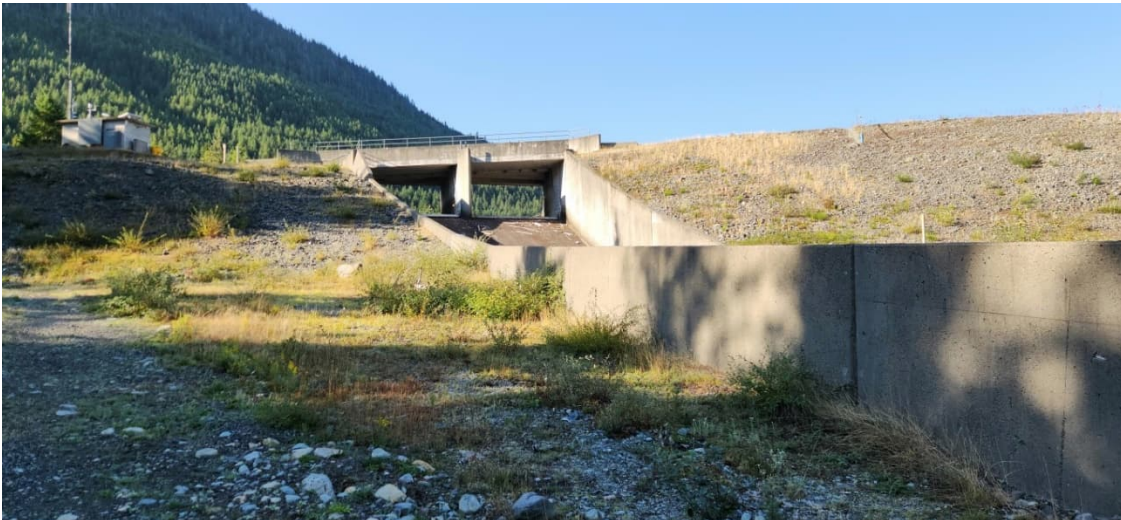
JCR 10: Vegetation near to Right Wall of Spillway Chute

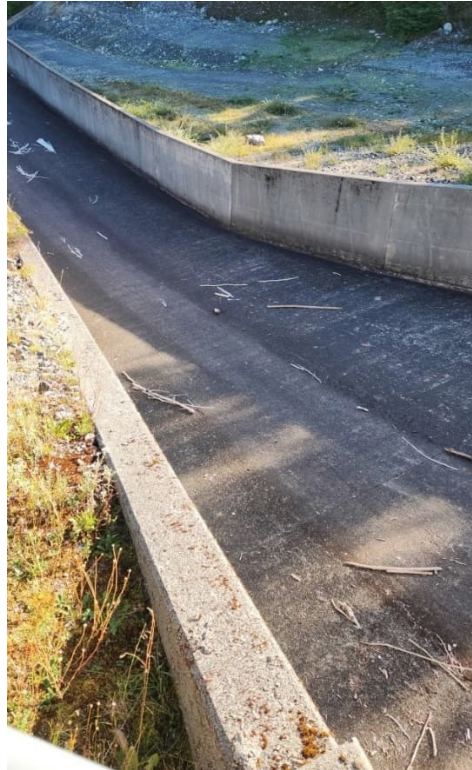
JCR 13: Small Debris Inside Spillway Structure Chute (Looking Downstream)

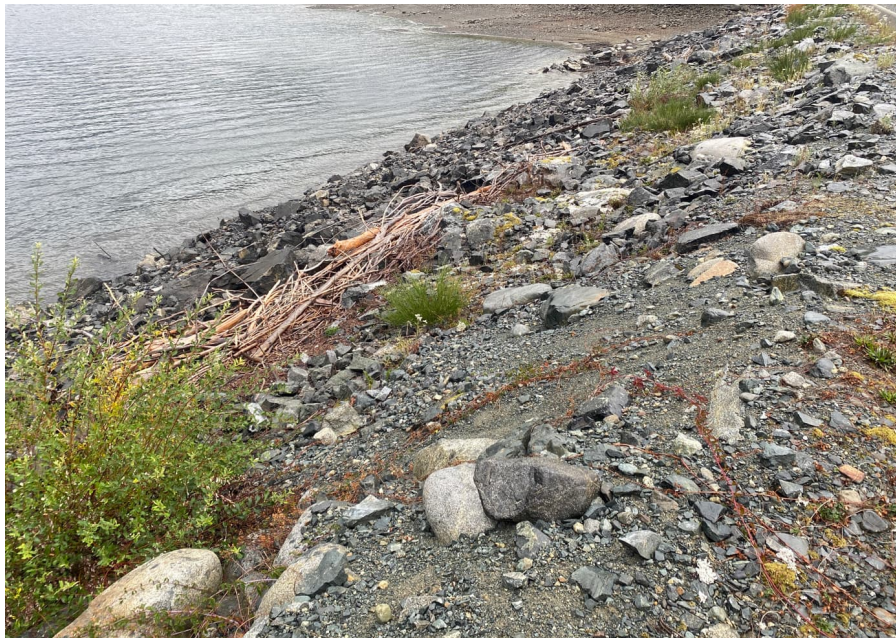
JCR 30: Poor Quality Riprap Left of Piezometer SP12

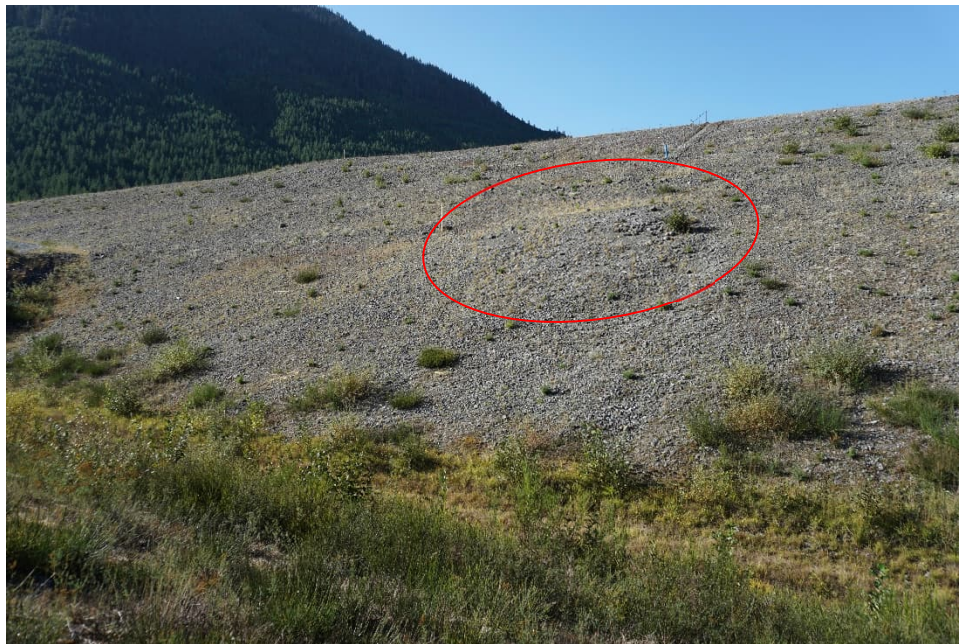
JCR 32: Bulge on Downstream Face (Looking from Downstream Toe)

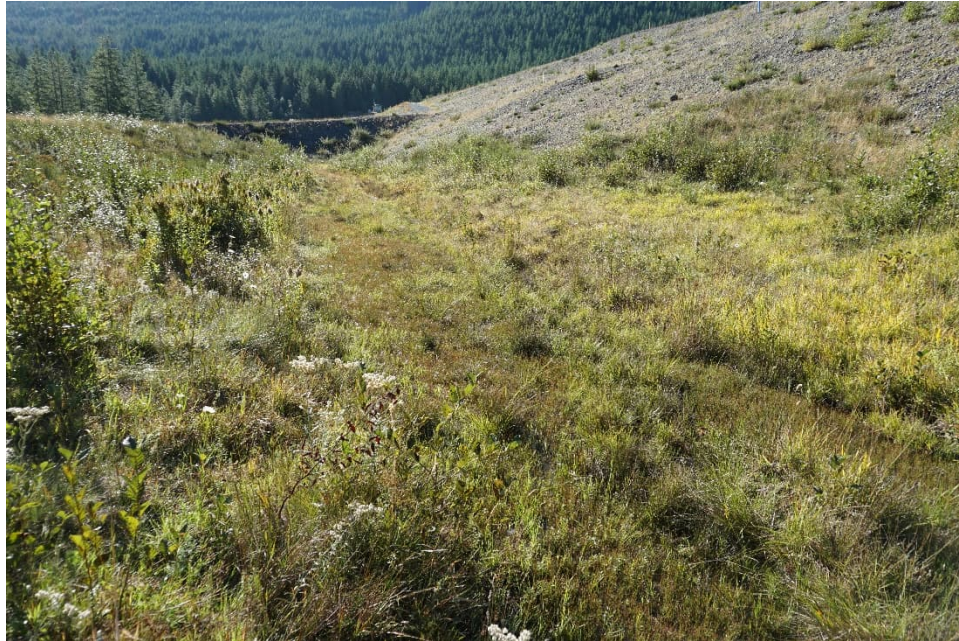
JCR 33: Downstream Toe with Ruts and Seepage

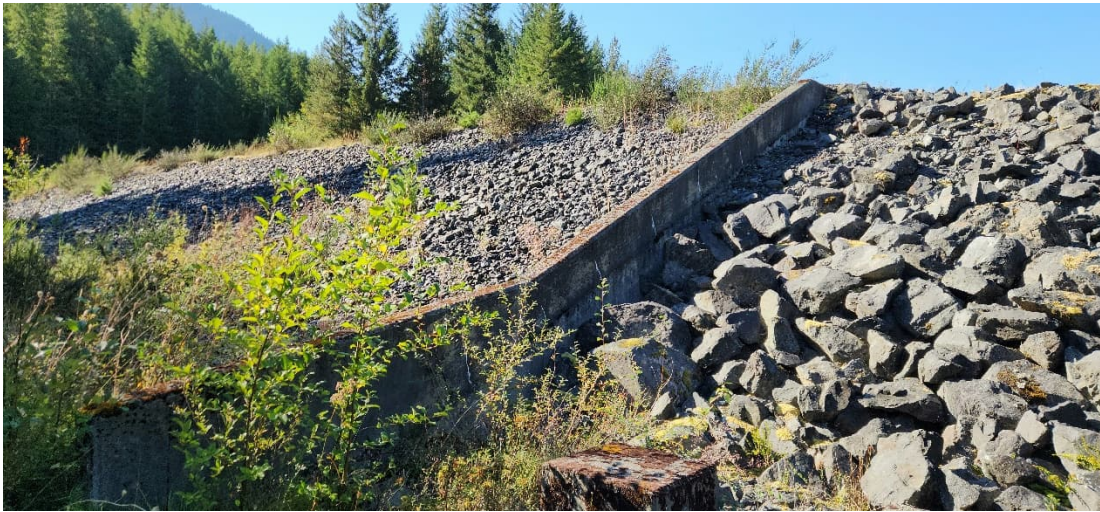
JCR 36: Auxiliary Spillway and Downstream Face of Dam, zone with sparse riprap

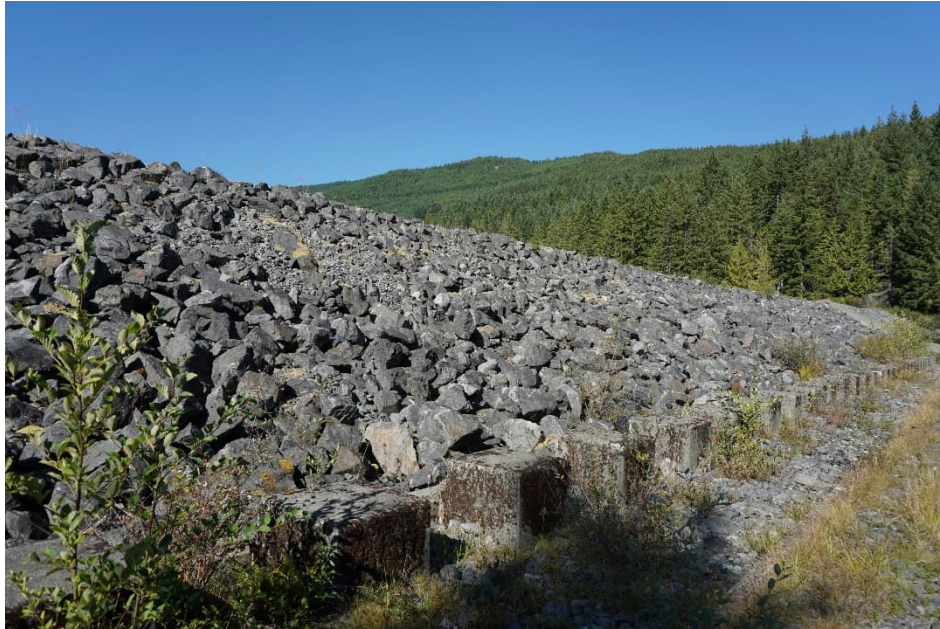
JCR 37: Auxiliary Spillway and Downstream Face of Dam, zone with sparse riprap

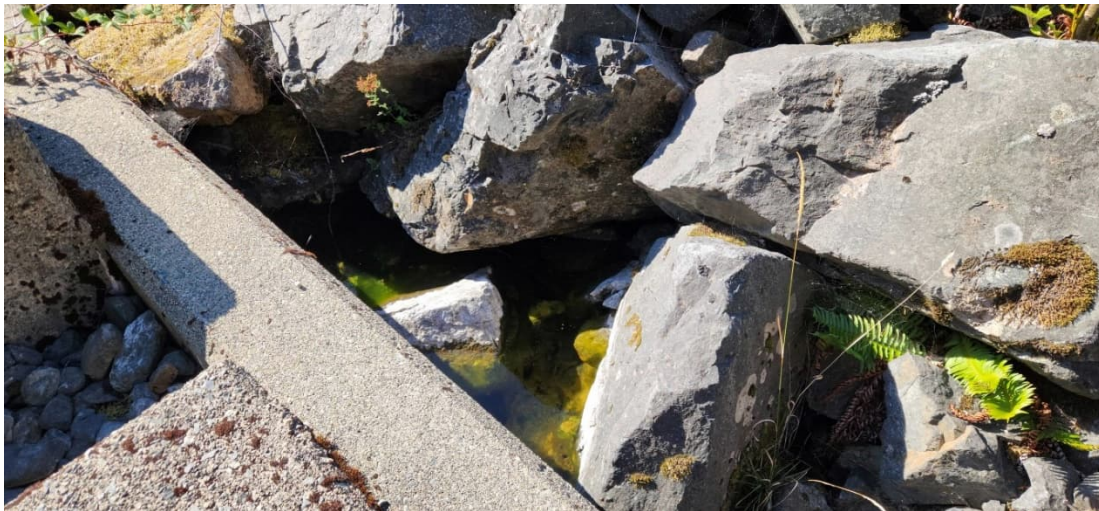
JCR 38: Seepage at Downstream Toe of Auxiliary Spillway

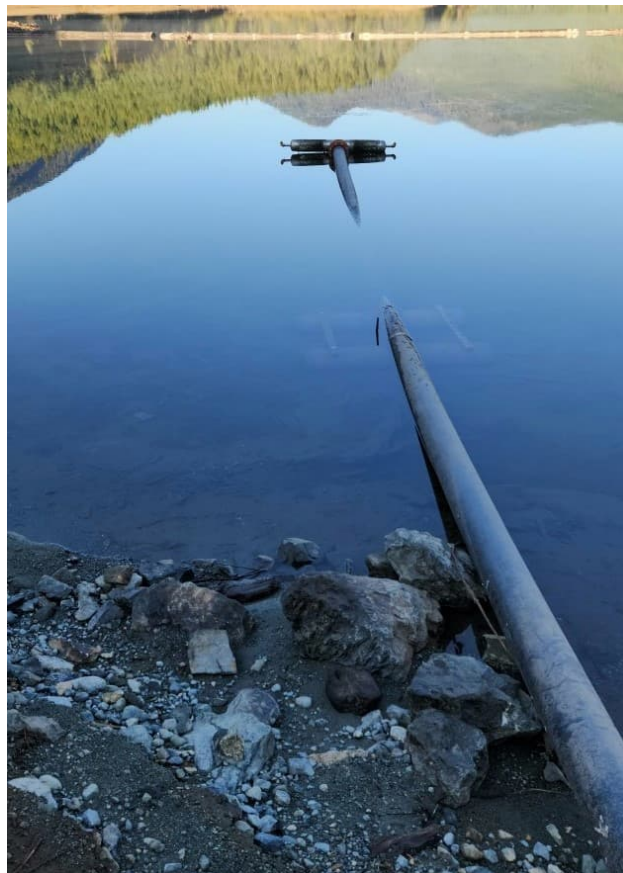
The new generating units were installed in November of 2024 near the right training wall of the spillway (**Photographs JCR 40** and **JCR 41**). A pair of turbines are housed in a seacan trailer slightly above the tailrace elevation, placed on a foundation of concrete lock-blocks.

Their water intake consists of a single siphon placed in the headpond to the right of the spillway. Due to the low water level at the time of inspection, the siphon was completely exposed above the water surface. The water is then passed through a pipe down to the units, which appears to be buried in fill. Some wash-out and erosion was noted on the hill to the right of the seacan; City staff noted that they had experienced some erosion during construction and had installed erosion protection blankets along the washed-out portions. The power from these generating units is used to power site services (including satellite internet, cameras, instrumentation, heaters in the generator building, etc.). However, the diesel generators on site are still required to operate the gates.

JCR 40: Turbine Siphon Inlet

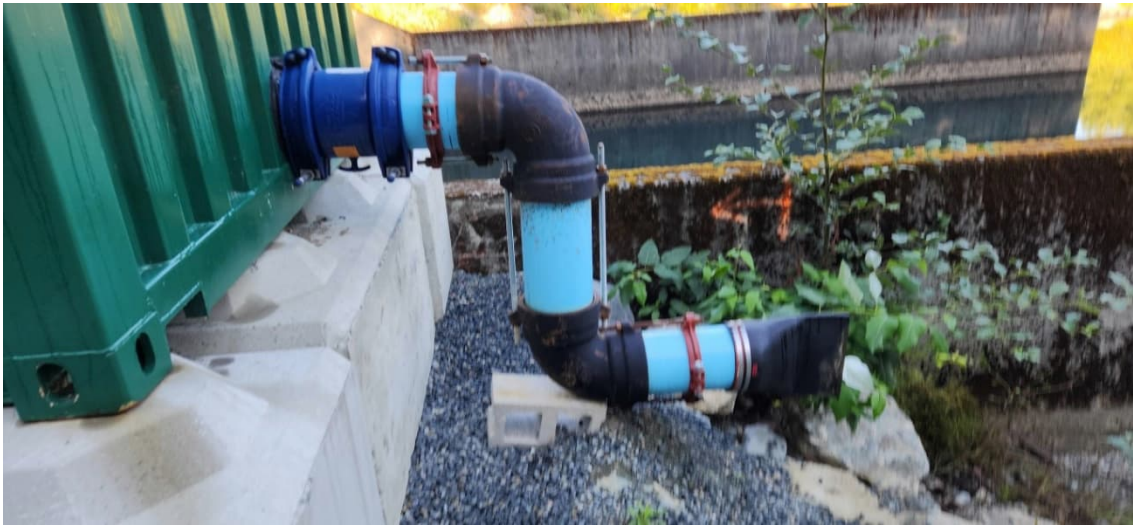
JCR 41: Turbine Outlet

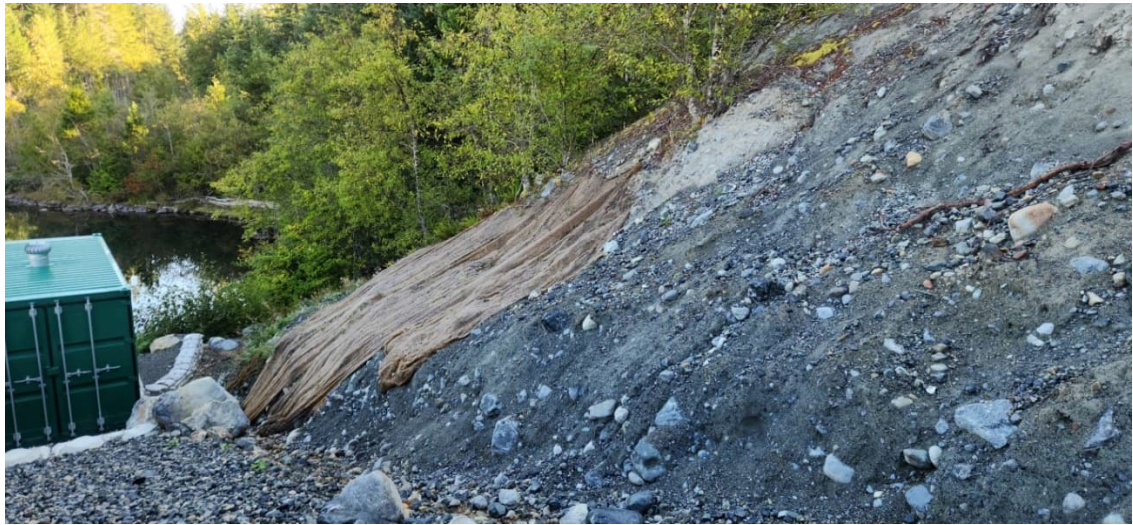
JCR 42: Erosion by Turbines

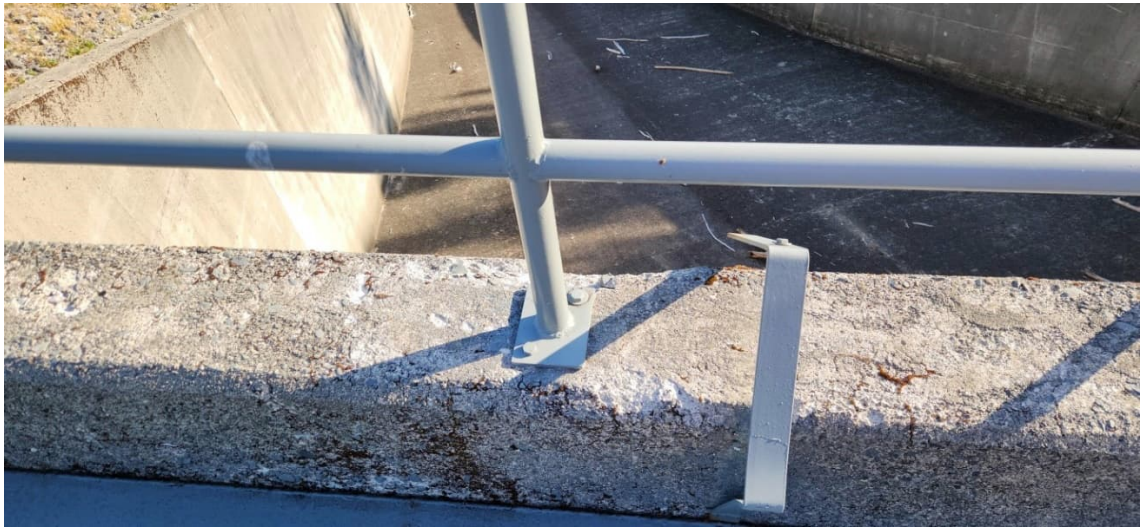
JCR 43: Spalling on Bridge Curbs

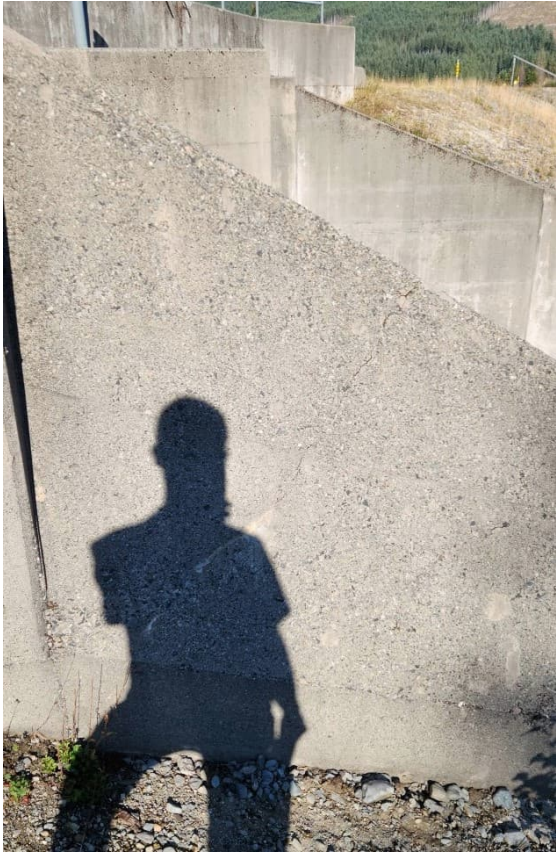
JCR 44: Cracking on Right Abutment Wall

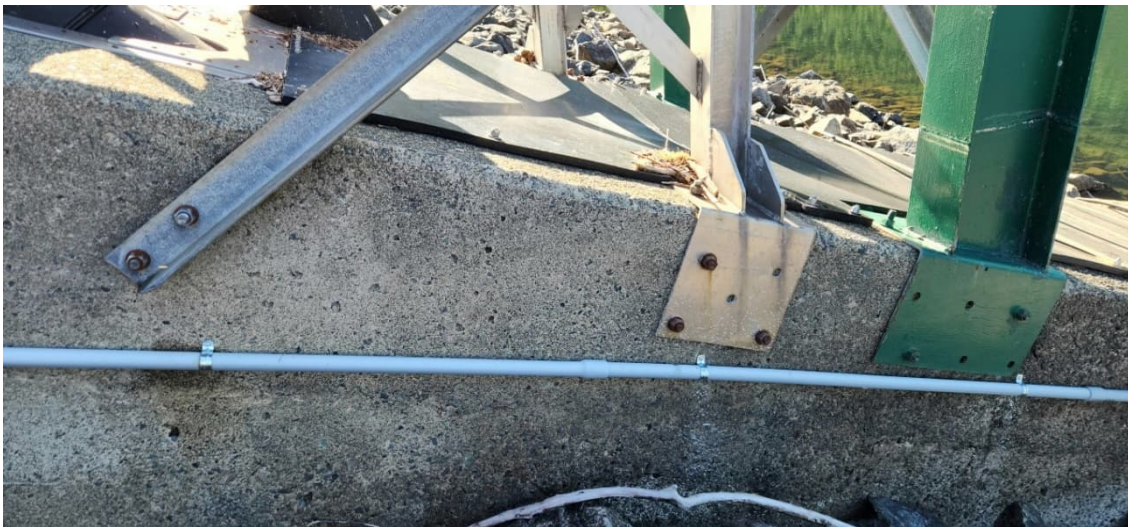
JCR 46: Corroded Fasteners on LLO Operating Platform

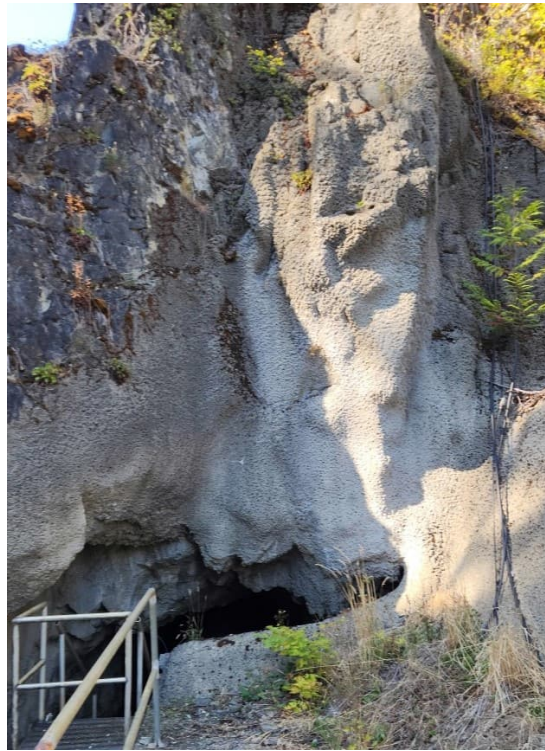
SFK 3: Shotcrete at the Entry to Water Supply Tunnel

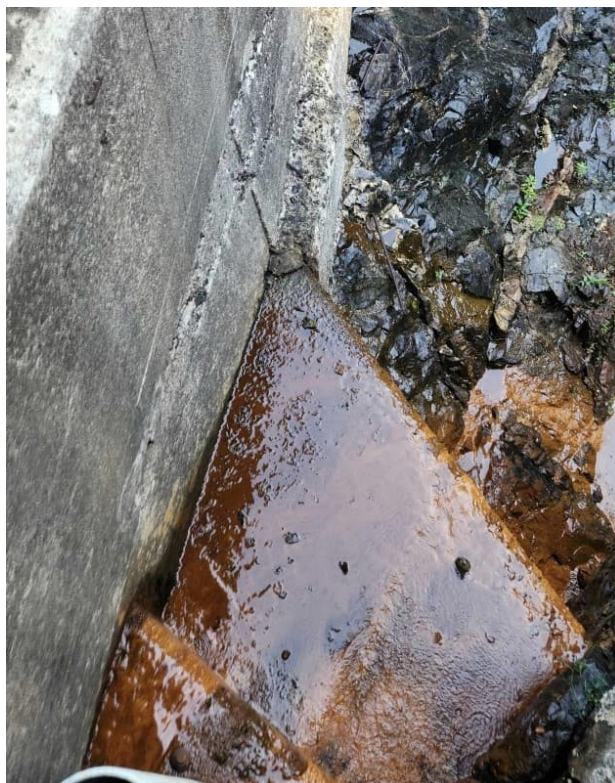
SFK 10: Tunnel Weir Seepage

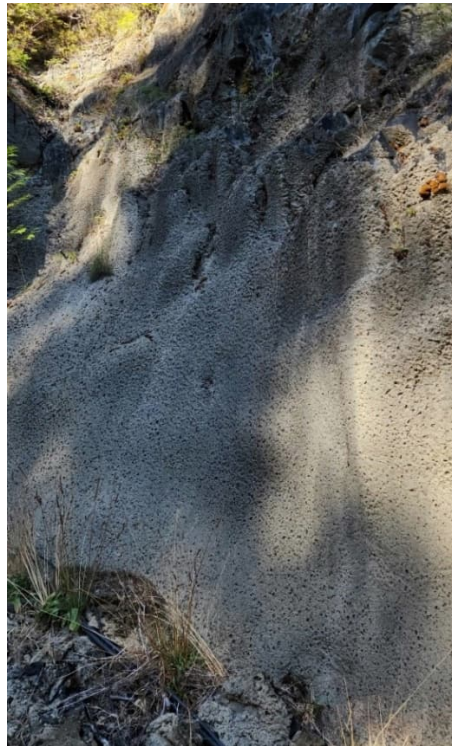
SFK 11: Headwall Shotcrete Condition (Downstream)

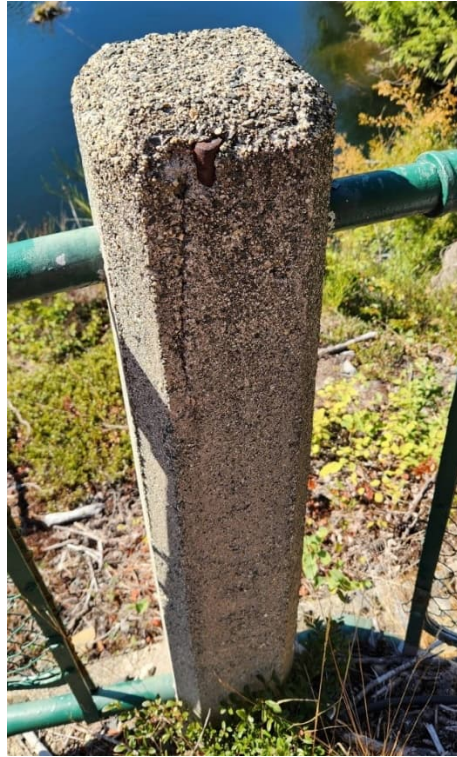
SFK 15: Handrail Post with Exposed Reinforcement

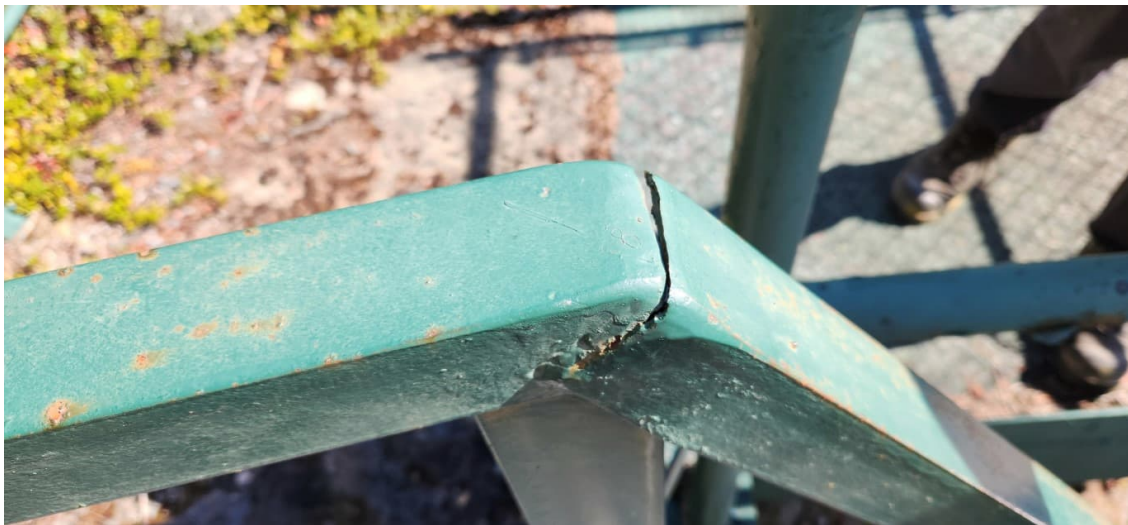
SFK 16: Broken Weld on Handrail at Inlet Operating Platform

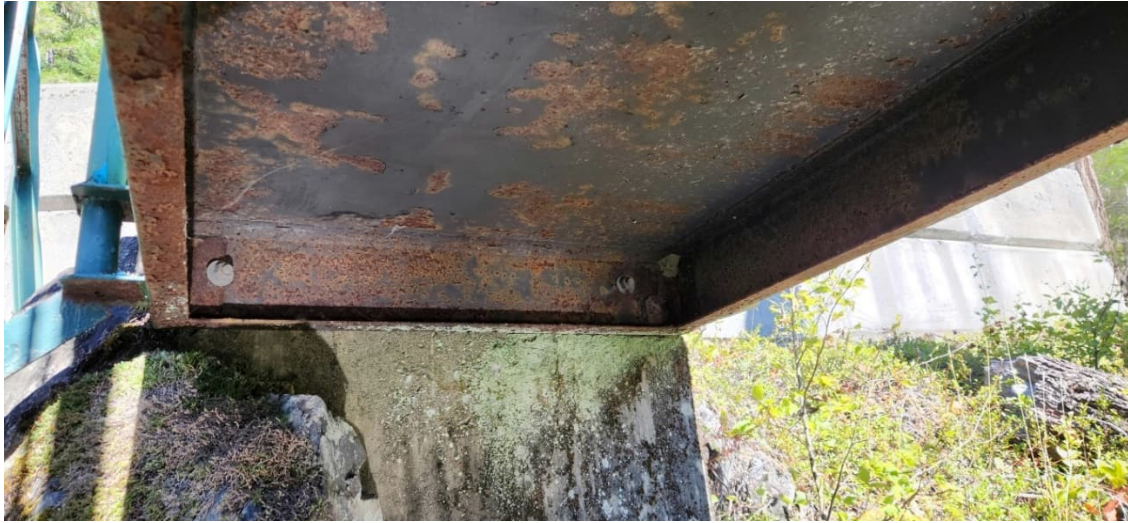
SFK 17: Corrosion on Underside of Inlet Operating Platform Ramp

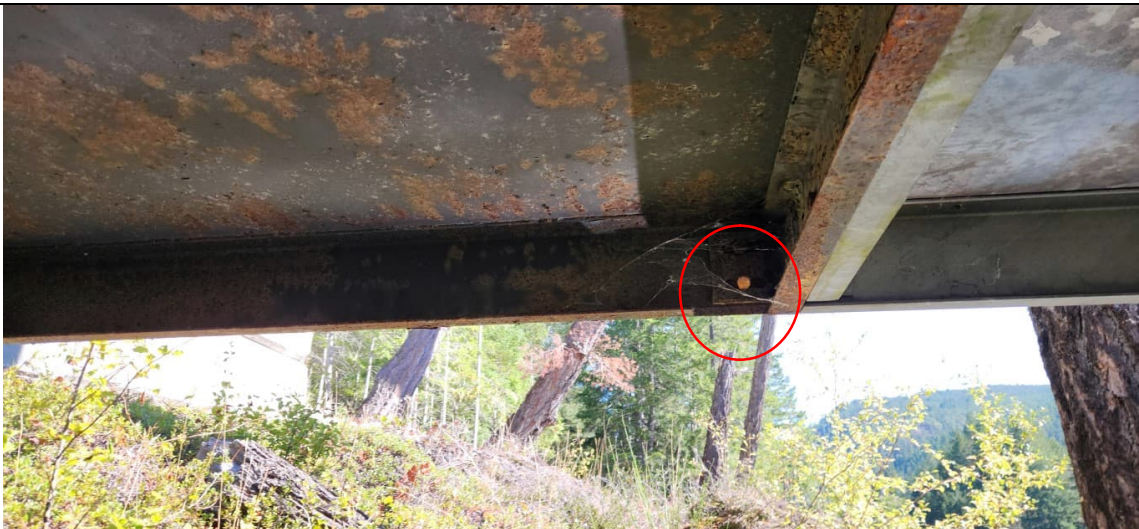
SFK 18: Missing Fasteners on Inlet Operating Platform
