2025 Formal Annual Dam Inspections – Recreational Dams

Final Report

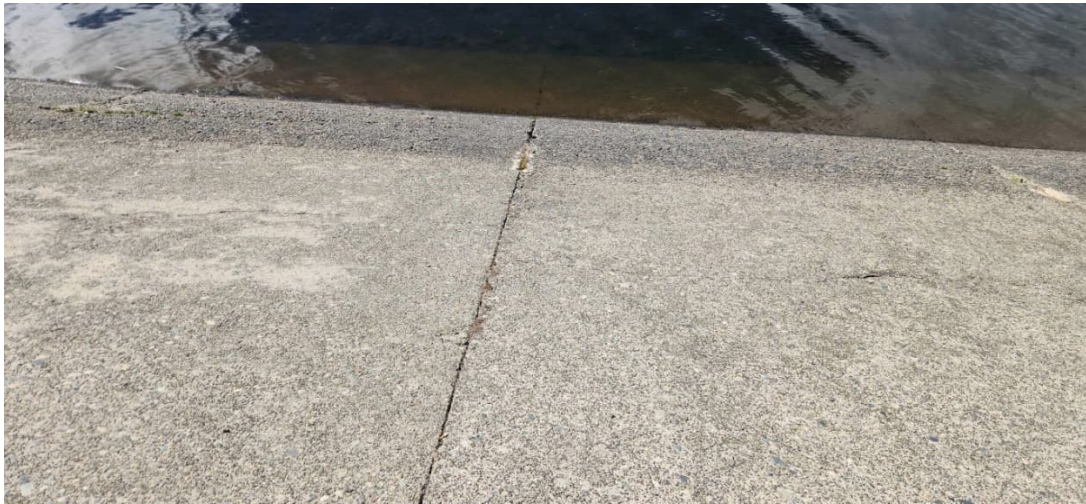
WWL 3: Upstream Concrete Face of Main Dam with Horizontal Cracking

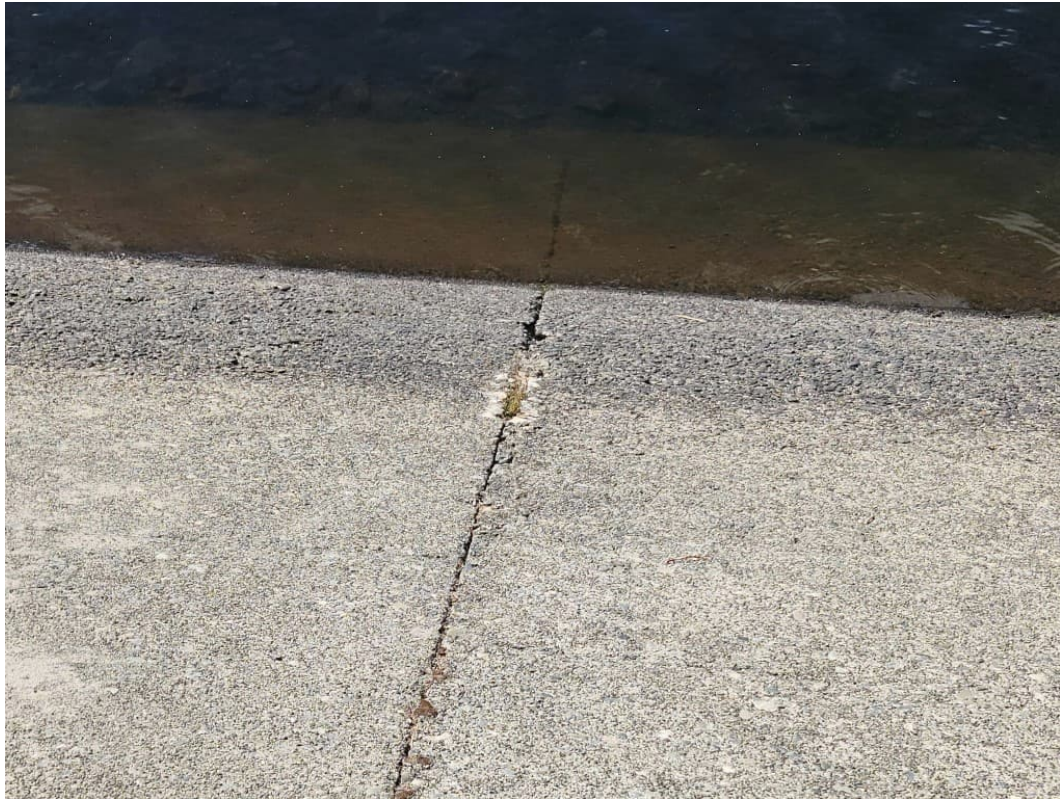
WWL 4: Upstream Concrete Face of Main Dam with Joint Deterioration and Cracking

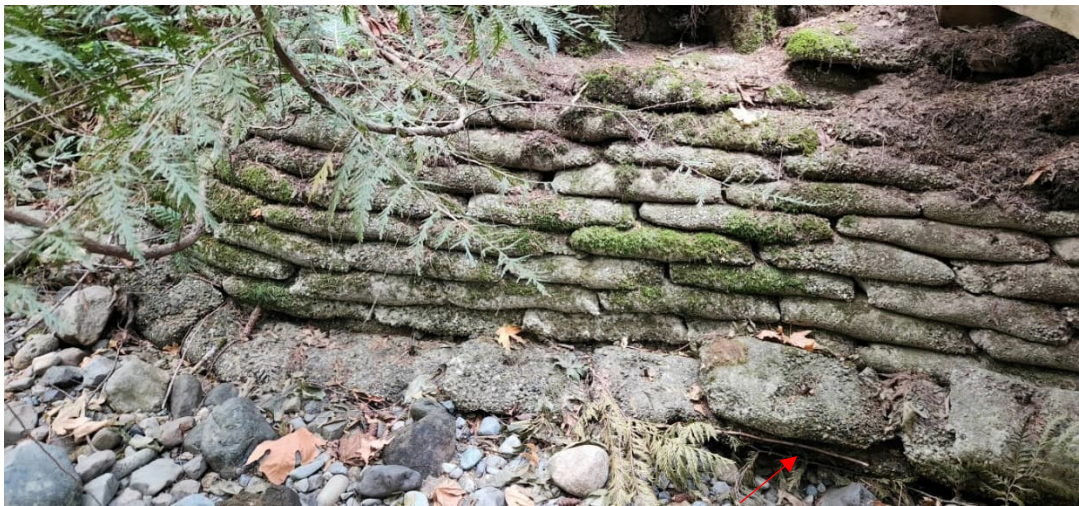
WWL 16: Erosion Damage on Downstream Right Abutment of Bridge (Inlet Channel)

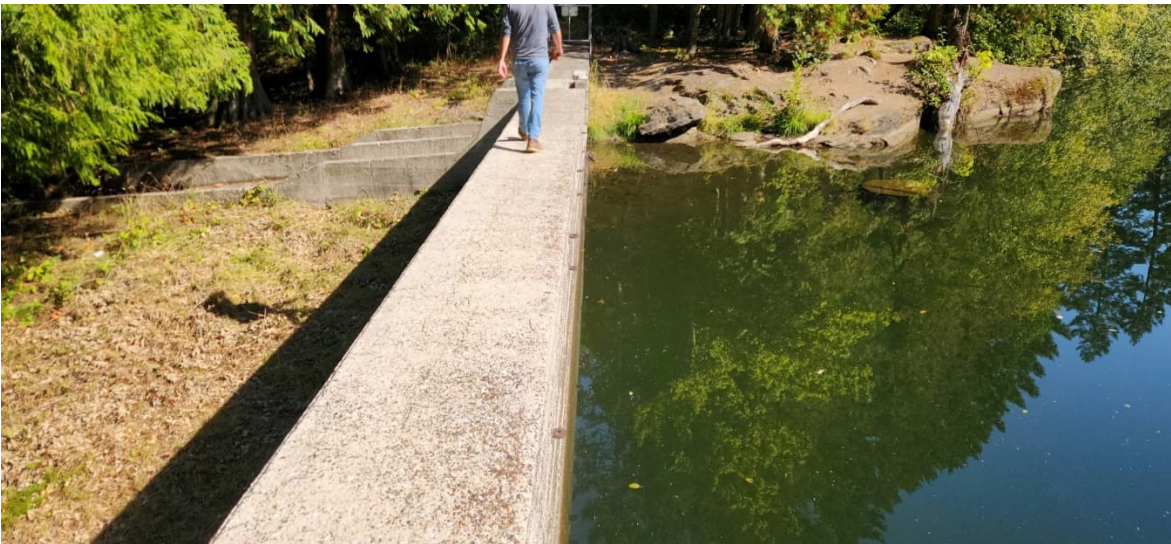
HAW 4: Concrete Deterioration of the Top of the Spillway Bridge

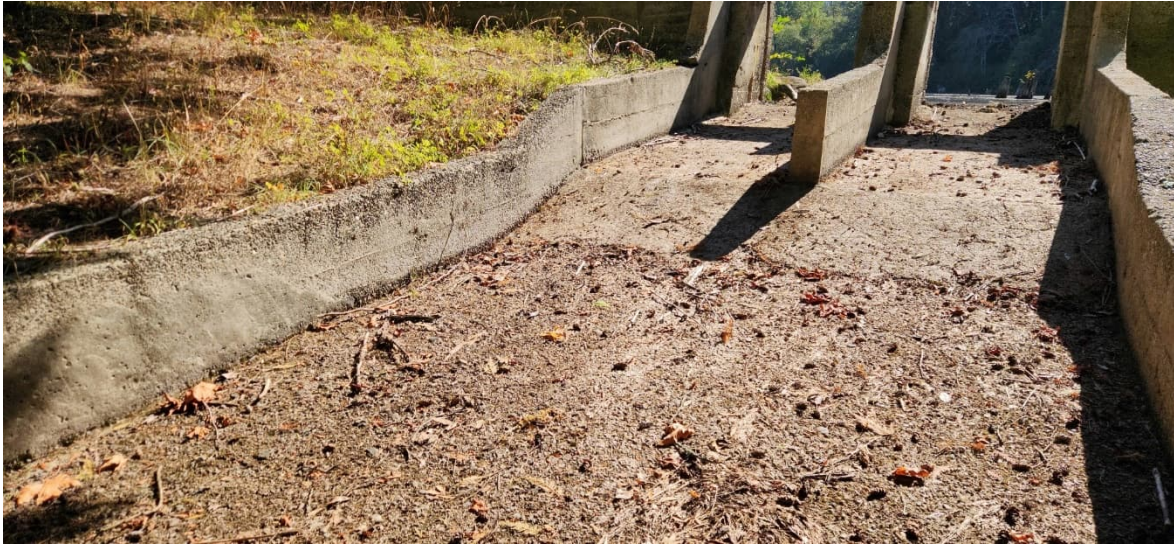
HAW 5: Spillway Chute looking Upstream

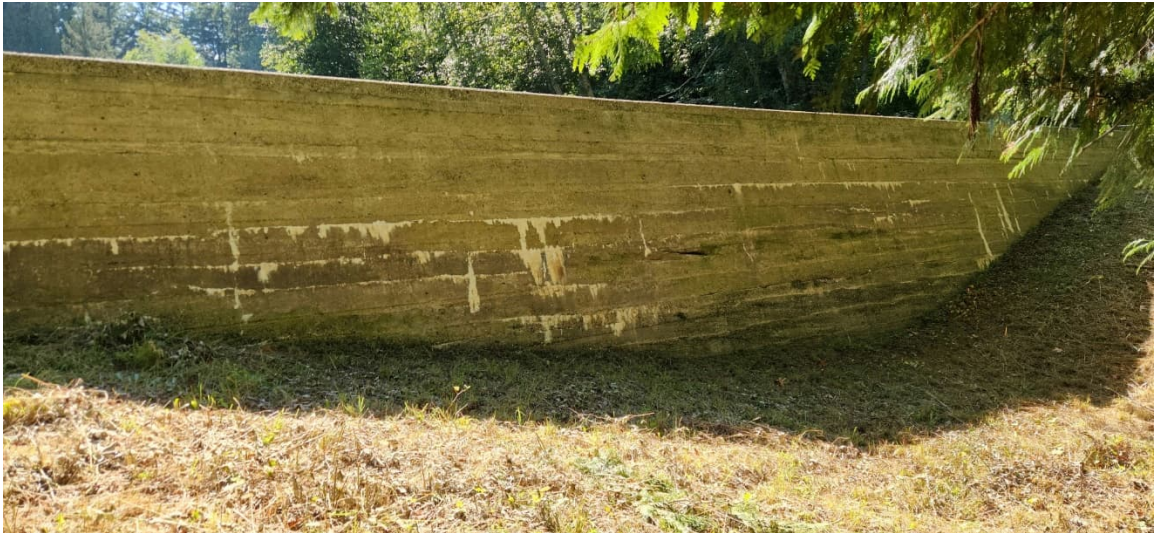
HAW 8: Concrete Deterioration at Downstream Face of the Dam

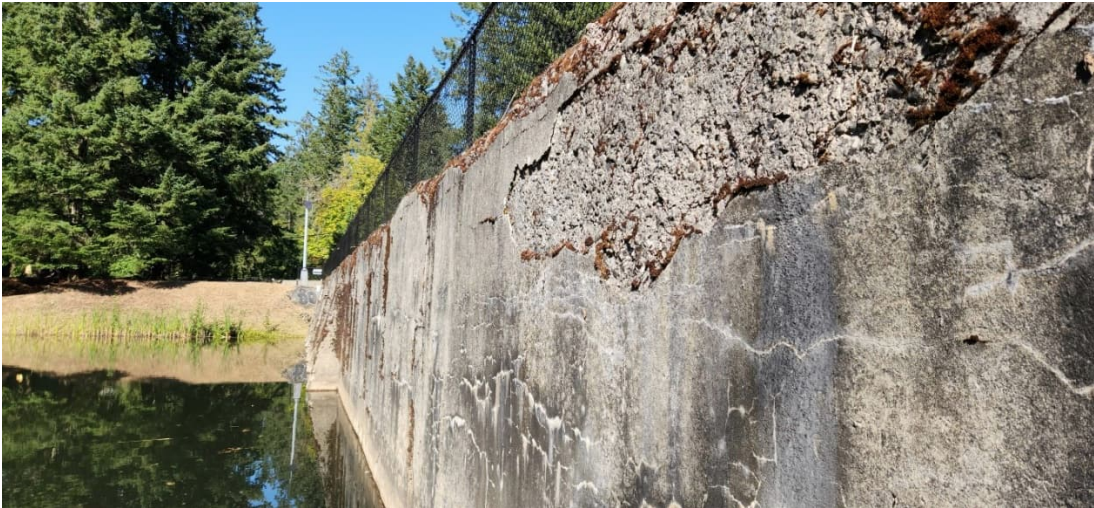
UCR 3: Concrete Deterioration at Right Side of Buttress Wall of the Dam

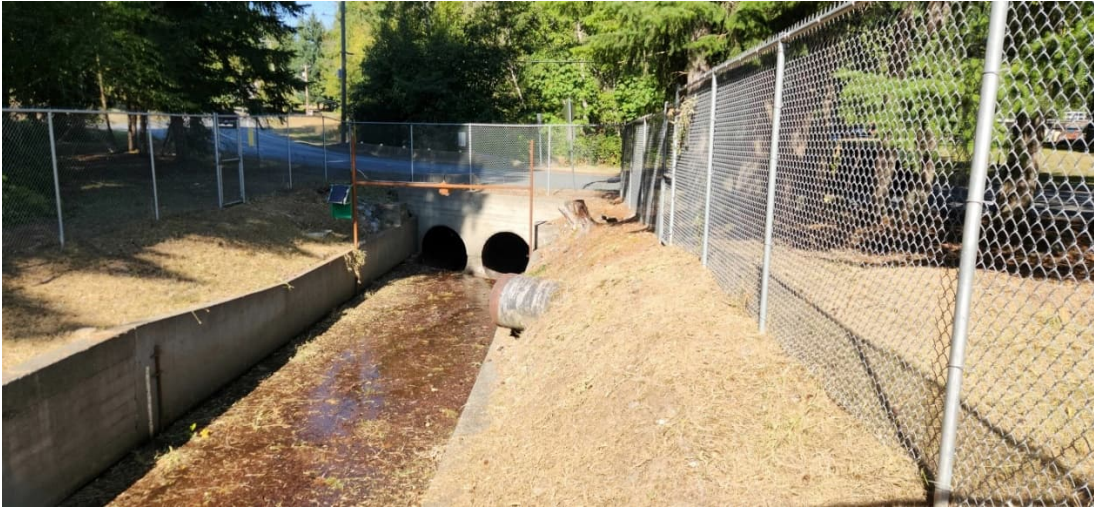
UCR 4: Spillway Structure and FlowDar System (looking Downstream)

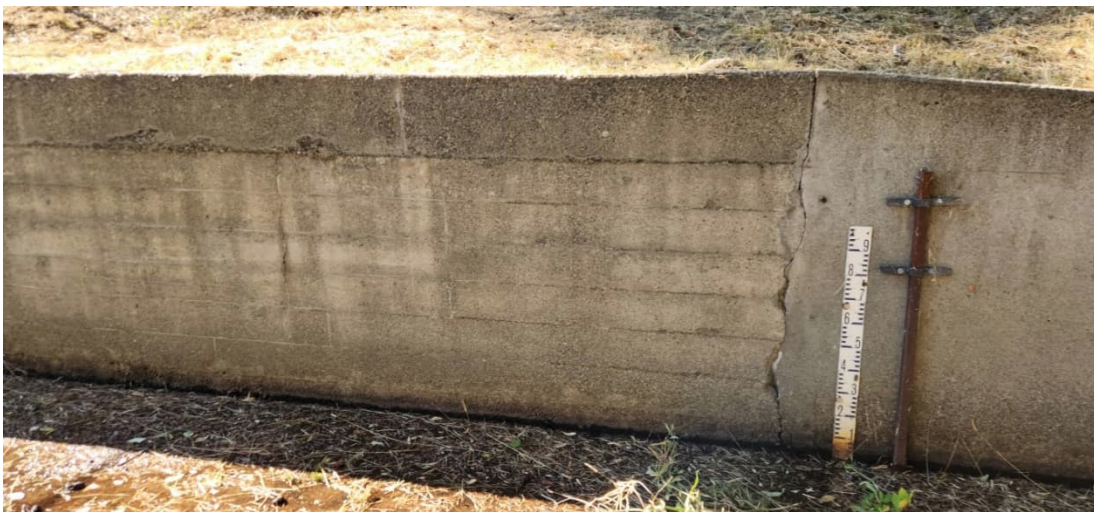
UCR 7: Left Spillway Chute Wall with Crack at Water Gauge

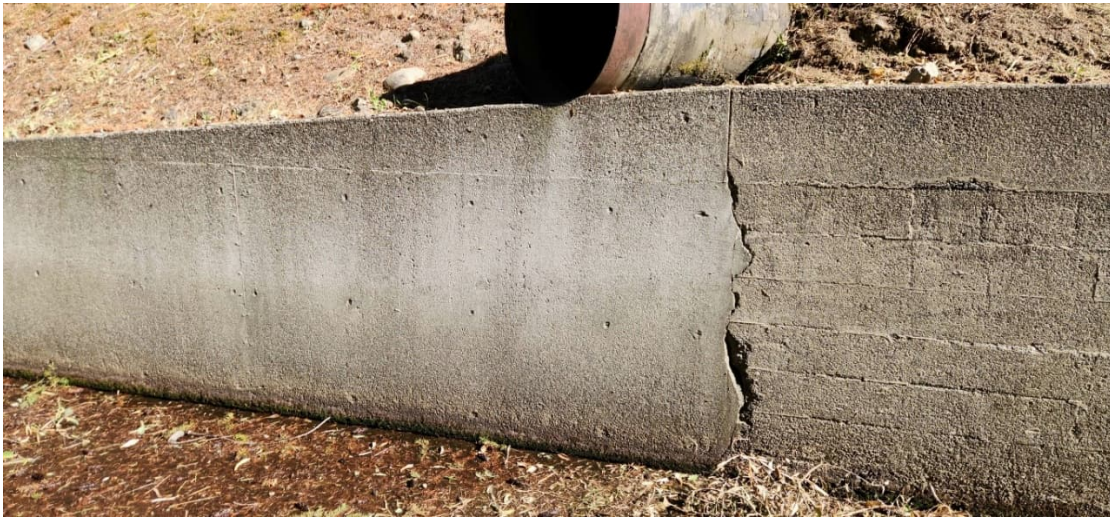
UCR 8: Right Spillway Chute Wall with Crack at Drainage Pipe

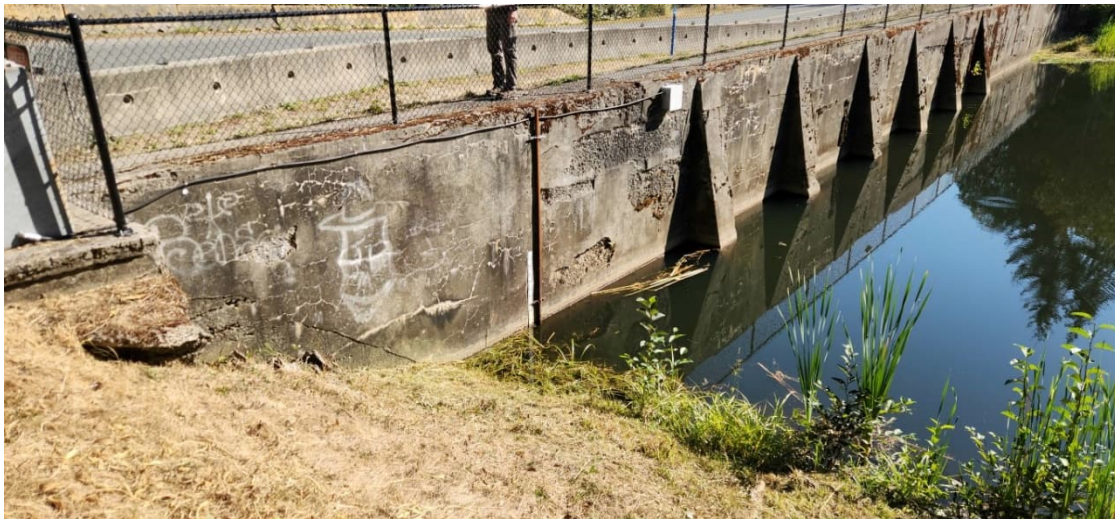
UCR 15: Camera Pole Foundation at Left Abutment

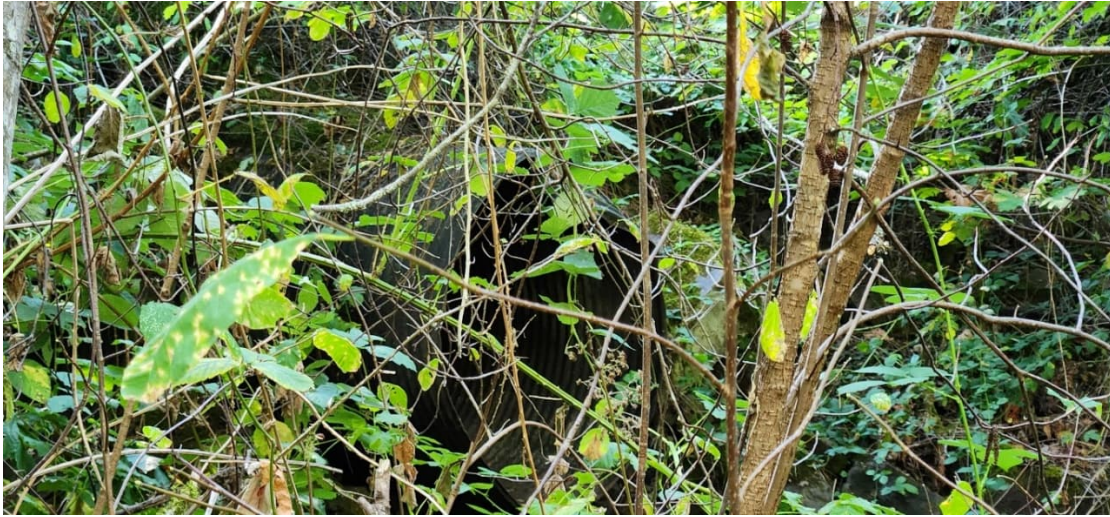
UCR 16: Damage to Left Culvert at Downstream End

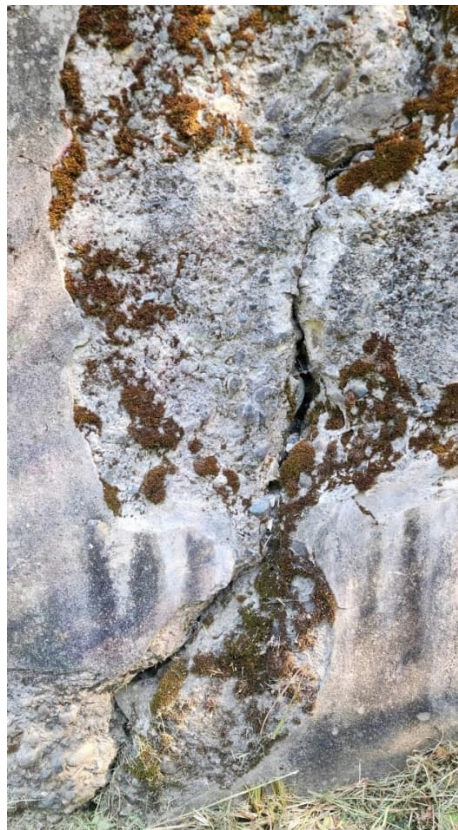
UCR 17: Large Crack on Upstream Wall Face

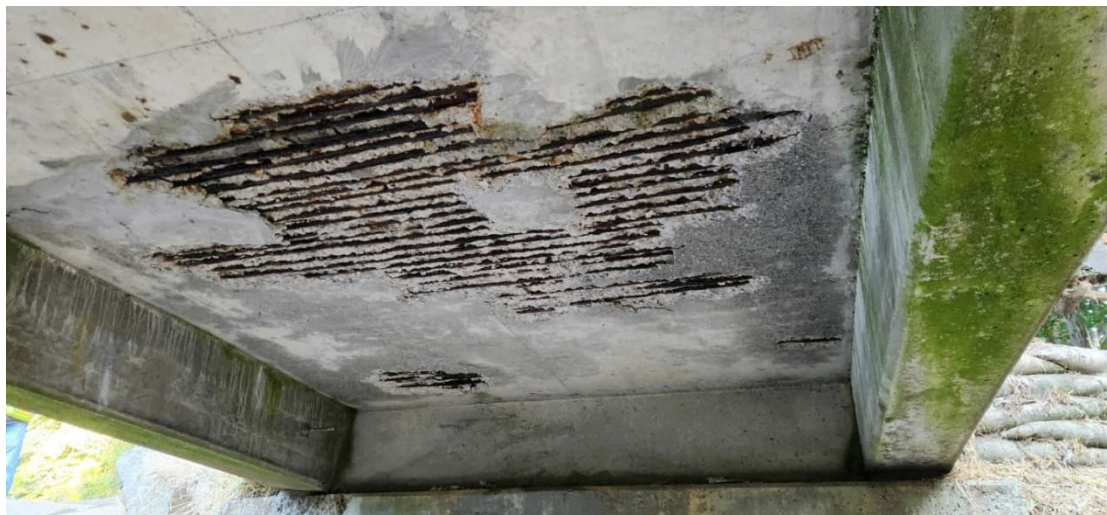
MCR 4: Concrete Deterioration with Exposed Reinforcing Bars Underside of the Spillway Bridge Deck (Left Bay)

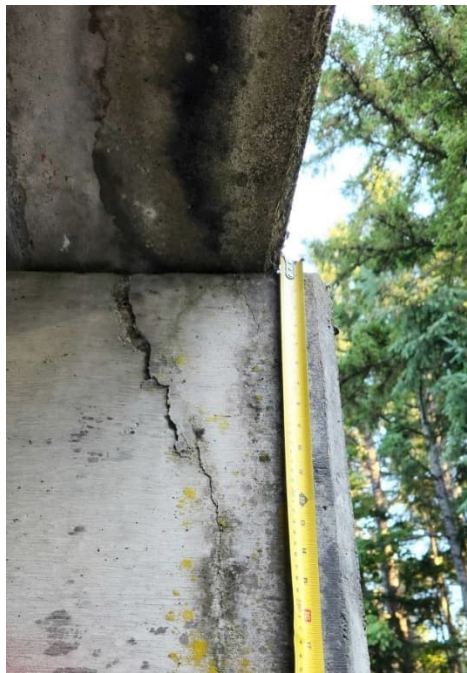
MCR 18: Concrete Crack at Top Corner of Centre Spillway Pier

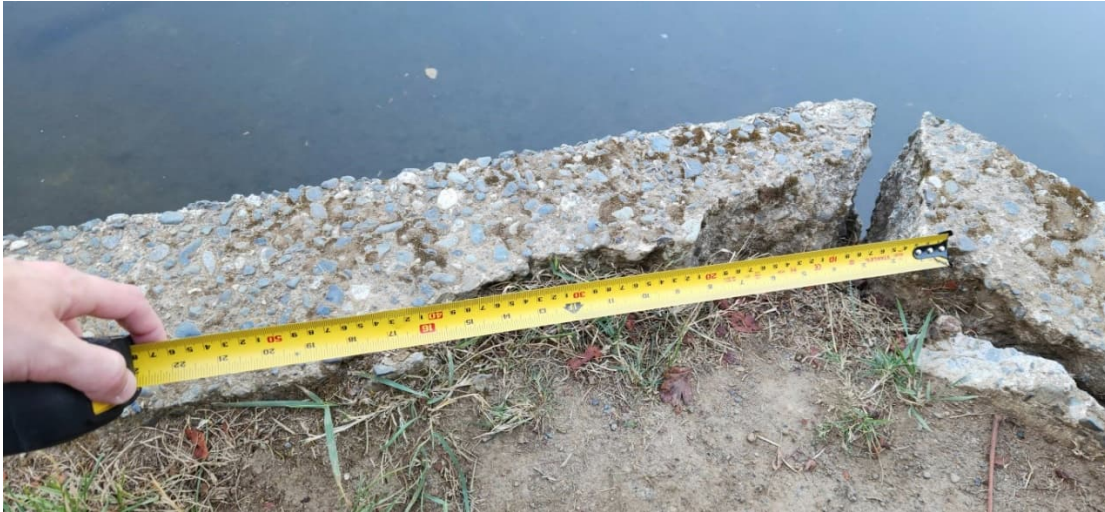
LCR 8: Cracks at Upstream Lower Wall Corner

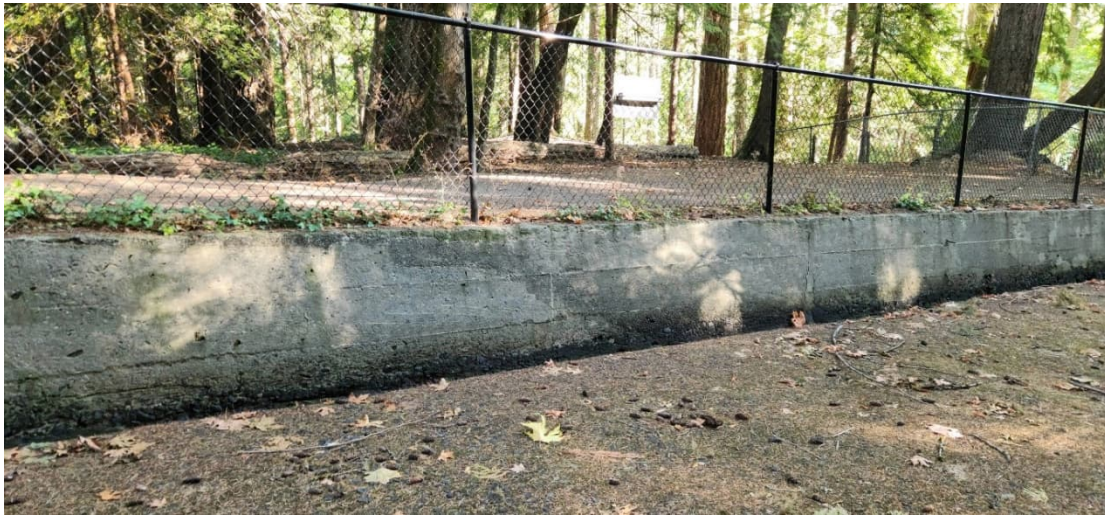
LCR 10: Repair at the Base of Spillway Chute Left Wall

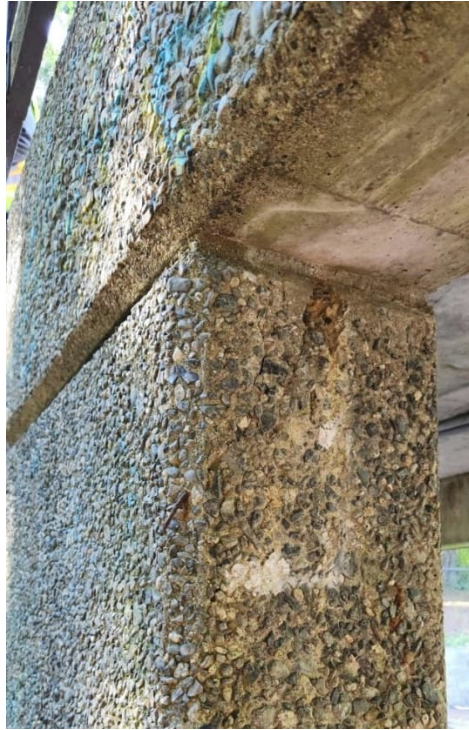
LCR 22: Diagonal Cracking on Downstream Bridge Pier

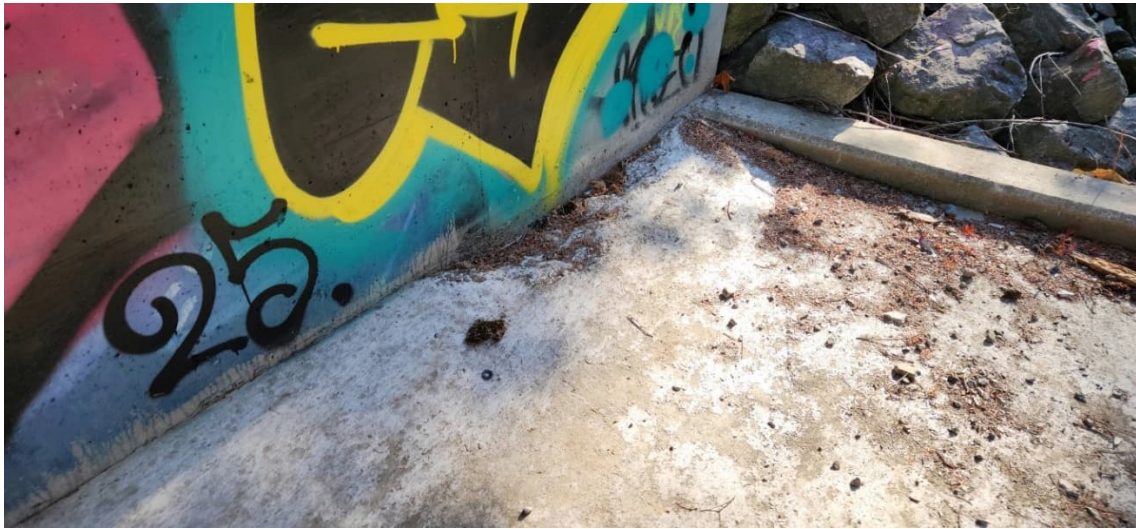
LCR 26: Spall at Left Wall of Auxiliary Spillway

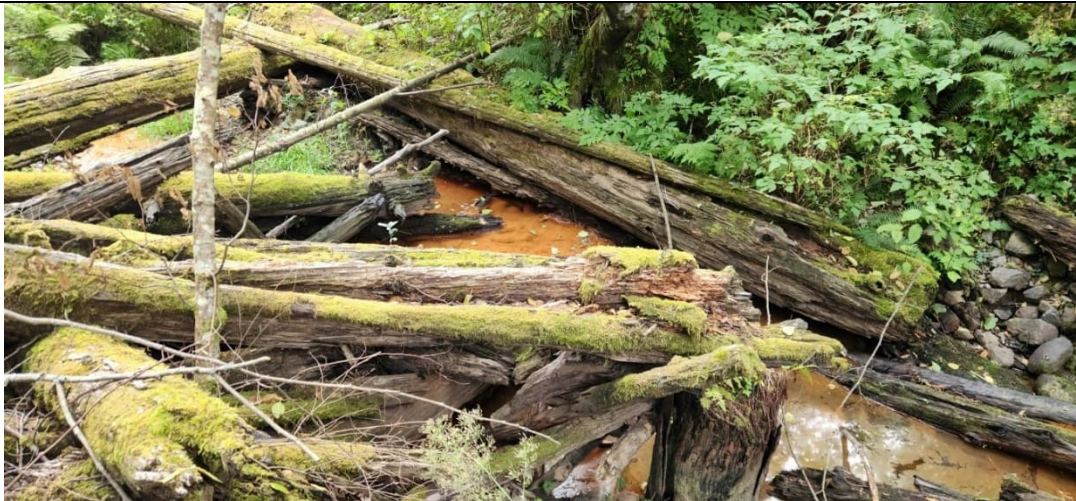
WCL 1: Left Abutment of Dam Showing High Degree of Deterioration

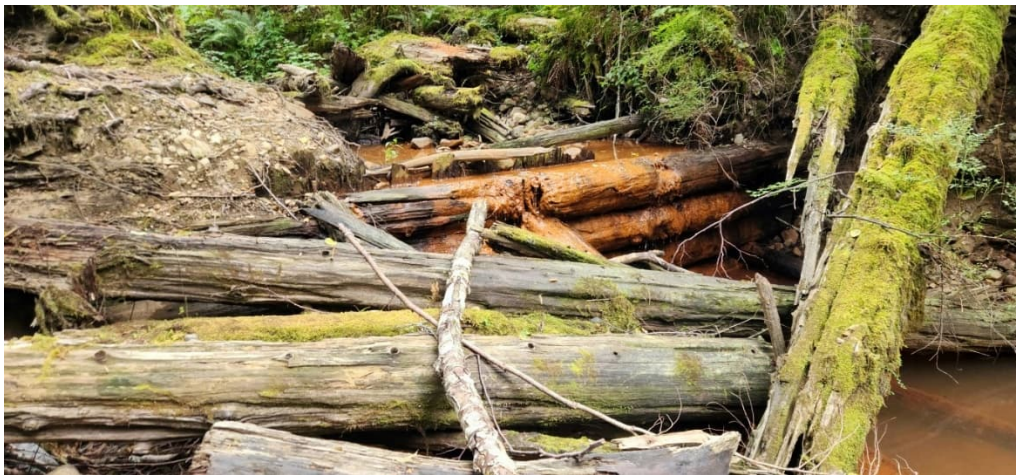
WCL 3: Dam Showing High Degree of Deterioration
