**UPPER CHASE DAM SEISMIC ASSESSMENT  
NANAIMO, BC**

**CITY OF NANAIMO  
NANAIMO, BC**

**EBA ENGINEERING CONSULTANTS LTD.  
EDMONTON, ALBERTA**

**Project No. 0802-2800097**

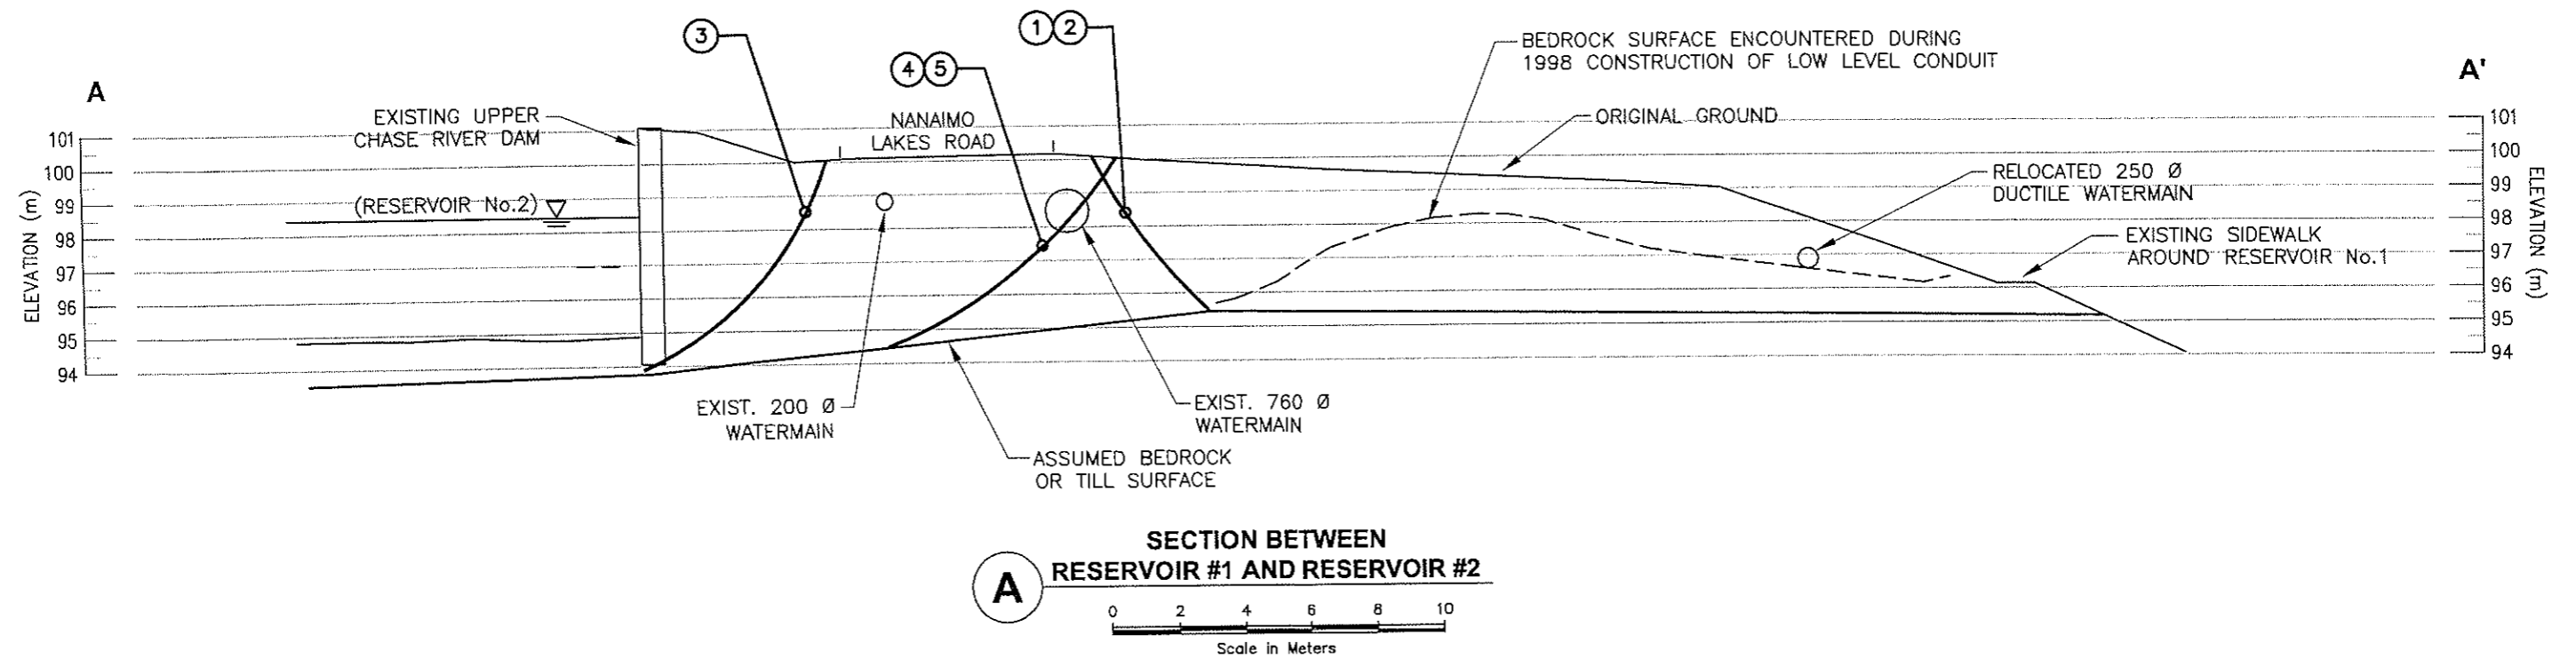
All of the calculated factors of safety exceed the requirements of the CDA Guidelines for slope stability. The downstream failure geometries presented in Figure 4 were selected because they impacted the road surface and the 760 mm diameter pipeline.

Failure of the concrete retaining wall will not immediately affect the 760 mm diameter waterline as illustrated in Figure 4. However, saturation of the dam fill upon failure of the concrete wall will result additional movement under static conditions and liquefaction with additional ground movement if further seismic activity (i.e. aftershocks) persists after the initial event. This combination of post seismic events could result in the 760 mm diameter waterline being impacted by ground movement related to retaining wall failure. However, the probability of this is judged to be relatively low.

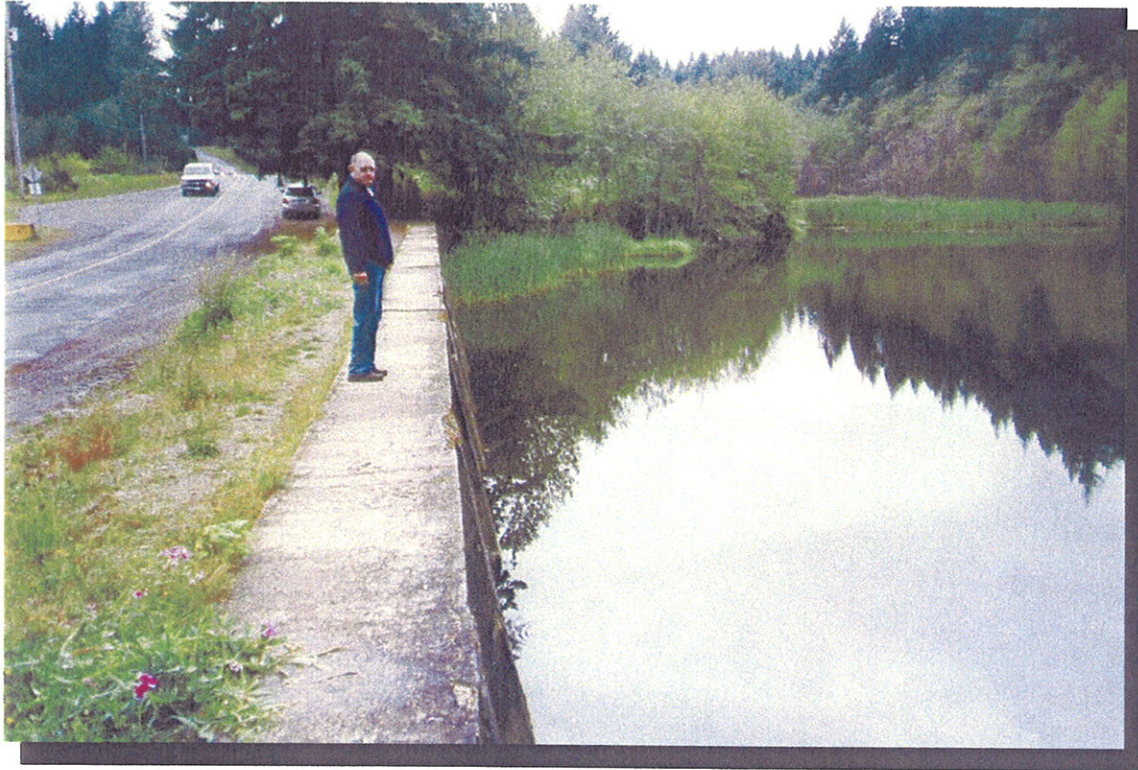
**Photo 3**

Concrete wall on upstream of Upper Chase River Dam,  
facing south. Note buttresses on upstream side.

The concrete retaining wall should be buttressed with coarse, angular, free draining rockfill founded on till to improve the static and seismic stability of the retaining wall. The rockfill buttress would have a 1:1 slope with a 1.5 m wide crest width at or just below normal reservoir elevation. The proposed geometry would result in a static factor of safety of 1.5 and a seismic factor of safety of 1.1.

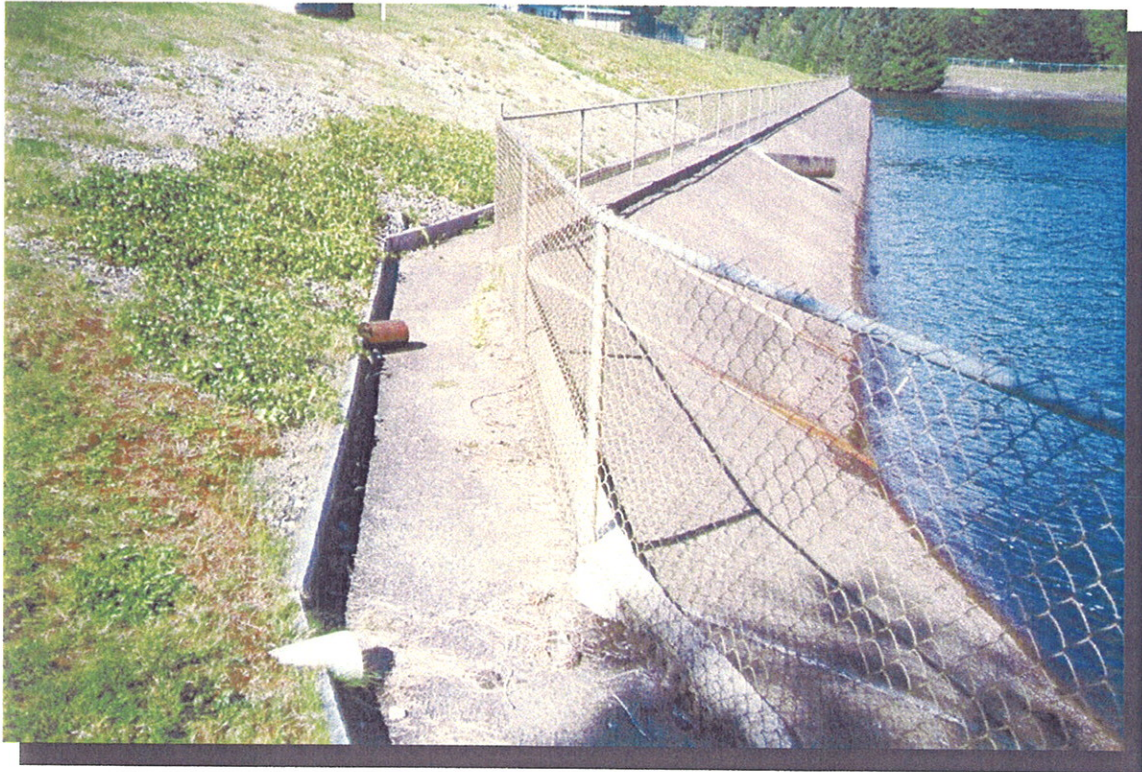
**Photo 7**

- Seepage has never been observed at the toe of the dam or at the abutments. Furthermore, the nature of the structure (i.e. concrete wall on bedrock or till) is such that seepage through the structure would be minimal; and

Downstream toe of Upper Chase River Dam at edge of Reservoir No. 1 , facing northeast. Note no evidence of seepage.

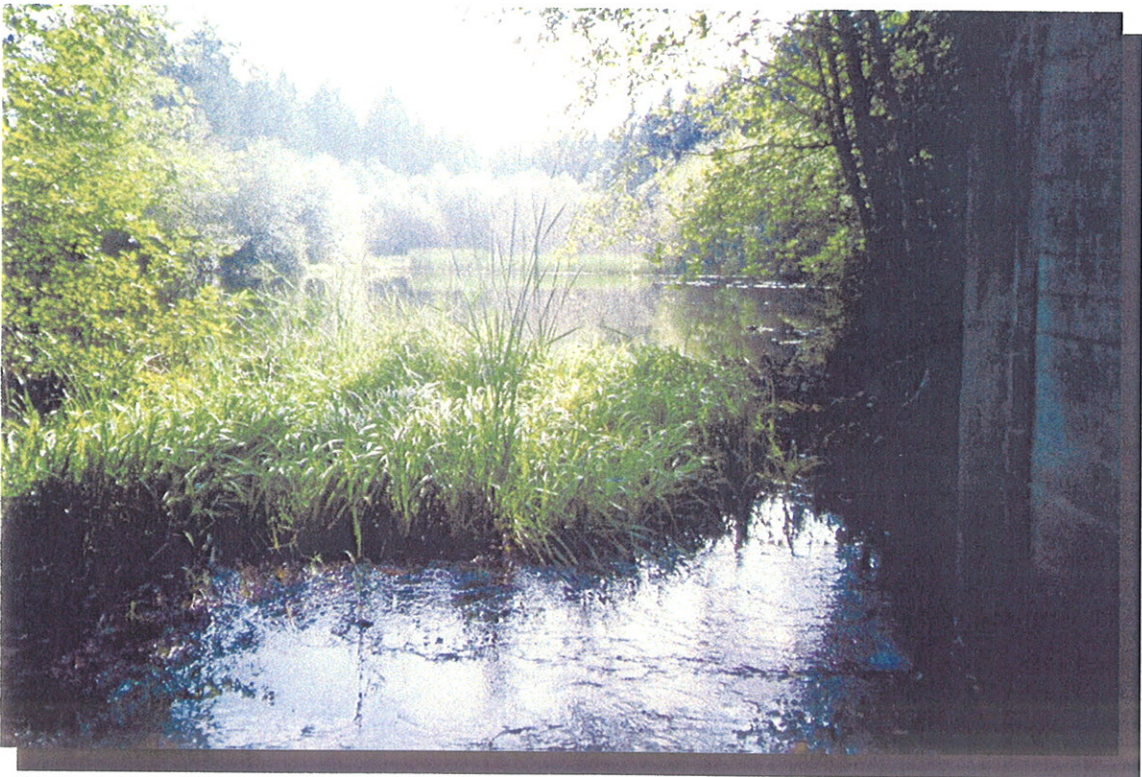
**Photo 8**

- There was approximately 2.3 m of freeboard below the top of the concrete wall;
- A beaver dam was present at the inlet to the spillway and had raised the No. 2 reservoir level by approximately 0.3 m at the time of our inspection. Thus, the available freeboard during normal operating conditions would be about 2.6 m upon regular removal of beaver dams at this location;
- The concrete wall appears to be in good condition with the exception of some limited surficial deterioration of the concrete;

Inlet to spillway, facing southwest. Note beaver dam at inlet.
