5 August, 1980

HOWARD DAM NUMBER THREE

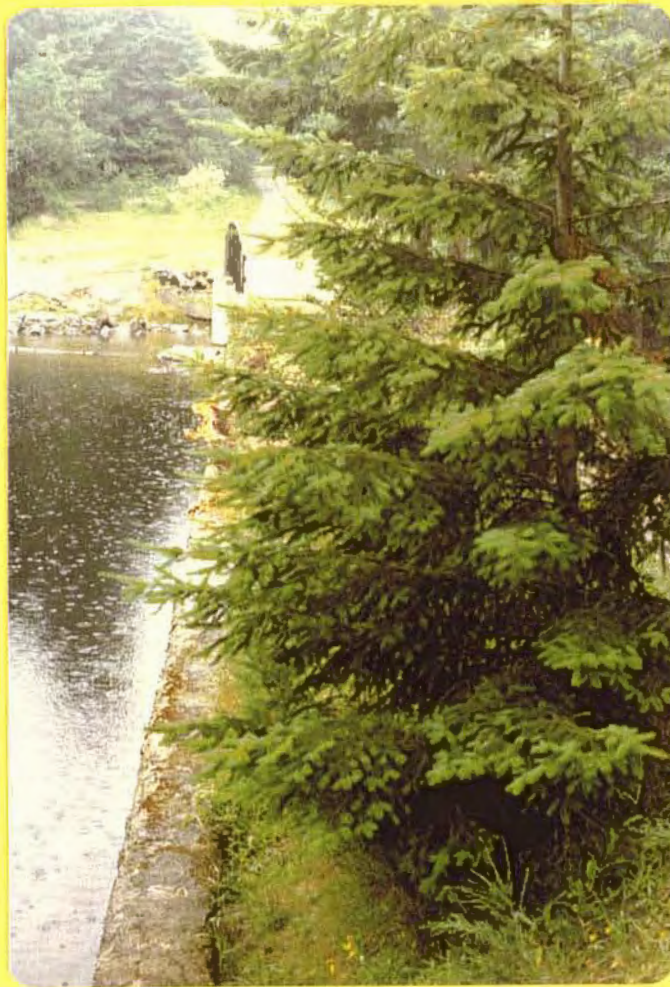
Upstream concrete wall on structure.

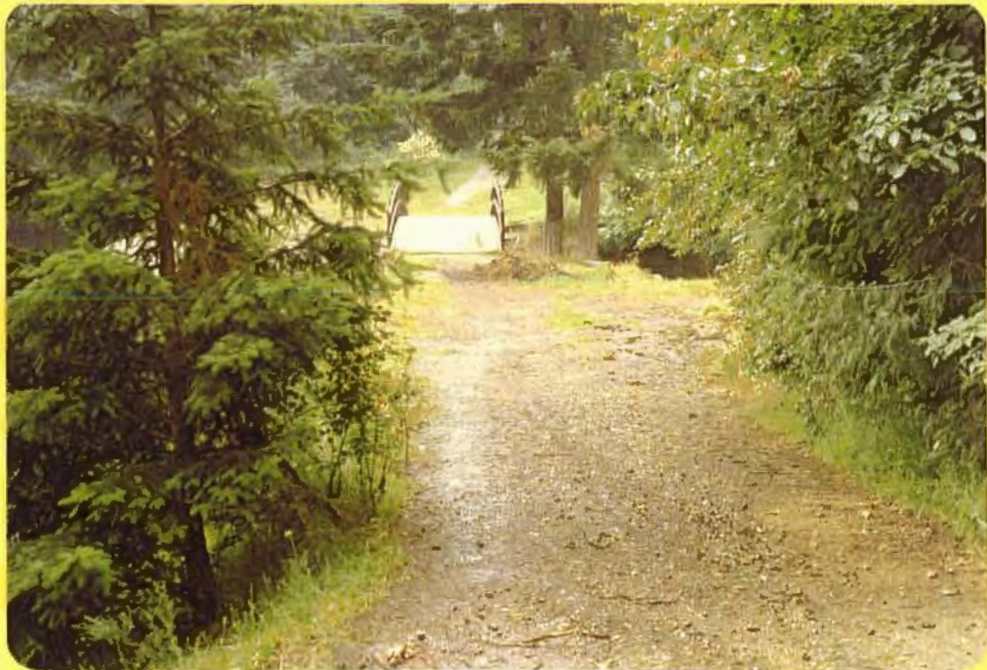
Dam crest viewed from right  
abutment prior to clearing.

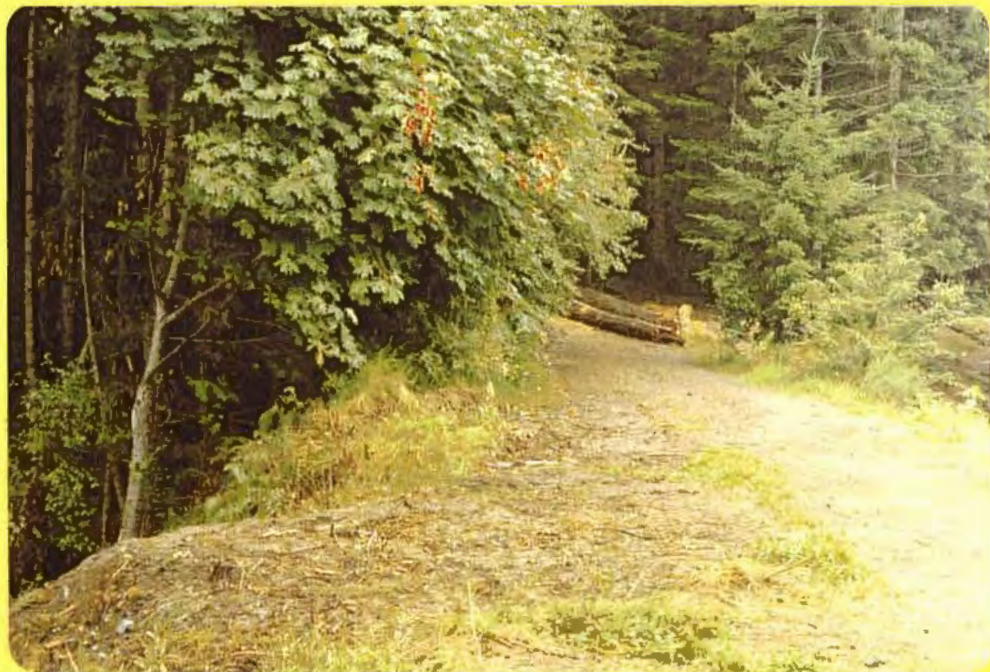
Crest viewed from spillway bridge prior to clearing.

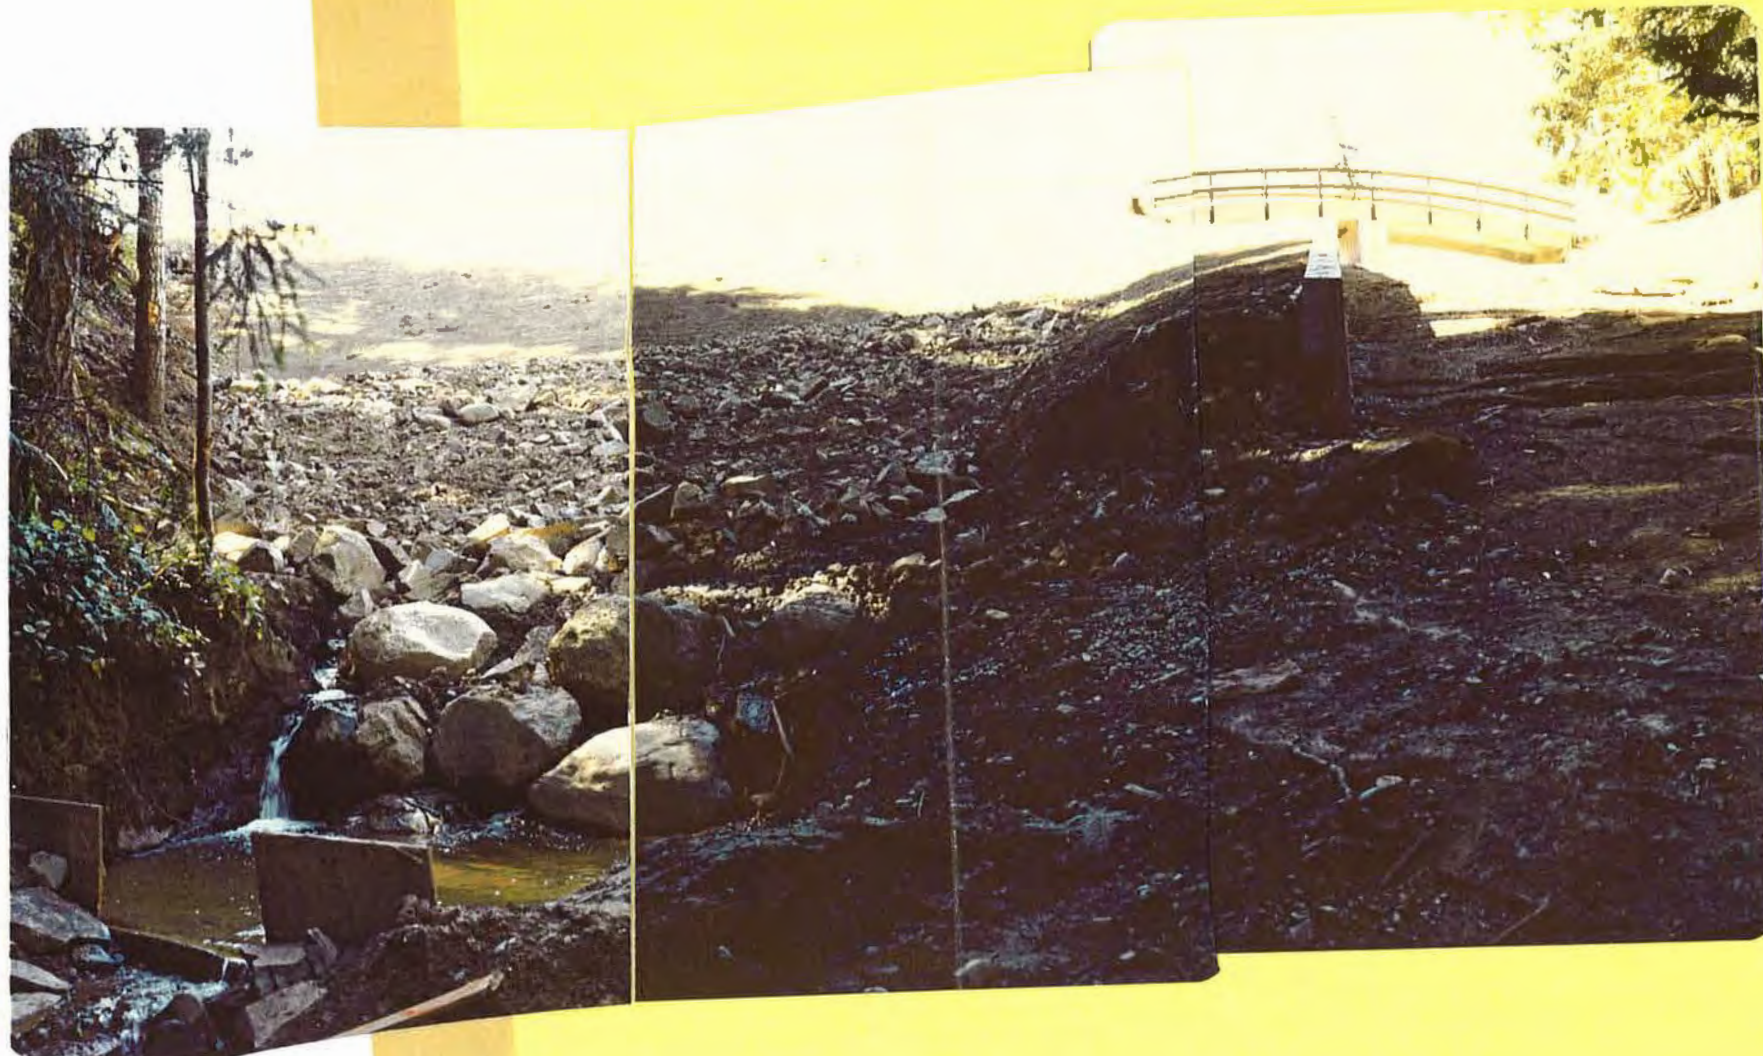
Seepage weir, downstream face of dam and spillway.

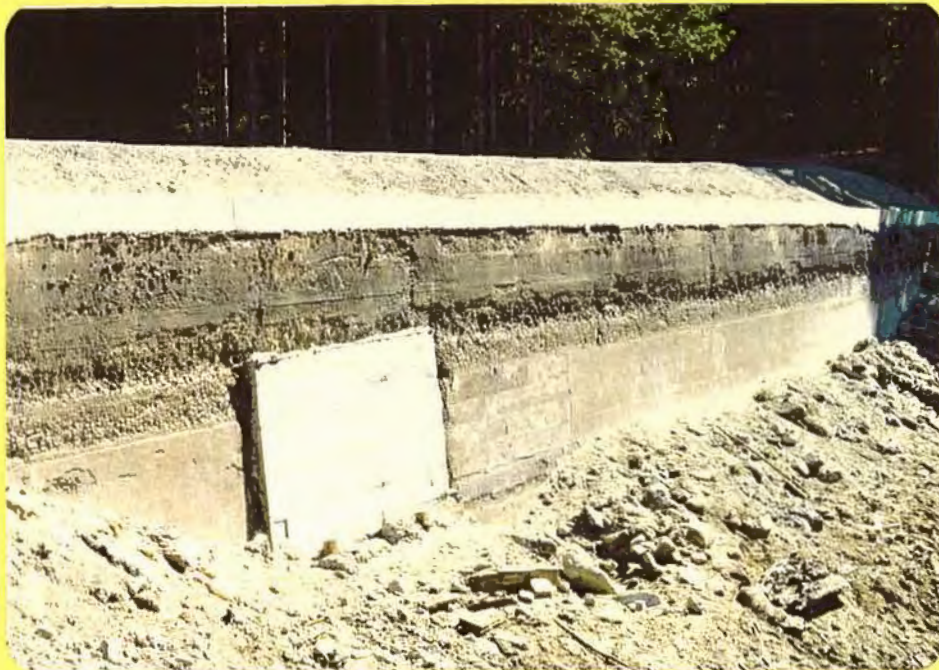
Upstream face of dam showing one foot high concrete wall addition and concrete plug at old outlet area. Note also deterioration of existing concrete.

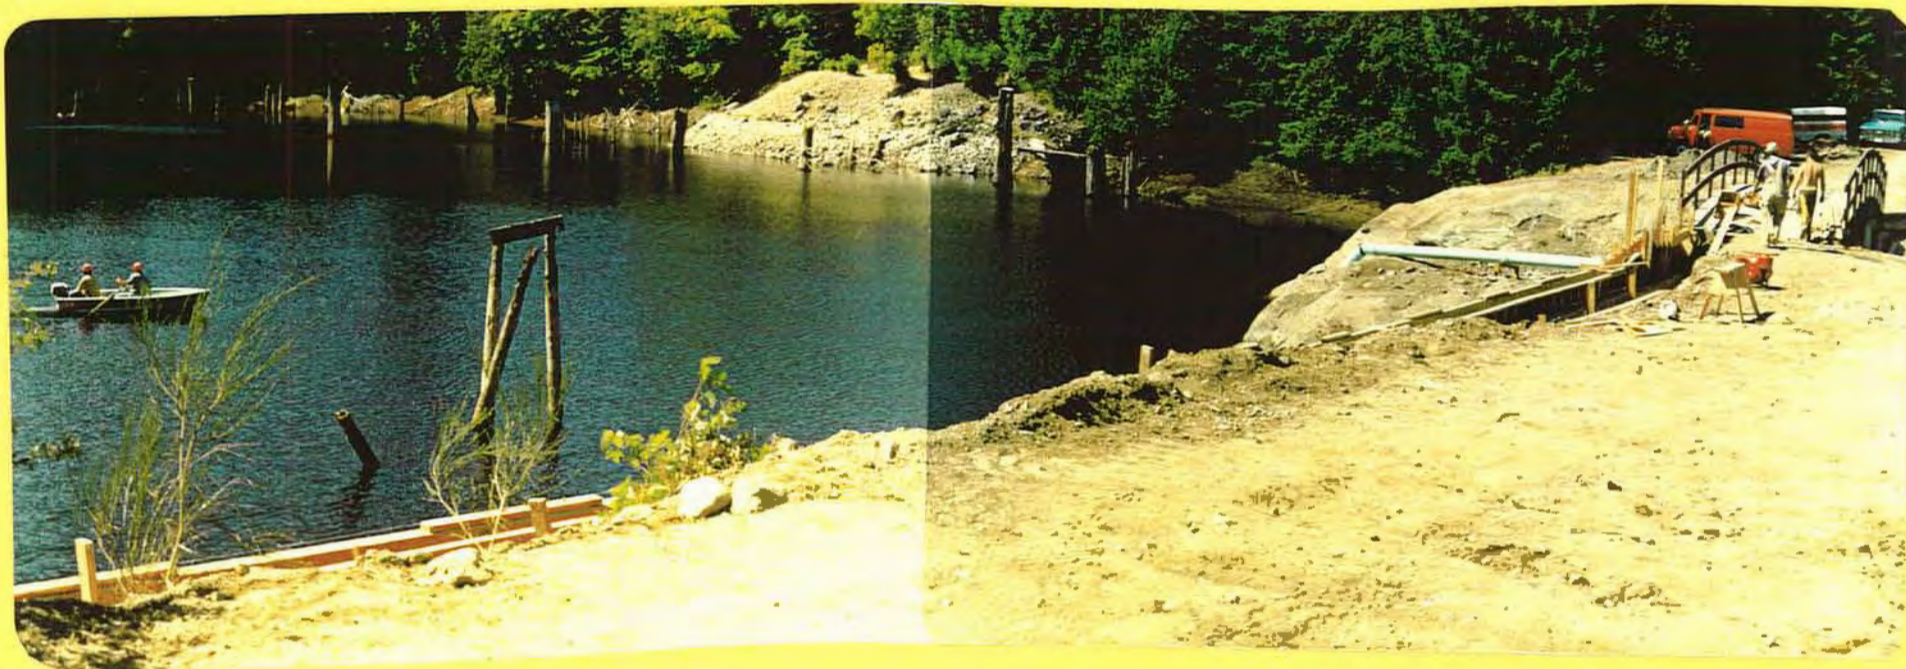
Upstream face of dam showing remains of low level outlet  
upstream gate. Diver had located the top of the valve.

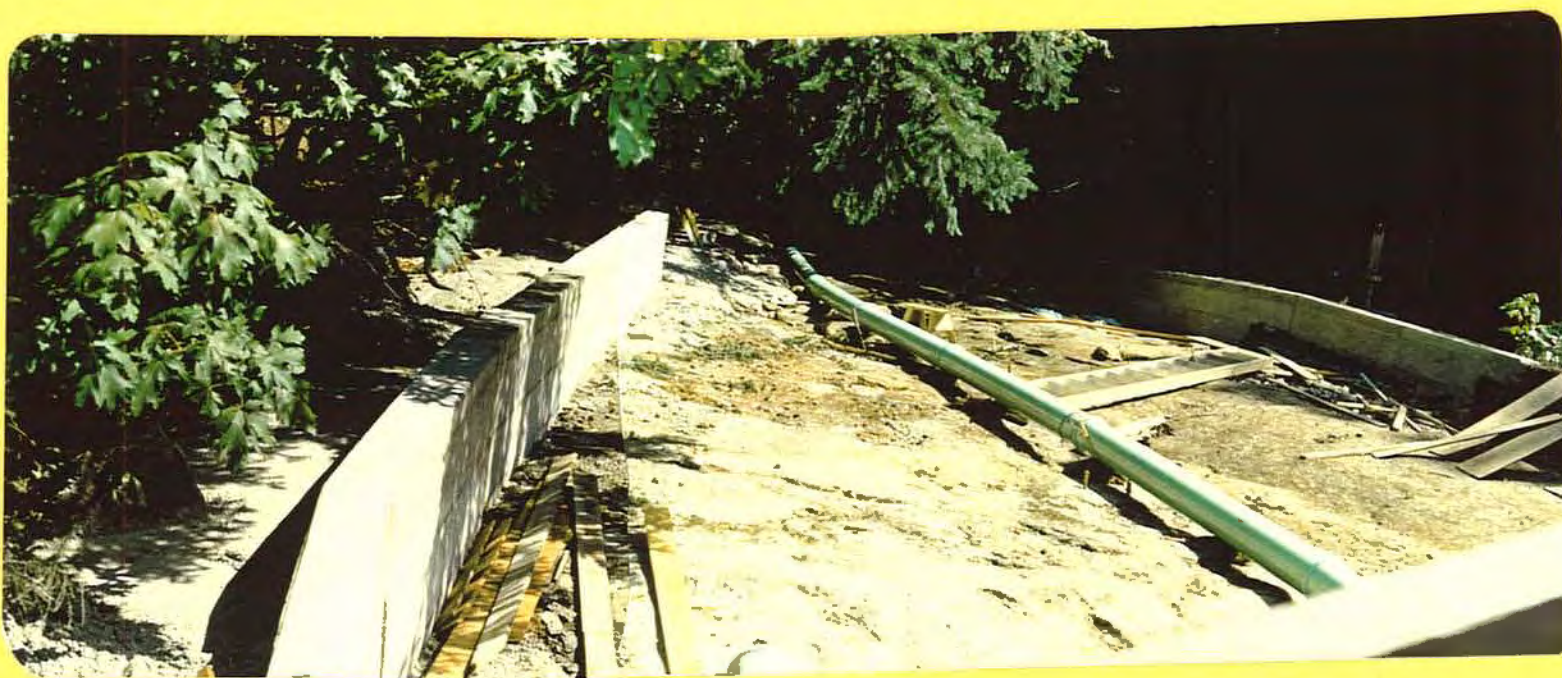
Spillway channel during rehabilitation. Note green 12"  
siphon used to draw the lake down.

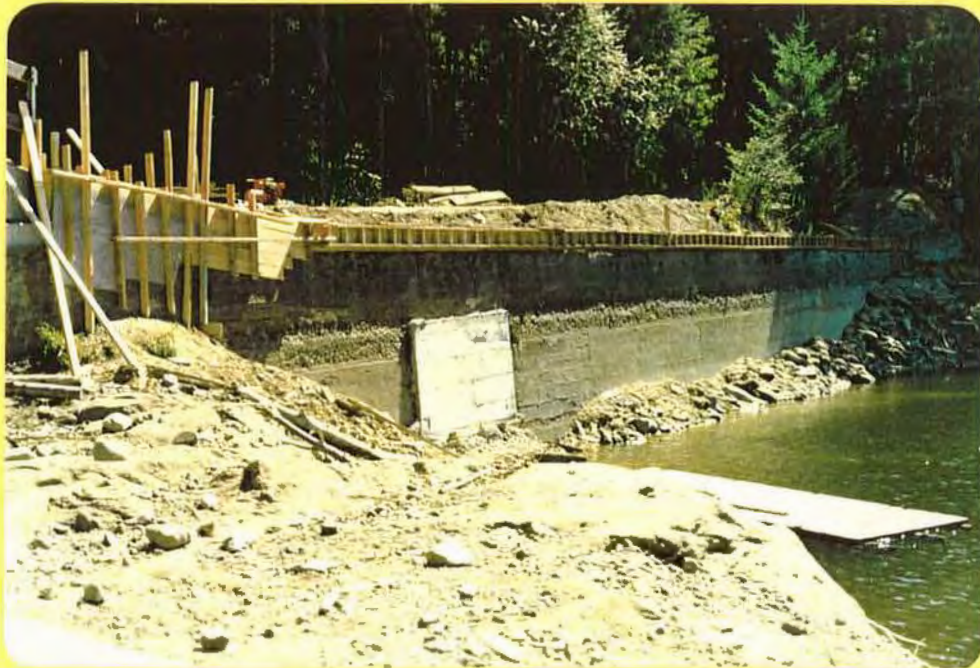
A concrete plug was used to patch a hole through the dam. Although no date was available the hole had been made several years ago for rapid drawdown during heavy rains.

Concrete plug from upstream face after stripping.

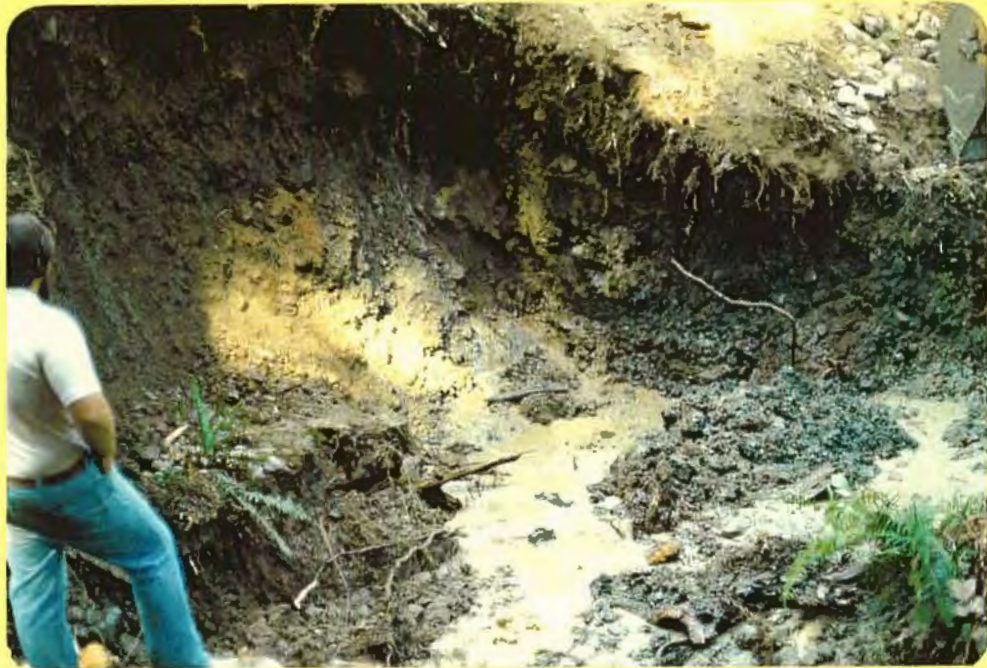
Seepages at downstream toe prior to excavation.

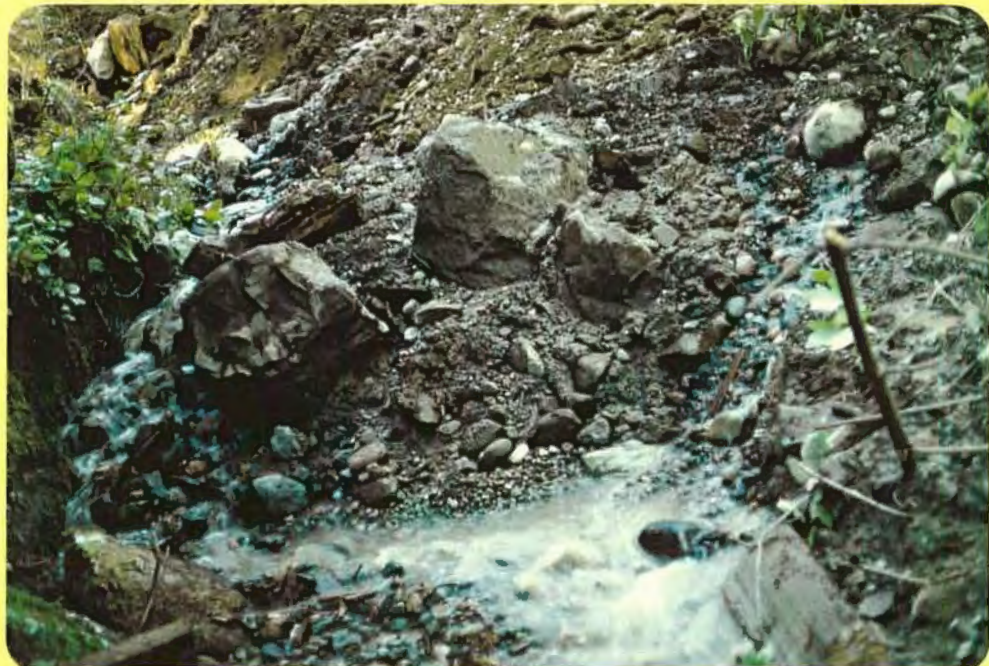
Heavy seepage noted passing through the original fill.

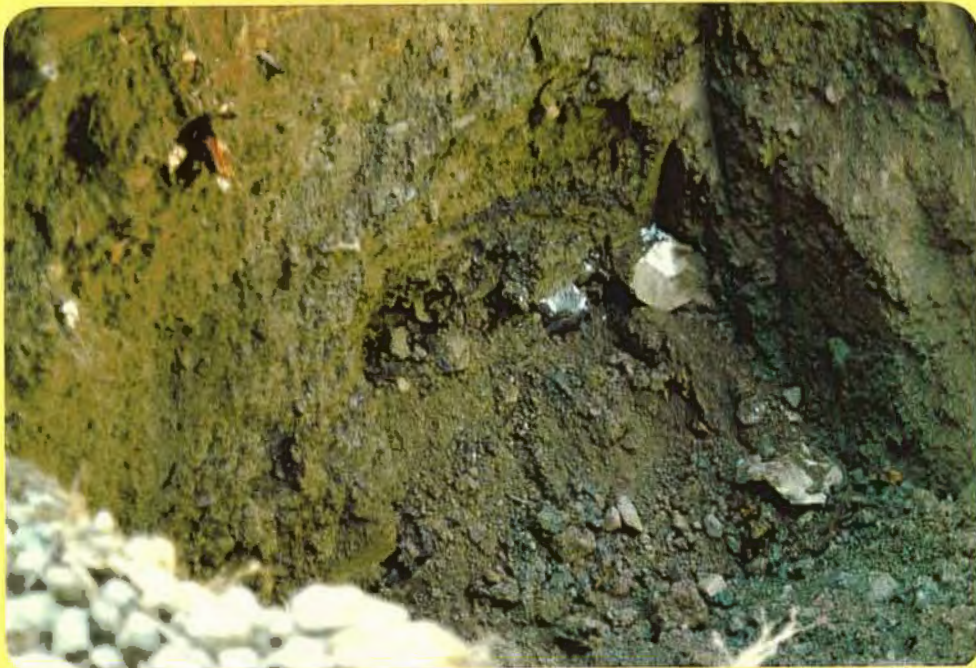
Beginning of original log crib dam was exposed - note log protruding from fill.

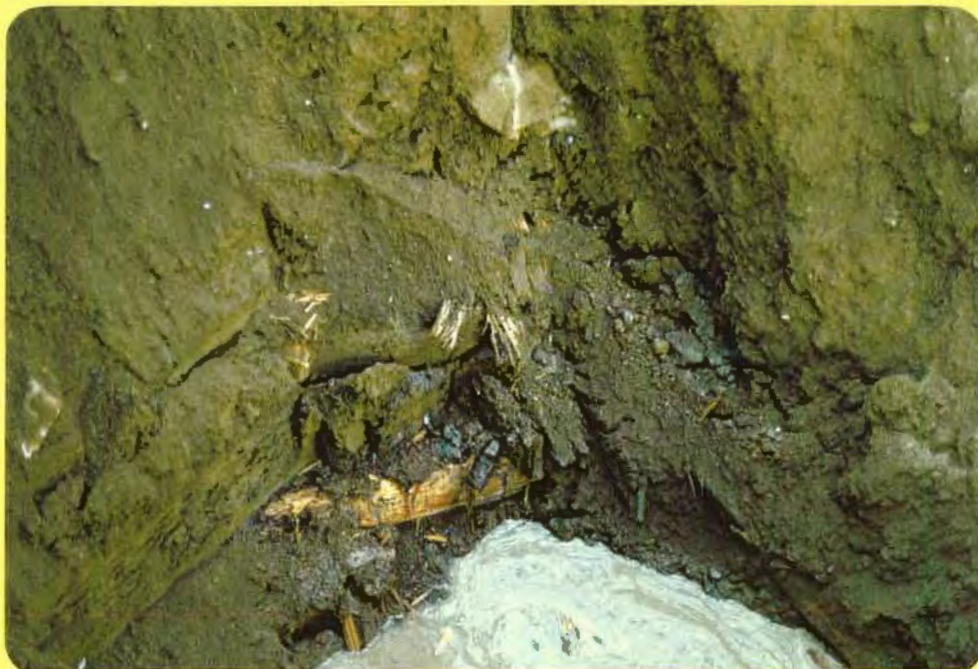
Original log crib dam exposed - logs were still intact.

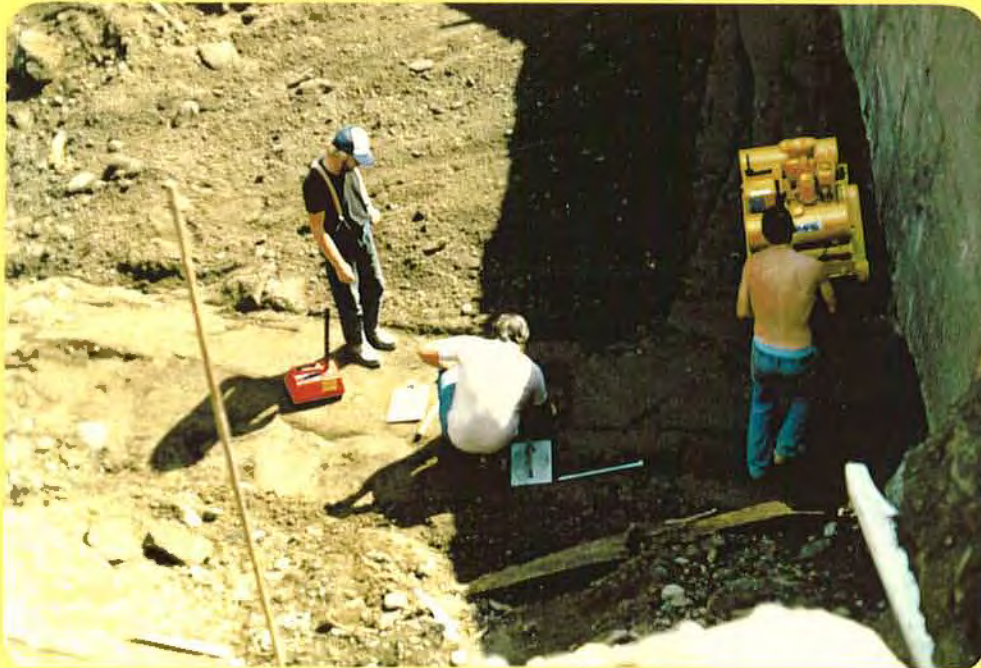
Replacement of fill in 12-18" lifts. A nuclear density tester was used to monitor compaction and moisture content after compaction on each lift.

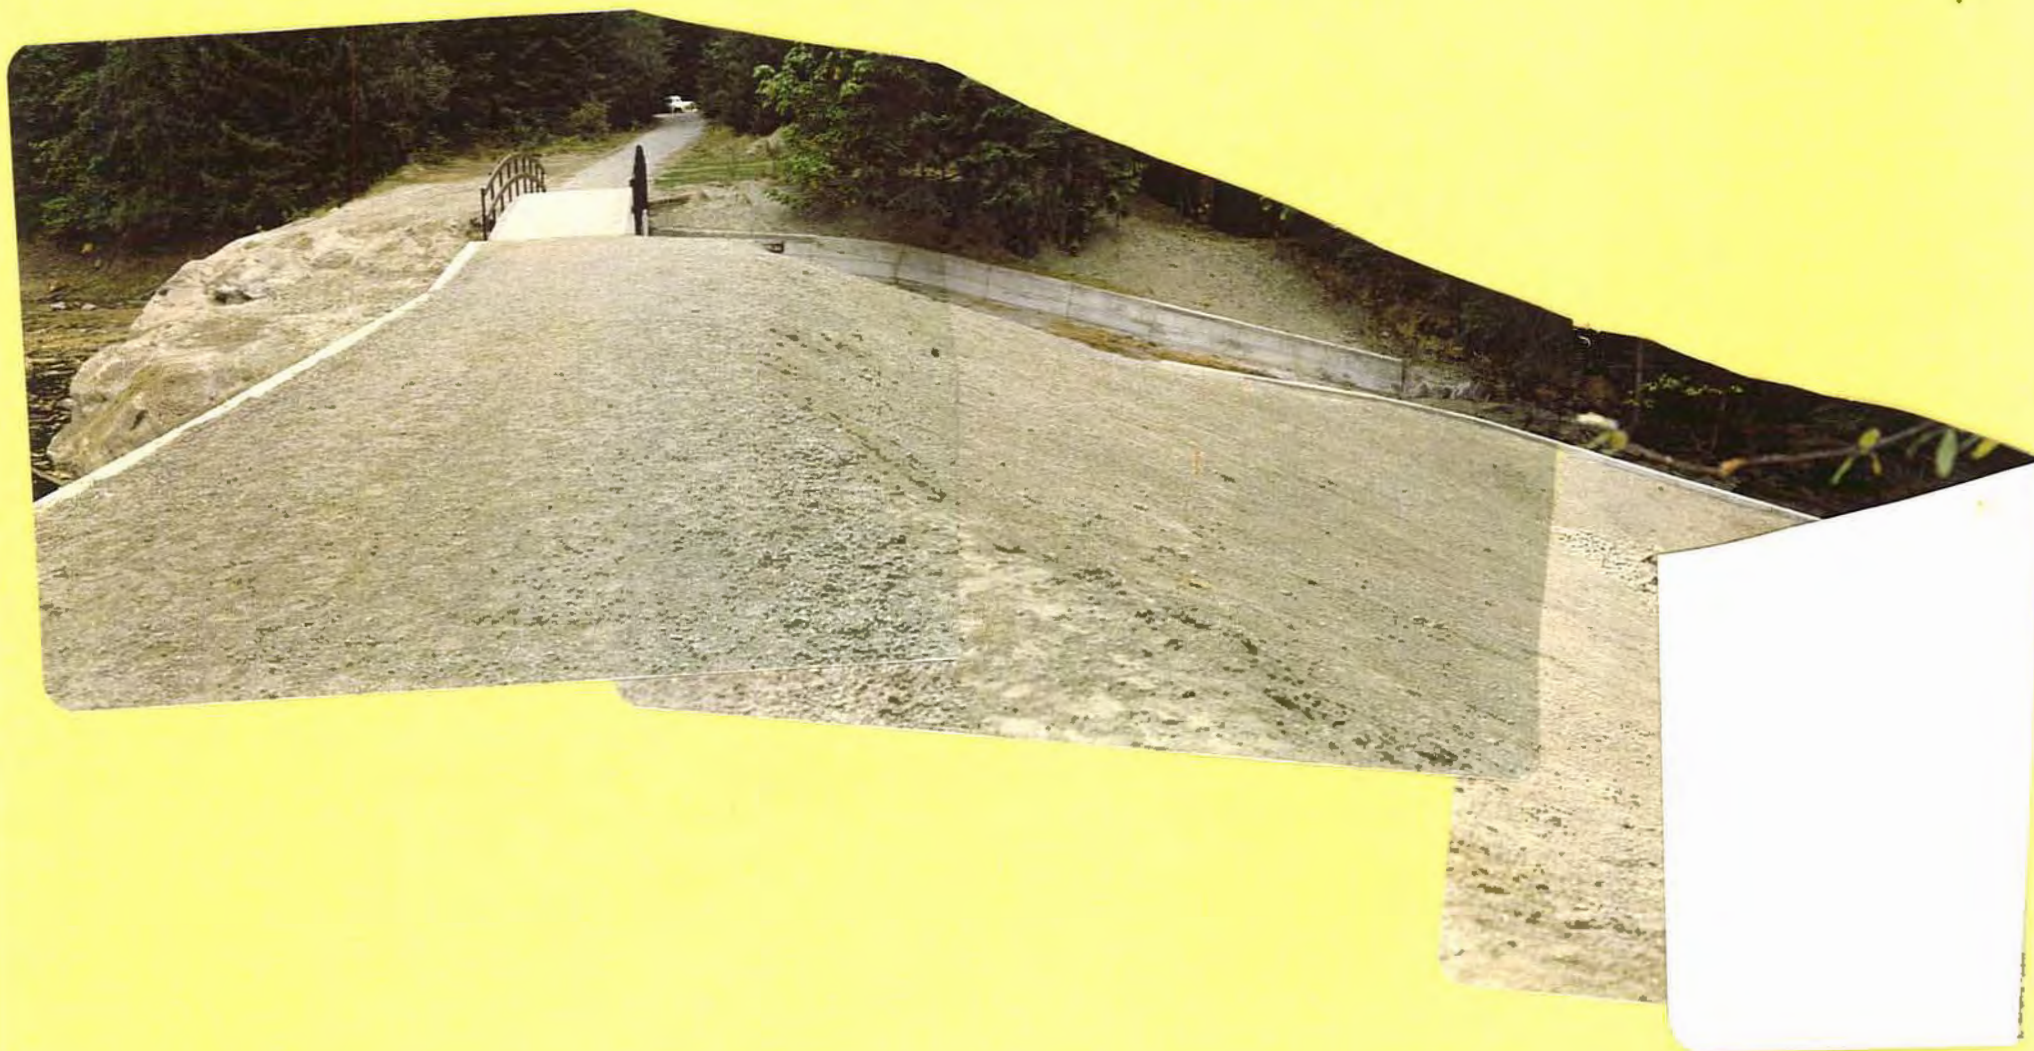
Recently repaired dam - note coarse drainrock at base  
to accommodate heavy seepages.

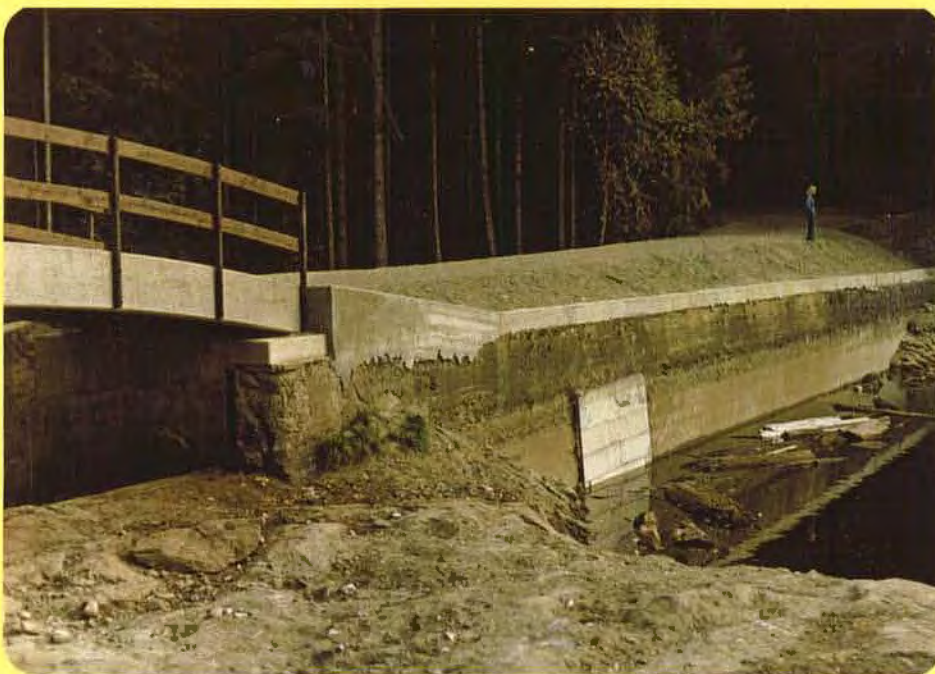
Upstream face of completed renovations.  
Note concrete plug repairing hole  
through concrete face.

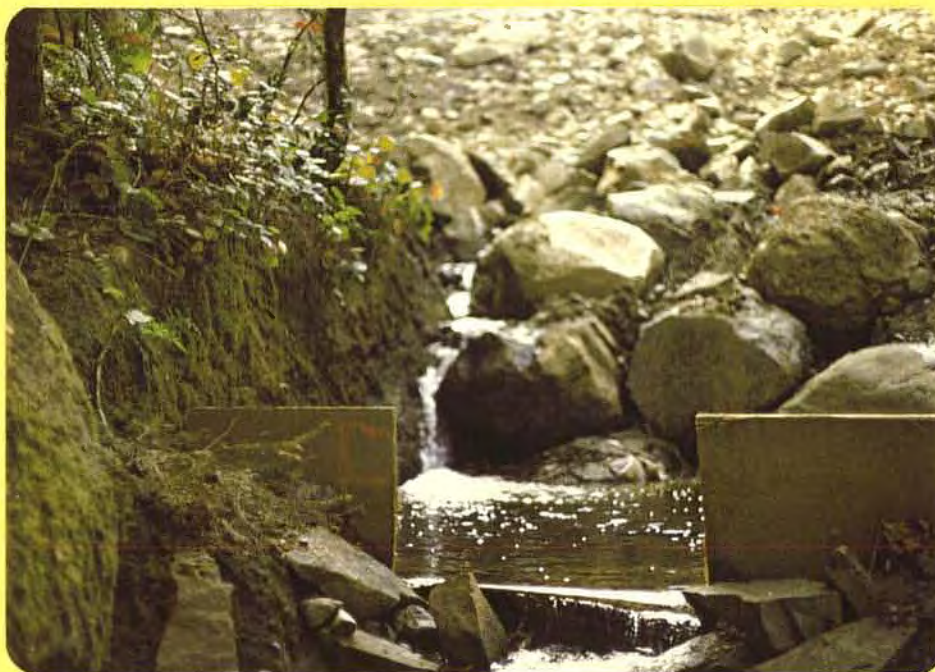
Temporary weir monitoring heavy seepages.

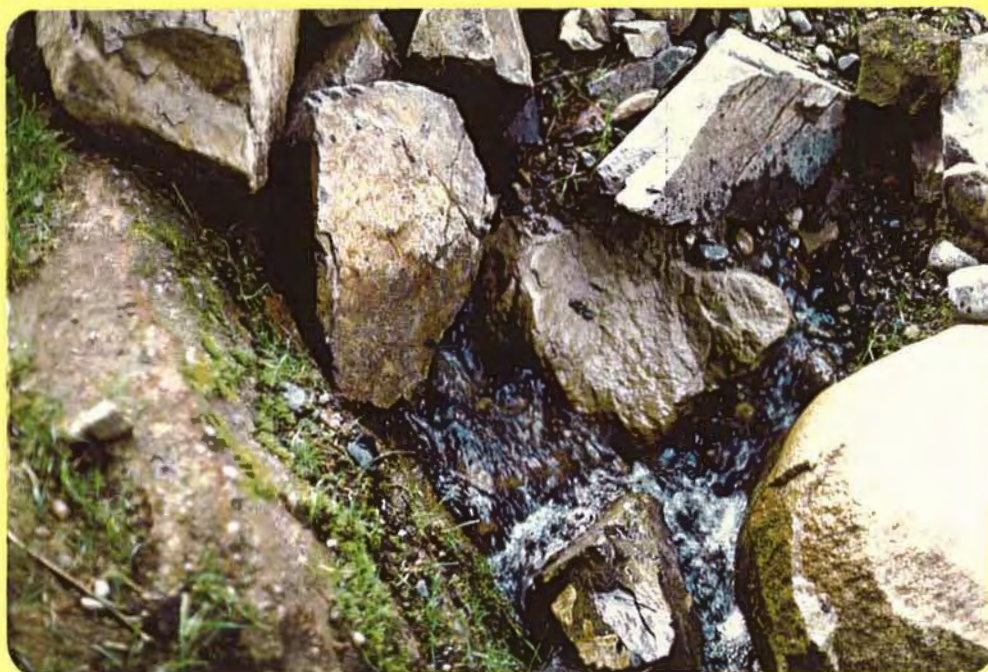
Seepage at downstream toe.
