HOWARD DAM #4  
~~HARWOOD DAM #2~~

September 1, 1976.

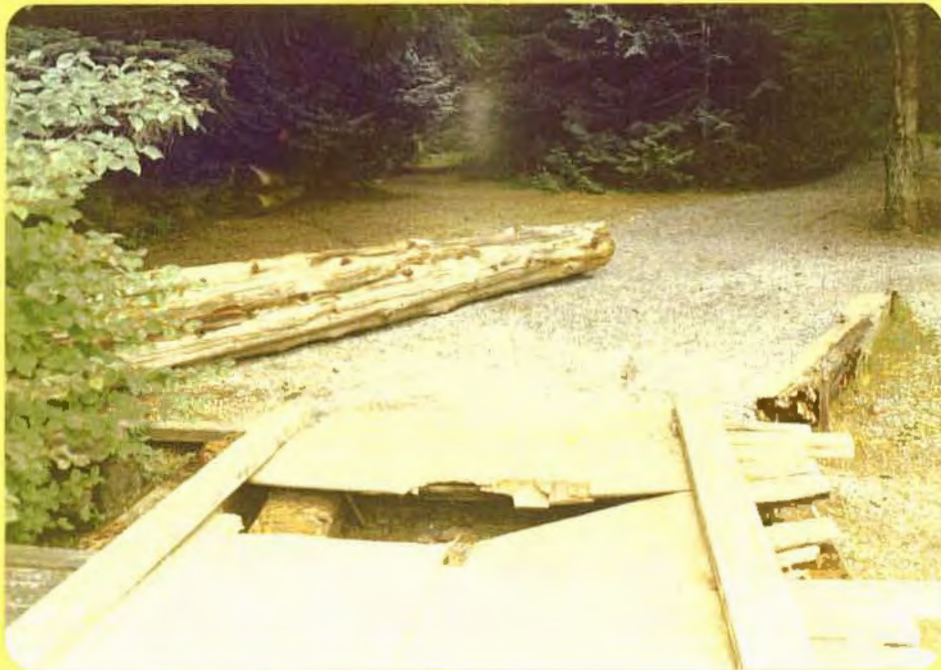
Spillway bridge. Note repairs needed.

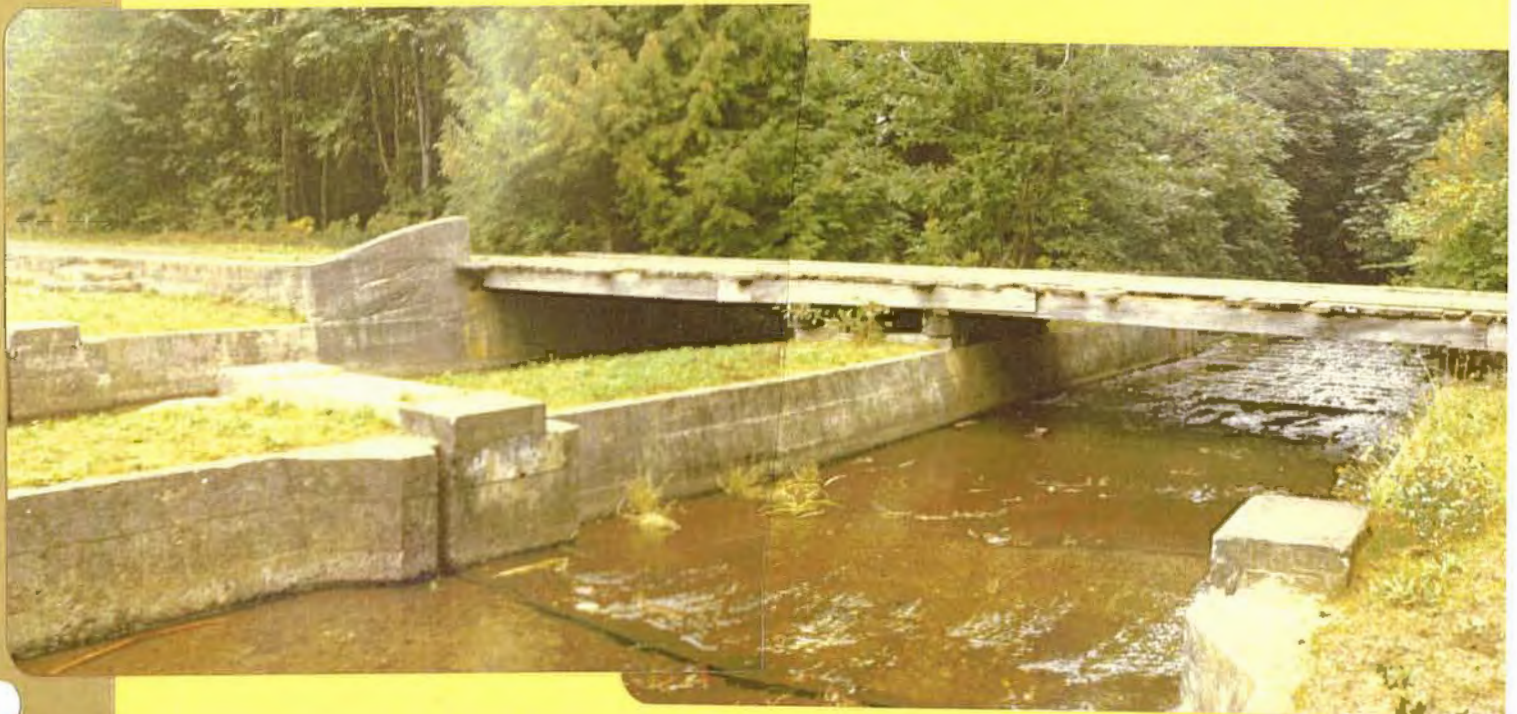
Spillway bridge on Dam centreline.

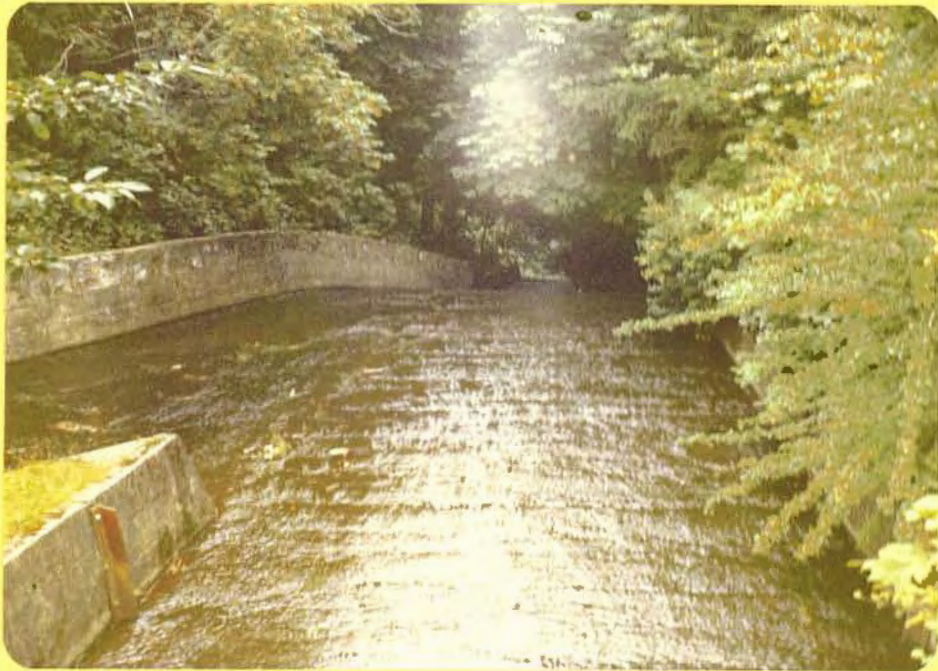
Spillway chute downstream of bridge.

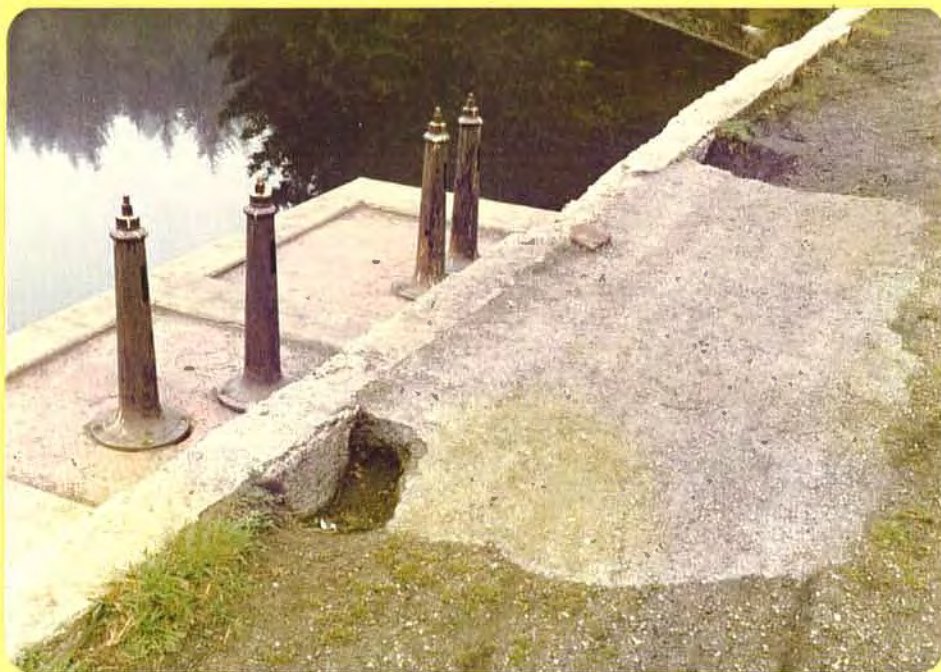
Sluice gates and area where dam crest fill has eroded away.

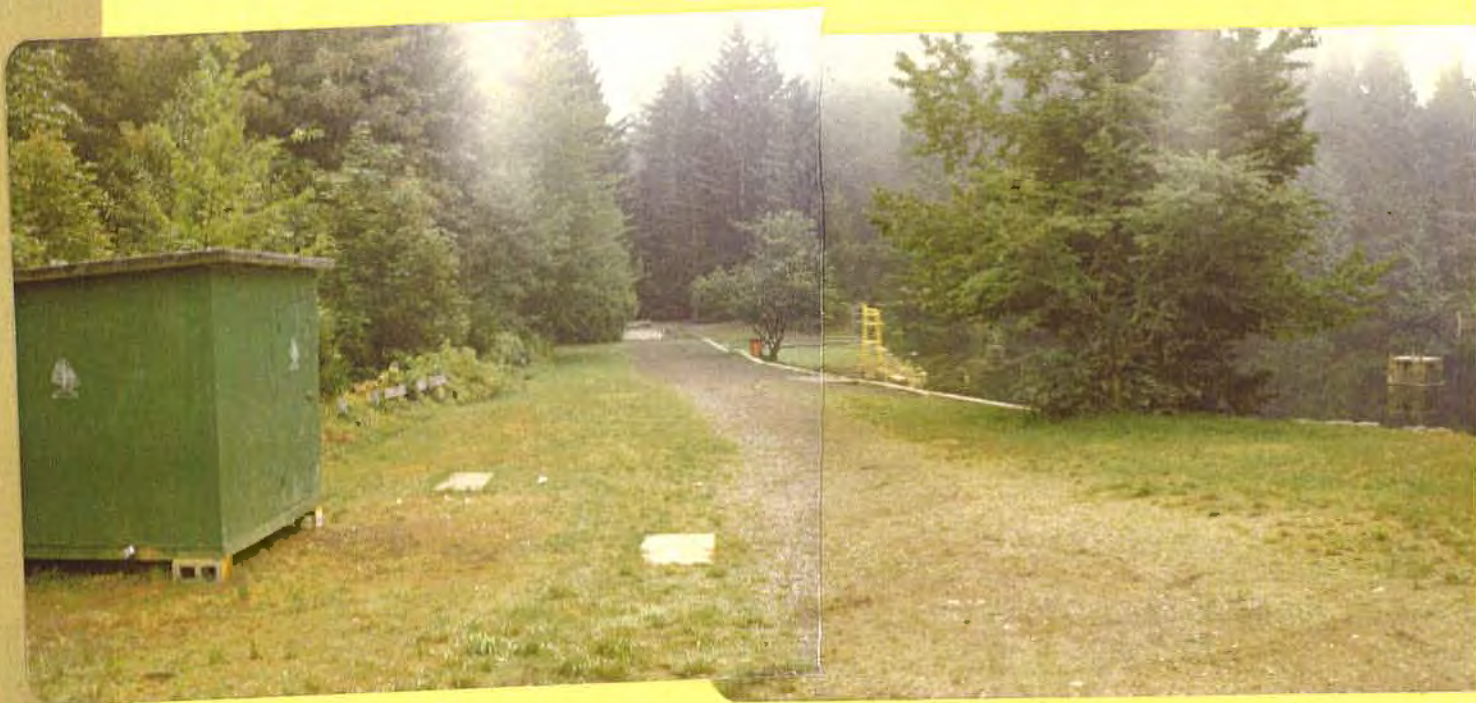
#137  
Crest of dam and reservoir. Note heavy growth on downstream face of dam.

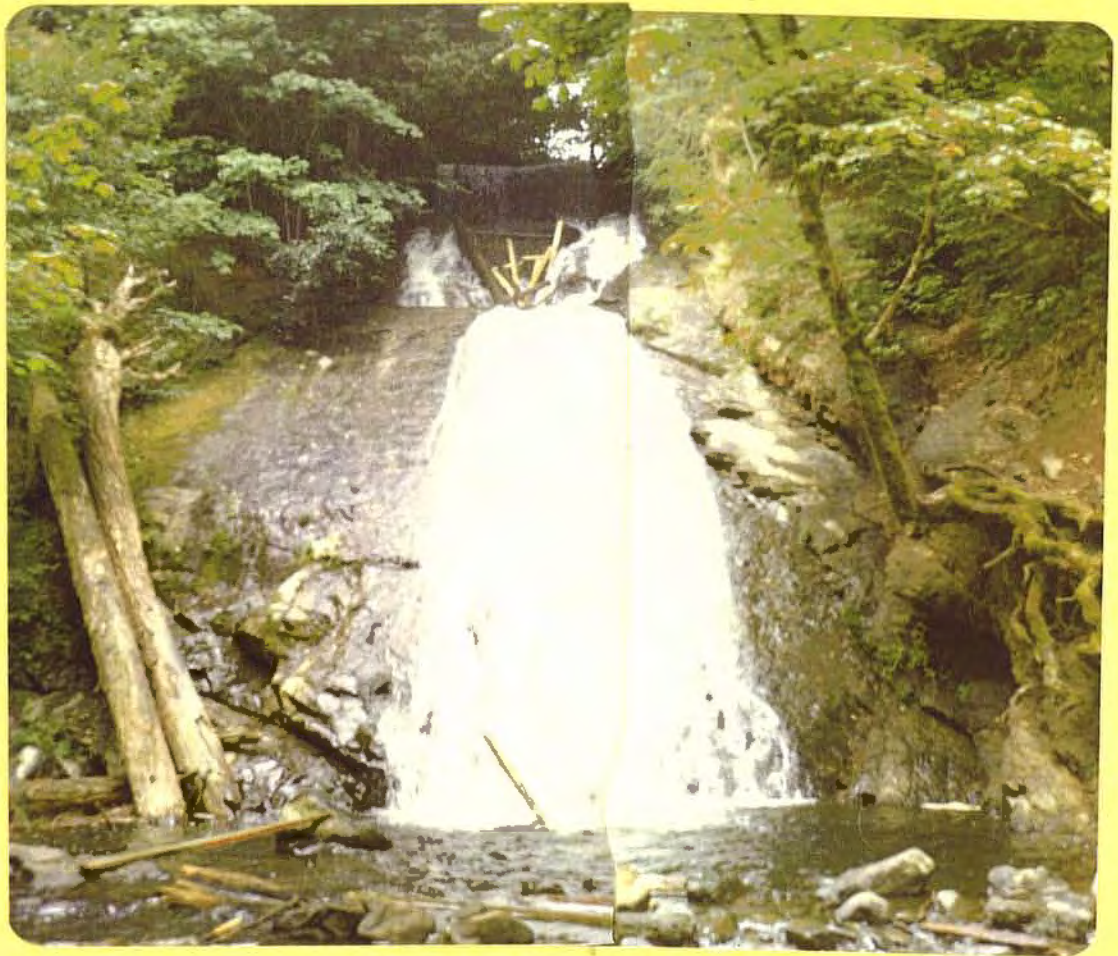
Spillway chute and plunge pool from downstream.

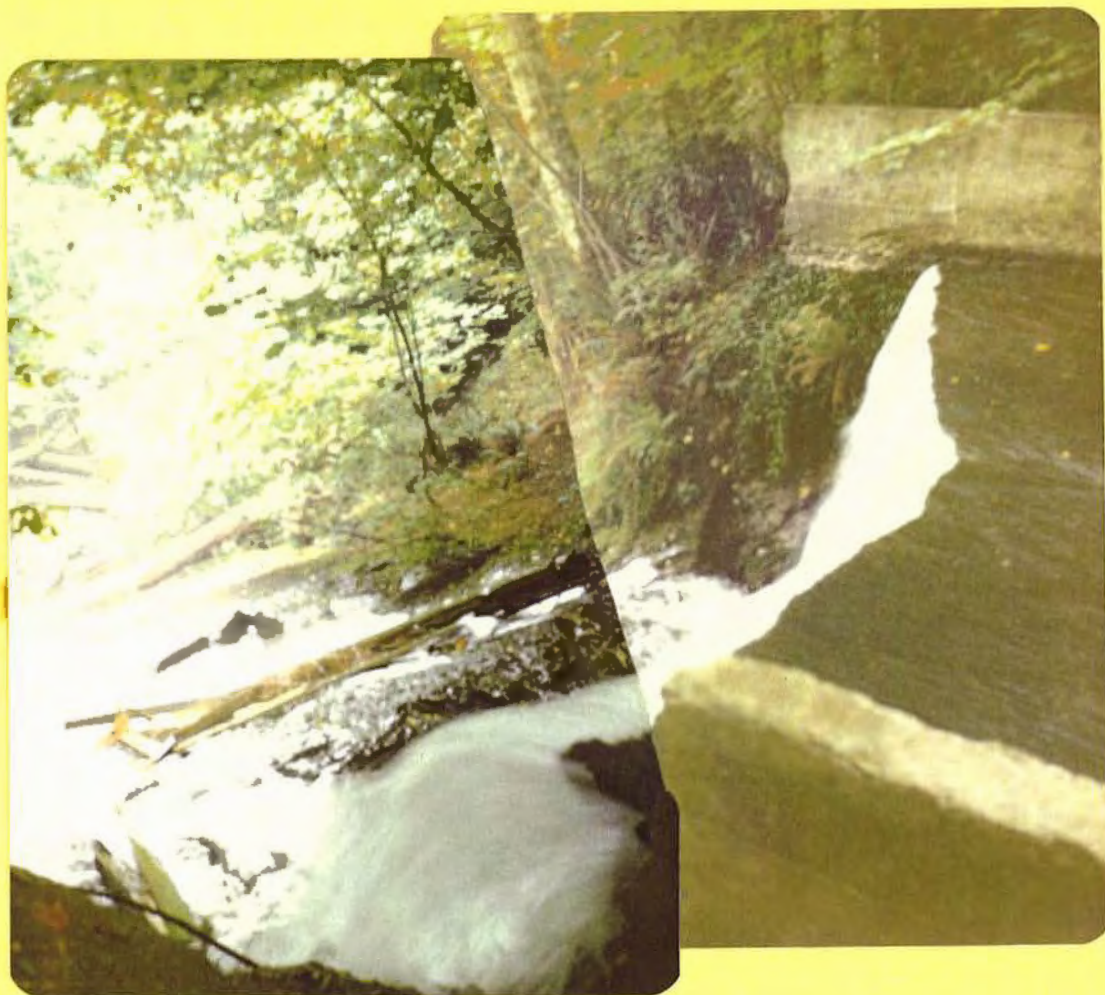
End of spillway chute showing concrete erosion water falls on sound rock.

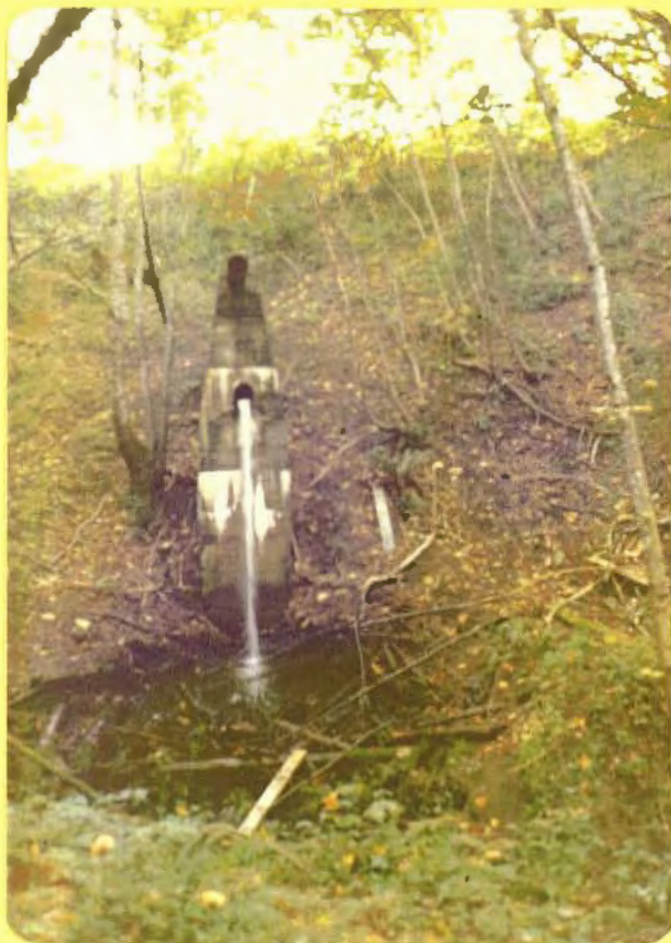
Two level sluice and  
plunge pool.

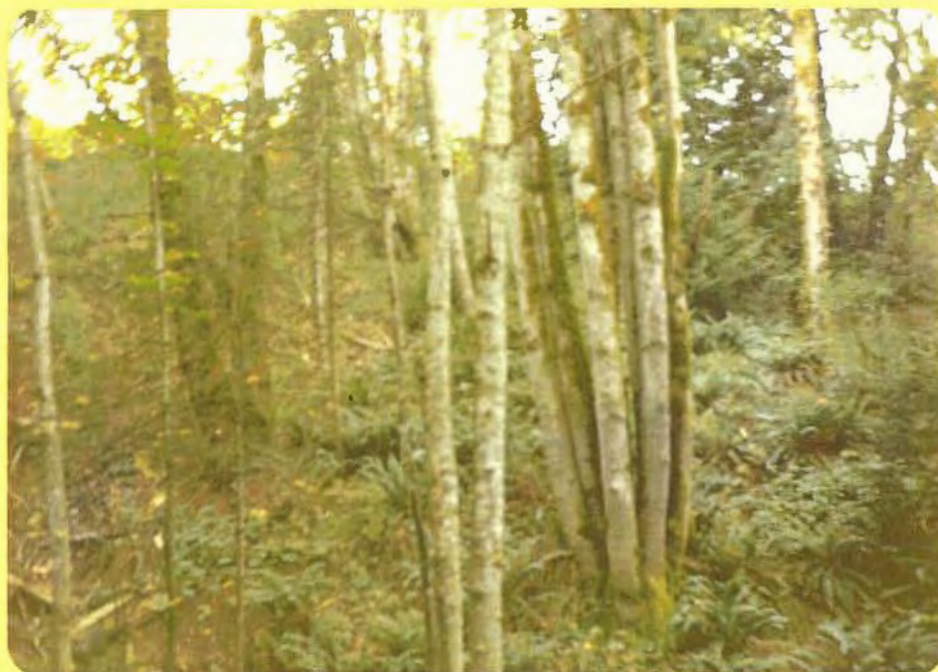
Typical overgrowth on downstream face of dam.

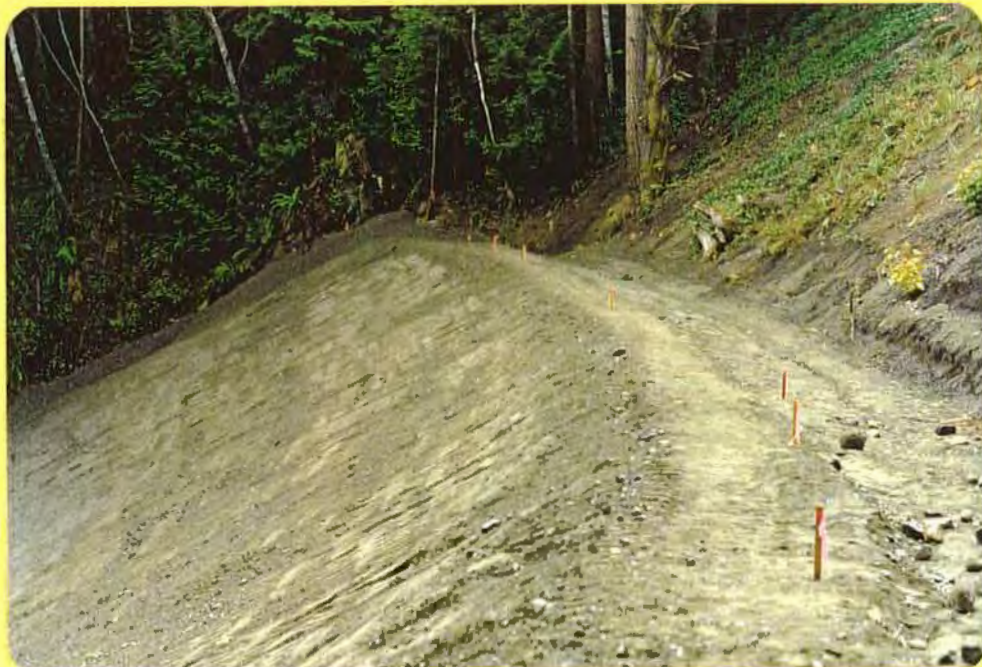
Stabilizing berm viewed from left abutment  
area.

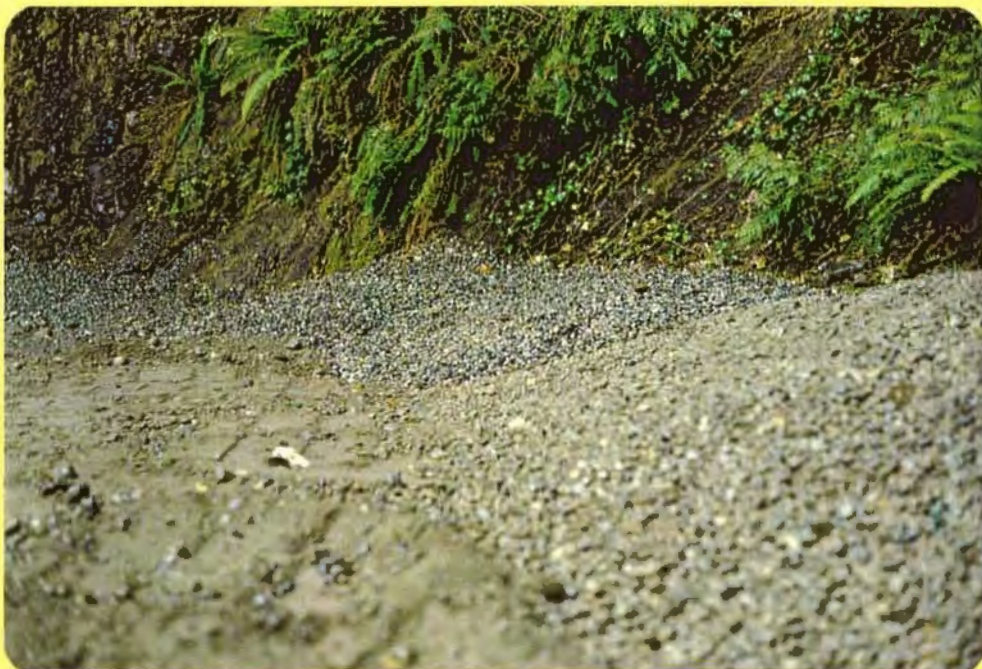
Filter material placed along abutment contact.

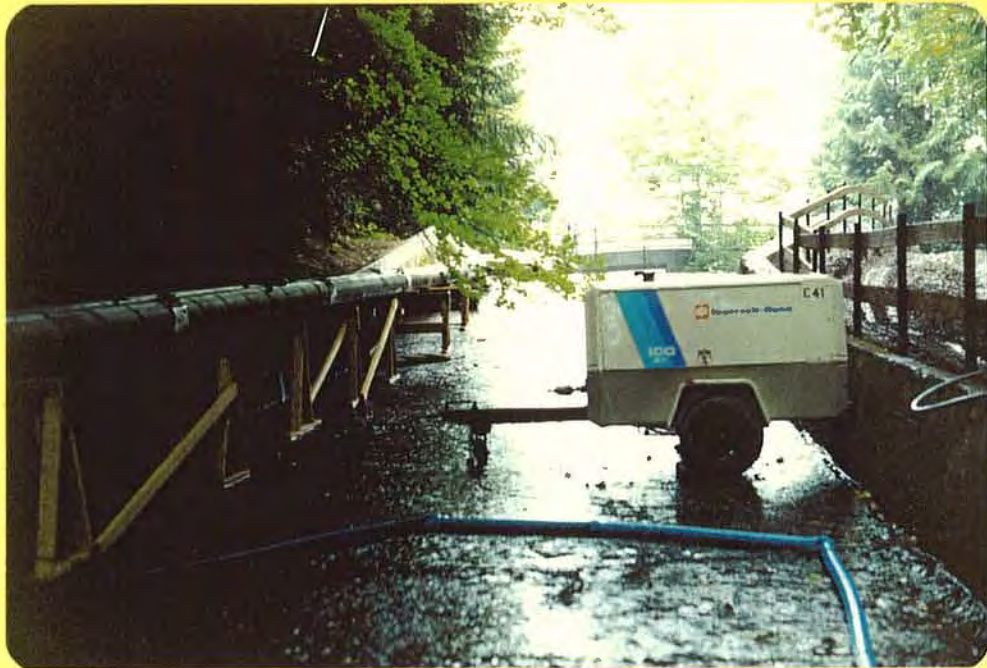
Diversion of spillway flows while  
undertaking spillway repairs.

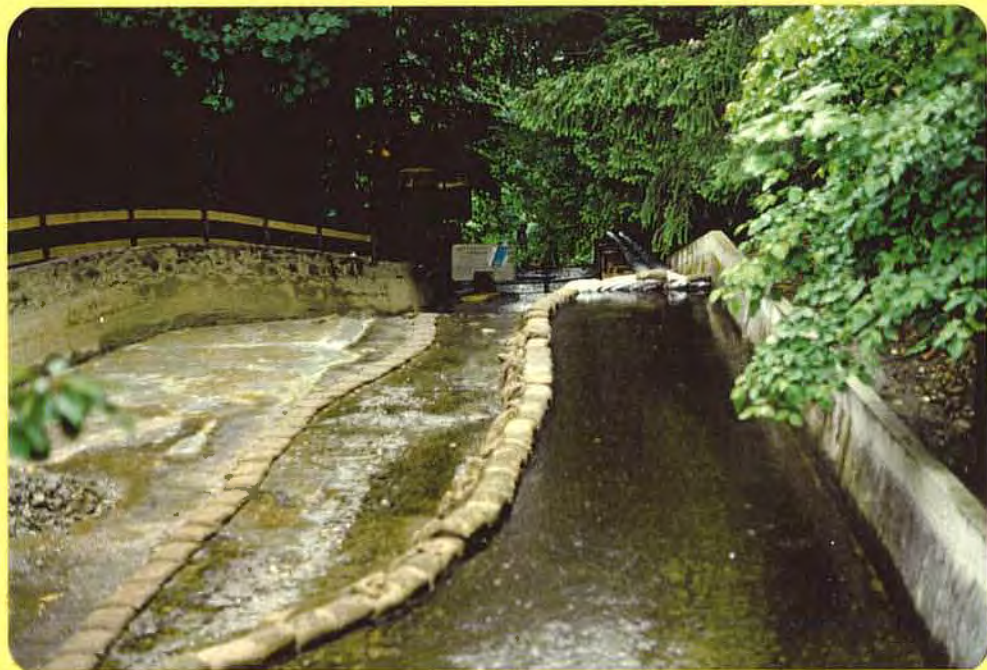
Sandbagging employed to divert water  
through 2-12" C.M.D. culverts while  
spillway repairs are undertaken.

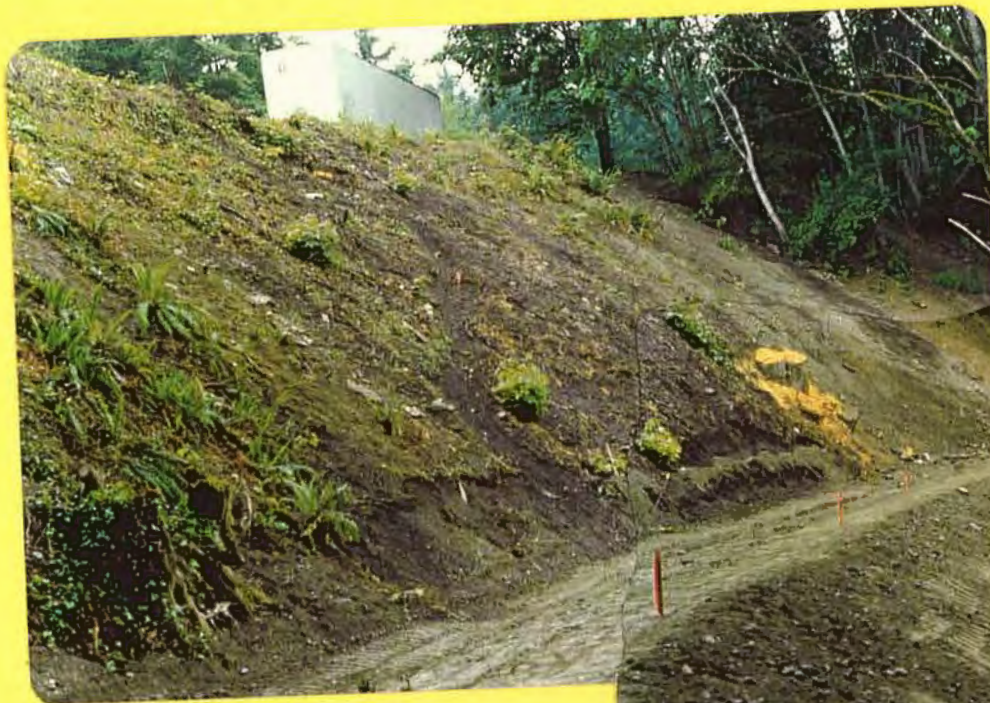
Stabilizing berm viewed from the right abutment contact.

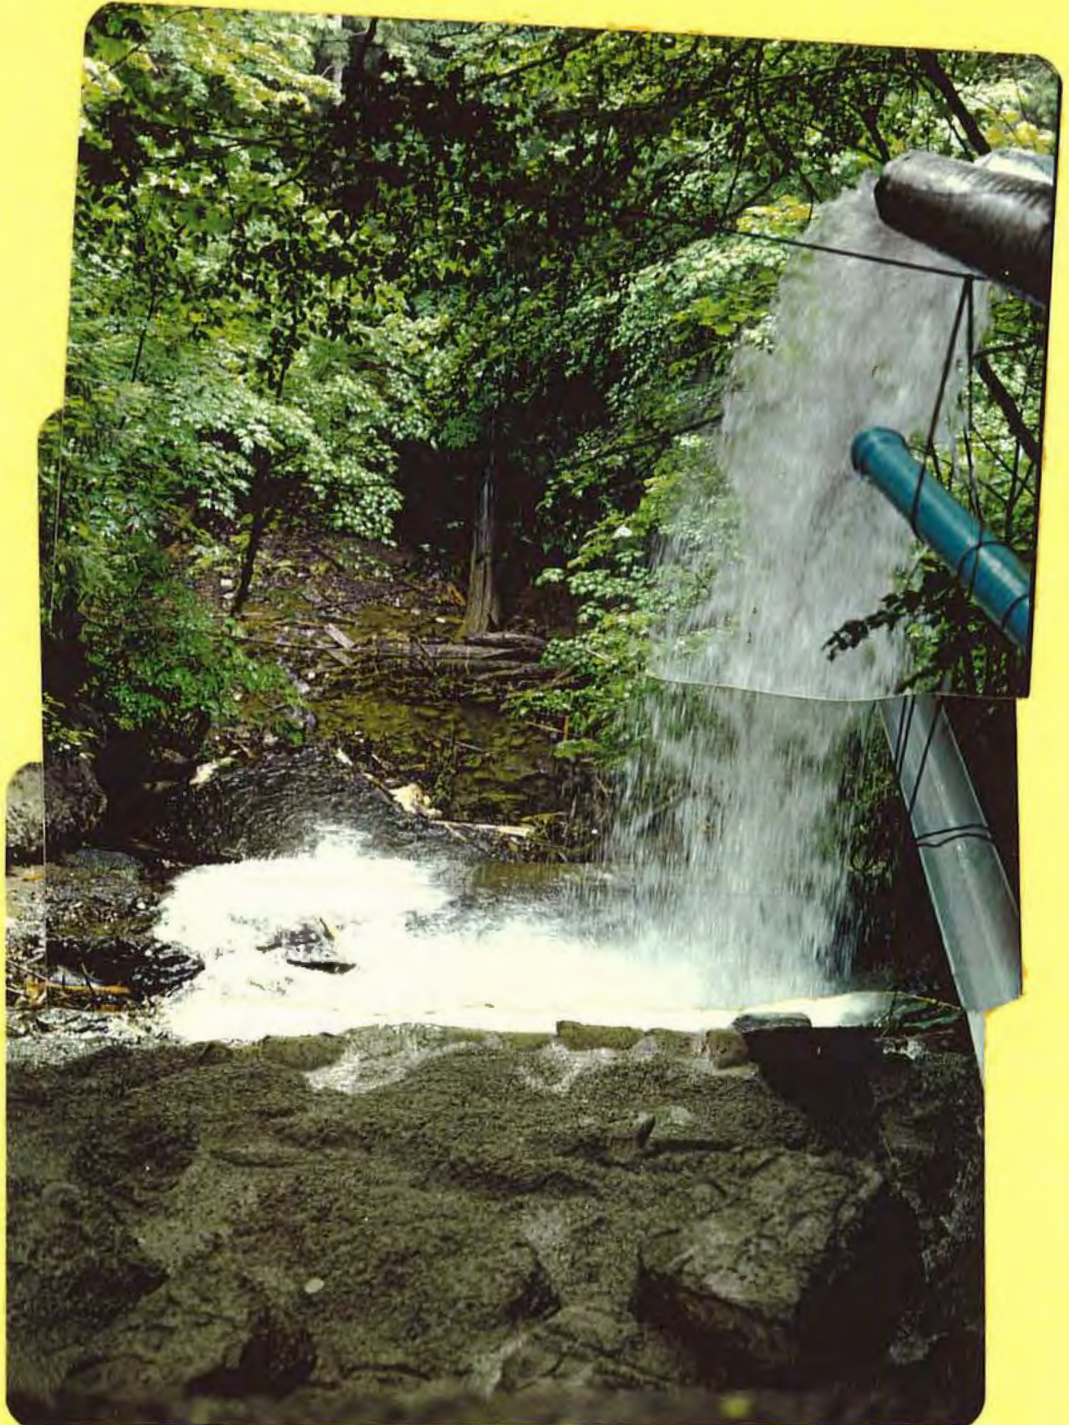
Repairs to the end of the spillway chute.

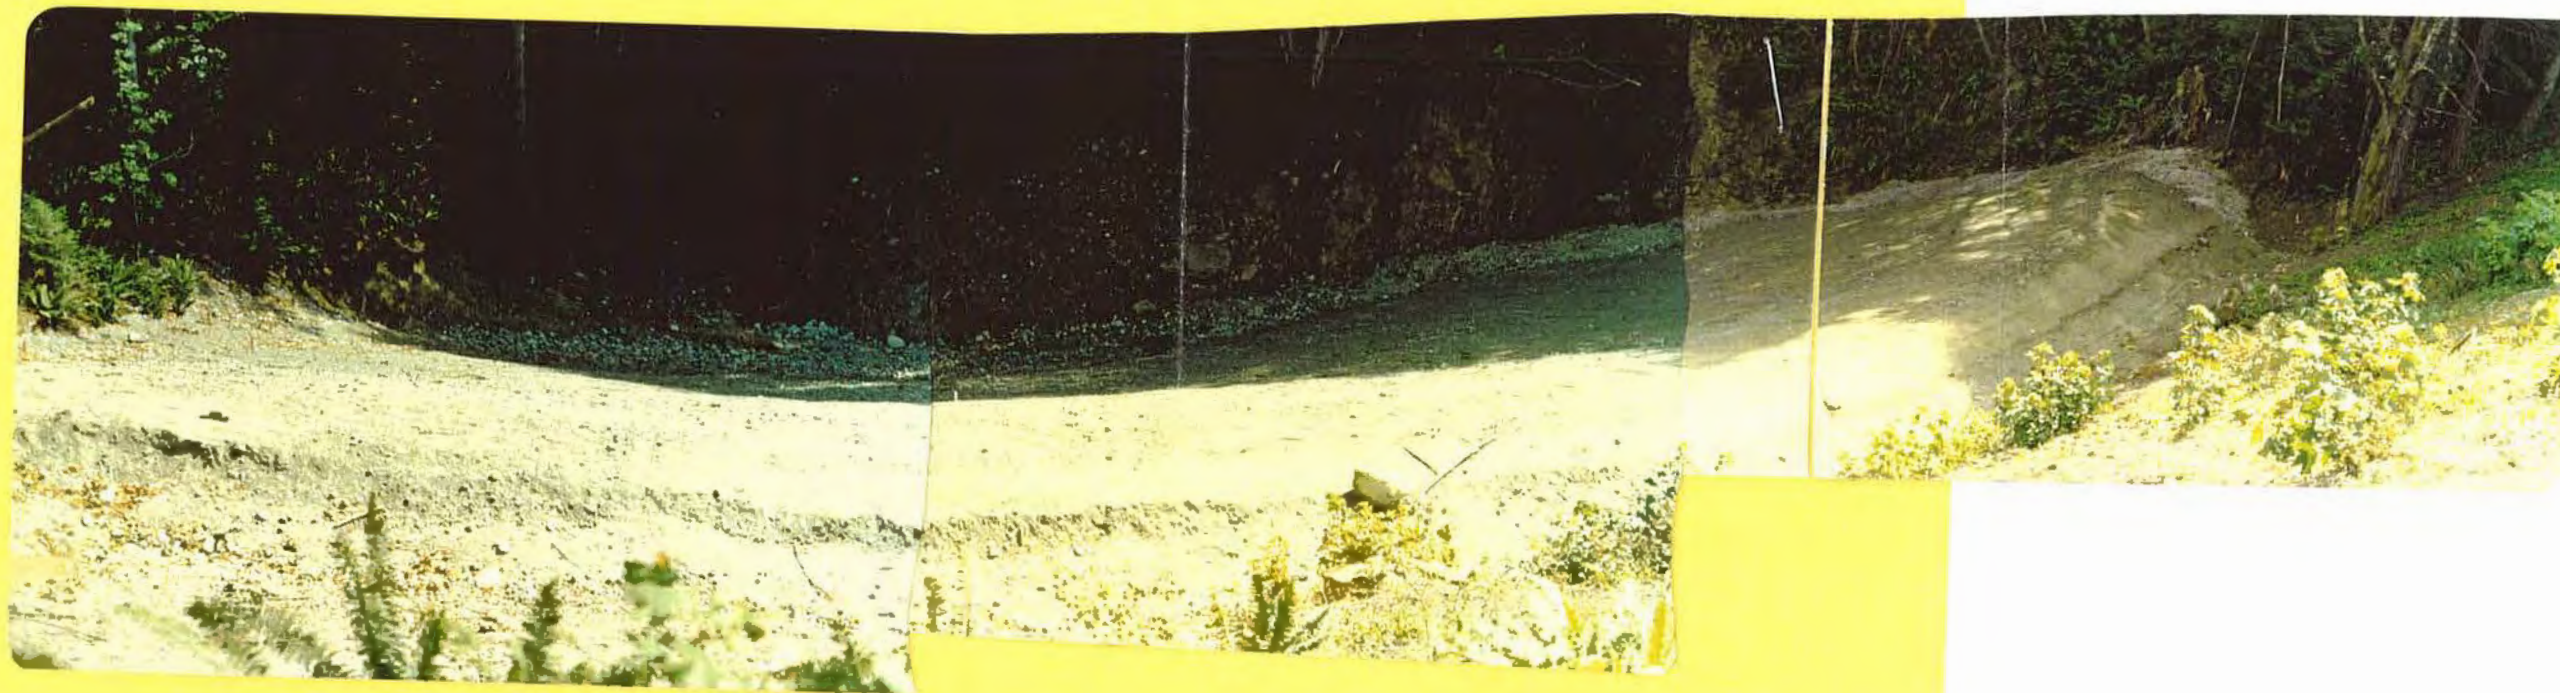
Downstream face of recent rehabilitation including a  
filter blanket and toe drain.

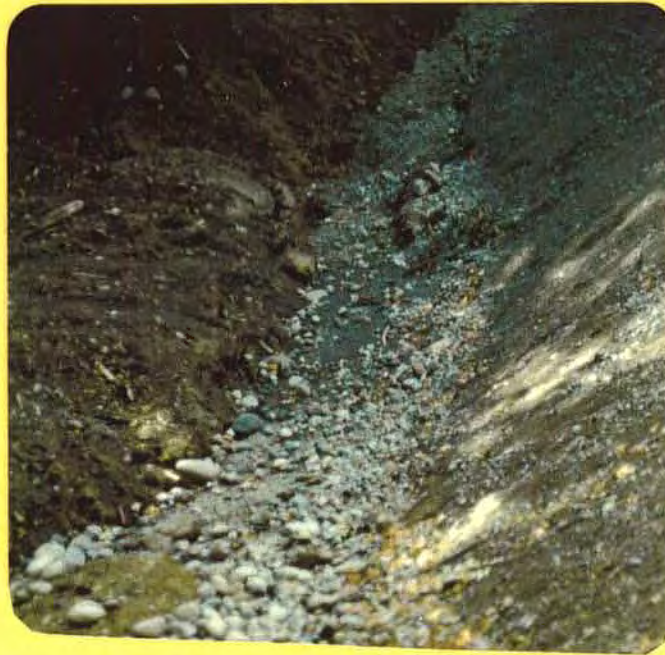
Drain rock toe drain used to pick up embankment seepages.

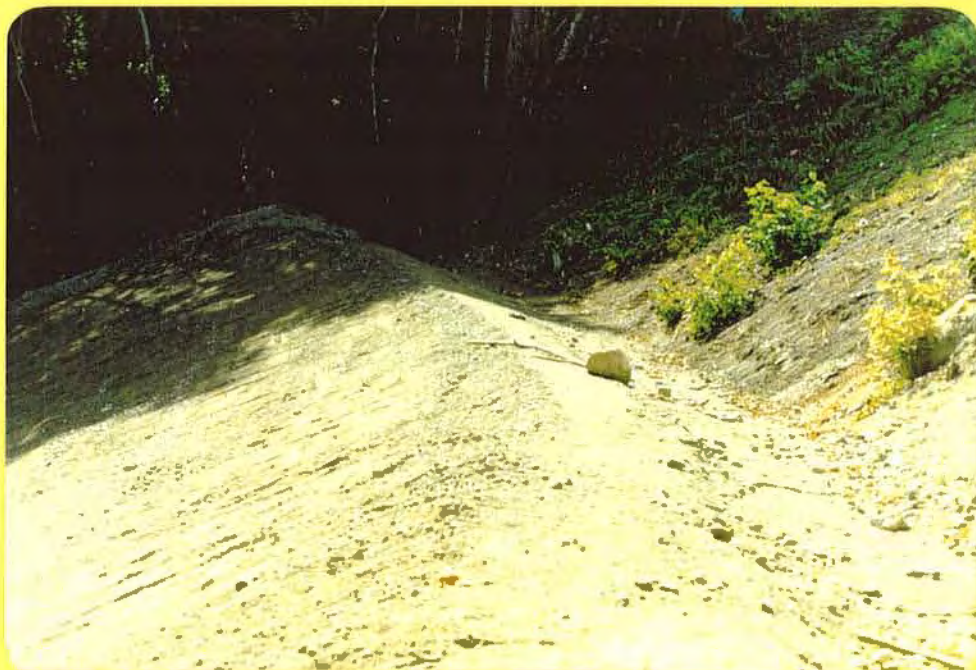
Top of filter blanket berm from left abutment.

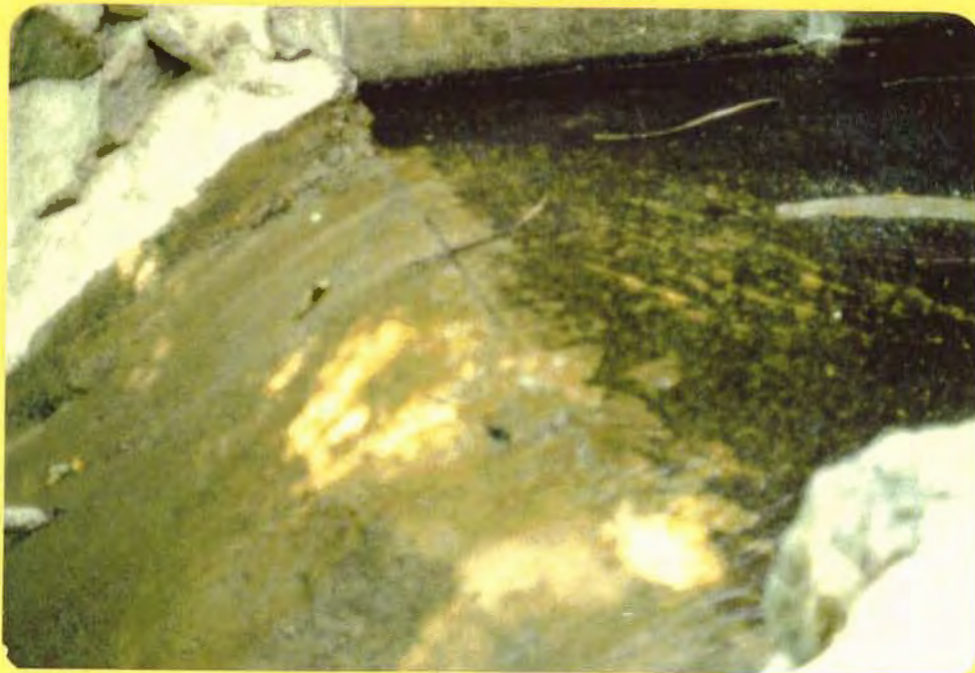
Toe of spillway patched during recent rehabilitation.

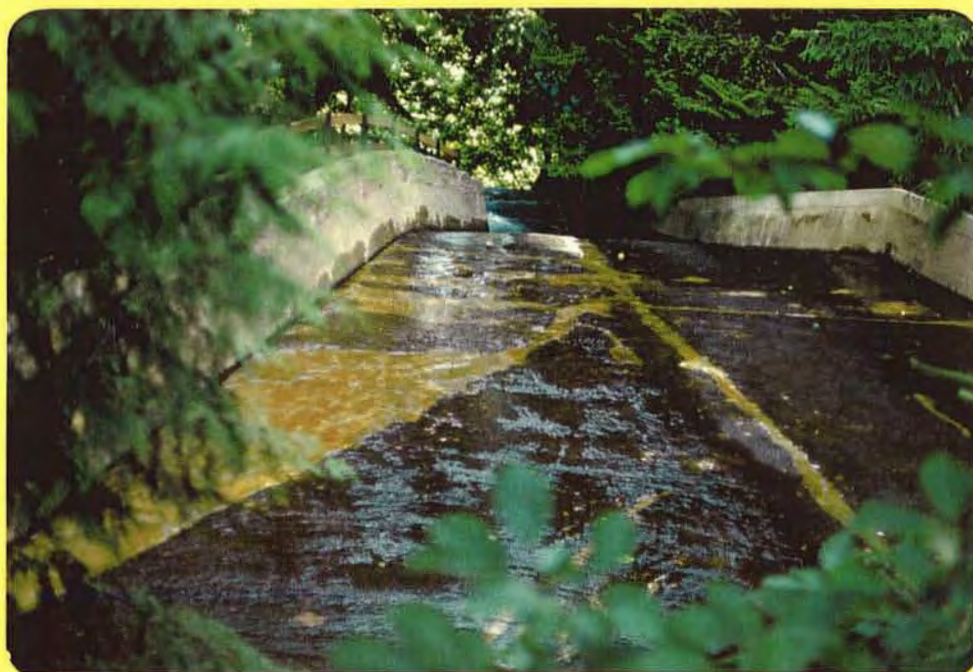
Repaired concrete spillway channel. Note right wing wall raised 8".

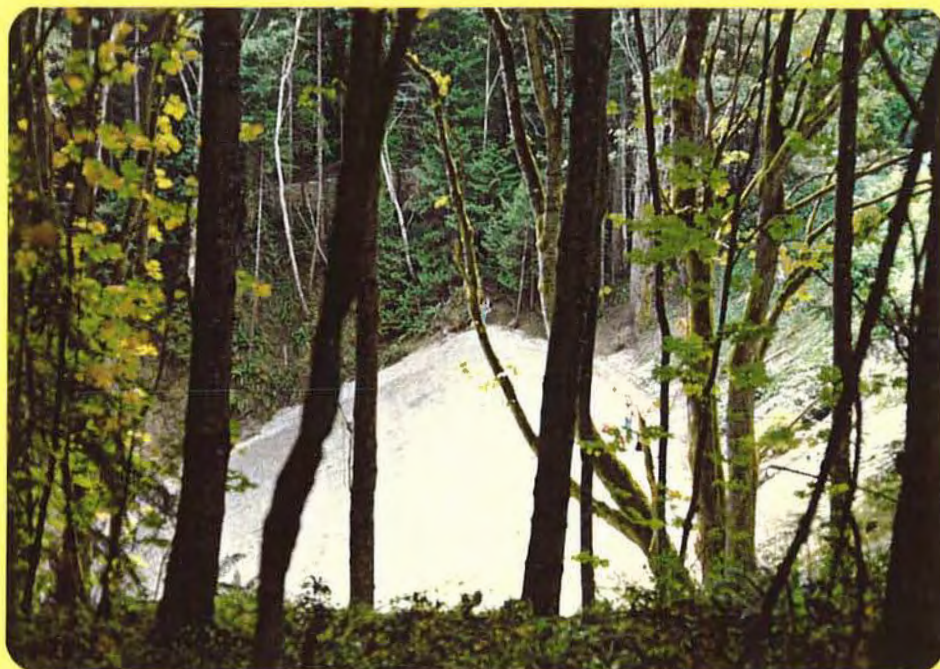
View of Downstream face from left abutment  
showing line of alignment points set to monitor  
cracking filter material.

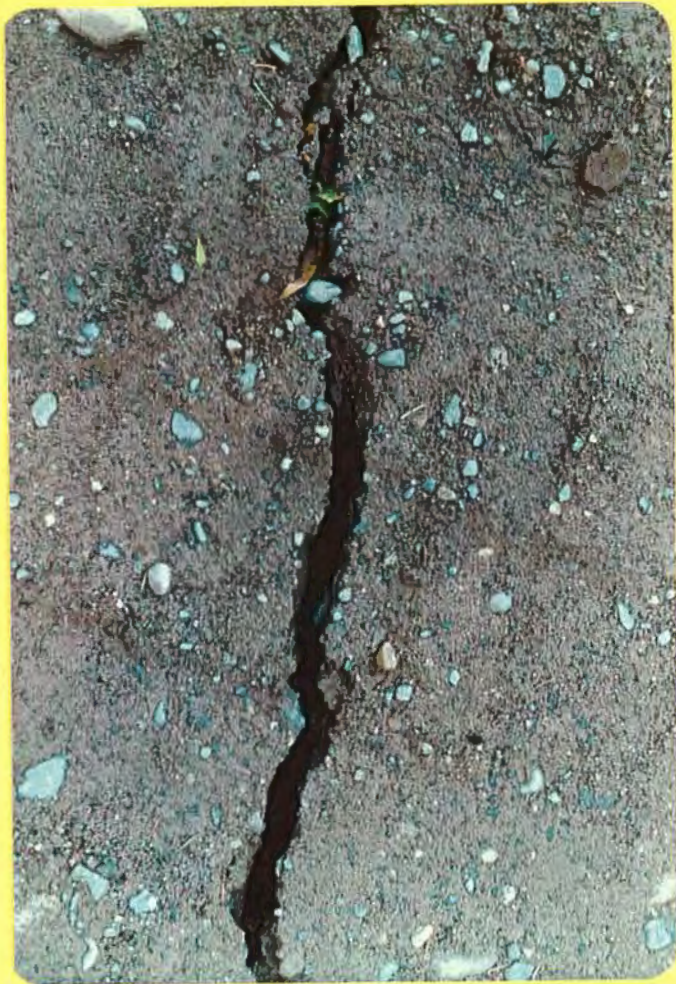
Closeup of crack in downstream berm.  
Note - crack just below break is  
approximately 1/10' in width.

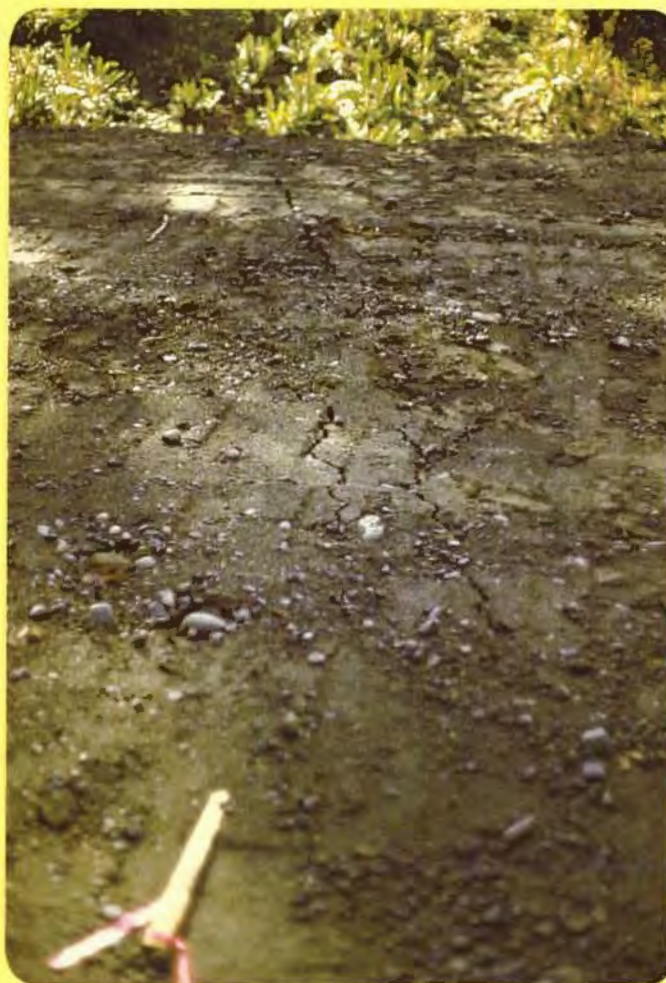
Cracking in berm observed from dam toe.

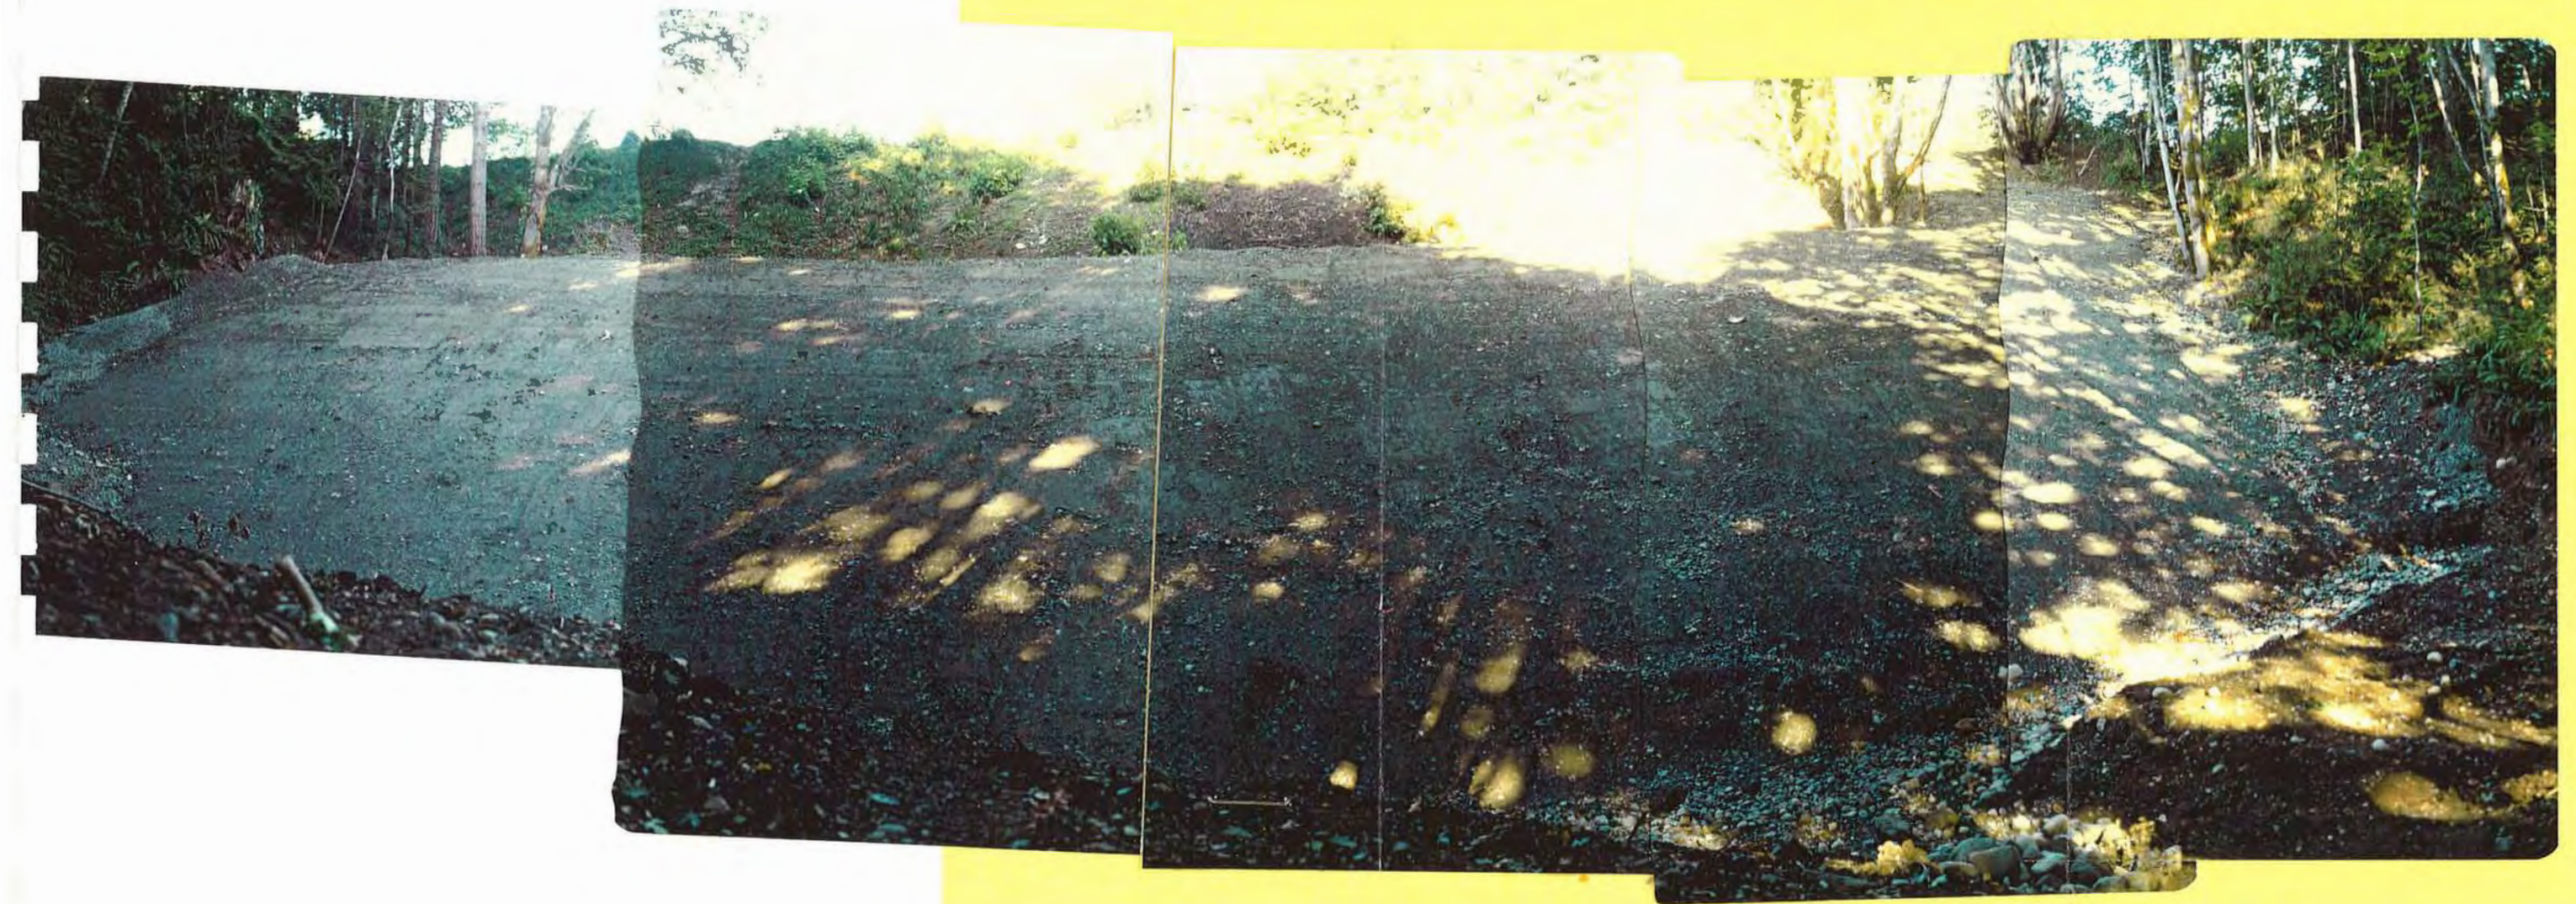
View of completed berm placed downstream of existing dam.

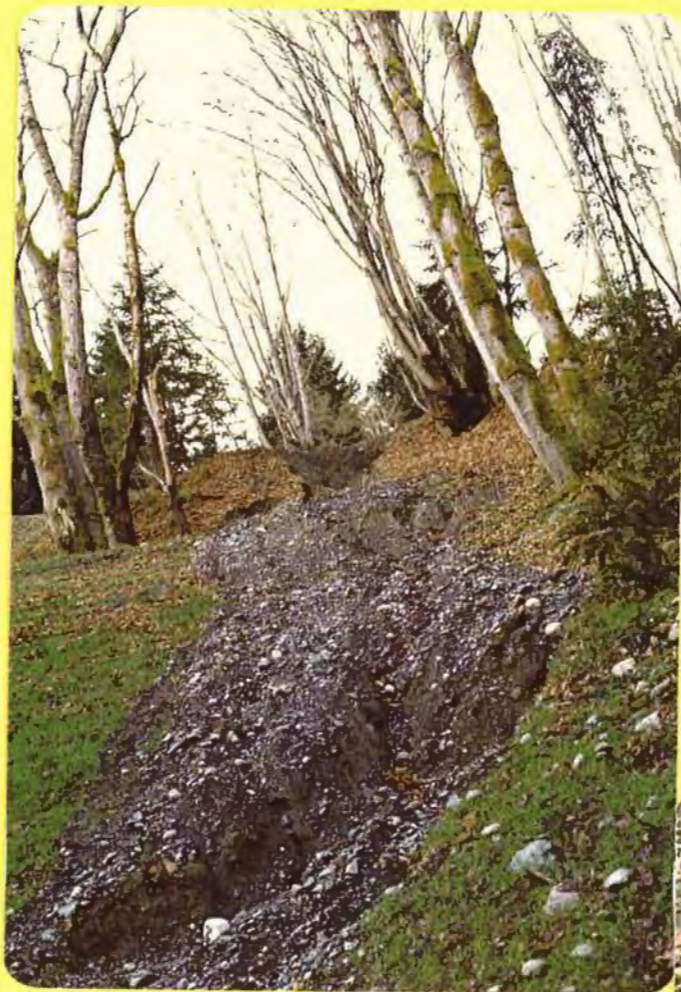
Erosion on  
left abutment.

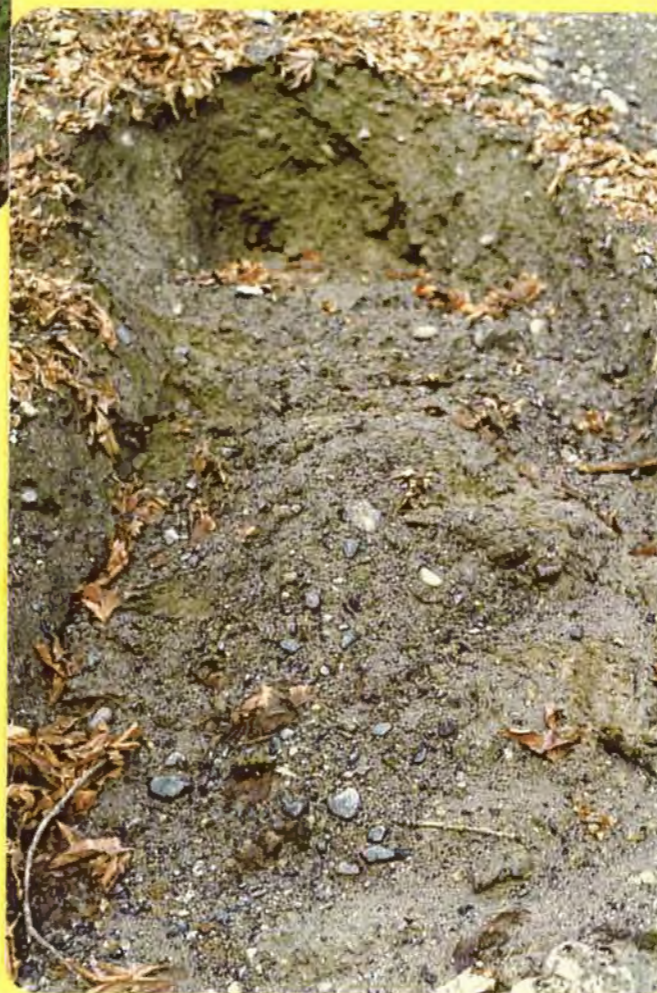
Seep causing sluff  
in area of left  
abutment.

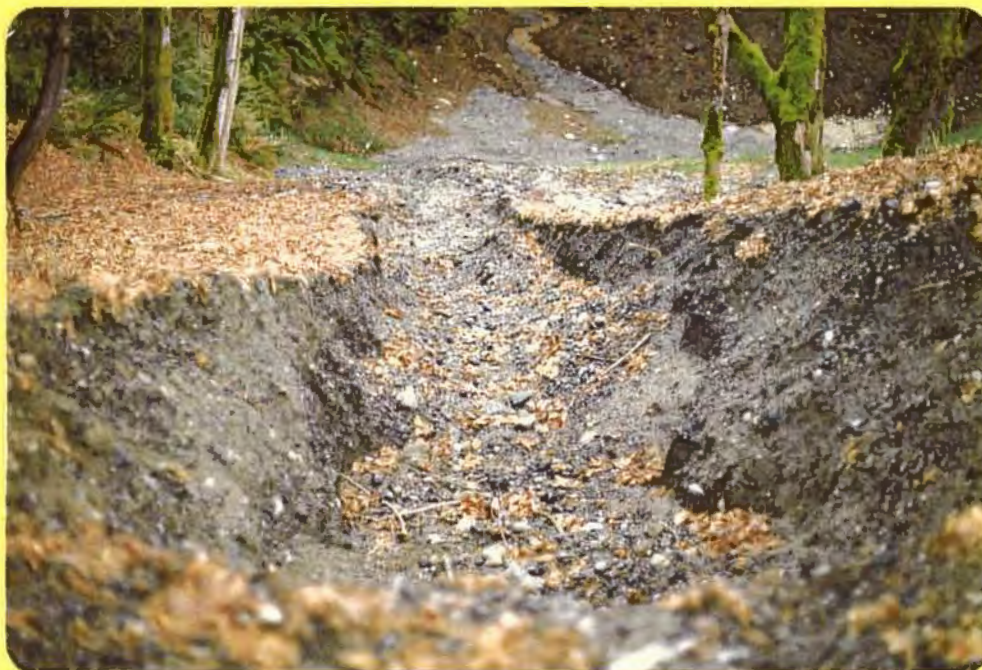
Left abutment washout.
