HOWARD DAM #4  
~~HARWOOD DAM #2~~

September 1, 1976.

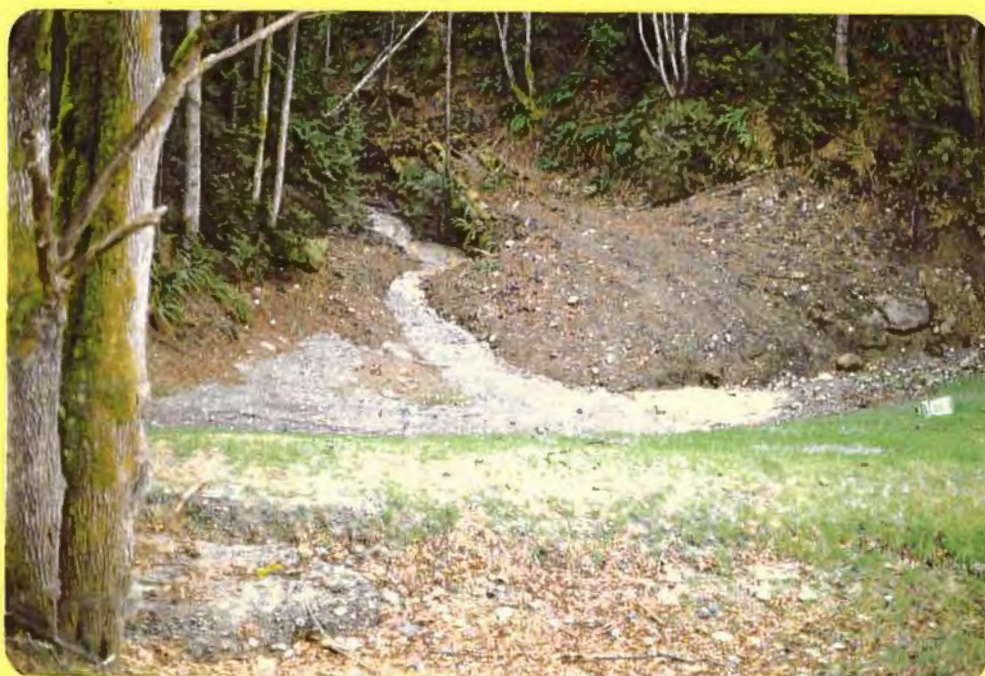
Infilling of toe drain from left abutment sluff.

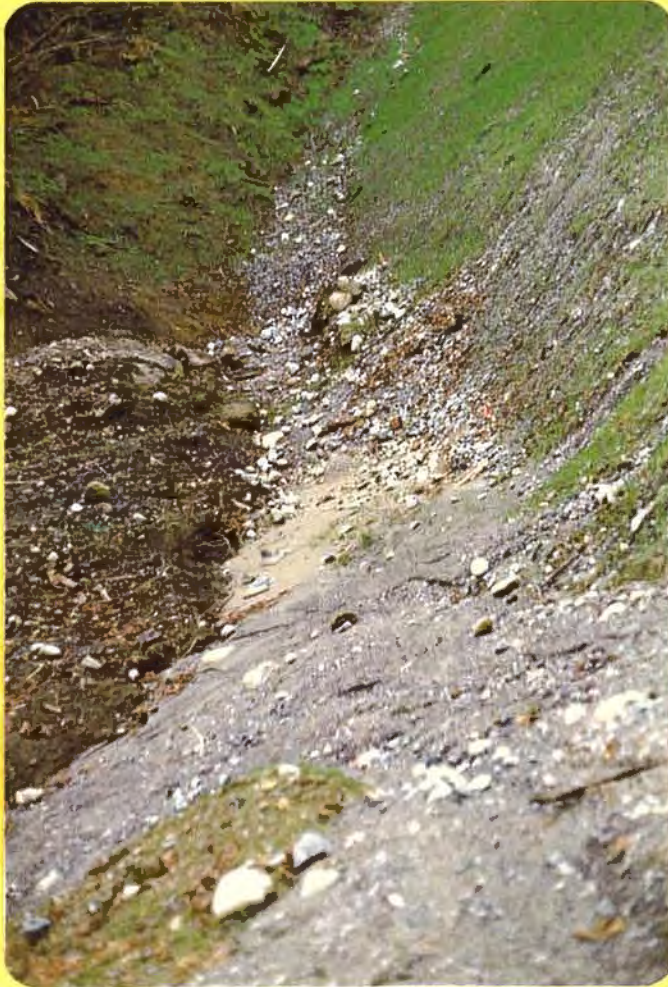
Downstream toe.

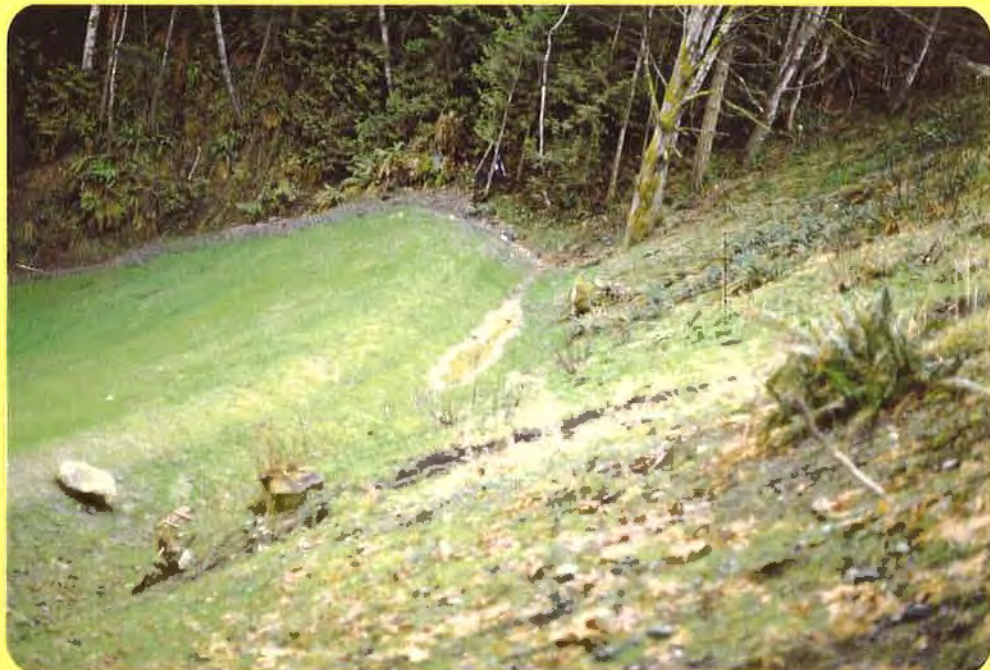
Run-off pooling on filter blanket.
