March 4, 2014

Middle and Lower Chase River Dams Progress Update

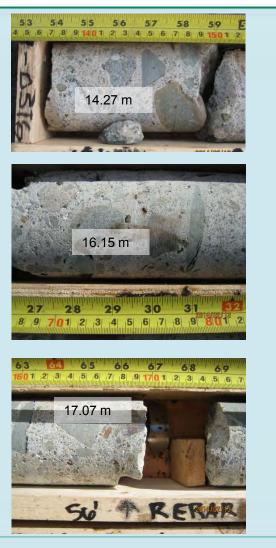
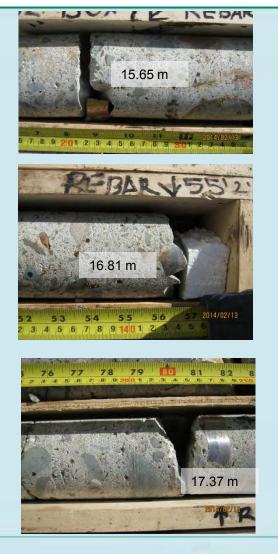
- CH14-02 Drilled Feb 11 and 12, 2014
- Hole located in the center of the reservoir wall
- Core was observed to be in good condition with no signs of
 - Deterioration
 - Voids
 - Honeycombing

- Core recovery was on average 96%
- Bedrock Encountered at 17.8 m (Elev. 55 m)
- Water introduced to corehole for drilling was measured at 2.53 m below ground surface at 6 pm February 13, 2014 and was measured at 2.82 m below ground surface at 7.30 am February 14, 2014.

- Reinforcement was encountered at depths:
 - **14.27 m**
 - 15.65 m
 - 16.15 m
 - 16.81 m
 - **17.07 m**
 - **17.37 m**

A layer of finer

material was encountered at a depth of 7.9 m (potentially representative).

of a cold joint at that location.

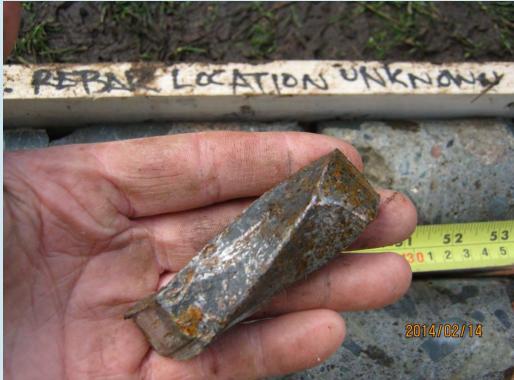
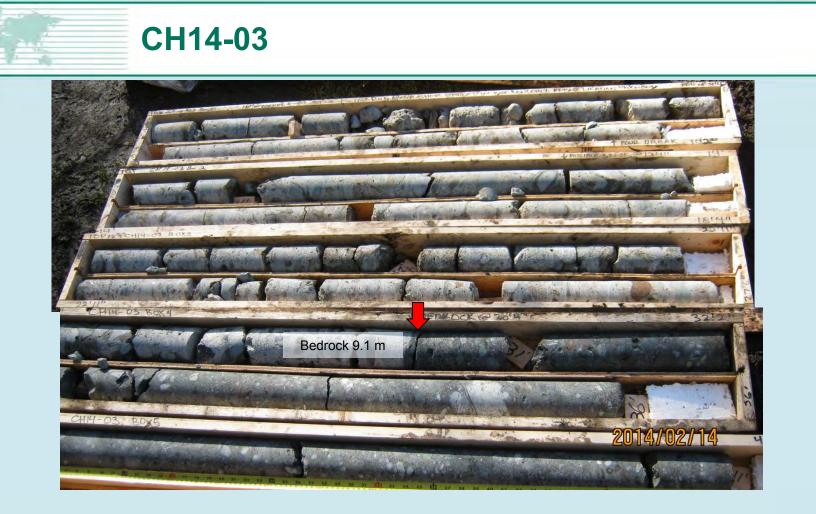
- CH14-03 Drilled Feb 13 and 14, 2014.
- Hole located at the South End of the reservoir wall.
- Core was observed to be in good condition with no signs of
 - Deterioration
 - Voids
 - Honeycombing
- Core recovery was on average 96%.
- Water introduced to corehole for drilling was observed to have reduced overnight, the exact amount of water loss was not measured however.
- Bedrock Encountered at 9.1 m (Elev. 63.8 m).

Reinforcement was encountered between 0.3 and 1.8 m (exact location is unknown as core became lodged within the drill shoe; when the core was recovered it was broken up with relative locations of pieces unknown).

A location of level breakage was observed at depths of 2.1 and 4.0 m, which may have indicated cold joints.

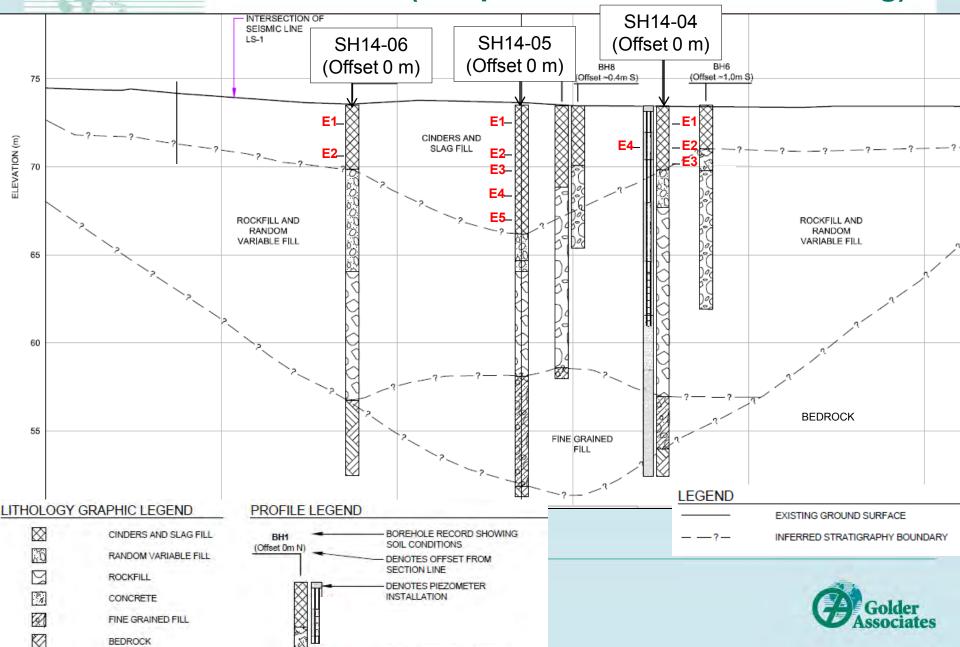
Section C-C' (samples taken in cinder and slag)

- Barium and/or arsenic concentrations were detected in all three samples that exceeded CSR Park Land Use (PL) soil standards. Concentrations also exceeded CSR Industrial Land Use (IL) soil standards, for the site-specific factors inferred to be applicable.
- Extractable Petroleum Hydrocarbon (LEPH, HEPH) concentrations and selected Polycyclic Aromatic Hydrocarbon (PAH) concentrations (benzo (a) anthracene, naphthalene) exceeded CSR PL standards in one of three samples.
- TCLP results indicated that material would not be classified as a Hazardous Waste, based on metals and hydrocarbon* leachability.

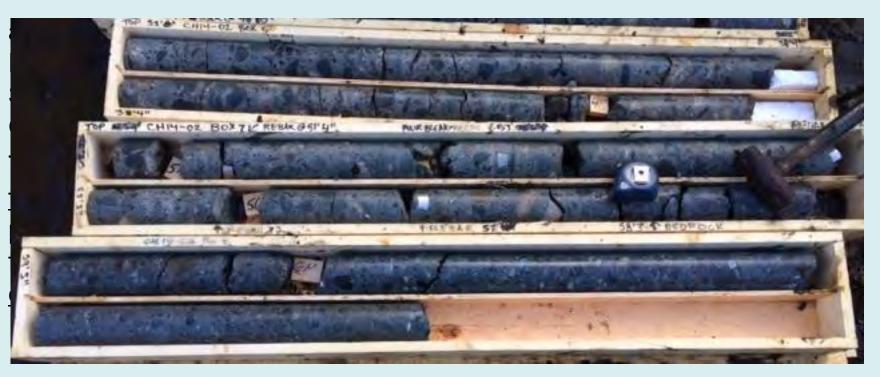
- Characterization of Concrete Core
 - Concrete Quality
 - Generally good no visible zones of poor quality (generally uniform)
 - No significant voids, (visible in the small mm range), etc
 - No honeycombing, no AAR was evident
 - Construction joints present but generally tight

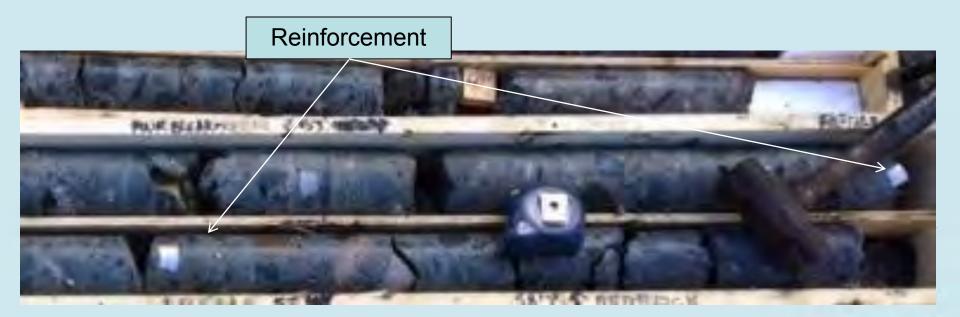
- Characterization of Concrete Core
 - Reinforcement
 - Two bars intersected (3/4" square twist) appear to be lapped
 - Likely indication of reinforcement throughout entire wall either on both u/s and d/s faces, or in middle of dam
 - 30" spacing (as indicated by surface GPR)
 - No sign of carbonation / deterioration

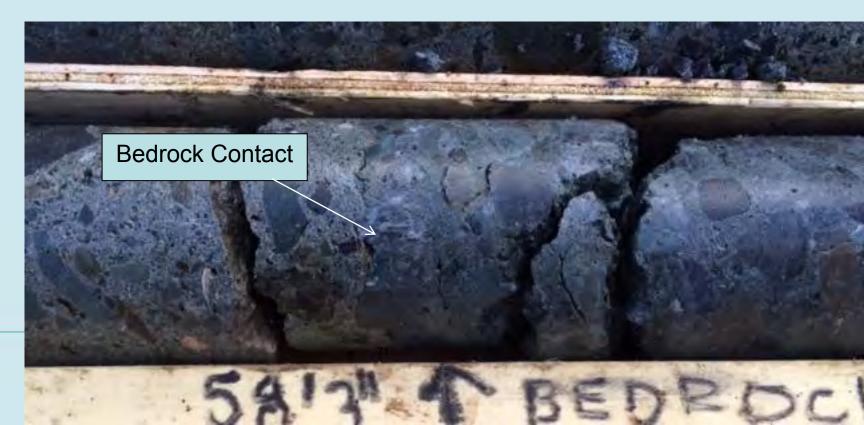
- Characterization of Concrete Core
 - Foundation
 - Bedrock good quality conglomerate
 - Very good quality bedrock/concrete contact
 - Indicates that careful construction controls must have been in place.
