January 21, 2014

Middle and Lower Chase River Dams Progress Update

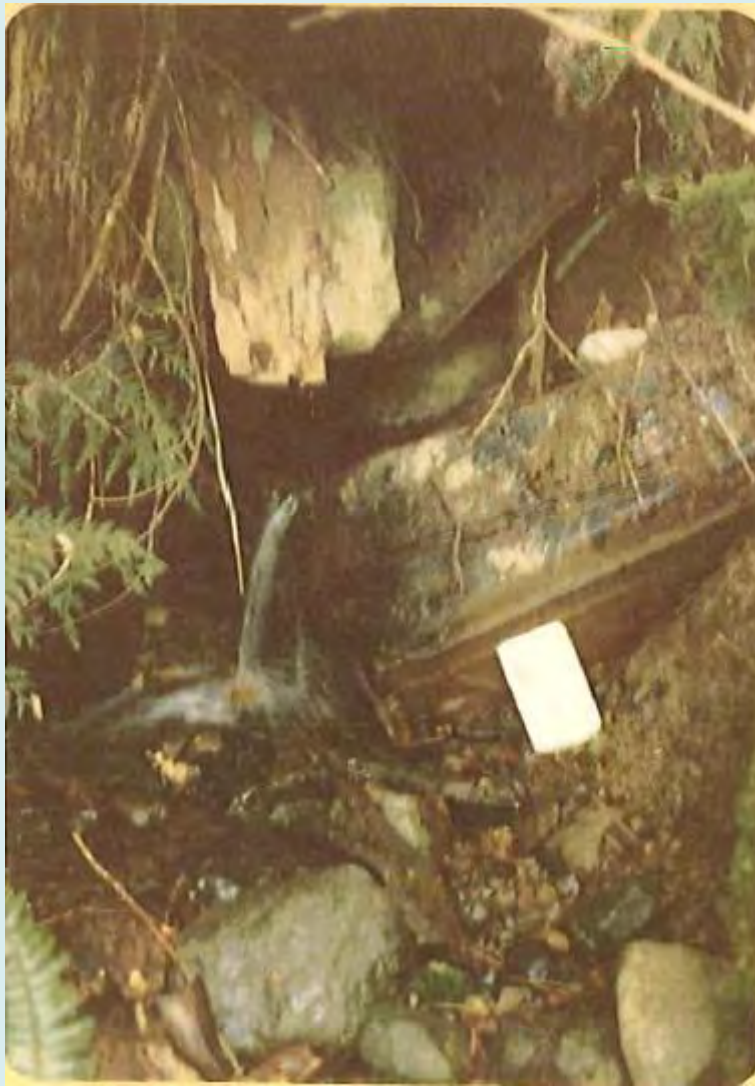
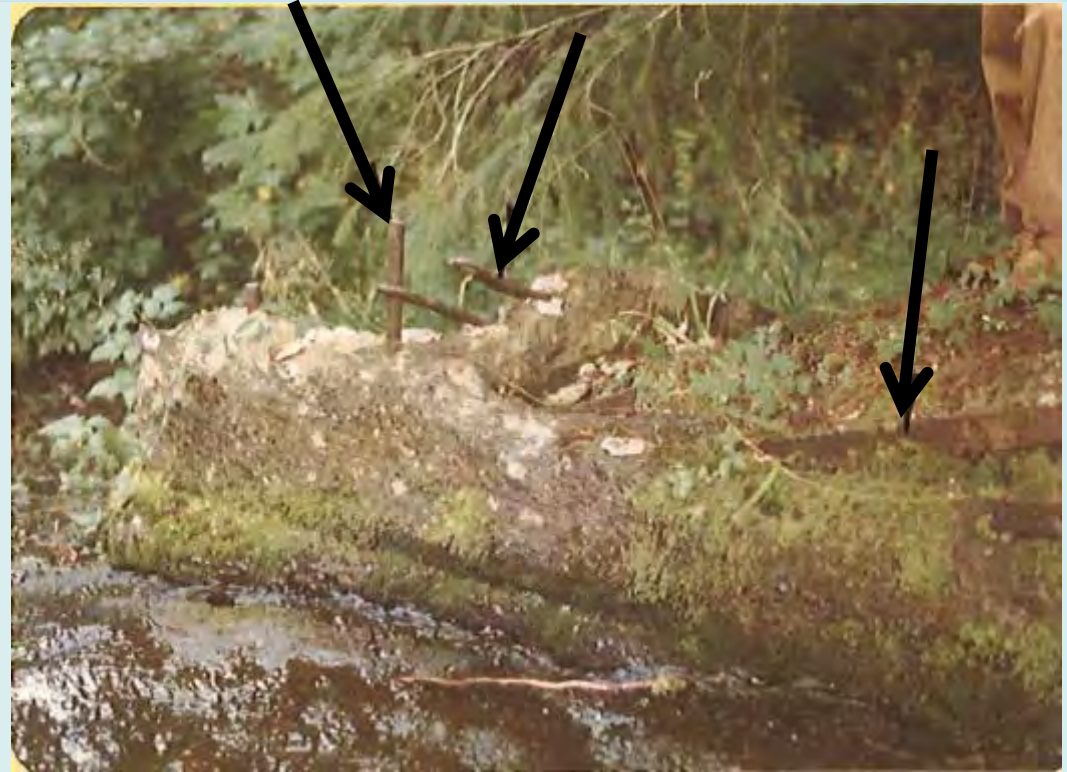
September 1, 1976 Inspection

↑
Typical Reinforcing used in dam – car springs, railway rails, drill steel

← Seepage along right abutment contact – scap material in embankment

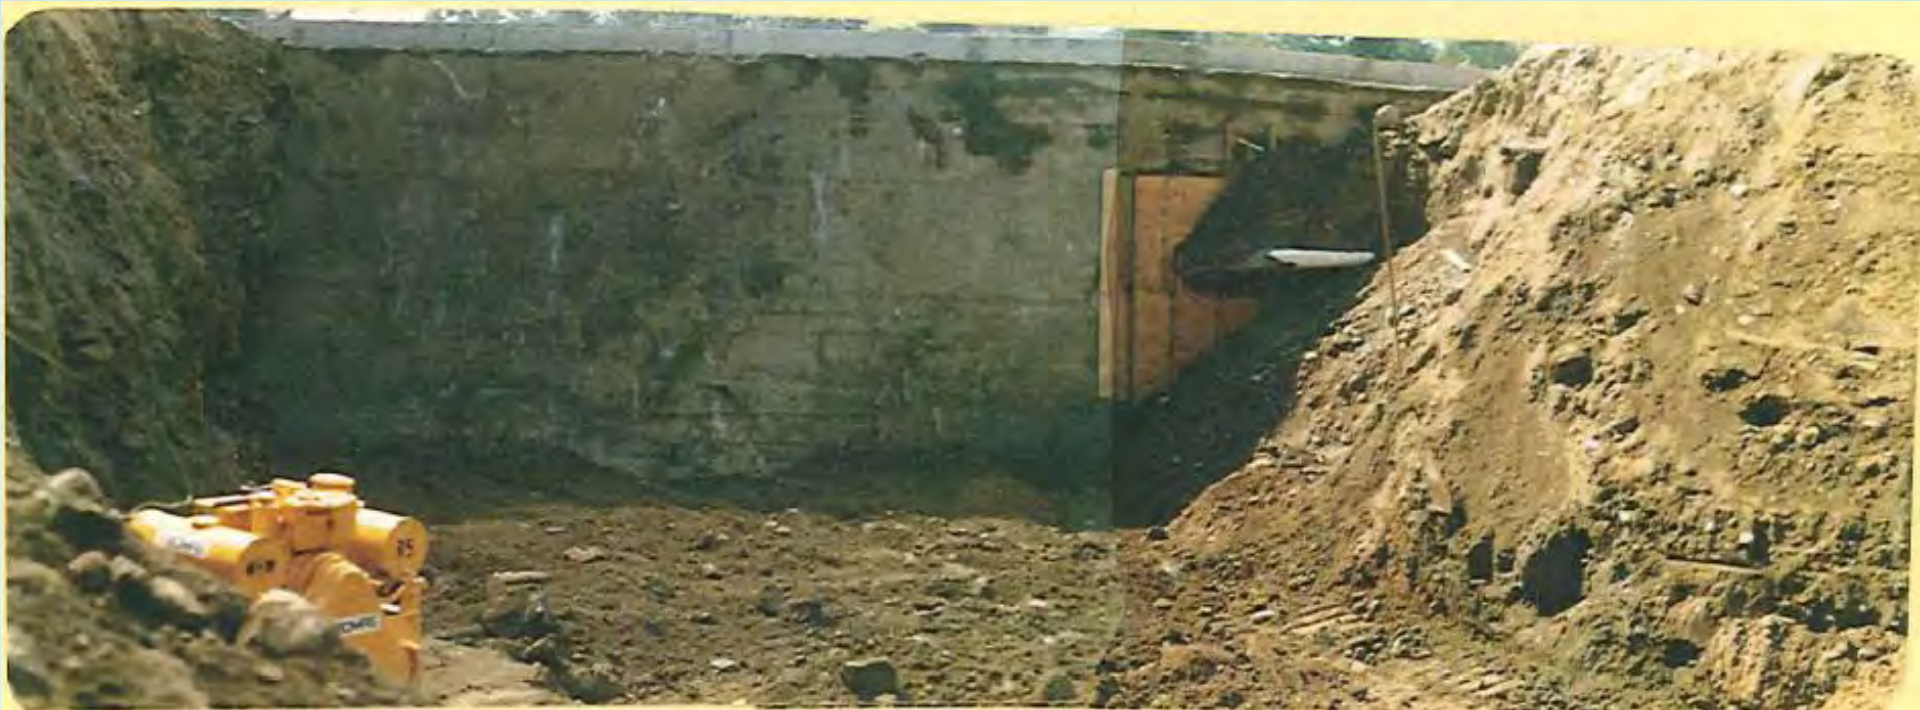
Beginning of fill replacement – note vibratory compaction in left foreground of photograph

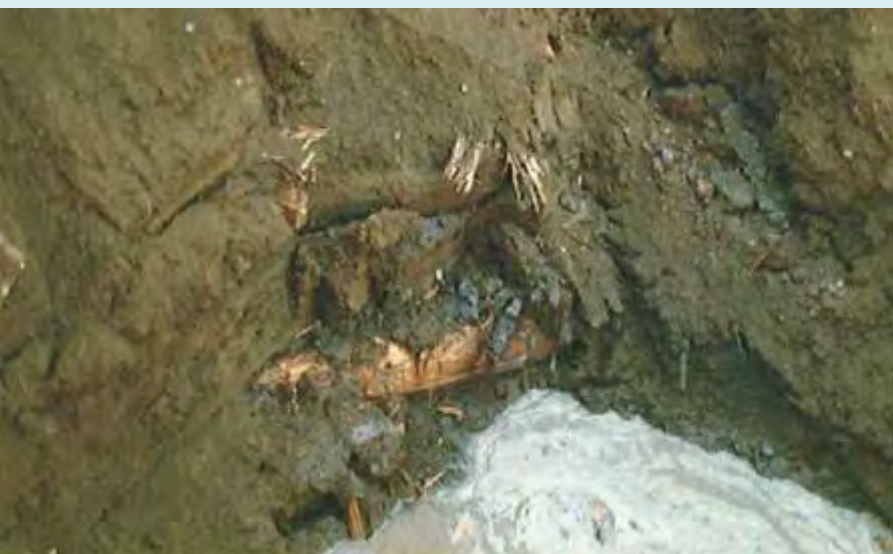
August 22, 1980 Inspection

Original log
crib exposed
– logs were
still intact

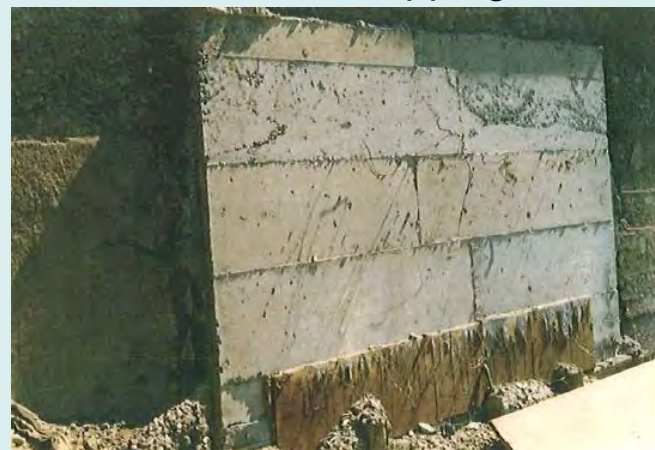
Concrete plug from upstream
face after stripping

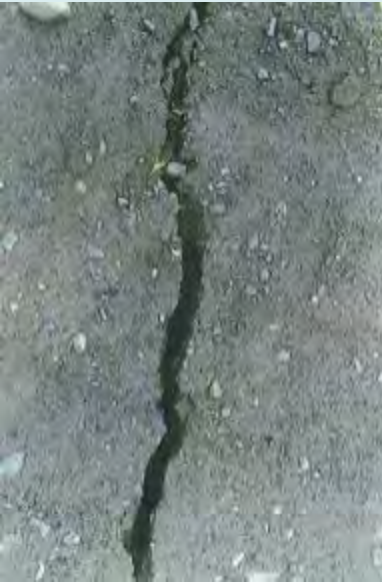
- Stabilizing sand and gravel toe berm constructed
- Seepage collection trench installed at toe and backfilled with drain rock
- Crack noted in cinders, slag sand and gravel deposit at crest of filter berm and monitoring commenced

Close up view of
crack

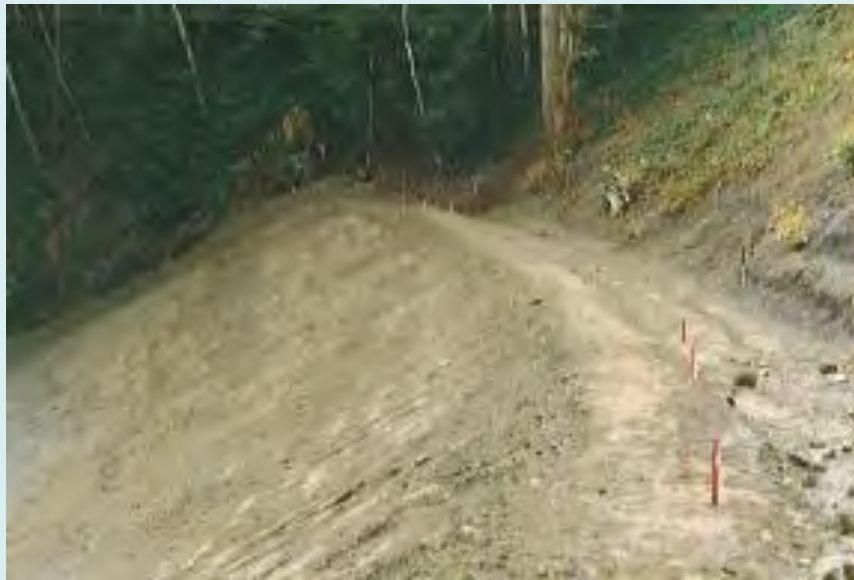
Stabilizing berm viewed from left
abutment

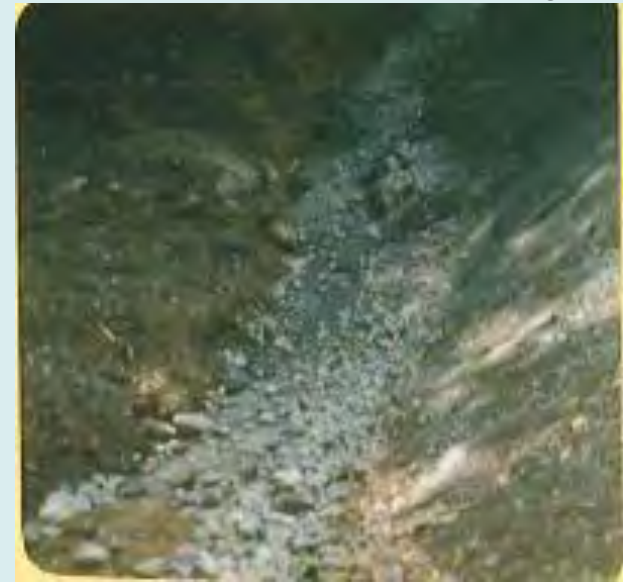
Drain rock toe drain used to
pick up embankment seepage

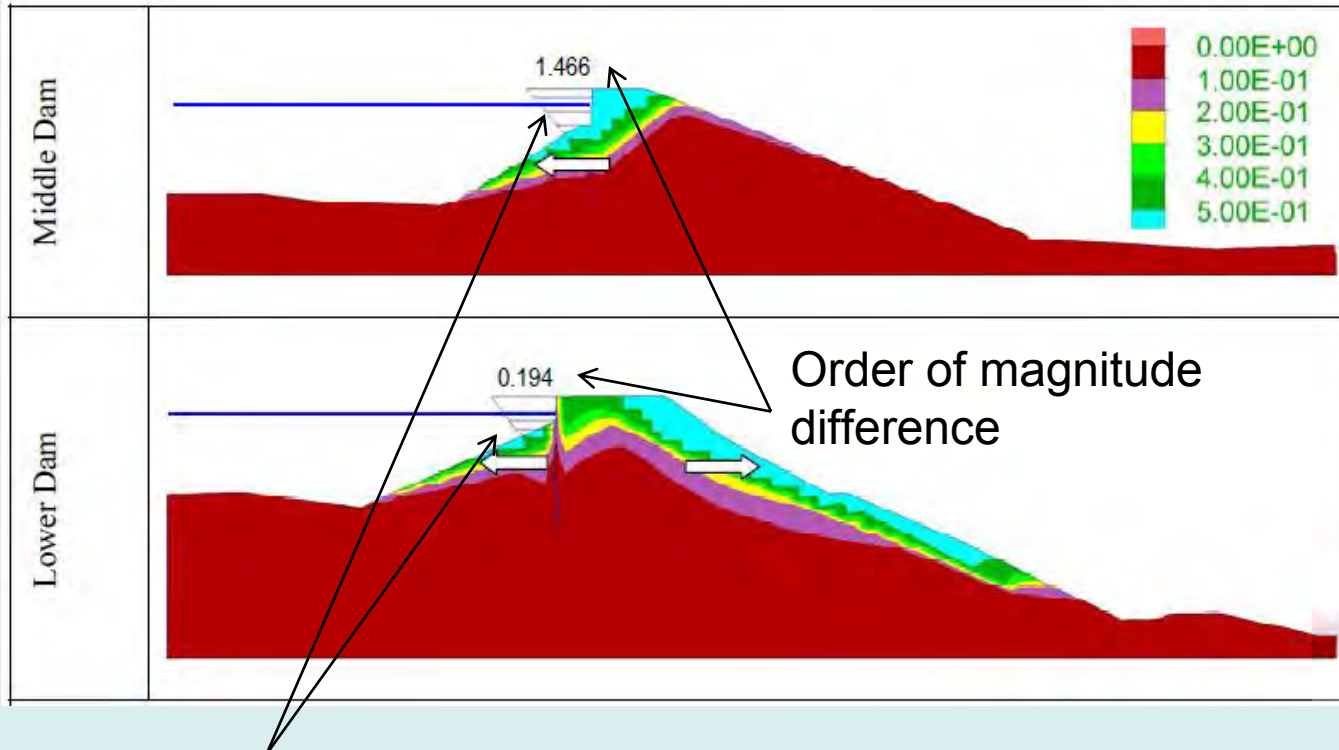
- Illustrates effect of inelastic behavior of concrete walls on deflections. Moment capacities of 150 and 600 KN were used for 0.6 and 1.2 m wide dams, respectively. This is the most critical case.

- Contours of Total displacement, deformed shape of concrete wall and its top deflection (m) for Most Likely case
