Assessment of trees potentially impacted by proposed development at 3614 Hillside Ave, Nanaimo and tree protection plan for trees to be retained.

Prepared for: Yash Bal – Dicoe Contracting

Date: May 6, 2025

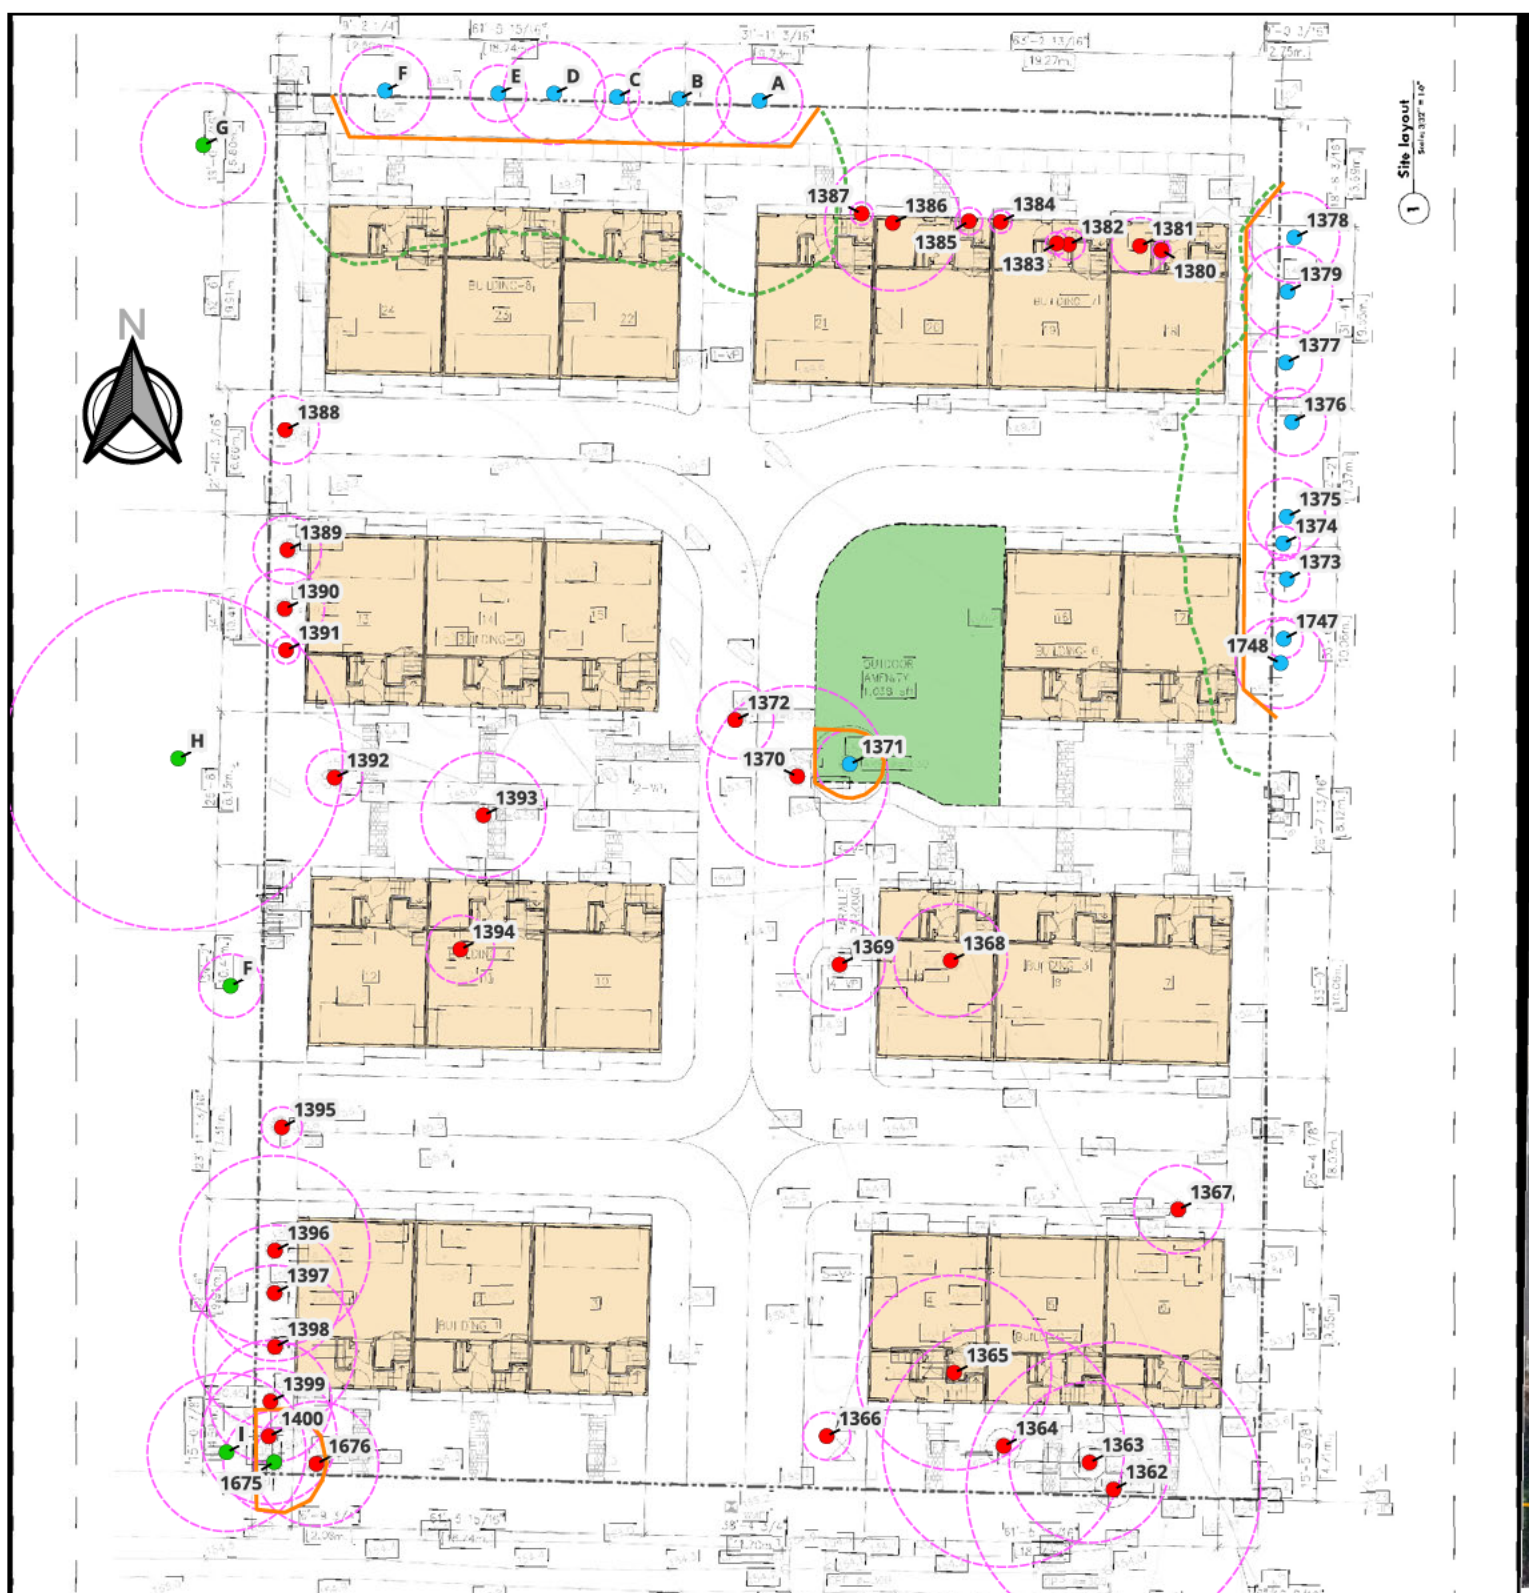
Appendix A: Map of trees assessed at 3614 Hillside Ave, Nanaimo BC potentially impacted by development activities over development plans

There are 26 trees recommended for removal that are outside of the construction footprint. Trees 1396, 1397, 1398, and 1399 are mature Douglas fir (*Pseudotsuga menziesii*) situated between the property line and proposed building 1 (Appendix A). With only approximately 1.1m of clearance between the tree center and the building foundation there is not sufficient space to maintain the root integrity of these trees through construction. Trees 1392 and 1395 are ornamental apple trees (*Malus sp*) located on the west side of the property. These trees have not been maintained in recent years and exhibit poor structure and form. They are therefore not good candidates for retention and are recommended for removal and replacement with a more suitable species.

Trees 1389-91 are located between the property line and proposed building 5. Trees 1389 and 1390 are Douglas fir trees that were previously topped at 4m height. Consequently these trees are in poor condition and would not be suitable for retention. Tree 1391 is actually a cluster of 4 planted Western Redcedar (*Thuja plicata*) trees ranging in size from 8-14cm DBH. These trees could conceivably be retained but if there is any grading in the area then replanting with a more desirable species in a better location would be preferred. Tree 1388 is a Pacific dogwood (*Cornus nuttallii*) along the fence line that has recently died. This tree does not pose a hazard in any way but also provides little to no wildlife value and should be removed. Tree 1393 is one of two ornamental Cherry trees on property. This tree is located very close to the intersection of two hardscape pathways. This tree would not be suitable in this location due to low overhead branching that would prevent pedestrians from utilizing the pathway.

There are several large Douglas fir trees at the front of the property in front of proposed building 2. All three trees have been previously topped at approximately 20m with regrown tops 15m high. The quality of attachment for the new tops could not be assessed from the ground but there was no indication of weakness or decay. A level 3 climbing risk assessment would be required to determine if these unions present any risk and what if any mitigative measures (pruning, mechanical bracing) could be utilized to reduce any associated risk. Tree 1364 is situated with proposed infrastructure on three sides with the house and two walking paths located 2-3m away from the main stem. This tree has a calculated root protection radius of 6.4m. With encroachments on this radius on three sides it is not practical to retain this tree with current building plans. The two other Douglas fir here (1362, 1363) are located slightly further away from the building footprint however they do not have sufficient space to accommodate a suitable root protection area and can therefore not be retained through construction. Trees 1366 are a cluster of 6 small Arbutus trees sized 9-21cm DBH. These trees are not practical to be retained with a hydro kiosk planned for this location. Tree 1367 is located at the rear of building 2. It is currently situated between the building and the access road with no suitable space to accommodate its root protection area.

Adjacent to building 1 there are several mature conifer trees. Tree 1675 can be retained with special management. Tree 1400 has an RPA that intersects with the corner of the proposed building footprint. To accommodate foundation excavation and construction the tree protection barriers would have to be positioned well inside of the root protection area. The same would be true of tree 1676 to accommodate foundation and foot path construction. Both these trees should therefore not be retained through construction. The stump for trees 1400 and 1676 are within the RPA for tree 1675 and should not be pulled with an excavator to avoid damaging the roots of this retained tree. Roots from 1400 and 1676

Tree 1371 is situated within an outdoor amenity green space. It is positioned at the toe of a small 1m slope. Based on civil drawings there is some grading expected throughout the site to produce a more moderate grade change. Civil drawings show the grading plan for the road centerline 5m to the west. Some minor cut up slope is likely possible (30-50cm) while maintaining root health and integrity. No soil can be added to the down-slope portion of the RPA which would bury established roots and the root collar. The final decision on the retention of this tree may have to be made once grading plans are finalized and laid out on site.

Along the rear of the and the east side of the property are several trees located on adjacent properties with crowns that extend into the site (Appendix A). Many of these trees will have an overhead conflict with proposed three story buildings. Trees at the rear of the site in particular (A-F) lean towards proposed building 8 and would require extensive pruning to achieve suitable building clearance. This level of pruning would not be sustainable for these trees health and longevity. These trees will have to be removed to accommodate this development plan. As they are not on the subject property an agreement will have to be made with the neighboring property owner. Trees along the eastern property line will require similar overhead pruning, though not quite as extensively.

Once plans are finalized and detailed land surveys are complete, RPA should be established and maintained throughout construction at the minimum distance listed in Table 1, Appendix A for trees to be retained.

Assess detailed grading plan around tree 1371 to determine if it can be retained with current plans or if plans can be adjusted to retain the tree with minimum root damage such as retaining walls to minimize grading required in outdoor amenity space.

Consult with neighboring property owners to the east and north regarding trees that represent an overhead conflict with proposed three story buildings.
