Vehicle Repair Shop

Seismic Assessment and High Level Costing Model

2020 Labieux Road Nanaimo, BC

January 19, 2018 RJC No. NAN.117803.0001

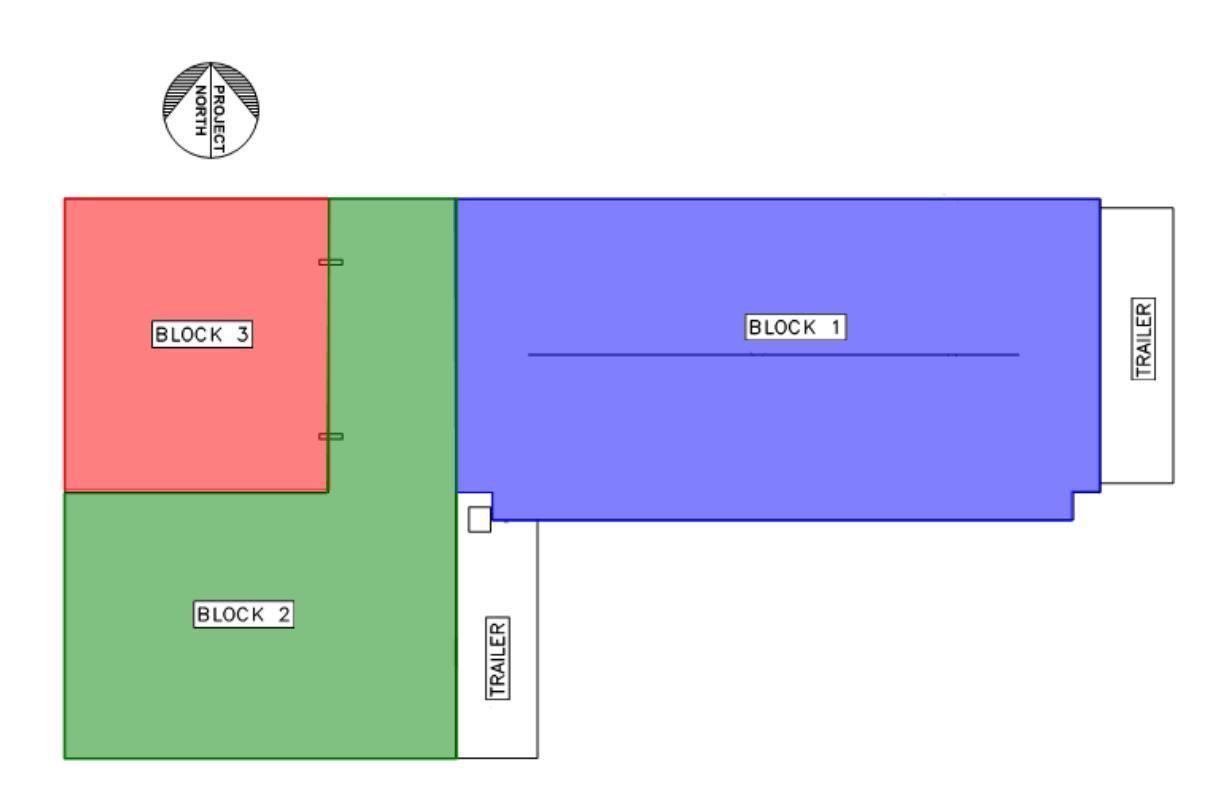
Figure 1: Block Definition

The building was divided up into three (3) different analysis "Blocks" for the purpose of performing the SRG analysis. Block definition is generally based on location, year of construction or upgrade, alignment of floor levels, number of stories and construction type.

Block 1 - Original Building

The original repair shop was built in 1965. The design code in effect at the time was NBC 1960. Seismic provisions at the time were limited, so it was likely that the building was not explicitly engineered to resist seismic forces.

Block 1 is 366 m² in plan, constructed with a T&G wood deck spanning to glulam beams supported by steel gravity columns and perimeter concrete masonry walls. The walls are supported by concrete foundation "walls", which do not appear to have a strip footing. The gravity columns are supported with spread footings. There are wood framed mezzanines on the east and west ends of the building supported by the concrete masonry walls. There are several large bay door openings in the south side of the building and strip windows in the north side, severely limiting the capacity of the LDRS in the east west direction.

- The LDRS in both the NS and EW directions is inadequate. The NS direction performs better due the presence of several masonry walls, and deemed a Medium Risk. The placement and size of openings result in the EW direction being High Risk. There is only incidental reinforcing in the walls to frame around these openings, and their capacity does not provide any additional strength.
- The diaphragm has inadequate capacity due to the large span and type of construction.
