Underwater Sonar Profiling Survey Of Westwood, Middle and Lower Chase Lakes for The City of Nanaimo

November 4th and 18th 2003

> Prepared by AquaCoustic Remote Technologies Inc 888 379 7601

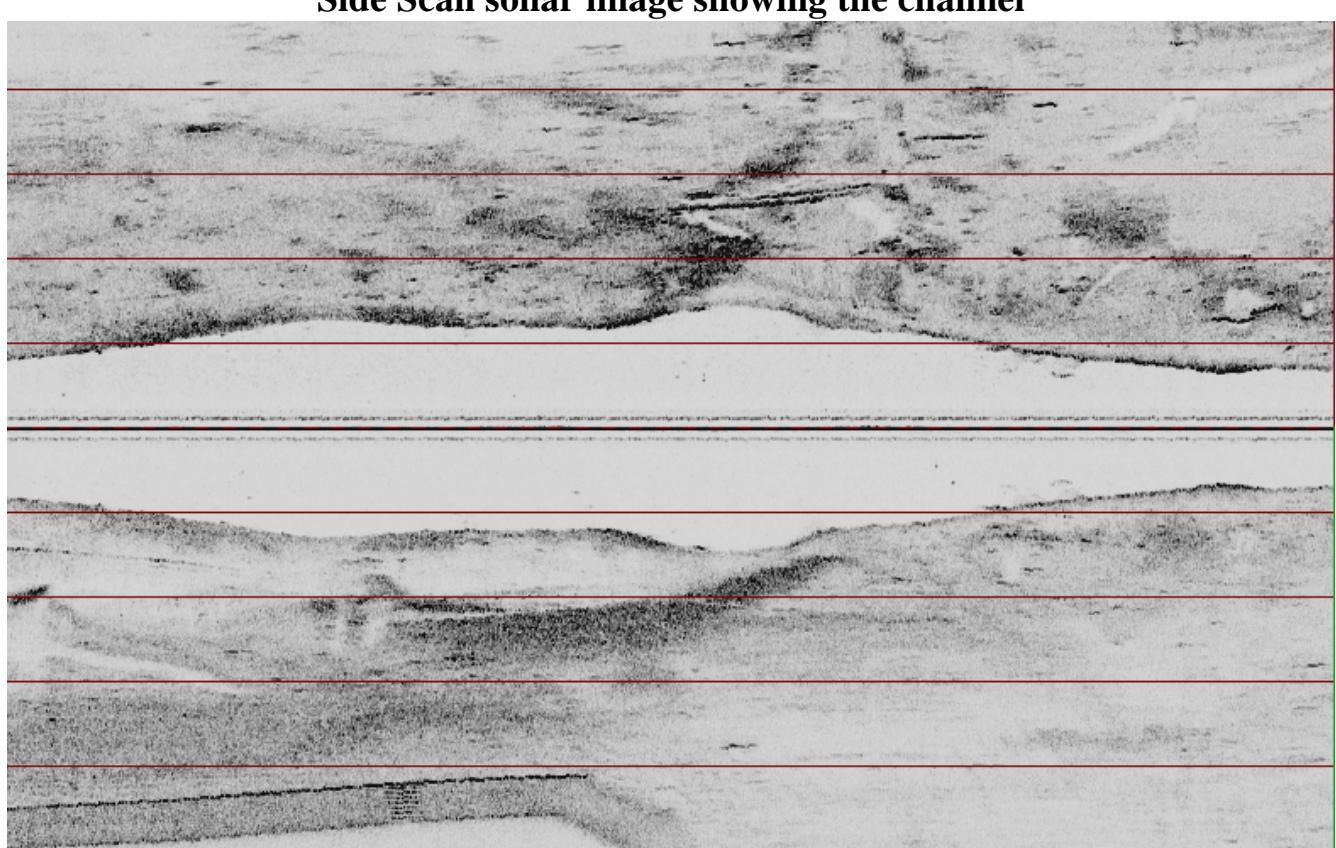
The Side Scan images of the area in front of the dam indicates soft sediment and some waterlogged timber debris. On the west side of the dam by the boat launch, there are indications of a straight depression in line with the above mentioned depression leading offshore. There is also a possible channel leading out from the deep area of the dam into the lake. This channel shows up well in the contours.

Side Scan sonar image showing the channel

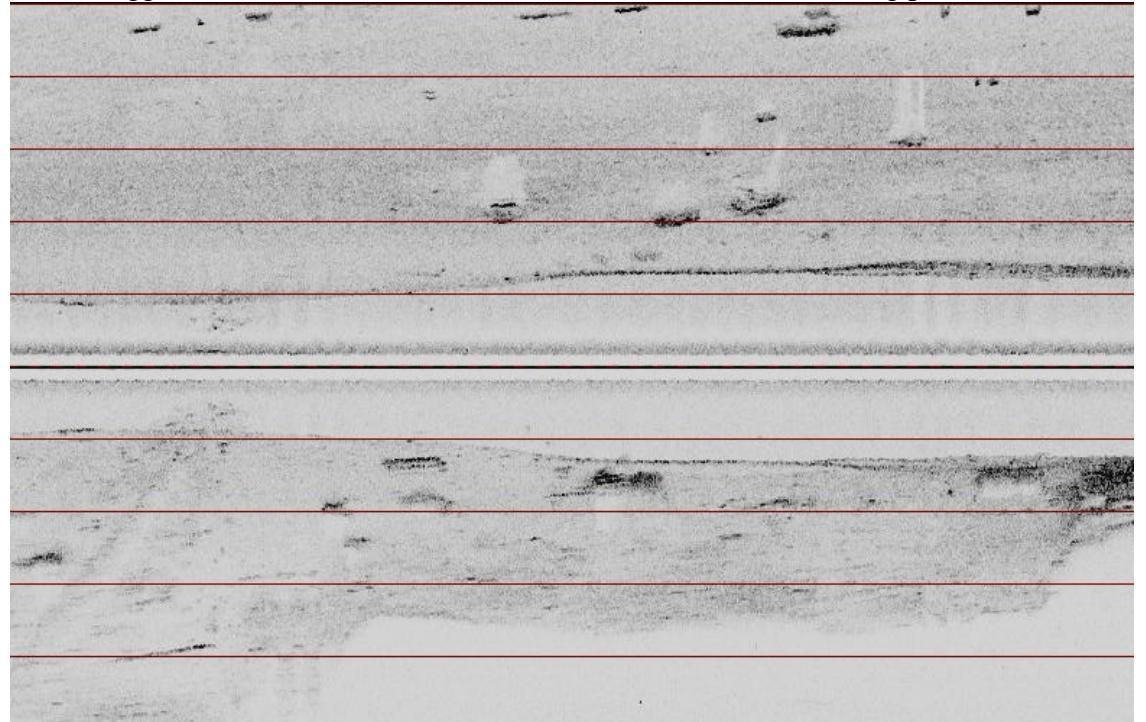
Possible pipe from south side of lake.

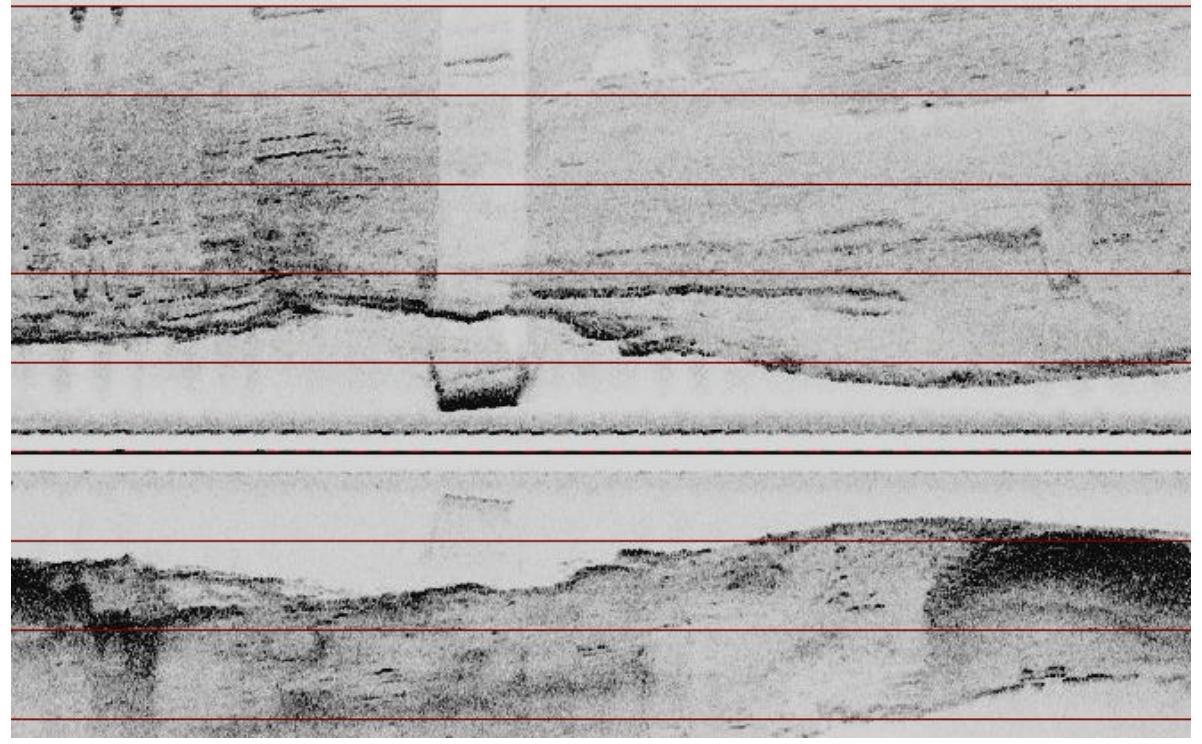
The Side Scan images of the area in front of the dam indicate rock outcrops and soft sediment and a small number of waterlogged timber debris. In front of the dam there is a channel running parallel to the dam.

Side Scan Image showing old valve structure and rock out crops

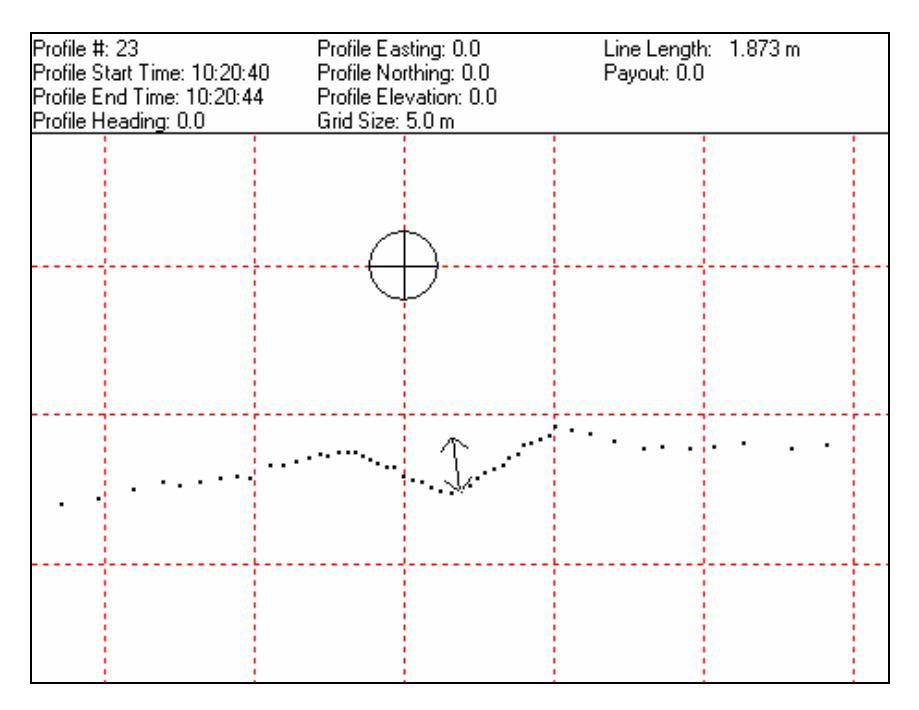
The sonar data shows a straight ditch proceeding from the west side of the dam and traveling offshore. This depression is approximately 6 metres wide by approximately 1 to 2 metres deep. Other straight line depressions are also observed in the lake bottom. These may have been drainage ditches before the reservoir was flooded. The deepest part of the lake is in front of the dam.

Sonar profile data across depression showing 6.738 m width

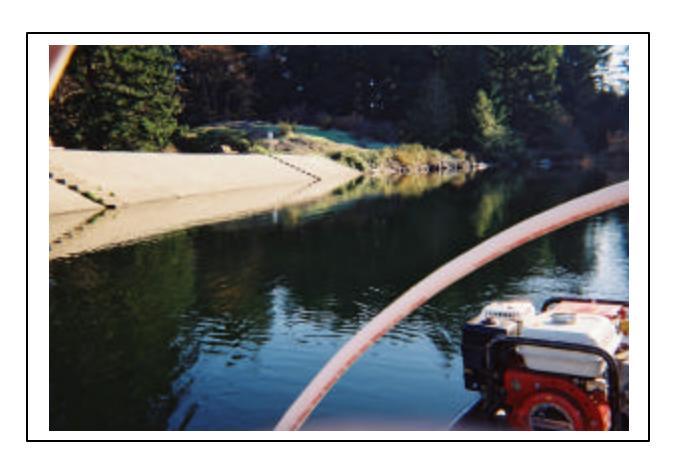
The photograph above and to the left shows the dam at Westwood Lake.

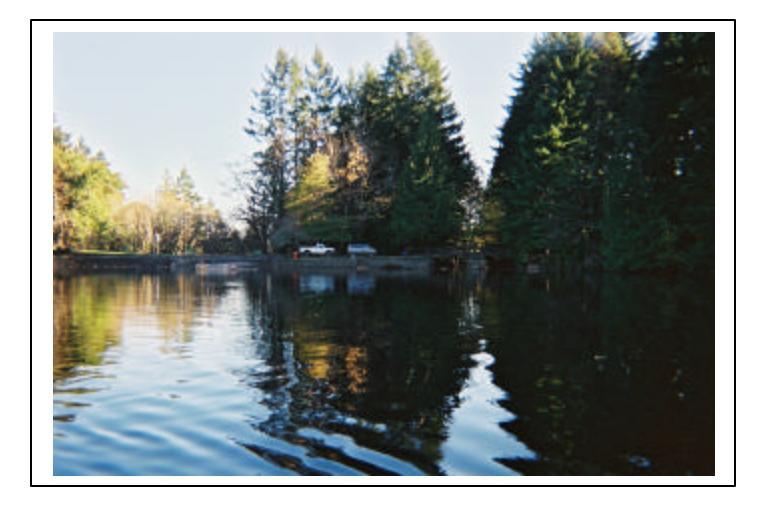
The photograph below shows the dam at Lower Chase Lake
