# **REPORT ON**

# Colliery Dams, Nanaimo, BC Dam Stability

Report Number: 1314470516-009-R-Rev0 Distribution:

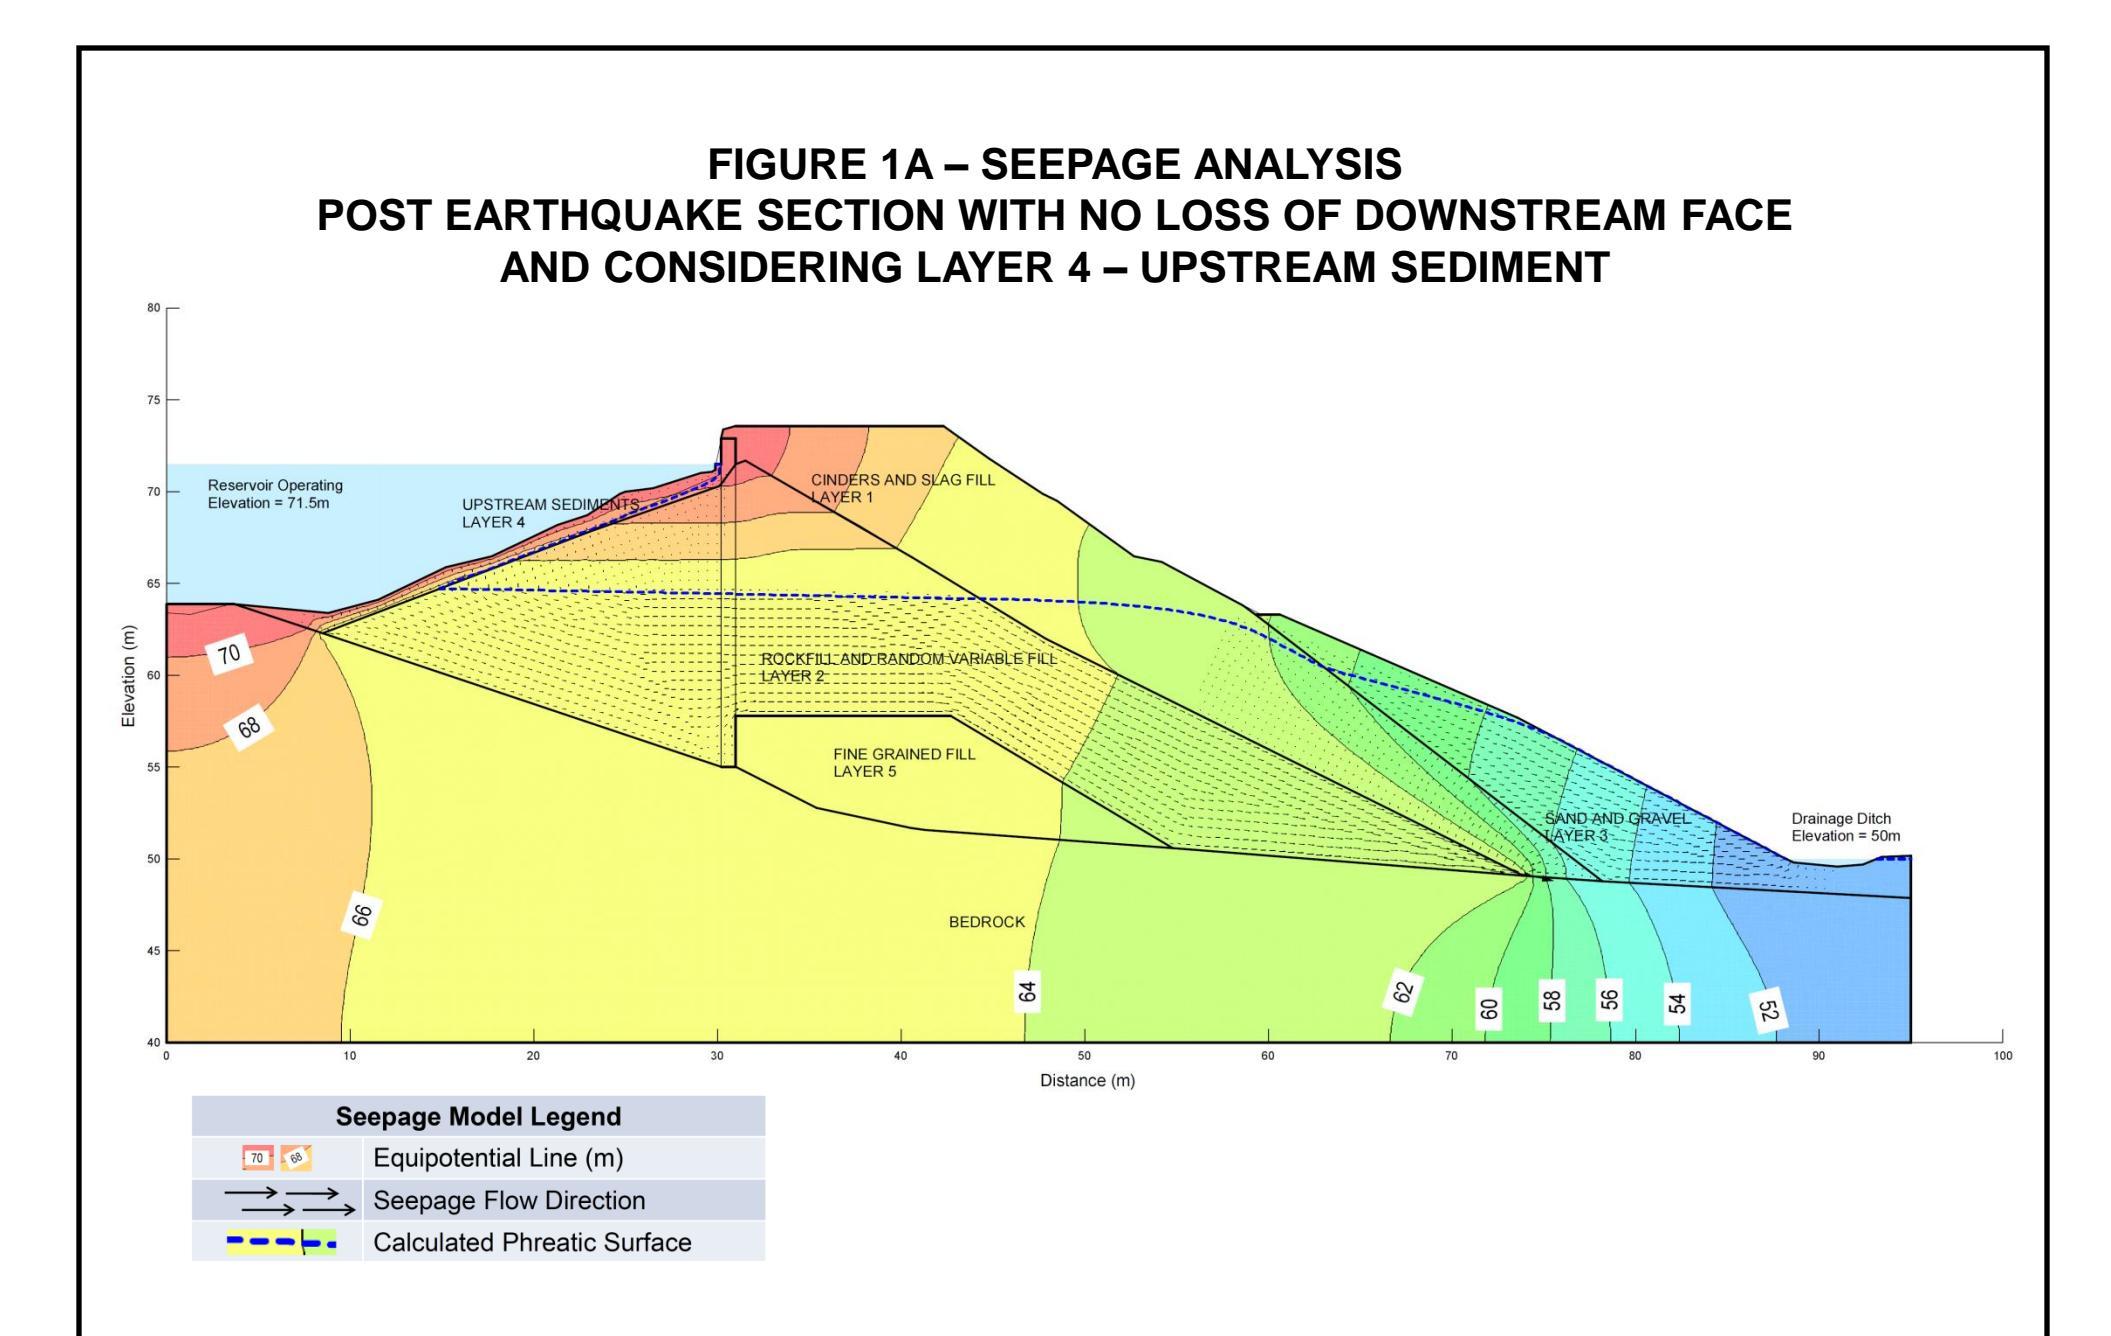
Analyses carried out where an upstream sediment layer is assumed to exist against the upstream face of the dam, and where the downstream face of the dam is intact (Figure 1A) indicate that seepage flow through the existing dam section is approximately 1.4x10<sup>-4</sup> m<sup>3</sup>/s per m of dam width. At an elevation of approximately 57 m, the calculated phreatic surface daylights along the downstream face of the dam, indicating that a portion of subsurface dam seepage would exit and flow along the downstream face below this point. Under this condition the stability analysis shown on Figure 1B indicates that the minimum Factor of Safety (FoS) against a shear failure considering the phreatic surface developed from the seepage analysis is 0.85 indicating that the surface shown in green on the figure is unstable and will slump. Therefore, Scenario 2 was developed, based on the assumption that Layer 1 had slumped and was removed from the dam section (with the slumped material forming a buttress at the base of the slope).

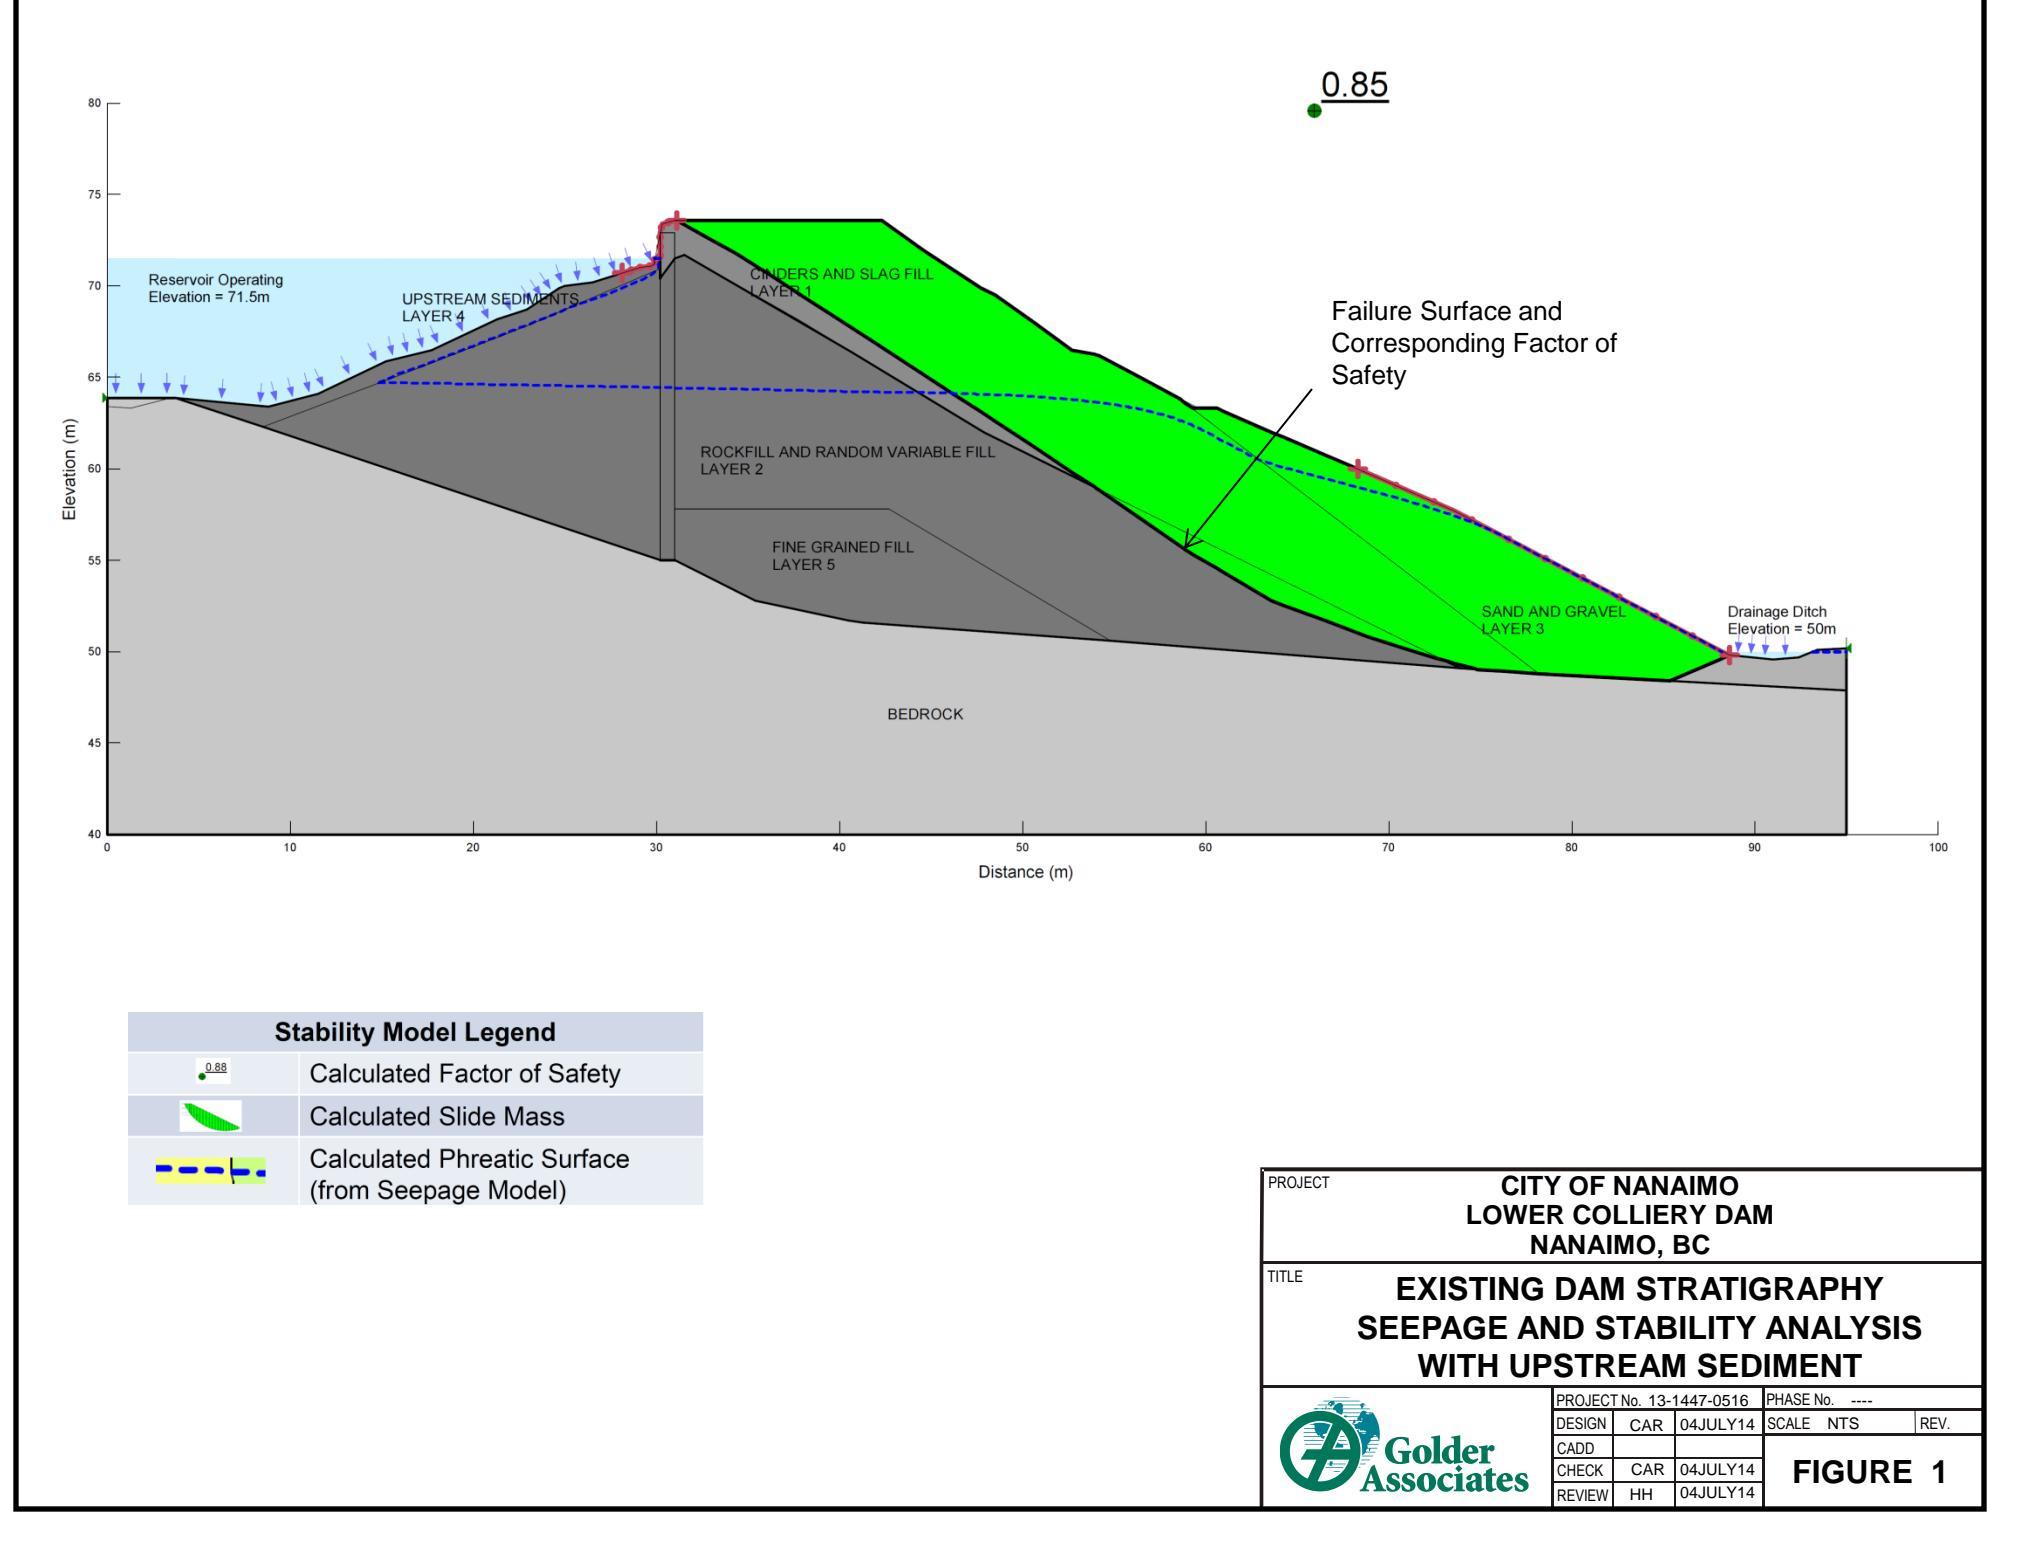
# FIGURE 1B – STABILITY ANALYSIS POST EARTHQUAKE SECTION WITH NO LOSS OF DOWNSTREAM FACE AND CONSIDERING LAYER 4 – UPSTREAM SEDIMENT

Modelling Condition	Figure Number	Factor of Safety
Scenario 1 - Post Earthquake with No Loss of - Downstream Face – Upstream Sediment Condition	1B	~0.8
<b>Scenario 2</b> - Post Earthquake with Loss of Downstream Face – Upstream Sediment Condition	2B	~1.5
<b>Scenario 3</b> - Post Earthquake with No Loss of Downstream Face – No Upstream Sediment Condition	3В	~0.2
<b>Scenario 4</b> - Post Earthquake with Loss of Downstream Face – No Upstream Sediment Condition	4B	~0.9

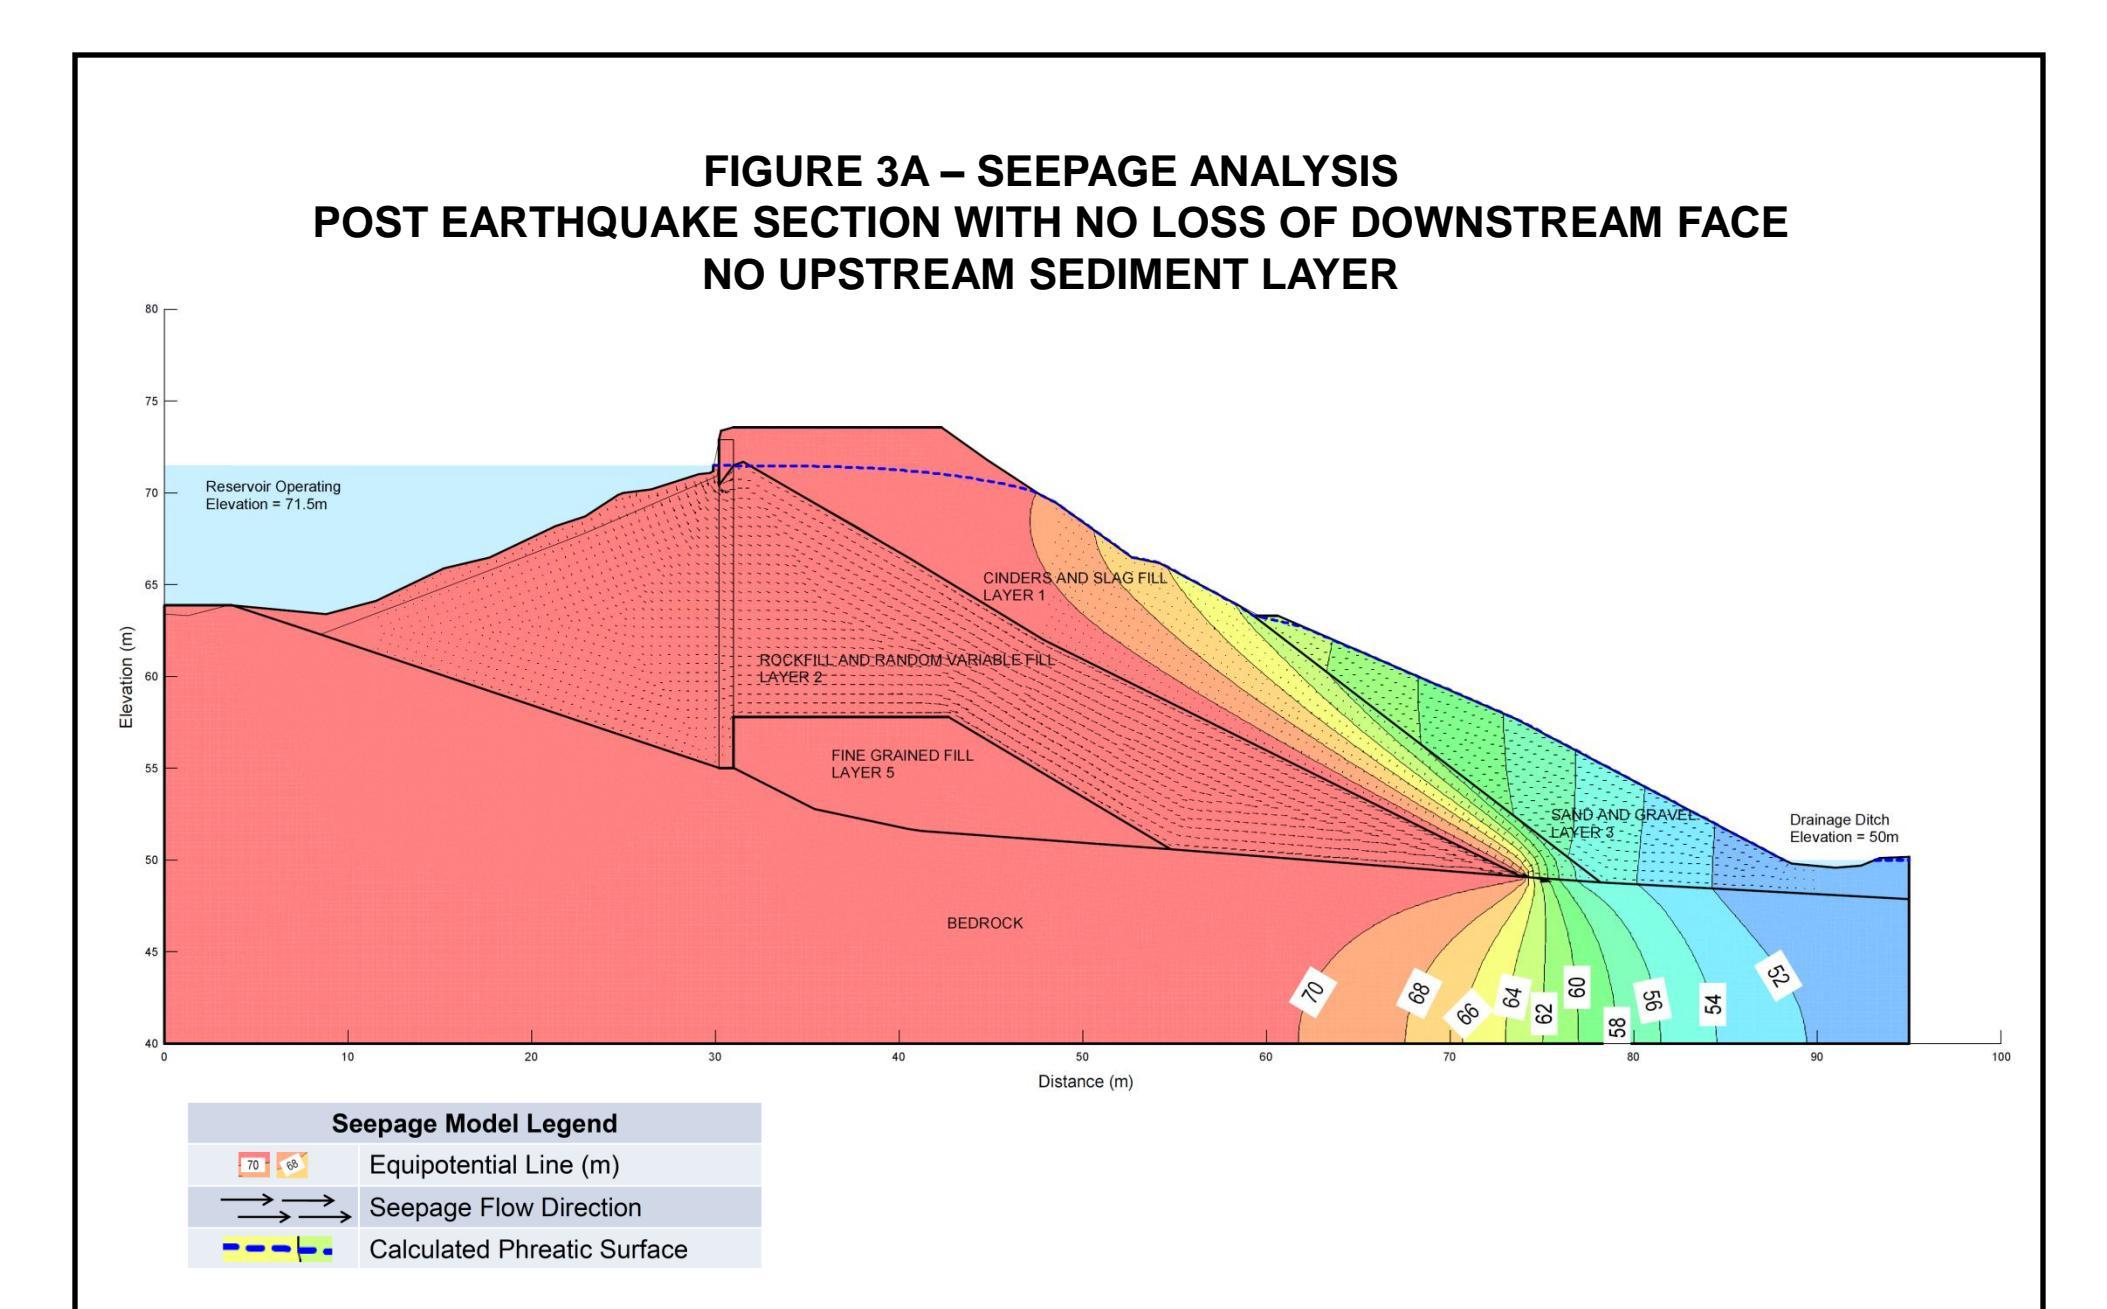
On Figure 3, a conservative condition where the presence of an upstream sediment layer on the upstream face of the dam is not assumed to exist, the seepage flow through the dam is estimated to be approximately  $3.7 \times 10^{-4}$  m<sup>3</sup>/s per m of dam width. The calculated phreatic surface daylights along the downstream face of the dam at an elevation of approximately 70 m, indicating that a portion of subsurface dam seepage would exit and flow along the downstream face below this location as shown on the figure. The stability analysis shown on Figure 3B indicates that the minimum FoS is approximately 0.21 which indicates that the original fill surface shown in green on the figure is unstable and will slump under this condition. Therefore, Scenario 4 was developed, based on the assumption that Layer 1 had slumped and was removed from the dam section (with the slumped material forming a buttress at the base of the slope).

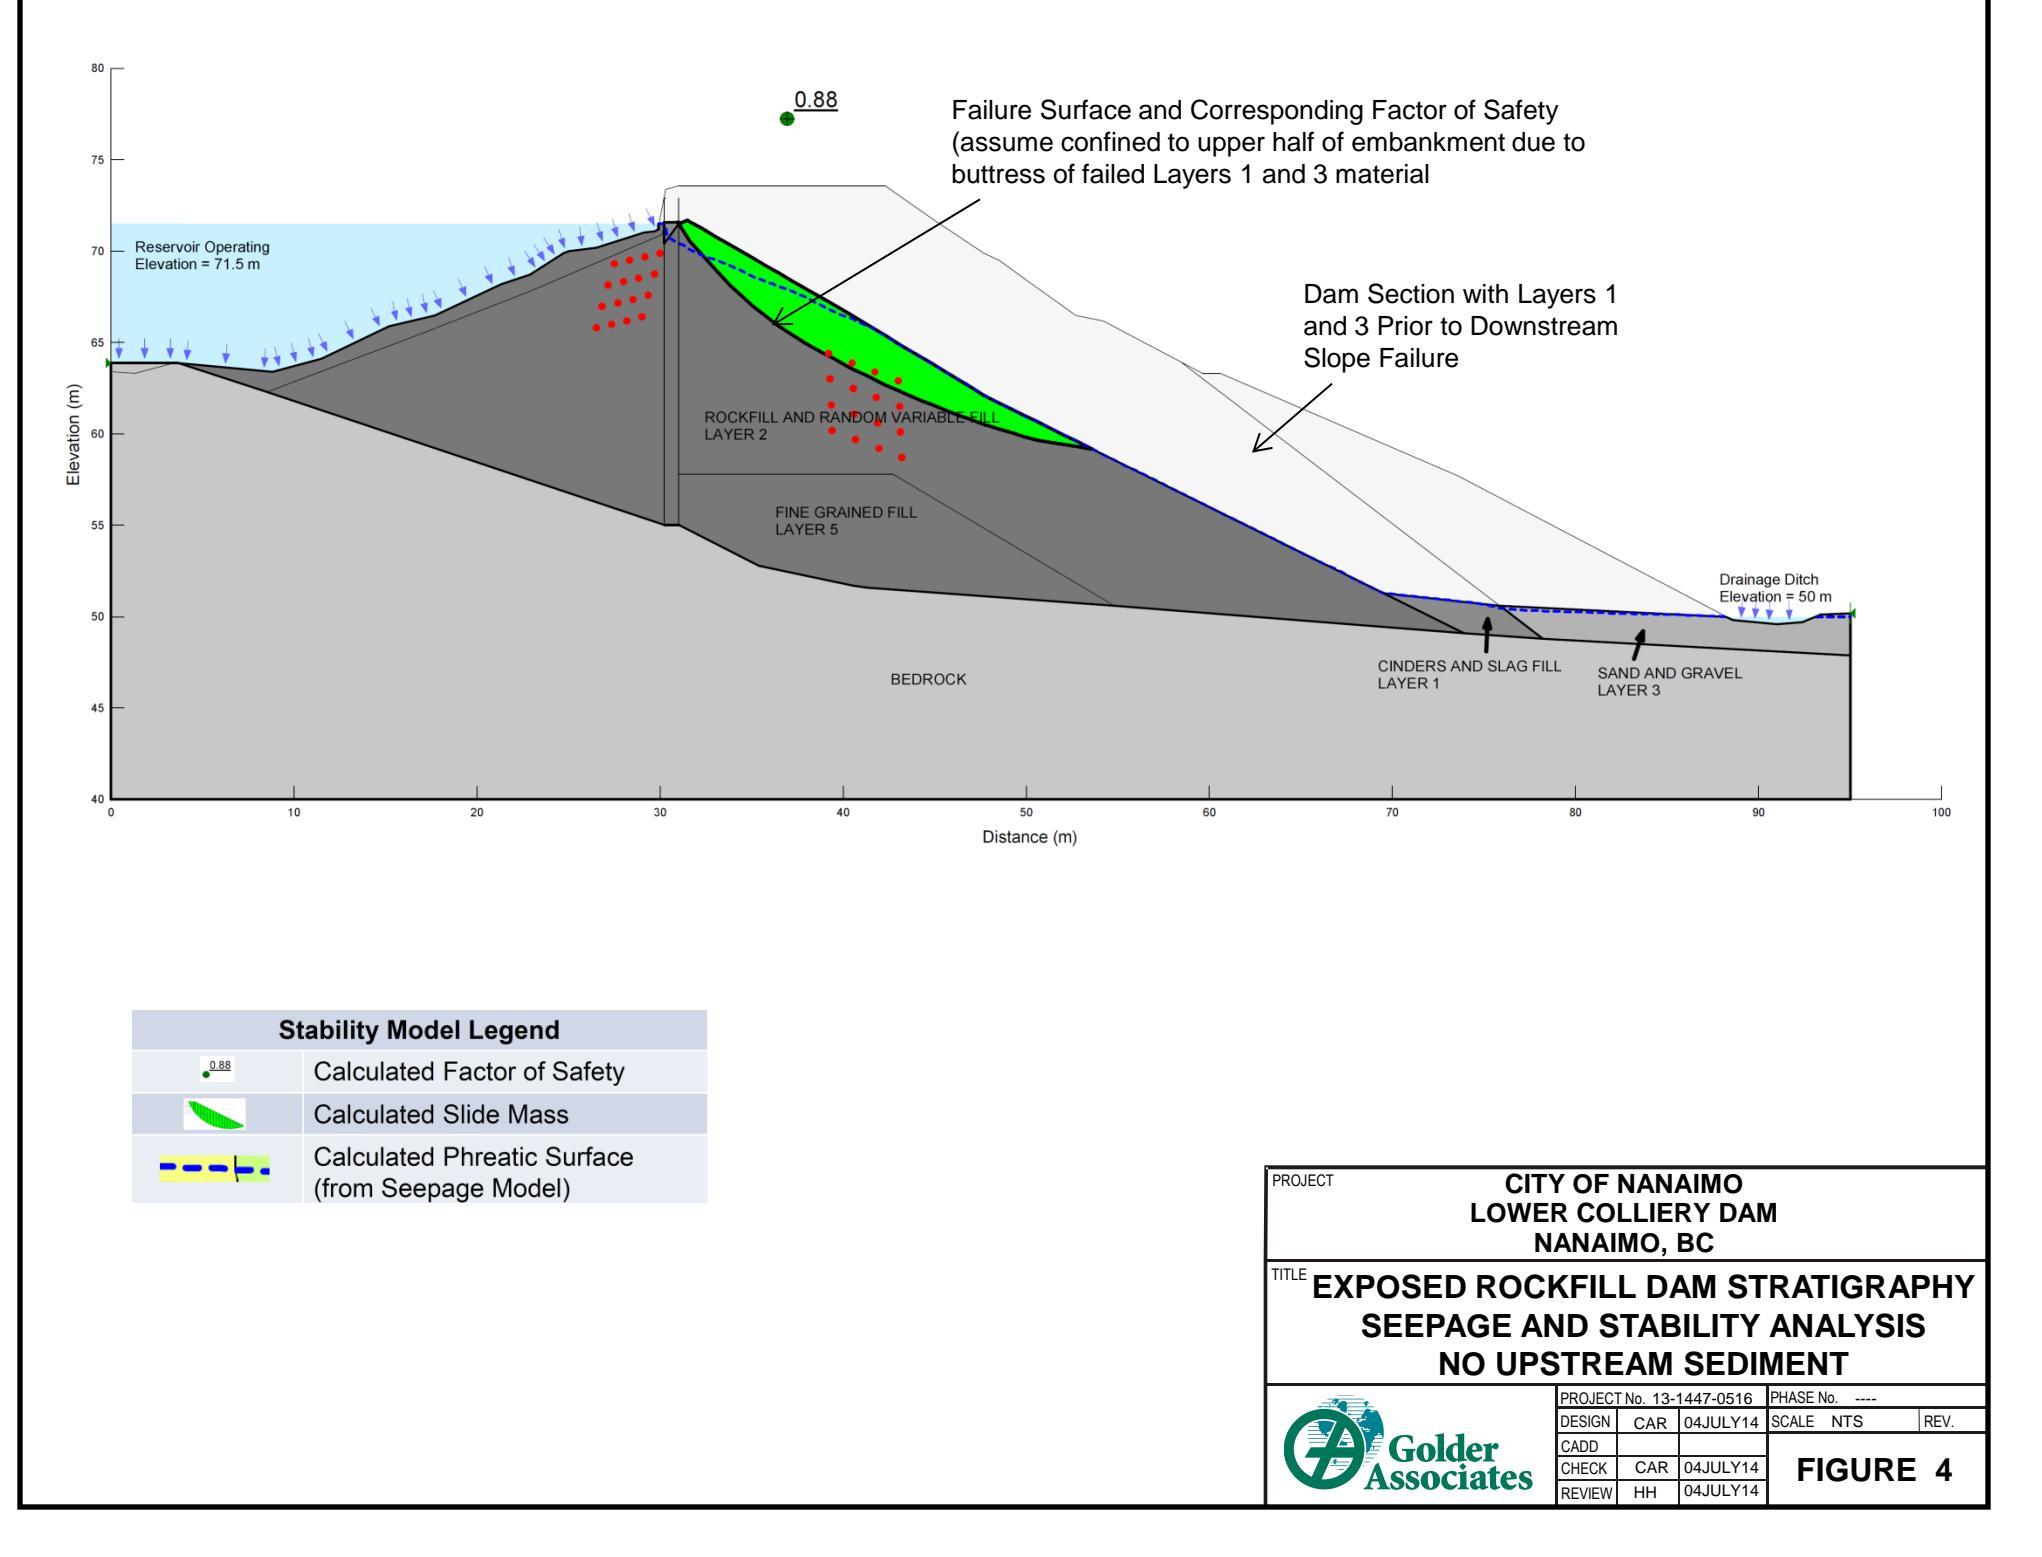
# FIGURE 4B – STABILITY ANALYSIS POST EARTHQUAKE SECTION WITH LOSS OF DOWNSTREAM FACE NO UPSTREAM SEDIMENT LAYER

On Figure 4, a conservative condition where the presence of an upstream sediment layer on the upstream face of the dam is not assumed to exist, the estimated seepage flow through the exposed rockfill embankment is approximately  $3.9 \times 10^{-2}$  m<sup>3</sup>/s per m of dam width. The increase in dam seepage flow from Scenario 3 is attributed to the loss of the confining effects of the lower hydraulic conductivity of Layers 1 and 3. At an elevation of approximately 67 m, the calculated phreatic surface daylights along the downstream face of the dam, indicating that a portion of subsurface dam seepage would exit and flow along the downstream face below this point. Under this condition the stability analysis shown on Figure 3B indicates that the minimum FoS is approximately 0.9 which indicates that the surface shown in green on the figure, although marginally stable, may be expected to slump although this slump may not be sufficient to cause loss of freeboard and overtopping of the dam.

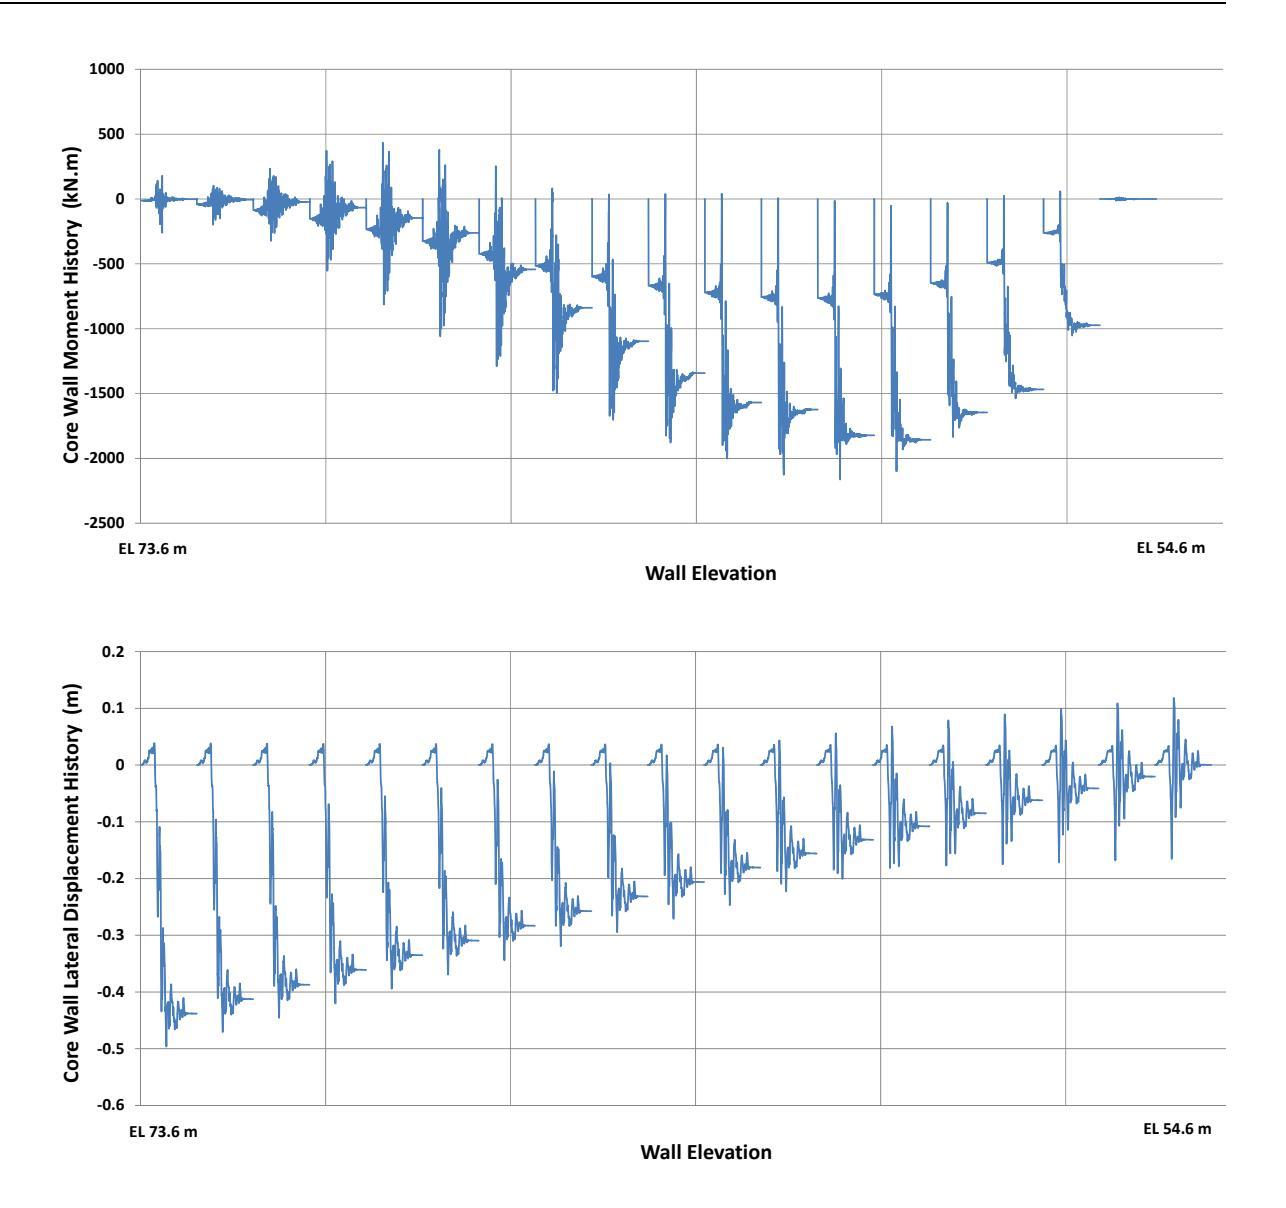
**Figure 3**: Elastic moment response history along the height of the concrete core wall together with the displaced profile of wall (1/2475 return period)

Figure 3 illustrates the elastic bending moment response history along the height of the concrete core wall together with the displaced profile of the wall for pinned/rolling base boundary condition and 1/2475 input ground motion. The computed maximum moment demand is about 3.5 times that of the probable plastic moment capacity of the wall occurring at about the lower third point of the wall or about 7m from the base of the wall. The peak lateral displacement at the top of the wall is about 0.5 m corresponding to the permanent displacement of the wall/dam. It is noted that the displaced shape of the wall under reversed cycles is biased towards the reservoir indicating the bending moment demand will be within the elastic range (but higher than the cracked moment) for cycles towards the downstream of the dam.

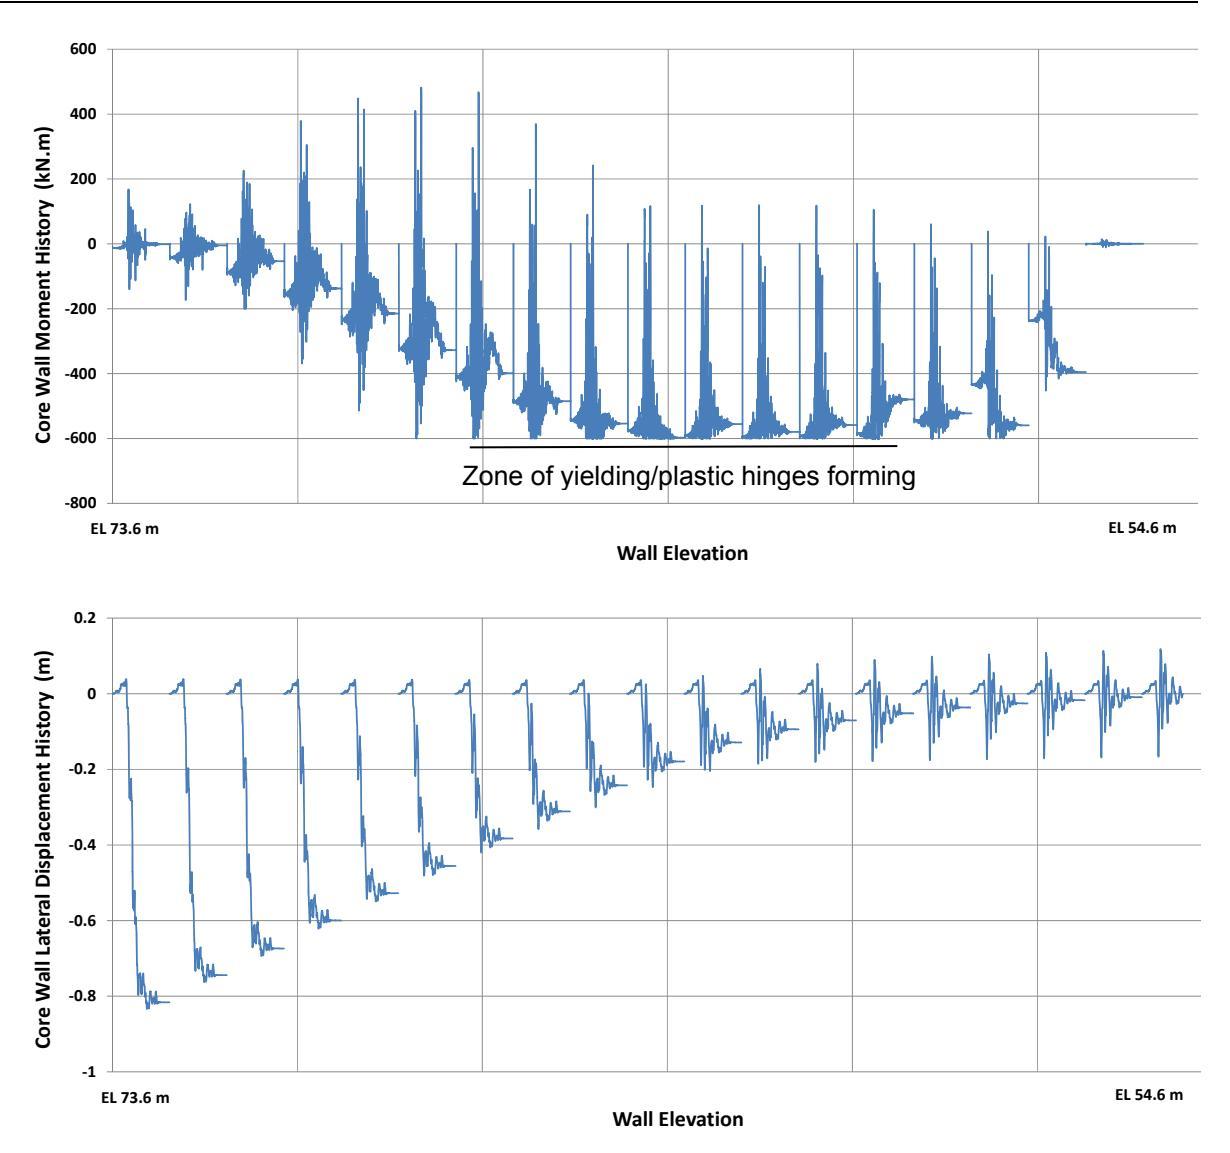
For a comparative study, the FLAC analysis was run for the elasto-plastic case, where the core wall was assigned a probable plastic moment capacity of 600 kN.m and pinned/rolling base boundary condition and 1/2475 input ground motion. Figure 4 illustrates the bending moment response history along the height of the concrete core wall together with the displaced profile of the wall.

The formation of plastic hinges along the mid-section of the wall is pronounced in Figure 4 in mid to lower sections of the wall. The displaced profile of the wall shows distinct change in the curvature of the wall starting around the mid-section of the wall.

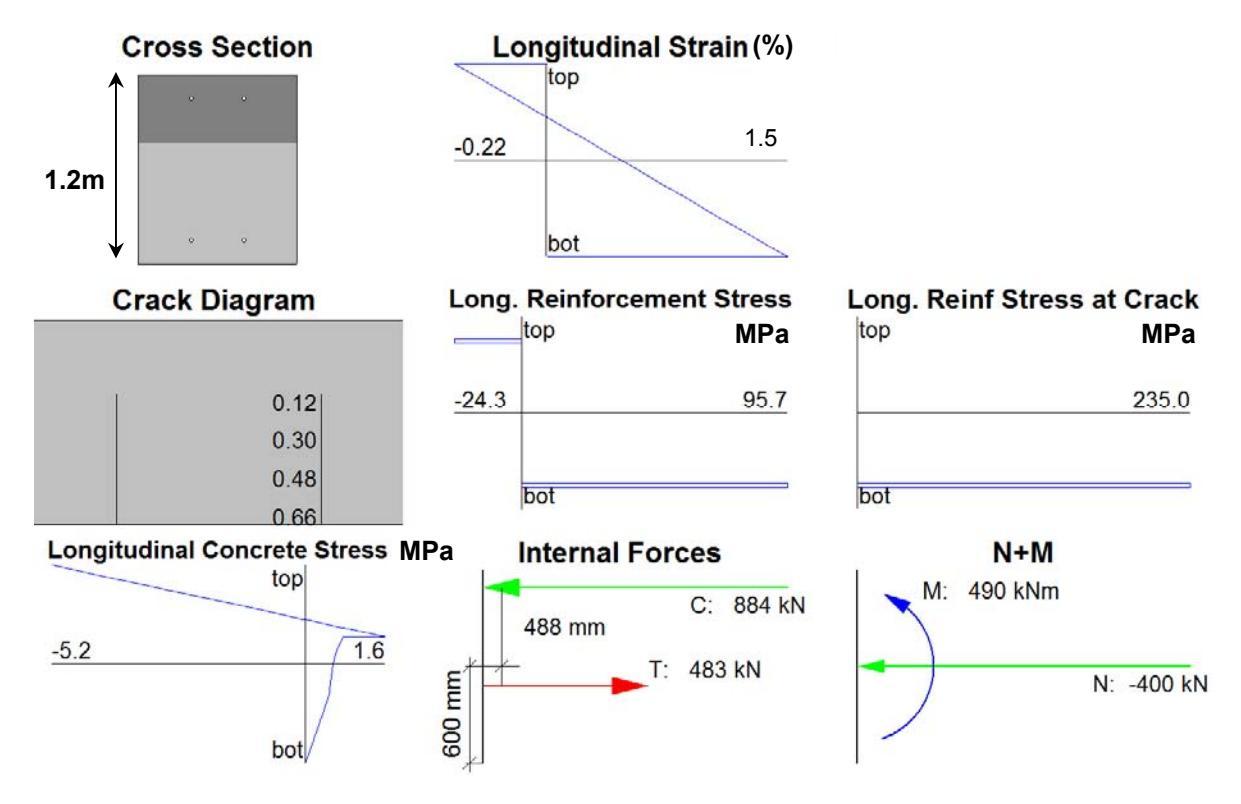
Figure 5: Sectional analysis of Lower Colliery Dam core wall at about onset of rebar yielding

and thermal strains are ignored in this case). The results indicates that the wall starts to yield at a moment demand of about 490 kN.m assuming two twisted bars within a meter length of the wall.

It is noted that the crack width is small at the onset of yielding; however, as the demand increases, so, does the strain in the rebar and crack width.

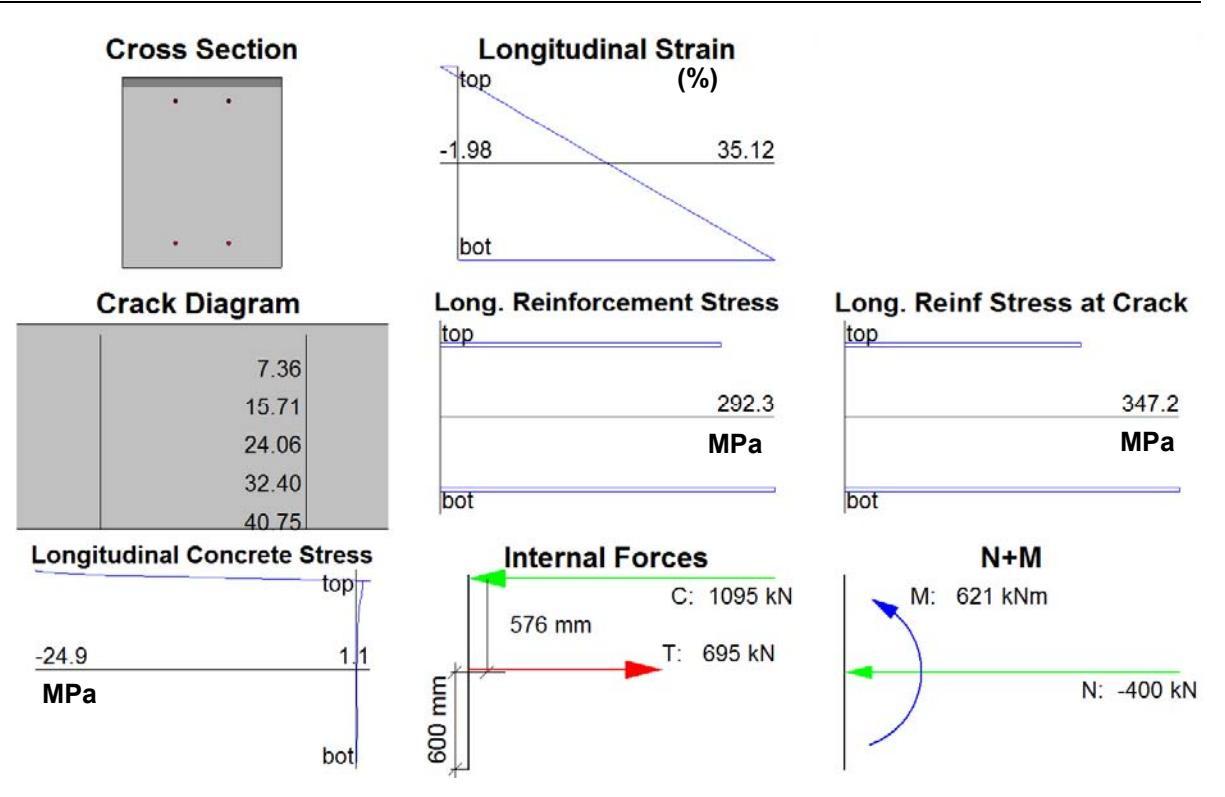
Figure 6: Sectional analysis of Lower Colliery Dam core wall at 2% rebar strain

As the demand increases and the vertical bars are subjected to higher strains, the crack width will widen. Figure 6 shows the results of sectional analysis for a metre length of the wall when the wall is subjected to demand past the yield strength of rebar to its limit states (this demand occurs for both 1/2475 and 1/10,000 return periods). As can be seen from Figure 6, at about 4% longitudinal strain the crack width widens to about 40 mm. Our sectional analysis indicates that pushing the wall further will results in crack width widening to 60-70 mm. It is noted that at these high strains the compression zone is rather small with concrete compressive stresses reaching about 25 MPa. It is noted that the level of accuracy presented in this work, given the nature of the input/output parameters, is not within a few millimetres. The estimated range of validity of these results could be +/-50%.

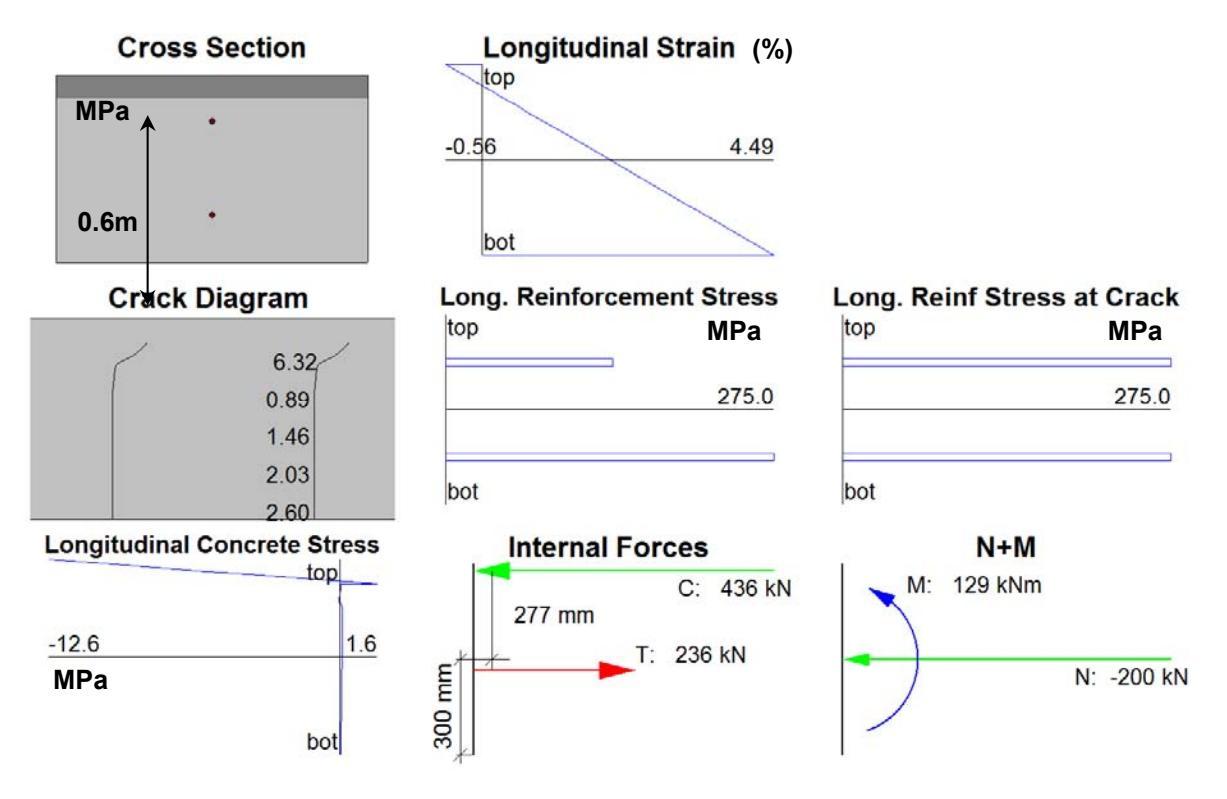
Figure 7: Sectional analysis of Middle Colliery Dam core wall

It can be observed that the probable moment capacity of the wall at onset of yielding (about 0.2 mm/m; note that the plot shows about 0.4% longitudinal strain) is 129 kN.m. The maximum demand tabulated by EBA FLAC analysis is 137 kN.m developed in the mid-section of the wall. This clearly indicates that there will be a nominal yielding in the rebar and that the wall will have adequate capacity to resist the tabulated demand.

On this basis that there will be at least a single vertical bar present within a metre length of the Middle Colliery Dam core wall, the possibility of the upper section of the wall failing and falling into the reservoir is extremely low.
