Dam Safety Reviews for the Middle & Lower Chase River Dams

Prepared for: City of Nanaimo Project Manager: Masoud Mohajeri Date: February 28, 2014

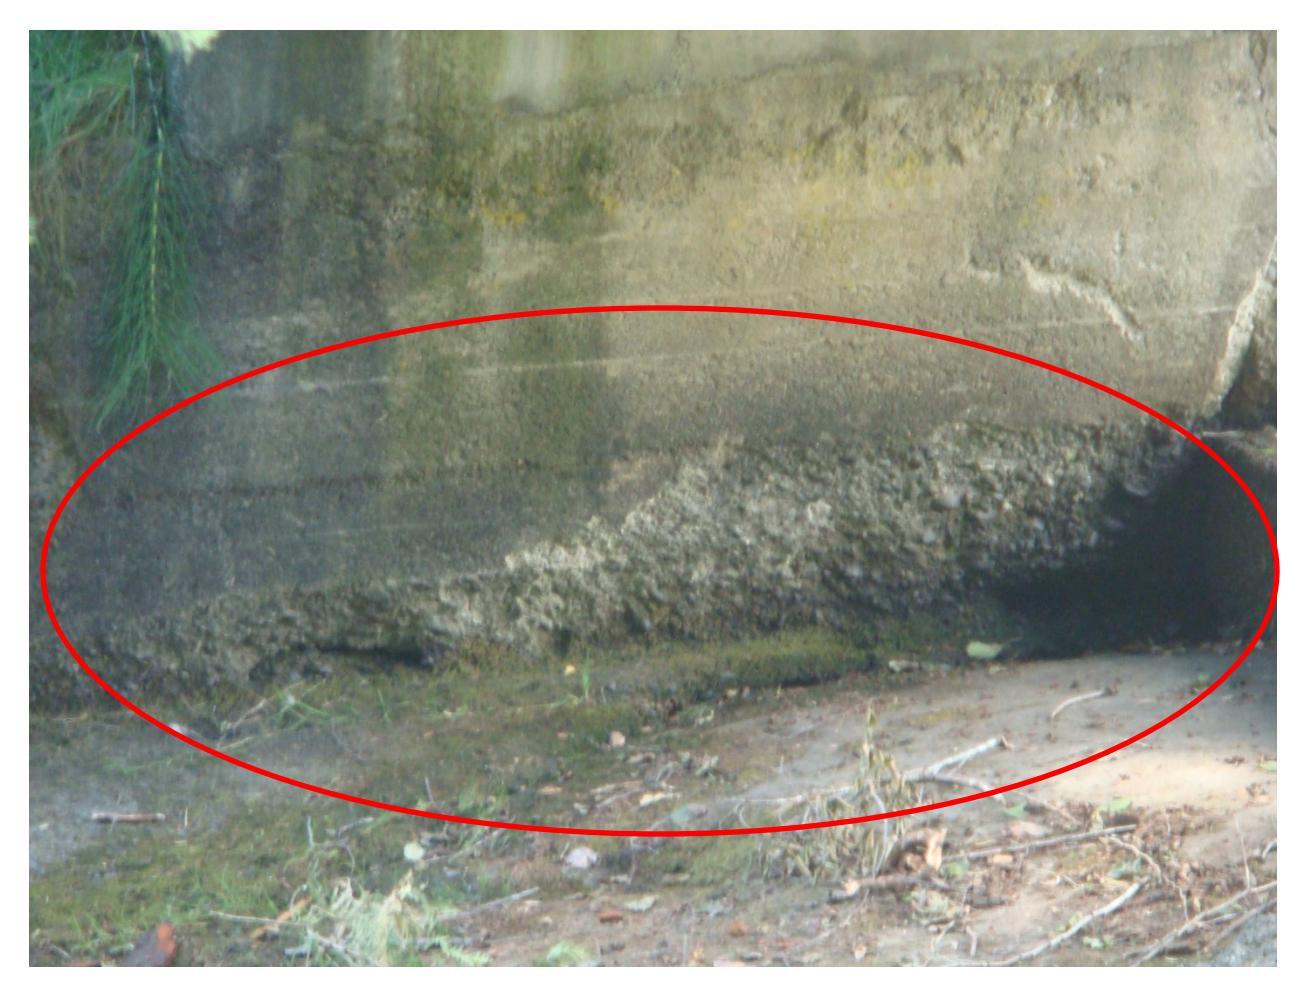
There is some erosion visible at the base of the centre pier and the side walls of the spillway (Photos MCR-02 & MCR-03). Undercutting of the pier base is only minor at present but this should be monitored and repaired at some point as erosion will

Middle Chase River Dam – Spillway Erosion in Pier on Right side

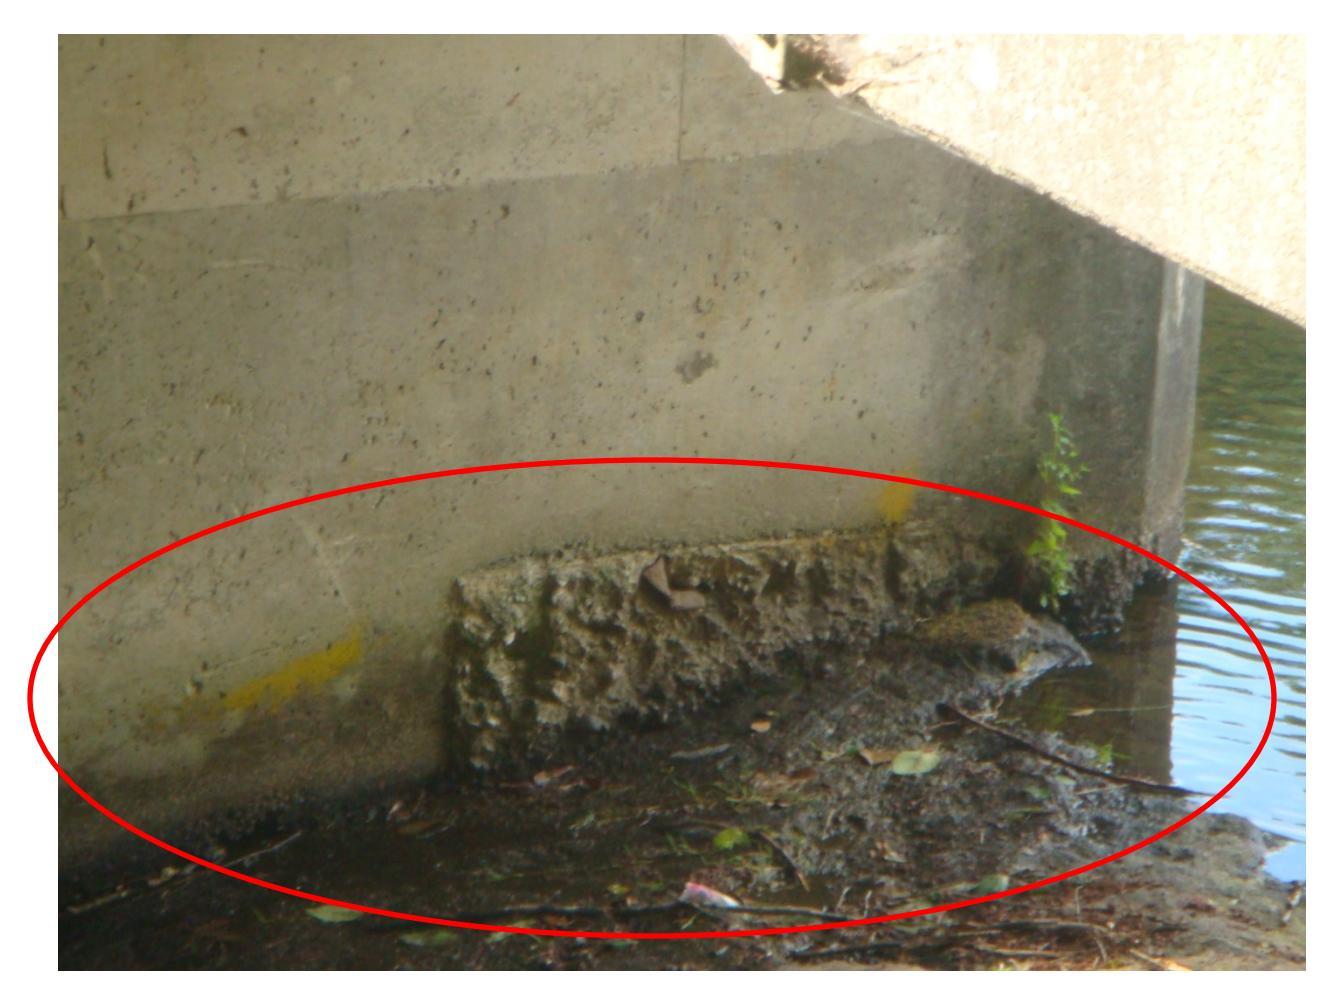
Middle Chase River Dam – Spillway - Erosion in Pier in Center Pier

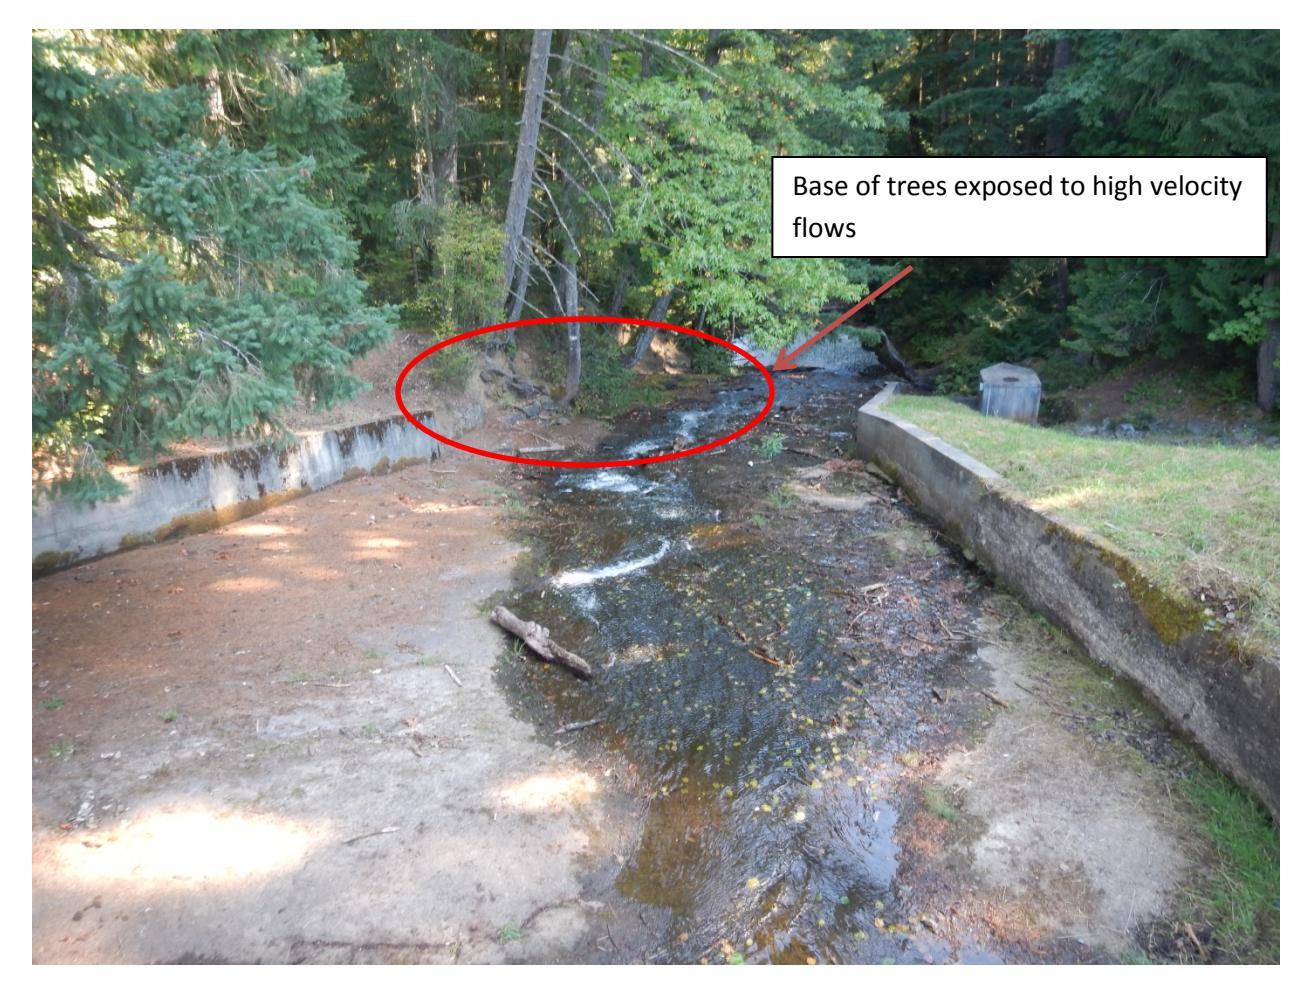
There is evidence of erosion taking place in unprotected areas of the spillway discharge channel which is cause for concern. There is undermining of trees along the channel's edge, causing them to lean towards the channel. In an unusual flood event these could be further destabilized and topple into the channel, causing a significant backwater. This has been previously identified as an issue with a high priority (MCR09-5) but no action has been taken by the City.

Middle Chase River Dam – Spillway – Outlet Channel – Note Trees in Background

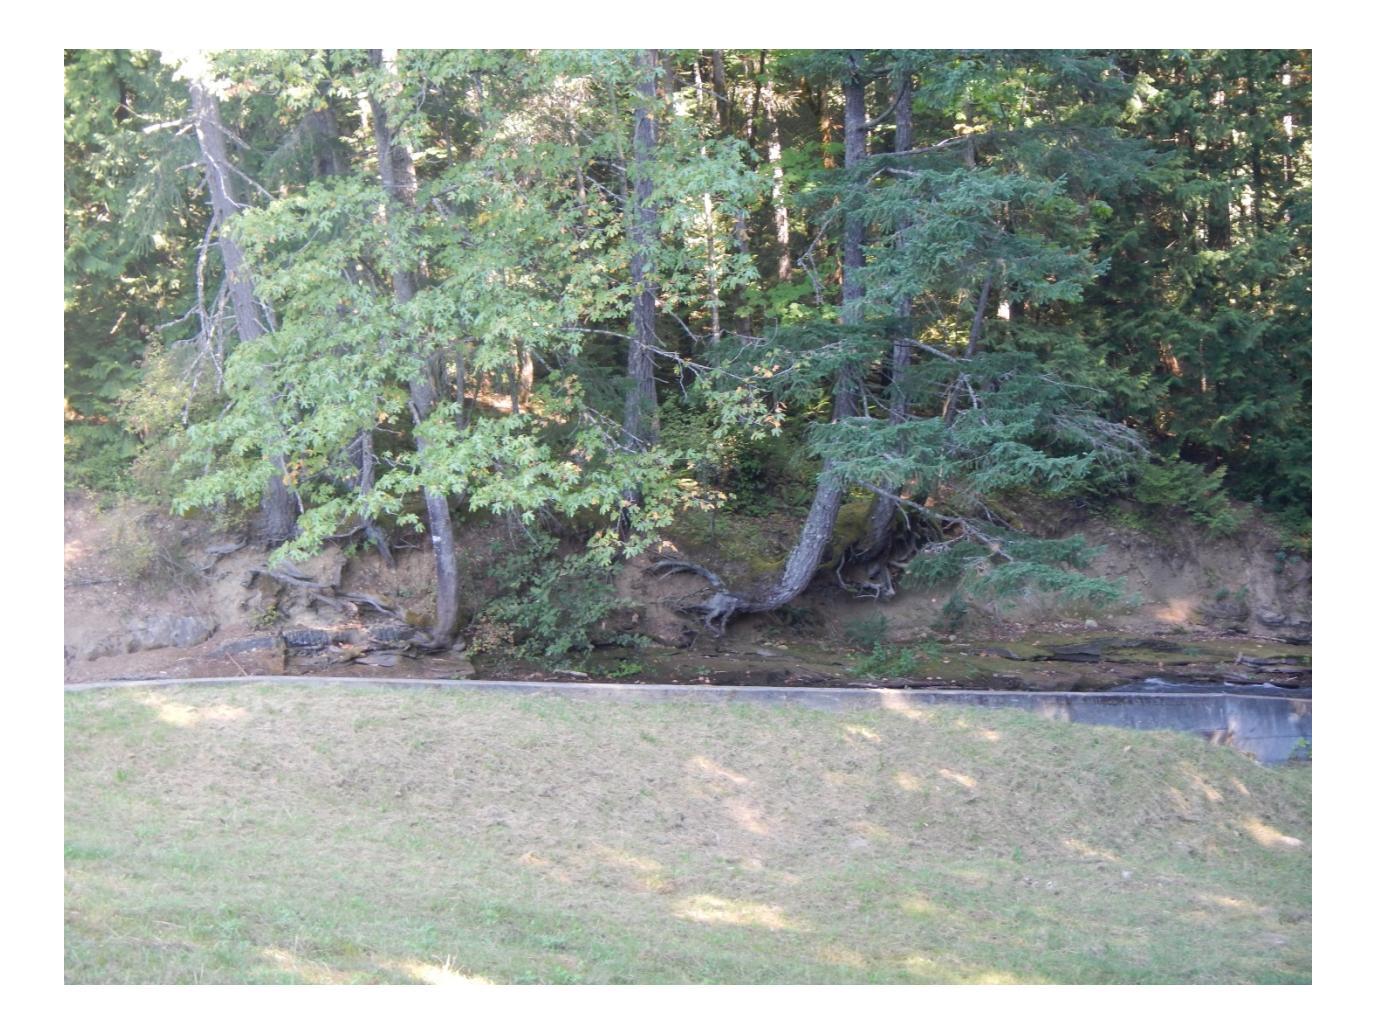
Middle Chase River Dam – Close-up of Eroded Are on Left Bank of Spillway

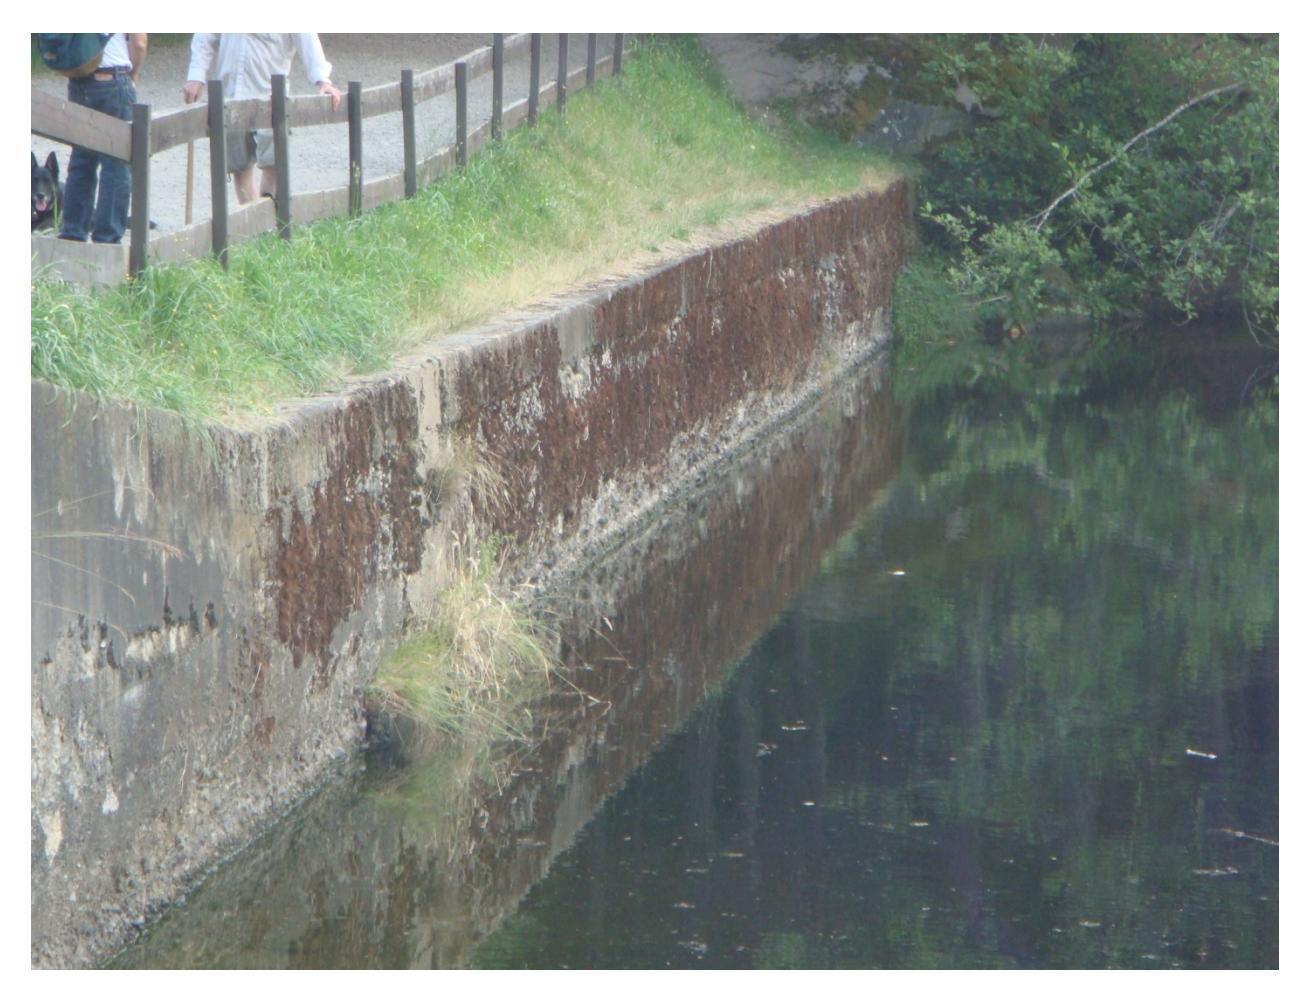
The exposed concrete core wall displays some minor cracking and spalling which one would expect for a structure of this age (Photo MCR-07) but nothing evident that compromises the structural integrity of the wall. There is a seepage weir on the downstream toe of the dam adjacent to the spillway channel (Photo MCR-06), readings from which are relayed to the SCADA system. As part of the field work conducted during the seismic stability assessment of the dam carried out by EBA Engineering Consultants in 2010 a diving inspection upstream of the dam was carried out. The diver located a woodstave pipe which appeared to pass through the left abutment of the dam adjacent to the spillway in the area where the fill was not removed during the 1980 remediation work. This is obviously a cause for concern as it could collapse any time due to its deteriorated condition and cause piping due to increase seepage along the pipe triggering failure of the dam. Although seepage has been noted at this location over the years there was no sign of excessive seepage at the time of this inspection.

Middle Chase River Dam –Exposed Section of Core Wall

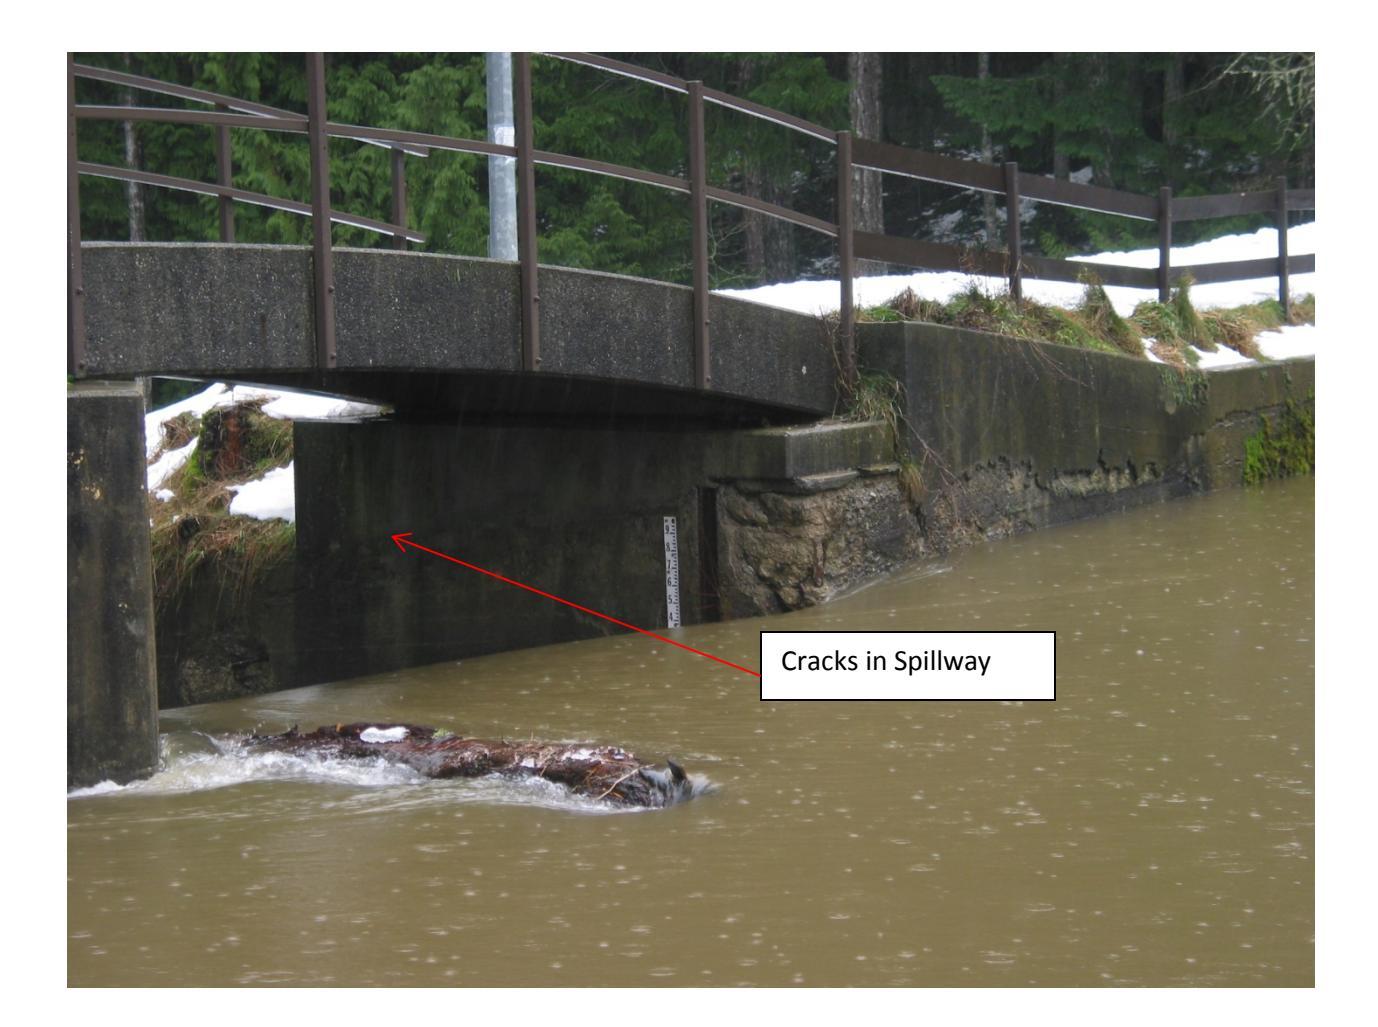
continue to occur. MCR-11 is a photograph taken (by others) during a high discharge period in winter. There are also cracks on the upstream face of the spillway and on the walls identified in previous FADSIs which should also be monitored **(MCR11-1)** but again do not display offsets which would indicate that there is a structural problem with the walls (Photo MCR-08). The pedestrian bridge abutment has also been eroded at the corner and should be repaired before its condition worsens (Photo MCR-08).

Middle Chase River Dam - Spillway - Cracks in Spillway Wall & Bridge Abutment

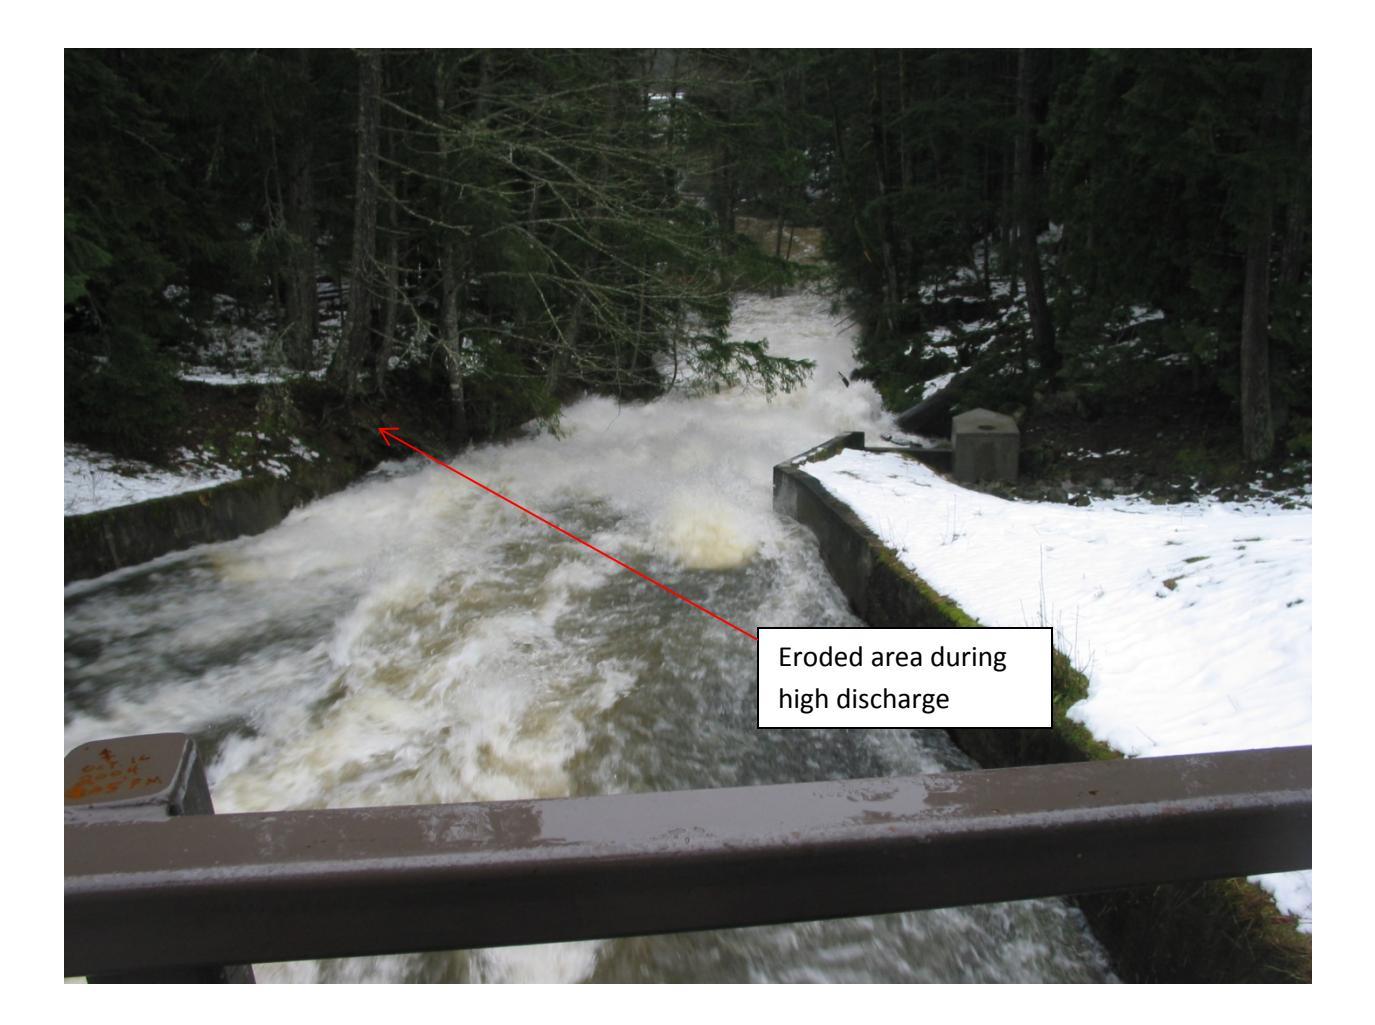
Middle Chase River Dam Spillway – Situation During High Discharge

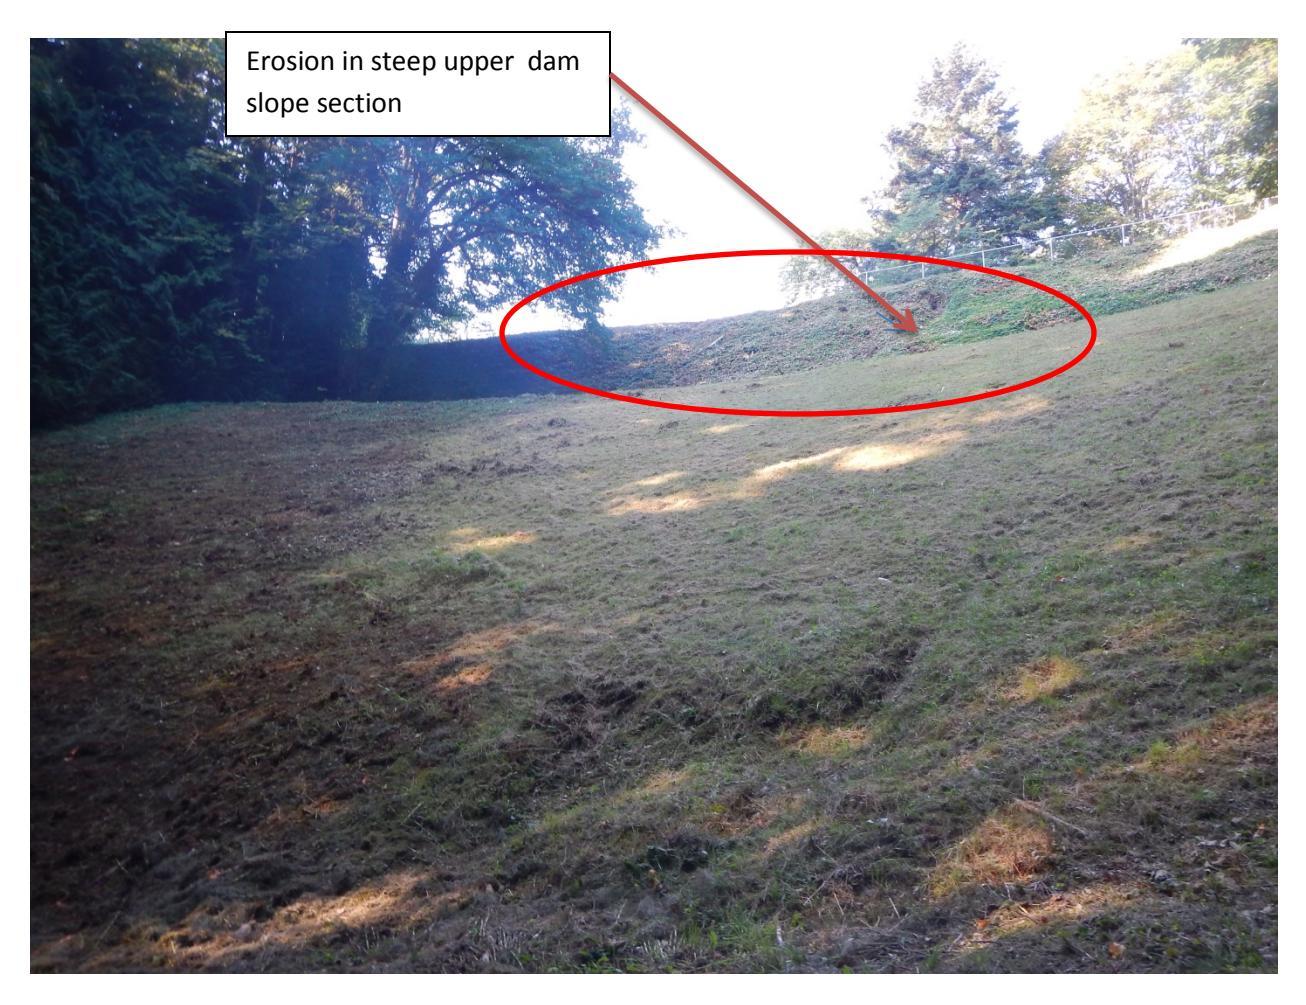
There was no significant leakage observed at the seepage measuring weir at the time of the visit. The upper part of the downstream slope is steep and is eroding in places causing some settlement in the crest of the dam. There is a severe crack visible on the right abutment of the footbridge and some cracking and erosion on the walls of the spillway approach channel. These issues have been reported in previous FADSIs and in the 2003 DSR. A new issue (LCR13-1) was raised in the Dam Issues Database to cover plotting of the dam monitoring data collected from the SCADA system so that any anomalies in dam performance could be readily identified.

Lower Chase River Dam – Downstream Slope of Dam – Note Erosion in Steep Upper Section

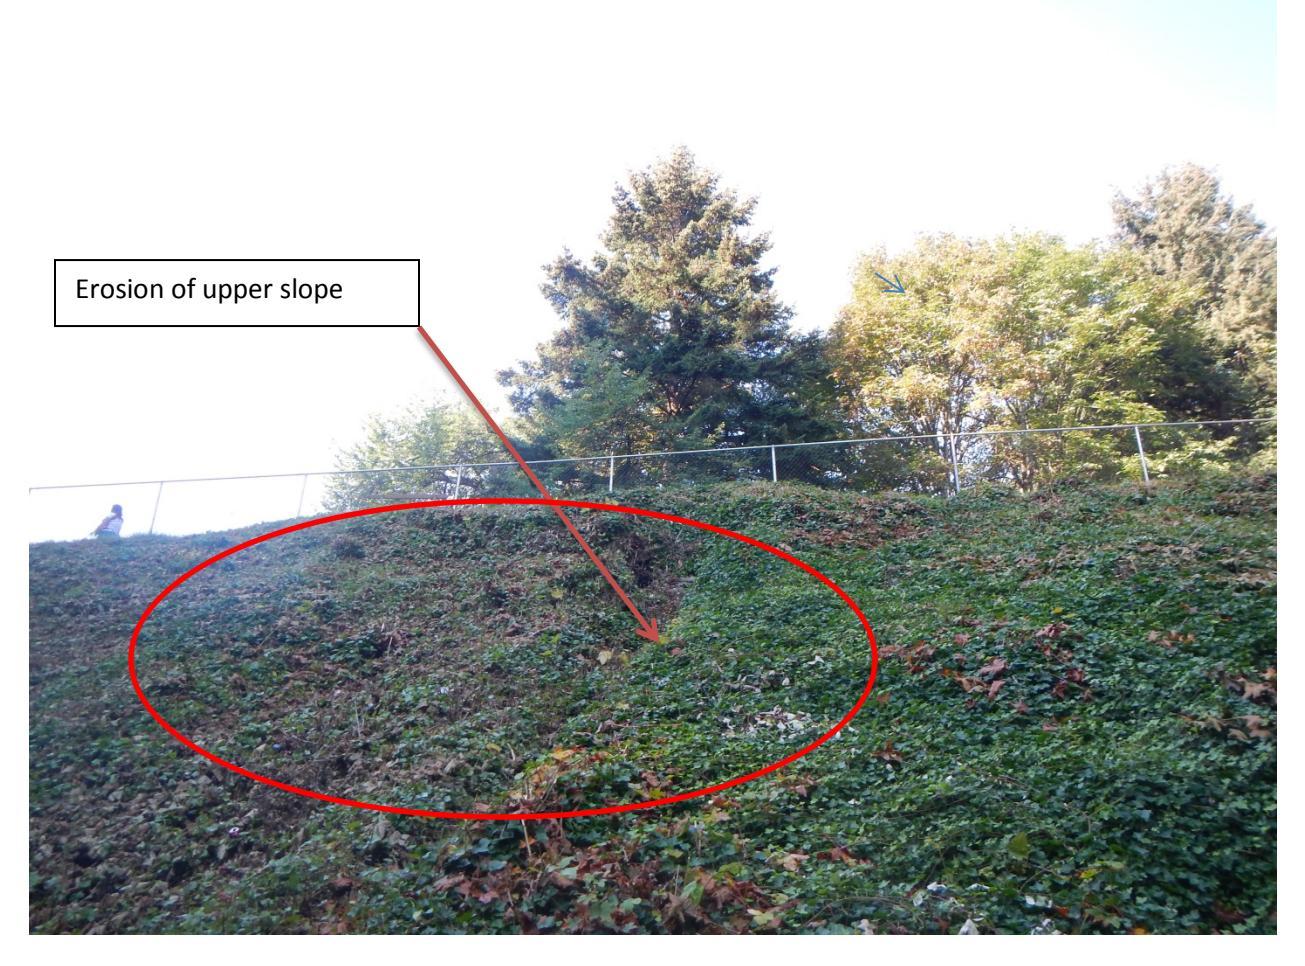
Lower Chase River Dam – Downstream Slope – Note Erosion in Steep Upper Slope

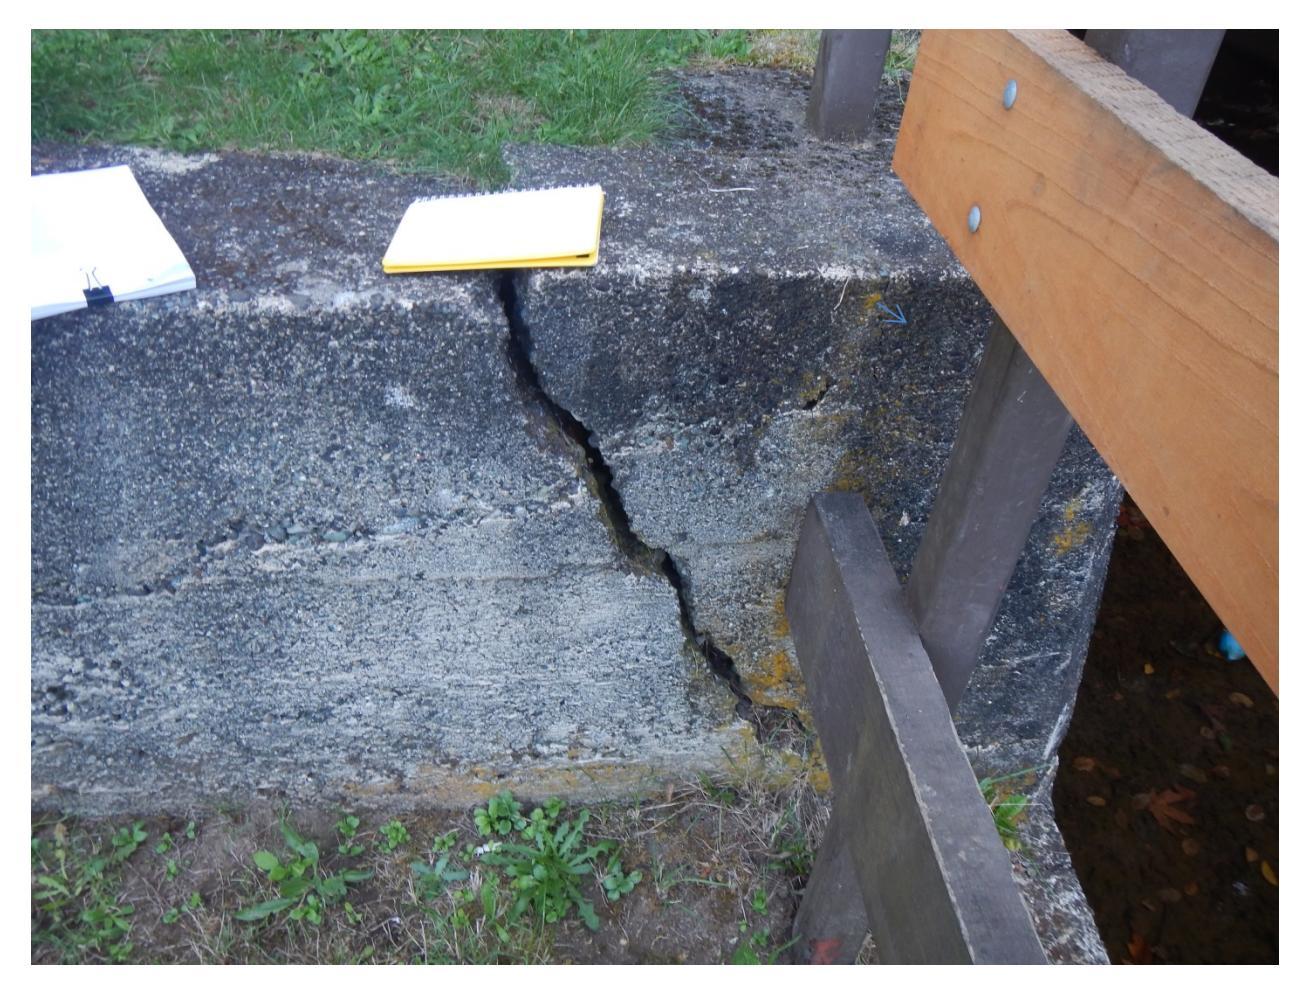
Lower Chase River Dam – Cracking in Bridge Abutment

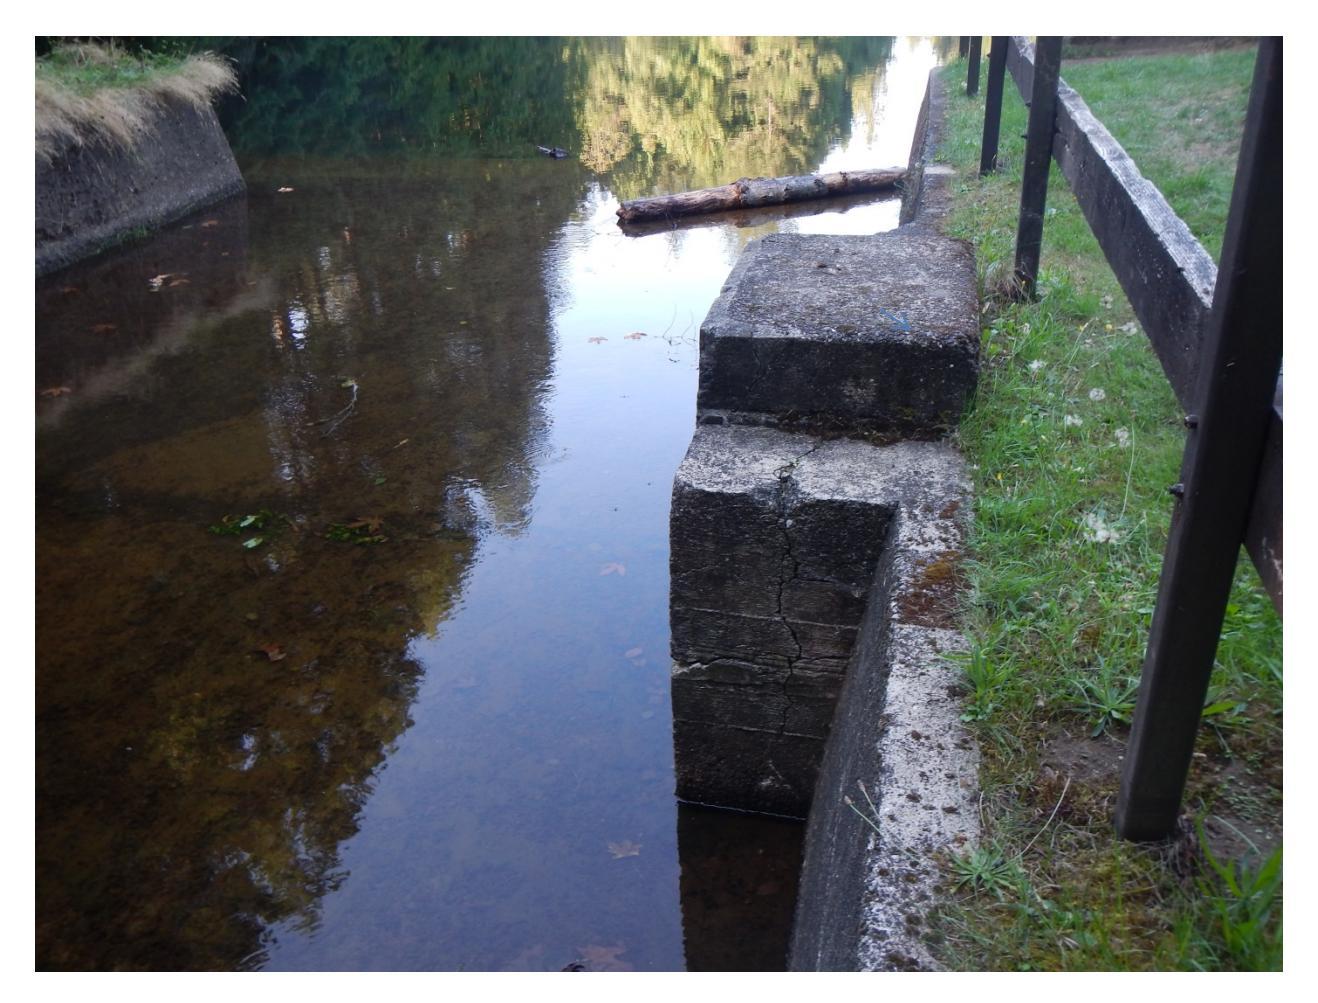
Lower Chase River Dam – Cracking in Spillway Approach Walls

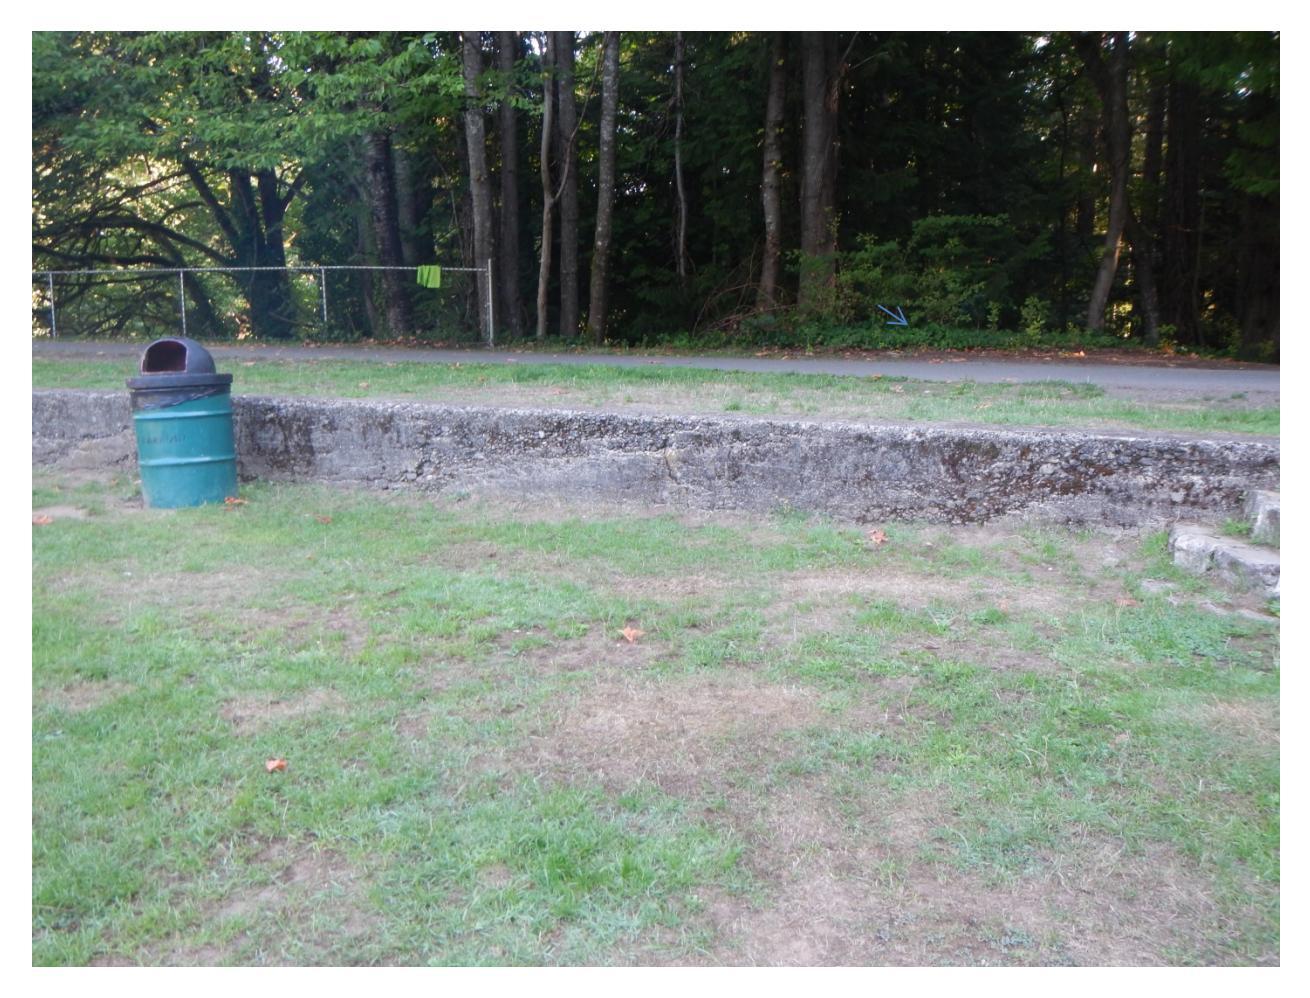
Photo No. LCR-12

Lower Chase River Dam – Top of Concrete Core Wall showing Cracking & Spalling
