The City of Nanaimo

SEISMIC HAZARD ASSESSMENT MIDDLE AND LOWER CHASE DAMS

N13101249

April 14, 2010

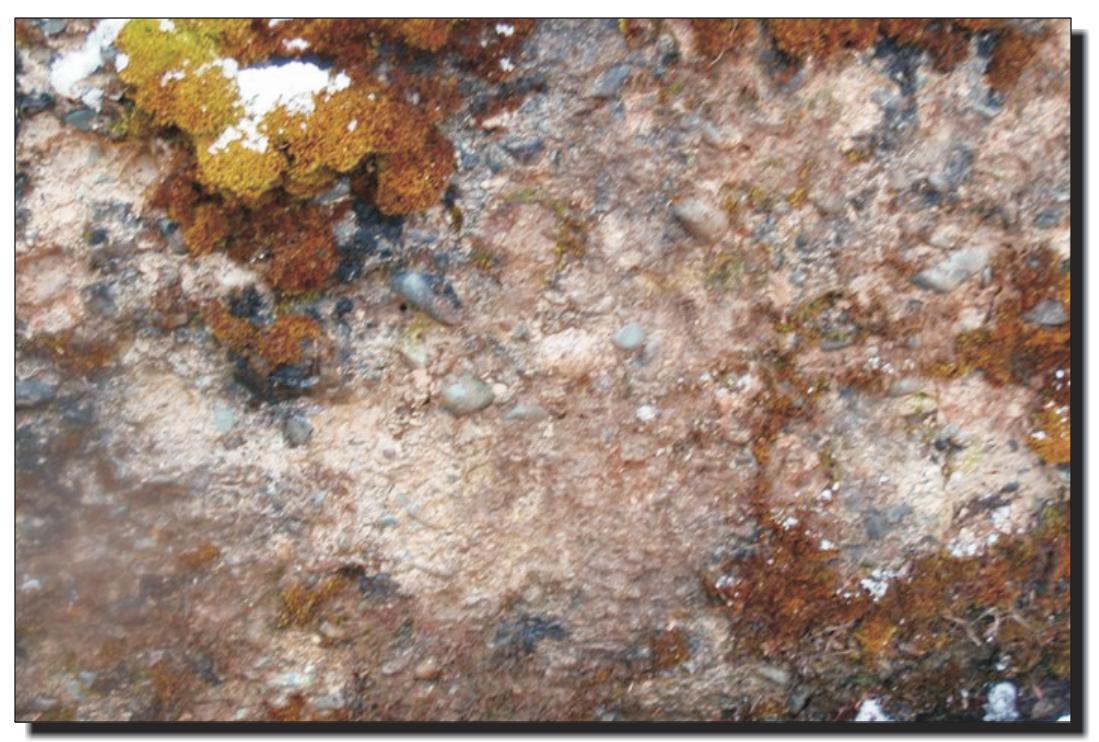
Photo 2 Concrete deterioration on upstream face of Middle Chase Dam

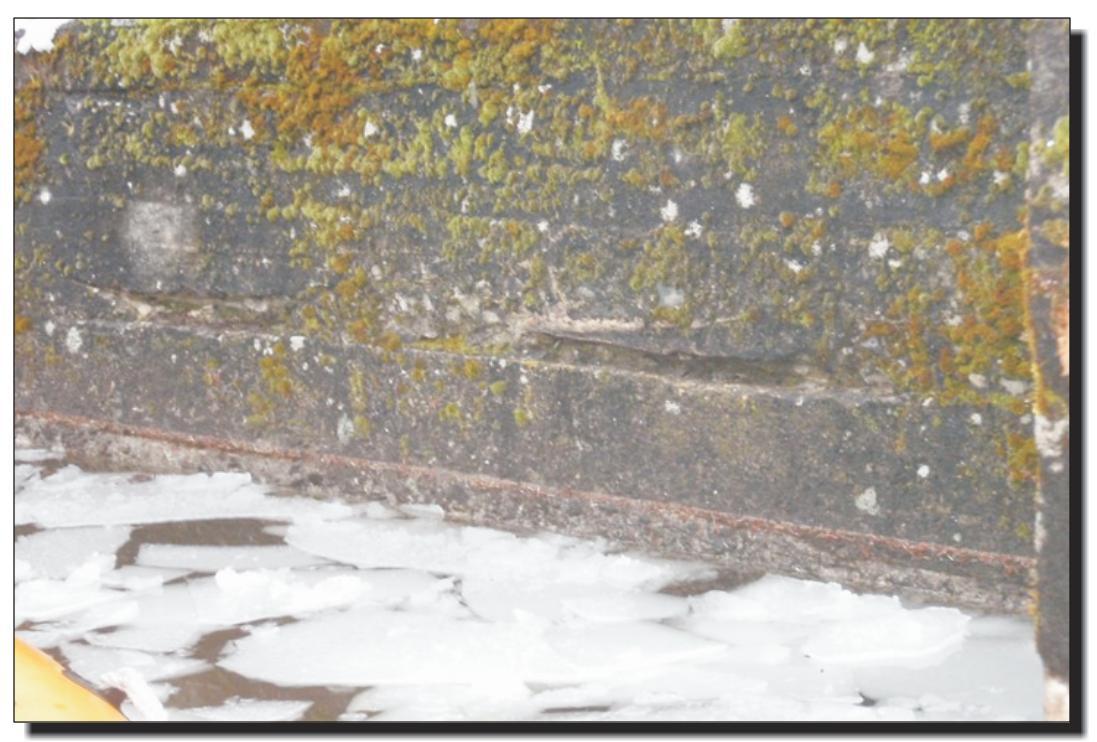
Photo 4 Deteriorated construction cold joints on upstream face of Lower Chase Dam near left abutment

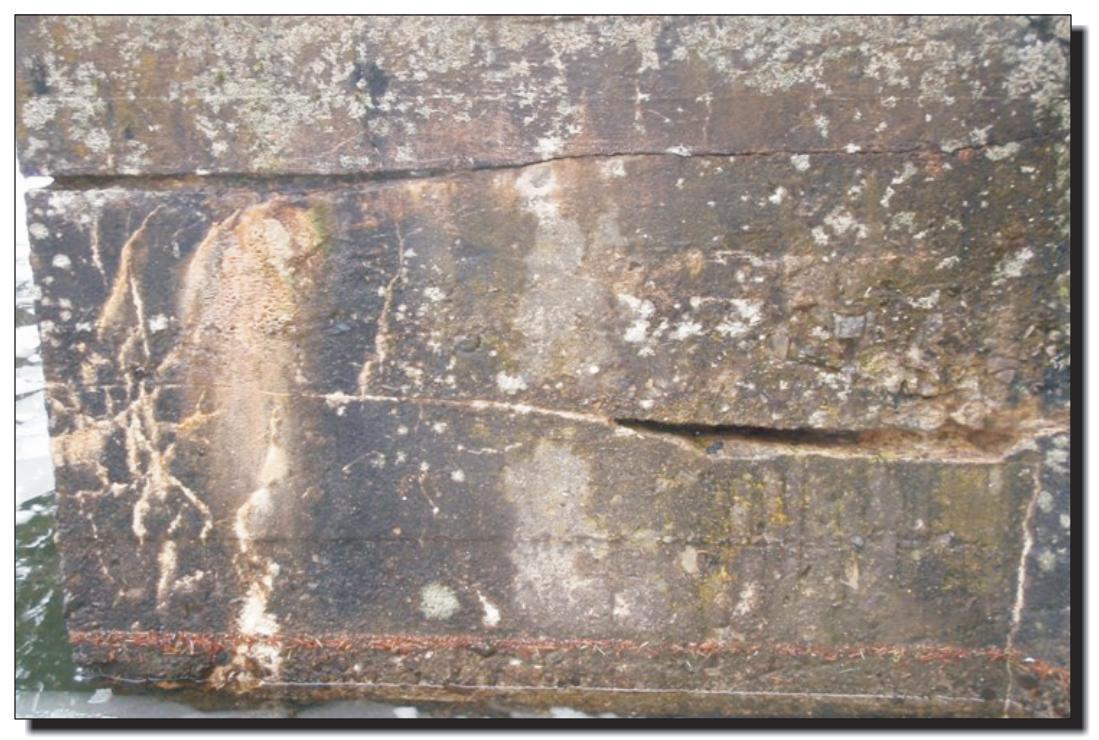
Photo 5 Deteriorated construction cold joints on entrance to spillway at Lower Chase Dam

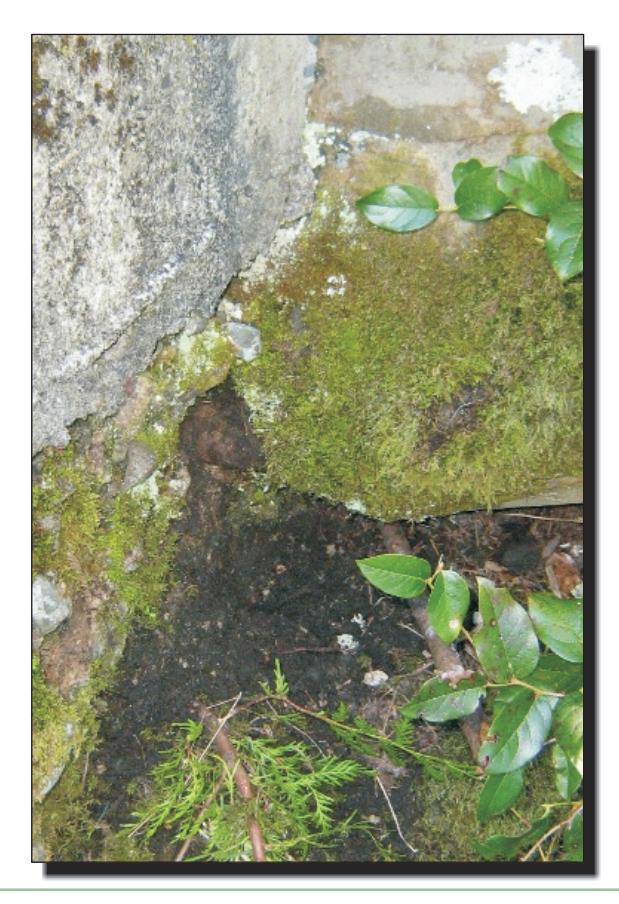
Photo 8 Concrete placed beneath a rock overhang on the right abutment near the crest of the concrete wall

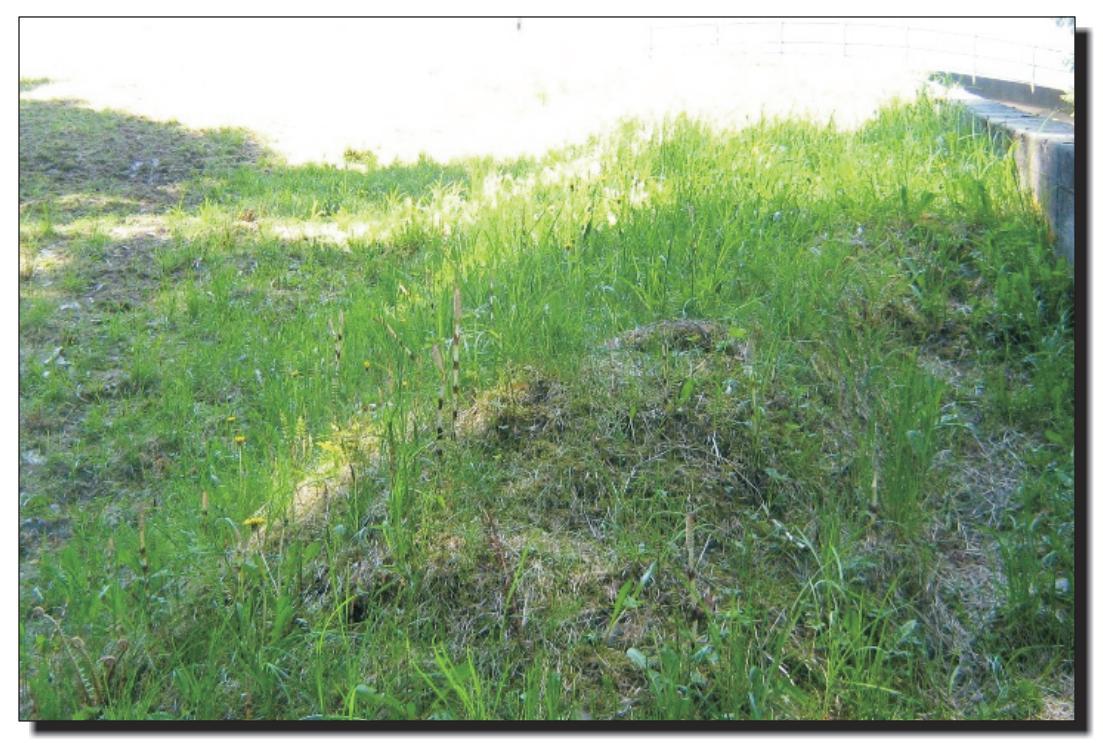
Photo 13 Mound of fill material adjacent to Middle Chase Dam spillway wall is believed to be the original rock fill left in place in 1980 when the downstream shell was substantially excavated and replaced.

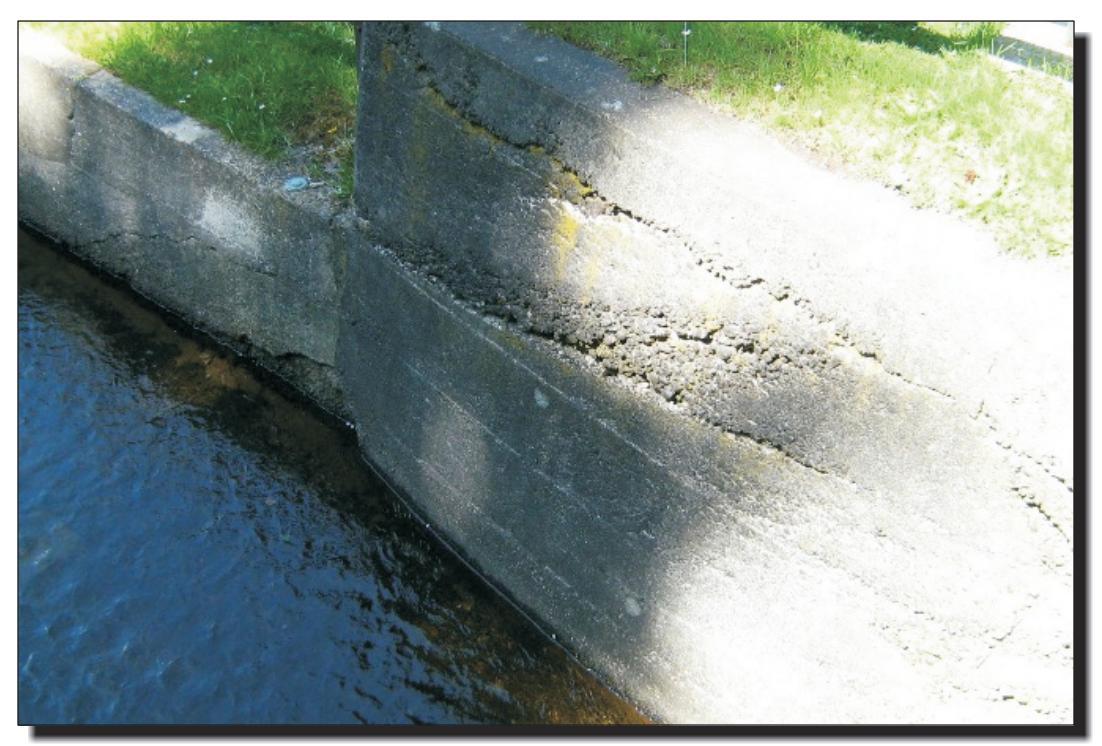
Smooth bar steel reinforcement is visible on the spillway walls at Lower Chase Dam where deterioration of the concrete has spalled some of the cover off of the steel. However, the age of this structure is unknown and it can not be confirmed whether or not this structure was constructed at the same time as the dam. Extensive honey-combing of the concrete is present at this location as well.

Photo 18 Honey combing and construction cold joints in left spillway wall at Lower Chase Dam.

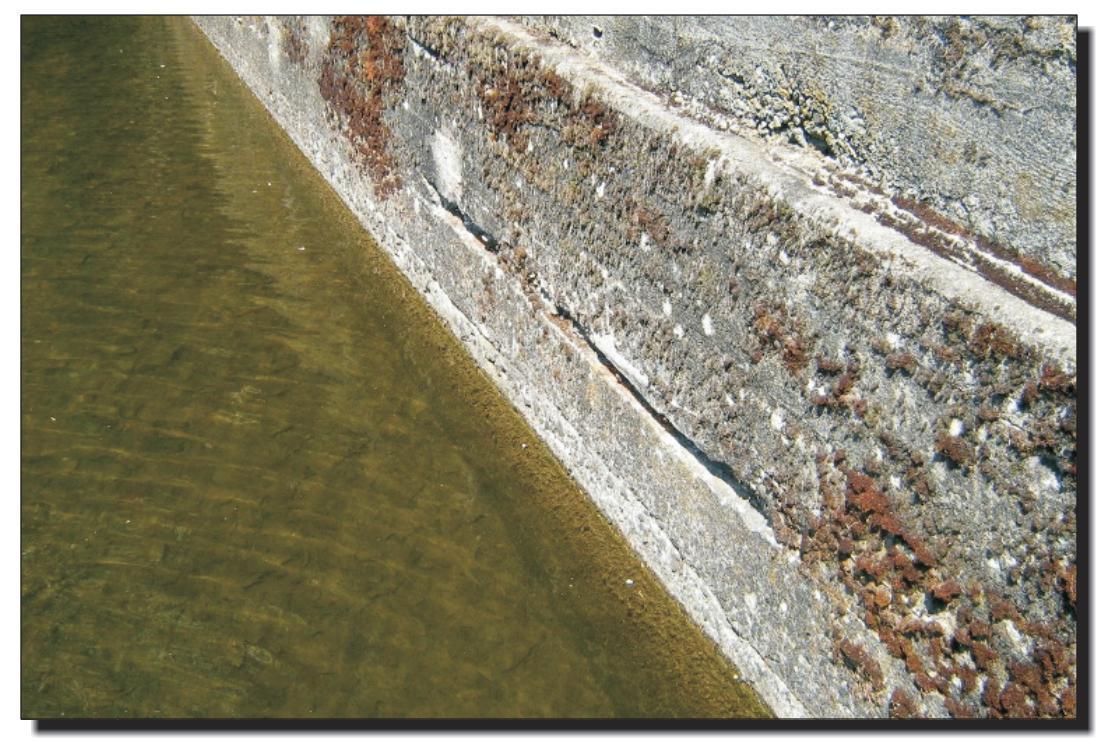
Photo 20 Original concrete wall with subsequent concrete wall cast on top of it. Note beveled edge of original wall and deterioration at cold joints or zones of poor quality concrete.

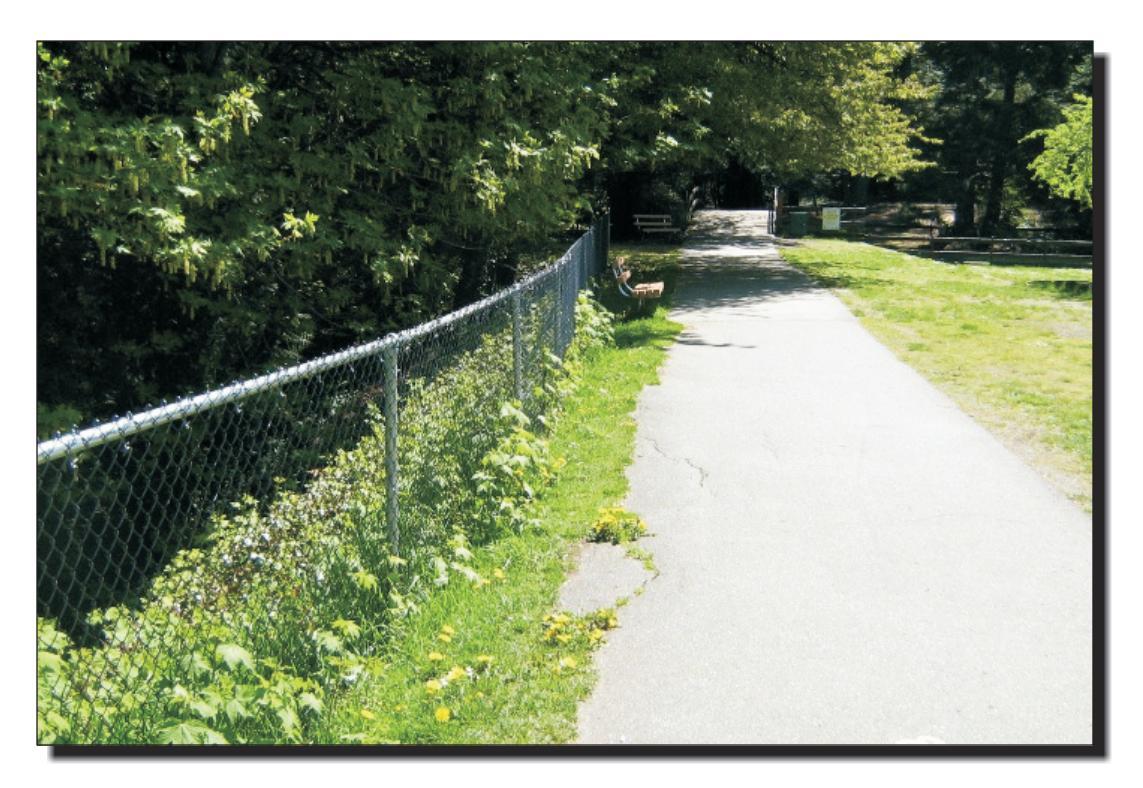
Photo 26 Settlement and cracking of asphalt walkway near downstream crest of dam where some shallow instability of the upper downstream face of the dam has occurred in the past.

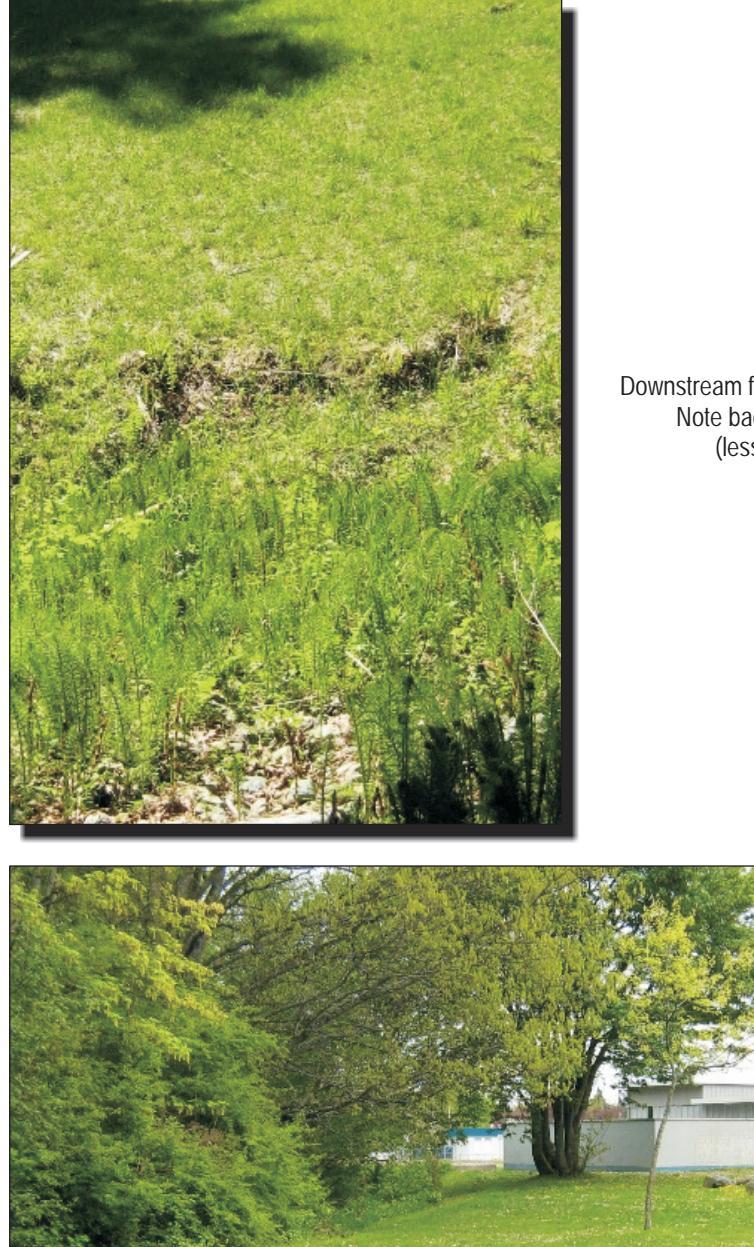
Photo 27 Downstream face of dam viewed from downstream toe. Note backscarps of small slope movements (less than 1.0 m high) at toe of dam.

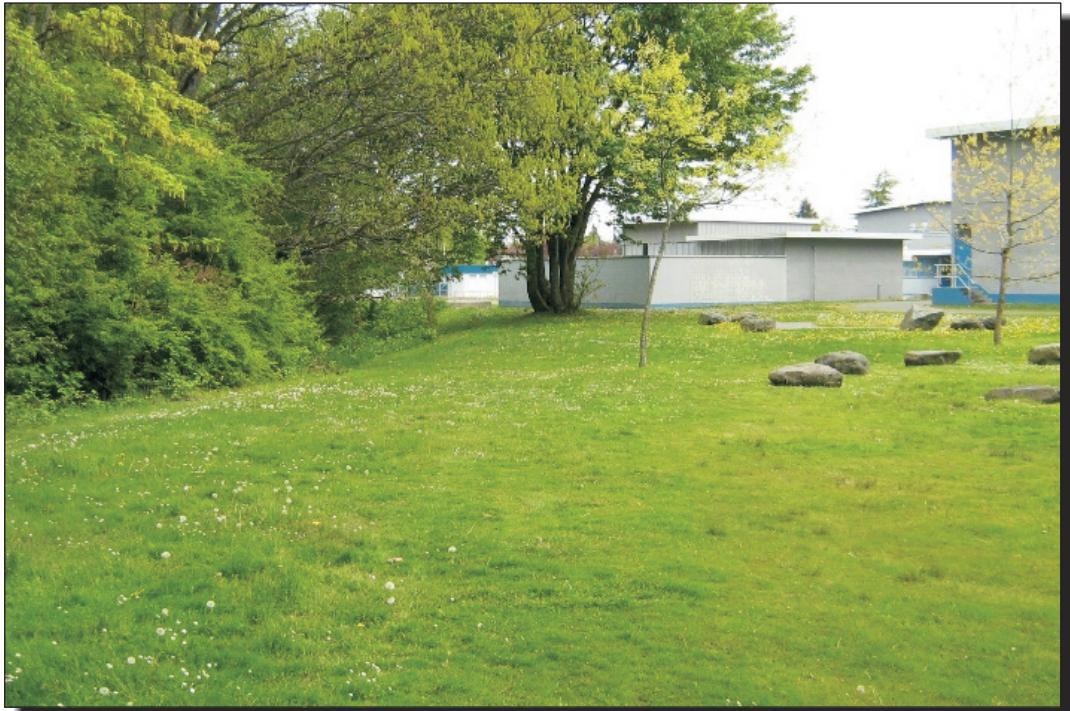
Photo 28 Proximity of Chase River channel crest to Barsby High School buildings
