MASTER PLAN
APPENDICES
OCTOBER 29, 2009

APPENDIX A -
WILDLAND URBAN
INTERFACE FIRE
HAZARD ASSESSMENT

WILDLAND URBAN INTERFACE FIRE HAZARD ASSESSMENT:

**Oceanview Golf Resort and Spa
Nanaimo, BC**

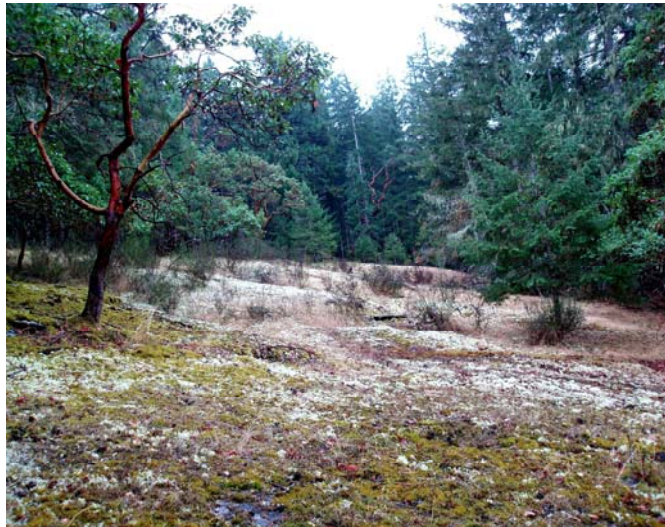
Photo. Terrestrial herbaceous ecosystem at subject property.

Several sensitive ecosystems occupy the subject property. Moss-covered rock outcrops support terrestrial herbaceous ecosystems with shallow soils and scattered trees and shrubs.

Terrestrial herbaceous ecosystems and riparian ecosystems present low fire hazards. Sparse tree cover at terrestrial herbaceous ecosystems negatively affects fire behaviour. Shaded, moist conditions at riparian ecosystems reduce the potential for fire start and spread.

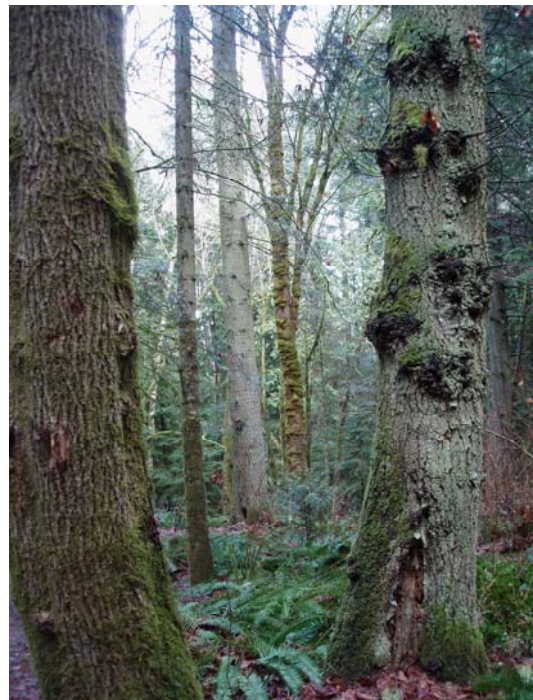
Photo. Mixed deciduous stands prevail in riparian areas.

Riparian ecosystems border streams and small wetlands, where soil moisture and light conditions favour nitrophytic and shade-tolerant plants distinct from surrounding land areas. Riparian ecosystems provide critical habitat for wildlife: food, cover, and water. Additionally, riparian vegetation helps to maintain the water quality and health of streams and rivers, and reduces erosion.

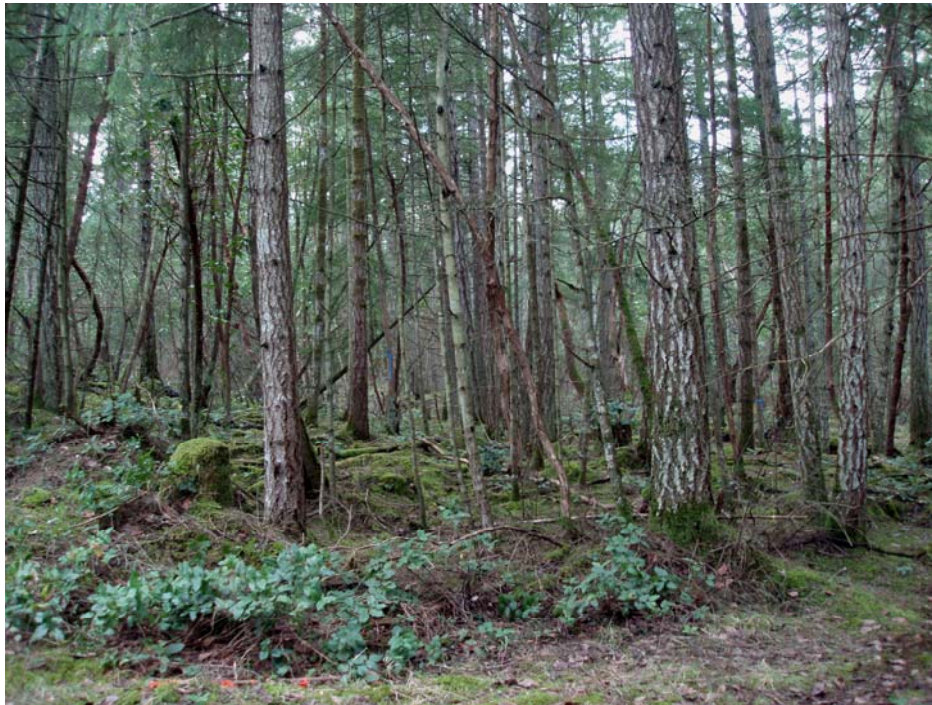
Photo. Second-growth forest occupies private land at the southwest corner of the subject property.

On its southwestern boundary, the subject property borders an undeveloped block of private forested land. Stand structure here consists of young and mature forest, with dense, well developed understoreys. Fuel loading (combustible natural fuels) is high.

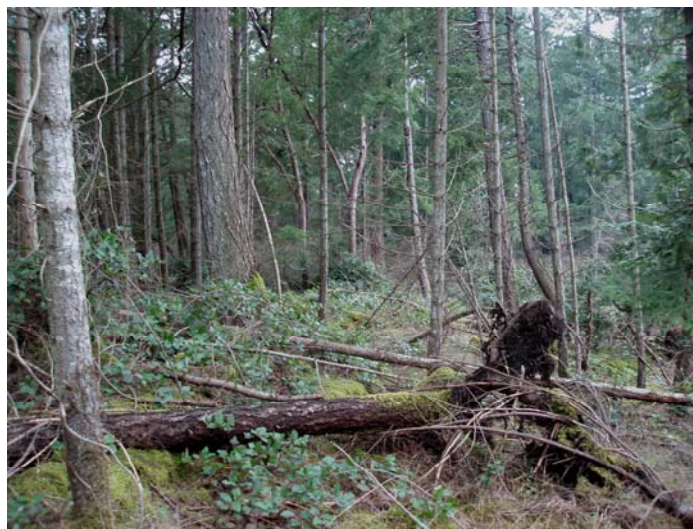
Root rot diseases, which are endemic to the forests of British Columbia, have a moderate (to high) incidence at the site. Root rot infection pockets (pockets of toppled trees, often with no apparent orientation) occur throughout the property. In areas where there is a high incidence of root rot, diseased and dying timber can pose a fire threat.

Photo. Root rot infection pocket, with windthrown coniferous trees, at the subject property.

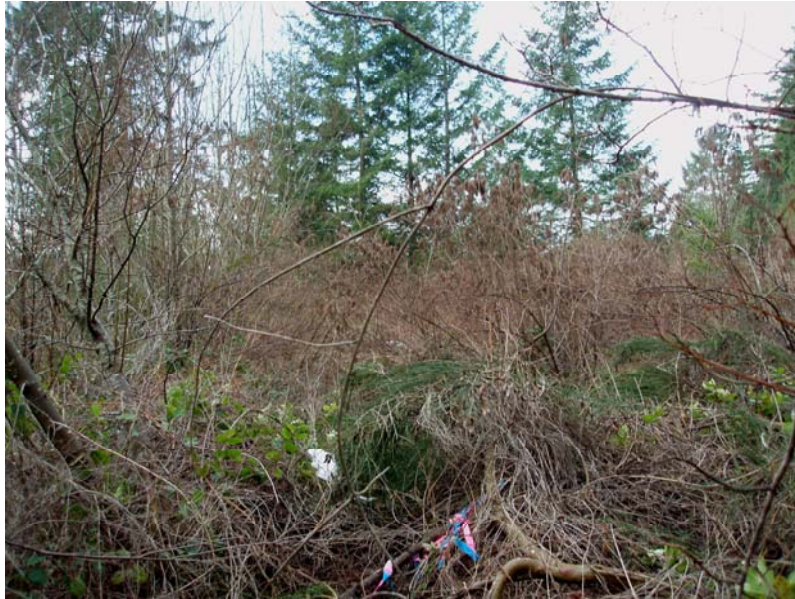
Moderate to major encroachment of invasive species (i.e., broom, holly, daphne, blackberry, ivy) has occurred at the site. Newly cleared construction areas will be vulnerable to ingress of invasive weed species, and should be promptly landscaped with native, fire-resistive species. Broom is a noxious and combustible invasive brush species.

Photo. Broom, an undesirable invasive brush species, is prevalent on the southwest border of the property.

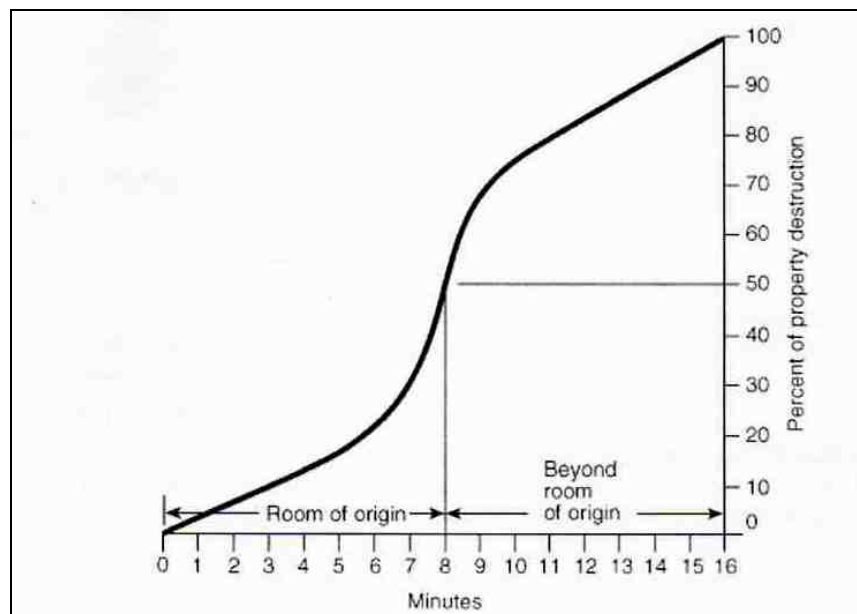
Figure 2. Fire Propagation Curve.

Fire department intervention time is crucial in determining the consequences of a fire in terms of deaths, injuries, and loss of property and damage to the environment. An early aggressive and offensive primary interior attack on a working fire is usually the most effective strategy to reduce the loss of lives and property damage. In the graph in Figure 2, the line represents a rate of fire propagation, which combines temperature rise and time. The line roughly represents the percentage of property destruction. In less than 10 minutes, a structural fire generally progresses to the point of flashover (very rapid spreading of fire due to the superheating of room contents and other combustibles). Data generated by NFPA provides empirical data that rapid and aggressive attack can substantially reduce the human and property losses associated with structural fires (NFPA 1710).

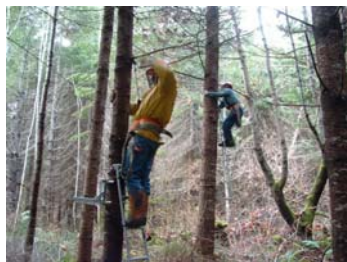
Photo. Vegetation management may be necessary in PZ 3 if fuel treatments in PZ 1 and 2 are insufficient to reduce hazard levels.

Fuel Modification: Priority Zone 3 - PZ 3 (Fuel Reduction and/or Conversion): This area begins 30 m from the building, extending to 100 m or farther, depending on topography.

Fuel management is required when high hazard levels are not sufficiently reduced by techniques used in PZ 2.

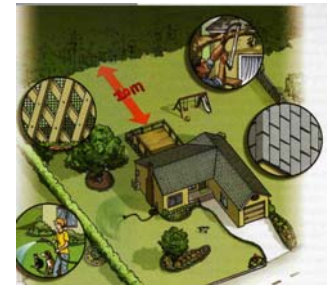
Figure 6. Vegetation management strategies in the interface zone should be directed at the establishment and maintenance of Fuel Modification Zones.

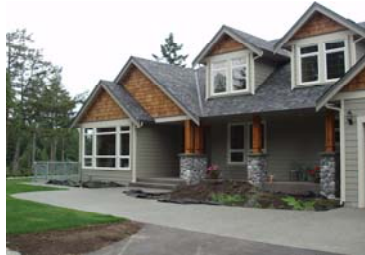
Photo. New residence features FireSmart landscaping and fire retardant construction.

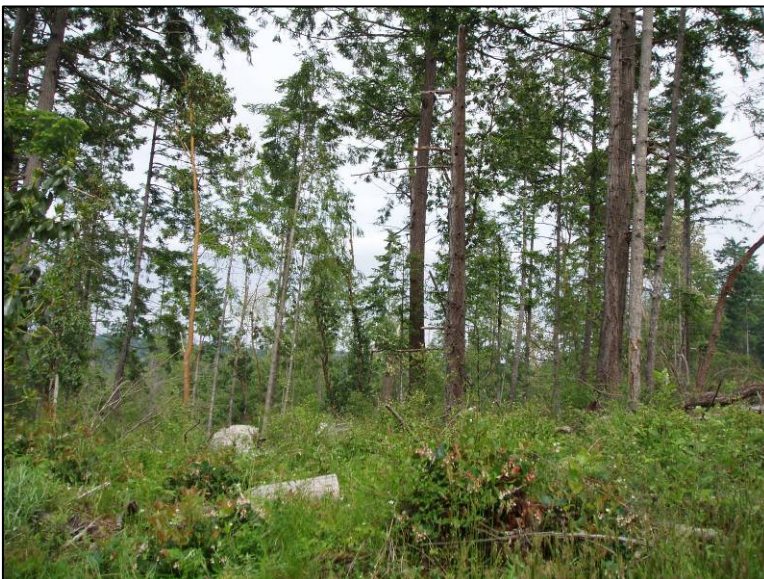
Photo 1. Recent selectively logged area in the western portion of the study area.

The project area is located within the Coastal Douglas-fir moist maritime (CDFmm) biogeoclimatic subzone, which represents the dry, Douglas-fir forests along southeastern Vancouver Island and the Gulf Islands (Green and Klinka, 1994). Most of the area has been logged once between the 1950's and 1990's. More recent selective logging has occurred throughout the property, with remnant large Douglas-fir (*Pseudotsuga menziesii*) and small patches of younger forest (Photo 1).

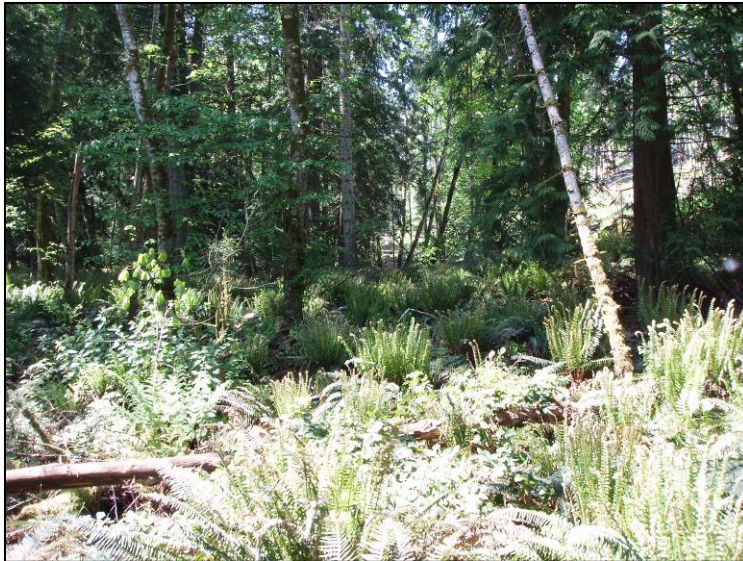
Photo 2. West of small wetland in northeastern portion of study area. The site series represented is western redcedar/grand fir – foamflower 06.

Also well represented is the richer, moister community labeled western redcedar/grand fir – foamflower (site series 06) (Photo 2). A small open area was found along the drainage from a small wetland near plot DN3 within the western redcedar/grand fir – foamflower (site series 06) plant community containing a patch of skunk cabbage and Pacific water parsley (Photo 3, and Figure 2).

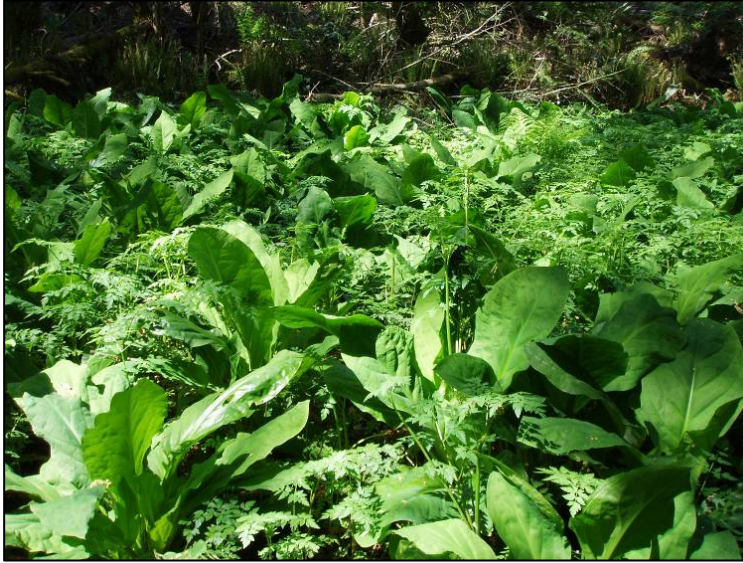
Photo 3. Skunk cabbage site near wetland (Polygon 31) and mature Western redcedar forest in northeastern portion of study area.

Two shrub-dominated wetlands were mapped in the southern portion of the property (Polygons 9 and 50), as well as Polygon 49 (a very small shrub wetland) located within the large selectively harvested Polygon 13 (Figure 2). These sites tend to be dominated by shrubs that include hardhack, willow species (*Salix spp.*) and red osier dogwood. Skunk cabbage and slough sedge are scattered throughout these wetland ecosystems (Photo 3).

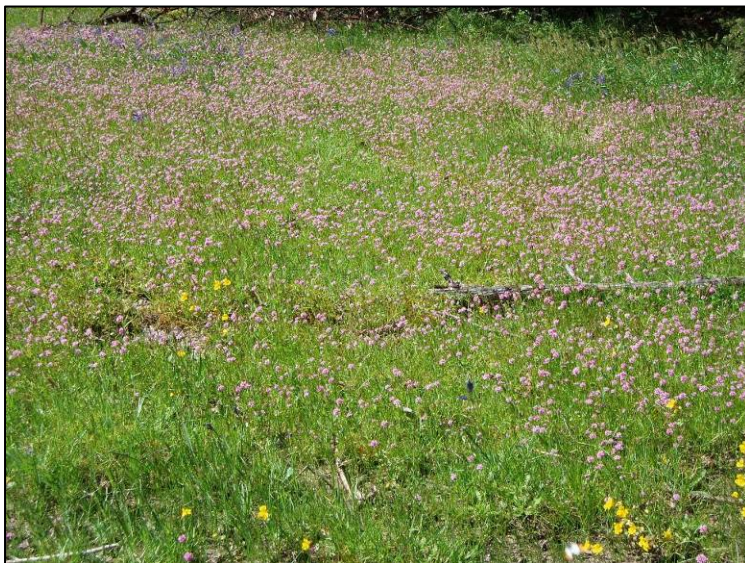
Photo 4. Blooming sea blush and monkey flower growing within ESA #634.

Dominant vegetation within the open meadows consists of rock mosses, grasses, lichens, and wildflowers. During the early field assessments, the meadows were covered with carpets of sea blush (*Plectris congesta*) and common camas (*Camassia quamash*) (Photos 4 and 5). The species lists on these sites are extensive (Appendix III). Several other commonly occurring species include yellow monkey flower (*Mimulus guttatus*), large-flowered blue-eyed Mary (*Collinsia grandiflora* var. *pusilla*), few-flowered shooting star (*Dodecatheon pulchellum*) and sweet vernal grass (*Anthoaxanthum odoratum*). Several Garry oaks were scattered throughout these herbaceous communities, particularly along the edges.

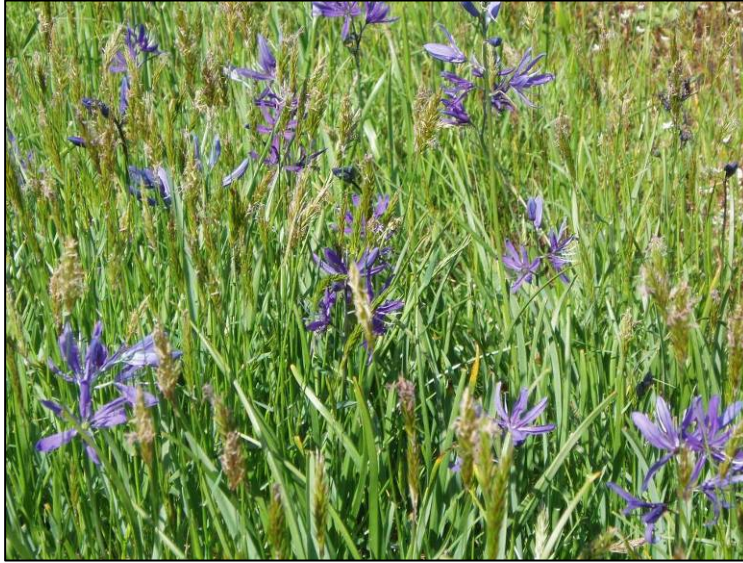
Photo 5. Camas growing within one of the open meadow ecosystems.

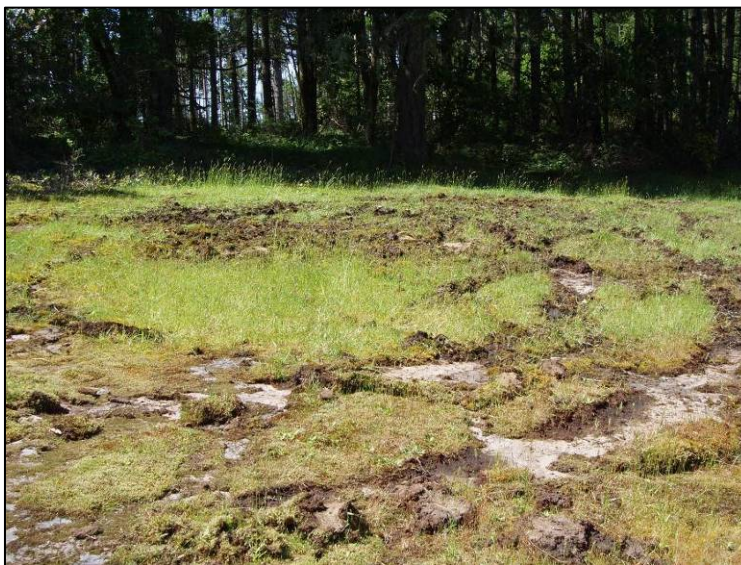
Direct evidence of ecological damage was witnessed during fieldwork assessments of the open meadows. Intrusion by off-road vehicles had resulted in the displacement of the thin coverage of vegetation and soil in many areas, especially in the south western portion of the largest meadow (ESA #634) and throughout ESA #653 (Photo 6). Another source of negative ecological impact is represented by the considerable infestation of broom, which is apparent throughout all the identified open meadows.

Photo 6. Example of damage from off-road vehicles within ESA #653.

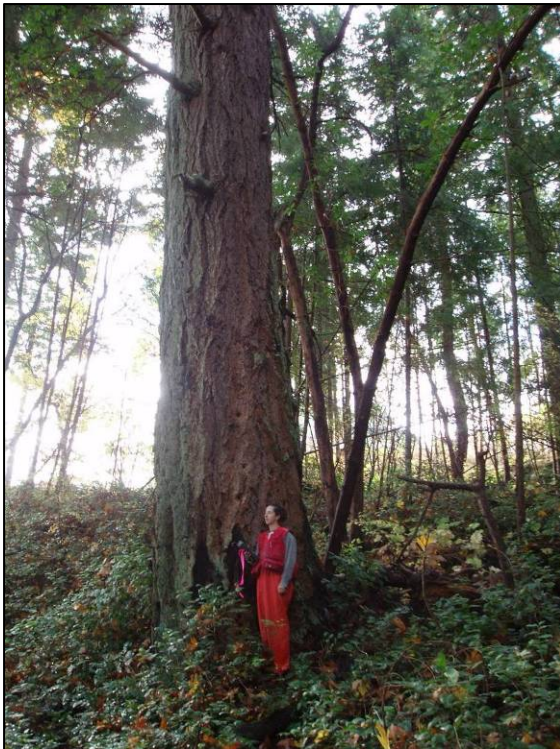
Photo 7. Example of Douglas-fir veteran found within the southern portion of ESA #642.

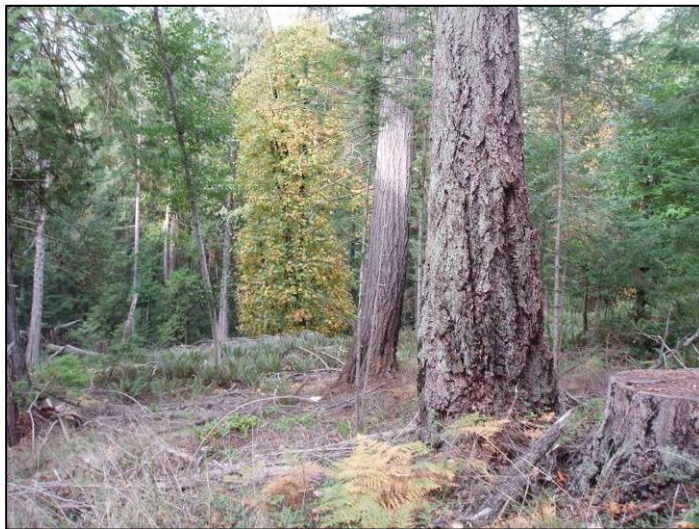
Photo 8. Example of isolated Douglas-fir veteran found within central portion of ESA #639. Note recent (within the last 10 years) disturbance from logging.

Disturbance through the construction of logging roads and skid trails is also apparent. Douglas-fir is the dominant tree species within ESA #639, with grand fir, bigleaf maple and redcedar also present. Despite the impacts of logging, patches of old forest and isolated veteran fir and redcedar are present (Photo 8).

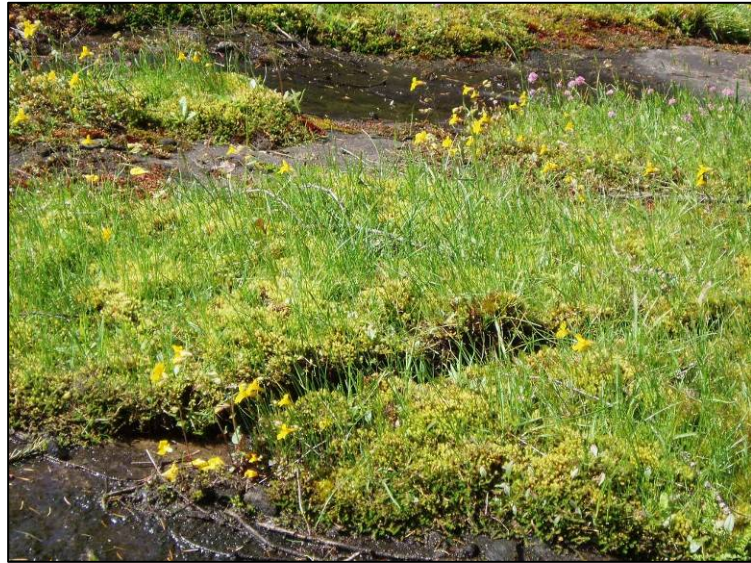
Photo 9. Sea blush and monkey flower growing on a wet seepage area within ESA #634. Note the thin and fragile nature of the available soil.

The presence of seepage sites through the meadows is an important habitat component for these rare plants (Photo 9). In addition, the meadows are bordered by second growth, selectively logged forest that creates a natural buffer around the meadows (Photo 10). It is important that these buffers be maintained in order to preserve the integrity of the sensitive meadows. The forest-meadow interface also provides highly suitable habitat for songbirds and other wildlife. Tree species within the forested edges consists mainly of Douglas-fir and arbutus, with the occasional Garry oak. Garry oaks can also be found within the open meadows (Photo 10).

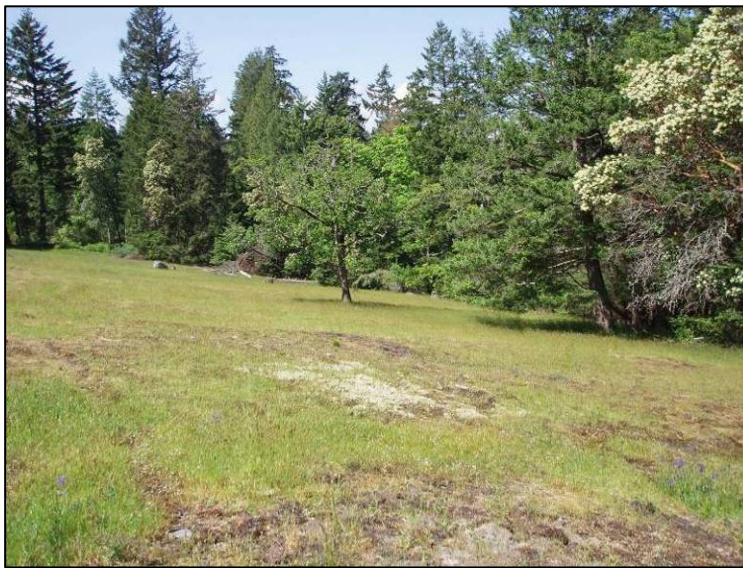
Photo 10. Typical forested buffer around the edge of one of the open meadows; Garry oak visible in centre of photo.

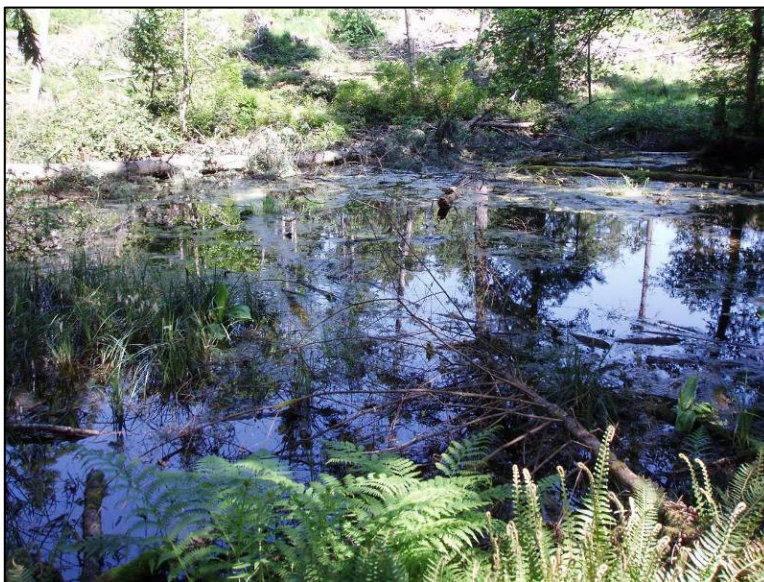
Photo 11. Wetland found at assessment plot DN2. This habitat could provide potential breeding habitat for red legged frogs. Note presence of aquatic vegetation, which is required by breeding females.

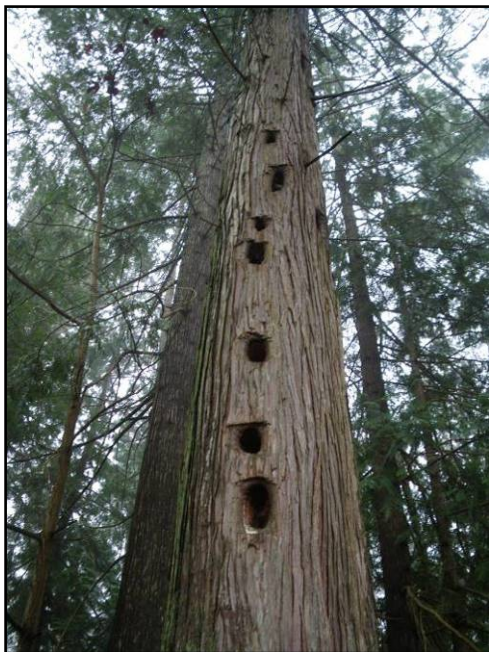
Photo 12. Example of Wildlife Tree exhibiting feeding activity from Pileated Woodpeckers.

As part of the 2006 and 2009 significant tree surveys, Wildlife Trees have been identified. Trees which displayed evidence of use, especially those with potential nesting cavities, were marked in the field with “WT” using blue or orange spray paint. All Wildlife Trees have also been mapped and measured for potential retention during subsequent development. It is understood that the retention of Wildlife Trees may not be feasible in many cases, due to safety concerns associated with dead or dying trees.

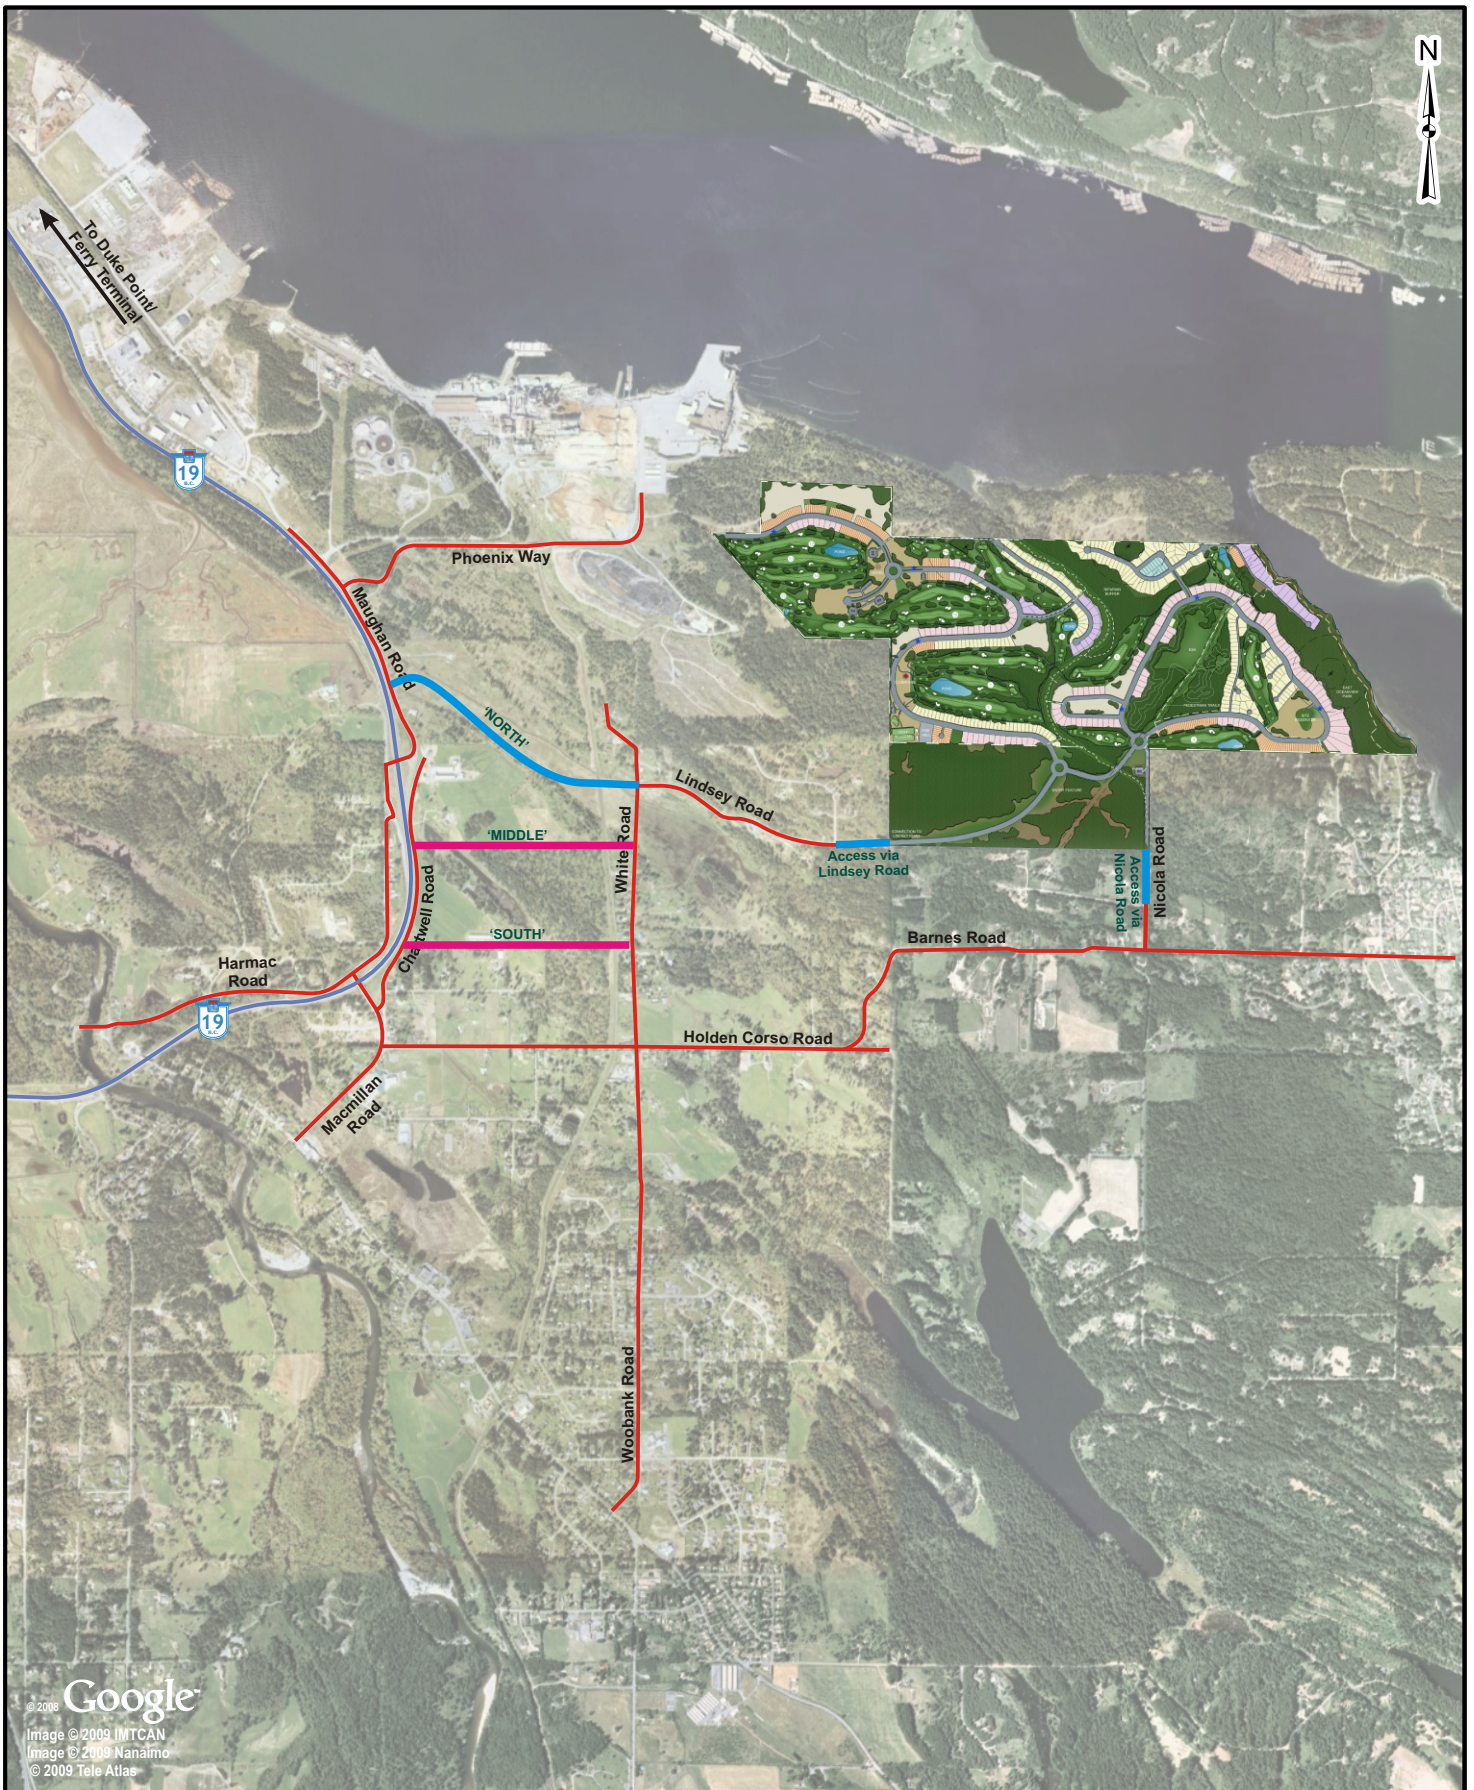
An earlier traffic impact assessment for the site assessed alternative alignment options for the extension of Lindsey Road to the west. The three extension options are illustrated in Exhibit 3.2.

- (a) Option 1: With this option, referred to as the ‘middle’ access route, the connector would be located approximately 800 metres north of Holden Corso Road and utilize an existing right-of-way to connect White Road and Chartwell Road.
- (b) Option 2: This ‘south’ option is similar to the first option with the connector located 400 metres to the north of Holden Corso Road.
- (c) Option 3: This option involves an extension of Lindsey Road to Maughan Road to the north of the Highway 19 ramp. It would provide a more direct access to Highway 19, as traffic would have the opportunity to access the highway directly from Maughan Road.

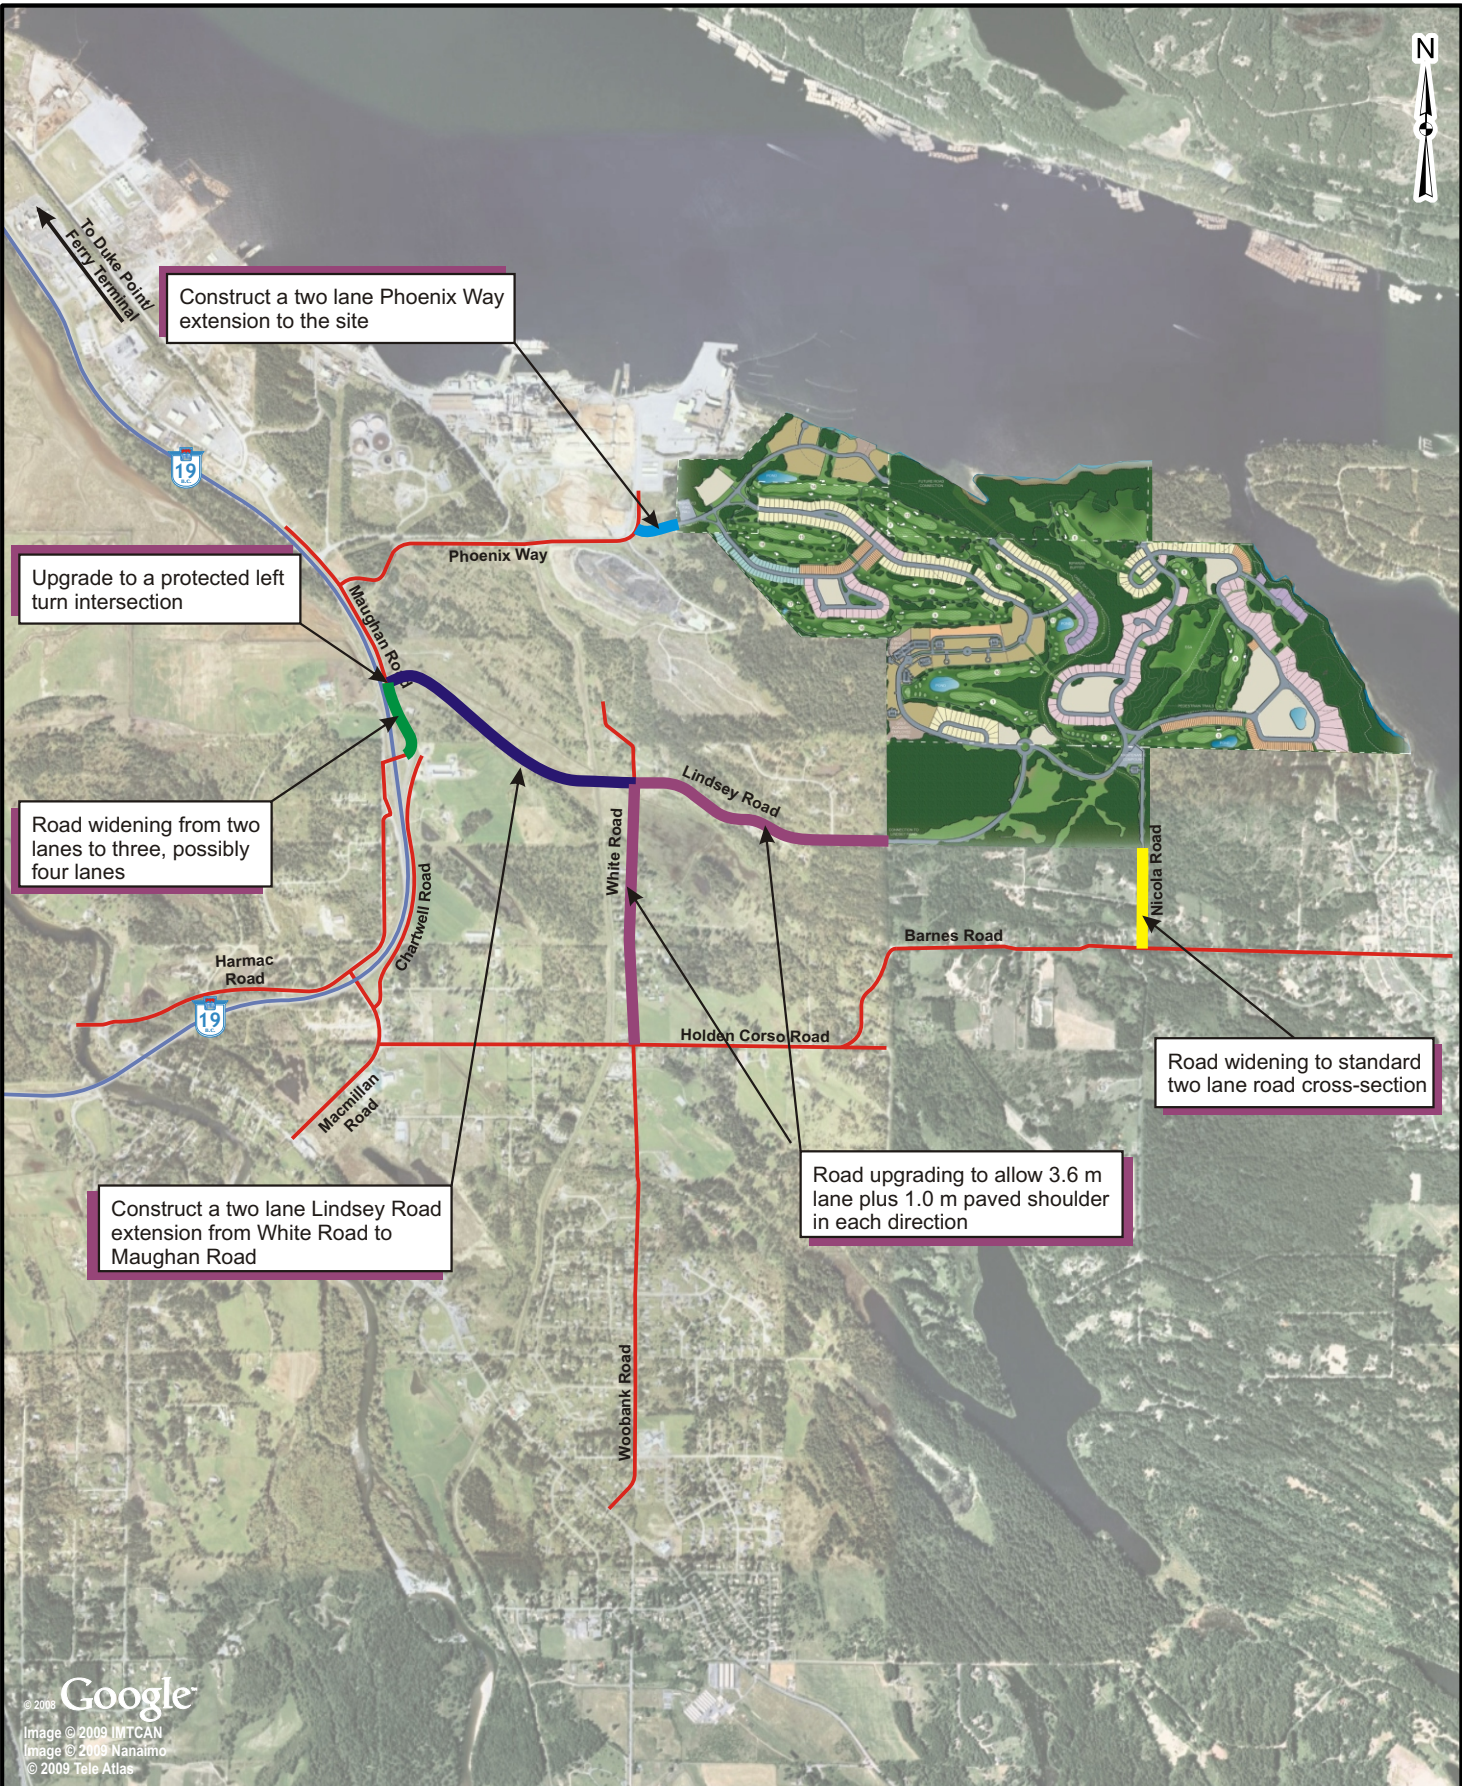
Construct a two lane Phoenix Way extension to the site

Upgrade to a protected left turn intersection
