# OAKWOOD PARK ESTATES ENVIRONMENTAL ASSESSMENT FOR MILLSTONE RIVERFRONT AT 1-1 TERMINAL AVE

PREPARED FOR:  
THE CITY OF NANAIMO  
455 WALLACE STREET,  
NANAIMO, BC, V9R 5J6

JULY 2022

**CORVIDAE**  
ENVIRONMENTAL CONSULTING INC

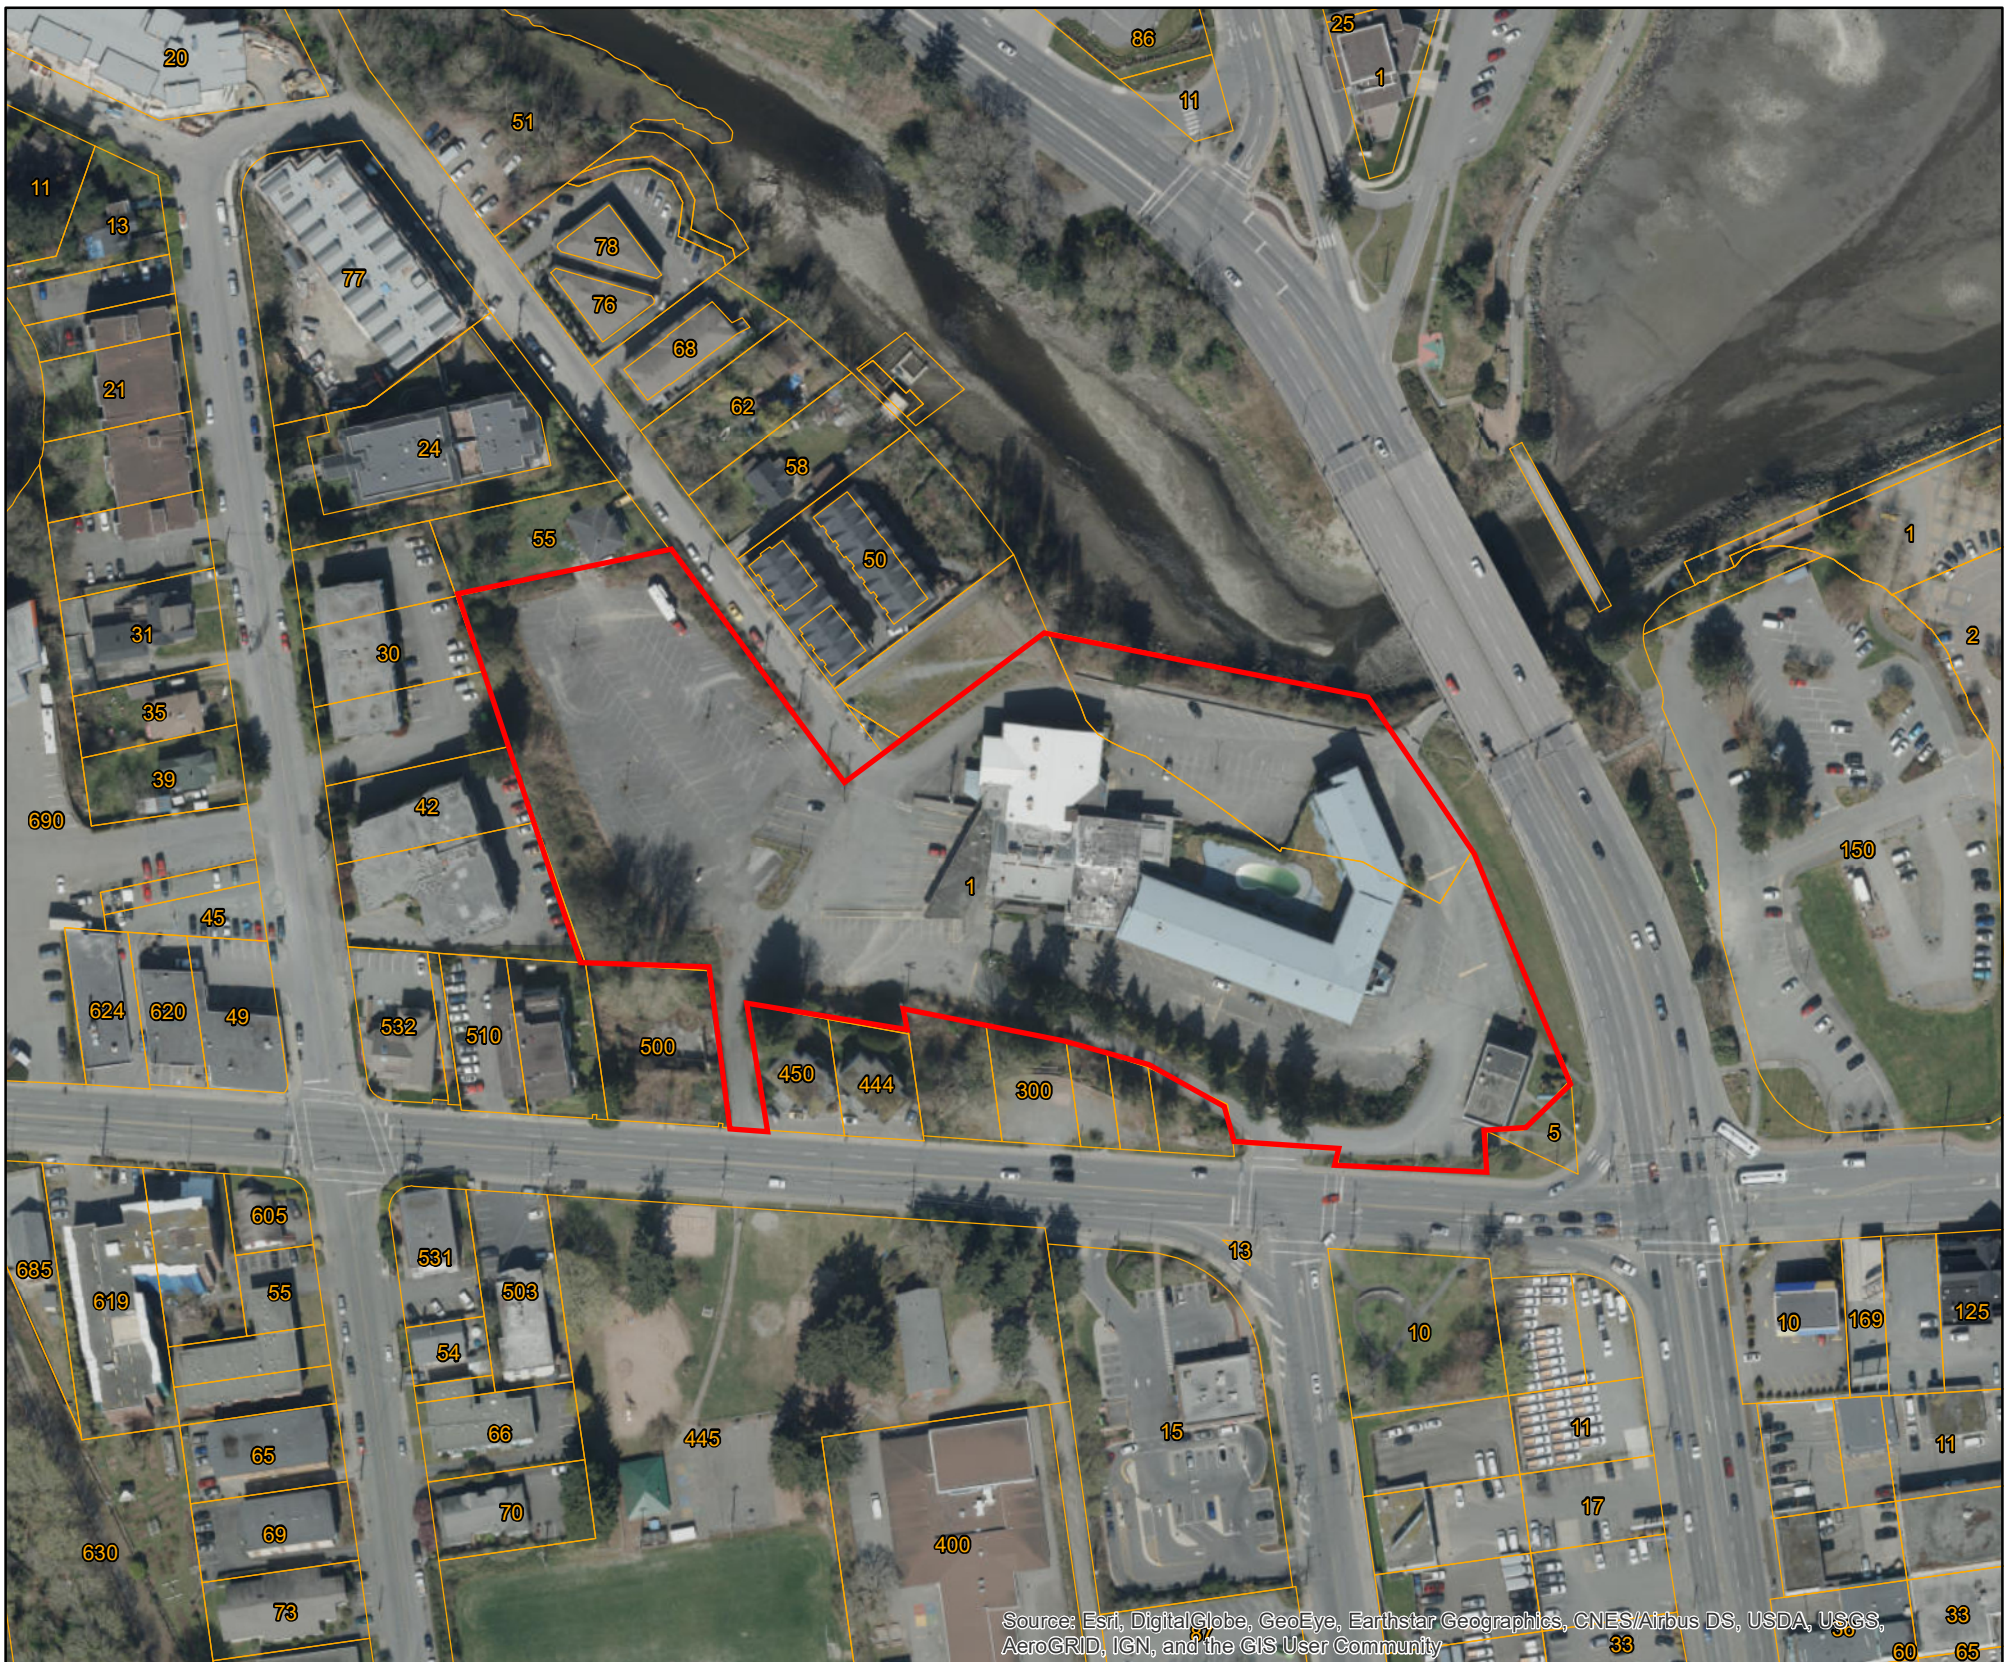
**Figure 1**

Figure 1: Property Location with current site conditions

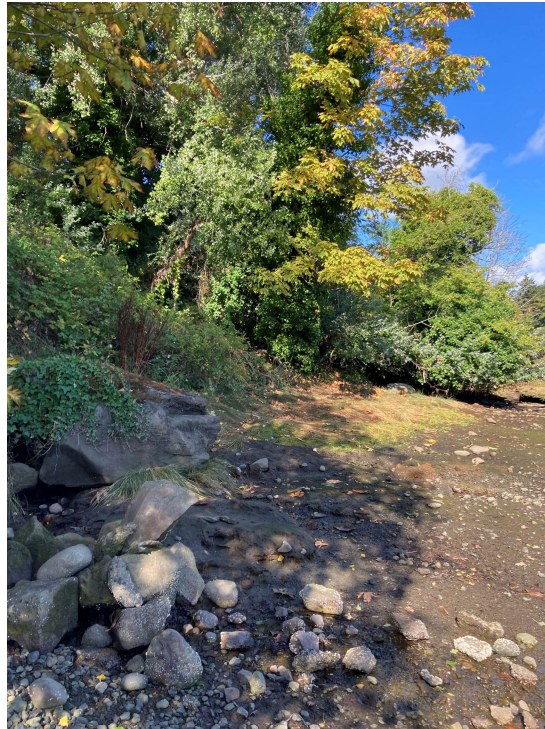
**Photo 1. Looking at the shoreline of Millstone River and adjacent vegetation. September 2021.**

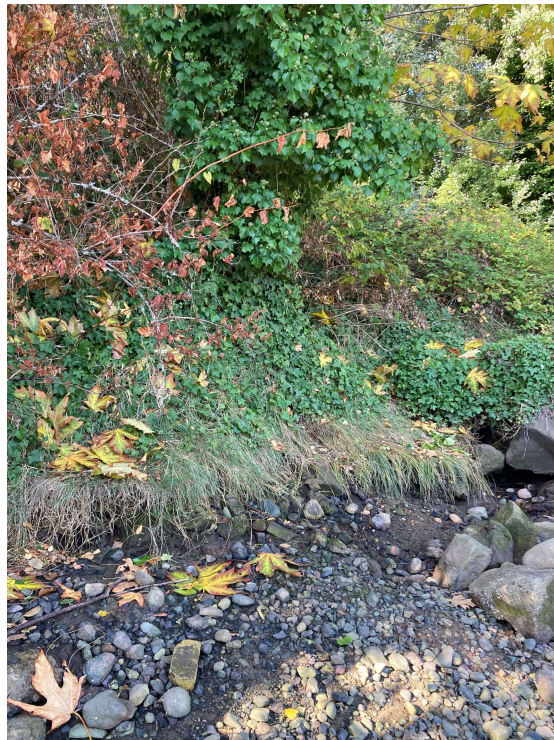
**Photo 2. Example of shoreline vegetation along Millstone River. The invasive English Ivy was seen in abundance. September 2021.**

Corvidae completed a site visit on September 16, 2021. The property is predominantly a paved area, with shoreline vegetation including with high densities of Himalayan blackberry and English ivy. The shoreline is large rock, with vegetation species listed in Table 1. There is extensive human use, indicated by the invasive species and garbage along the shoreline. Appendix B shows photos of the shoreline vegetation.

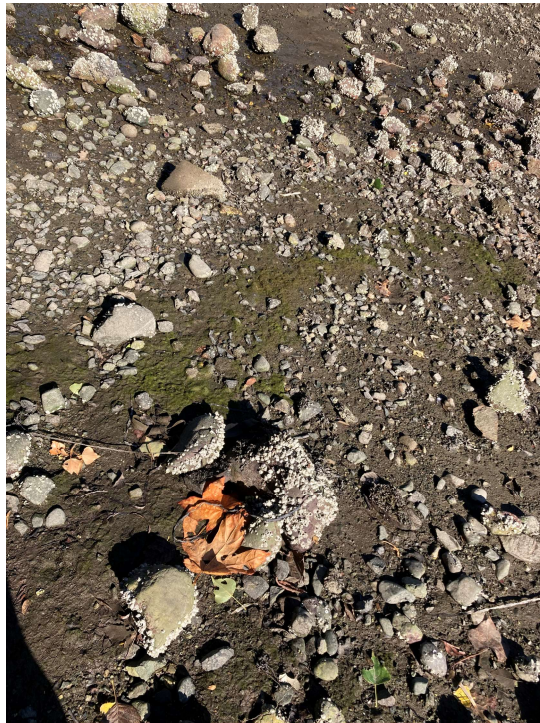
**Photo 3. Mud, gravel and cobble substrate on the floor of Millstone River. Marine species including barnacles and mollusks were observed in abundance indicating the area is estuarine. September 2021.**

At the time of the assessment the tide was ebbing into the wetted area adjacent to the project. The QEP also noted a muddy substrate interspersed with gravels and cobbles covered in barnacles and saltwater mollusks. Given the visual markings of tidal influences on the landscape, marine muddy substrate and abundant presence of saltwater organisms including barnacles and molluscs, the waterbody description of this segment of Millstone River is estuarine.

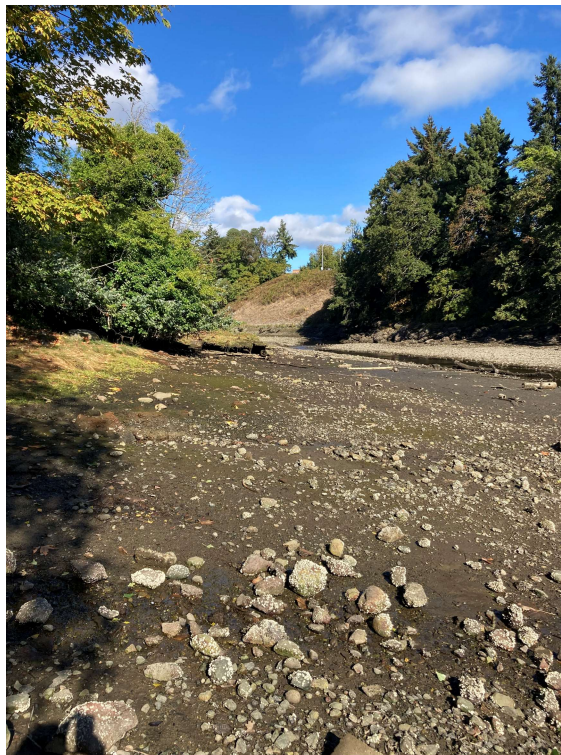
**Photo 4. Looking at the wetted width and highwater mark of Millstone River. September 2021.**
