STAGE 1 PRELIMINARY SITE INVESTIGATION 1 PORT DRIVE, NANAIMO, BRITISH COLUMBIA

PRESENTED TO
City of Nanaimo

OCTOBER 2014
ISSUED FOR REVIEW
FILE: ENVIND03511-01.001

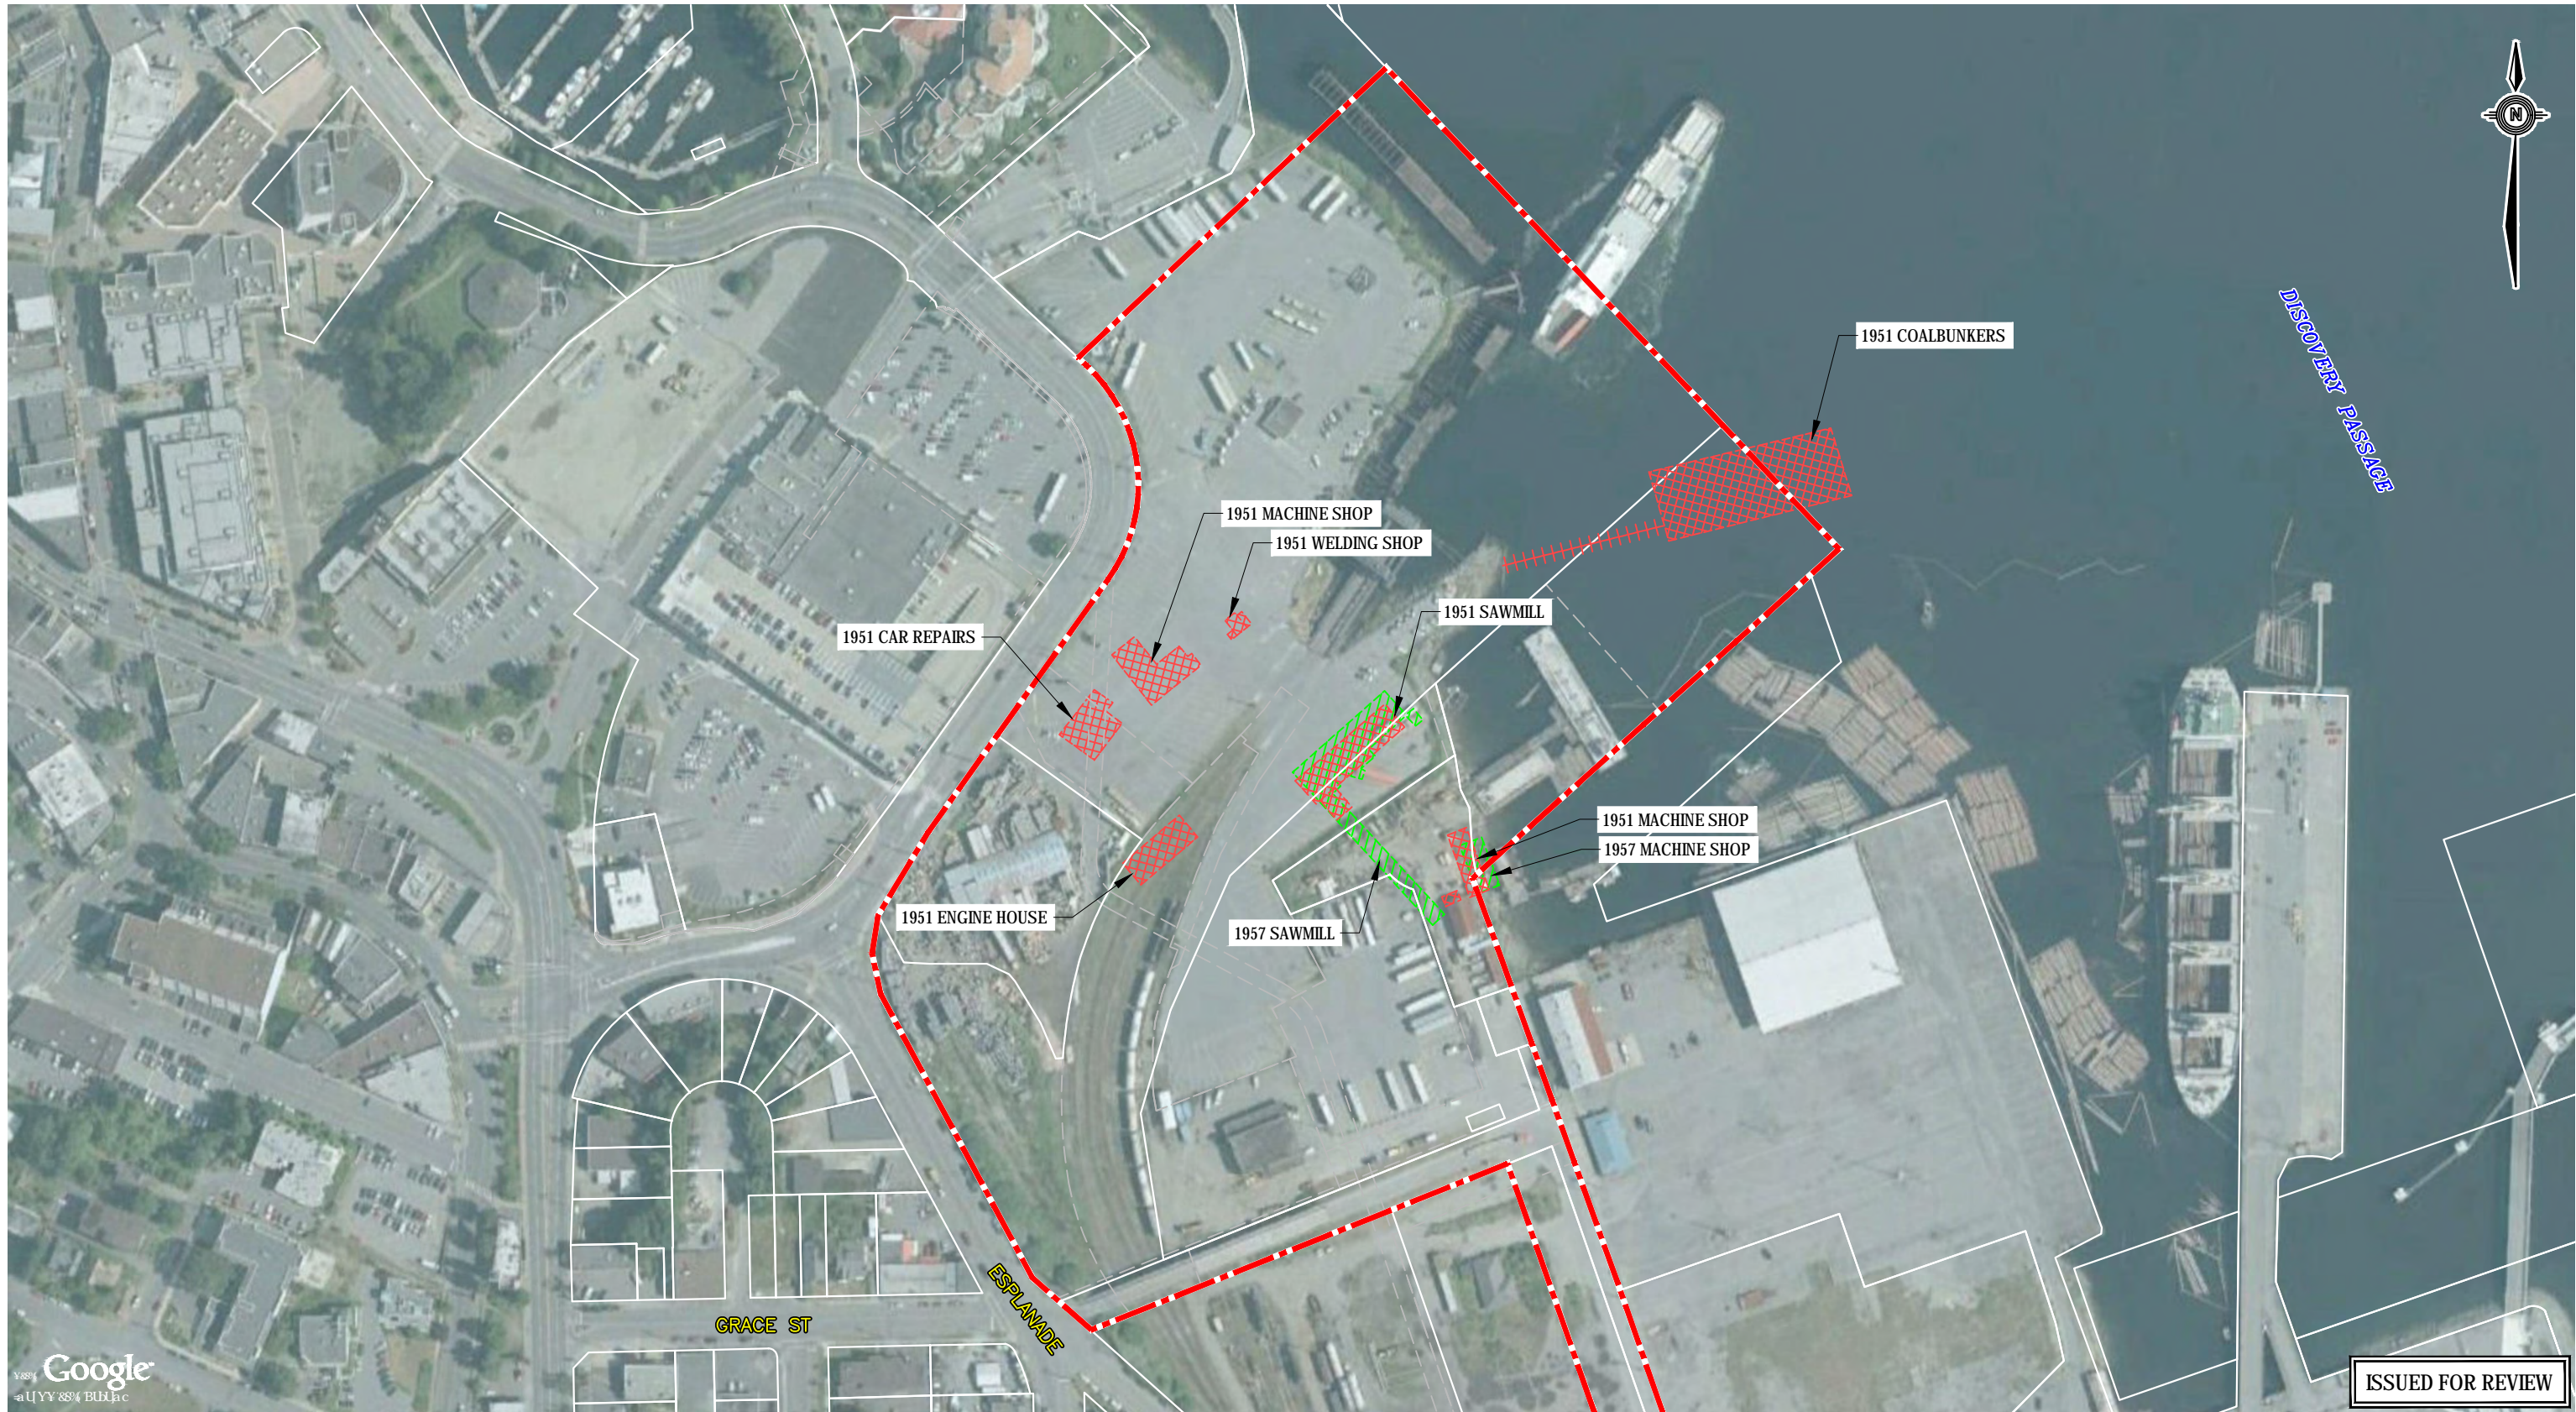
CLIENT		STAGE 1 PSI 1 PORT DRIVE, NANAIMO, BC			
CITY OF NANAIMO THE HARBOUR CITY		HISTORICAL SITE PLAN			
TETRA TECH EBA	PROJECT NO. ENVIND03511-01	DWN SF	CKD KG	REV 0	Figure 7
	OFFICE VANC	DATE January 29, 2015

The 1939 and 1951 Fire Insurance map (Appendix G), viewed at the Nanaimo Community Archives, show historical buildings on the Property labelled as two machine shops, welding shop, engine house, car repairs, and a sawmill. The 1957 Fire Insurance map (Appendix G), also viewed at the Nanaimo Community Archives, shows the machine shop location on the GADD Marine site has changed and shows an addition to the sawmill that was shown on the 1951 fire insurance map. See Figure 7 for approximate location on the Property.

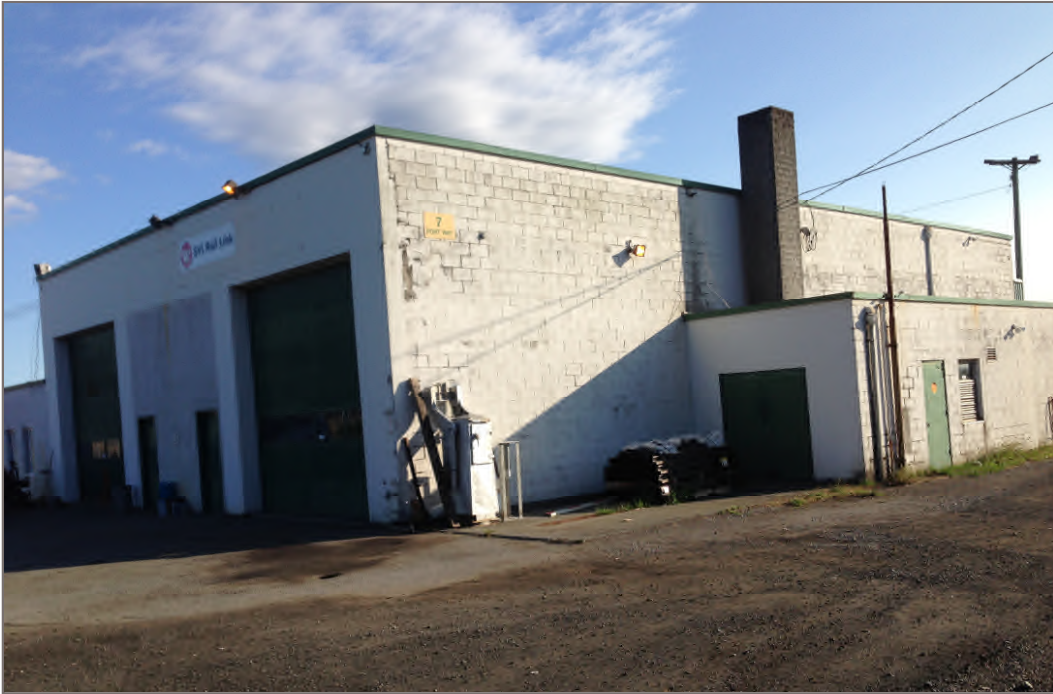
The SVI building is one floor constructed of concrete cinder blocks. The floors throughout the building, where exposed, appeared to be in good condition with minor surficial cracks. The building was reported to have formerly been a Canadian Pacific Railway (CPR) building for the Wellcox railyard and was moved to its current location in circa 1995. CPR had the building gutted and renovated in 1995. The SVI office building is heated with electric baseboard and serviced with City water and sewer.

Photo 1: On Site facing north– view of the SVI office building

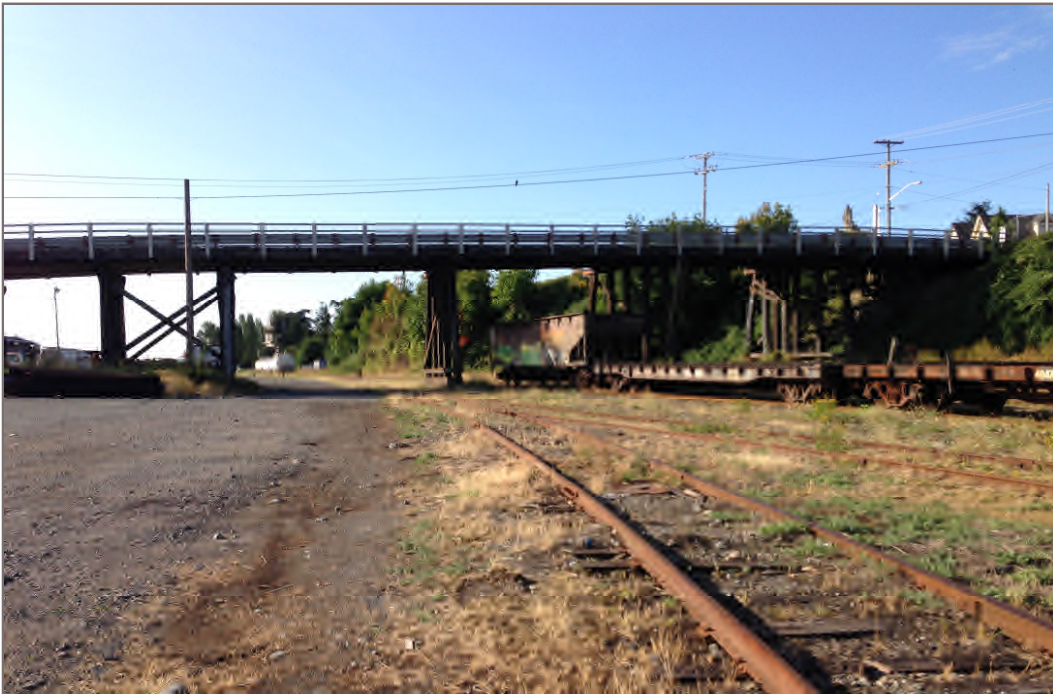
Photo 2: On Site facing south – view of the SVI rail tracks on the Property

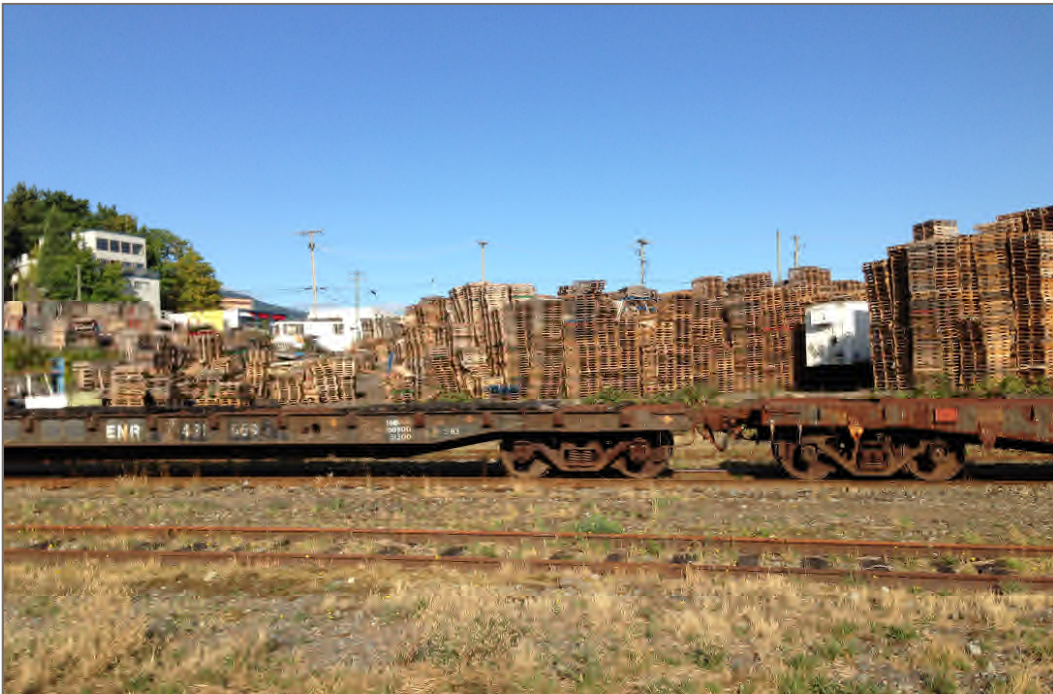
The interior of the Island Pallet Solutions building was not visited during the site inspection at the request of the CON. This area was formerly 190 Front Street before combining to become part of 1 Port Drive. The hazardous building materials survey (Appendix D), provided by CON, stated that the site currently operates as a warehouse used for pallet storage, office and washroom. The warehouse uses mobile equipment and hazardous materials such as used motor oil, antifreeze, fuels, paints, etc., may be present.

Photo 3: On Site facing west- view of Island Pallet Solutions

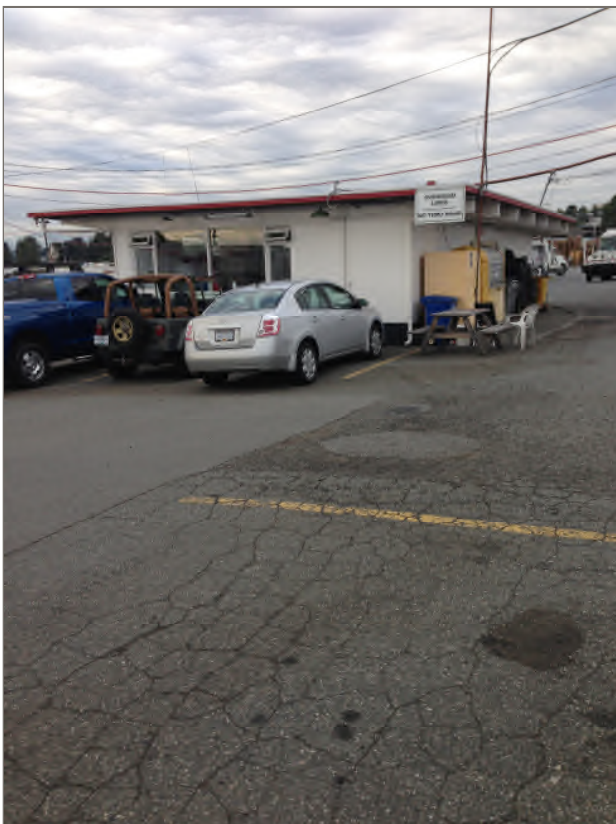
The Seaspan office building is one floor and is constructed of concrete cinder blocks. The floors throughout the building, where exposed, appear to be in good condition with minor surficial cracks. The Seaspan office building is heated by an electric furnace and serviced with City water and sewer.

Photo 4: On Site facing north – view of
Seaspan office building

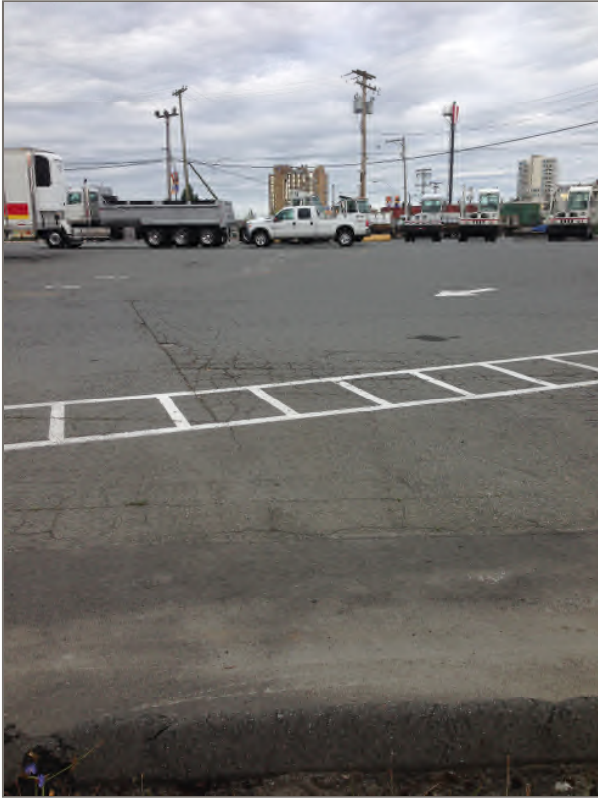
Domestic waste is picked up by BFI Canada. Storage of creosote-treated lumber was observed on this site as well there was a locker observed with paint and other chemical supplies in domestic quantities.

Photo 5: On Site facing west – view of Seaspan site

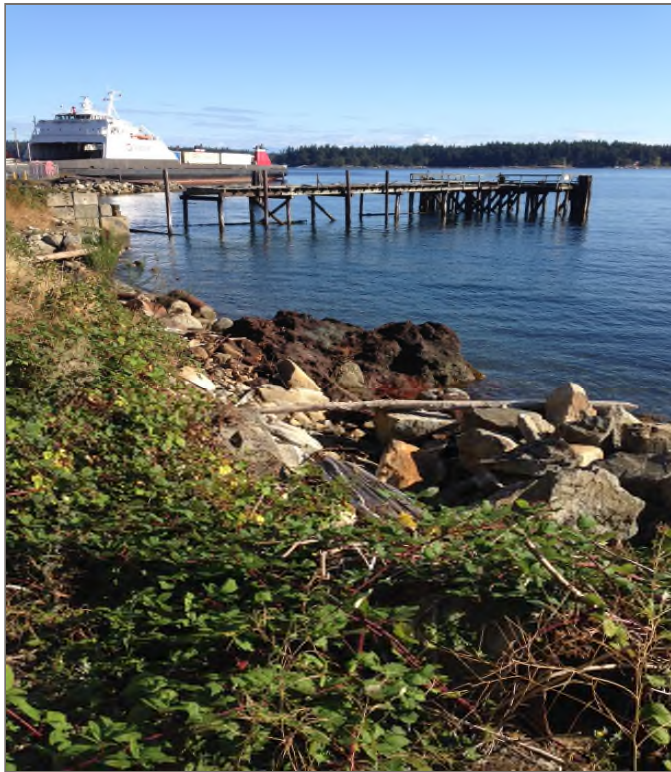
Metal debris observed on the foreshore during the site inspection was reported to have been in place before Gadd Marine operated at the site, according to Mr. Gadd. The metal debris observed is likely metal lathe chip debris generated from a former machine shop that had been present on the site, prior to use by GADD Marine. The former machine shop building was constructed on pilings and was removed prior to Gadd Marine occupying the site. Also observed on the foreshore were metal and concrete pilings that were likely part of the overall historical former machine shop operations. The location of the metal debris pile is shown on the attached Figure 2.

Photo 7: On Site facing east
- view of former Gadd Marine foreshore

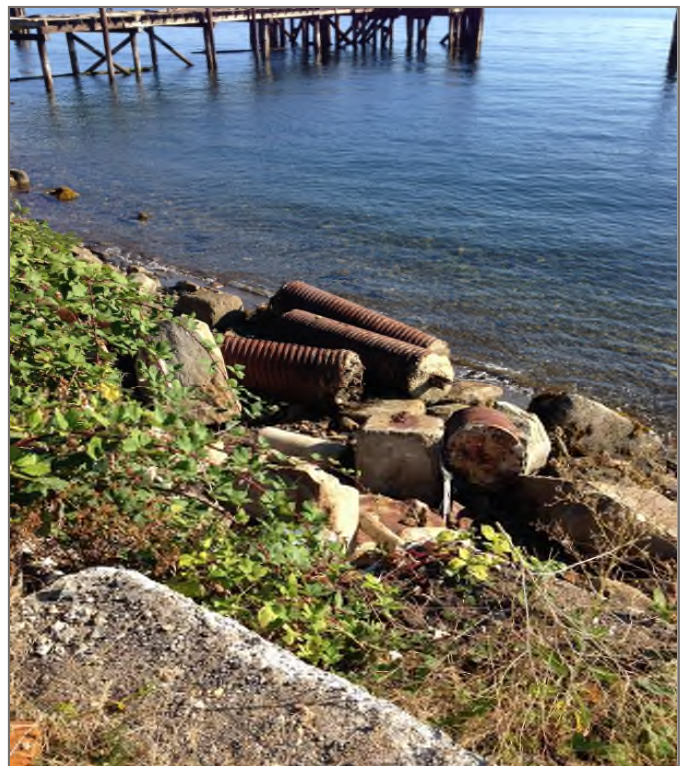
Photo 8: On Site facing east
- view of former Gadd Marine
foreshore

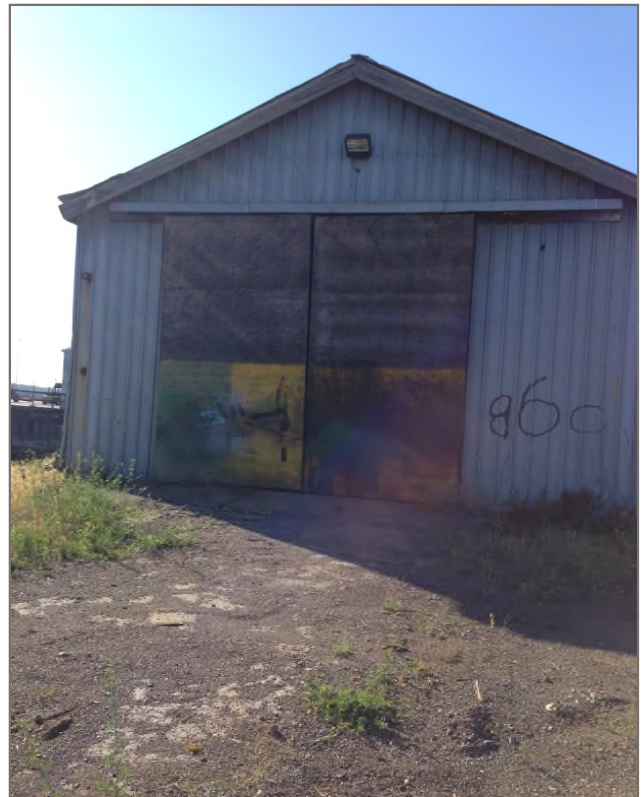
The current onsite building was a former marine equipment repair shop and was constructed of a metal roof and siding. The building could not be accessed but was observed to be empty through cracks in the siding. Through the phone conversation with Mr. Gadd it was understood that the current building had been moved to its current location from the adjacent former CIPA lumber mill.

Photo 9: On Site facing south – view of former Gadd Marine building

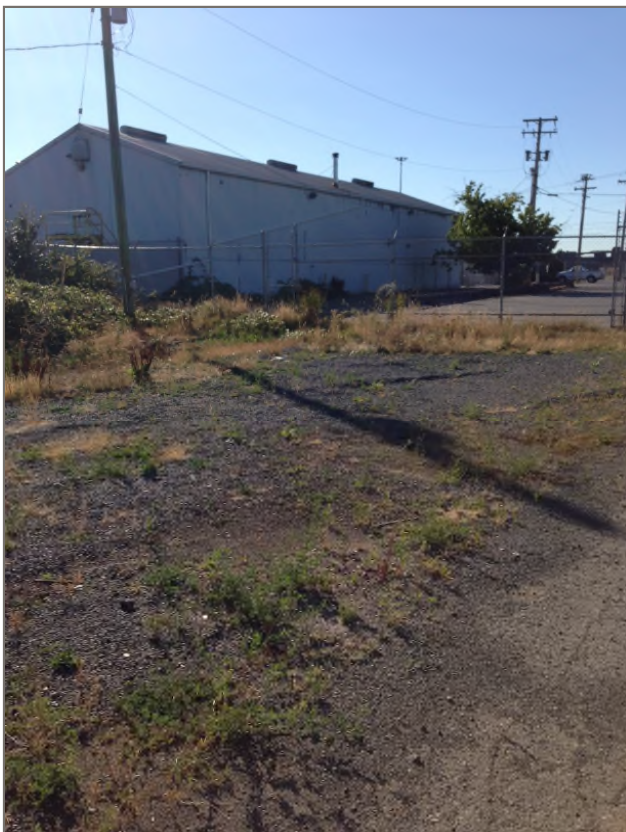
Photo 10: On Site facing south – view of former Gadd Marine site and offsite building to the south
