FACTUAL GEOTECHNICAL REPORT FOR

Colliery Dams Remediation Project, Nanaimo, BC

Report Number: 1314470516-004-R-Rev0-7000

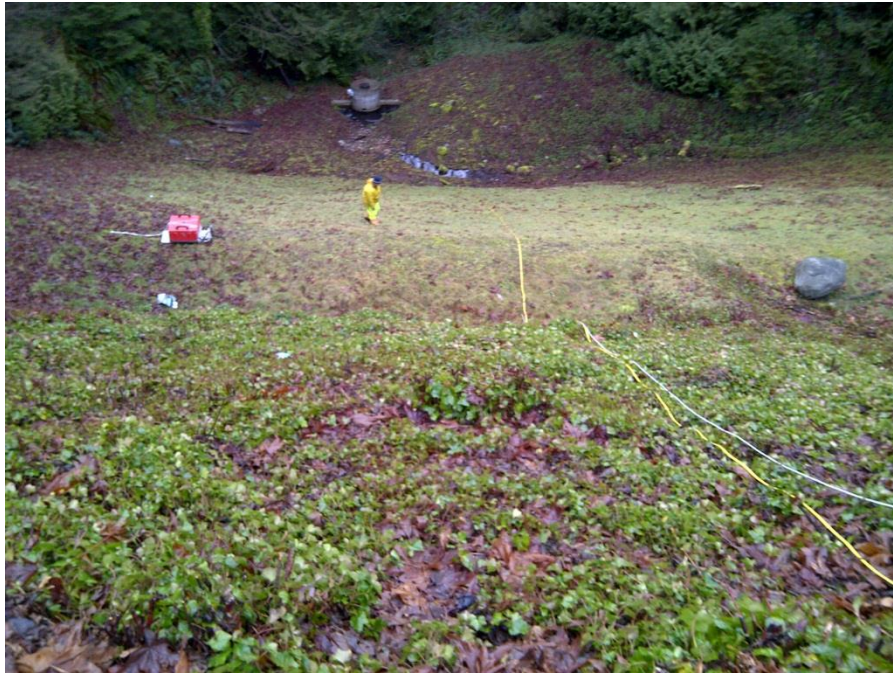
Photograph B-1: Lower Dam—looking down geophysical line L-1 from the dam crest. The red box staged on the berm bench is the 200 MHz GPR antenna.

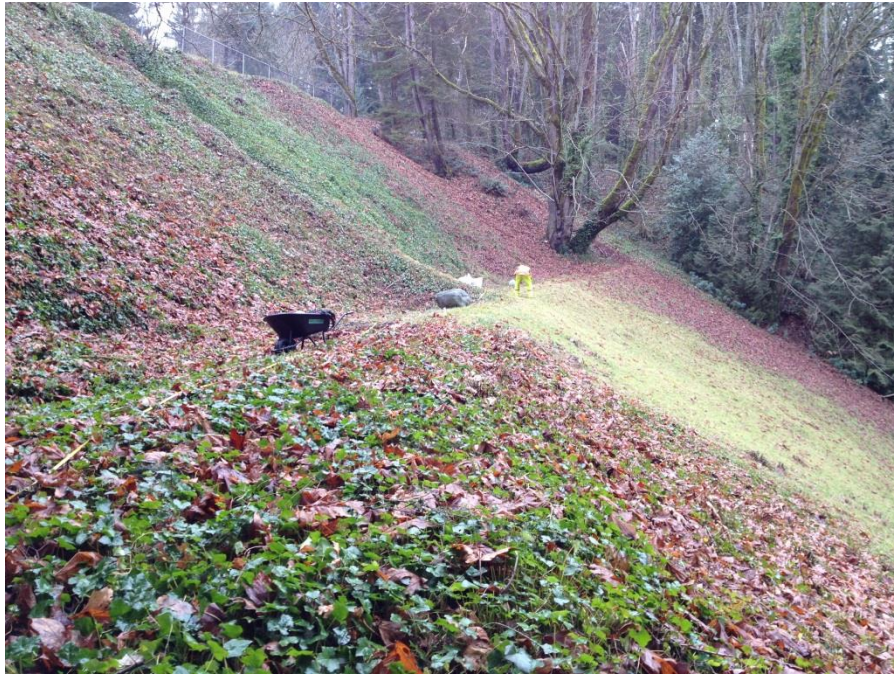
Photograph B-2: Lower Dam—looking north along geophysical line L-3.

- Two 200 MHz GPR profiles down the dam face—**L-1** and **L-2**;
- One 200 MHz GPR cross-profile on the face, along the top of the toe-berm—**L-3** (Photograph B-2);
- One 50 MHz GPR profile down the toe-berm section of **L-1**, starting from the toe of the upper slag slope (Photograph B-3);
- Two seismic refraction profiles on the dam face—**L-1** and **L-3**;
- Seven GPR profiles on the dam crest (all at 200 MHz, except for **L-9** at 400 MHz) consisting of:
 - Extension of **L-1** across the crest;
 - **L-4** along the top of the face;
 - Eastern portion of **L-5** and **L-6** and all of **L-7** acquired primarily to confirm the buried concrete core-wall;
 - Western portion of **L-5** and **L-6** and all of **L-8** acquired to investigate “The Peninsula,” and
 - **L-9** acquired on the top of the exposed additional wall (Photograph B-4).

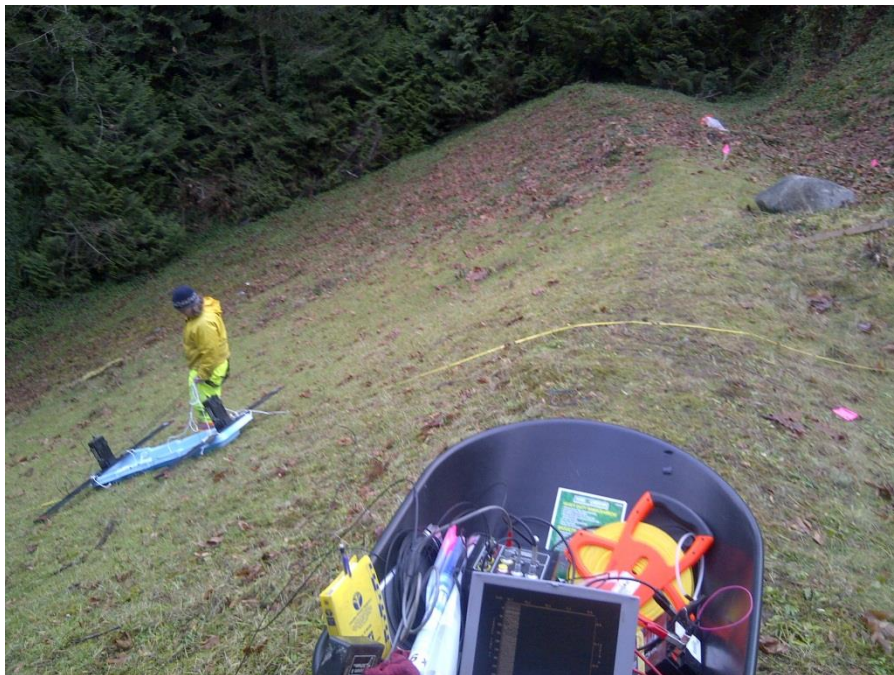
Photograph B-3: Lower Dam—from the toe-berm bench, looking south with the high powered GPR electronics in the wheelbarrow and the 50 MHz antennas profiling on line L-1.

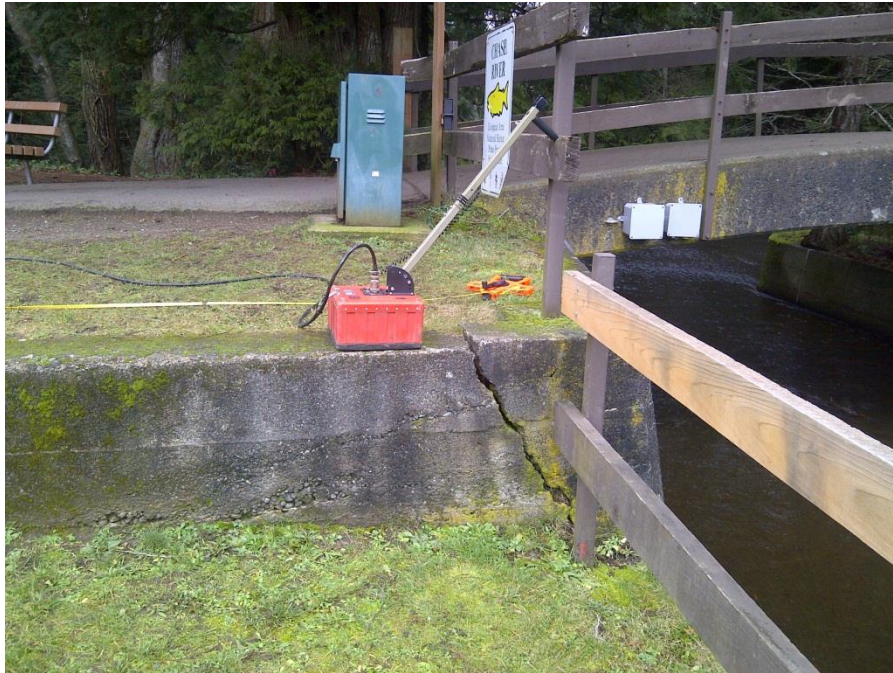
Photograph B-4: Lower Dam—from The Peninsula looking east, adjacent to the spillway (on the right). The red box on top of the retaining wall is the 400 MHz GPR antenna at the south end of line L-9.

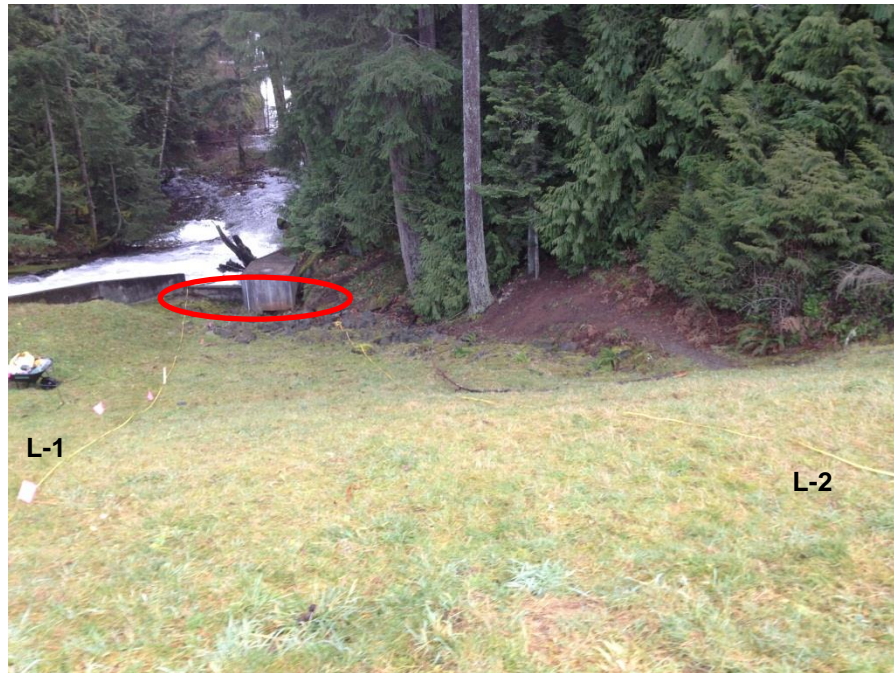
Photograph B-5: Middle Dam—from the crest, looking down the face between lines L-1 and L-2 marked by measuring-tapes. Bedrock outcrop occurs within the red circled area and spans the floor of the spillway.

- Two 200 MHz GPR profiles down the dam face—**L-1** and **L-2** (bedrock outcrop within the bottom 3 m of the 40 m long L-1, see Photographs B-5 and B-6);
- Three 200 MHz GPR cross-profiles within the lower 17 m of the dam face targeting the Lower-Level-Outlet—**L-3**, **L-4**, and **L-5** (Photograph B-7);
- One 50 MHz GPR profile on the dam face—**L-1** (Photograph B-8);
- Two 200 MHz GPR profiles along the dam crest—**L-6** and **L-7**; and
- One 400 MHz GPR profile acquired on the top of the concrete core-wall—**L-8**.

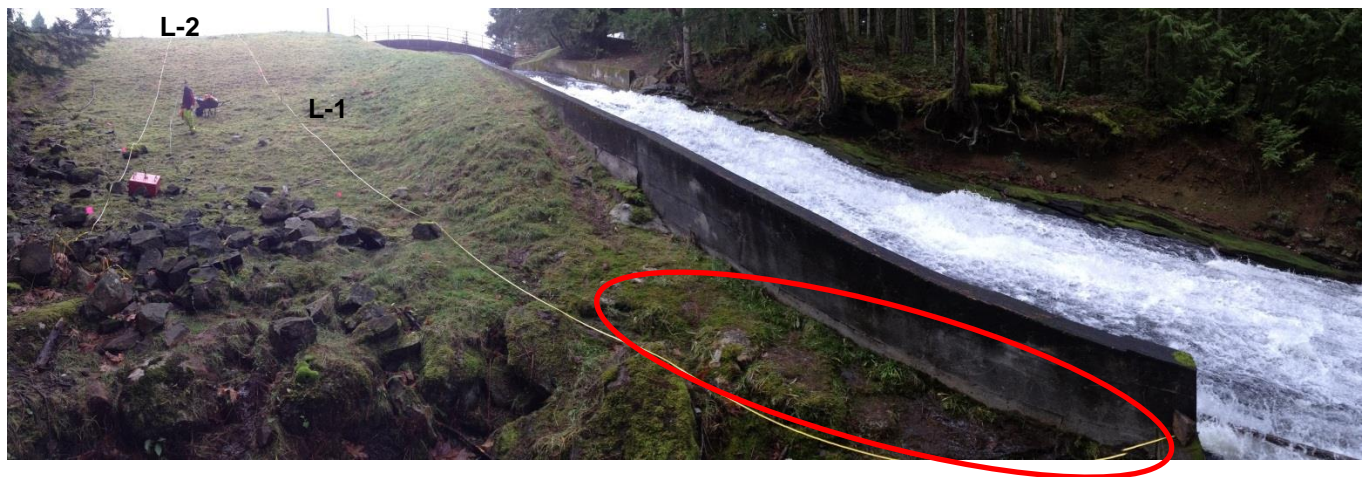
Photograph B-6: Middle Dam—looking up from concrete weir. Lines L-1 and L-2 are marked by the measuring-tapes. Bedrock outcrop occurs within the red circled area and spans the floor of the spillway. The red box on L-2 is the 200 MHz GPR antenna.

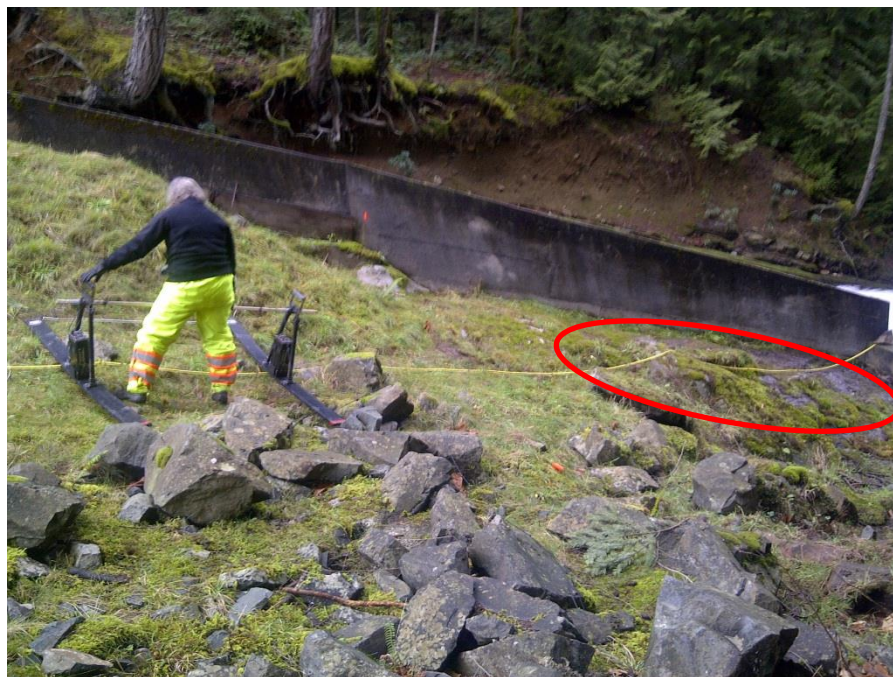
Photograph B-8: Middle Dam—High-powered 50 MHz antennas on line L-1. Bedrock outcrop occurs within the red circled area and spans the floor of the spillway.

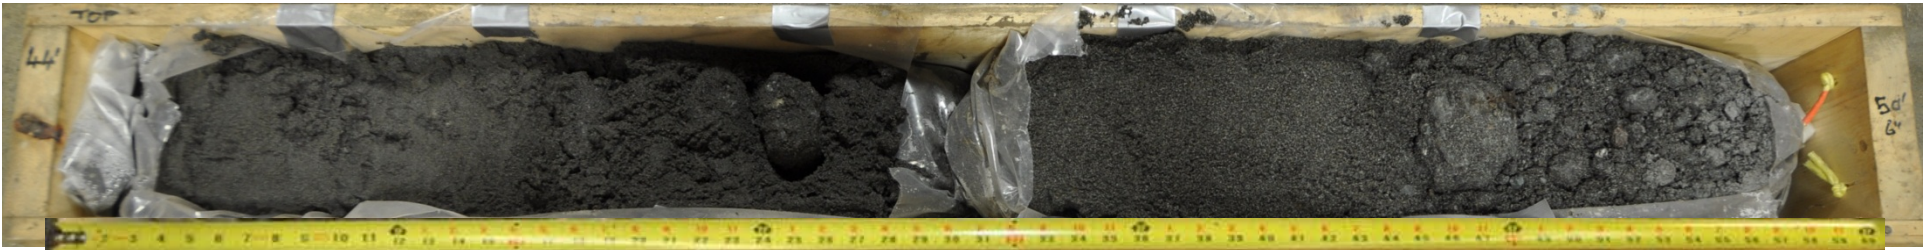
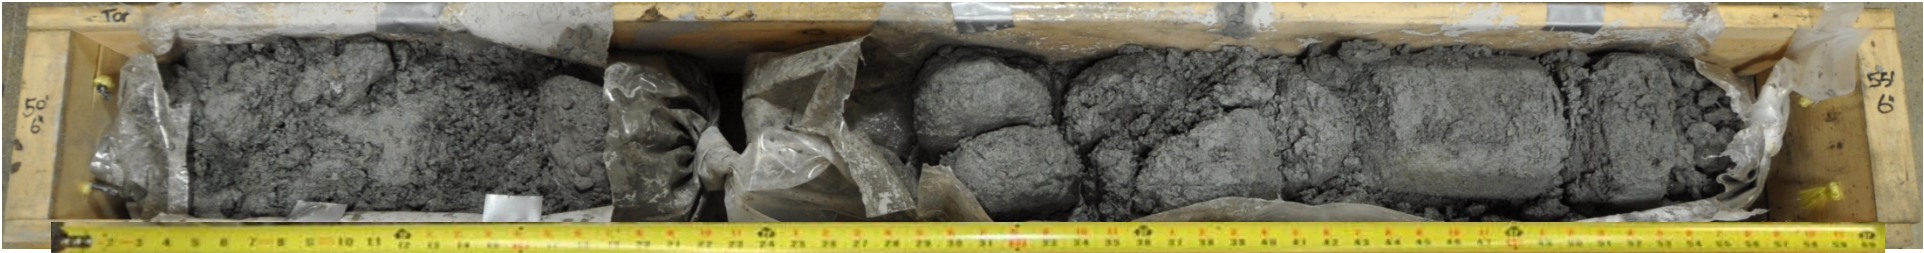
PROJECT No.	13-1447-0516	Phase / Task No. 7000/7300
	DESIGN	TM 25FEB14	SCALE NTS
	CADD	TM 06MAR14	REV.
	CHECK		
		REVIEW	
FIGURE C-7

PROJECT		CITY OF NANAIMO COLLIERY DAMS PARK – LOWER DAM NANAIMO, B.C.	
TITLE		SH14-06 SONIC CORE PHOTOGRAPHS BOXES 6 TO 10 OF 13, 8.8 m to 16.9 m (29.0 ft to 55.5 ft)

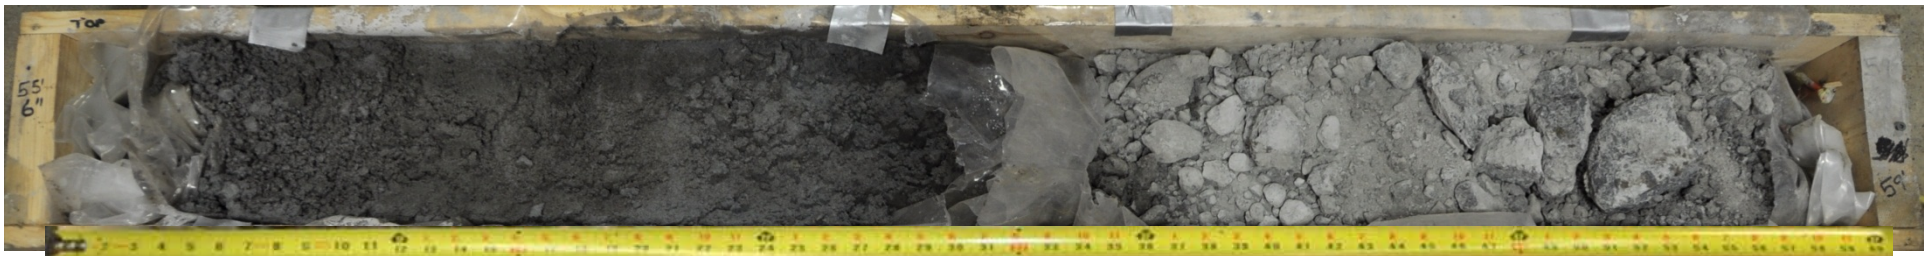
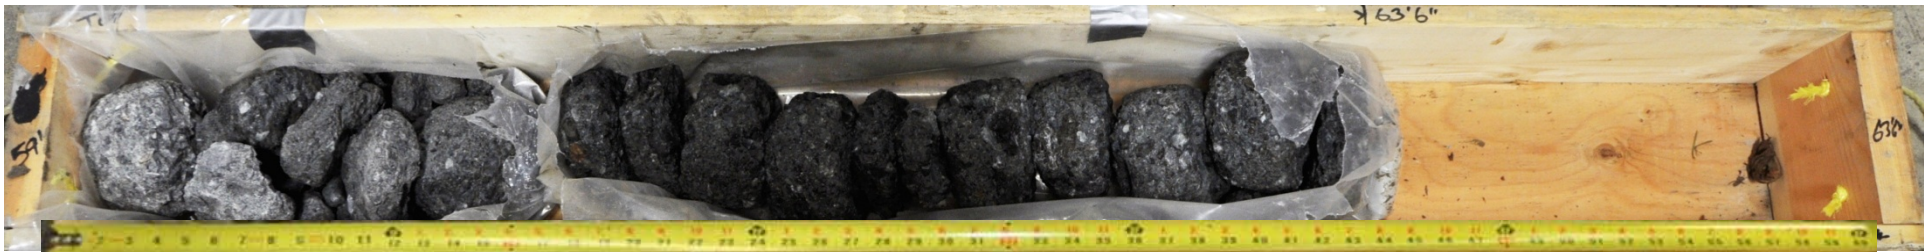
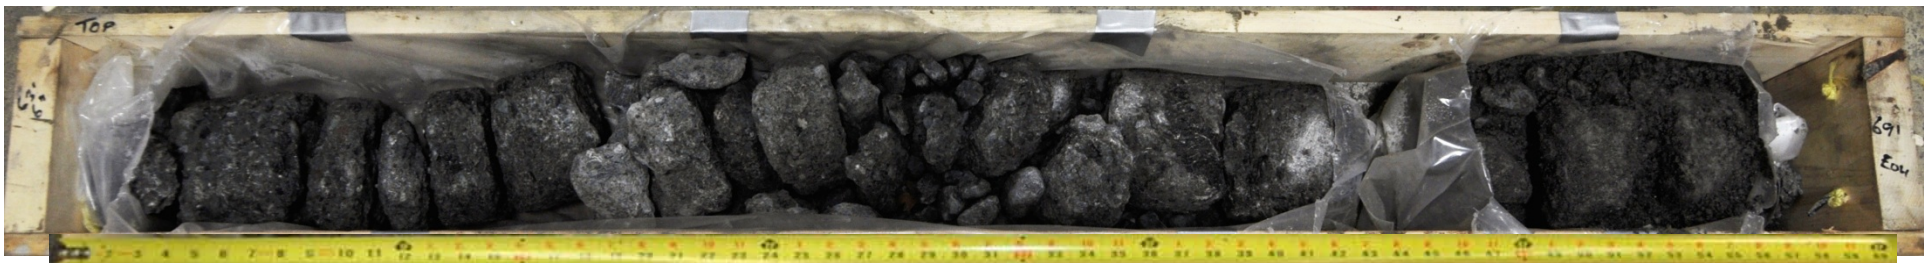
PROJECT		CITY OF NANAIMO COLLIERY DAMS PARK – LOWER DAM NANAIMO, B.C.		
TITLE		SH14-06 SONIC CORE PHOTOGRAPHS BOXES 11 TO 13 OF 13, 16.9 m to 21.0 m (55.5 ft to 69.0 ft)

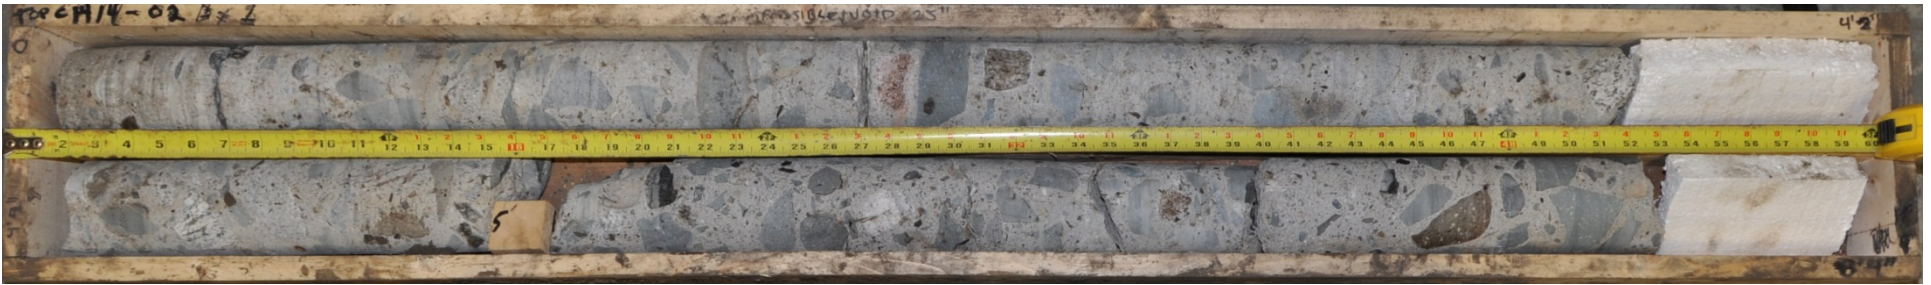
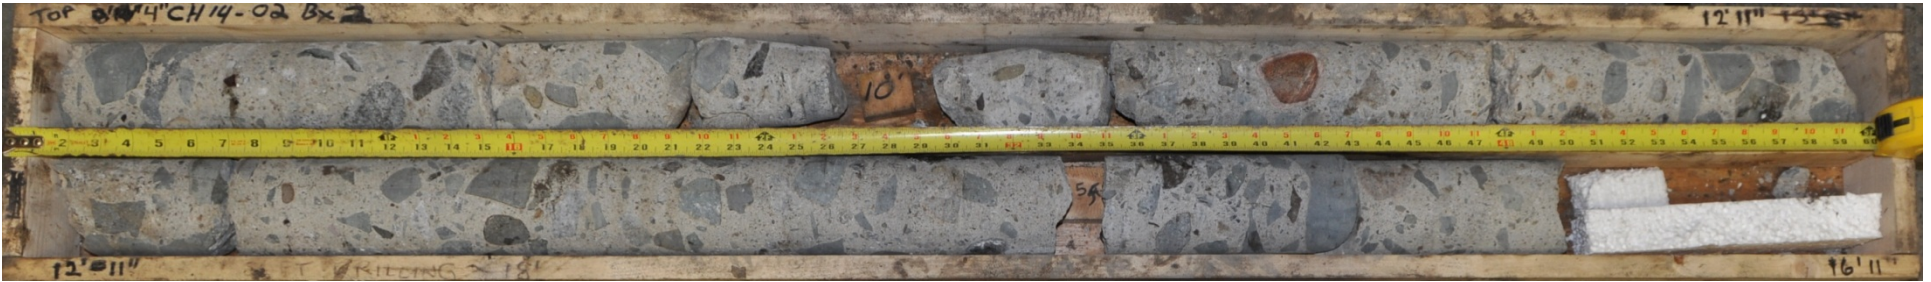
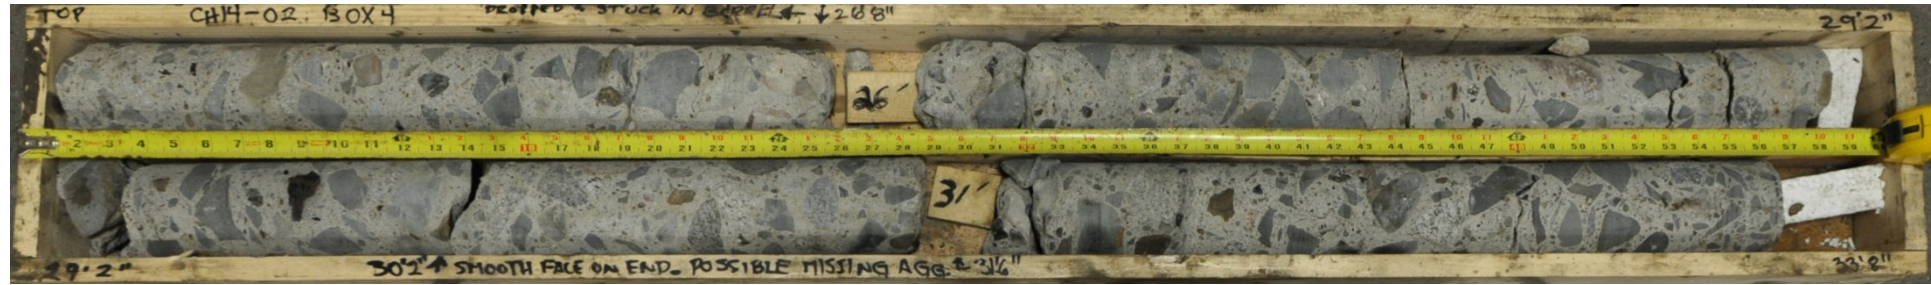
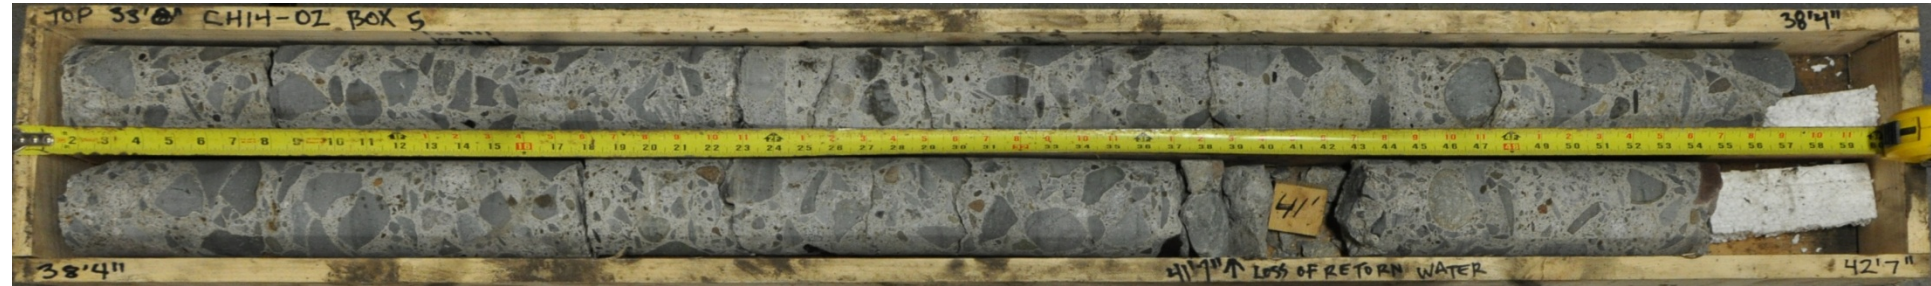
Golder Associates	PROJECT No.	13-1447-0516		Phase / Task No. 7000/7300	
	DESIGN	TM	18MAR14	SCALE	NTS
	CADD	TM	24MAR14	REV.	
	CHECK			FIGURE C-1	
	REVIEW

PROJECT	CITY OF NANAIMO COLLIERY DAMS PARK – LOWER DAM NANAIMO, B.C.				
TITLE	CH14-02 DIAMOND DRILL CORE PHOTOGRAPHS - DRY BOXES 1 TO 5 OF 8, 0 m to 12.9 m (0 ft to 42.5 ft)

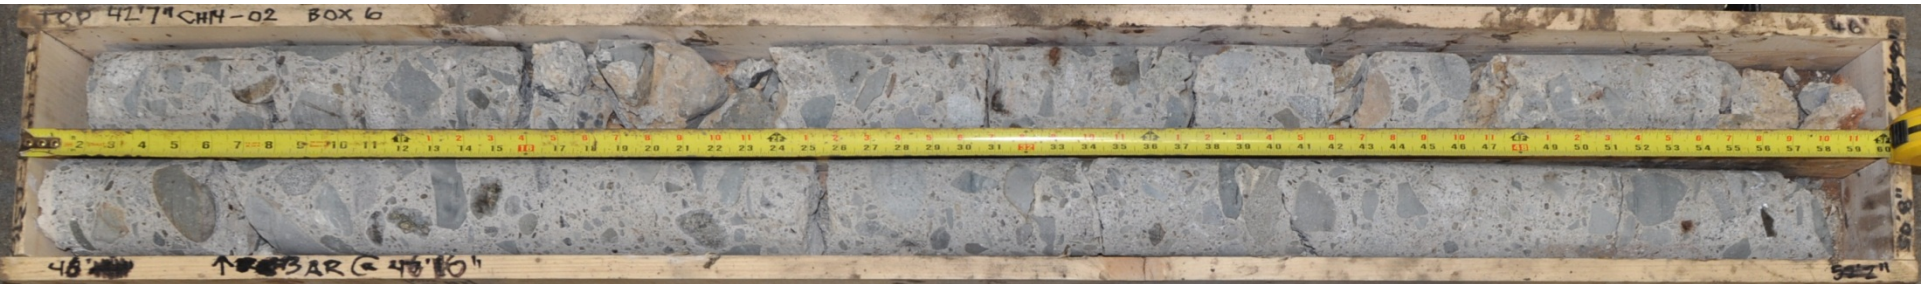
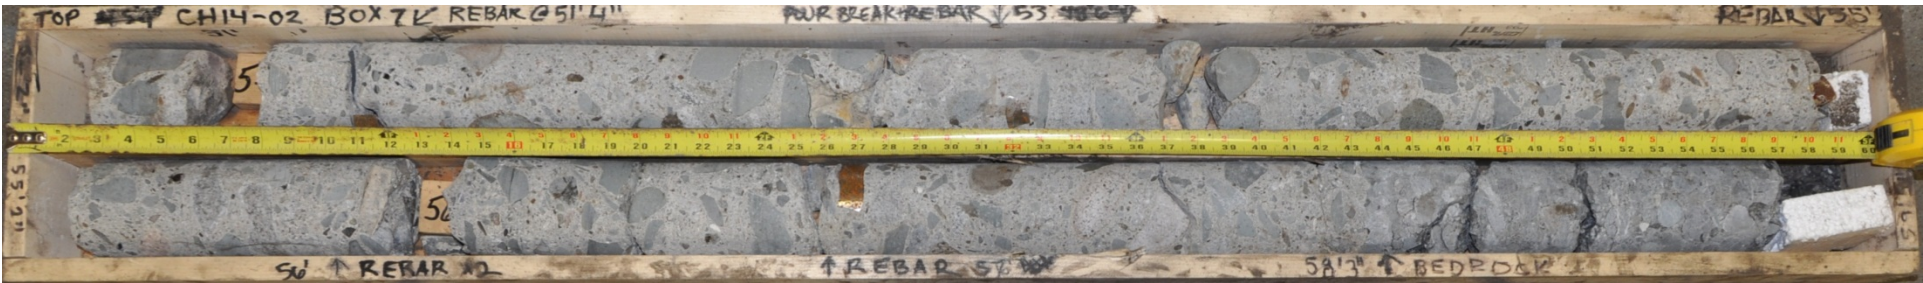
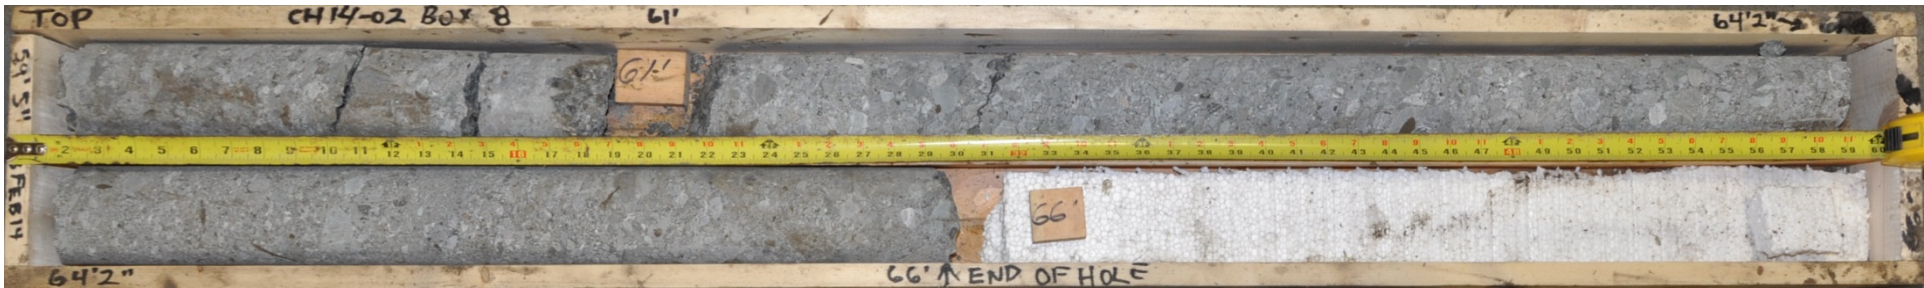
PROJECT No.	13-1447-0516	Phase / Task No. 7000/7300	
	DESIGN	TM	18MAR14	SCALE NTS
	CADD	TM	24MAR14	REV.
	CHECK			FIGURE C-2
REVIEW

PROJECT		CITY OF NANAIMO COLLIERY DAMS PARK – LOWER DAM NANAIMO, B.C.		
TITLE		CH14-02 DIAMOND DRILL CORE PHOTOGRAPHS - DRY BOXES 6 TO 8 OF 8, 12.9 m to 20.1 m (42.5 ft to 66.0 ft)

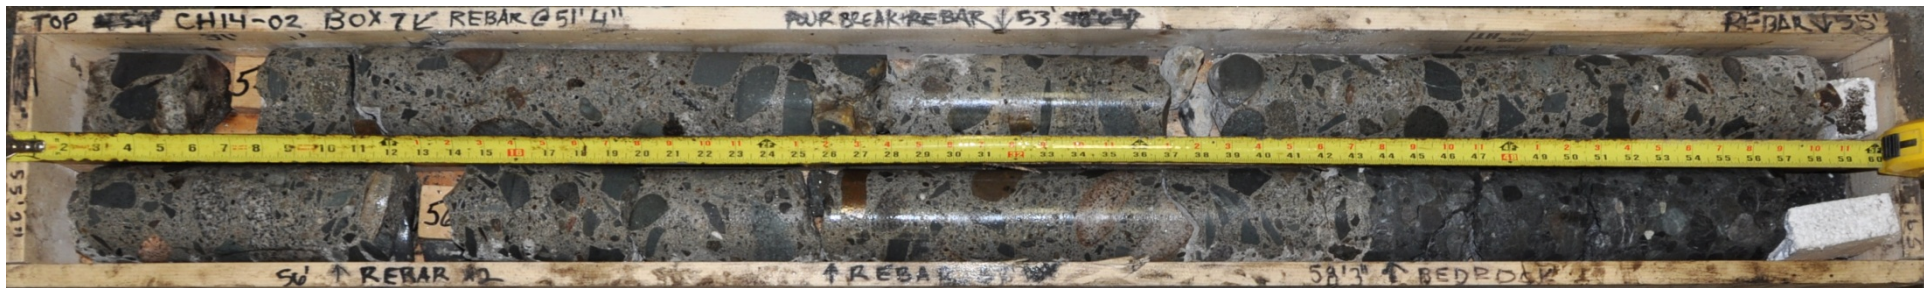
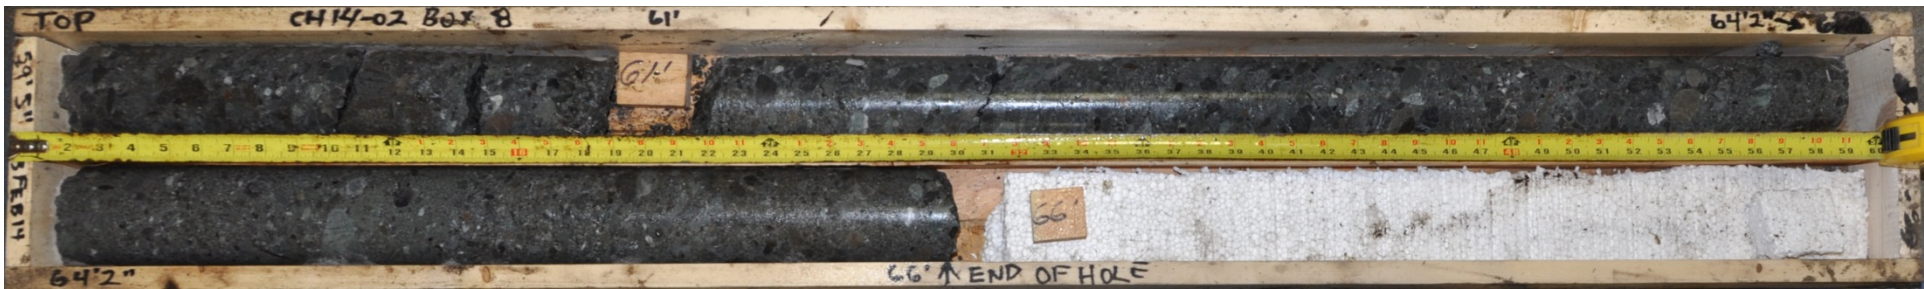
PROJECT No.	13-1447-0516	Phase / Task No. 7000/7300
	DESIGN	TM 18MAR14	SCALE NTS
	CADD	TM 24MAR14	REV.
	CHECK		FIGURE C-4
REVIEW

PROJECT		CITY OF NANAIMO COLLIERY DAMS PARK – LOWER DAM NANAIMO, B.C.	
TITLE		CH14-02 DIAMOND DRILL CORE PHOTOGRAPHS - WET BOXES 6 TO 8 OF 8, 12.9 m to 20.1 m (42.5 ft to 66.0 ft)

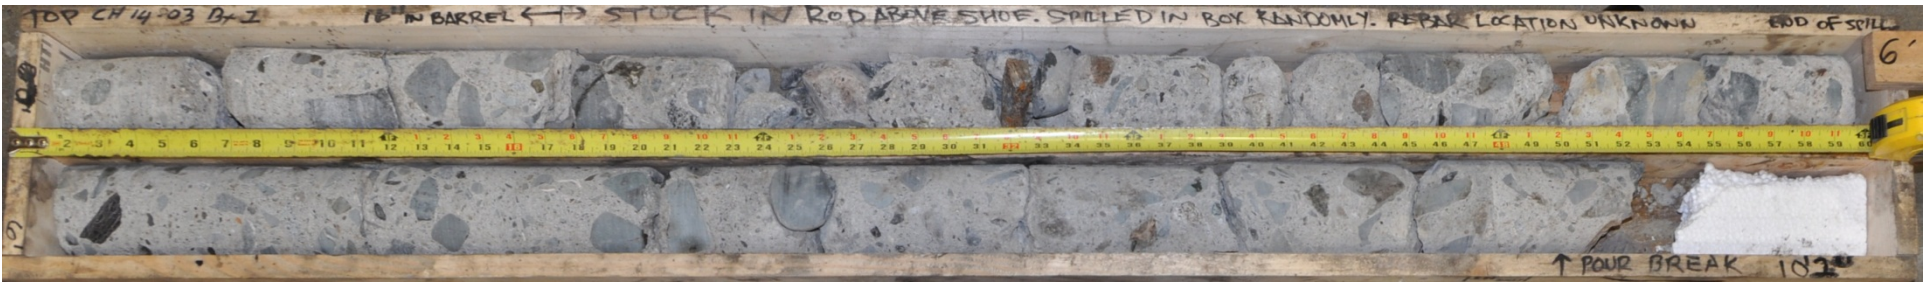
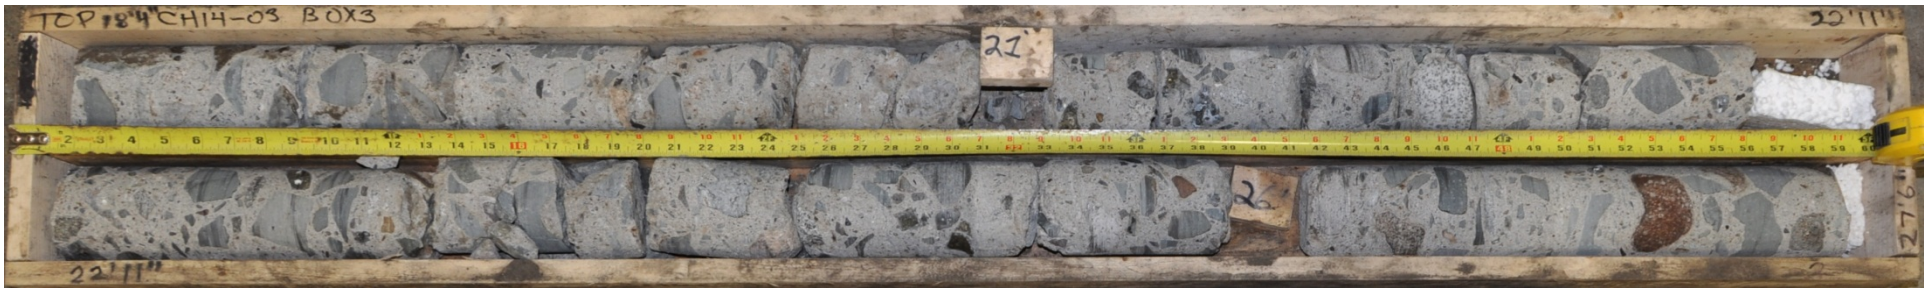
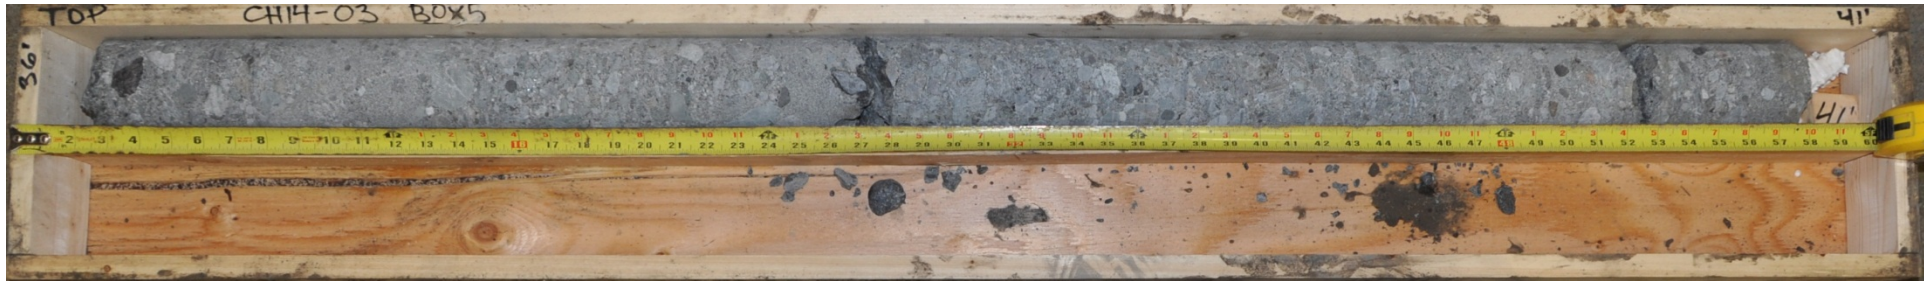
PROJECT No.	13-1447-0516	Phase / Task No. 7000/7300	
	DESIGN	TM	18MAR14	SCALE NTS
	CADD	TM	24MAR14	REV.
	CHECK			FIGURE C-5
	REVIEW

PROJECT	CITY OF NANAIMO COLLIERY DAMS PARK – LOWER DAM NANAIMO, B.C.			
TITLE	CH14-03 DIAMOND DRILL CORE PHOTOGRAPHS - DRY BOXES 1 TO 5 OF 5, 0 m to 12.3 m (0 ft to 40.5 ft)

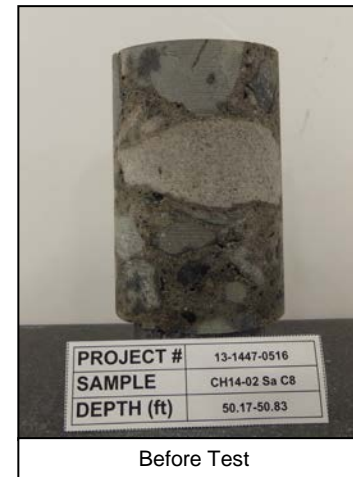
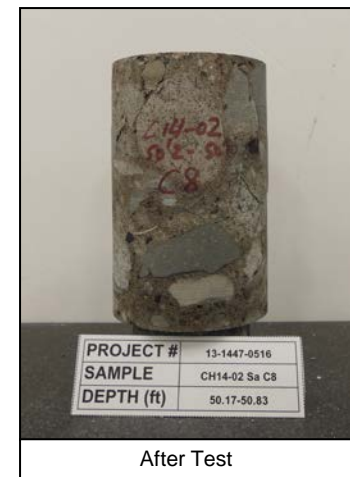
Test Summary			ASTM C469/C469M – 10 Modulus in Uniaxial Compression		Project Details	
Peak Stress σ_{peak}	32.10	MPa	Sample:	CH14-02 C8	Project No.:	13-1447-0516
Chord Modulus E_{40}	10.26	GPa	Depth (ft):	50.17-50.83	Project:	Nanaimo Dam-Concrete Core Testing
Poisson's Ratio ϵ_{40}	0.16				Client:	City of Nanaimo
Sample soaked in lab for not less than 48hrs prior to testing					Test Date:	April 10, 2014
					Tech:	G. Patton
					Checked:	E. Kostyukov

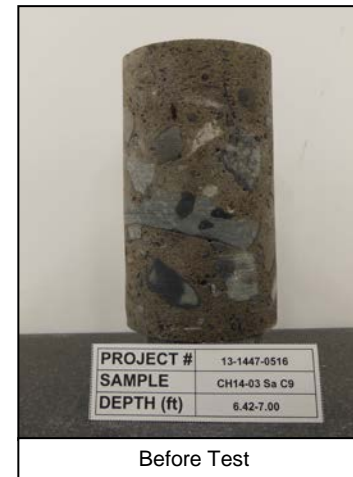
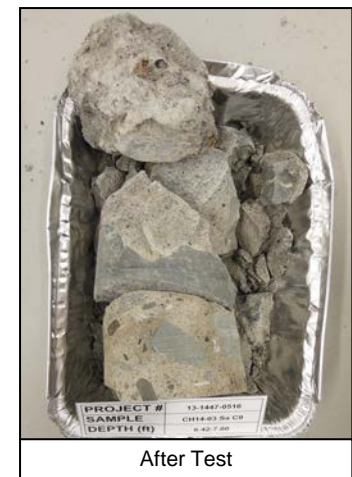
Test Summary			ASTM C469/C469M – 10 Modulus in Uniaxial Compression		Project Details		
Peak Stress σ_{peak}	29.10	MPa	Sample:	CH14-03 C9	Project No.:	13-1447-0516	
Chord Modulus ϵ_{40}	11.47	GPa			Project:	Nanaimo Dam-Concrete Core Testing	
Poisson's Ratio ϵ_{40}	0.17		Depth (ft):	6.42-7.00	Client:	City of Nanaimo	
Sample soaked in lab for not less than 48hrs prior to testing					Test Date:	April 10, 2014	
					Tech:	G. Patton	
					Checked:	E. Kostyukov

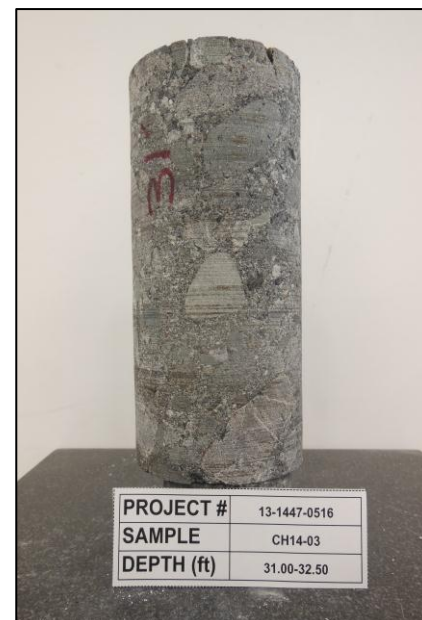
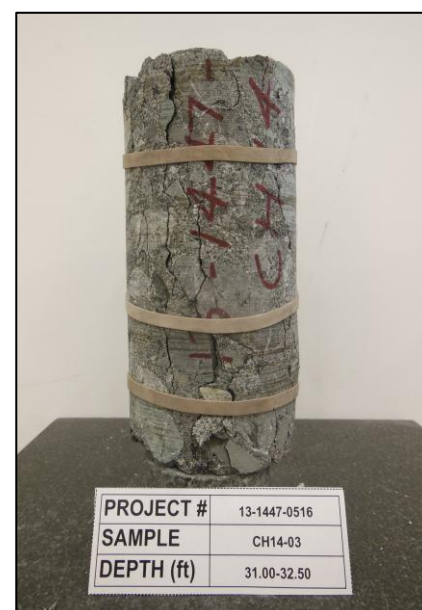
Comments
Failed around clasts, through matrix material

BEFORE TEST

AFTER TEST
