## **Staff Report for Decision**

File Number: DP001080

SUBJECT DEVELOPMENT PERMIT APPLICATION NO. DP1080 -

3062 HAMMOND BAY ROAD

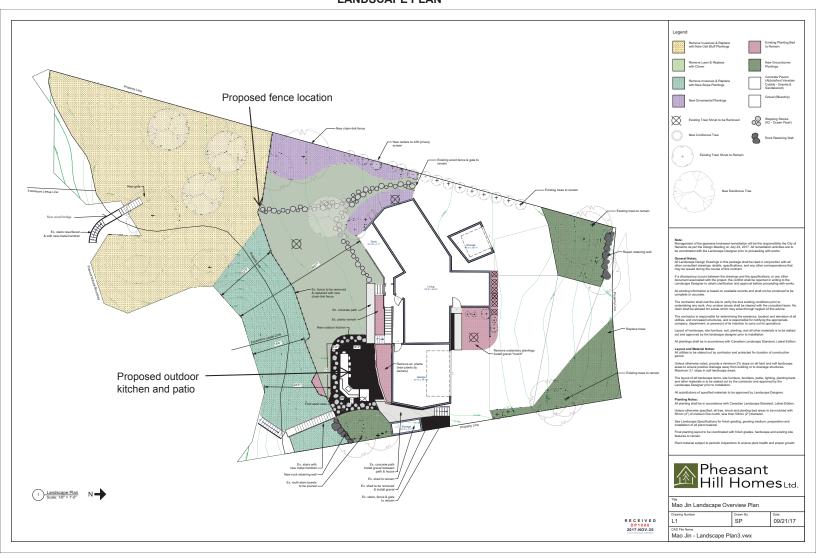
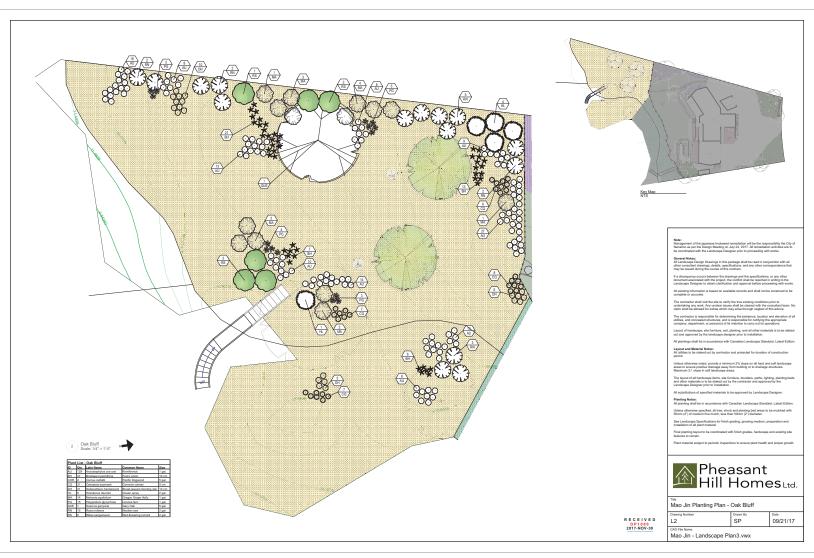
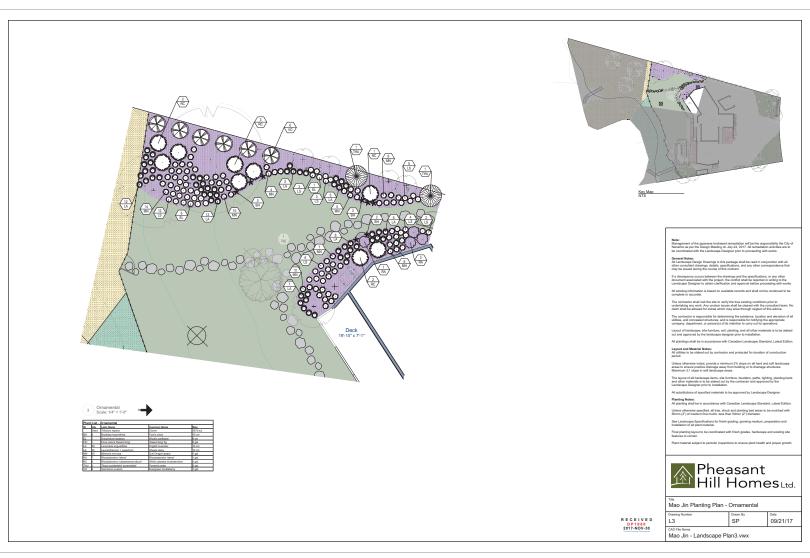
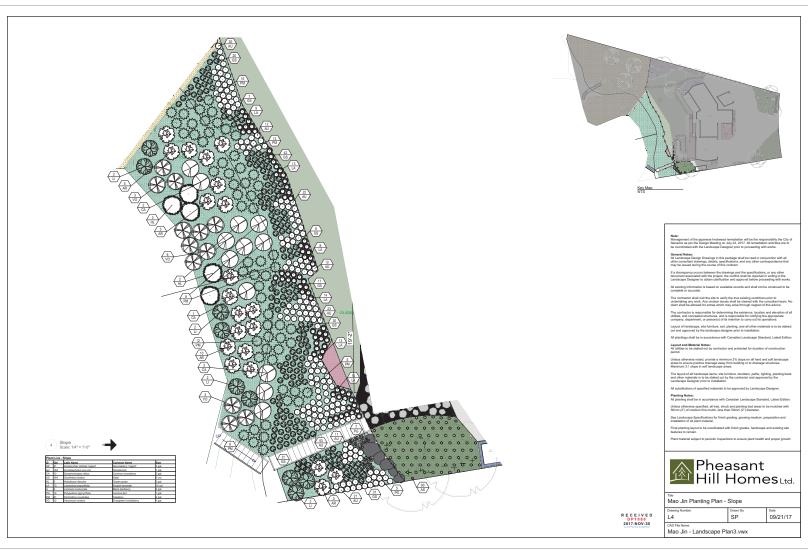
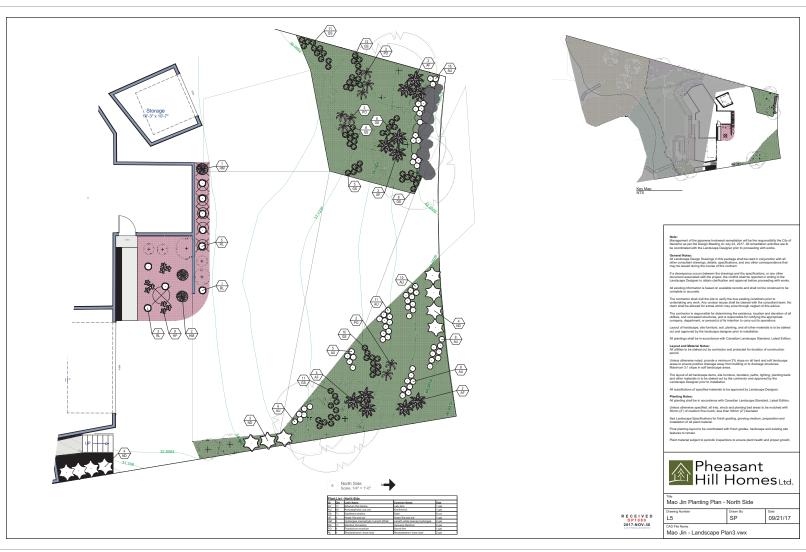
- construct a new patio with an outdoor kitchen and foot wash area in the rear yard;
- repair two existing beach access staircases and install new handrails;
- replace the existing fence with a new chain link fence in the rear yard and along the west property line in the location shown on Attachment C;
- replace a failing retaining wall with a new rock retaining wall along the top of the slope at the east side of the property; and,
- implement an extensive landscape management plan for the rear yard area, including invasive species removal and restoration with native plant species.

The proposed 23m² outdoor kitchen/patio will be located within the existing lawn area and will not require the removal of any native vegetation. The patio area will be constructed with permeable materials. As part of the proposed landscape restoration, the owner will replace the grass lawn with clover, a drought-tolerant plant that requires no fertilization. In addition to the patio area, the owners will repair two existing beach accesses that lead to separate, isolated beaches. The Qualified Environmental Professional states repairs to the beach accesses will ensure safe access to the beach and will be contained within the footprint of the existing stairs.

- 1. The riparian area improvements shall be completed in substantial compliance with the Landscape Plan prepared by Pheasant Hill Homes Ltd. dated 2017-NOV-30 as shown on Attachment C.

- 2. A permanent fence shall be installed as per the landscape plan prepared by Pheasant Hill Homes Ltd. dated 2017-NOV-30 as shown on Attachment C.
- 3. The subject property shall be developed generally in accordance with the environmental assessment prepared by Toth and Associates Environmental Services dated 2017-NOV-30 as shown on Attachment D.
