OAKWOOD PARK ESTATES ENVIRONMENTAL ASSESSMENT FOR MILLSTONE RIVERFRONT AT 1-1 TERMINAL AVE

PREPARED FOR:
THE CITY OF NANAIMO
455 WALLACE STREET,
NANAIMO, BC, V9R 5J6

AUGUST 2022

CORVIDAE
ENVIRONMENTAL CONSULTING INC

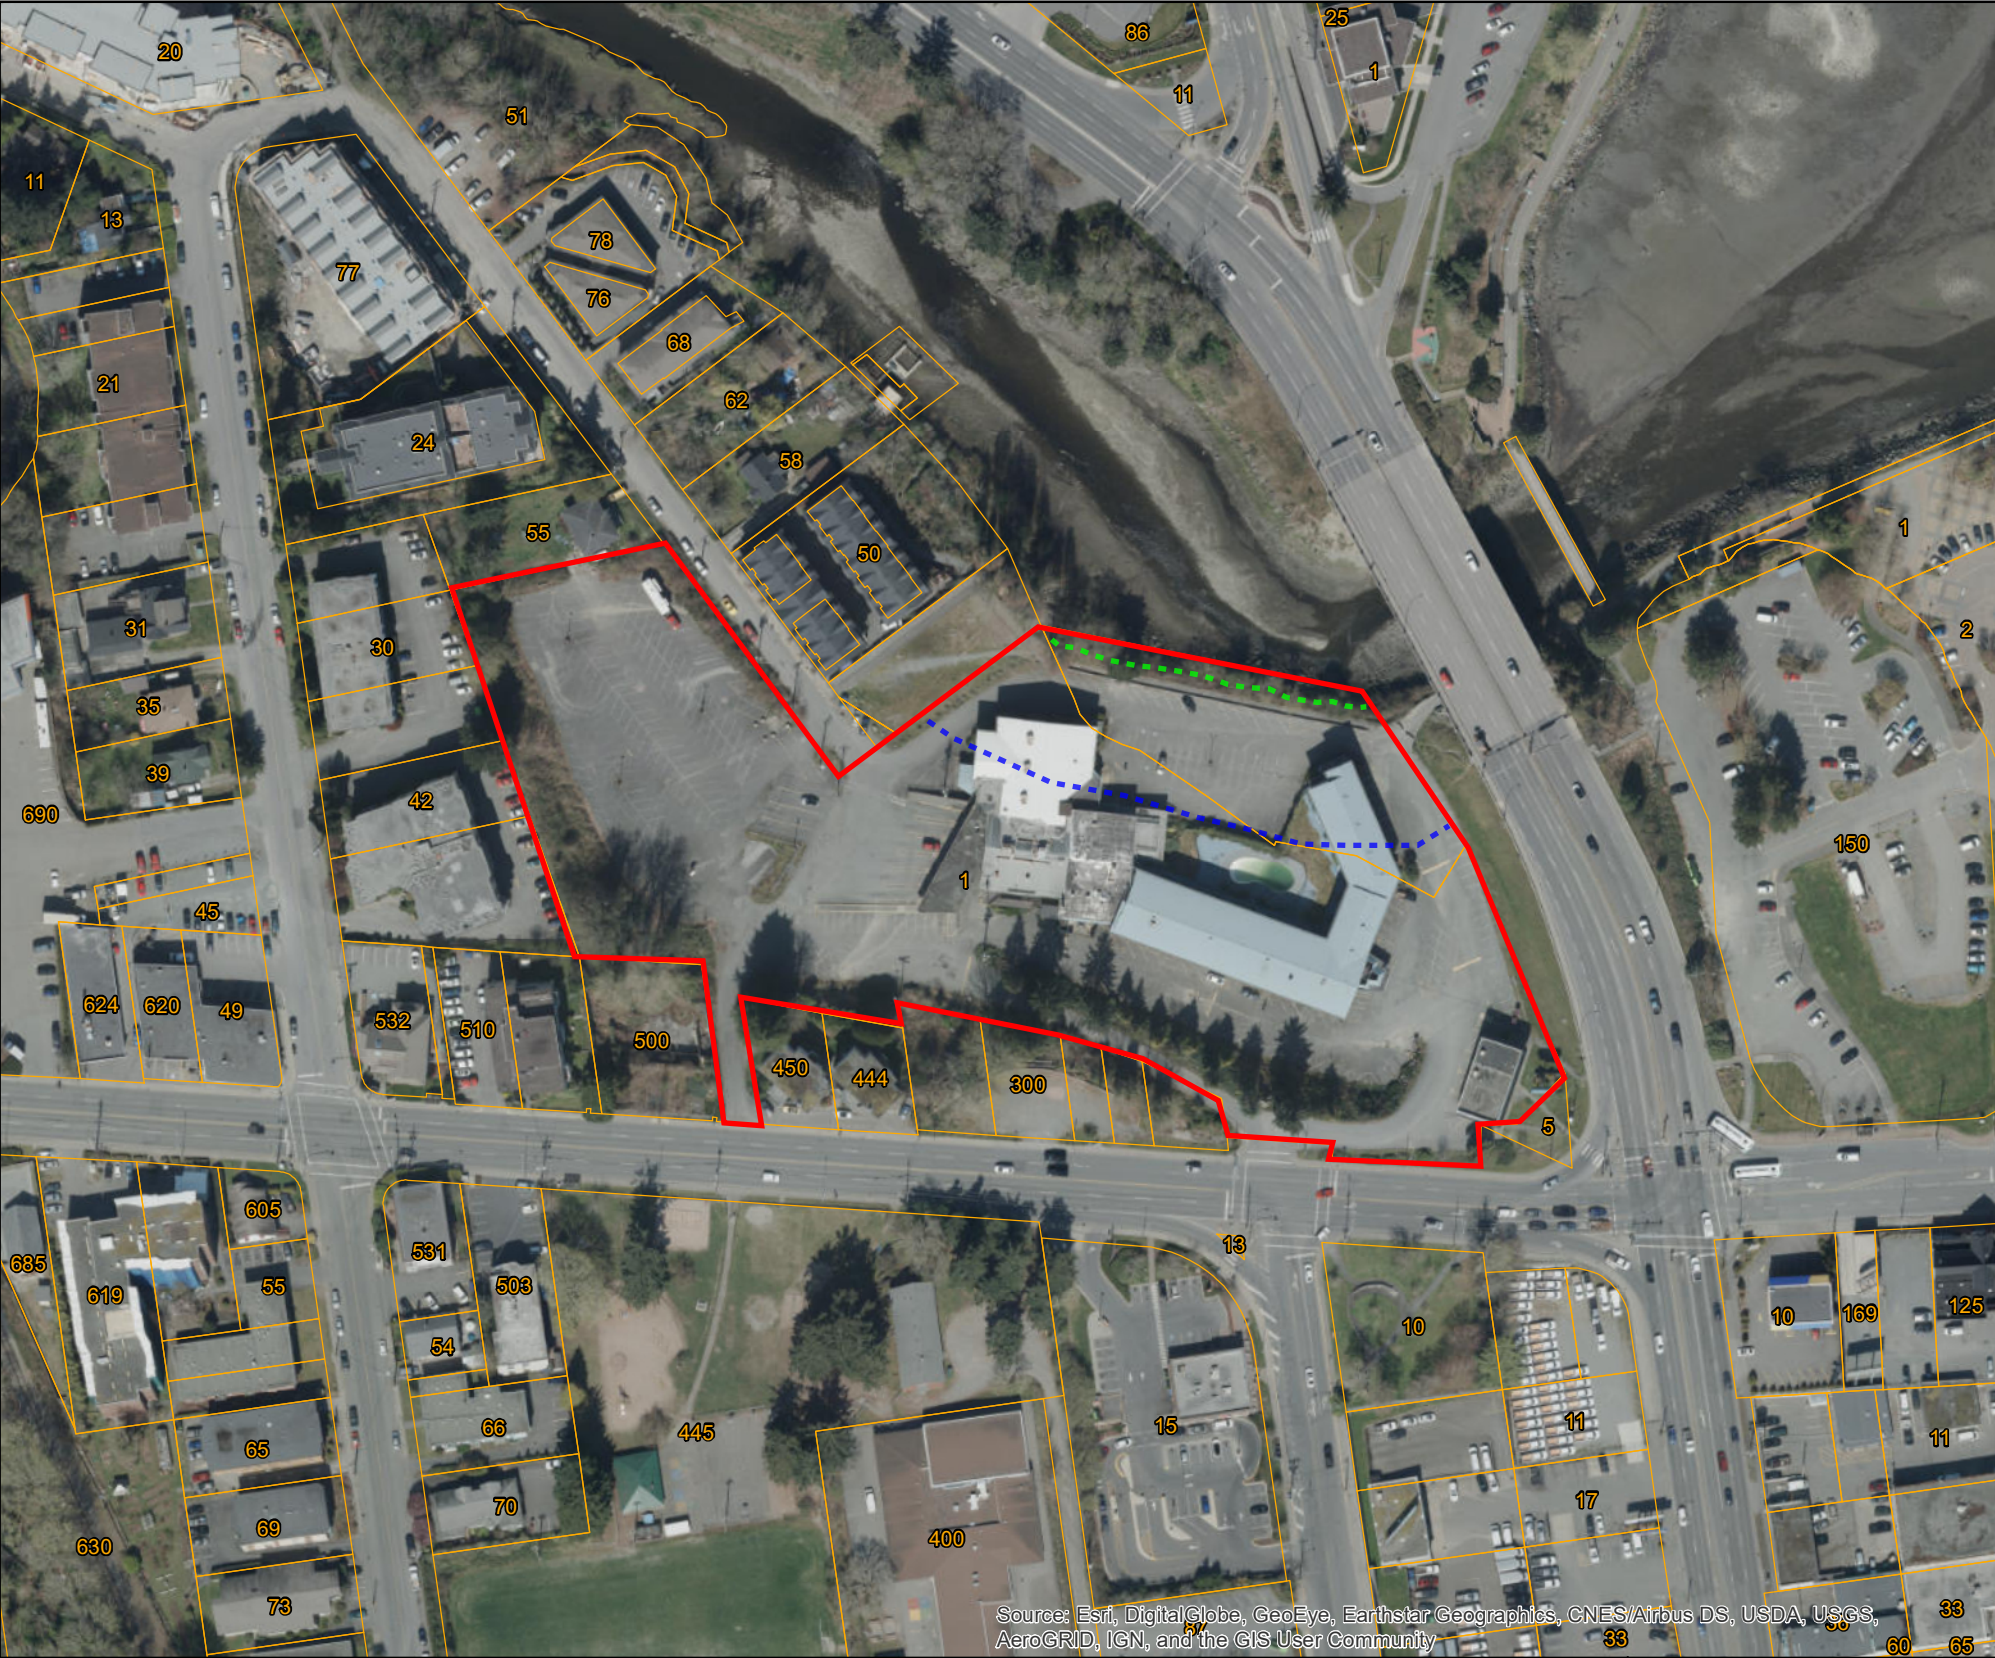
Figure 1

Figure 1: Property Location with current site conditions

Project Location

Top of Bank

30 m setback from current Top of Bank

The northern portion of the project area is within the 30 m assessment area from the top of bank (part of DPA 1 in the 2022 OCP). This area is currently paved, except for 6.2 m of shoreline along the river above the high-tide line (the river in this area is tidally influenced). A path is proposed inside the 30 m DPA assessment, to connect with the existing path along the shoreline in Maffeo Sutton Park. The rest of the 30 m area will include trees, shrubs, forbs, seating, rain gardens and road access (see the design plans for details). All building structures will be located outside of the 30 m DPA area. The community area along the river will add to the connectivity of the adjacent community park and trail system.

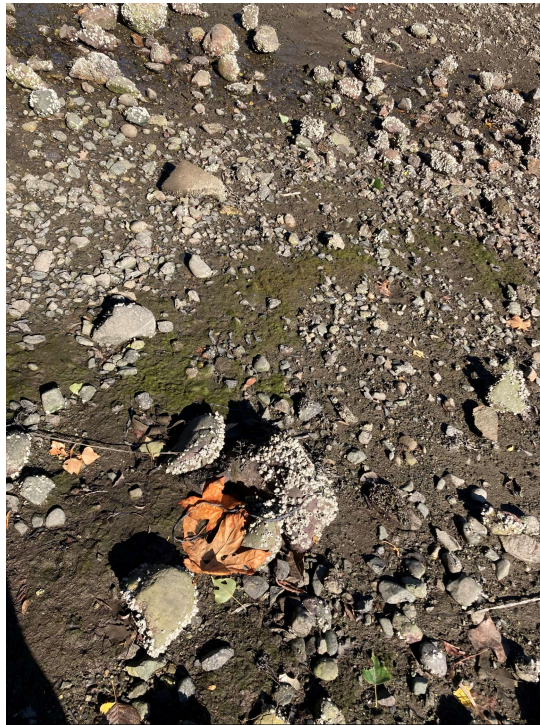
Photo 3. Mud, gravel and cobble substrate on the floor of Millstone River. Marine species including barnacles and mollusks were observed in abundance indicating the area is estuarine. September 2021.

At the time of the assessment the tide was ebbing into the wetted area adjacent to the project. The QEP also noted a muddy substrate interspersed with gravels and cobbles covered in barnacles and saltwater mollusks. Given the visual markings of tidal influences on the landscape, marine muddy substrate and abundant presence of saltwater organisms including barnacles and molluscs, the waterbody description of this segment of Millstone River is estuarine.
