HERITAGE BUILDING DESIGN GUIDELINES

CITY OF NANAIMO

AUGUST 2018

PREPARED BY: RDH BUILDING SCIENCE INC.

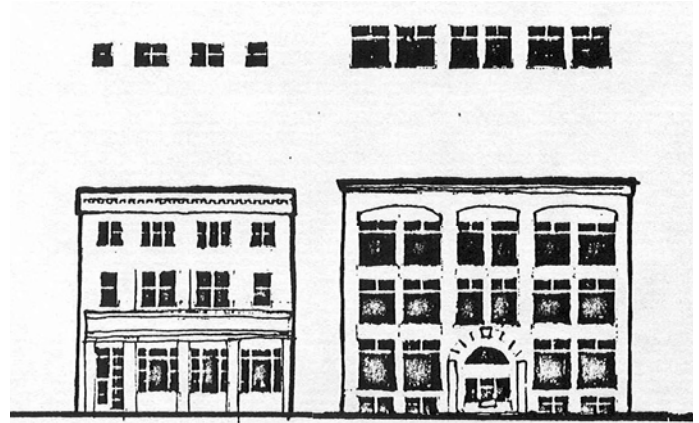
Example patterns established in heritage building façades by solids (walls) and voids (openings). Sympathetic relationships may be formed between old and new construction by incorporating similar rhythmic patterns.

The alternation of solids and voids (walls to openings) in the façade establishes a pattern which may be sensed by observing the building from a distance. This pattern is perceived as a rhythm by the passerby, and a sympathetic relationship between old and new construction may be achieved by incorporating similar rhythmic patterns.

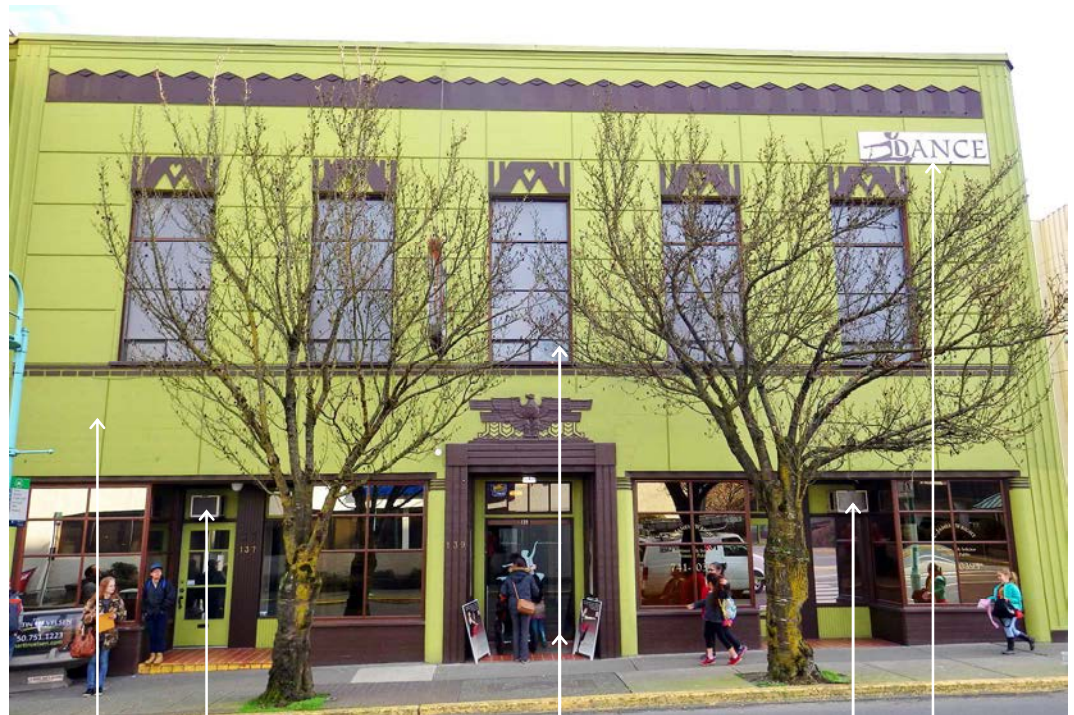
- 1 Retain and maintain original elements
- 2 Re-stain and seal weathered second and third storey window sashes
- 3 Future restoration could include removal of paint to expose the original pressed brick

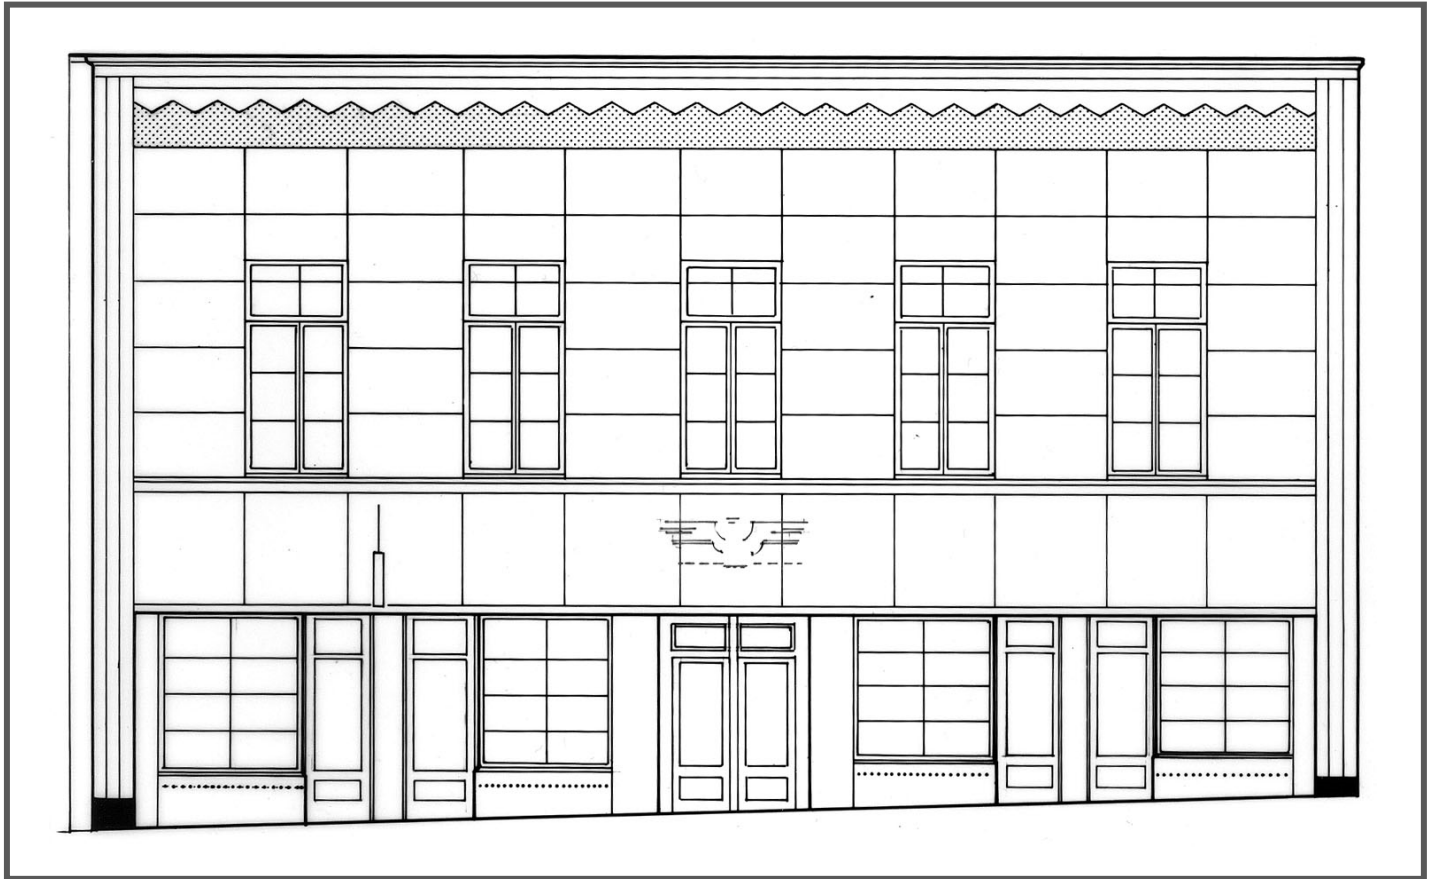
11.4 | EAGLE'S HALL

Suggested Bastion Street façade design

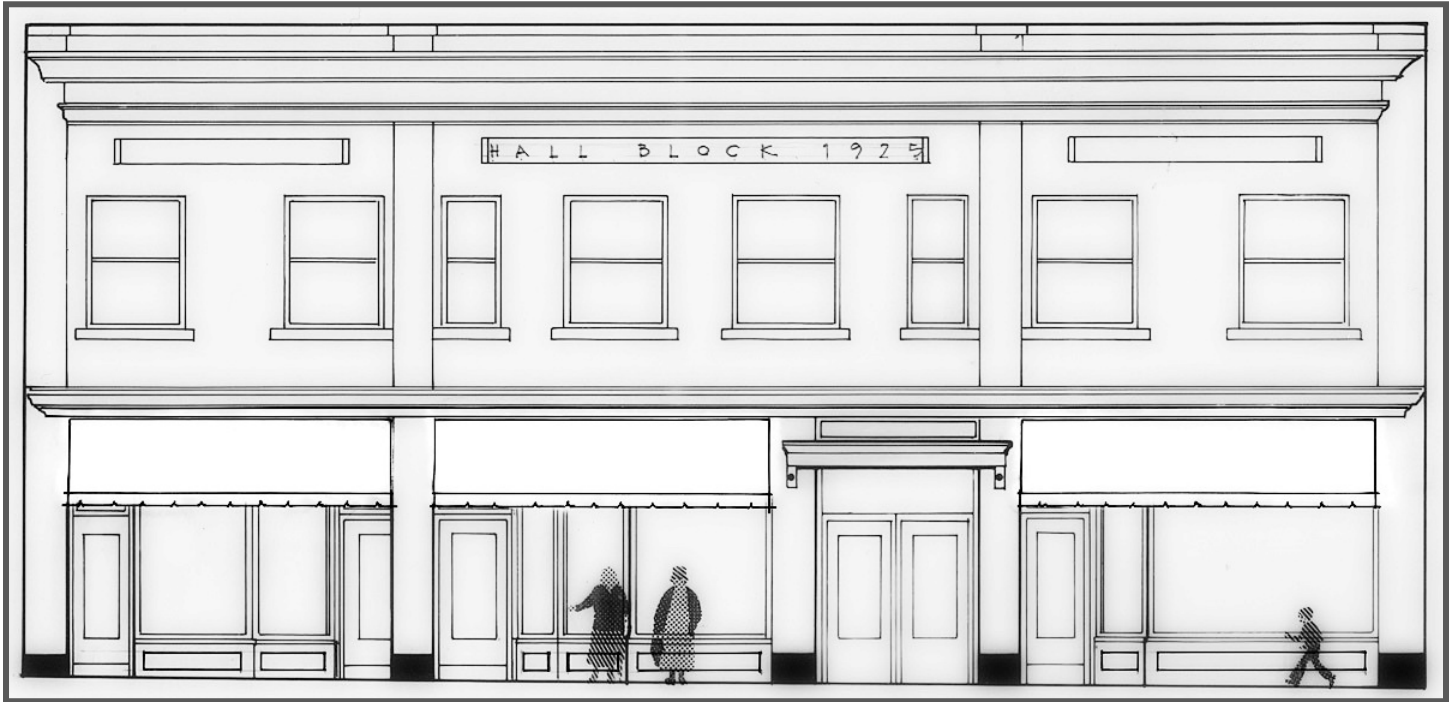
11.15 | HALL BLOCK

Suggested Commercial Street façade design

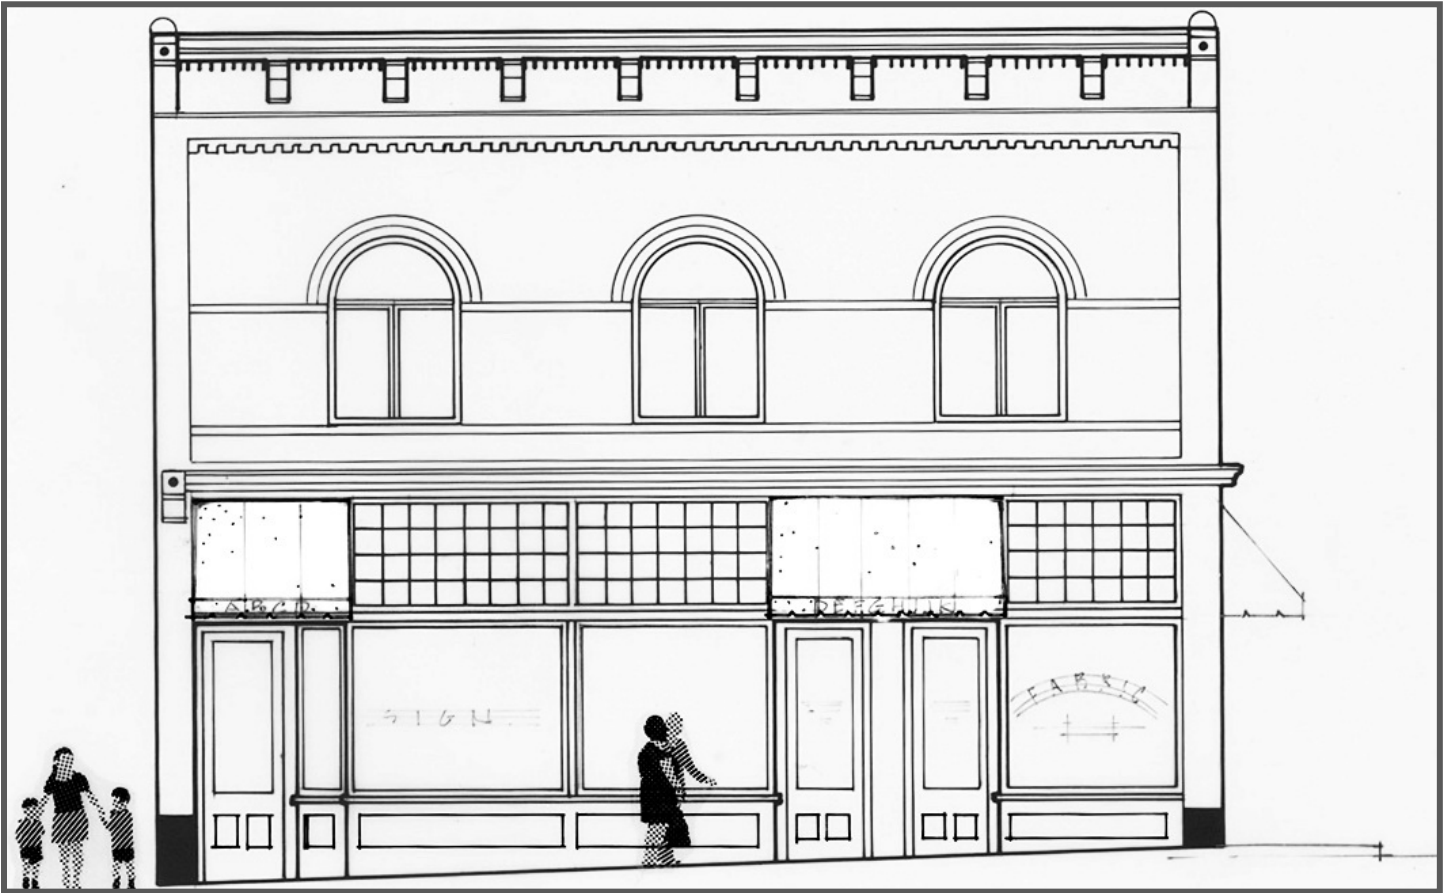
11.17 | HIRST BLOCK (DAKIN BLOCK)

Suggested Commercial Street façade design

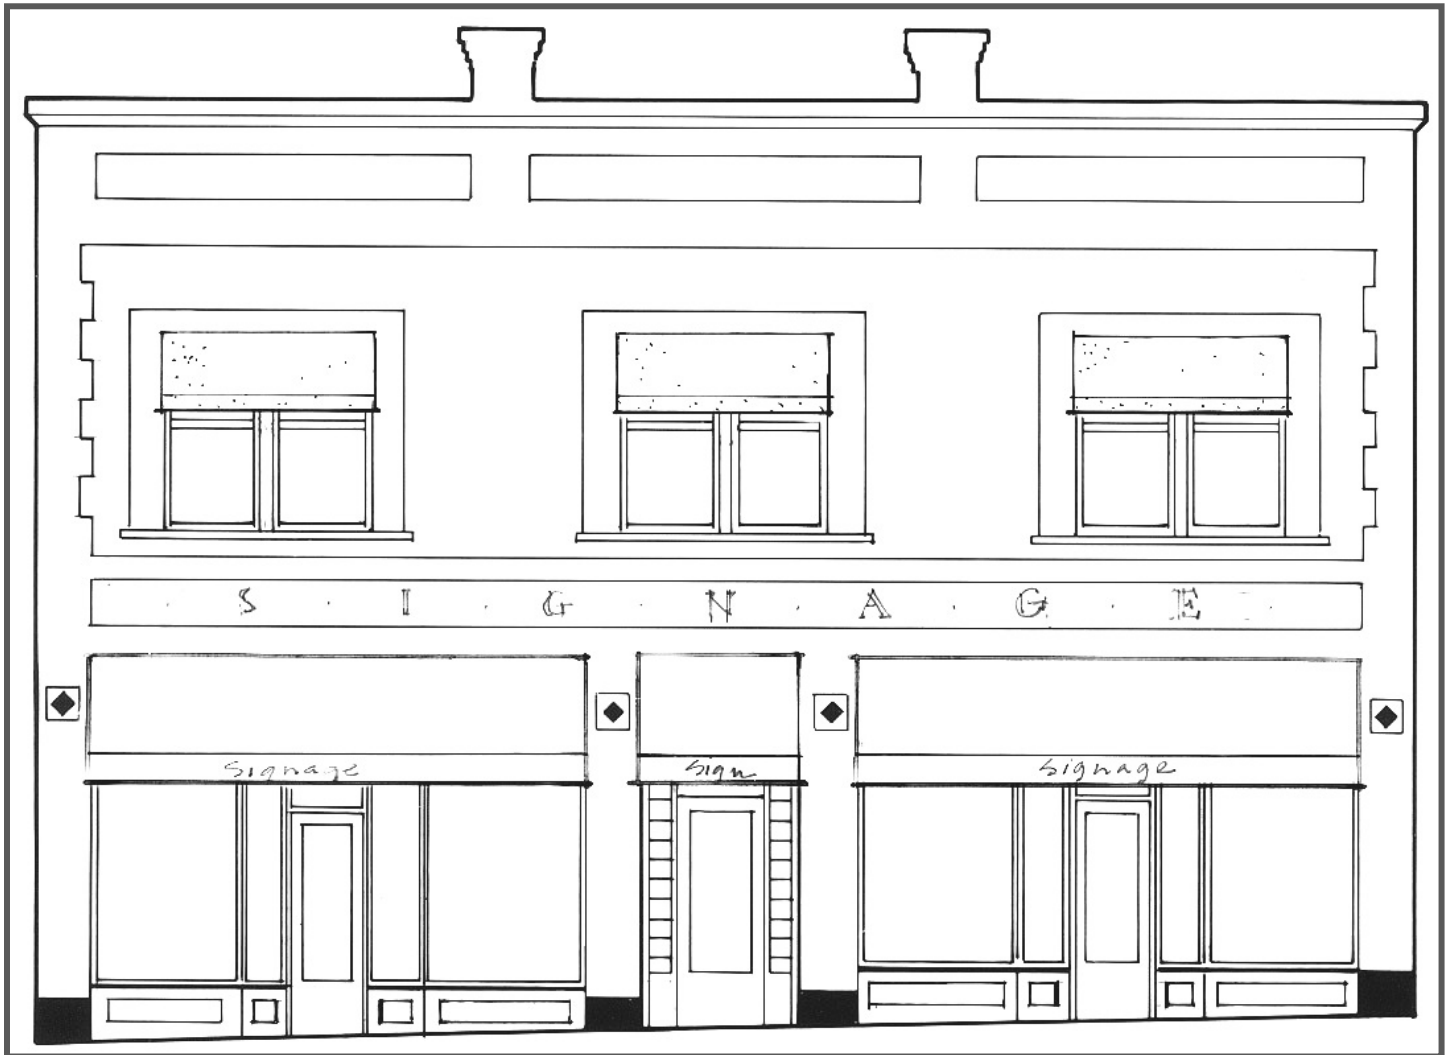
11.20 | PARKIN BLOCK

Suggested Commercial Street façade design

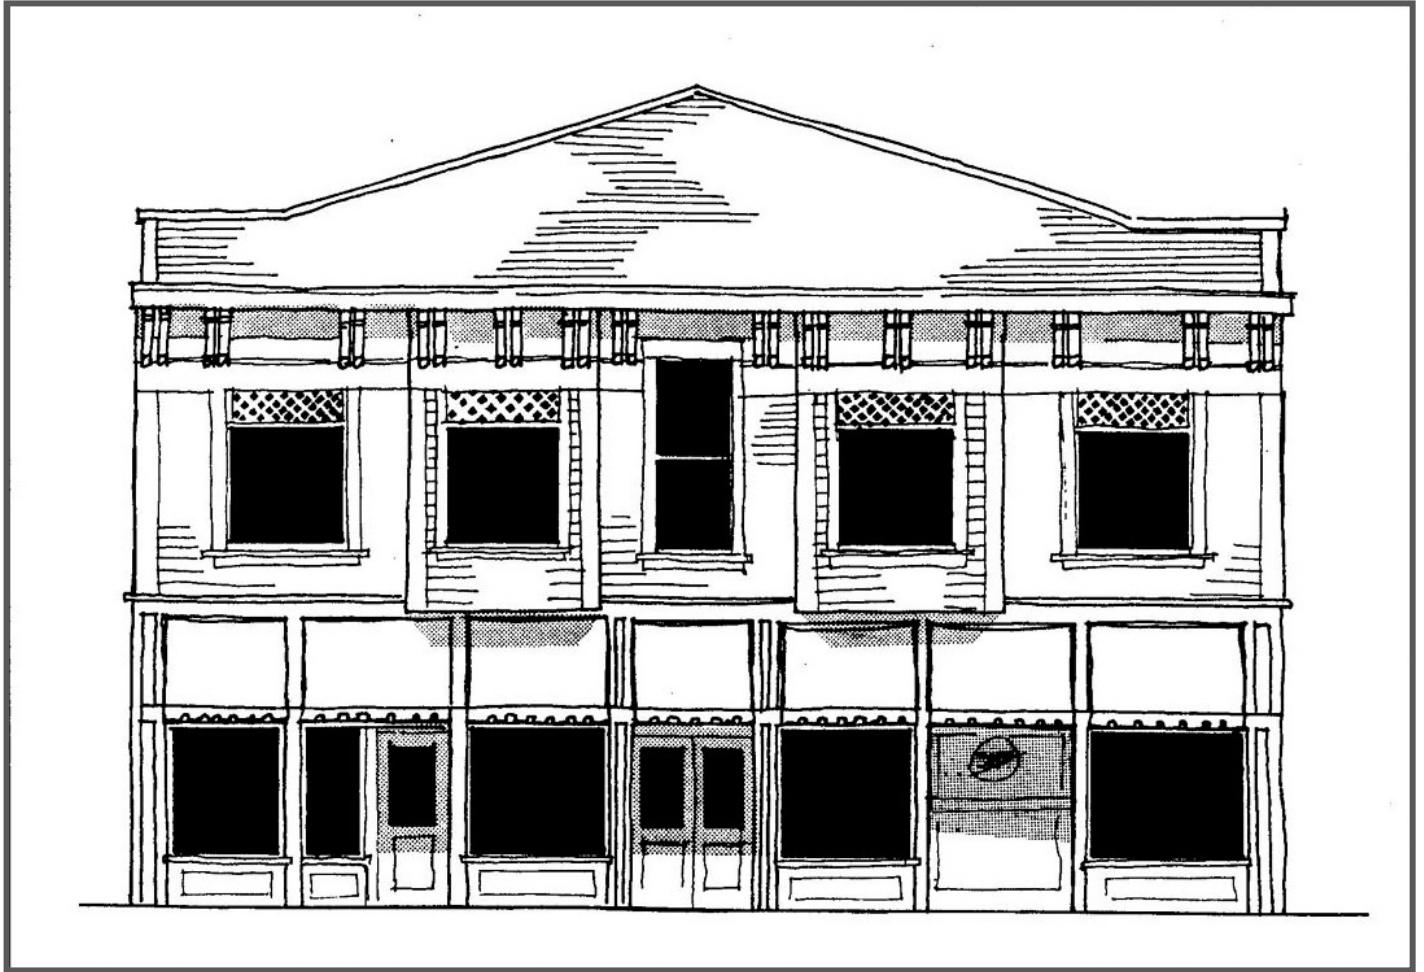
11.27 | S&W APARTMENT BLOCK

Suggested Fitzwilliam Street façade design

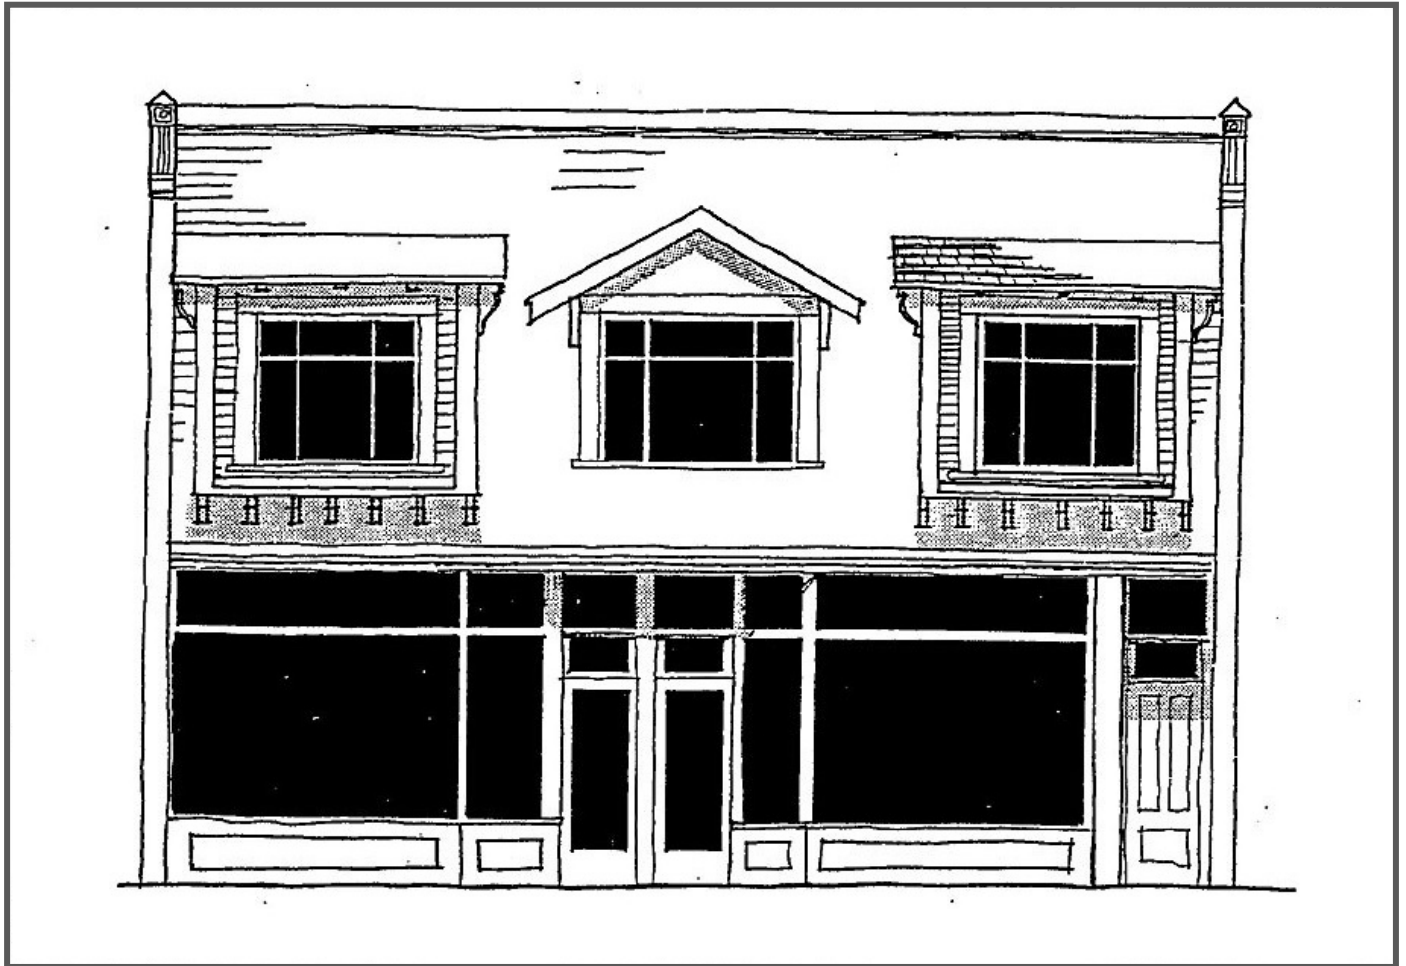
11.29 | T&B APARTMENT BLOCK

Suggested Fitzwilliam Street façade design
