Monitoring Riparian Forest Health in the Linley Valley

Using a Proper Functioning Condition Assessment on Cottle Creek

Prepared by: Joe Clark, Jr. Biologist

June 2026

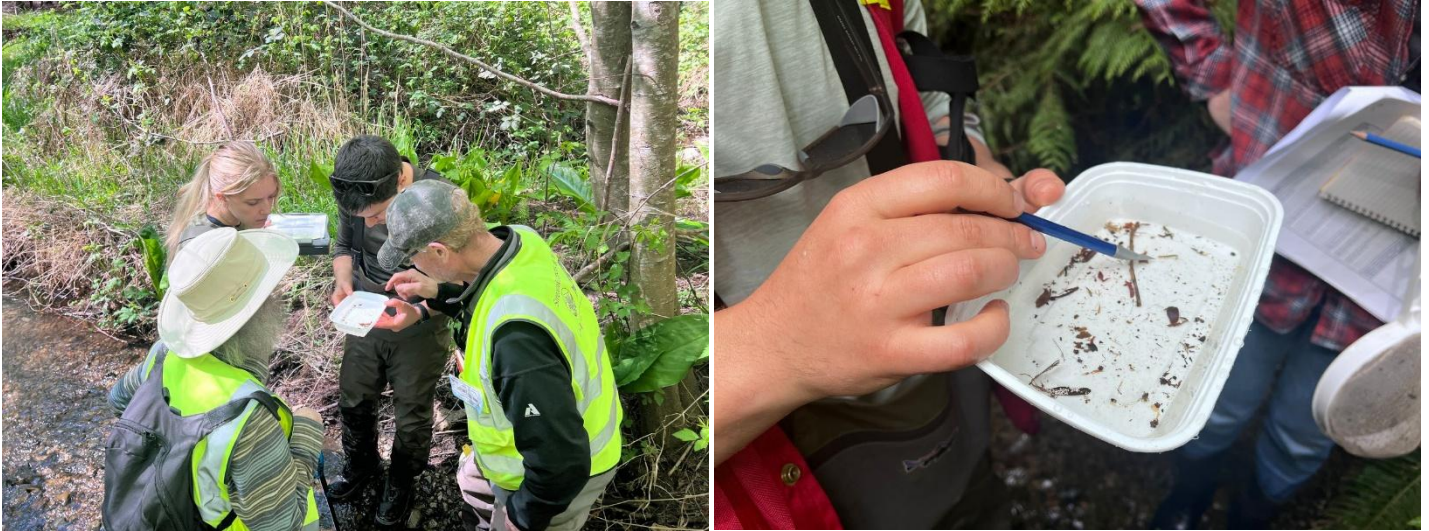
Figure 2. FREP RMREE Assessment crew (BCCF, FOCC, MABRRI) identifying and enumerating benthic macroinvertebrates at riffle sites on Cottle Creek.

A representative “sub-sample” length was selected within each reach. Sample lengths were determined as described in the protocol by multiplying the average channel width by 30 (with a minimum of 100 m). Each surveyor was assigned three to four continuous indicators (e.g., lateral bars, pool length, windthrow), and these indicators were measured along the entirety of the sample length. All data was collected directly onto a printed paper field card. Continuous indicators were measured using various methods (eg. 30m measuring tape, or visual estimation). Once all continuous indicators were recorded, point indicators (e.g., benthic invertebrates, invasive plant cover, shade) were recorded at six riffle sites evenly distributed through the transect (e.g., in a 150 m transect, point indicators were measured approximately every 25 m). Point indicators were measured by visual estimation. Benthic invertebrates were collected by disturbing riffle substrate by hand with a 15 cm mesh sieve held immediately downstream.

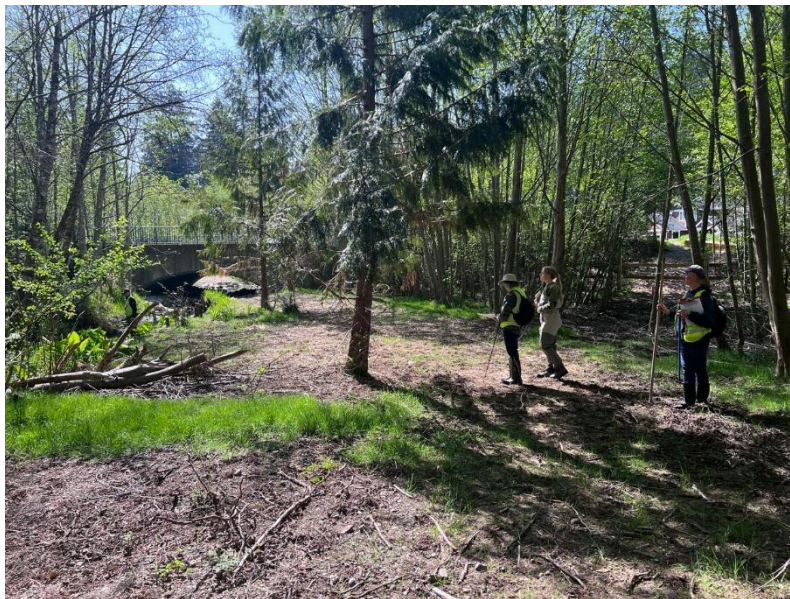
the creek channel by instream work by the City to repair infrastructure and remove sediment accumulations in the floodplain at Nottingham Drive (Figure 3).

Figure 3. Current riparian zone conditions in reach three of Cottle Creek upstream of Nottingham Drive.

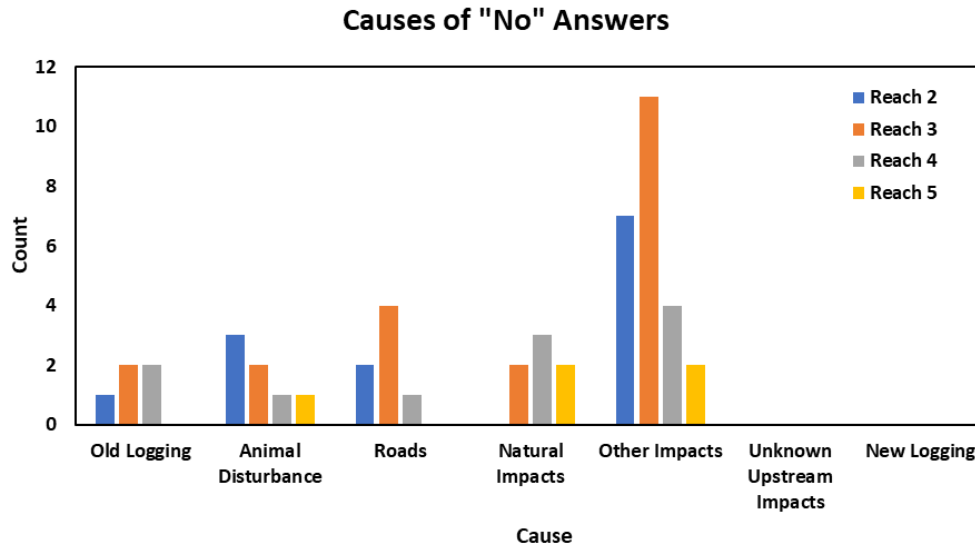
The most common cause of ‘no’ answers was ‘other’ impacts (n = 25) which includes urbanization and historical agricultural impacts (Figure 5). Old logging was the cause of five ‘no’ answers. Both animal disturbance (inclusive of humans) and roads were the cause of seven ‘no’ answers, while natural impacts (e.g., floods or wind) were the cause of nine ‘no’ answers.

Figure 5. Causes of 'no' answers determined for all four FREP RMREE assessed reaches of Cottle Creek.

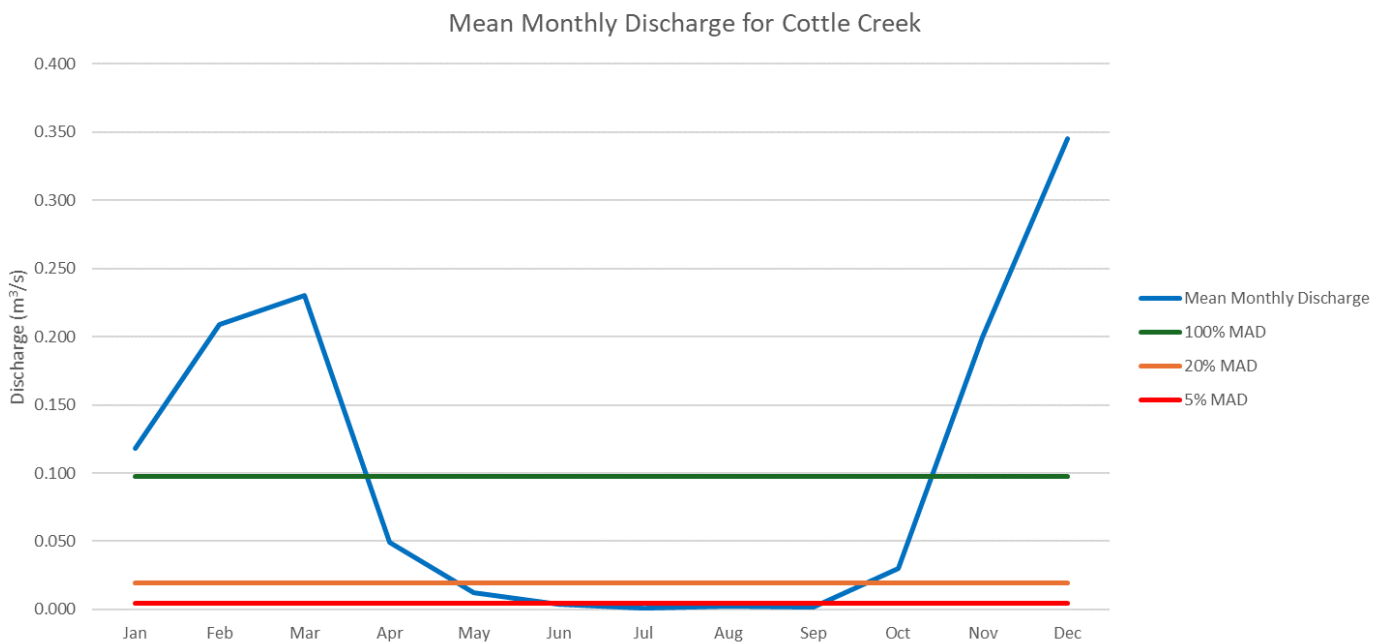
For three of the four reach assessments, Cottle Creek was below 10 % MAD, (Figure 6). At such low discharge, there is not enough water in the stream to maintain uninterrupted surface flows resulting in dry gravel bars. The severity and duration of the summer low-flow period (Figure 7) in Cottle Creek is the main cause of the lack of aquatic habitat connectivity observed in all reaches during this field assessment and remains a main limiting factor for productivity of aquatic life in the stream.

Figure 6. Annual Flows as shown in Mean monthly discharge (m³/s) values recorded in Cottle Creek from 2024 through 2025

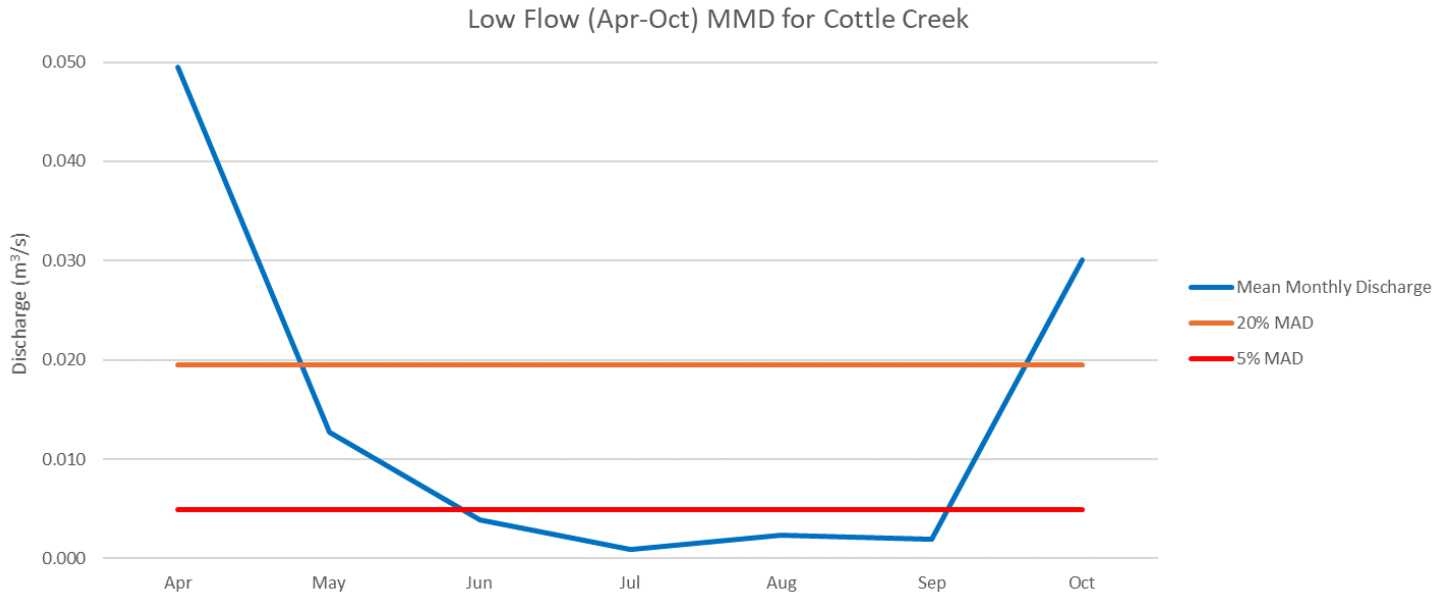
Lack of aquatic habitat connectivity in Cottle Creek can be largely attributed to low stream flows, especially during the summer low-flow period from April through October.

Figure 7. Mean monthly discharge (MMD; m^3/s) values recorded in Cottle Creek during low-flow period of April through October. (Courtesy of A. Wall, 2026).

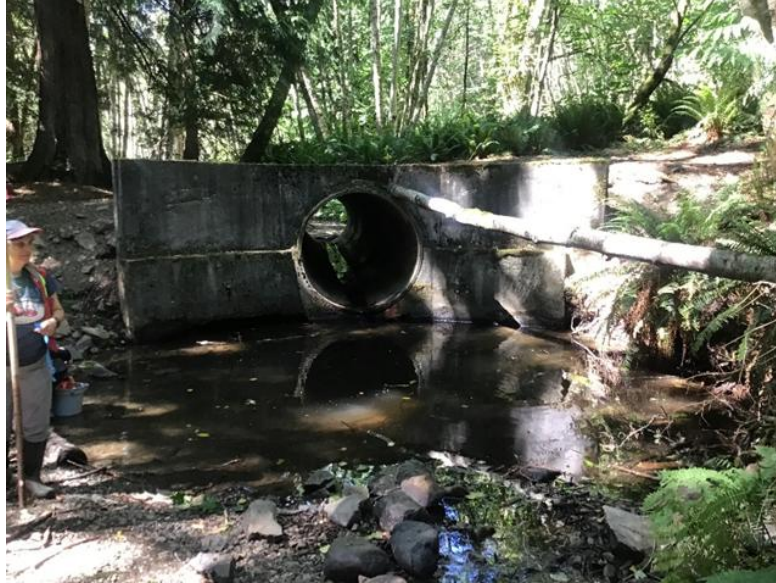
In lower Cottle Creek where residential urban land use dominates (reaches 2 and 3), the abundance of linear road networks intersecting the creek corridor, has caused site disruptions that limit fish movement, constrict flow patterns, and cause sediment deposition in the channel.

A total of five culverts (four impassable to fish), an old concrete dam, stormwater headwalls and rip rap installed to protect streambanks from erosion are commonly found here (Figure 8).

Figure 8. The 200 Linley Road culvert is impassable to fish and large organic material (barrier between Reaches 3 and 4).

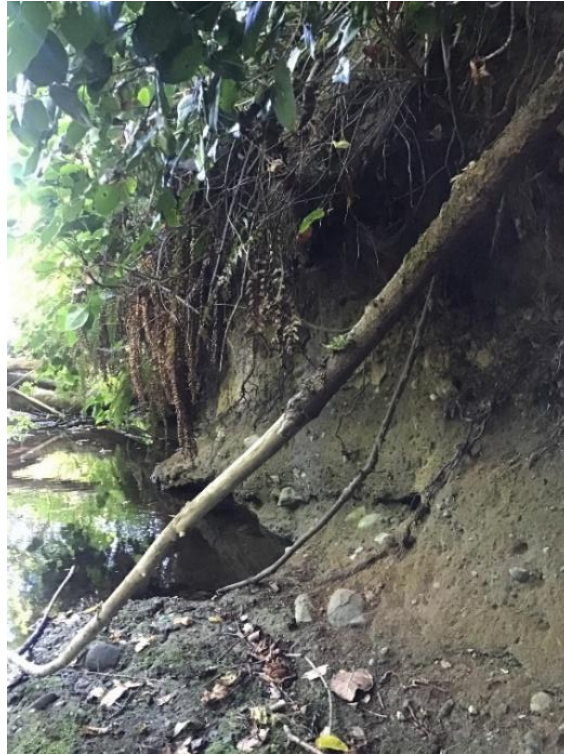
Multiple areas of channel downcutting and severe bank erosion were commonly observed in our survey (Figure 9). Channel bank erosion of mineral soil is a contributing factor to the sediments observed in the stream substrate. The majority of erosion-causing discharge occurs at streamflow levels above the mean annual discharge of 100 liters/second (Dumont, 2017). In a review of the hourly discharge on Cottle Creek from September 2024 to October 2025 we can see that discharges above the MAD are common for weeks at a time in the winter months (Figure 10).

Figure 9. Eroded bank and channel downcutting exposing the soil profile in Reach 3 of Cottle Creek.

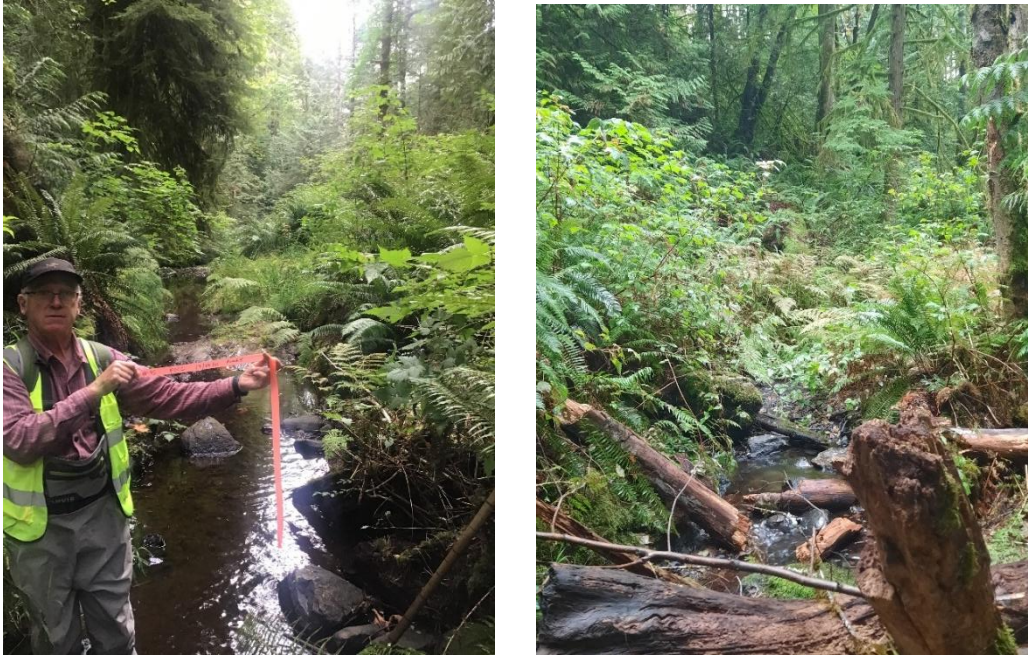
Reach 5 was used as a reference reach within the watershed, as the riparian zone was in a generally undisturbed condition. The reach appeared to have mostly recovered from, or been buffered from the direct effects of historical logging, likely due to running in a deep ravine that is unfavourable to human access. A vigorous understory dominated by salal (*Gaultheria shallon*) and sword fern (*Polystichum munitum*) now provide year-round shade and overhanging vegetation to the stream. A multi-layered canopy of coastal douglas fir, red cedar, and bigleaf maple trees (Figure 11) also provide year-round shade. LWD recruitment processes appeared intact in the reach, with multiple stable LWD structures observed. Invasive plant cover was minimal, except for individual English holly trees randomly distributed throughout the reach.

Figure 11. Cottle Creek Reach 5 riparian vegetation structure and condition.

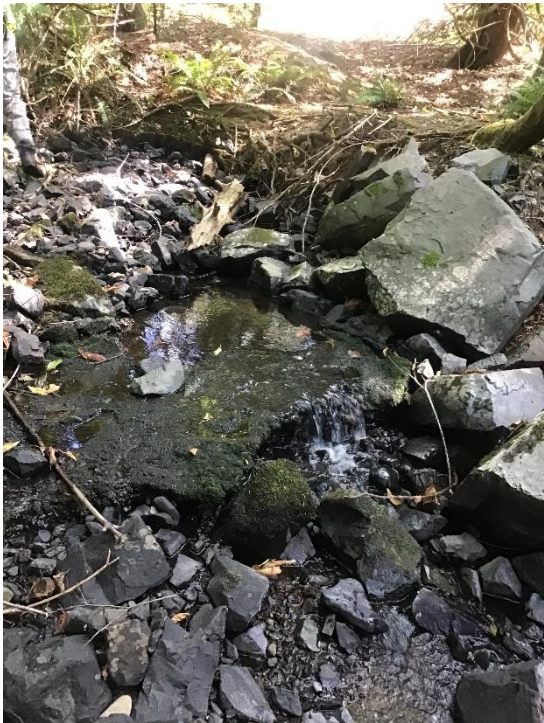
The riparian forest in reaches 2 and 3 have been replaced with grass lawns, walking trails, and bank armouring (Figure 12). This has precluded the growth of native riparian vegetation along the banks of the creek. Invasive plant species such as Himalayan blackberry and English ivy (*Hedera helix*) have established in these disturbed areas, which has interrupted LWD recruitment, deep-rooted vegetation development, canopy shade, and overhanging bank vegetation for the stream.

Figure 12. Boulders used for bank armoring in Reach 2 of Cottle Creek within Stephenson Point Park.

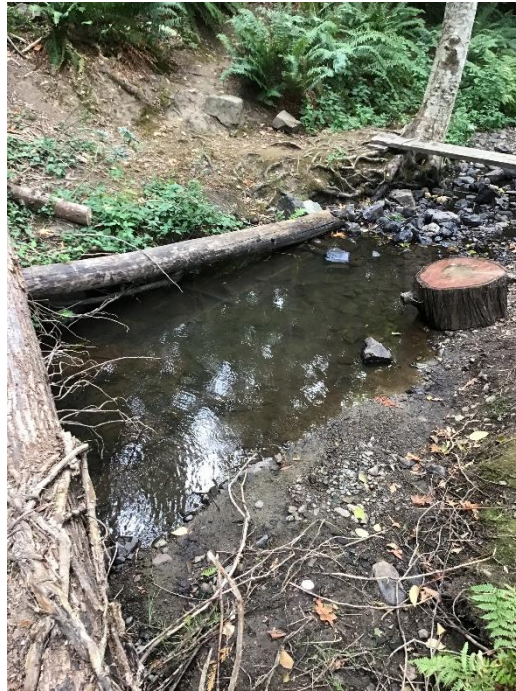
Reaches two, four and five have walking trails through the riparian zone. Trail users and their pets have blazed informal side trails that access the creek from the designated trails. In these areas understory vegetation has been trampled and eroded to bare soil (Figure 13), and invasive plants were more common. This access has suppressed the establishment of native riparian understory vegetation, and provides a direct link for surface runoff to carry erodible soils into the stream.

Figure 13. Bare soil on stream banks in Reach 2 due to access from walking trails.
