DEVELOPMENT PERMIT NO. DP000856

4171 JINGLE POT ROAD

Nanaimo, British Columbia
Landscape
Restoration Plan

Re: 4171 Jingle Pot Road, Watercourse Restoration / Riparian Area

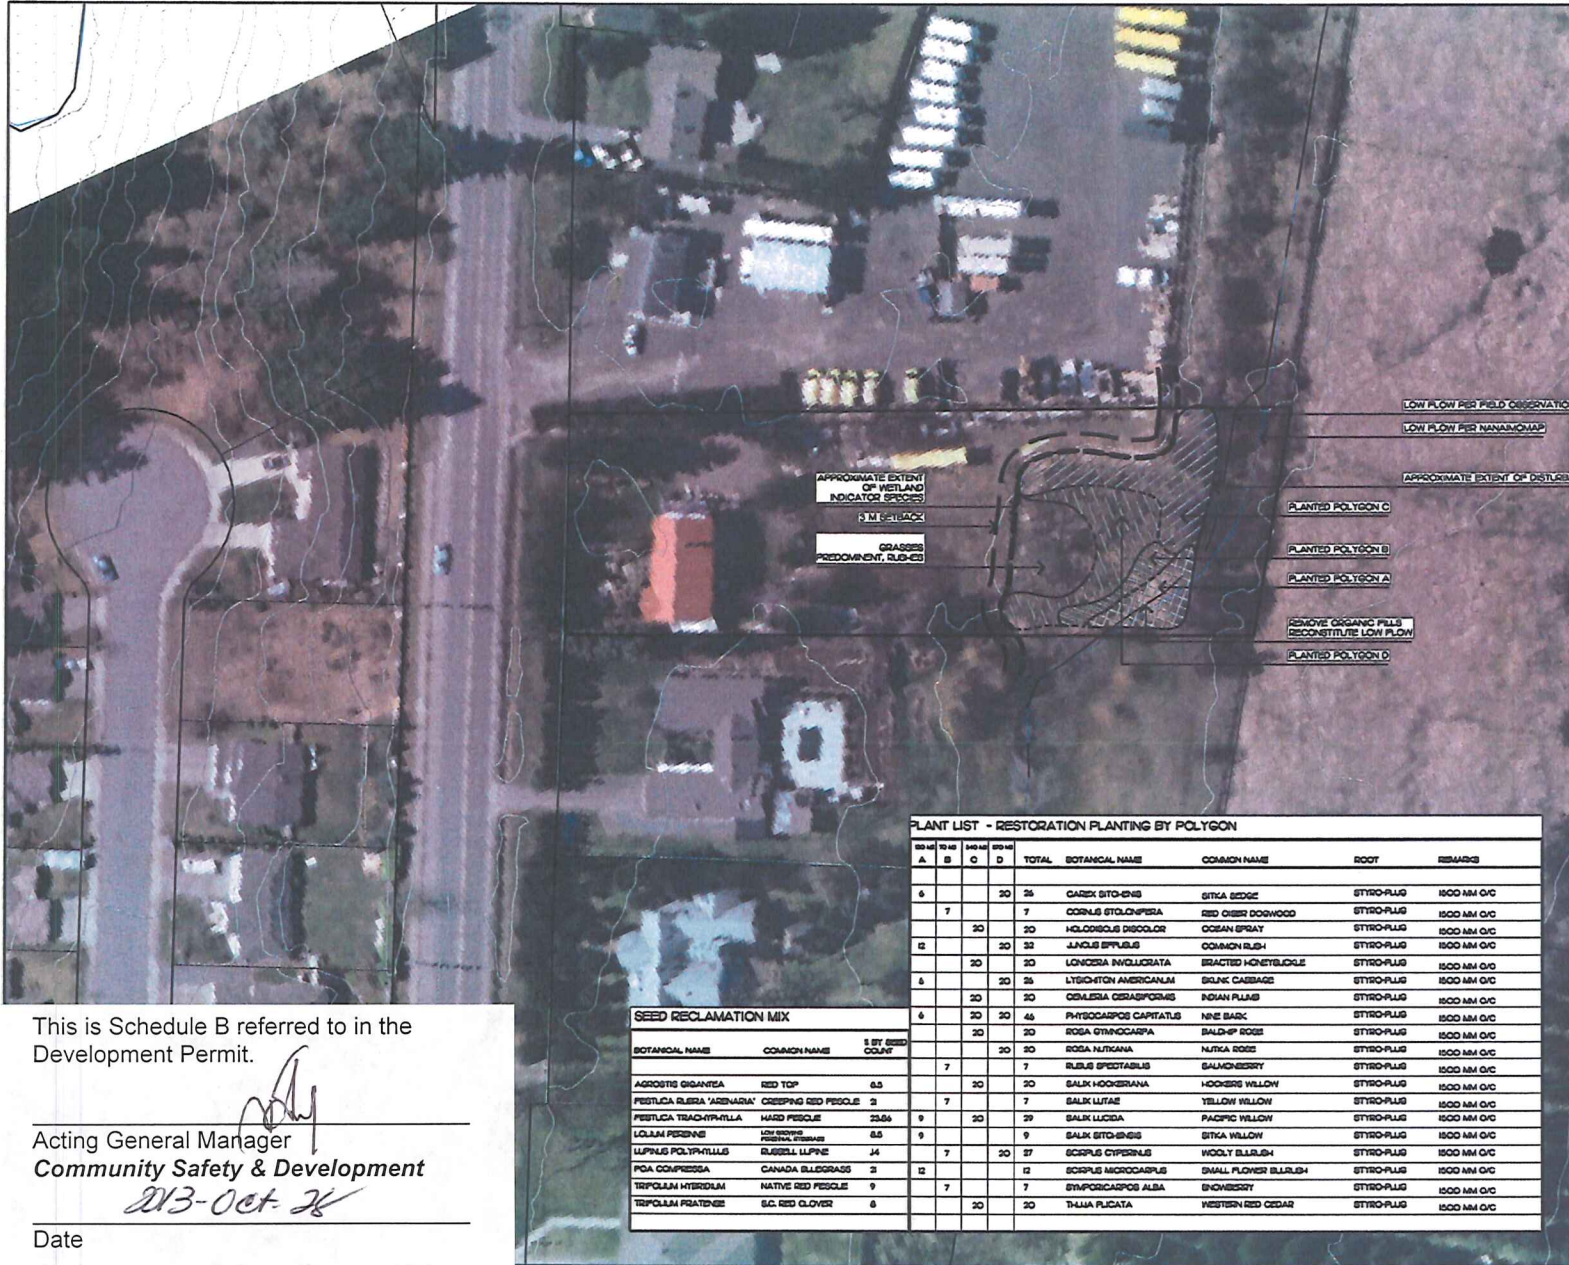
L1.2

PLANT LIST - RESTORATION PLANTING BY POLYGON

We have prepared a landscape remediation plan that will accomplish several objectives, including the reinstatement of the baseline flow pattern, and the replanting of the disturbed area with a diverse range of native plant species. The species are arranged in four polygons with a variation of species selection and distribution for each polygon.

Polygon "A" is about 130m² in area and is intended to repopulate the lower flow area reconnecting the existing watercourse broken by disturbance.

Polygon "B", as the watercourse edge will help define the newly constituted edge.

Polygon "C" is largest area of about 340m² and as located as the higher of the four zones may support Western Red Cedar, for example.

Polygon "D" is an area previously populated by aggressive grasses, interspersed with a limited population of rushes.

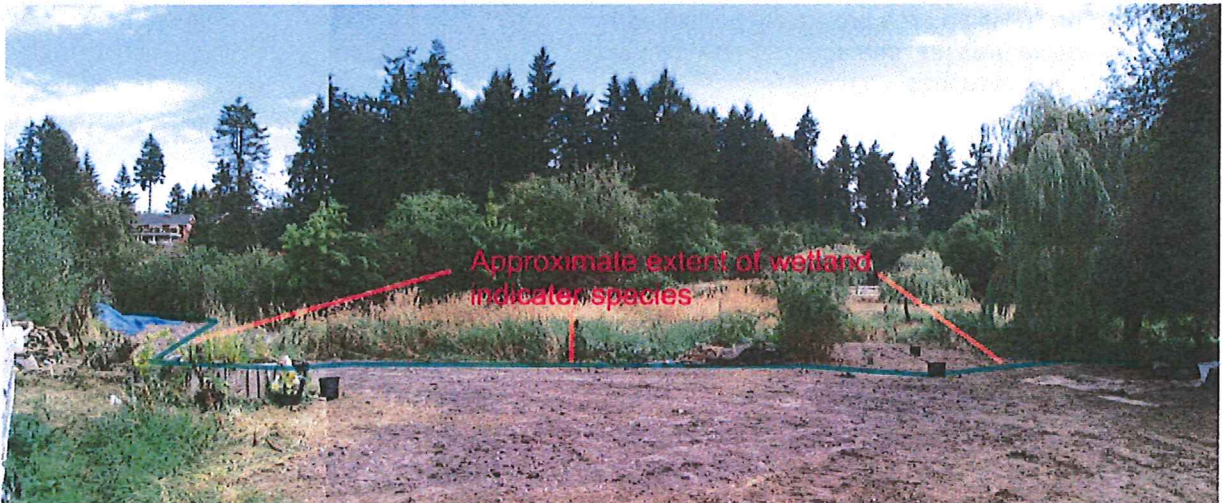
We have visited the site on several occasions during the latter part of August to assess and to document the approximate extent of riparian indicator species together with the approximate extent of physical disturbance. We note that a recent assessment prepared for the abutting property immediately downstream by Streamline Environmental Consulting Ltd. forms a reasonable documentation of baseline of conditions prior to disturbance and did not defined the riparian area as a stream under the Riparian Areas Regulation This area is however, subject to development restrictions and requires that Aquatic Development Permit be obtained.
