DEVELOPMENT PERMIT NO. DP000884

850/870 JACKSON ROAD

DUKE POINT TERMINAL
UPLANDS ENGINEERING - PHASE 2A
LANDSCAPE PLAN

Subject: Duke Point Marine Terminal Modification - Vegetation Assessment, including
Options for Invasive Species Management and Restoration

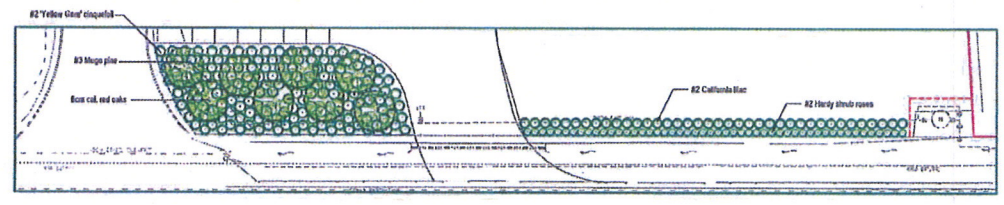
Jackson Rd Frontage Landscape 1:200

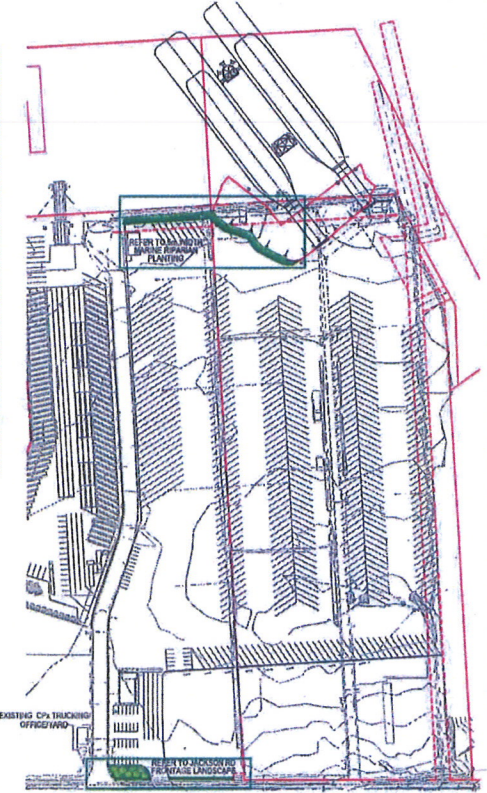
Landscape General Arrangement 1:1500

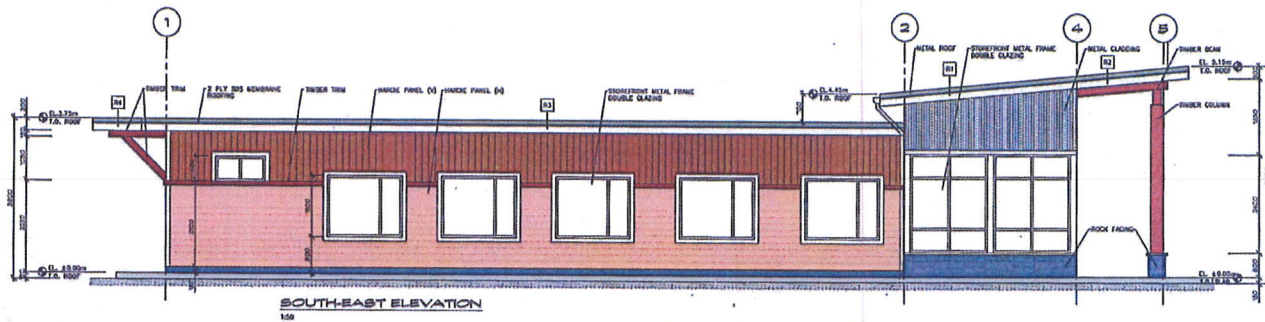
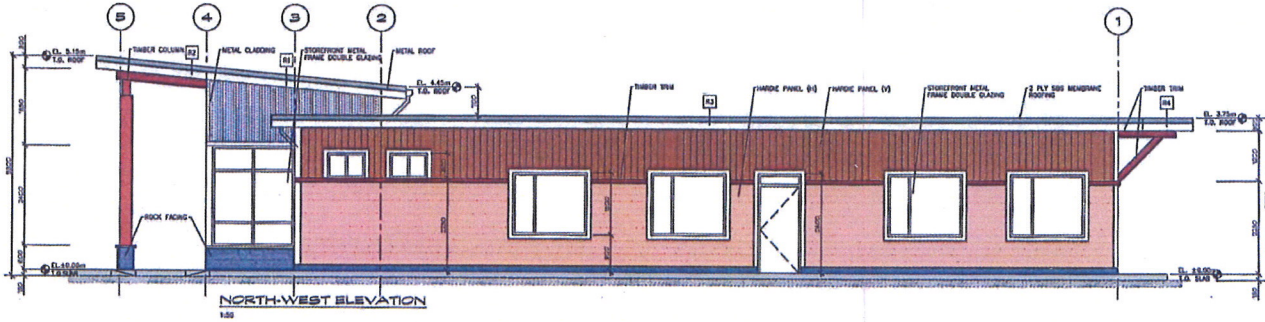
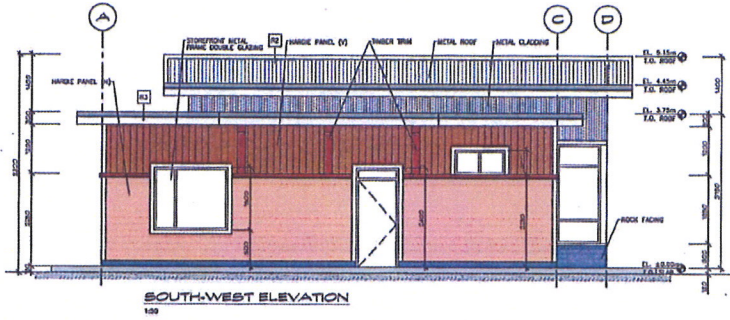
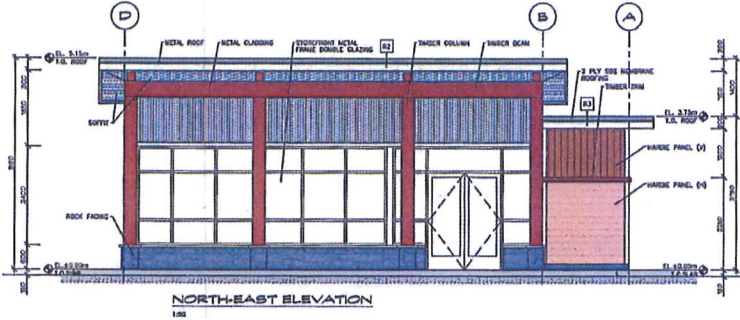
OFFICE BUILDING ELEVATIONS

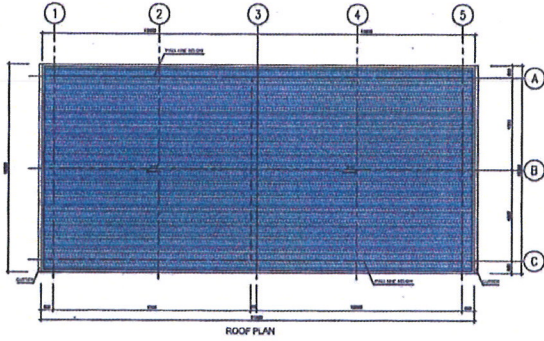
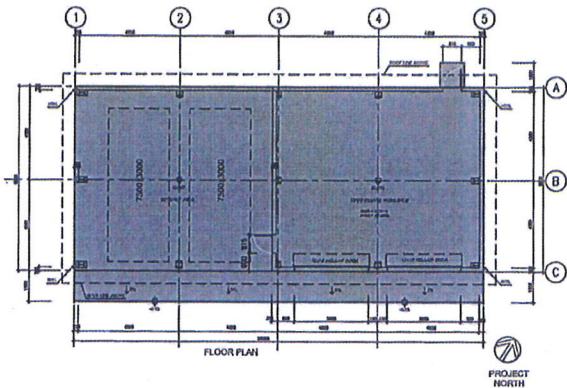
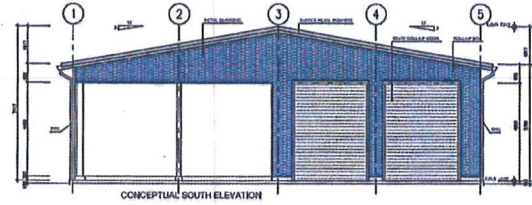
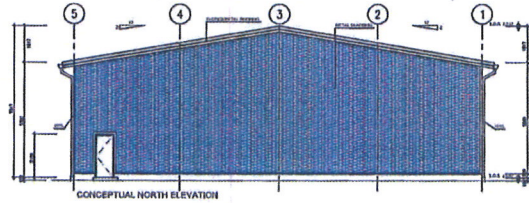
MAINTENANCE WORK SHOP PLANS/ELEVATIONS	
DESIGNED BY	ENGINEER'S SEAL
CHECKED BY	
DRAWN BY	
DATE	
PROJECT NO.	CLIENT DRAWING NO.
SCALE	FOLIUM NO.
DATE SHOWN	NO. OF SHEETS
SCALE	REVISION
A2.5	3

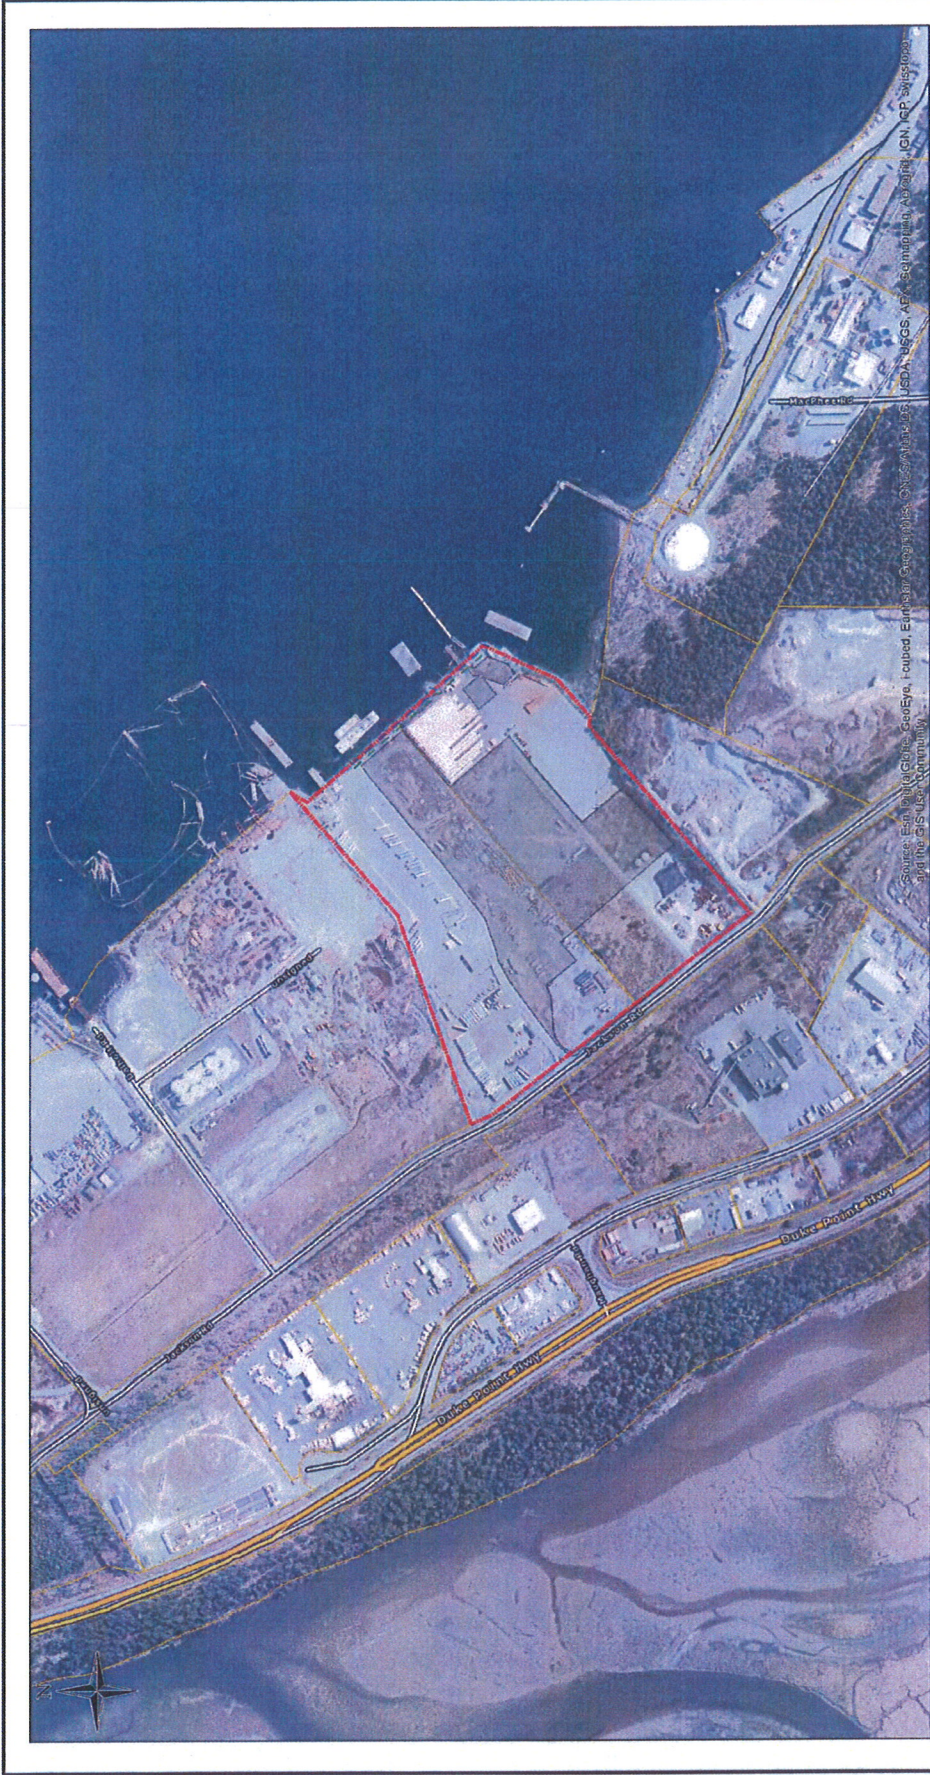
BY: LH	SCALE: 1:5,000	DATE: 2014/11/03	REV: 0
CHG: AP	PROJECT CODE: 075	PROJ CODE: 075_MAD 1883 LUTM Zone 10N	REV: 0
			614819-001

**Duke Point Vegetation Assessment
Site Layout**

The Project area has a long history of industrial activity. The Project is located on two industrial lots (Lots 850 and 870, zoned Industrial 4), both of which have been previously developed (in 2006 and 2000, respectively) for marine transfer operations, and include marine terminal, launch facility, storage containers, trailers, lay-down areas, access roads, parking lots and utility servicing (Drawing 614819-001).

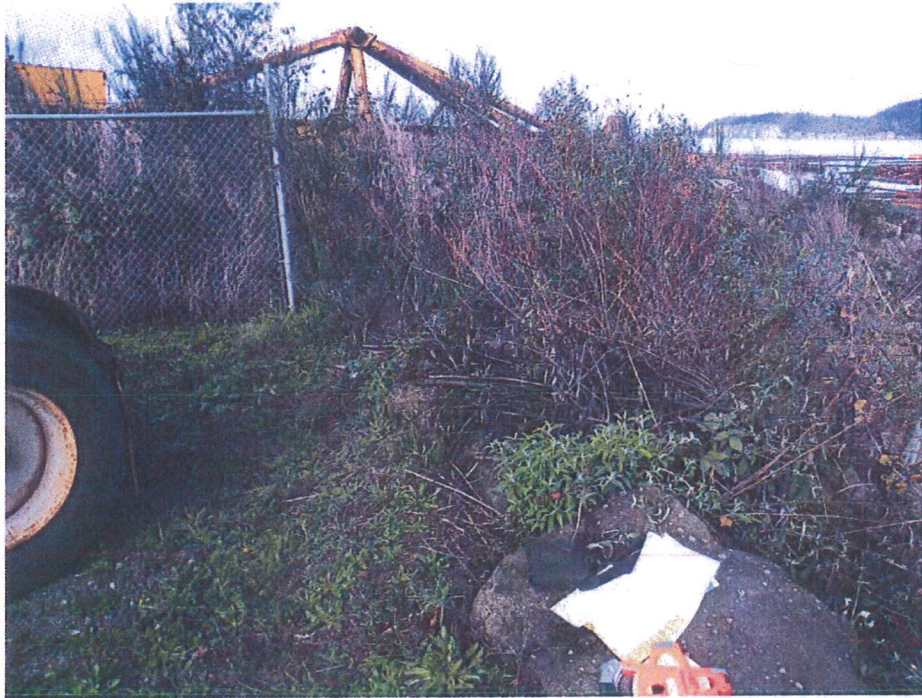
Photograph 1: Vegetation plot AP1, east side facing northwest (NW).

- Plot AP1 was established in a small patch of shrub-herb vegetation on the west side of the Project site boundary, including a small vegetated strip on the neighbouring property (log sort).
- Plot AP2 was near the centre of the Project site, in a 45 m long patch of vegetation consisting of small (shrub size) trees (below 10 m in height), shrubs and herbs east of the proposed terminal, adjacent to a paved parking lot.
- Plot AP3 was on the east side of the Project site, next to a concrete ramp, in an approximately 35 m long shrub-herb dominated area.

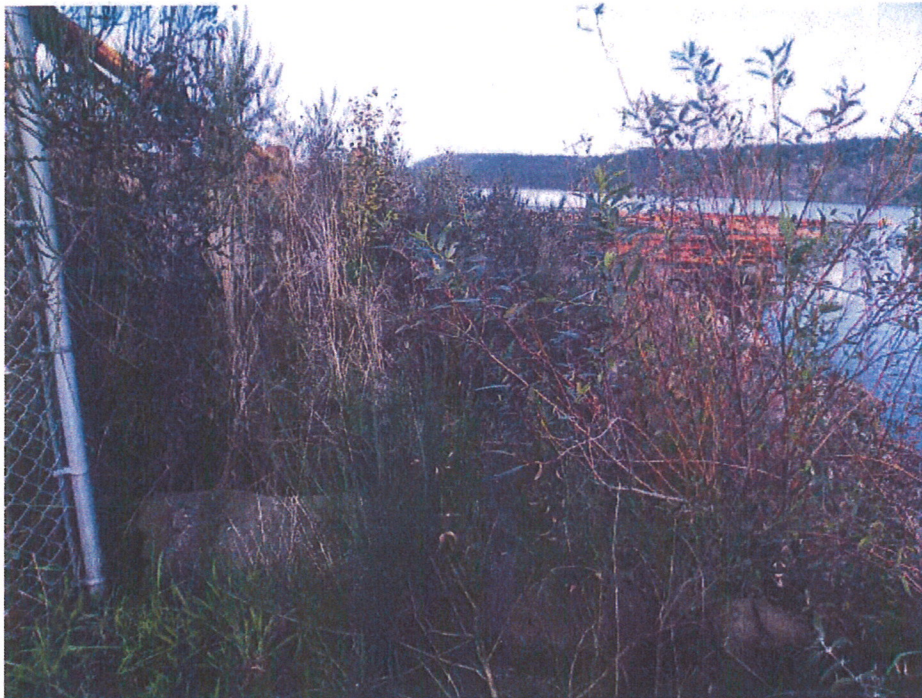
Photograph 2: Shrub vegetation on plot AP1 is dominated by scotch broom.

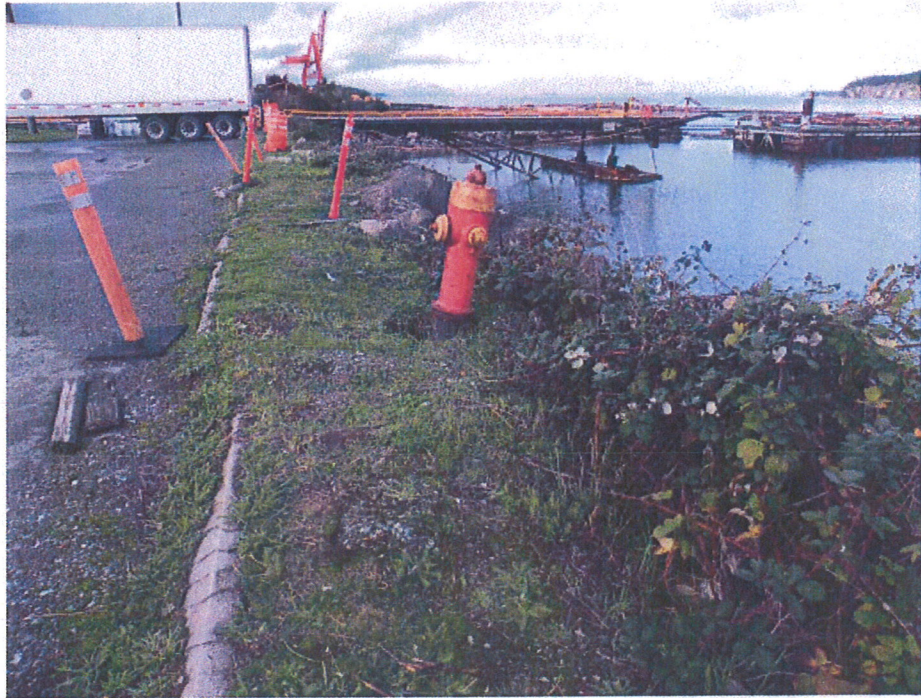
Photograph 3: Sparse vegetation between plot AP1 and AP2, near west corner of proposed parking lot, facing northwest. Himalayan blackberry dominant throughout.

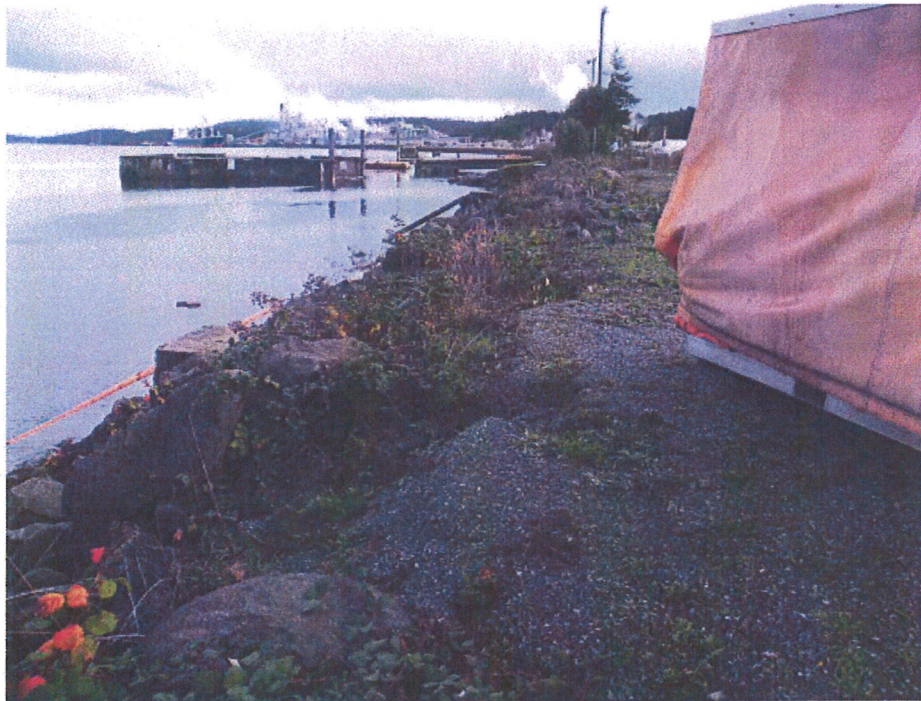
Photograph 4: Sparse vegetation between plot AP1 and AP2, near west corner of proposed parking lot, facing southeast. Note low growing Himalayan blackberry.

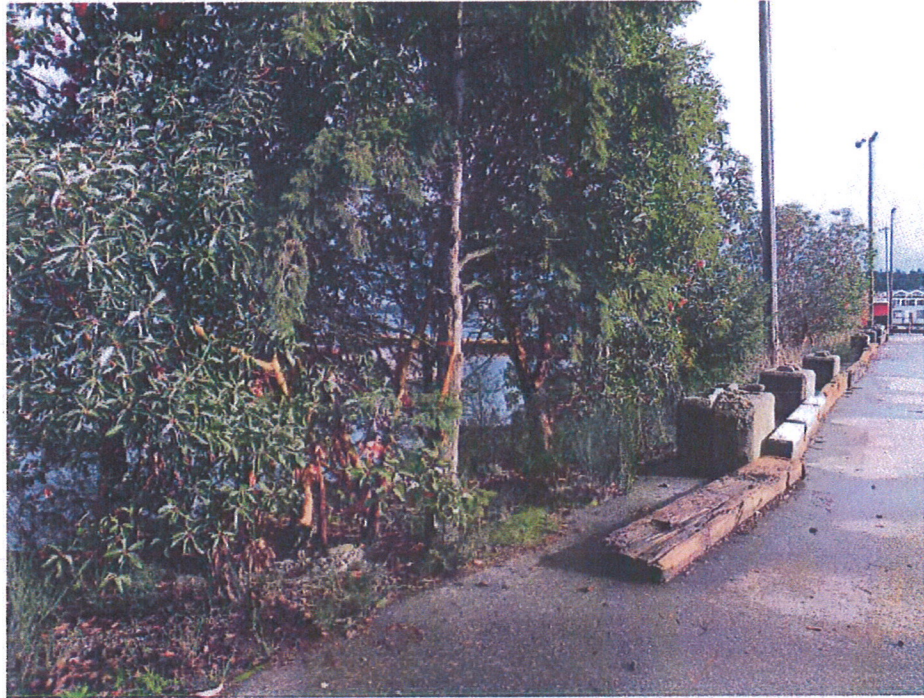
Photograph 5: Vegetation plot AP2, west side facing southeast.

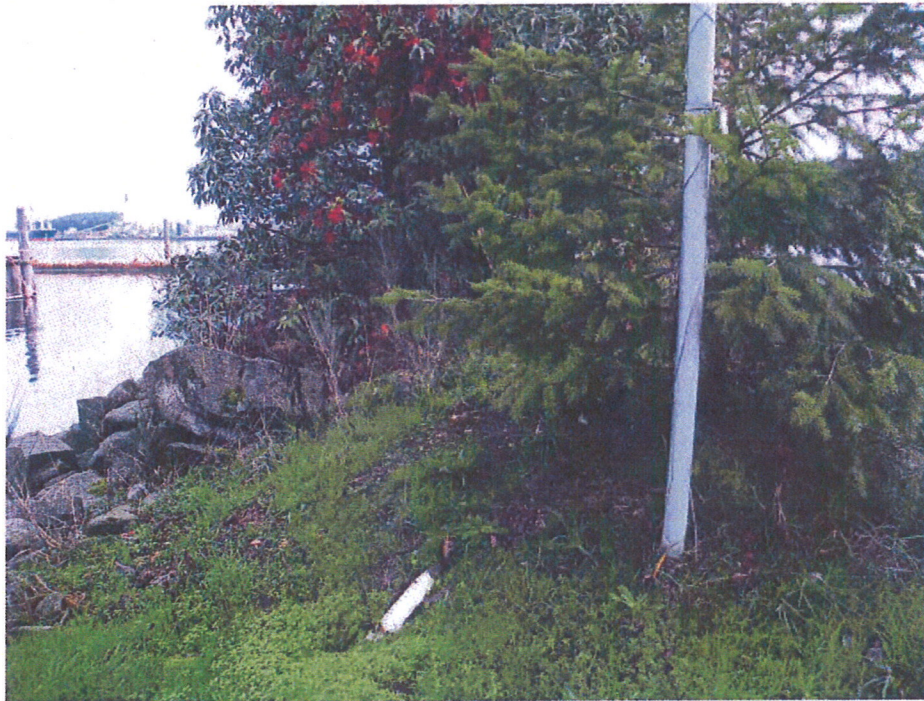
Photograph 6: Shrub and herb vegetation in riparian setback of plot AP2 (west side).

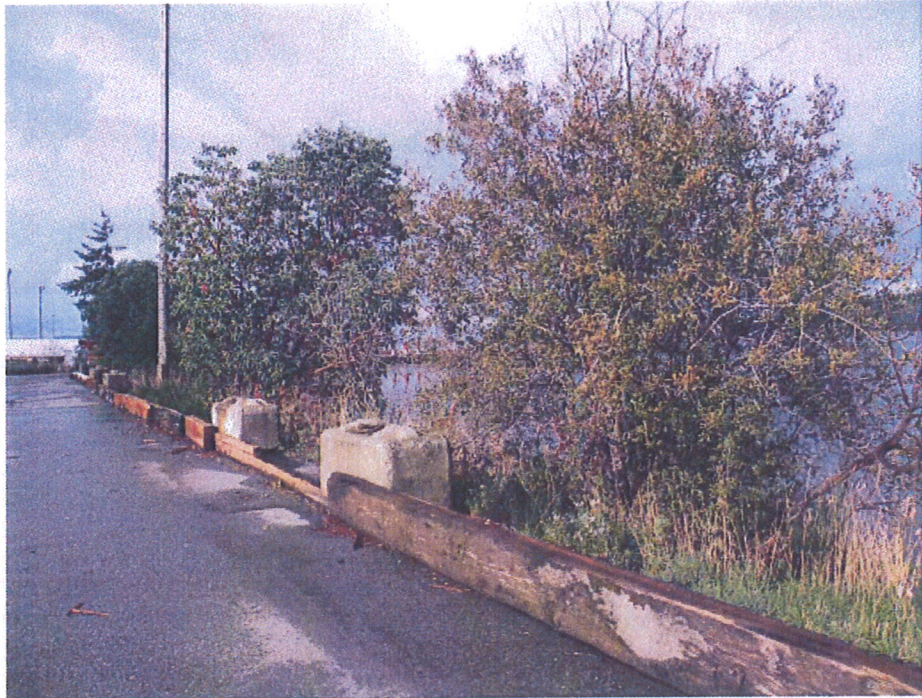
Photograph 7: Vegetation plot AP2, east side facing northwest.

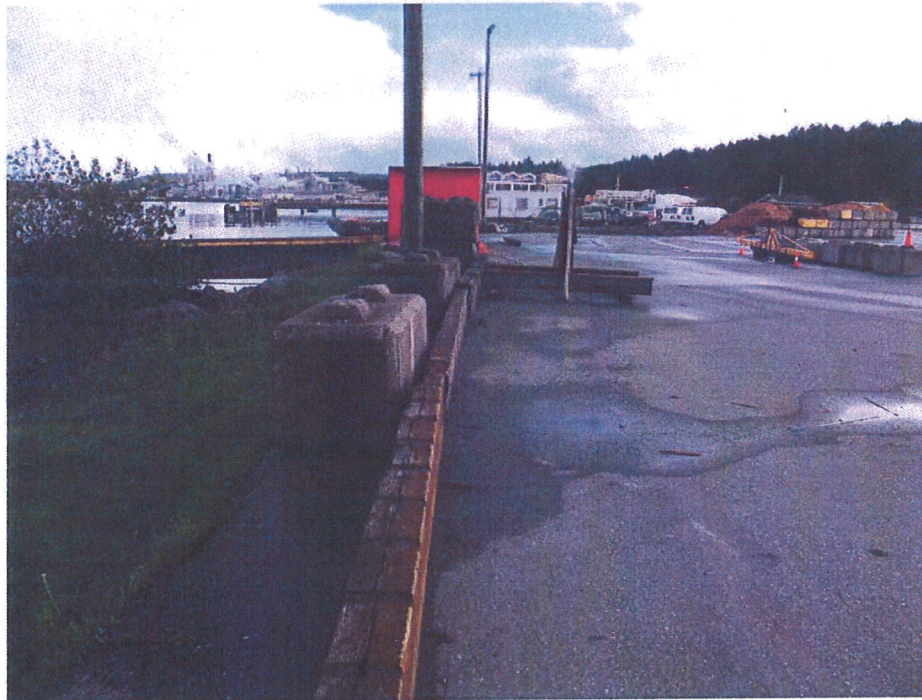
Photograph 8: Sparse vegetation between plot AP2 and AP3 on east side of Project site, facing southeast.

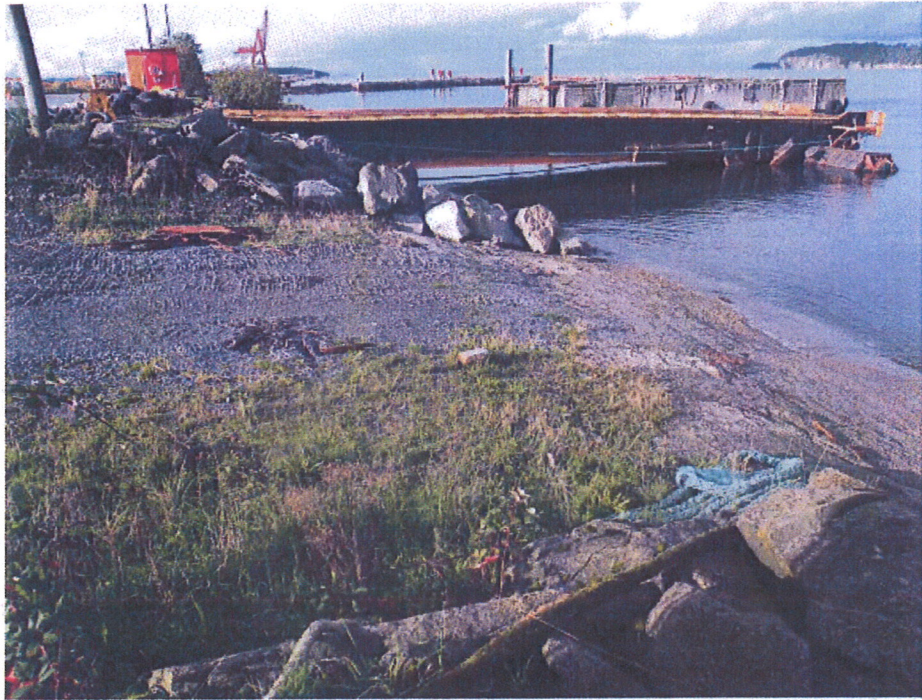
Photograph 9: Sparse vegetation between plot AP2 and AP3, east of ramp and launch facilities, facing northwest.

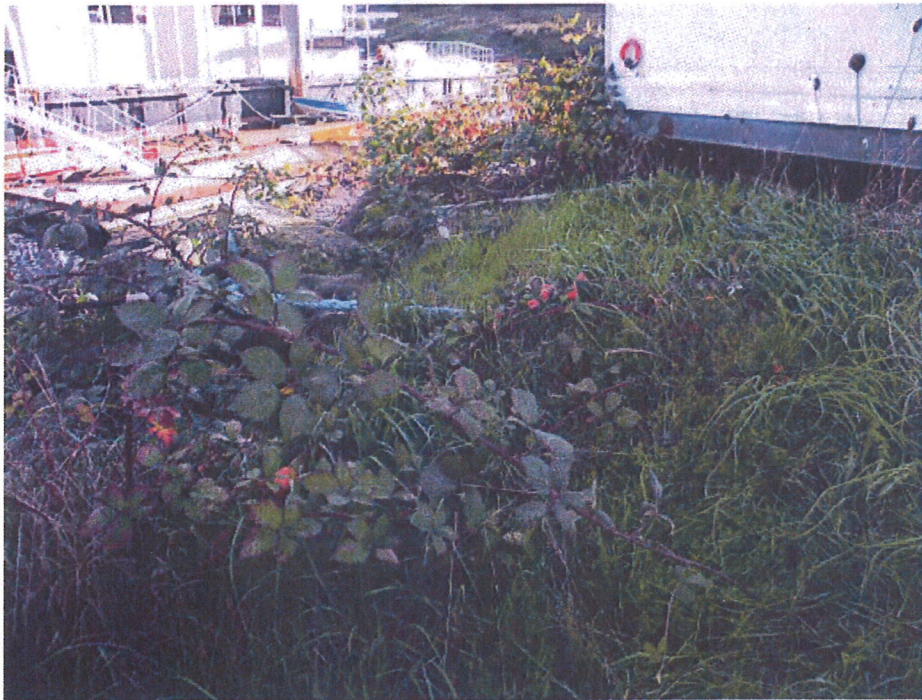
Photograph 10: Vegetation east of ramp and launch facilities, at east corner of property, facing southeast. Himalayan blackberry and grasses dominate.

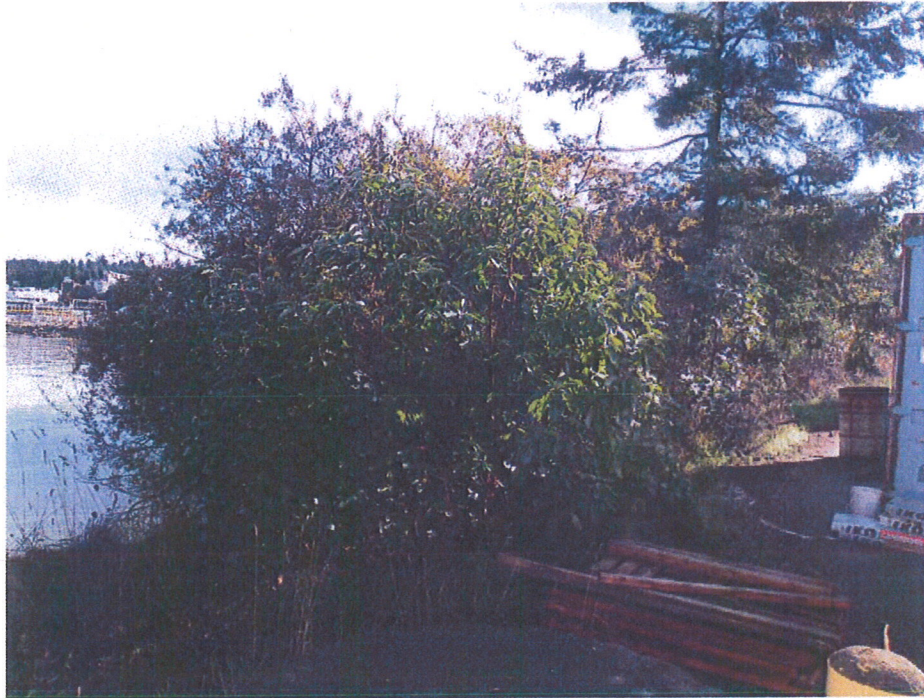
Photograph 11: Vegetation plot AP3, north side facing south.

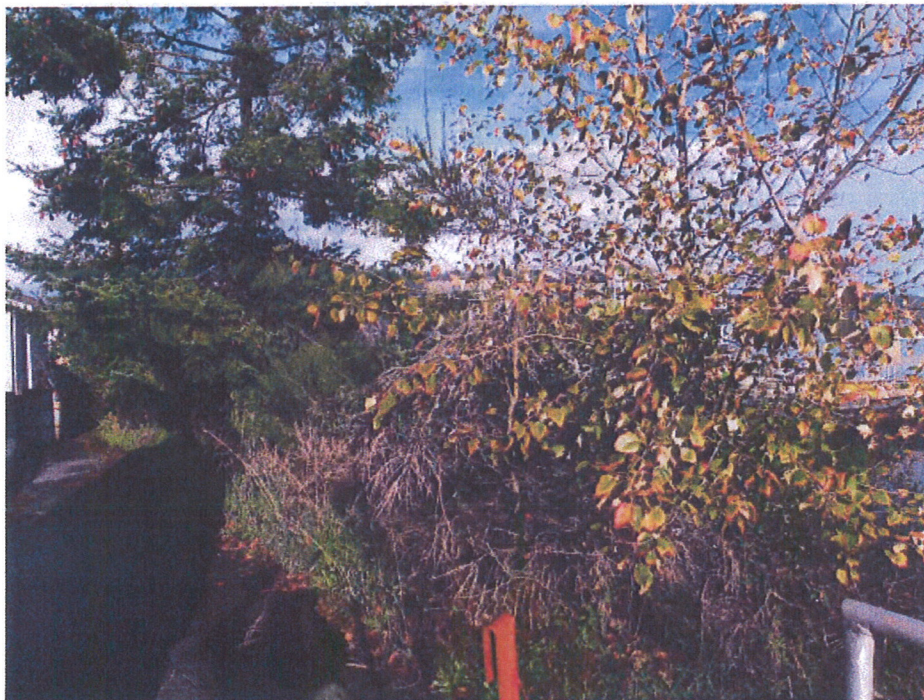
Photograph 12: Vegetation plot AP3, south side facing north.

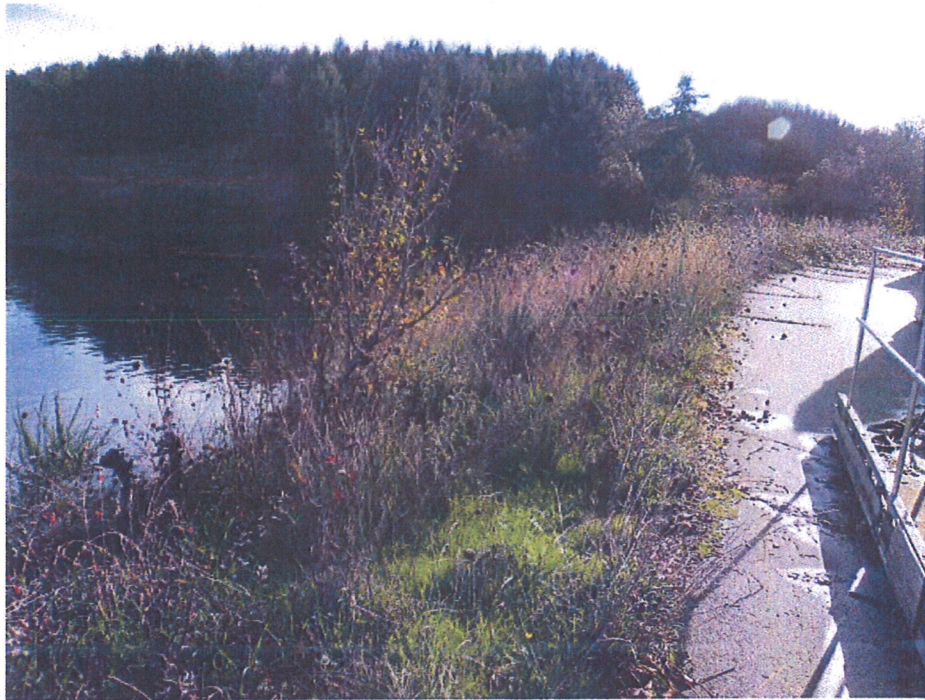
Photograph 13: Herb dominated riparian area south of plot AP3, facing south.
