DEVELOPMENT PERMIT NO. DP001014

1019 VANCOUVER AVENUE
Civic Address

EXECUTIVE SUMMARY

WATER FEATURES ASSESSMENT

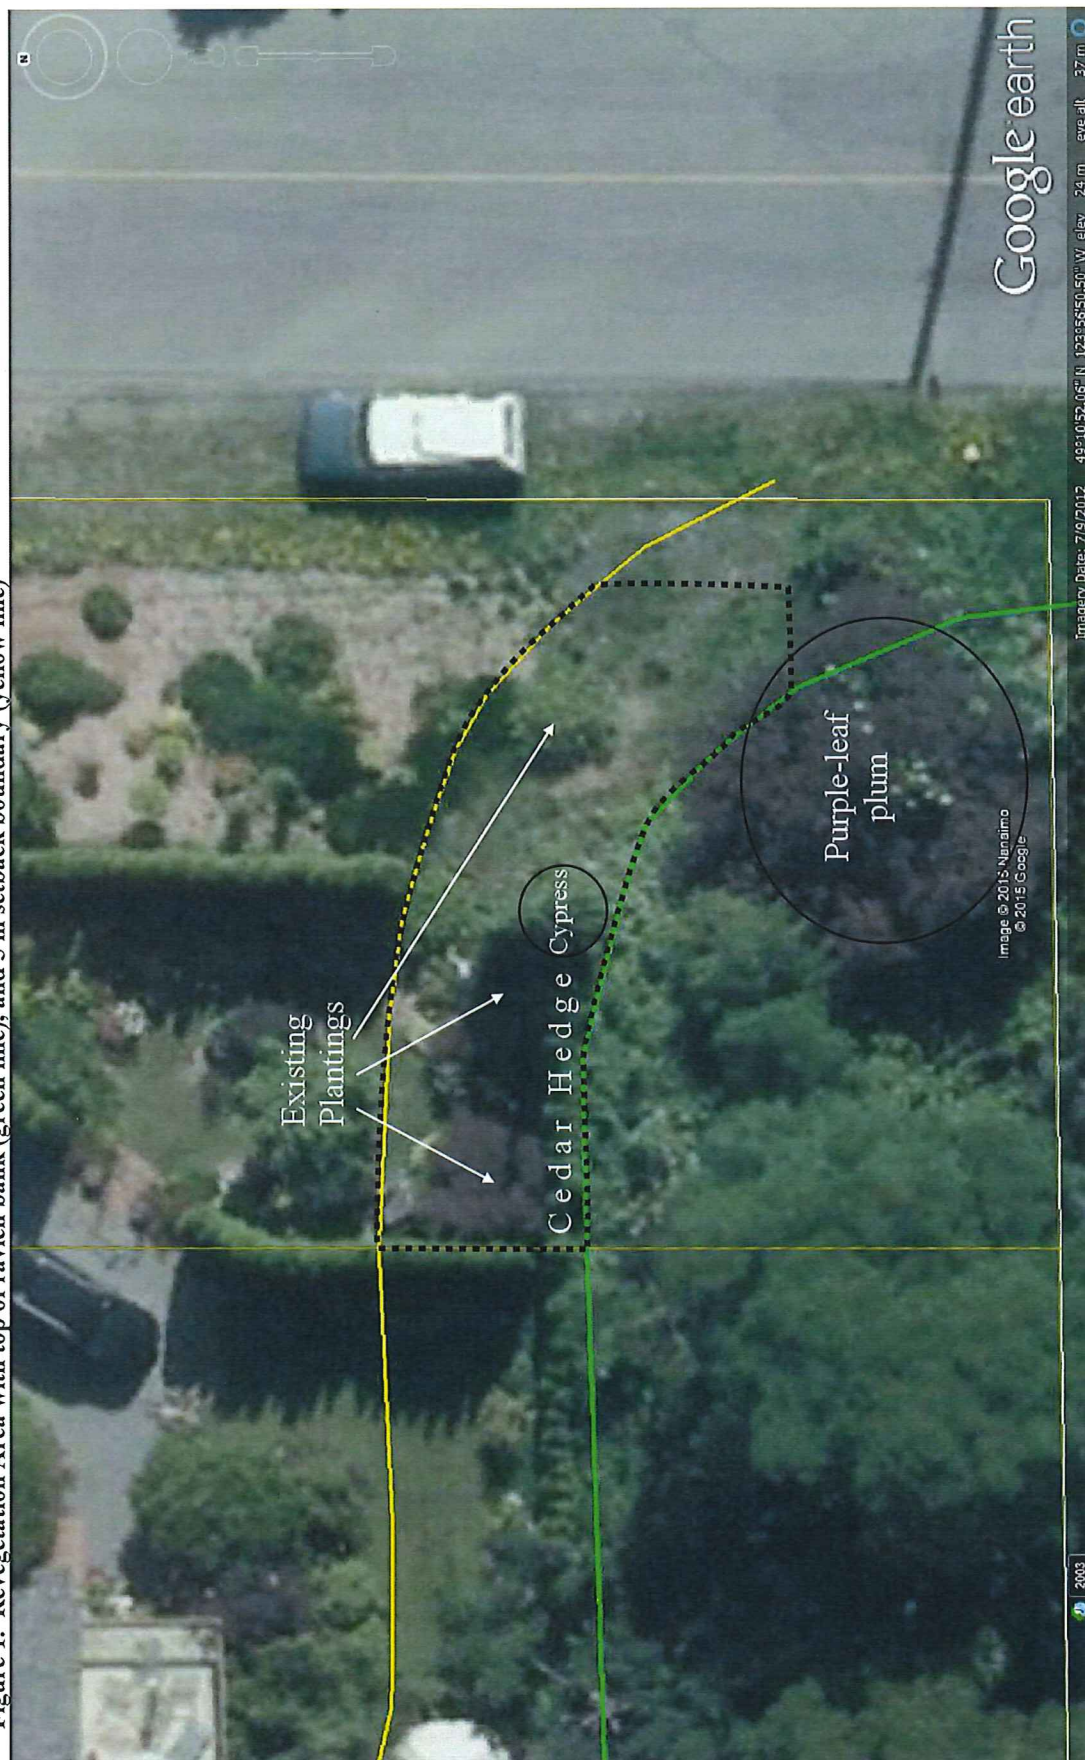
Figure 1. Revegetation Area with top of ravine bank (green line), and 5 m setback boundary (yellow line)

In order to fulfill this requirement I offer the following re-vegetation plan for the 5.0m setback from top of ravine bank on the subject property. The 5.0m setback area is already vegetated with a mix of nursery variety small tree, shrub, and herb plantings contained within a rectangular courtyard area bordered by a cedar hedge, as well as along the slope fronting Vancouver Avenue. These existing plantings will be incorporated into the re-vegetation plan and augmented with native plant species. In order to allow more sunlight into the planting area the line of cedar hedging running along the top of ravine bank on the subject property will need to be removed. I would also recommend removal of the purple-leaf plum tree and the Leyland cypress (Figure 1).

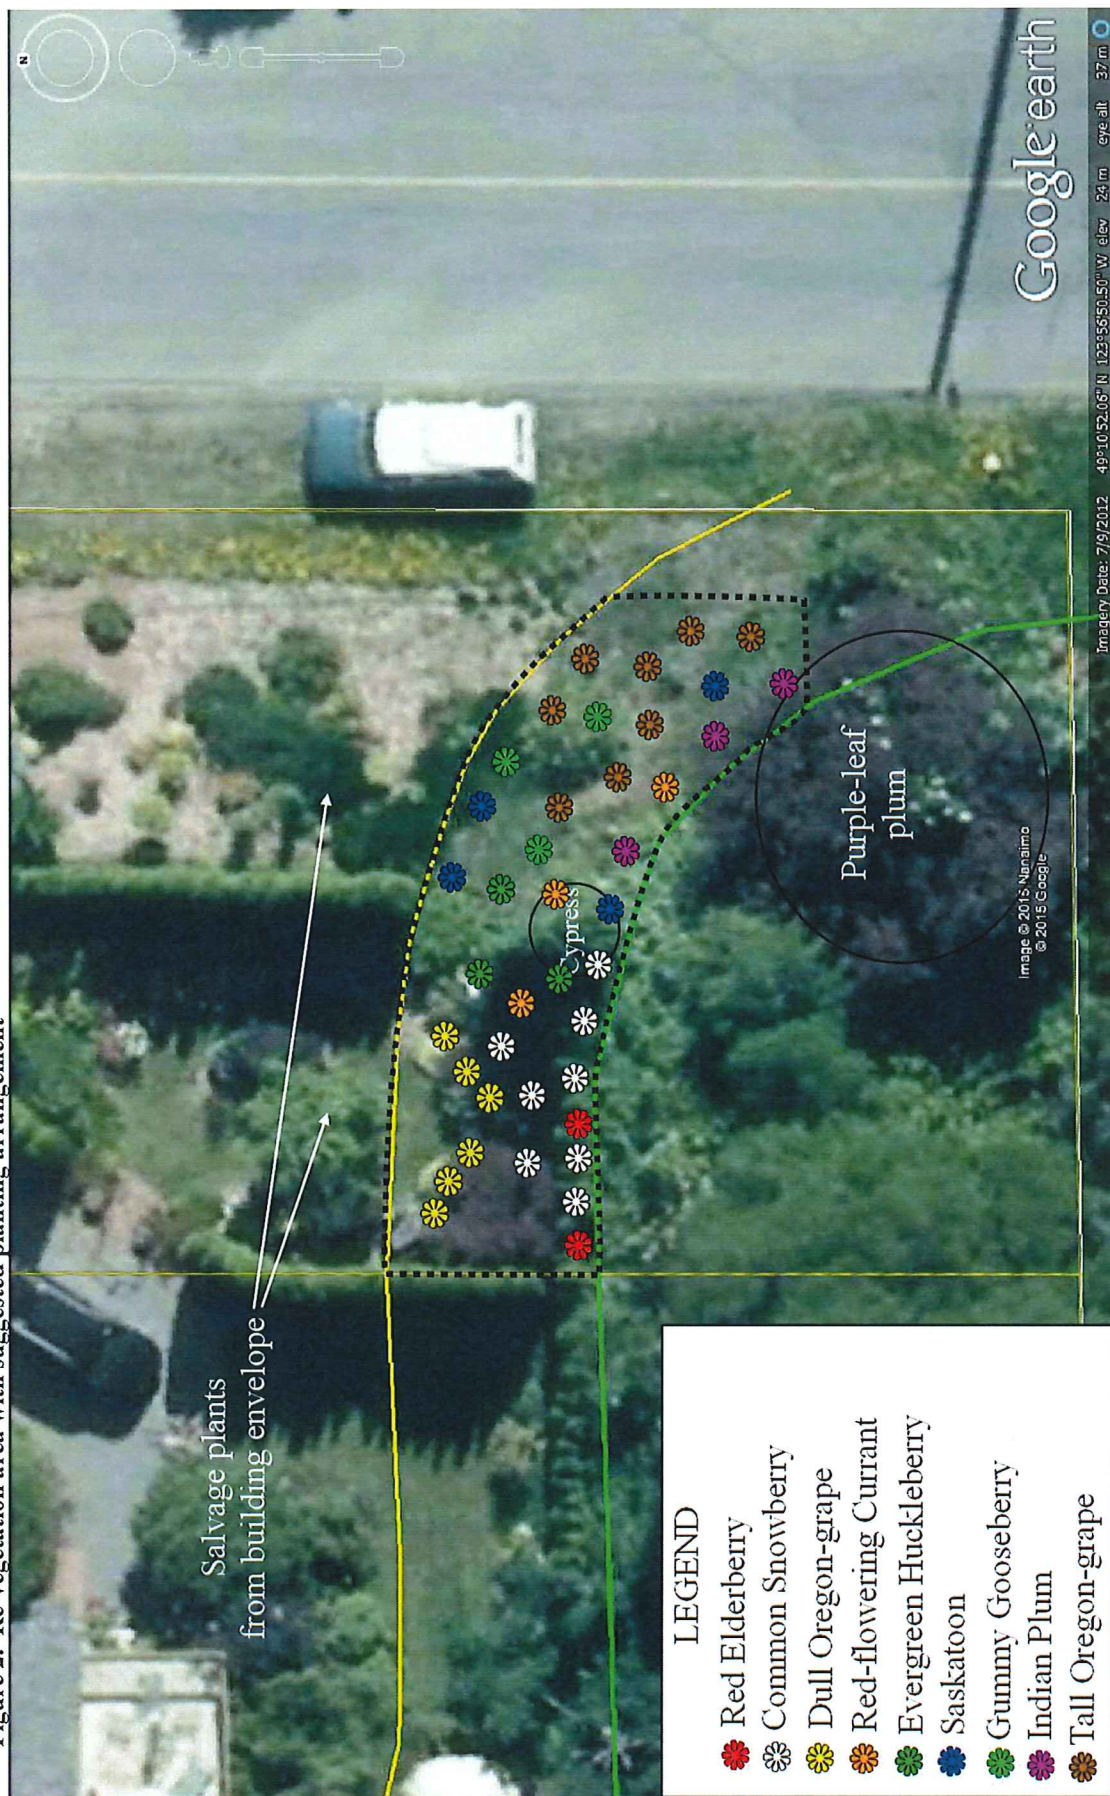
Figure 2. Re-vegetation area with suggested planting arrangement

The proposed re-vegetation area is approximately 80m² in size. Existing nursery plants occupy approximately 50% of the re-vegetation area, leaving approximately 40 m² for re-vegetation with native species. At a planting density of 1 shrub per 1 square metre there is room for 40 plantings. Recommended plantings are indicated in Table 1, below and shown on Figure 2.

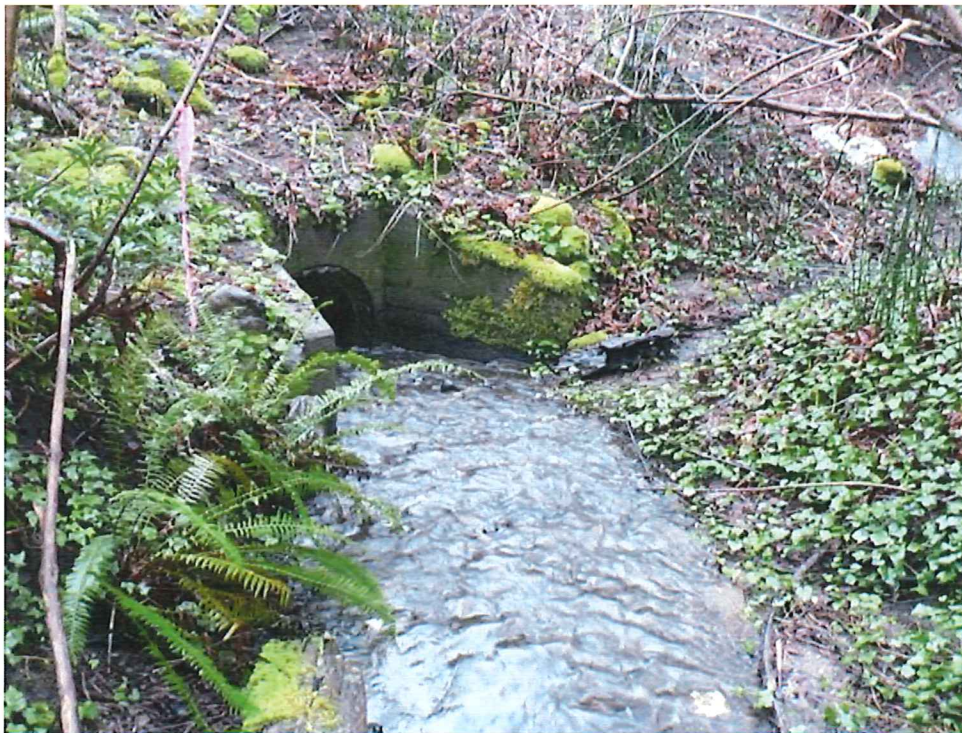
Photograph 1. View of St. George's Creek at culvert inlet at Vancouver Avenue.

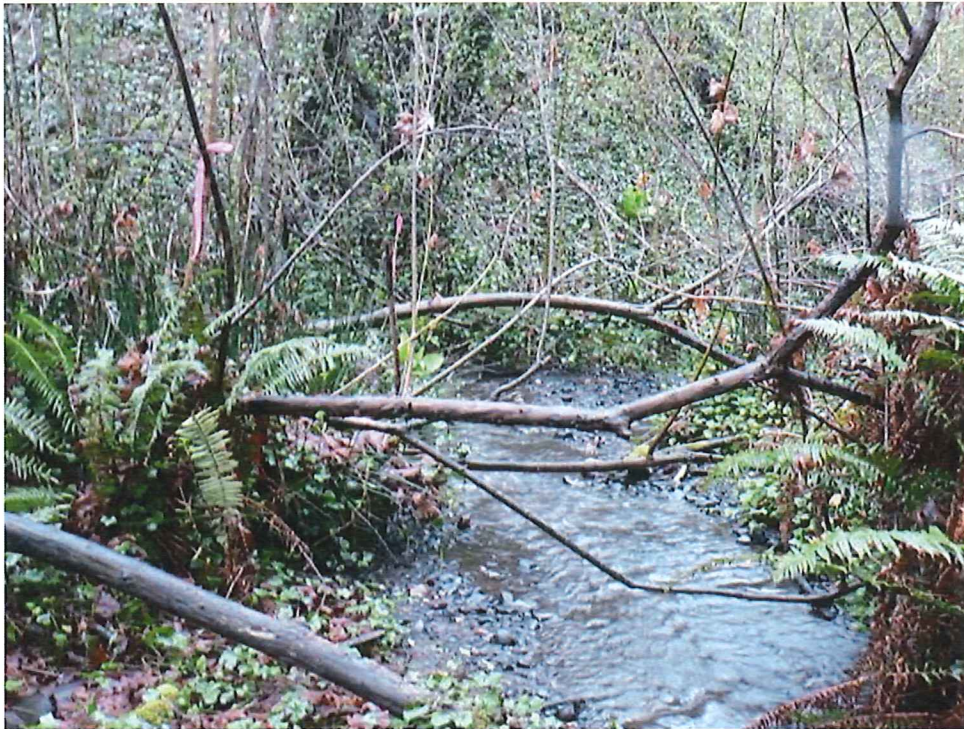
Photograph 2. View downstream on St. George's Creek.

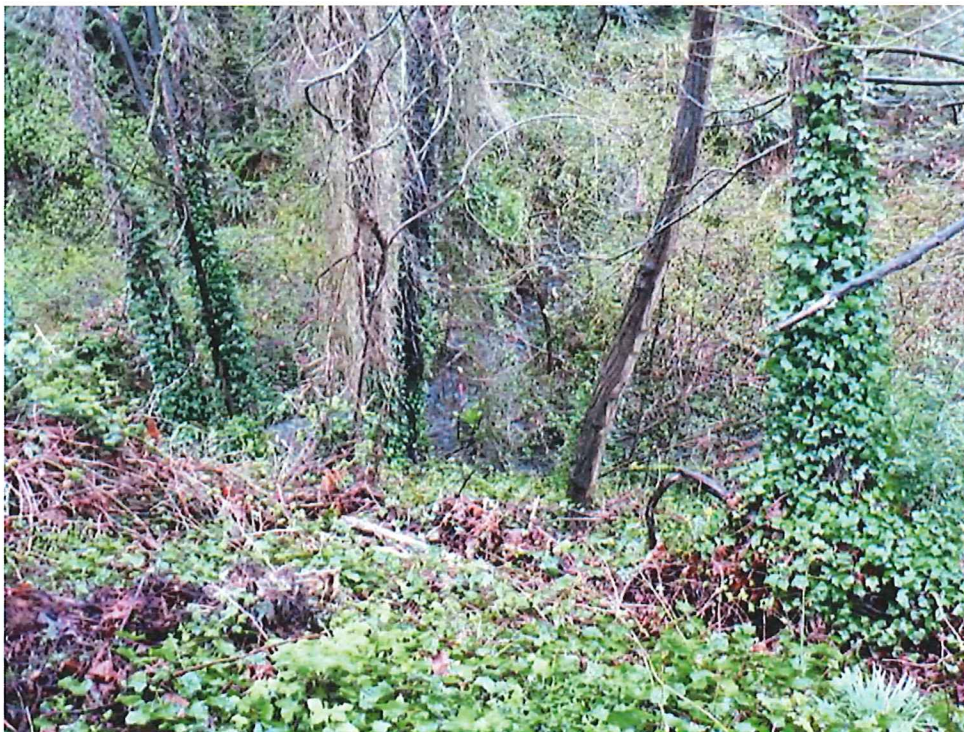
Photograph 3. View from top of ravine bank to St. George's Creek.

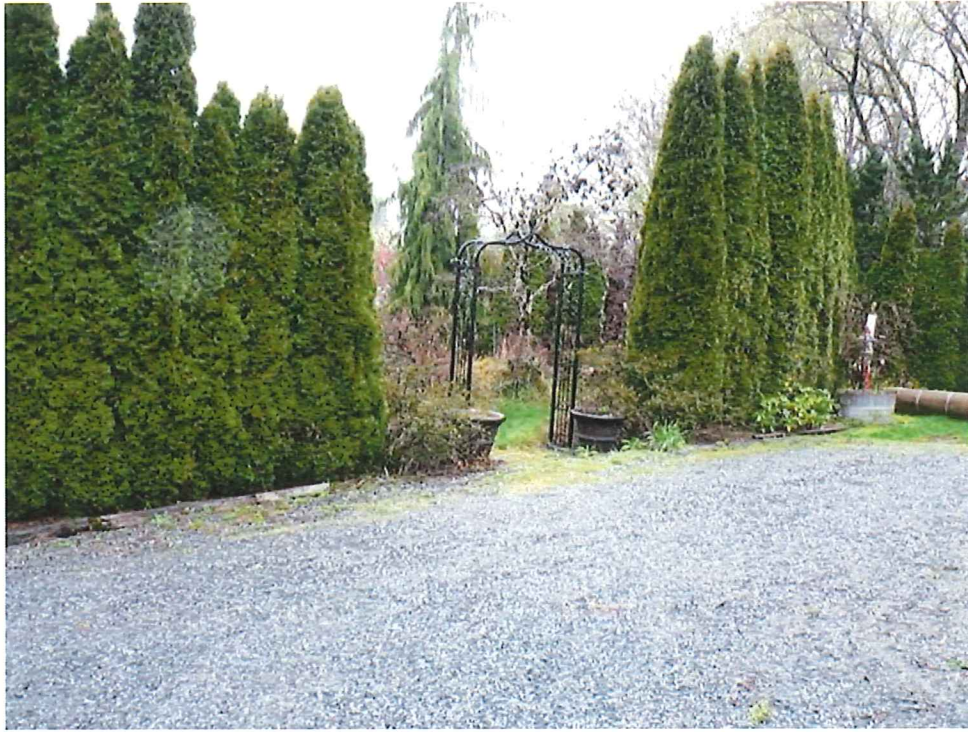
View from existing driveway to proposed building envelope.

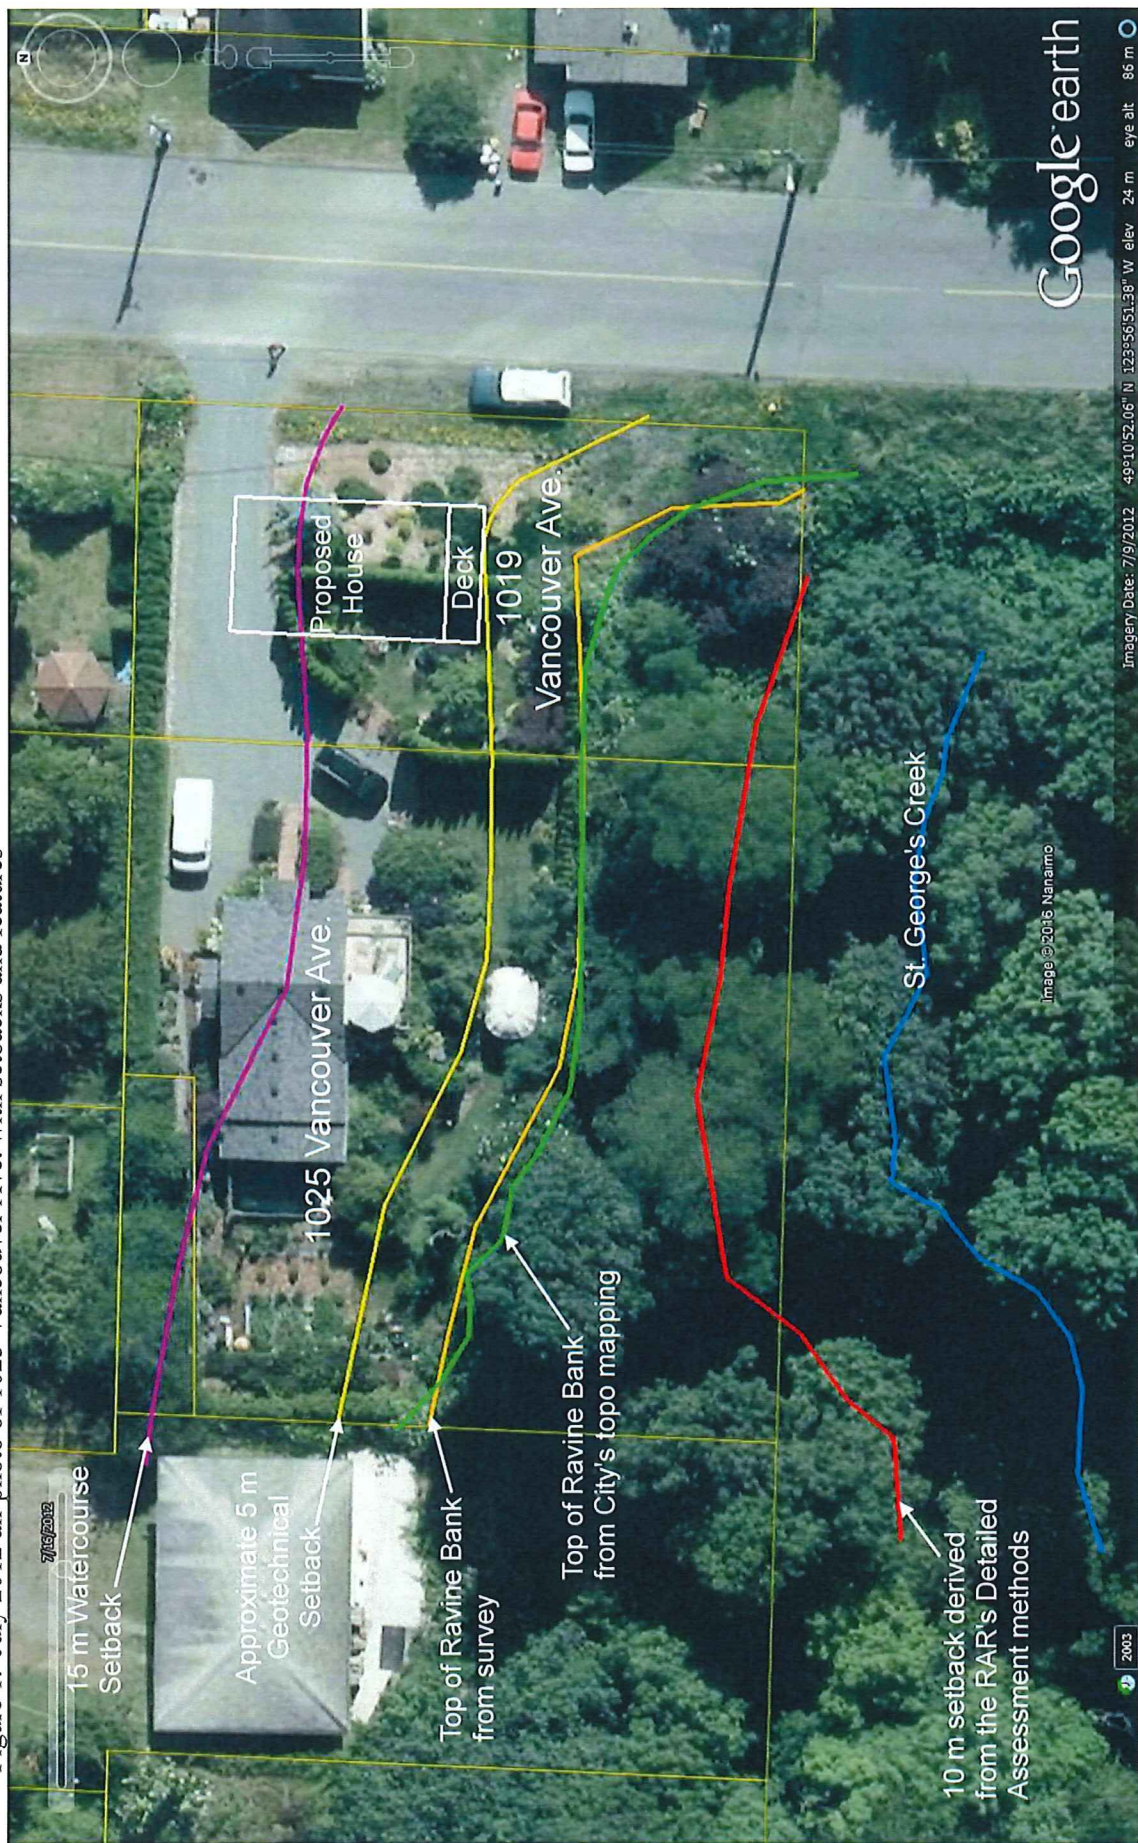
Figure 1. July 2012 air photo of 1025 Vancouver Ave. with setbacks and features

According to the City of Nanaimo's mapping, St. George's Creek requires a watercourse setback of 15 m from "top of bank", which in this case means top of ravine bank. Based on our map measurements (Figure 1) approximately $\frac{3}{4}$ of the subject property is located within the watercourse setback. As a comparison, under the RAR's Detailed Assessment methods St. George's Creek would receive a 10 m setback from high water mark, which would fall upon the ravine side slope below the top of ravine bank.
