**DEVELOPMENT PERMIT NO. DP001056**

**3500 / 3520 CHINOOK ROAD**  
Civic Address

**ENVIRONMENTAL REPORT**

**RE: 3500 & 3520 CHINOOK ROAD, NANAIMO BC  
SLOPE REPAIR PLANTING PLAN**

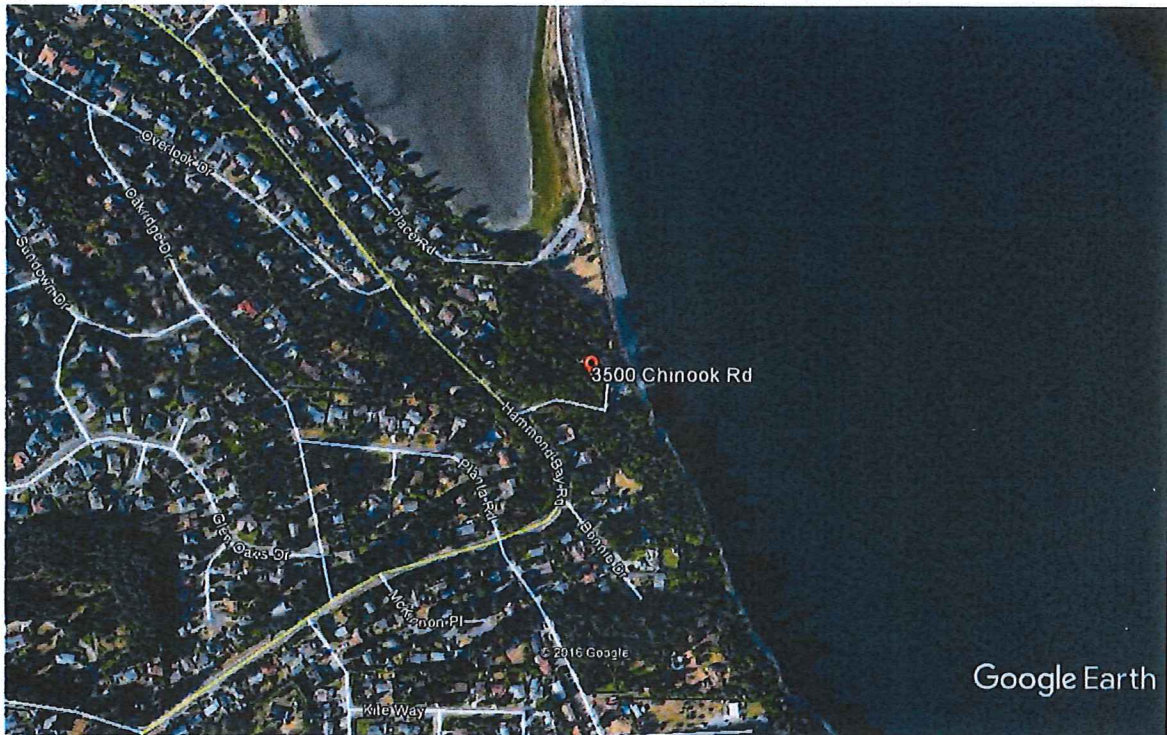
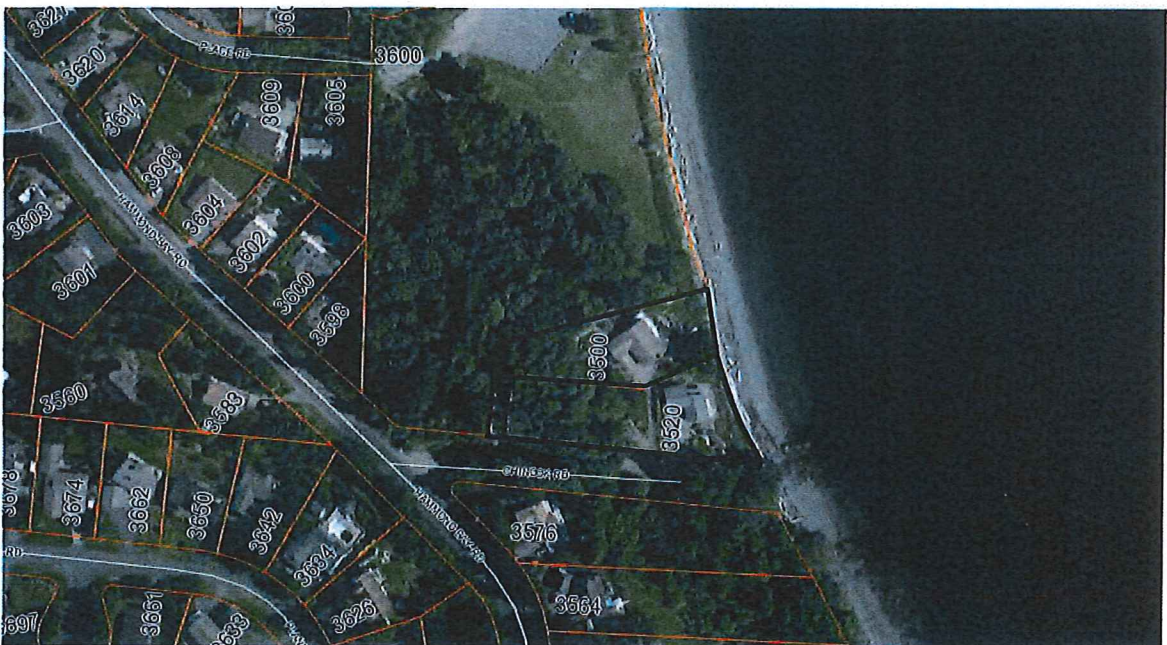
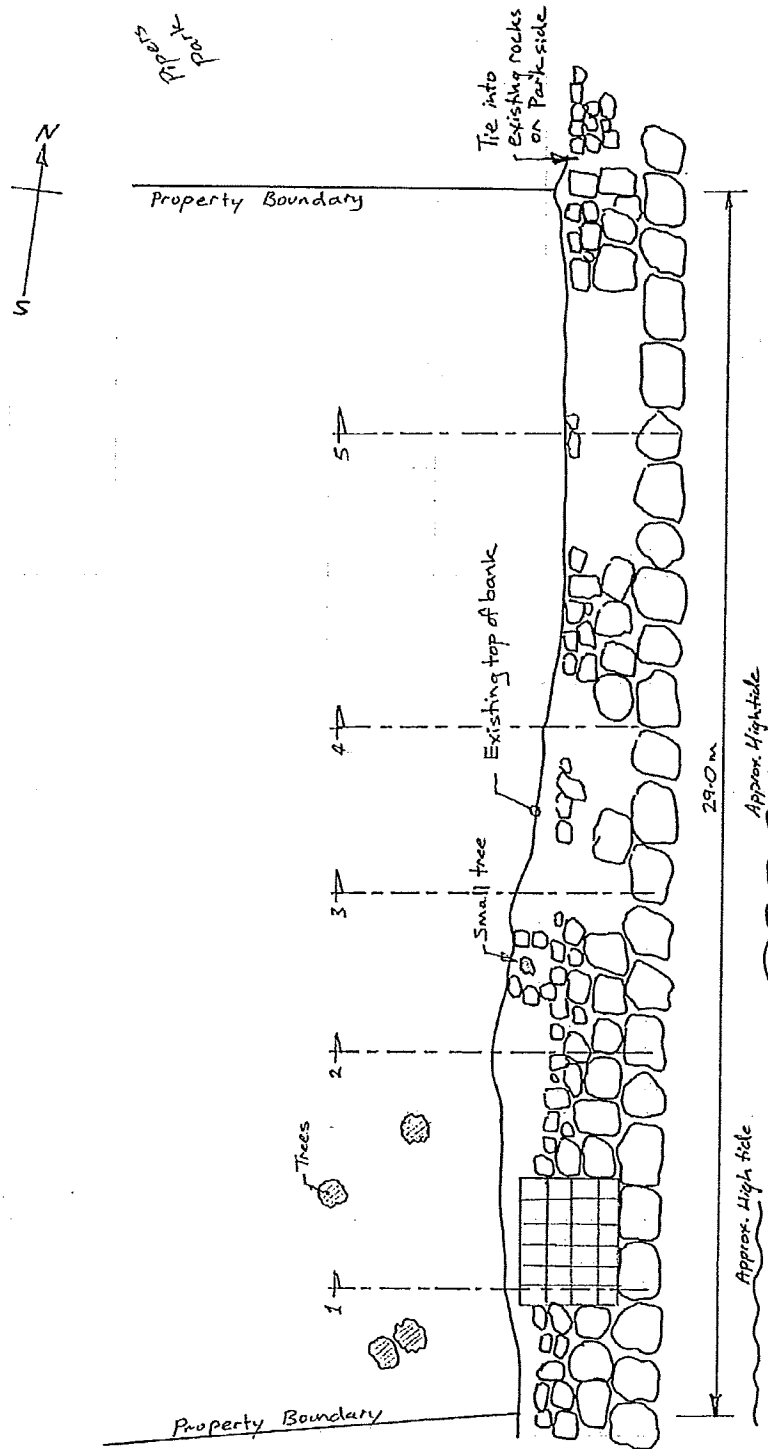
FIGURE 2. SITE PLAN

3500 Chinook Road  
Nanaimo  
Basher Property

Rock Revetment Wall

Plan View

1. The proposed revetments shall be installed generally in accordance with the Site Plans in Figure 2 of the Environmental Report prepared by Aquaparian Environmental Consulting Ltd., dated 2017-MAY-30, as shown on Schedule C..

The proposed project works for 3500 Chinook Road include minor excavation for placement of buried toe rock, placement of geotextile over the installation area, installation of large (0.5 - 1.0m diameter) partially buried toe rock above the high tide line along the existing toe of the slope, placement of rock infill over eroded embankment areas, creation of a walkway down to the beach near the south property boundary using armorflex blocks, revegetation of the newly constructed embankment with dune grass and installation of native shrubs along the top of bank.

The eroded areas along the embankment will require infilling to protect the slope from wave action. The rock infill is to be placed by an experienced excavator operator over the repair areas consisting of well-graded 300mm minus rock rubble creating a slope of 1 to 1.5 thus lessening the existing vertical grade. The infill will be placed in previously eroded sections along the 29m long embankment in 2m wide infill areas. Driftwood logs that are pushed up on the upper beach in the footprint of the rock revetment can be moved to the toe of the newly constructed rip rap slope. The walkway is to be installed using armorflex blocks overlying beach gravel infill in a 2.4m long by 3.1m wide section with topsoil, grass and turfmat overlying fill material at the top of the bank.

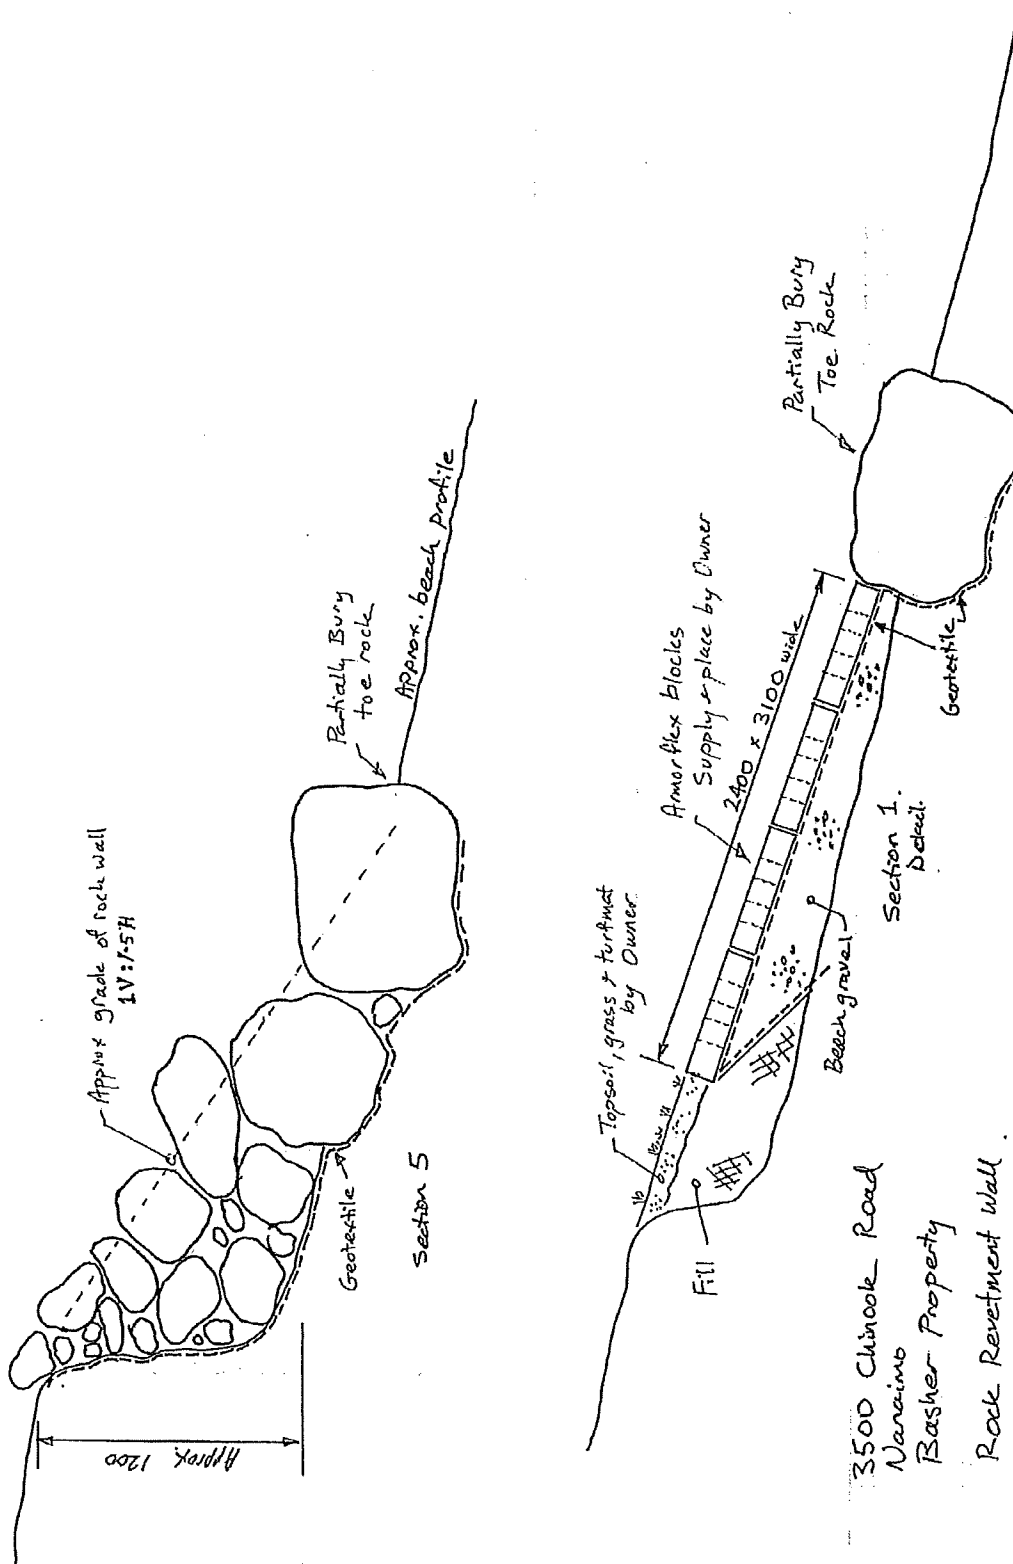
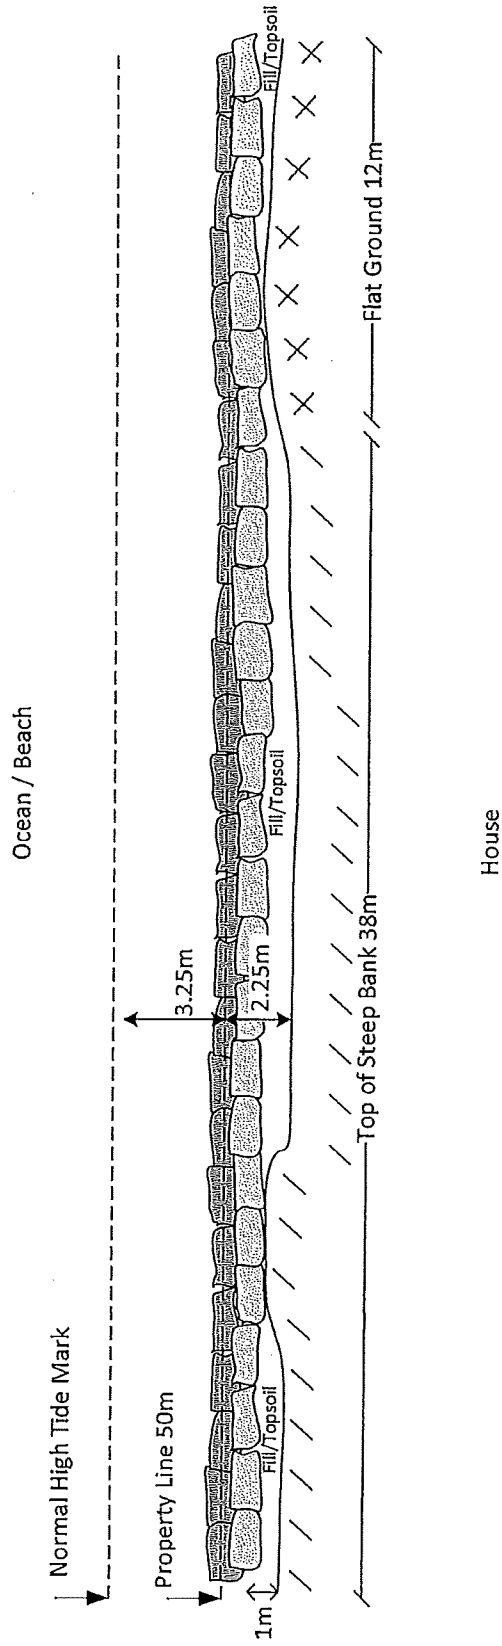
Proposed Soft Barrier — 3520 Chinook Rd.  
Overhead View

← Basher Property  
3500 Chinook Rd

Scale  
85mm = 17m  
5 mm = 1m

The proposed project works for 3520 Chinook Road include minor excavation for placement of buried toe rock, placement of geotextile over the installation area, installation of large (0.5 - 1.0m diameter) partially buried toe rock above the high tide line approximately 2.25m out from the existing toe of the embankment and placement of rock infill at the toe of the embankment to create a rip rap bench of 1.5m high and 2.25m wide with a 1V:0.5H grade facing the ocean. The toe of the newly constructed rip rap revetment can be planted with dune grass and the 1m wide top of the bench can be vegetated with native shrubs.

The rock infill is to be placed by an experienced excavator operator along the 50m long embankment between the toe rock and the existing slope consisting of well-graded 300mm minus rock rubble creating a slope of 1 to 0.5 thus lessening the existing vertical grade and with the intention of protecting the erosion areas at the toe of the existing embankment. The brush that is currently piled on the beach from pruning of vegetation at the top of bank can be removed and any driftwood logs in the footprint of the rock infill can be moved down the beach to be placed at the toe of the revetment.

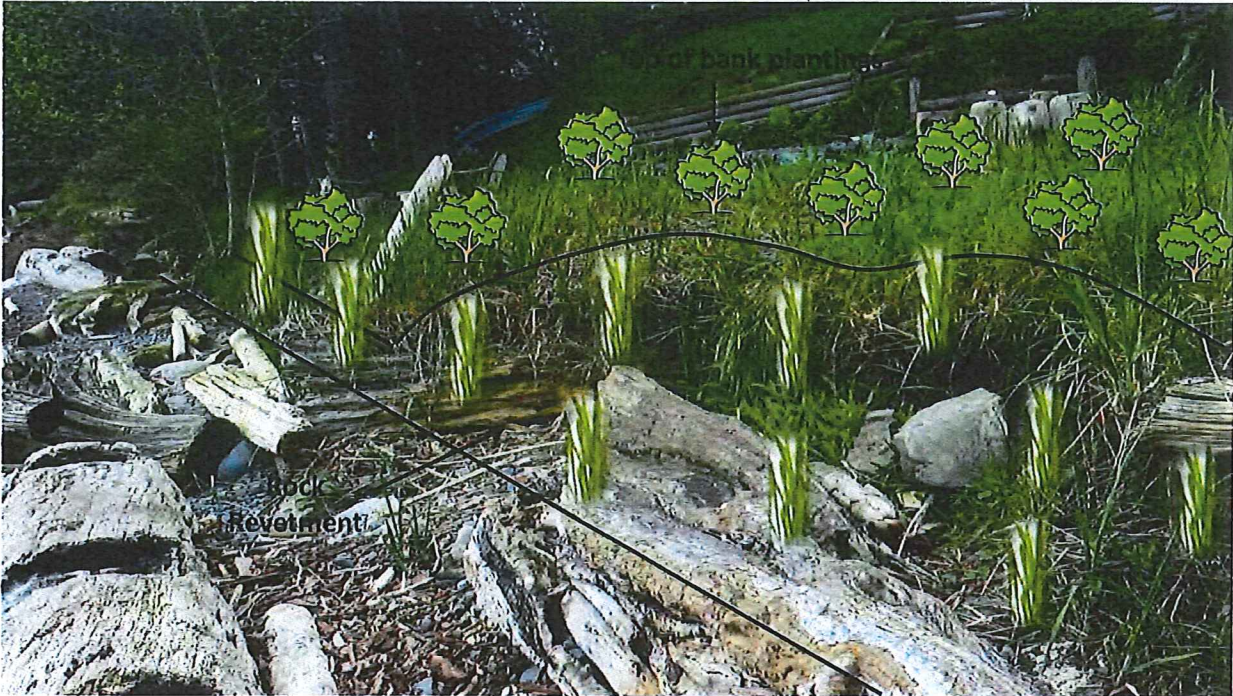
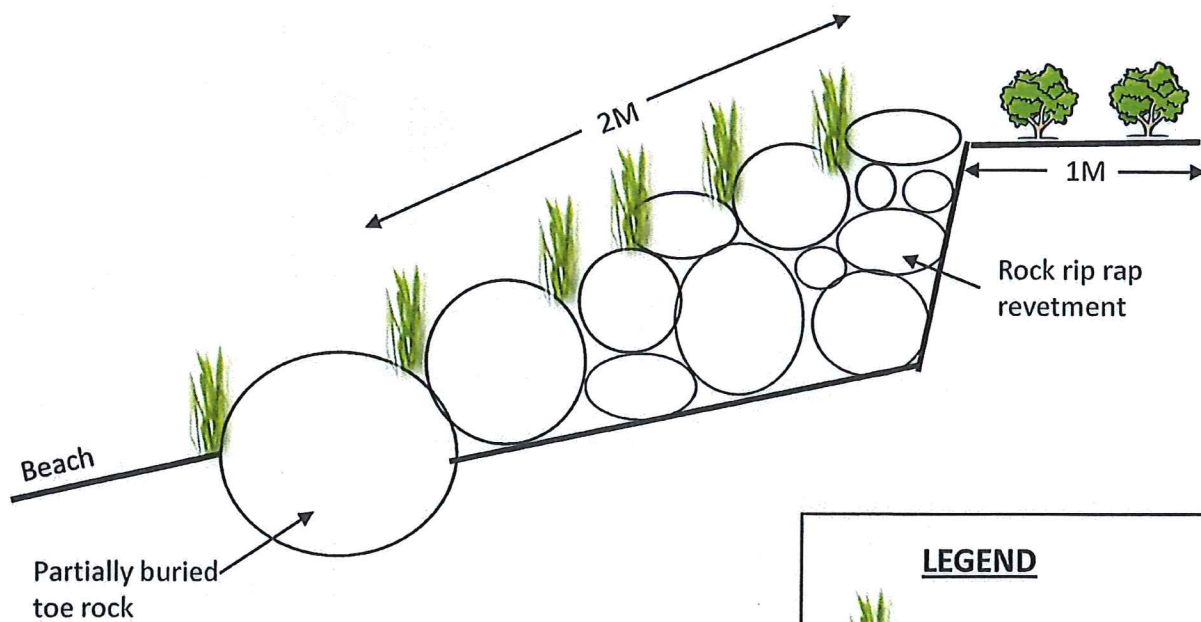
**FIGURE 3. PLANTING PLAN  
3500 CHINOOK ROAD**

Native shrubs: nootka rose, snowberry, oceanspray

2. The subject properties shall be developed in accordance with the Planting Plan in Figure 3 of the Environmental Report prepared by Aquaparian Environmental Consulting Ltd., dated 2017-MAY-30.

The following species have been selected for the restoration area at 3500 Chinook Road with species selection based on existing native shrubs adjacent to the restoration area (see Table 1). Approximately 25% of the rip rap surface area in the voids between will be planted. Overall planting density to be achieved is a minimum of four plants per m<sup>2</sup> for the dune grass within the rip rap and one plant per m<sup>2</sup> for the 1m wide strip of native shrubs at the top of the revetment with the goal of 100% cover within 2-3 years. If there are revisions to the shoreline grading or rock placement plan, the planting plan is to be adjusted accordingly to achieve the desired density. Refer to Figure 3 for an illustrative planting plan.

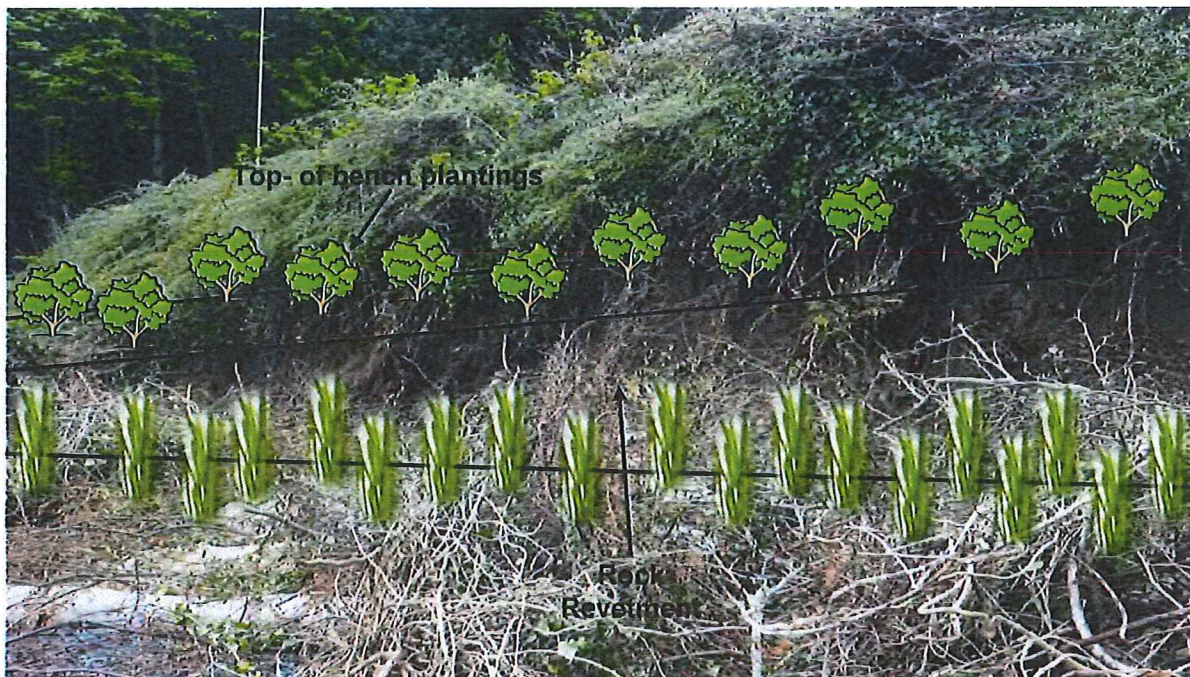
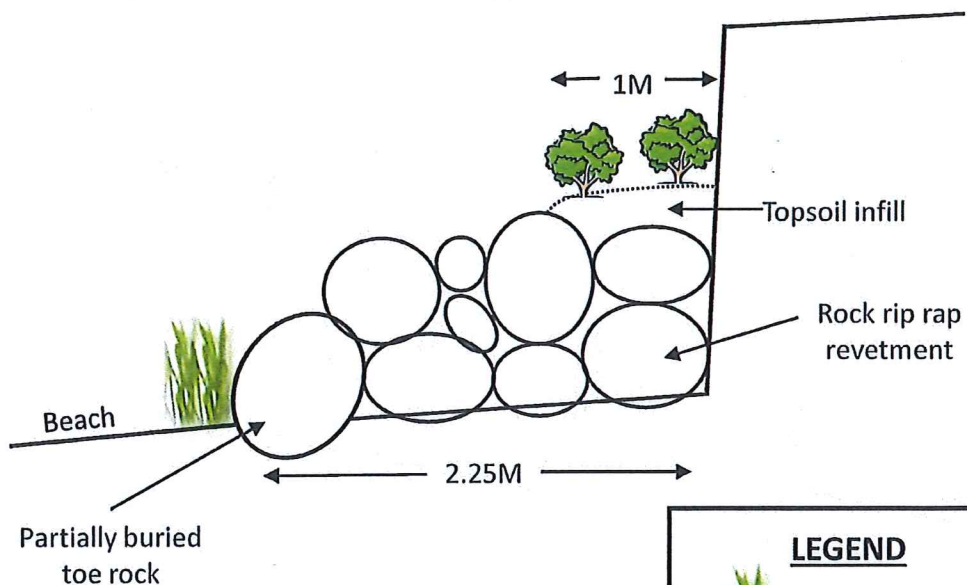
# PLANTING PLAN 3520 CHINOOK ROAD

Native shrubs: snowberry, nootka rose, oceanspray

The following species have been selected for 3520 Chinook Road (see Table 2). Overall planting density to be achieved is a minimum of four plants per m<sup>2</sup> for the dune grass and one plant per m<sup>2</sup> for the 1m wide strip of native shrubs at the top of the revetment with the goal of 100% cover within 2-3 years. If there are revisions to the shoreline grading or rock placement plan, the planting plan is to be adjusted accordingly to achieve the desired density. Refer to Figure 3 for an illustrative planting plan.

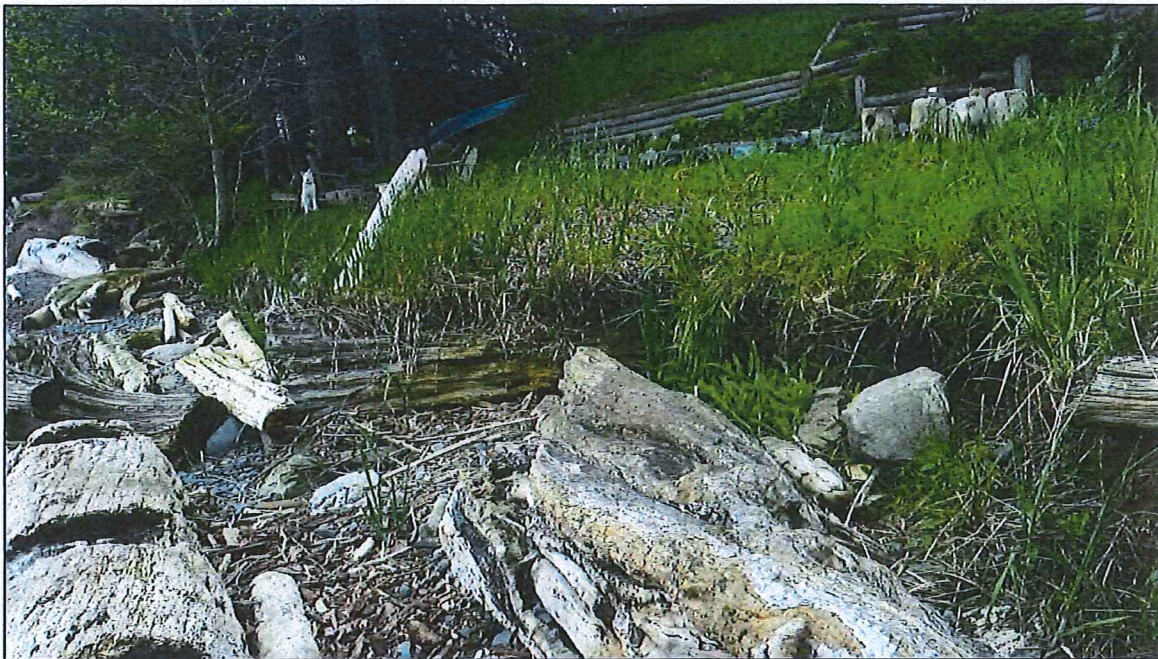
Photo 3. Showing the embankment slope down to the beach vegetated with dune grass. Slope erosion areas evident. The rock rip rap will cover the erosion areas.

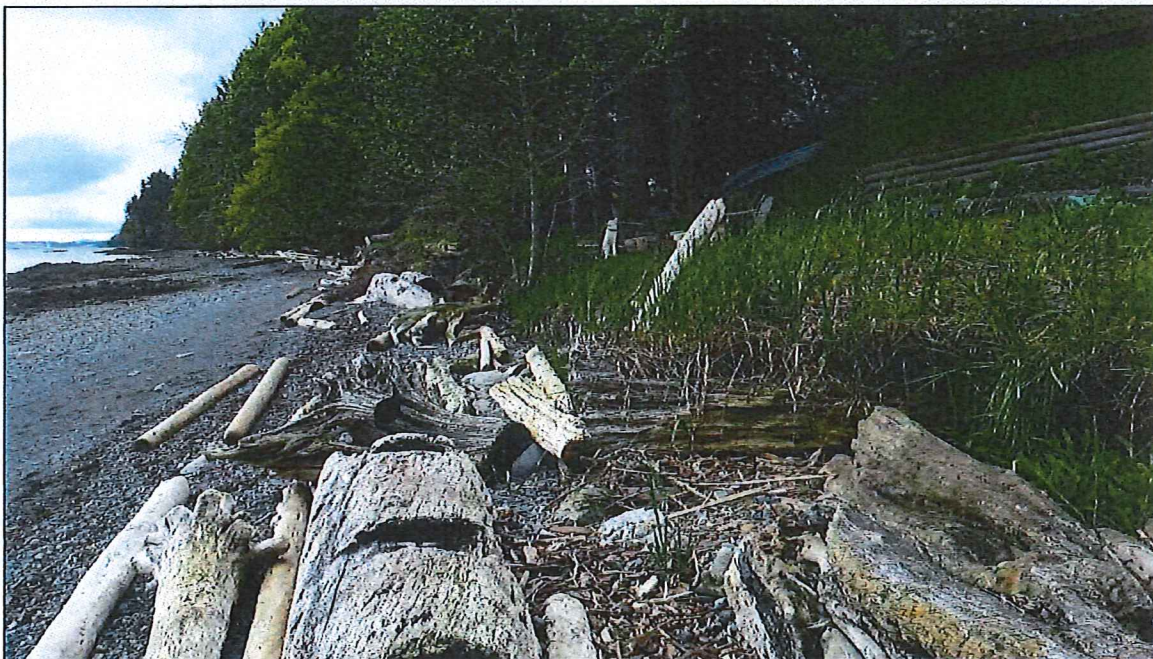
Photo 4. Facing south down the shoreline towards the neighbouring property. Showing slope above the high tide line to be reinforced with rock revetment.

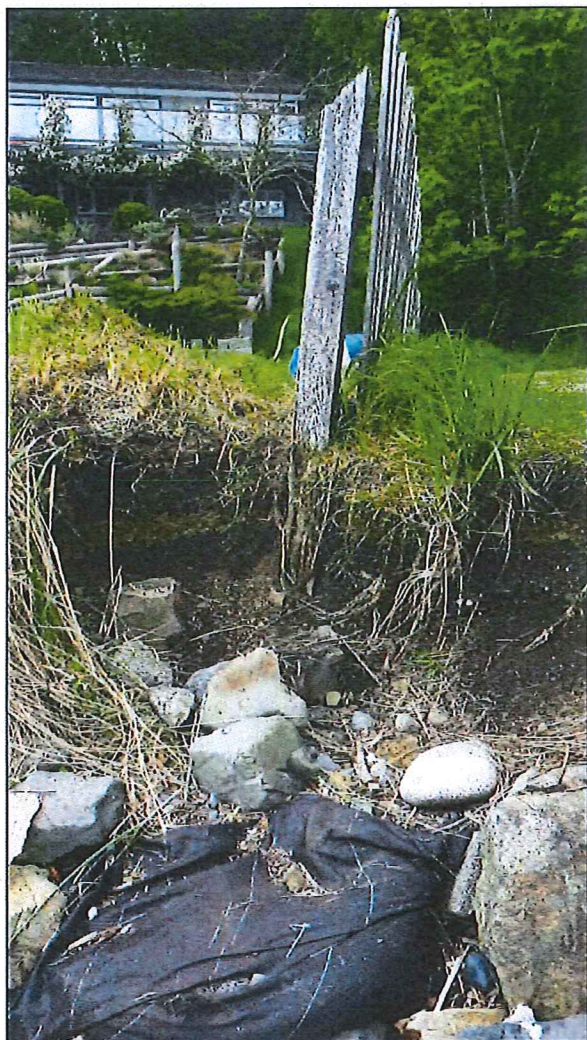
Photo 5. Showing the north property line fence and slope failure area.

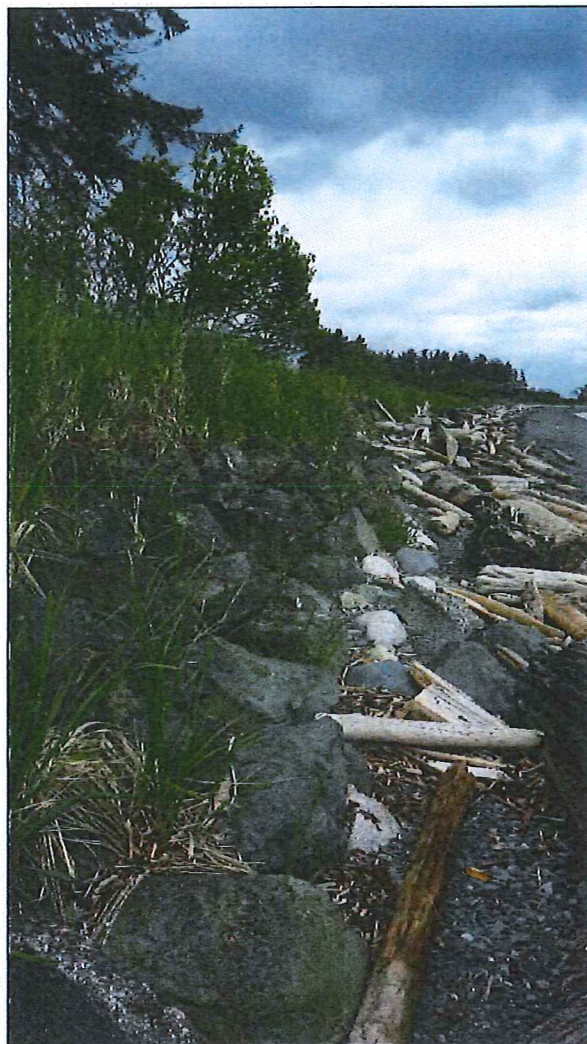
Photo 6. Showing the shoreline facing north towards Piper's Lagoon Park with rock rip rap shoreline protection.

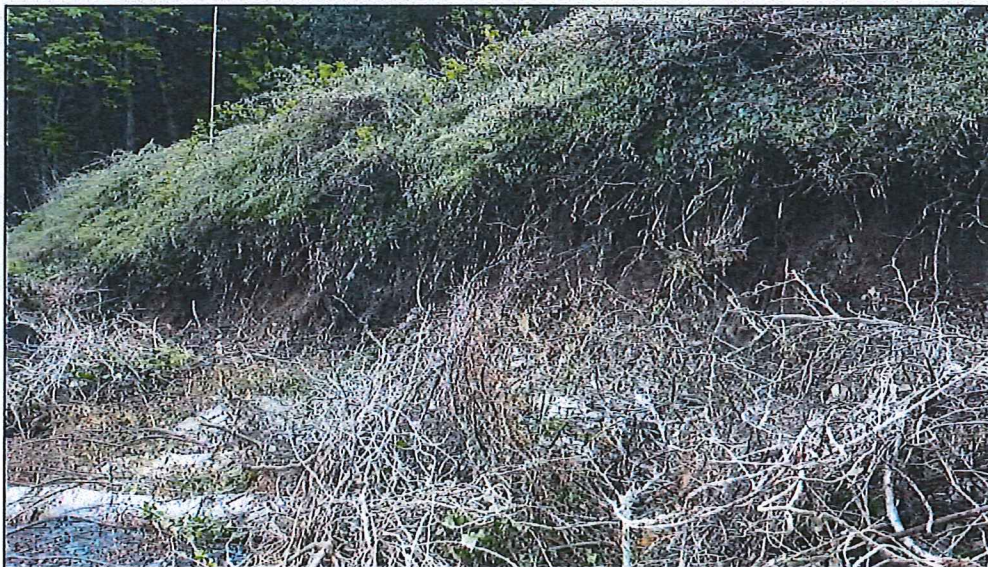
Photo 2. Showing thickly vegetated embankment with erosion along the toe of the slope.

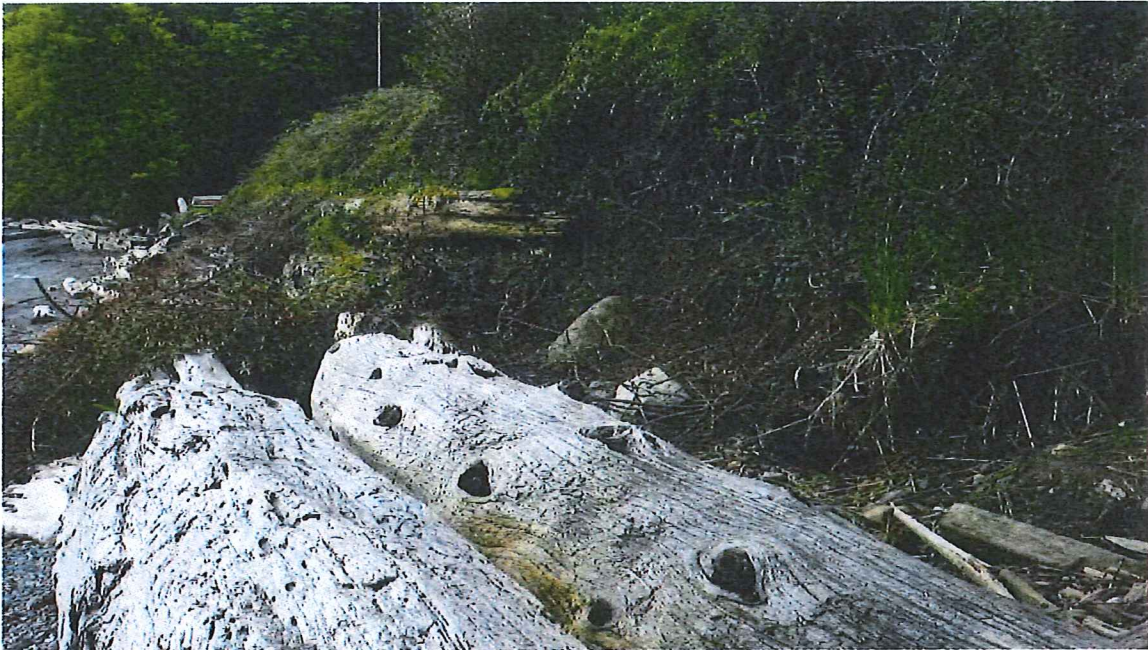
Photo 3. Large driftwood logs at the base of the slope piled up from storm events. Logs can be moved to make room for rock rip rap and be placed near the toe of the revetment. Facing south.

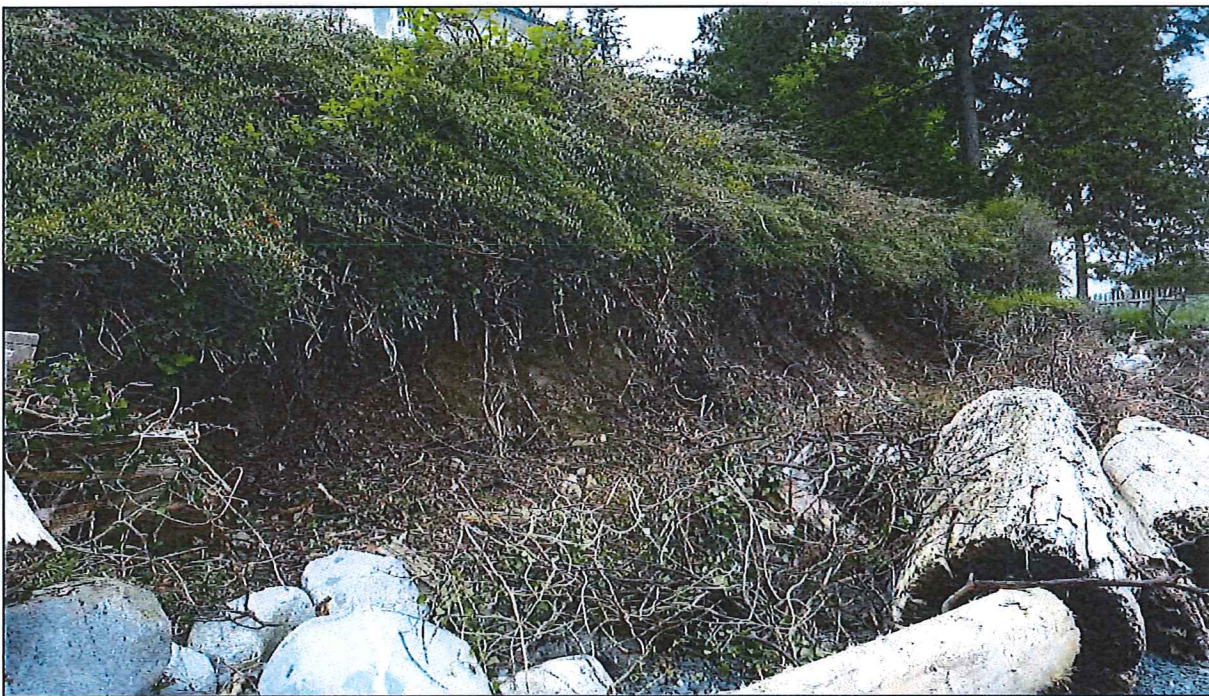
Photo 6. Showing the embankment slope facing north towards the neighbouring property (3500 Chinook Road). Erosion evident at the toe of the slope.
