# 2080 & 2160 East Wellington Road Environmental Assessment

**East Wellington Developments Limited Partnership**  
110-33973 Gladys Ave  
Abbotsford, B.C. V2S 2E8

**EDI Environmental Dynamics Inc.**  
208A-2520 Bowen Rd  
Nanaimo BC V9T 3L3

22N0345  
Version: V4  
March 2025

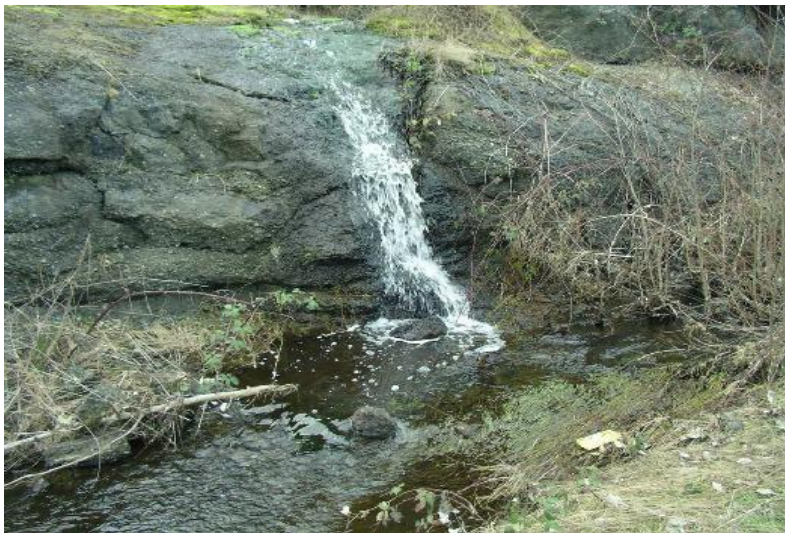
**Photo 1.** Feb. 8, 2011. 2 m high waterfall and cascade at Stream 1 confluence with Boxwood Creek between Parkway Trail and Nanaimo Parkway.

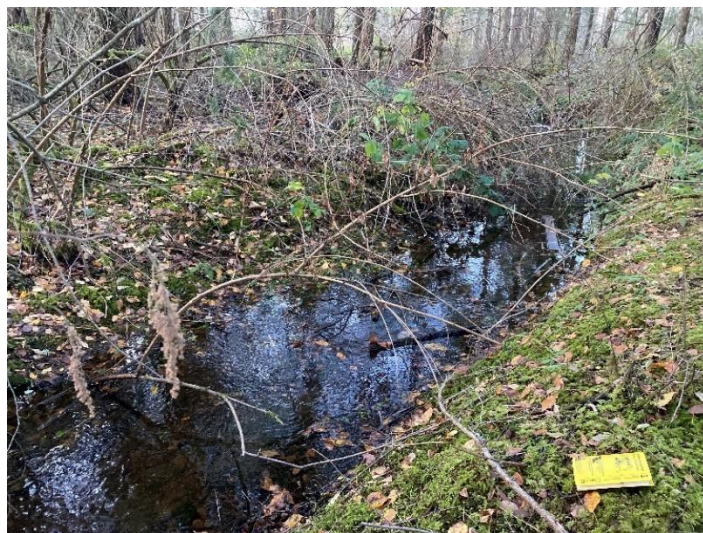
**Photo 2.** Dec. 12, 2022. View looking upstream at Stream 1, Reach 1 a short distance upstream of the waterfall.

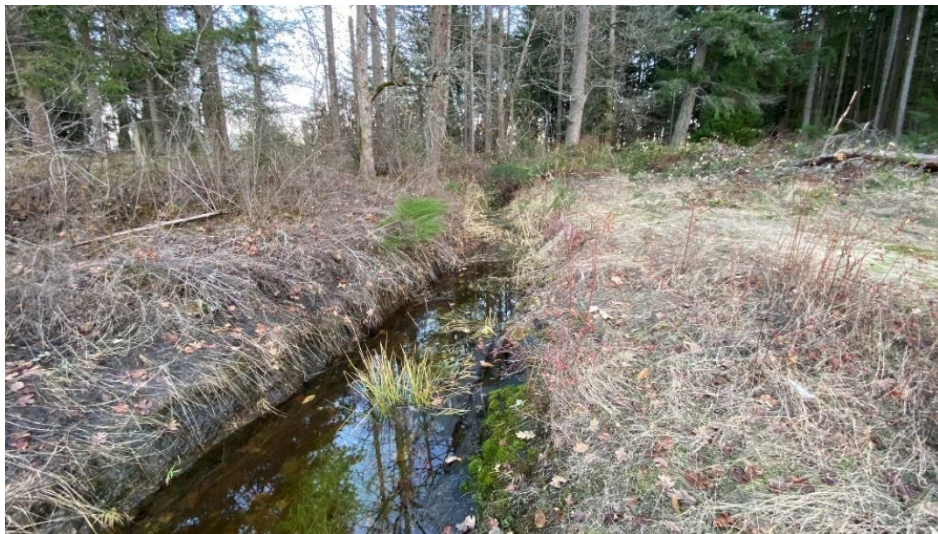
**Photo 3.** Dec. 12, 2022. View looking downstream at Stream 1, Reach 1 immediately downstream of the wetland (Reach 2).

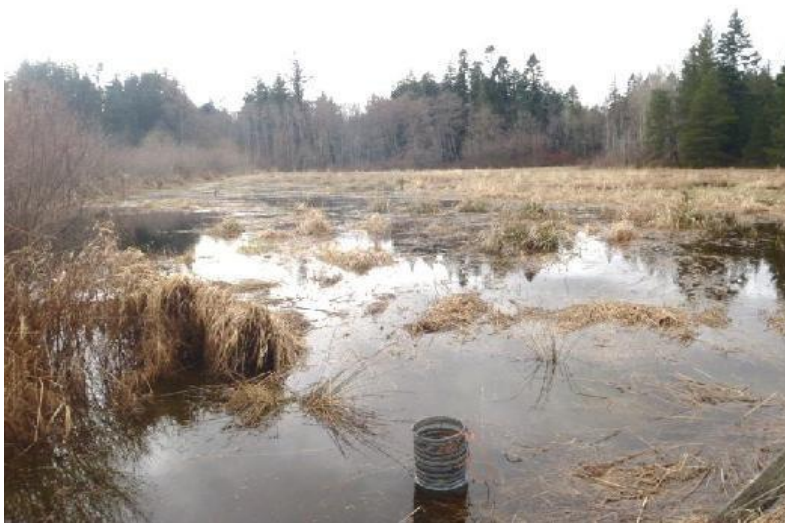
**Photo 4.** Mar. 15, 2011. Looking northwest at Stream 1, Reach 2 (portion that was a seasonally flooded agricultural field).

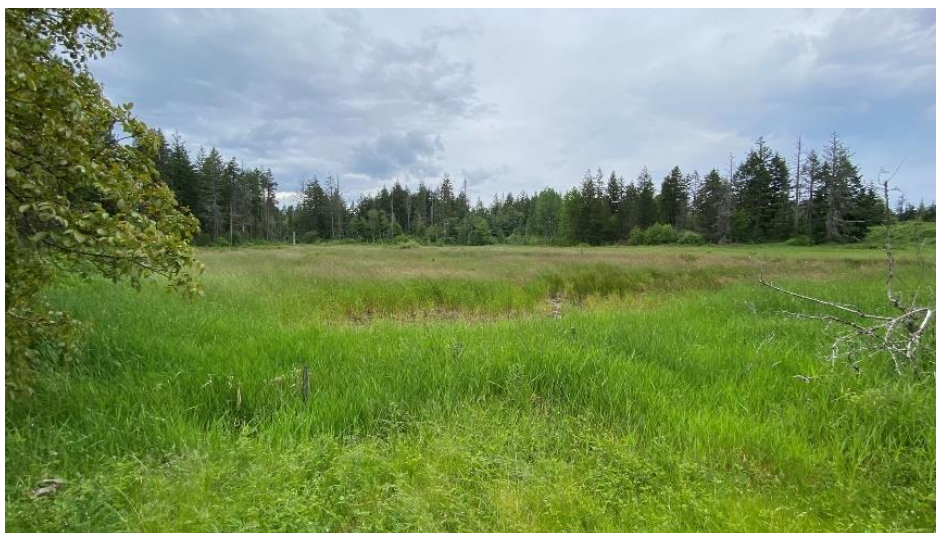
**Photo 5.** Jun. 6, 2022. Looking northwest at Stream 1, Reach 2 (portion that was a seasonally flooded agricultural field).

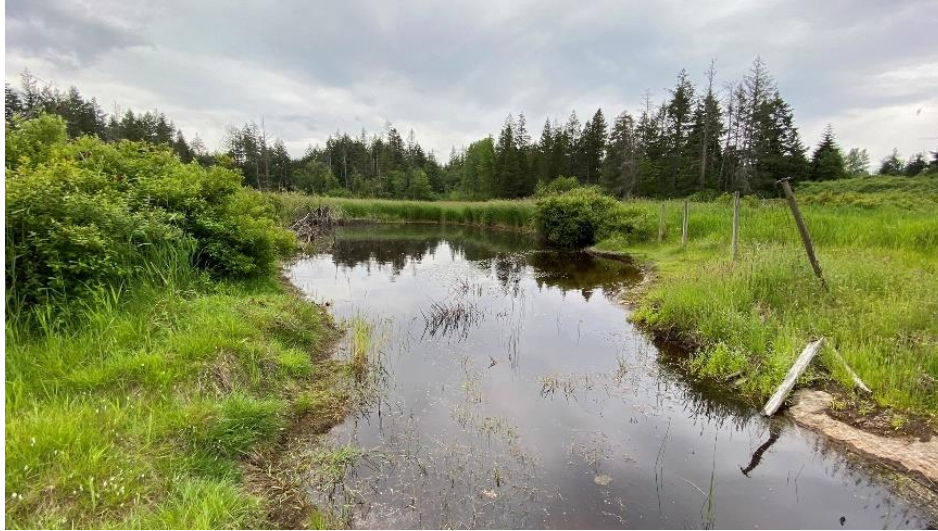
**Photo 6.** Jun. 6, 2022. Looking northwest at Stream 1, Reach 2 (portion that contains a large pond that drains into Reach 1).

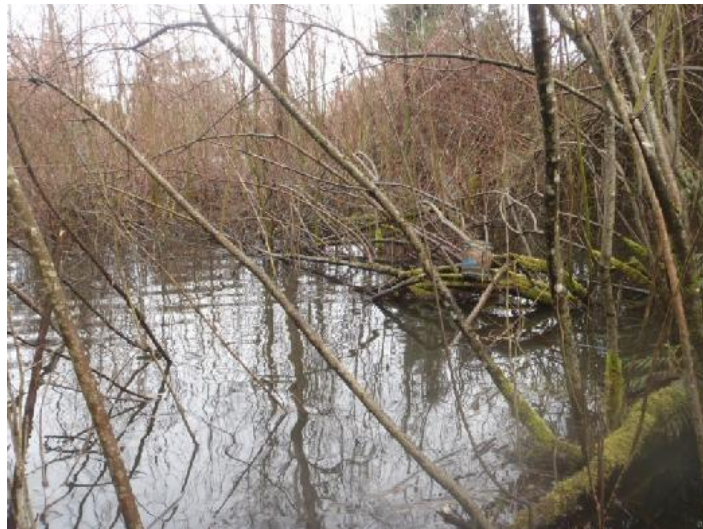
**Photo 7.** Mar. 15, 2011. Seasonally flooded, swamp that is adjacent to Boxwood Creek and is considered potentially fish bearing.

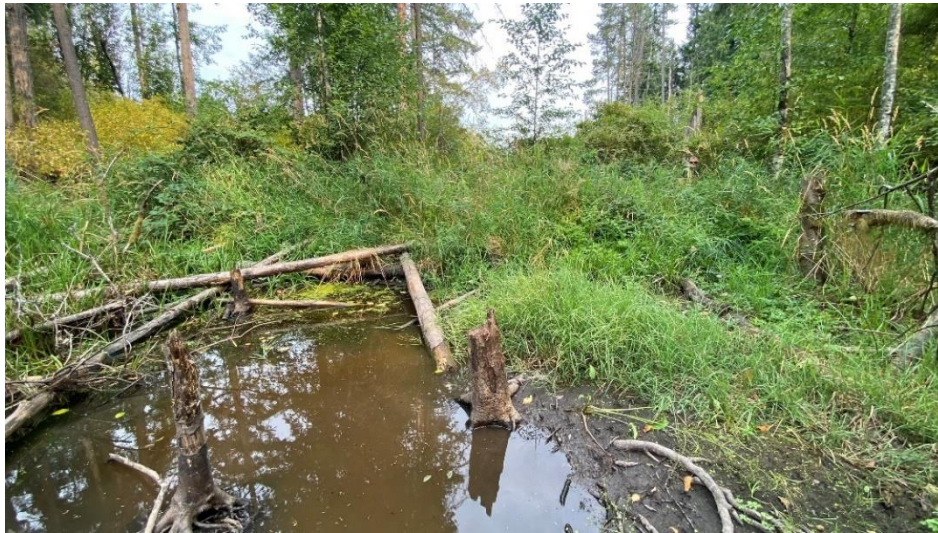
As shown in Figure 2, an old overgrown beaver dam (Photo 7) is present near the east boundary of this reach and an old beaver lodge was observed near the west end. The beaver dam creates open water areas within Reach 3.

**Photo 8.** Aug. 23, 2023. Looking east at overgrown beaver dam and pooling water at the upstream (west) side of the beaver dam.

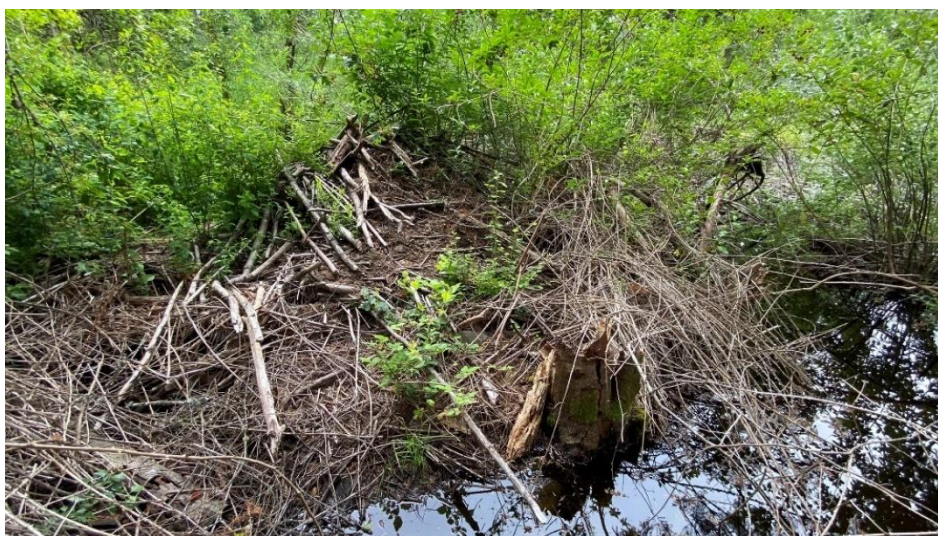
**Photo 9.** Jun. 17, 2023. Old beaver lodge near west end of Stream 1, Reach 3.

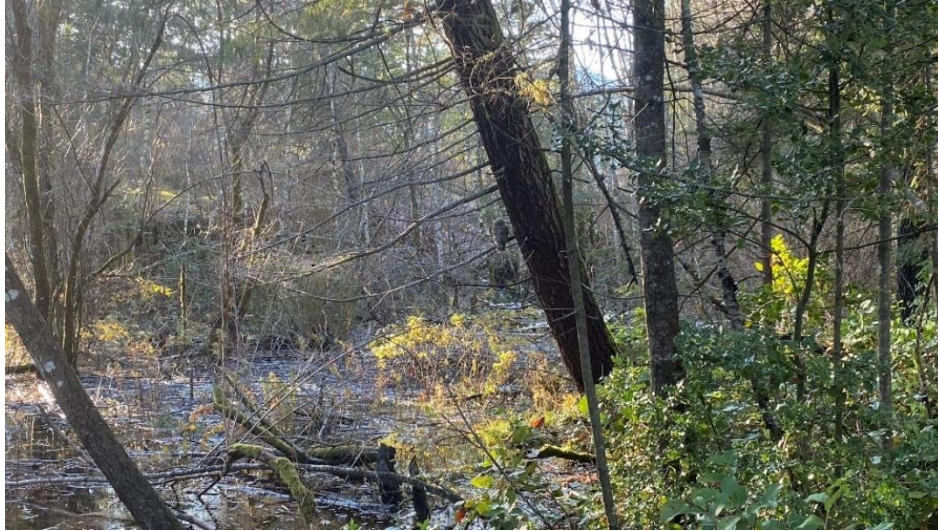
**Photo 10.** Dec. 12, 2022. Looking west at northwest end of Stream 1, Reach 3. A Barred Owl is observed roosting on a Douglas fir tree at north edge of wetland (centre of photo).

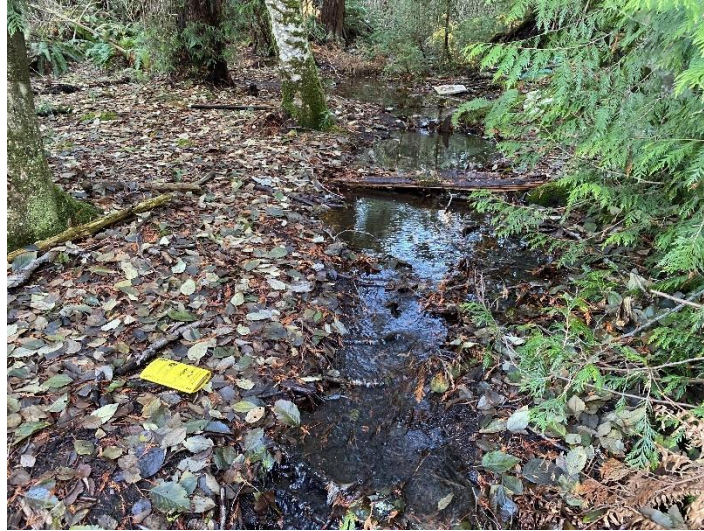
**Photo 11.** Dec. 12, 2022. Looking upstream at segment of Stream 3 with a well-defined channel, just upstream of the old agricultural field.

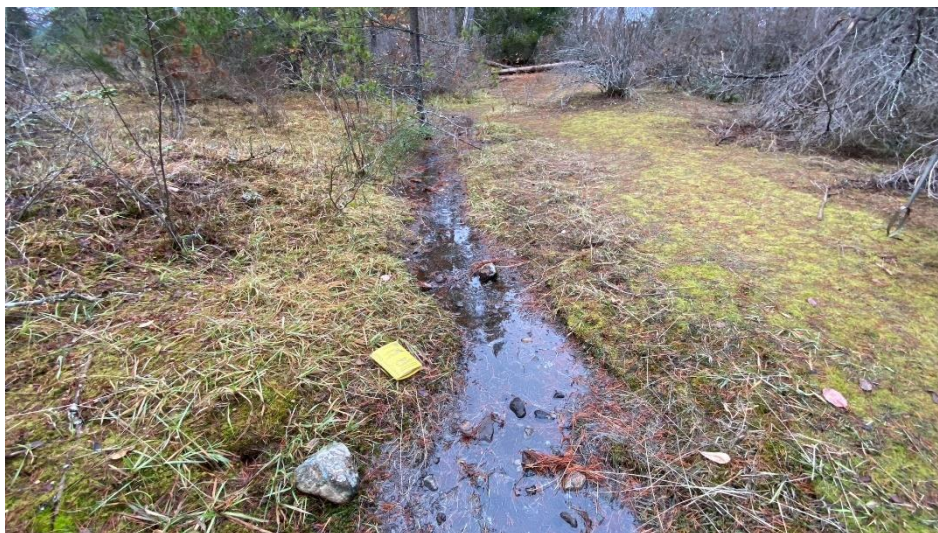
Photo 13. Dec. 14, 2022. Looking upstream at a segment of Stream 4 with a well-defined, narrow channel.

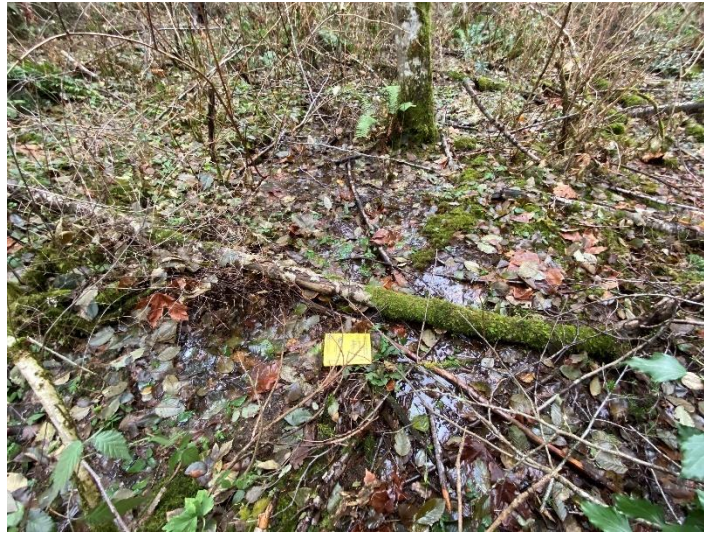
**Photo 14.** Dec. 14, 2022. Looking upstream at a segment of Stream 4 without a well-defined channel (water flows over the forest floor along an indistinct drainage path).

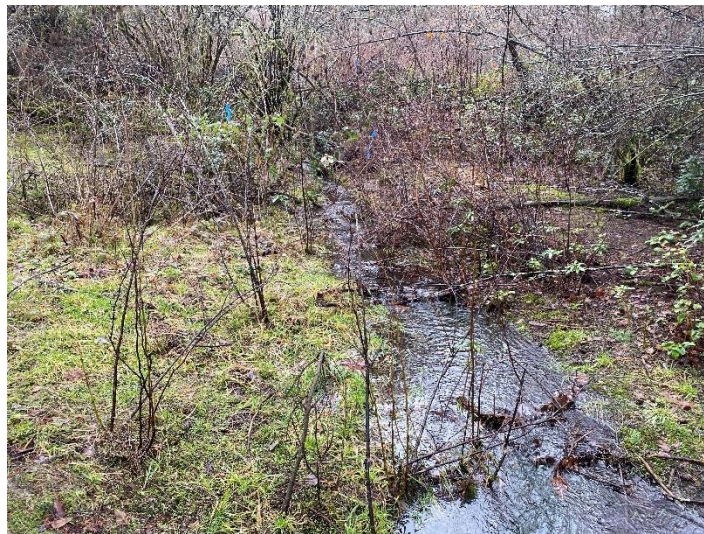
**Photo 15.** Jan. 13, 2023. Looking upstream at Stream 5, Reach 1 following a significant rainfall event.

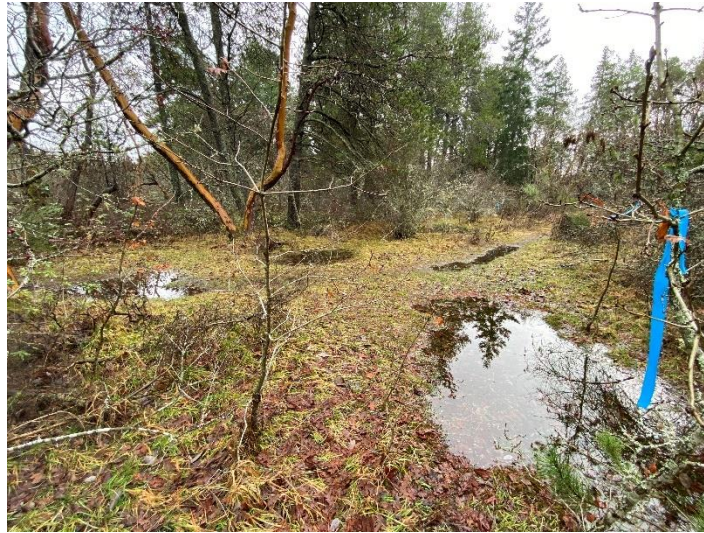
**Photo 16.** Jan. 13, 2023. Looking upstream at upstream extent of Stream 5, Reach 2 following a significant rainfall event.

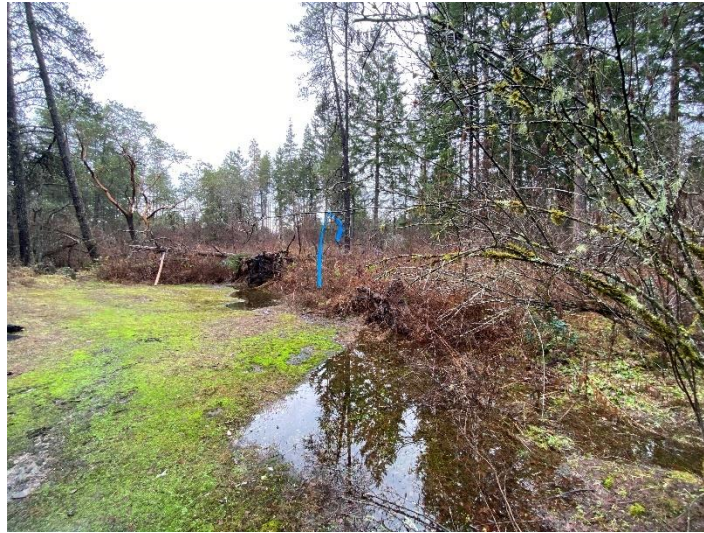
Photo 17. Jan. 13, 2023. Looking upstream at ponding water within upper portion of Stream 6 following a significant rainfall event.

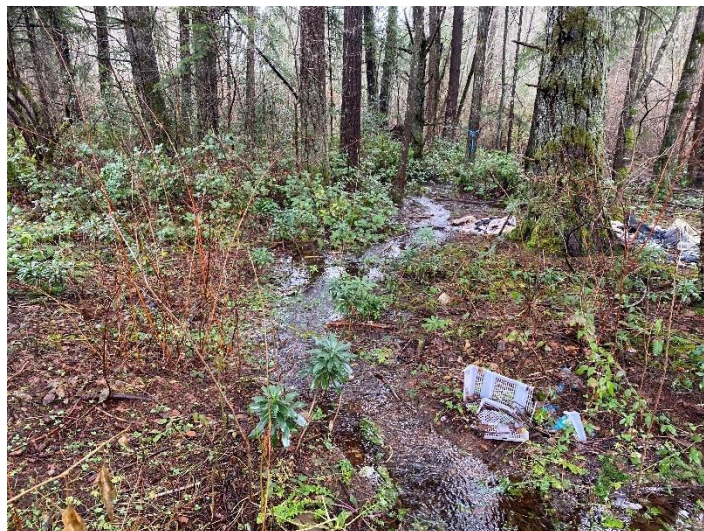
Photo 18. Jan. 13, 2023. Looking downstream at lower portion of Stream 6 immediately upstream of Stream 1, Reach 3 following a significant rainfall event.

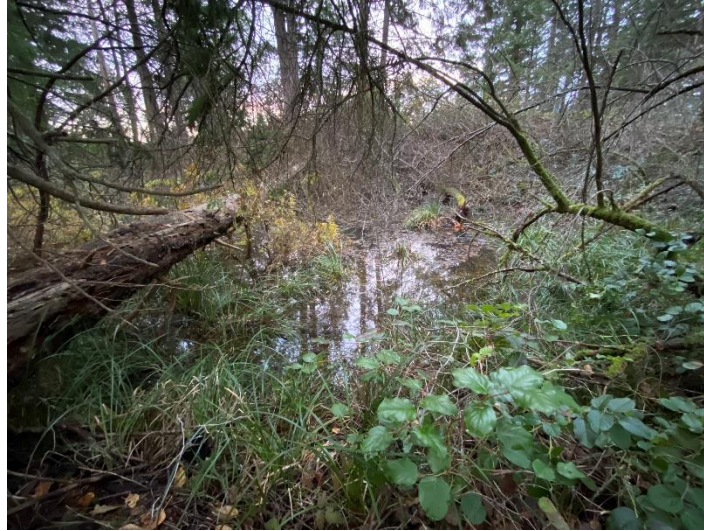
Photo 19. Dec. 14, 2022. View of western part of Isolated Pond.

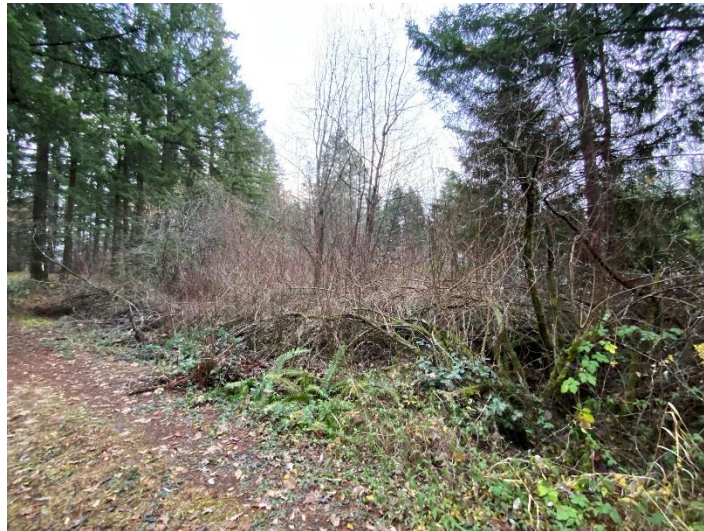
Photo 20. Dec. 14, 2022. View from existing driveway of eastern part of Isolated Pond.

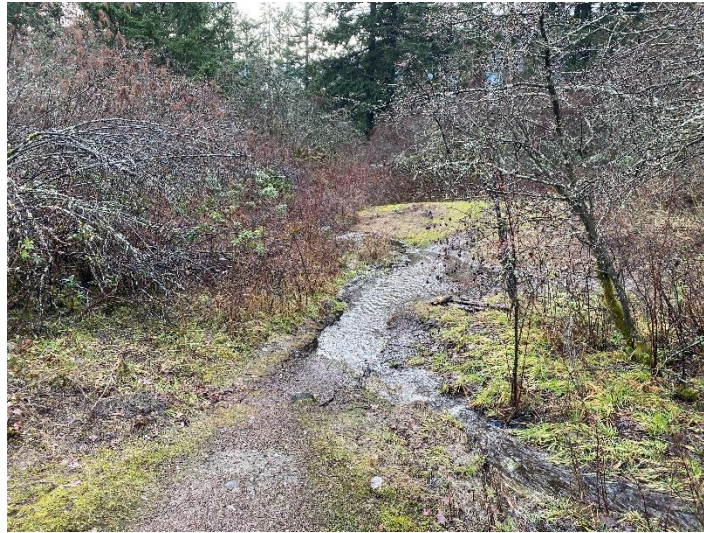
**Photo 21.** Jan. 13, 2023. Looking downstream at Millstone Tributary, Reach 1 following a significant rainfall event. This section of channel is just below the wetland reach and just above the steep ravine.

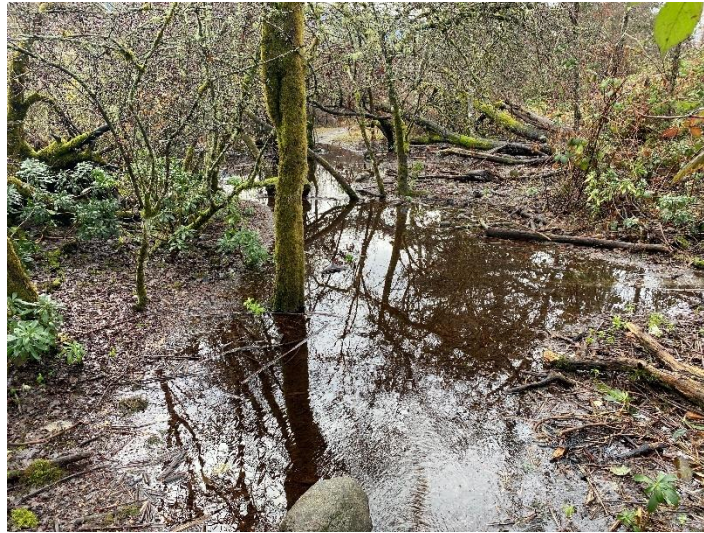
Photo 22. Jan. 13, 2023. Looking upstream at Millstone Tributary, Reach 2 following a significant rainfall event.

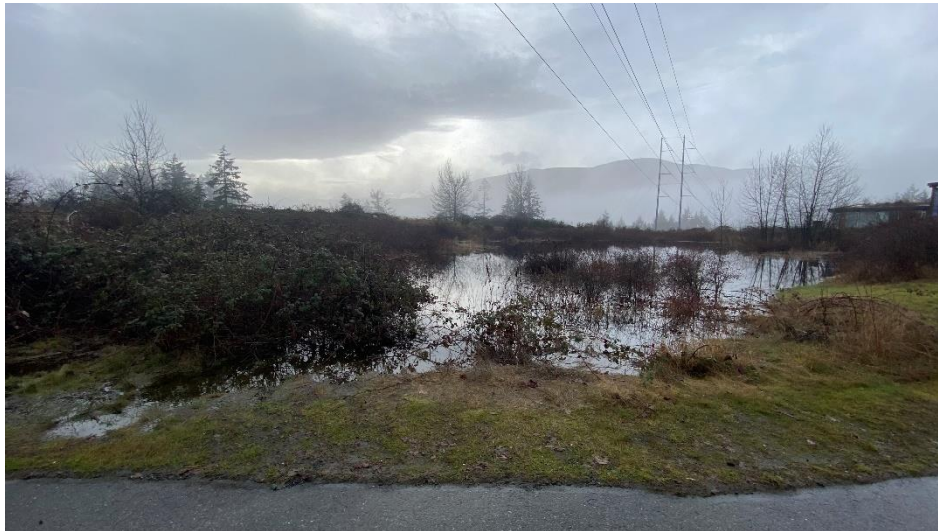
Photo 23. Jan. 13, 2023. Looking west at the ditched outlet of the constructed pond adjacent to the Tourism Nanaimo Visitor Centre following a significant rainfall event.

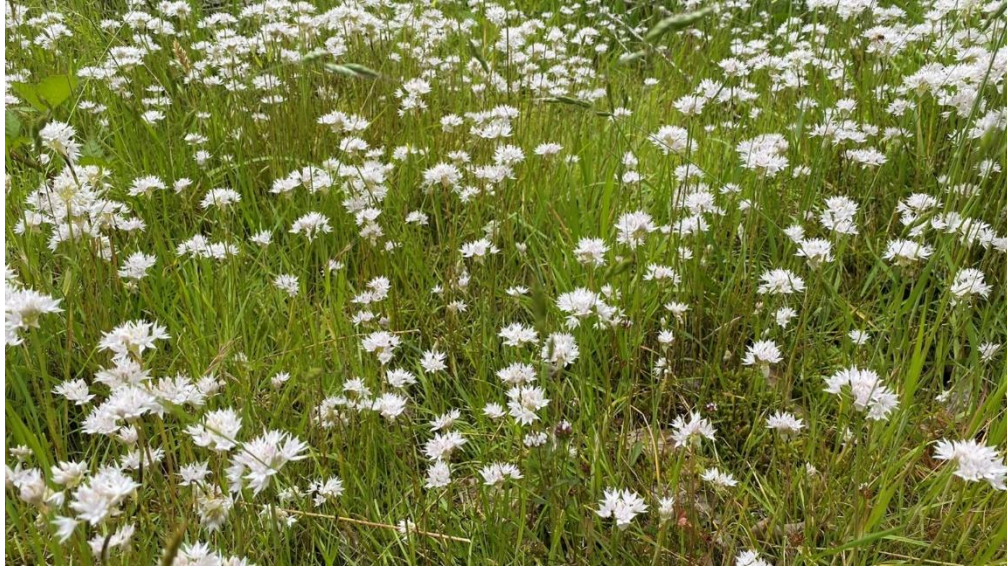
Appendix Photo B-1. Large patch of provincially blue-listed slimleaf onion observed just outside of the Properties during the targeted rare plant survey.

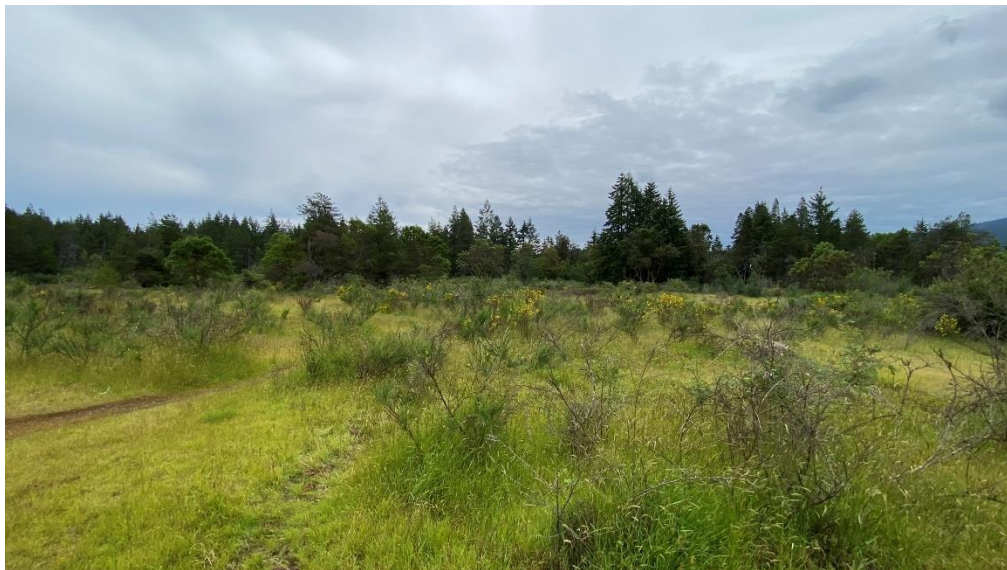
Appendix Photo B-2. Representative view of open, terrestrial herbaceous areas that are significantly disturbed by human activities and are often infested with invasive species (Scotch broom).

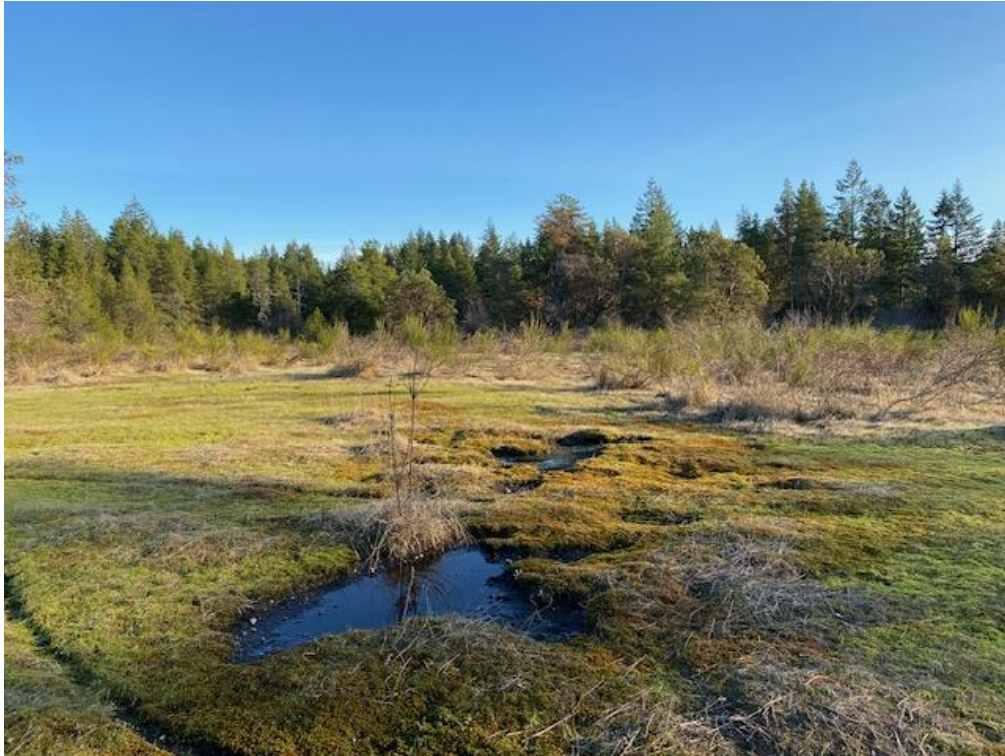
Appendix Photo B-3. Representative view of open, terrestrial herbaceous area with shallow vernal pools. Typical coniferous forest north of Stream 1, Reach 3 riparian areas shown in background.

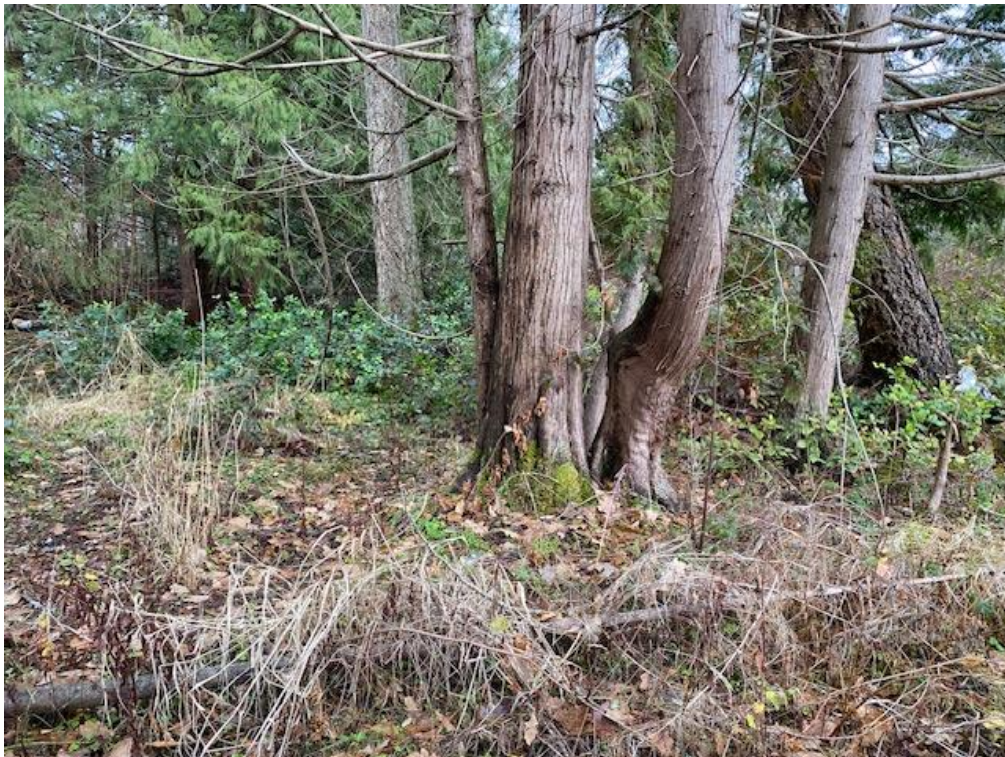
Appendix Photo B-4. Typical maturing forest riparian area with western redcedar and Douglas fir.

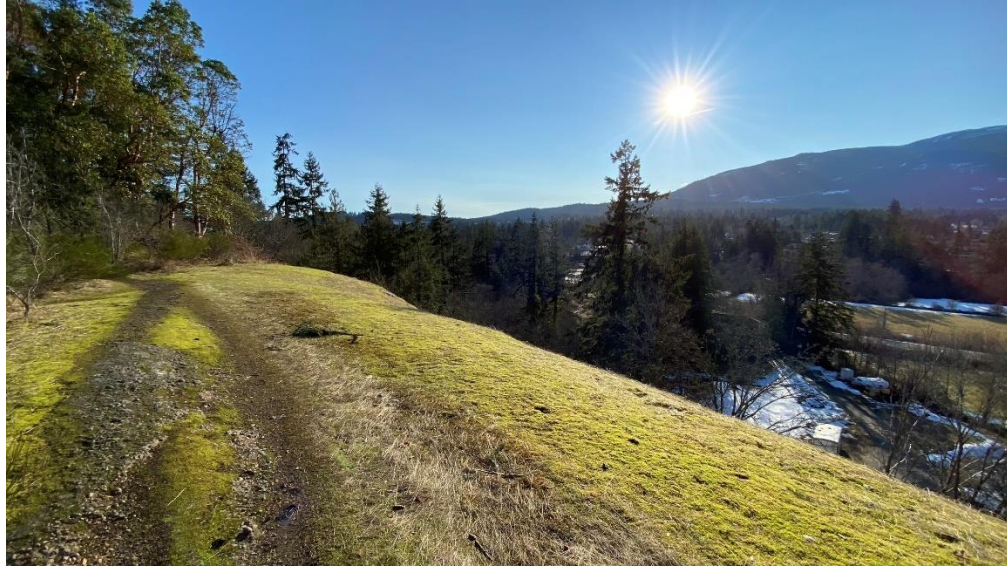
Appendix Photo B-5. Representative view of bluff ecosystem adjacent to west boundary of Properties.

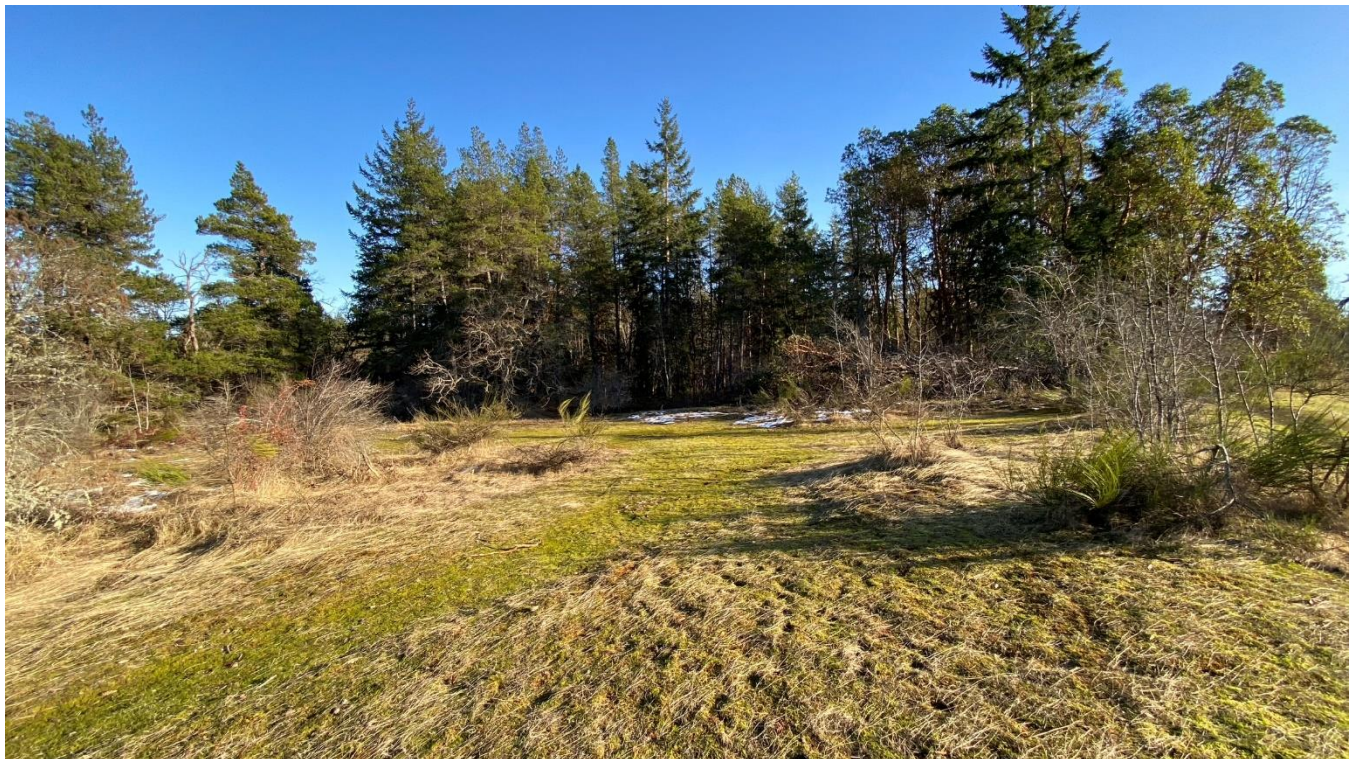
Appendix Photo B-6. Representative view of open, terrestrial herbaceous areas that are less disturbed by human activities and are less infested with invasive species. Typical coniferous forest shown in background
