**UPPER CHASE DAM SEISMIC ASSESSMENT  
NANAIMO, BC**

**CITY OF NANAIMO  
NANAIMO, BC**

**EBA ENGINEERING CONSULTANTS LTD.  
EDMONTON, ALBERTA**

**Project No. 0802-2800097**

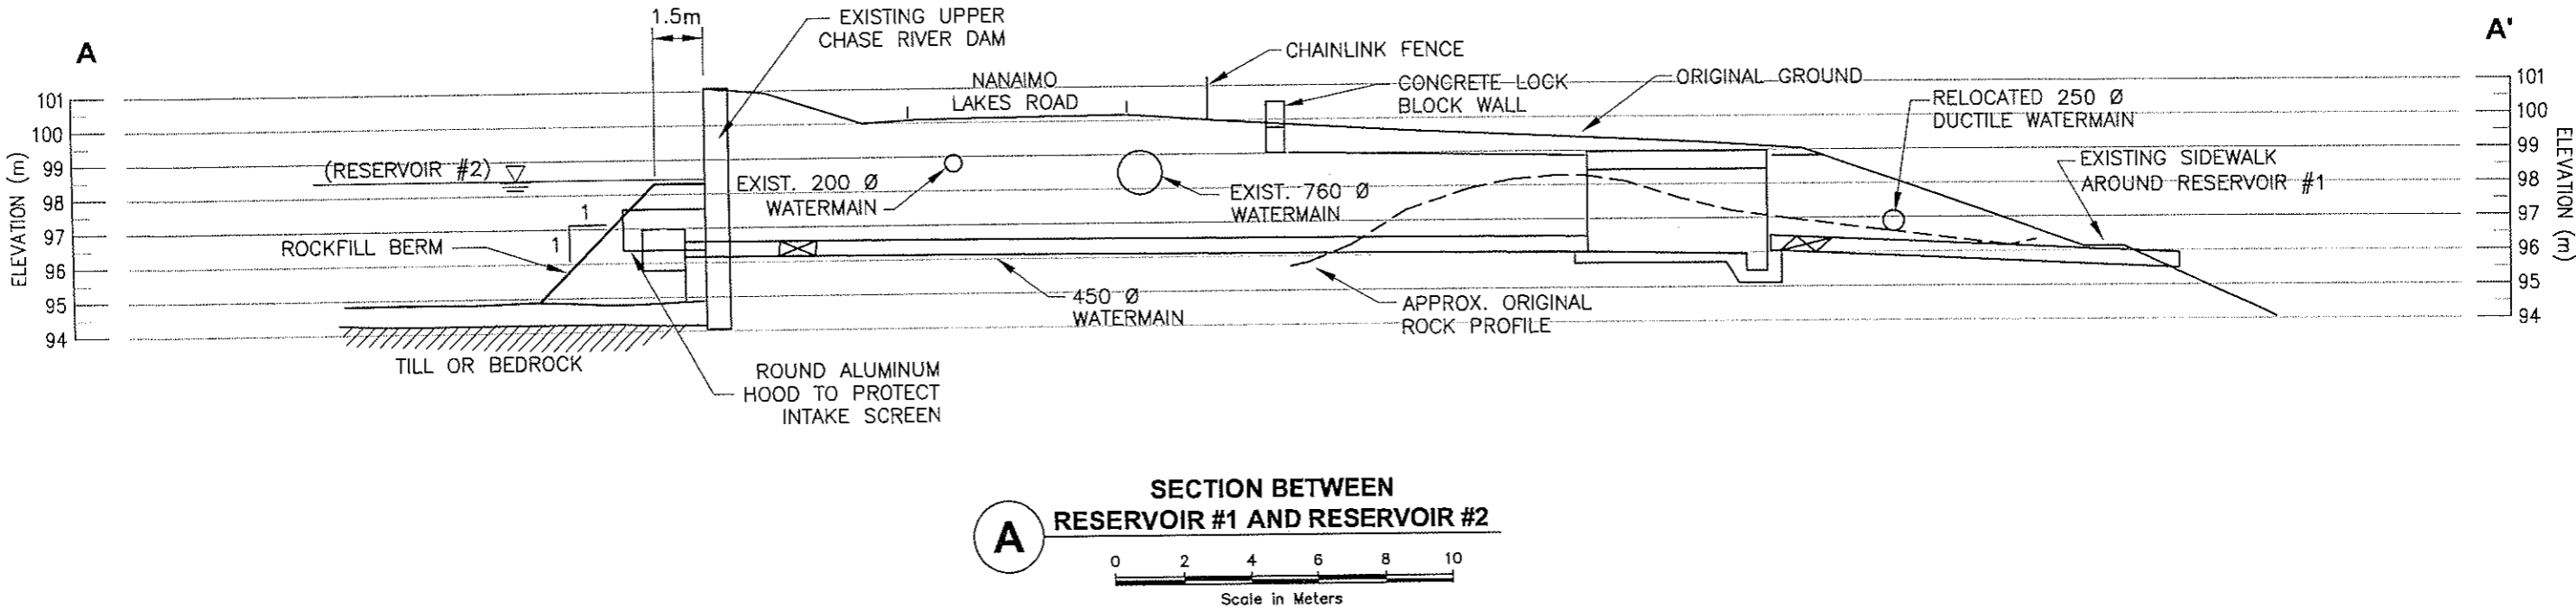
Figure 5

A conceptual design of the proposed rockfill berm is presented in Figure 5. The estimated cost of construction of this berm is approximately \$20,000, excluding any environmental work that the City may require. A rough order of magnitude for environmental work that may be required would be between \$7,000 to \$15,000, depending on whether a fish habitat study would be required or not.

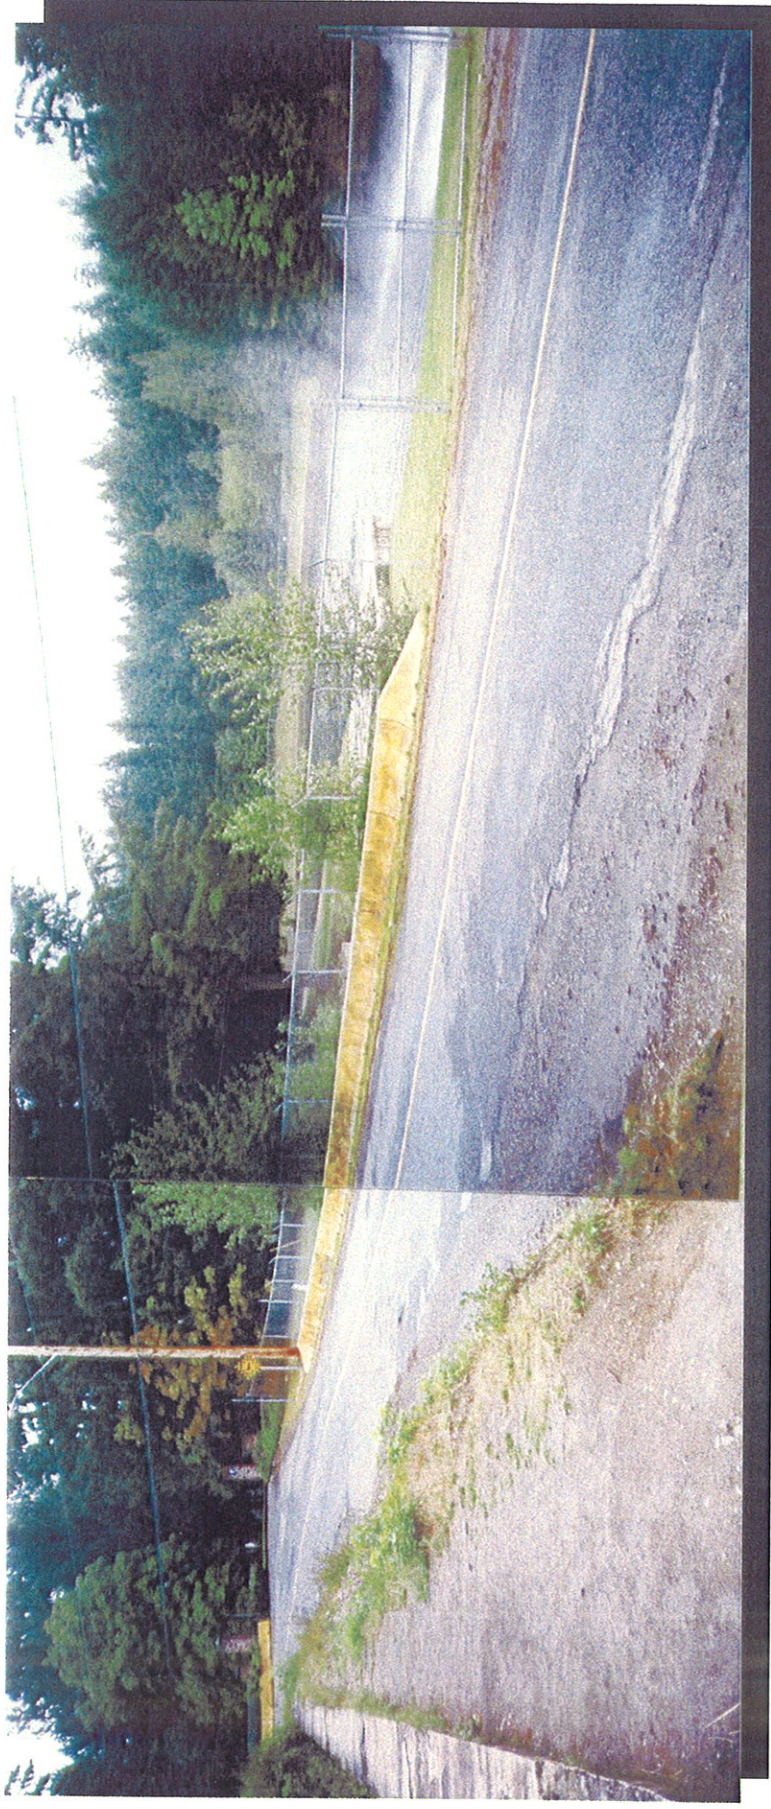
**Photo 2**

Upper Chase River Dam, facing north. Reservoir No. 1 in rear right of photo.

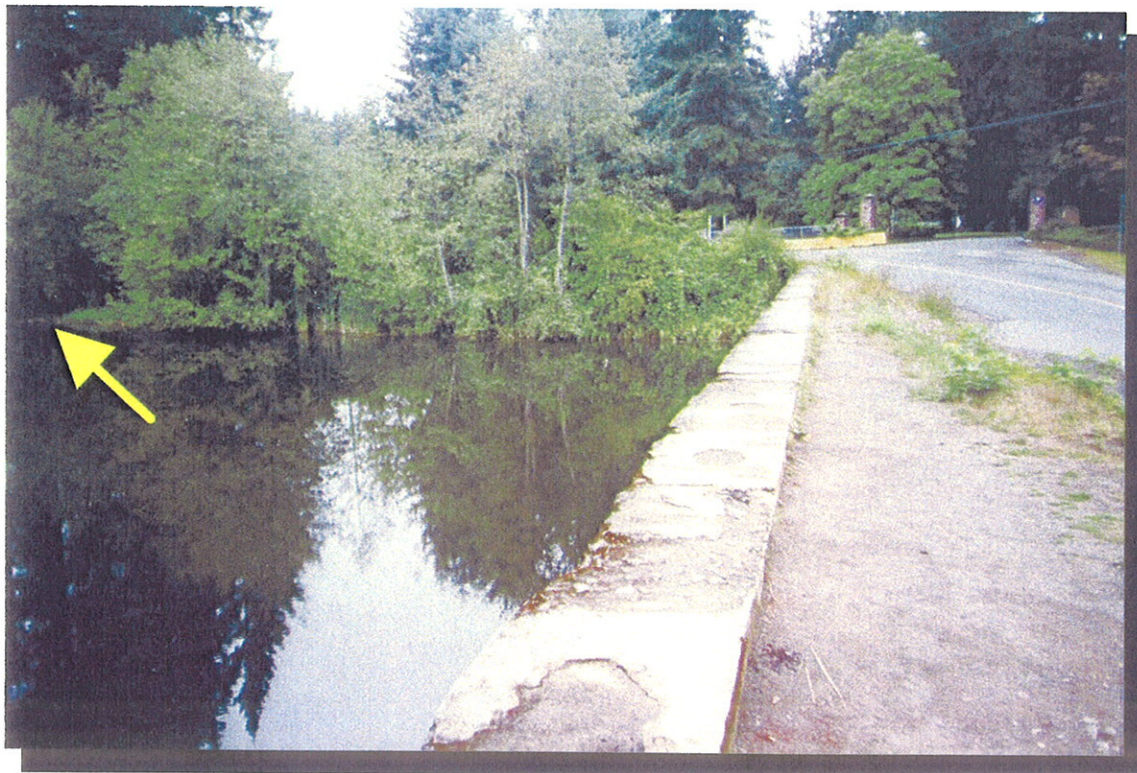
**Photo 4**

Concrete wall on upstream side of Upper Chase River Dam.  
Spillway inlet at far left of photo (see yellow arrow), facing north.

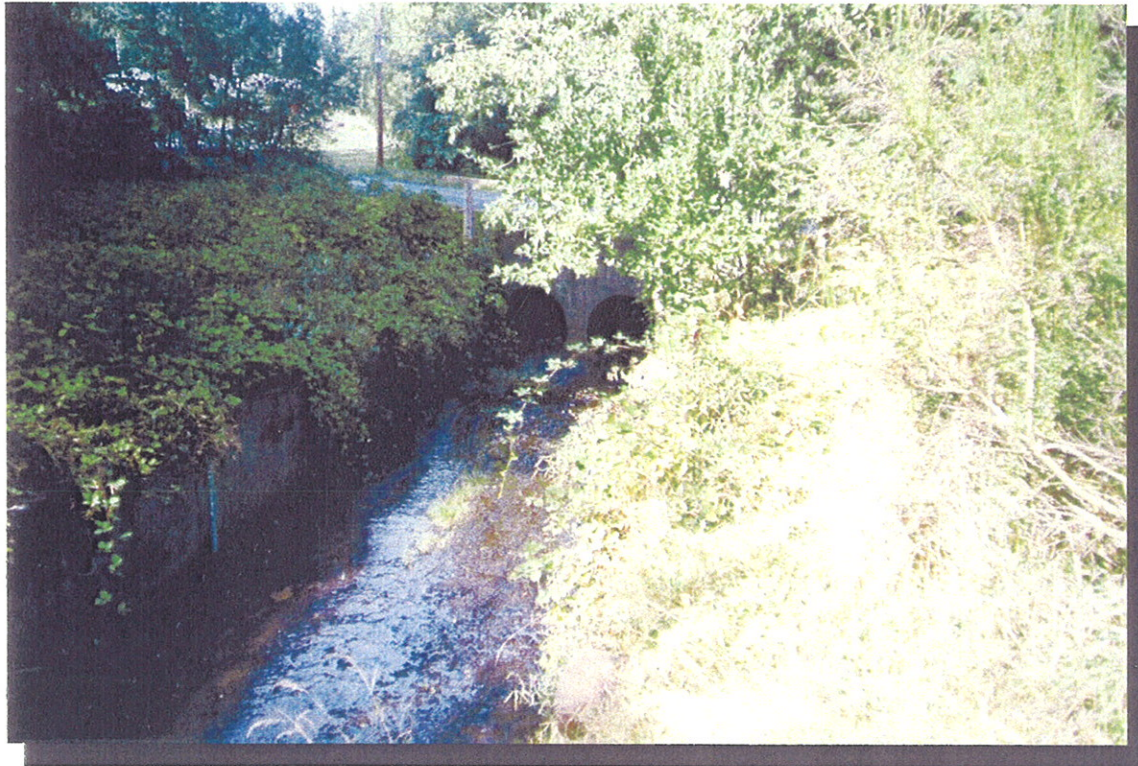
**Photo 9**

Spillway channel to twin culverts under Nanaimo Lakes Road, facing northeast.

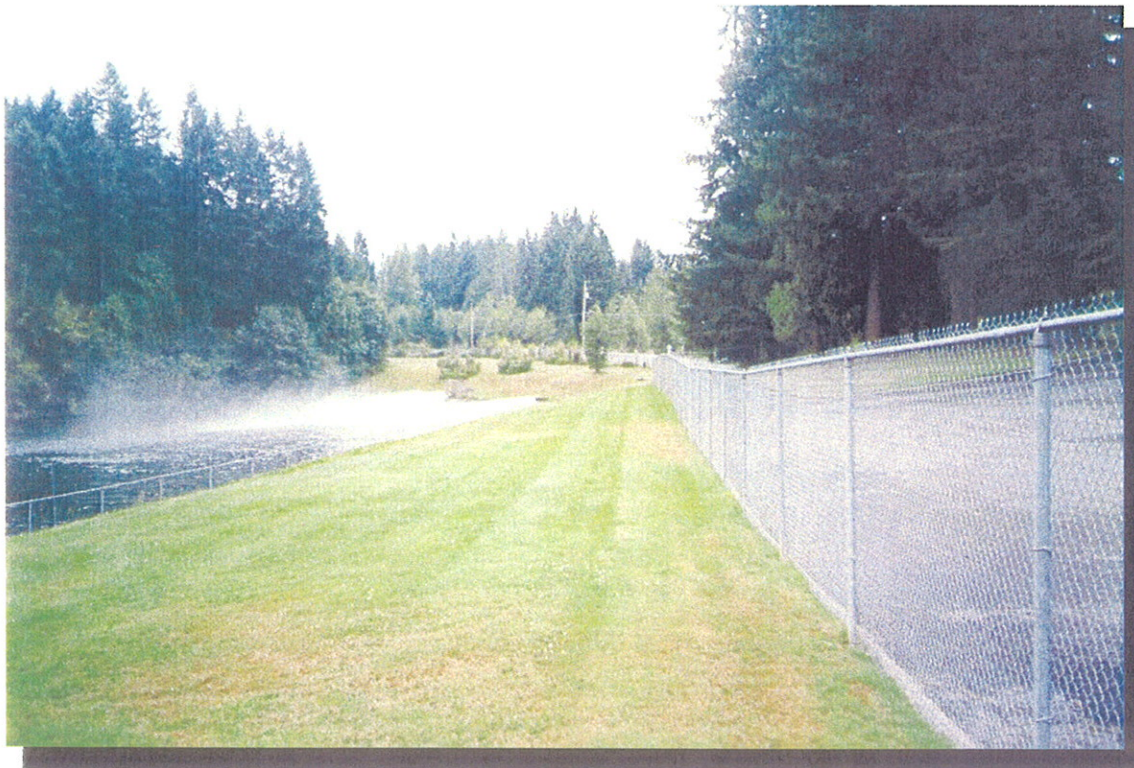
**Photo 10**

Downstream slope of Upper Chase Dam from control building for Reservoir No. 1, facing southwest. Water jets are from pipeline from South Fork Dam.

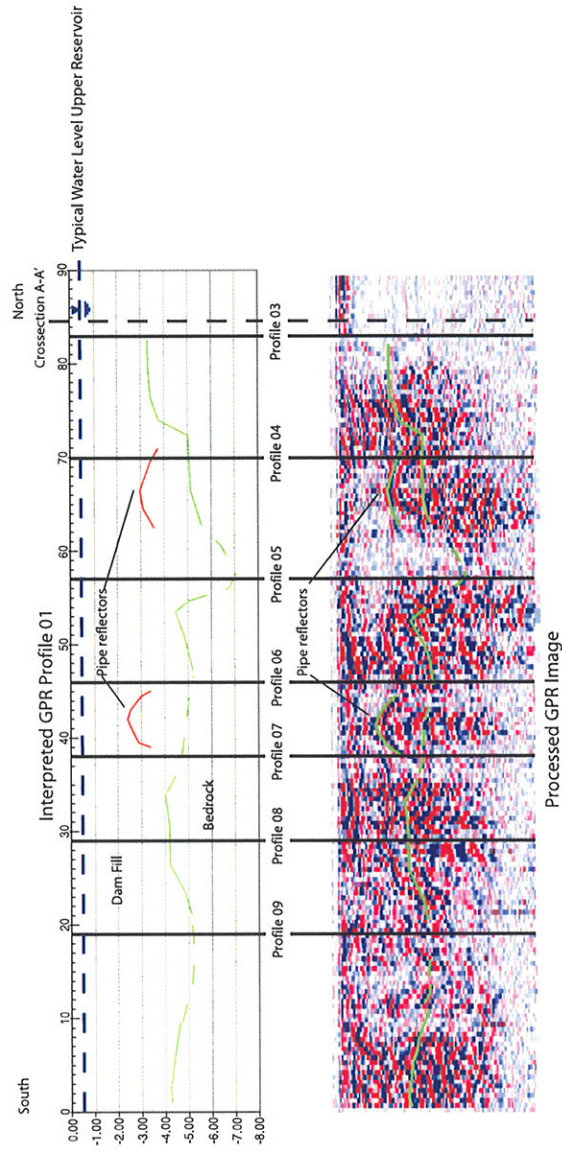
Figure 2

The GPR data collected using the 200 MHz Pulse Ekko IV data had lower horizontal and vertical resolution than the 500 MHz data but typically identified reflections between 6 to 8 metres below grade on the majority of the profiles. This penetration depth was sufficient to identify any bedrock horizon of interest provided the bedrock contact was detectable (see Limitations Section 3.1). The Geophysical Profile data collected using the 200 MHz antennas are shown in Figures 2, 3 and 4.

Figures 2, 3, and 4 consist of two panels for each geophysical profile, the lower panel shows the processed GPR profile with reflectors that have been identified as significant selected, and the upper panel shows an interpreted panel with depth of the reflectors, their location along the profile line and some descriptive comments. In addition, significant tie points between lines are provided as well as the approximate water level in Reservoir No. 2.
