Underwater Sonar Profiling Survey Of Westwood, Middle and Lower Chase Lakes for The City of Nanaimo

November 4th and 18th 2003

> Prepared by AquaCoustic Remote Technologies Inc 888 379 7601

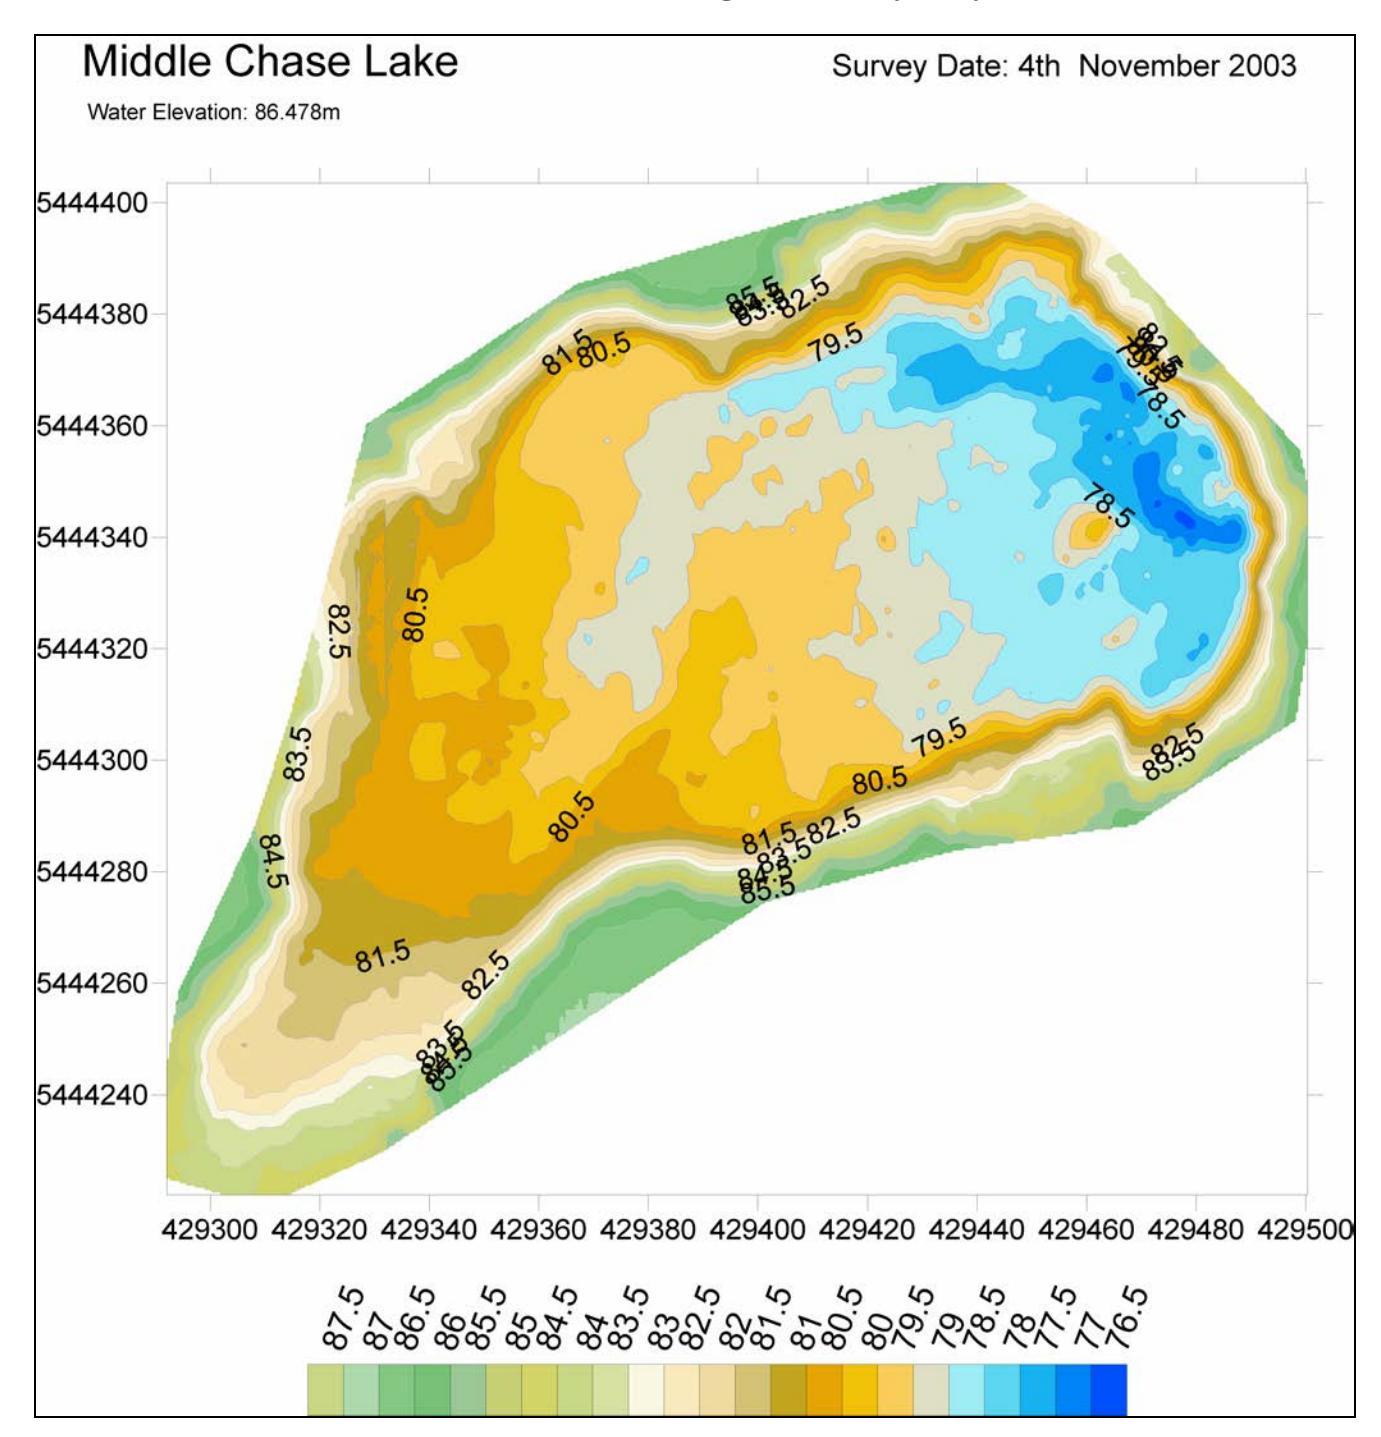
Possible pipe from south side of lake.

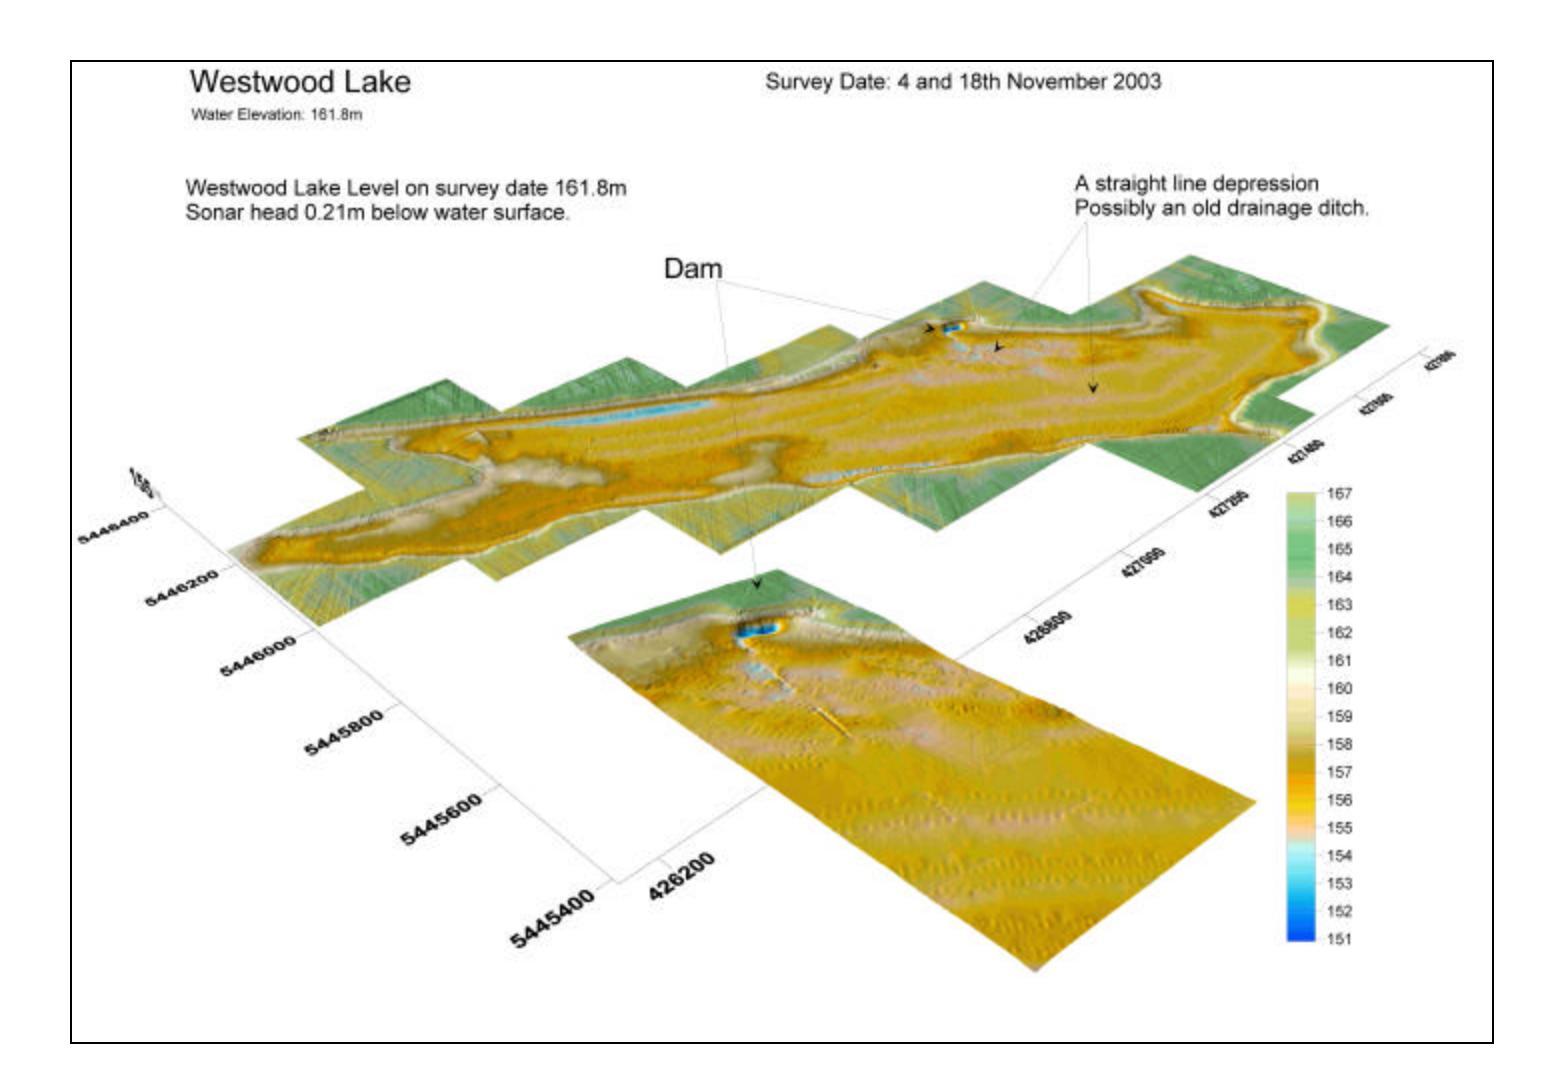
The sonar data shows a straight ditch proceeding from the west side of the dam and traveling offshore. This depression is approximately 6 metres wide by approximately 1 to 2 metres deep. Other straight line depressions are also observed in the lake bottom. These may have been drainage ditches before the reservoir was flooded. The deepest part of the lake is in front of the dam.

Sonar profile data across depression showing 6.738 m width
