March 4, 2014

Middle and Lower Chase River Dams Progress Update

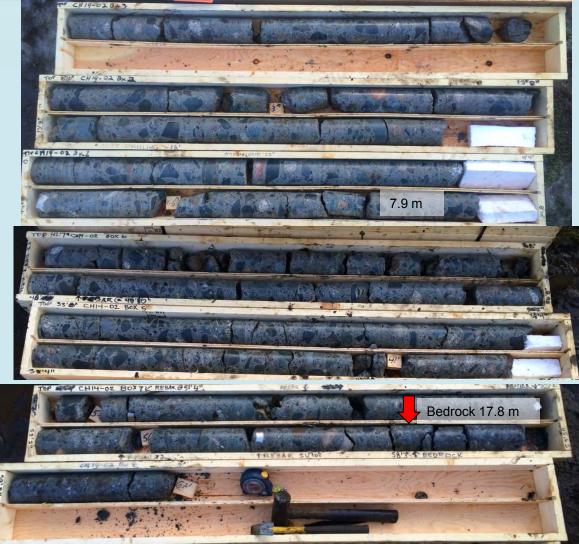
of a cold joint at that location.

Due to time constraints,
 the corehole was advanced
 0.8 m into bedrock.

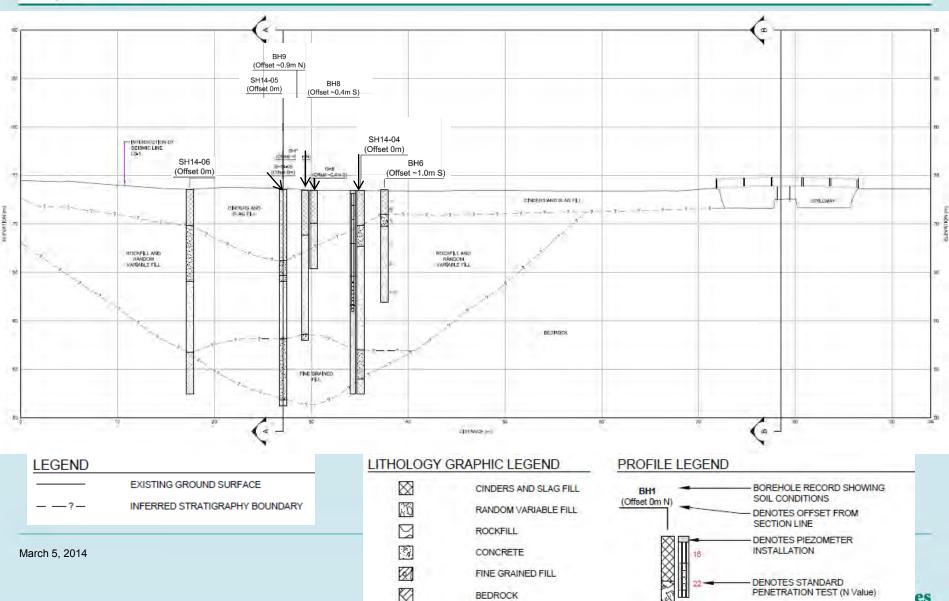
Section C-C' (through sonic holes)

- SH14-04 Drilled Feb 12 and 13, 2014.
- Drilled with 150 mm core barrel and 178 mm casing.
- Recovery in the following materials:
 - Cinders and slag was on average 80%
 - Rockfill and Random variable fill (contains Concrete) was 20 to 80%
 - Fine grained fill was on average 50%
 - Bedrock was on average 100%

NOTE: The sonic drilling method tended to "pulverize boulder and cobble sized particles" while advancing through the Rockfill and fine grained fill strata.

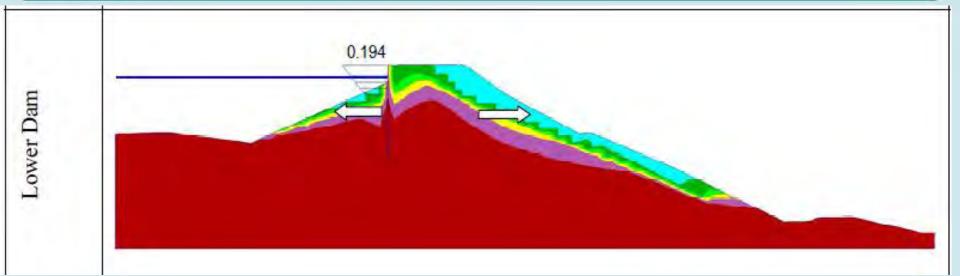
- Failure Modes shown for 1:3000 year EQ
 - 1. Toppling
 - Low likelihood for Lower Dam insufficient displacement
 - 2. Cascading Failure overtopping and toppling
 - Remediation required to control addressed later
 - 3. Post Seismic Internal Erosion
 - Further evaluation (next slide)

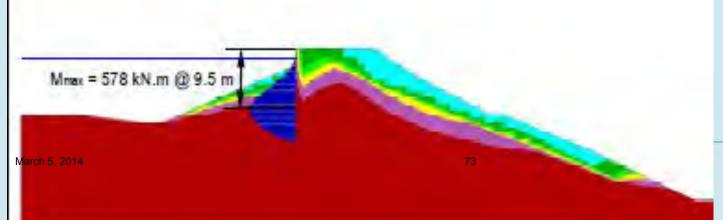
- EBA indicated cracking could be severe due to influence of construction joints, honeycombing, poor quality concrete, lack of reinforcement, etc
- We now know the concrete is in significantly better condition than previously expected - cracking likely to occur, but will not be as severe as expected (further analysis would be required to determine extent)
- Dam core has already experienced a large EQ (1946, 0.14g, 125 year return period), with no visible damage (MWH, 2014 DSR)
 - Maximum bending moment at 9.5 m depth (based on a average height of 14.5 m) maximum depth of persistent cracking

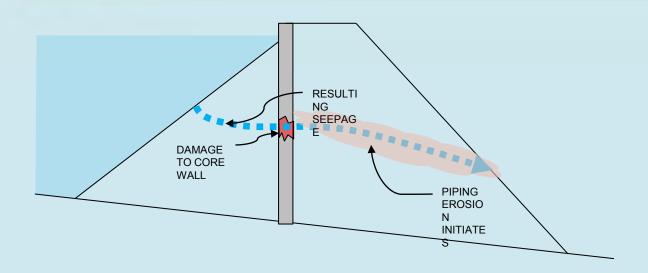
FM 3 – Cracking, Internal erosion and instability of downstream shell

- As indicated earlier, cracking in core will be limited
- Coal waste will deflect (and crest will settle about 0.5 m), but displacement of rock fill is limited
- Increased seepage may result in increased water levels in fills and potential piping/erosion of coal waste.
 - Destabilization of rock fill very unlikely therefore dam breach due to this failure mode very unlikely.
