January 21, 2014

Middle and Lower Chase River Dams Progress Update

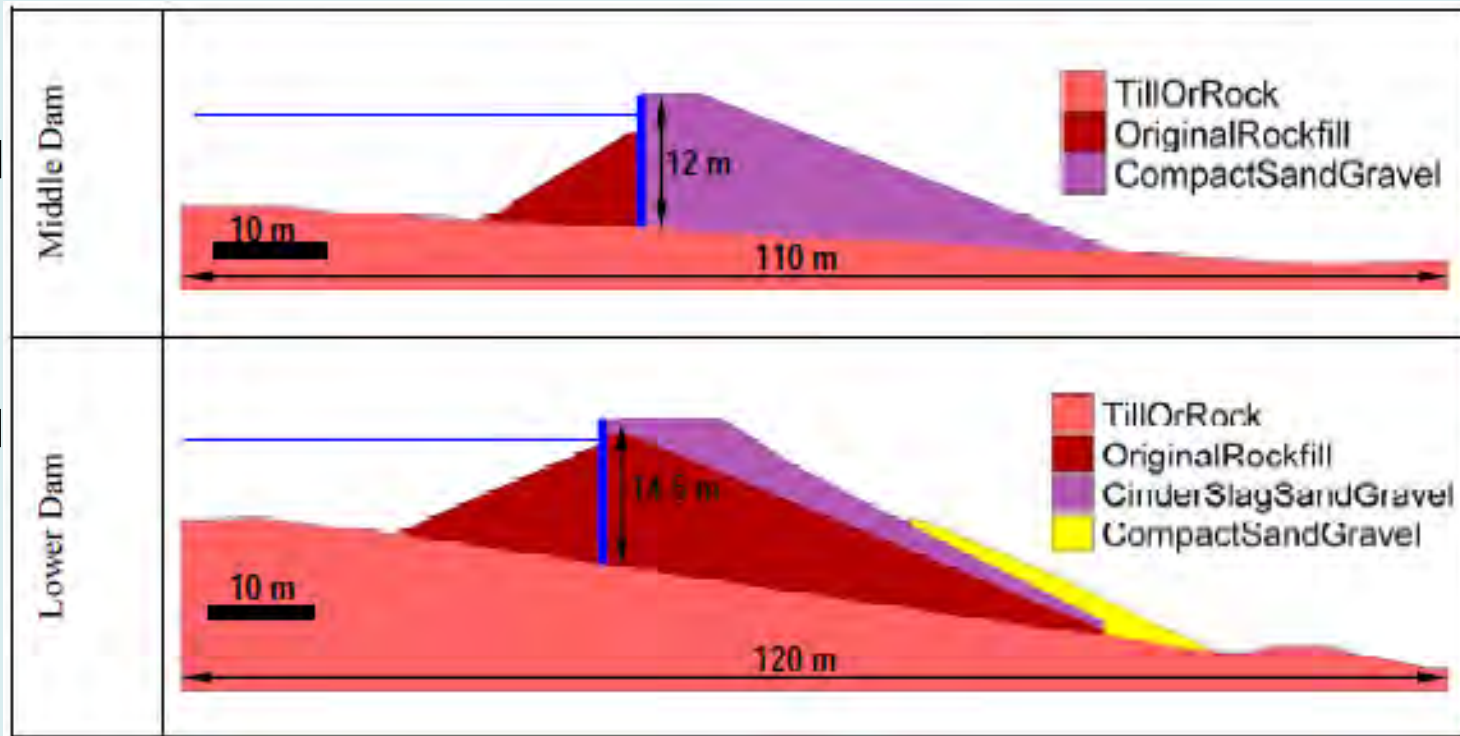
- Parametric 2D analysis carried out by EBA (April 2010), based on 3 assumed scenarios
 - Best case scenario material properties reasonably assumed
 - Reasonably worst case scenario material properties assumed
 - Most likely case scenario material properties assumed based on available data and engineering judgment
- Friction angle and shear modulus numbers based on SPT “N” values

available for
Rock Fill,
Sand/Gravel and
Cinder/Slag.
The dam till-like
foundation
parameters used
for analysis not
clear

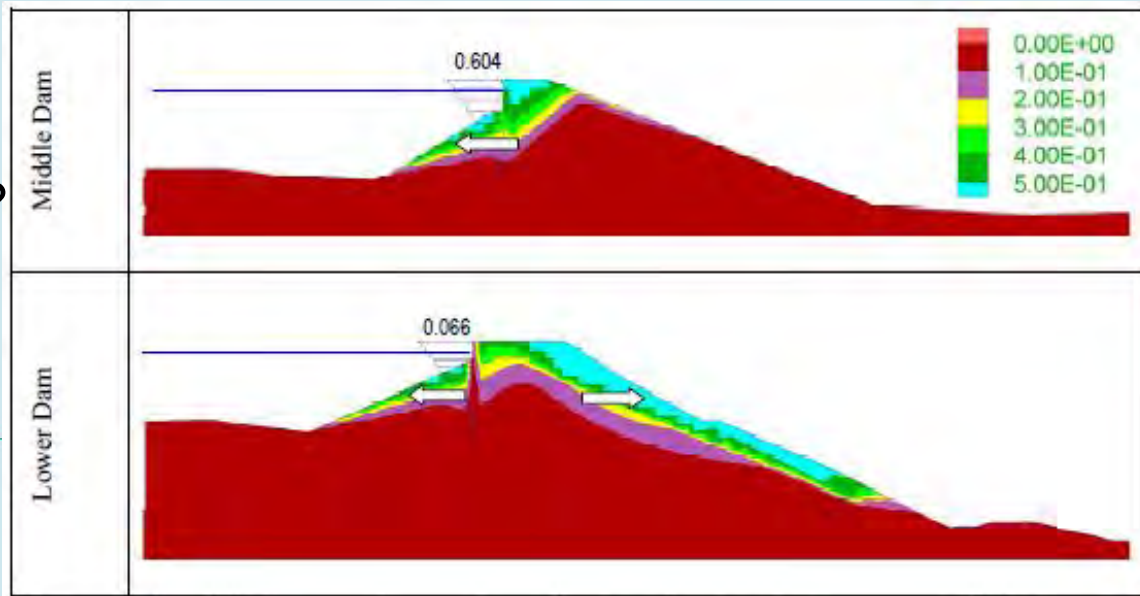
Middle Dam

- Toppling or shearing more likely
 - Loss of containment?

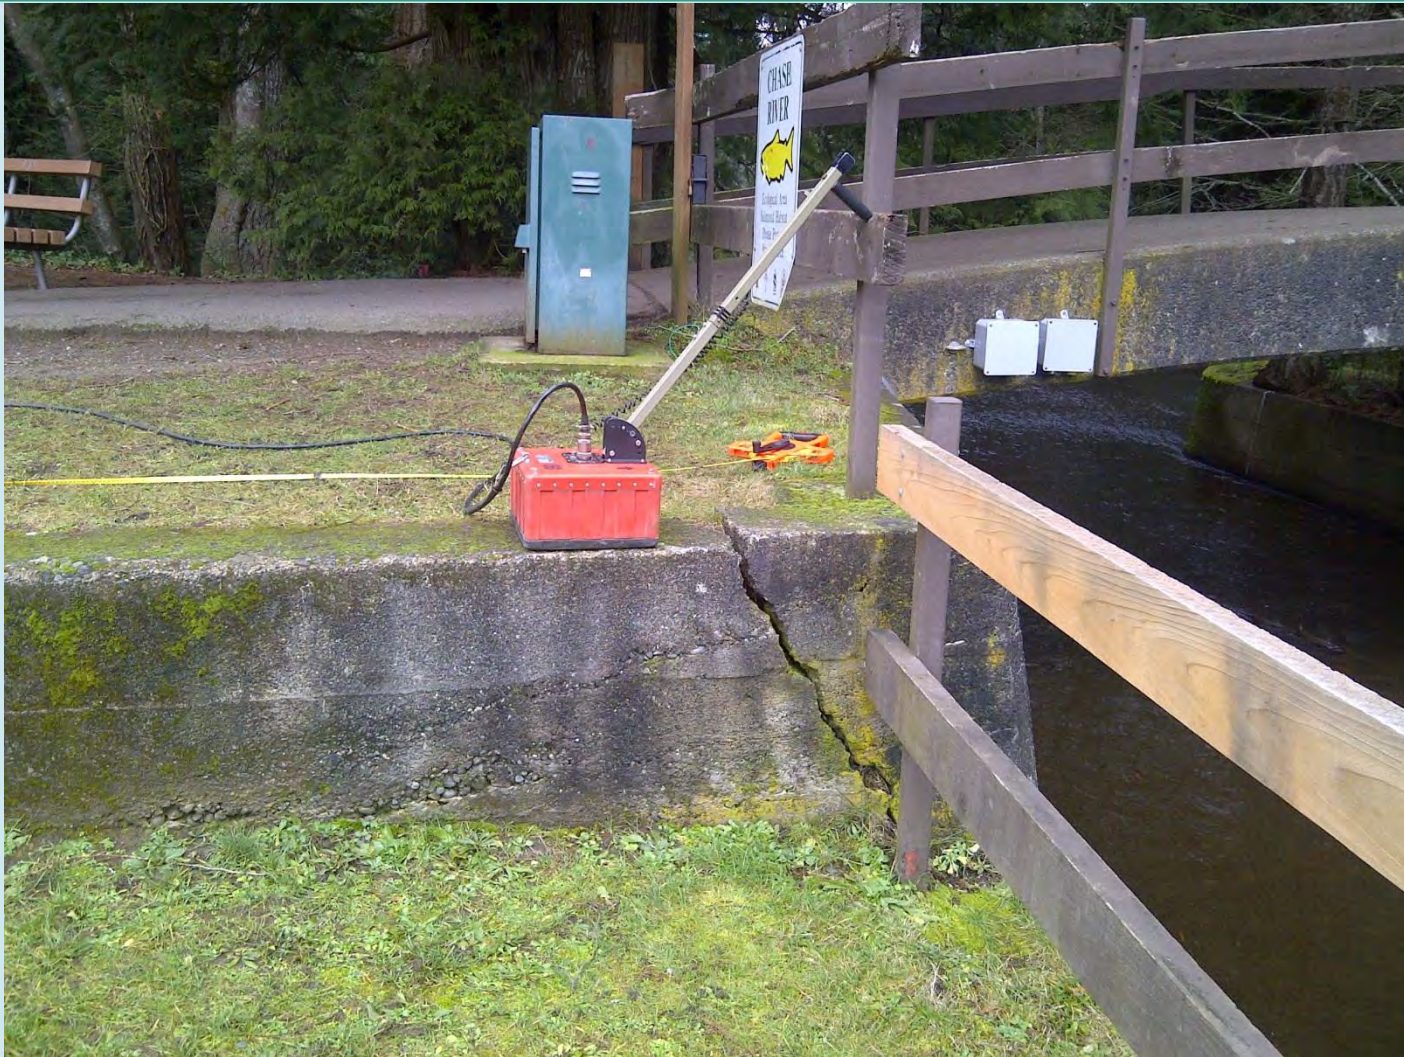
GPR 400 MHz-Lower Dam, Top of Wall (L-9)

- **Characterize amount of reinforcement (such as rebar) within the concrete wall as discernable from the top of the wall along the dam crest:**
 - **Both Dams** – Depths of radar penetration to be determined (possibly to ~2 m). **GPR data yet to be processed and interpreted;**
 - **Middle Dam** – Possibly see 2 or 3 horizons of rebar (shallowest rebar spaced approximately 0.8 m).
 - Possible layering is apparent (possibly 4 interfaces w/in depth range);
 - Anomalous reflective zones – suggest possible variations in moisture content and/or other properties;
 - **Lower Dam** – Rebar not immediately obvious; however a variety of internal structures are apparent—possibly irregularly spaced rebar and nonexistent in some sections.
