# MILLSTONE RIVER EAST WELLINGTON PARK SIDE CHANNEL CONCEPTUAL DESIGN

## **FINAL REPORT**

#### Northwest Hydraulic Consultants Ltd.

13 April 2021

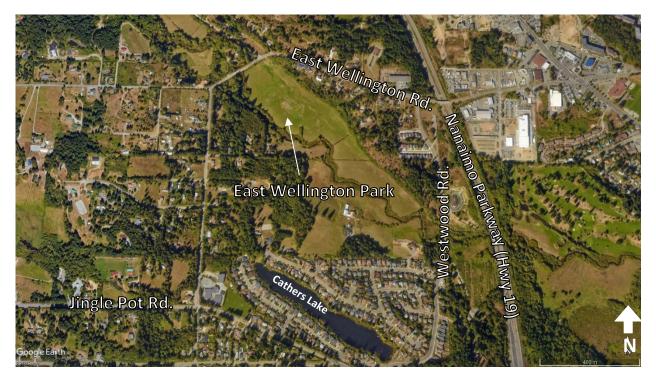
#### Figure 1. Overview map

The City of Nanaimo (CoN) retained Northwest Hydraulic Consultants Ltd. (NHC) to determine a side channel's feasibility on the Millstone River within East Wellington Park. The project intends to restore and enhance the Millstone River's salmonid habitat and provide opportunistic enhancement of other native wildlife habitats. **Figure 1** provides an overview of the project location.

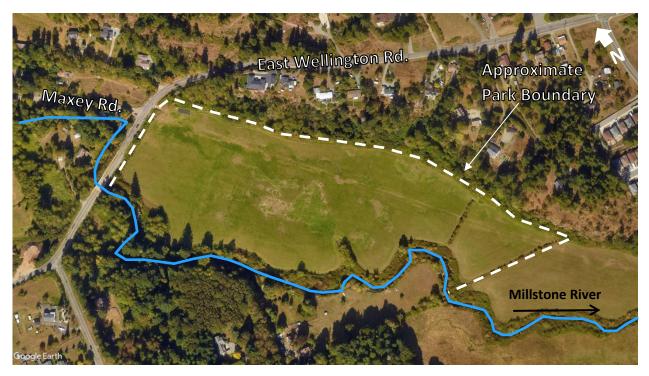
Figure 2. Close-up view of East Wellington Park

Located within the North Jingle Pot Neighbourhood, the 12.7 hectares East Wellington Park is currently used to cultivate hay and pedestrian use. The park is accessed via East Wellington Road near the intersection of Maxey Road. The boundaries include East Wellington Road to the north, a steep forested hillside to the east, a farmer's field to the south, and the Millstone River to the west. Located along the steep hillside's toe is a CoN sewer line scheduled for an upgrade in the coming years. **Figure 2** provides a close-up view of the park.

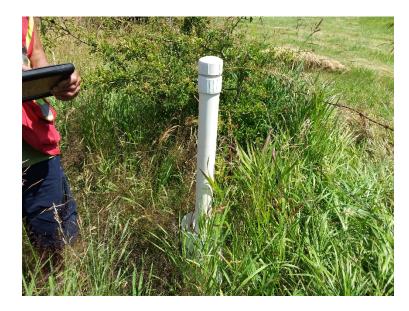
During the site visit, an existing standpipe with an unknown purpose was identified at the Park's southern extent along the fence line, approximately 40 m from the Millstone River. The pipe consists of a 2" PVC pipe with a threaded cap that extends approximately 3 m below the soil surface (**Photo 1**).

Photo 1. The existing standpipe of unknown origin is located along the southern boundary of the Park.

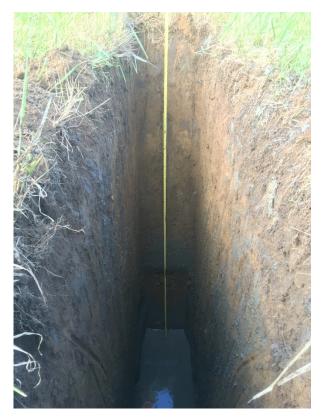
Photo 4. Physical measurements of the soil profile and depth to water.

- a. Soils of similar properties were separated and stockpiled for documentation and backfilling (**Photo 3**).
- 3. Measurement and photo documentation of the soil profile from the surface, documenting the thickness and types of soils encountered (**Photo 4**).

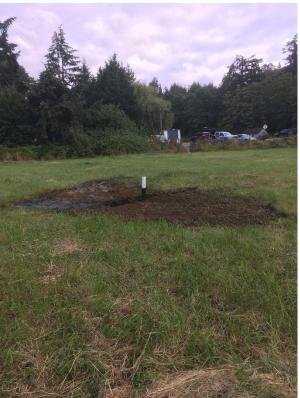
Photo 5. Completed well installation.

- 7. Installation of a cap on the PVC pipe.
- 8. The backfilling of the pit to the surrounding ground elevation, placing the material in the order it was excavated to maintain similar stratigraphy (**Photo 5**).

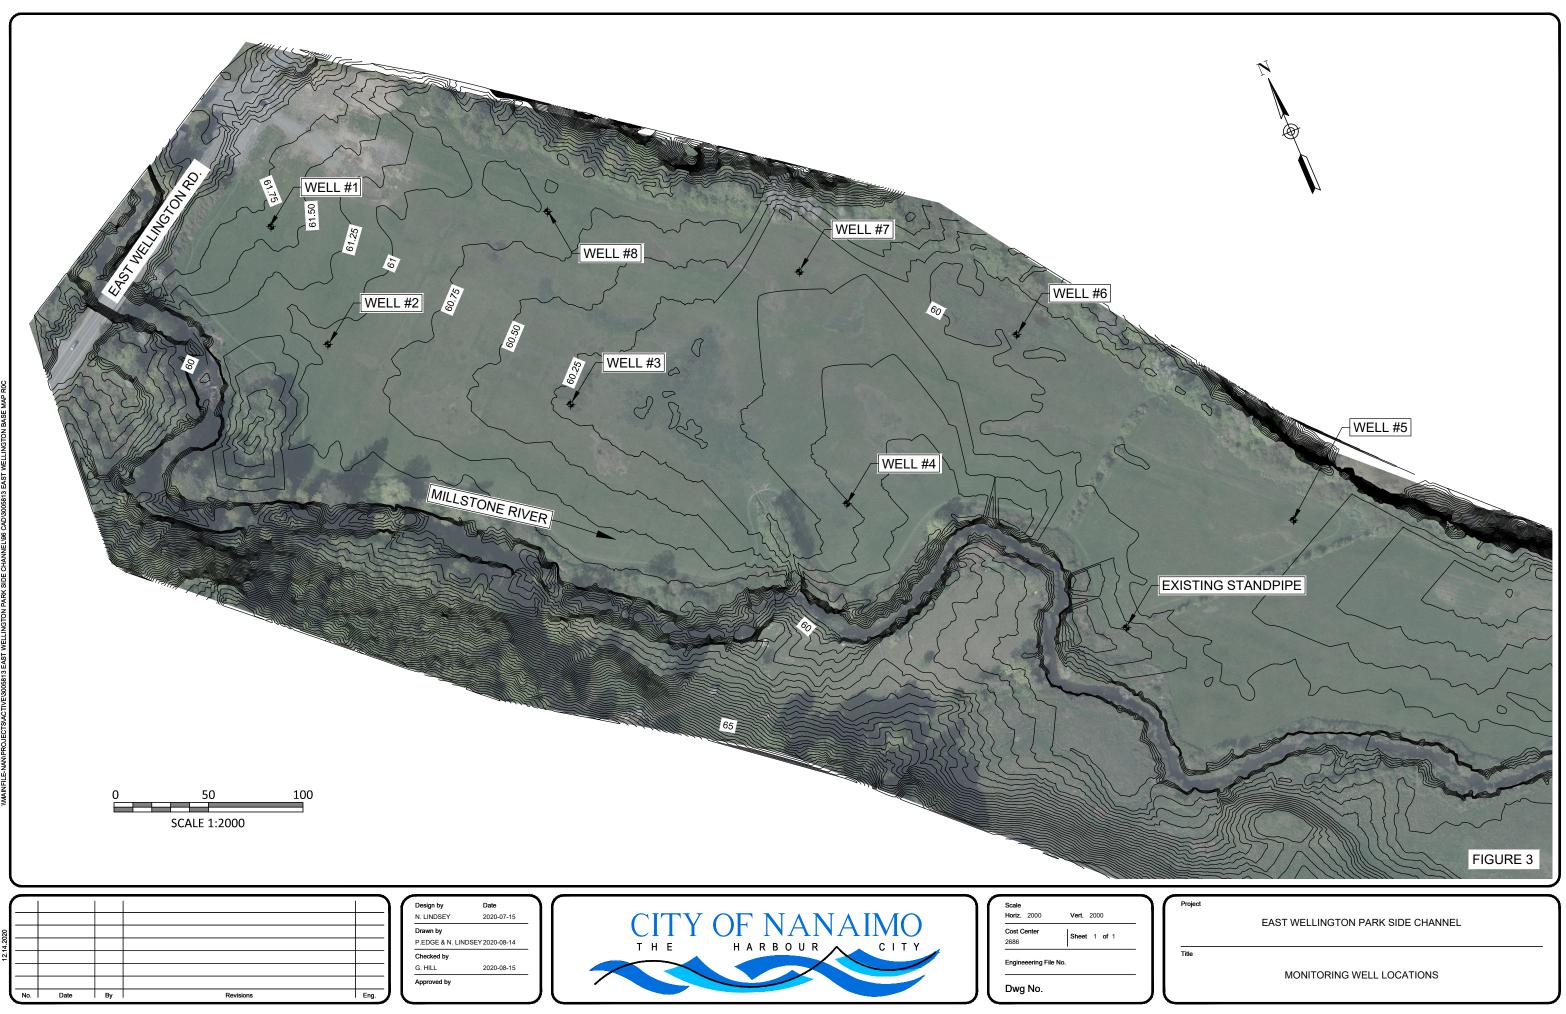
The well locations were selected to assess the groundwater parallel to the Millstone River and the hillside's toe. The wells were installed along two alignments 50 m apart with a well spacing of about 50 m. Each well consists of a perforated 100 mm PVC pipe wrapped in filter fabric. **Figure 3** provides the locations. A Hitachi EX70 excavator was used to excavate open pits for the well pipes. The pit depth's varied depending on the soil conditions and groundwater levels. The maximum pit depth, limited by the excavator's reach, was 4.3 m. The general monitoring well installation procedure was as follows:

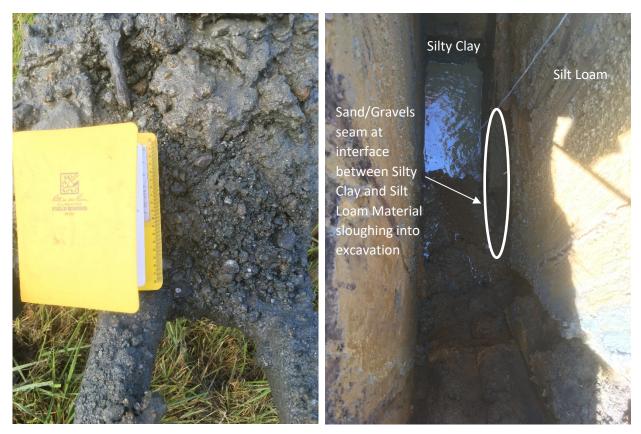
Photo 6. Sand and gravels from the bottom of the Well #1 excavation.

- Well #1, sand and gravel (<=20 mm) encountered at the bottom of the excavation (Photo 6).
- Well #6 and #7, pieces of wood encountered in the Silty Clay horizon.

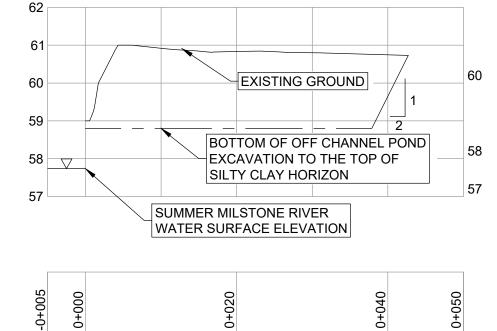
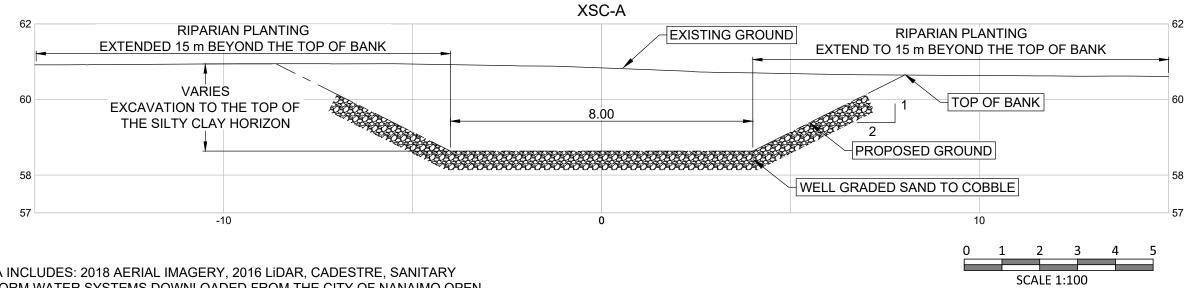
# TYPICAL OFF CHANNEL POND PRFOILE

CONCEPT SIDE CHANNEL PROFILE AND TYPICAL SECTION VIEW

Based on the matrix results and the above rationale, the off-channel pond is the most suitable restoration option to pursue. It has the added benefit of being implemented as a pilot project with a single pond's construction. This pilot project will explain fish usage in the area and inform the need for additional restoration activities. The ponds will provide important off-winter refuge habitats. Fish use will be low (on none) in the summer when water quality parameters are poor, and the ponds drain. Fish are expected to migrate in and out of the ponds adapting to site conditions. There is a potential for sediment accumulation at the inlet, creating a potential for stranding issues. Periodic maintenance of the inlet to remove the material may be required. In addition to the off-channel ponds', we would recommend constructing the riffles proposed in the intake-fed side-channel option. It enhances habitat but also provides the ability to construct an intake side-channel in the future.
