NANAIMO HERITAGE BUILDING DESIGN GUIDELINES

THE FOUNDATION GROUP
#1 – 2629 West Fourth Avenue, Vancouver, B.C., V6K 1 P8
733-4593

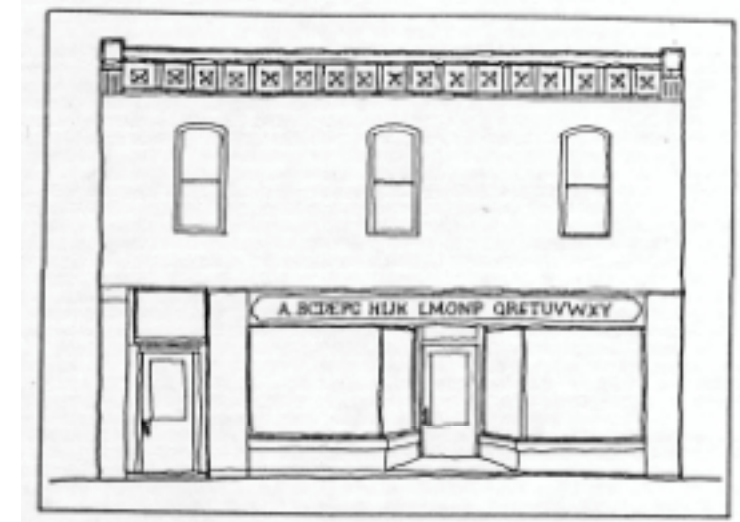
PLACEMENT OF SIGNAGE ON FASCIA

FASCIA SIGNS: are those which are placed on the fascia of a building, mostly in the area between the first and second floors. Fascia signs should not exceed sixty centimeters in height or exceed in length ninety percent of the width of the building. On buildings with two or three storefronts, fascia signs should be centered over the storefront areas. Fascia signs should be mounted flush to the fascia surface and should not interfere with either moldings or building ornamentation. Lettering on fascia signs may be routed or incised, applied flat (painted), cut-out, or carved. Uses of illustrations, sketches, or photographs on the fascia are strongly discouraged. Fascia signage, as all signage, should be in harmony with the nature of the building on which it is applied.

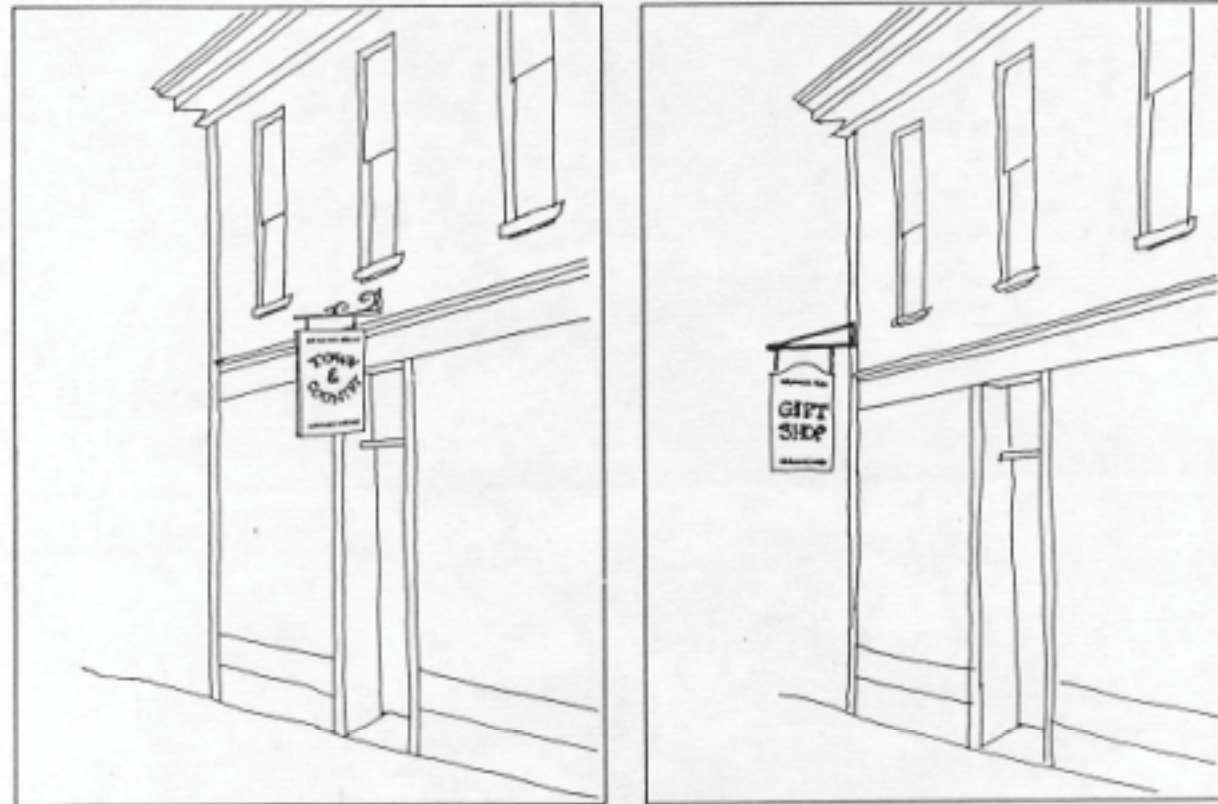
LOCATION OF PROJECTING SIGNS

PROJECTING SIGNS: are those which are hung or fixed at ninety degrees to the face of the building. They serve as an identification device and often convey a secondary message, such as street address or proprietor's name. Sculptural cut-outs in the shape of objects may represent merchandise offered, e.g., a boot advertising a shoe store. Projecting signs should not be mounted lower than three metres and may be mounted almost anywhere on the building as long as they do not extend above the eaves. For best effect, they should be centered above the entrances to building establishments. These signs should be positioned to align with the vertical elements of the building or aligned with the midpoints of windows or doors. The recommended material for projecting signs is wood, either painted, or routed and painted, hung from a wrought iron sign standard.

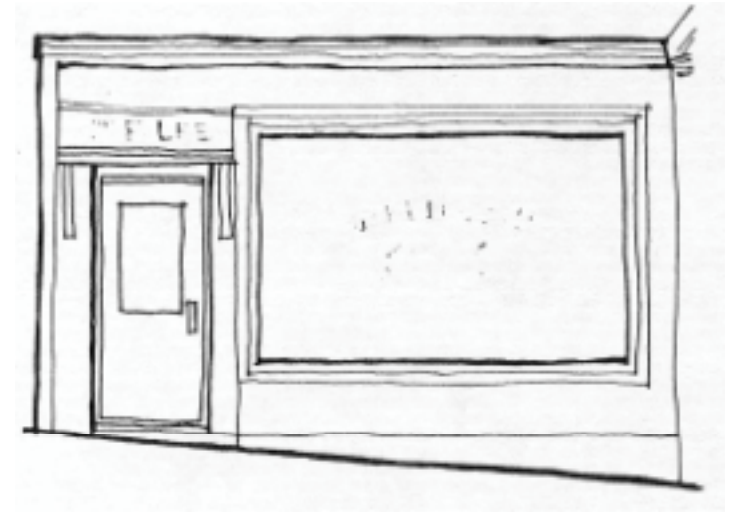
WINDOW SIGN

WINDOW SIGNS: are those which are painted, gold-leafed or otherwise affixed to a window or door, and identify the business within. Storefront windows are the most suitable for window signs. Window signs should occupy no more than thirty percent of the window area, or with door glazing, no more than fifty percent of the glassed area. Type should be simple, traditional and centered.

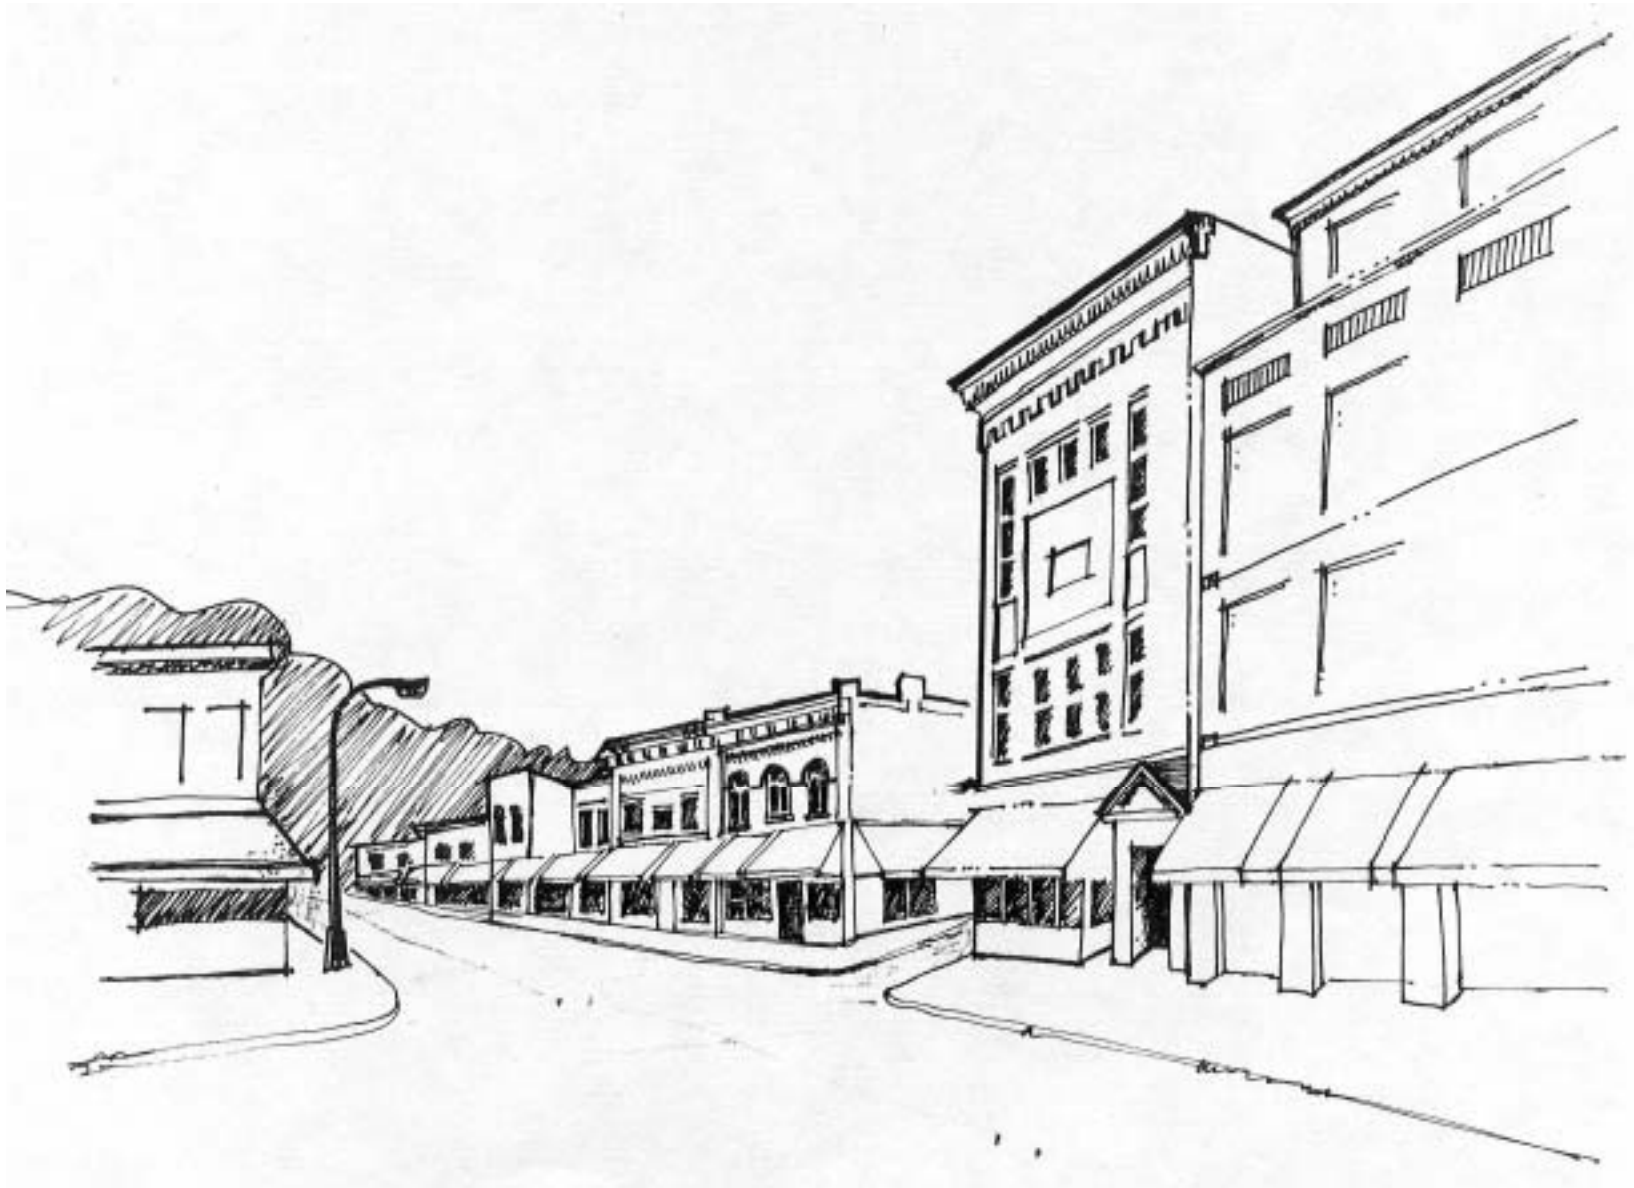
REVITALIZED STREETScape

Information on the design, construction and placement of canopies may be found directly in the Nanaimo Design Guidelines. The most appropriate form of canopy for the older buildings is the 3-point fabric canopy with valence drop. Canopies should be shaped to fit individual structural openings rather than run in a continuous band. Colour should be in harmony with the building facade and with adjacent colour schemes.

Lighting and signage may be integrated in the canopy design for an overall integrated effect. Canopies are the finishing touch for each individual project and emphasize the horizontal continuity of the streetscape.

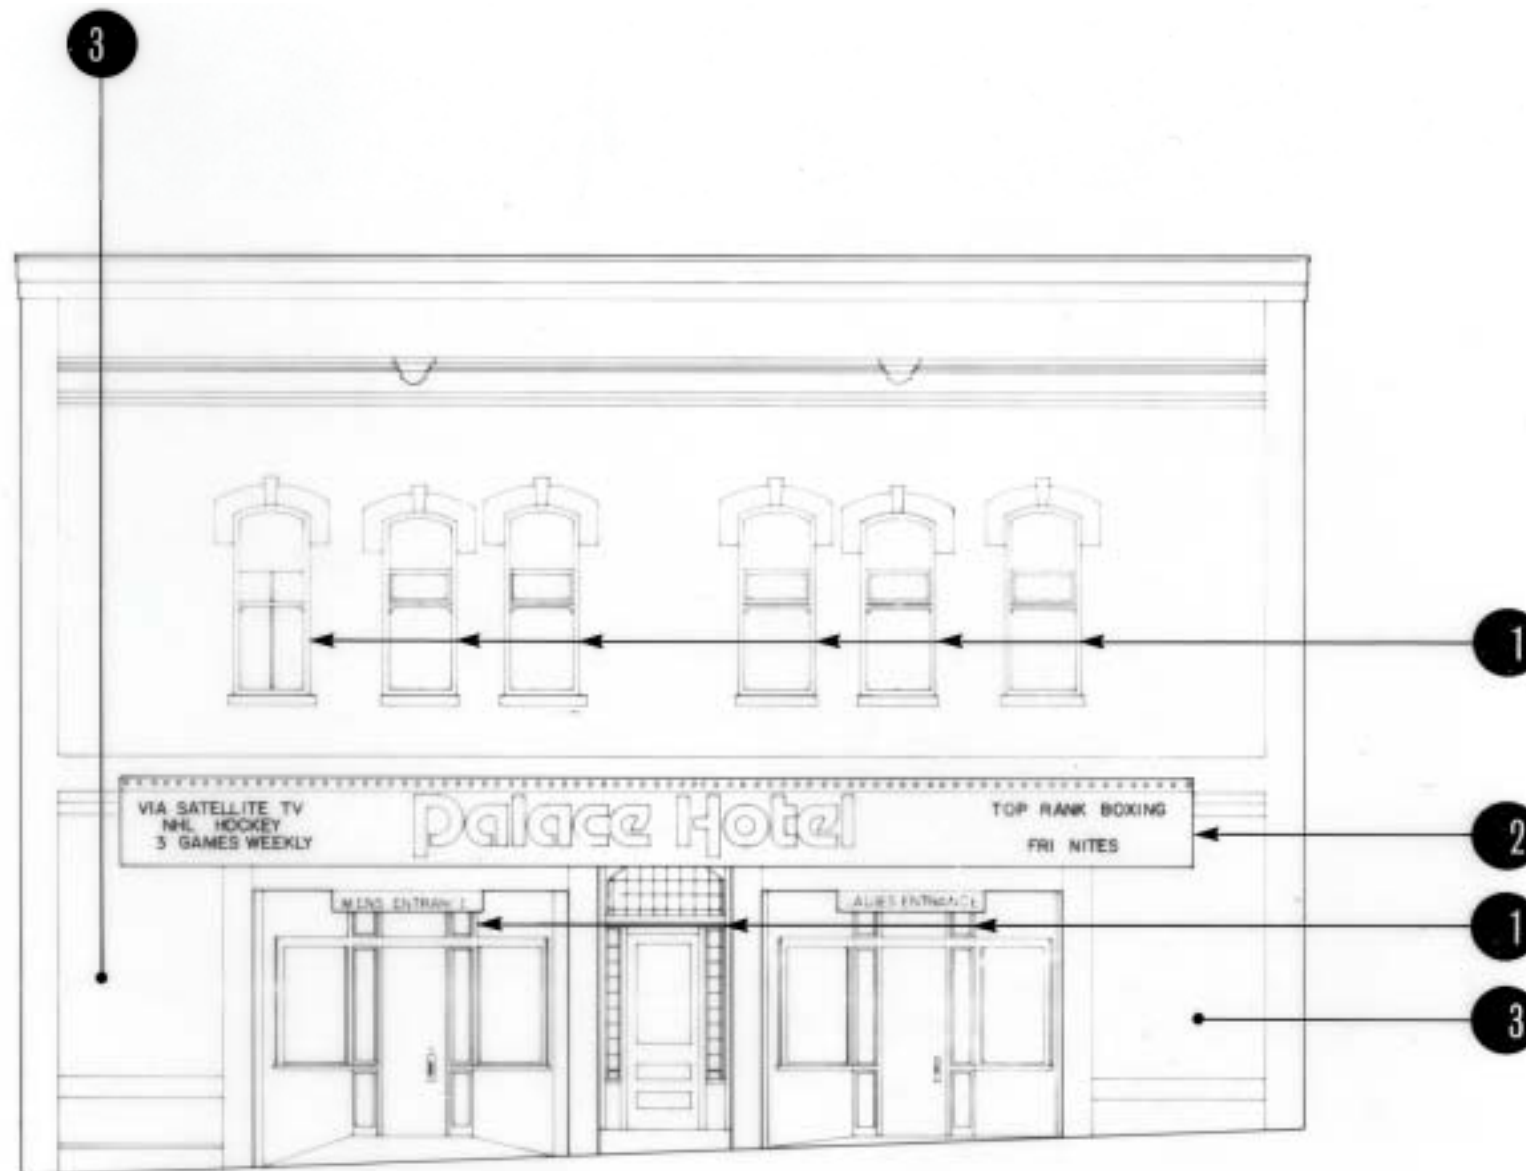
B. Recommended design

1. Existing signage removed
2. Brick removed from blocked-in ground floor arched openings. Blind fenestration added
3. Sympathetic surfacing materials to be used around entrances

GROUND FLOOR: The blocked-in arched openings should be unblocked and filled with appropriate blind fenestration.

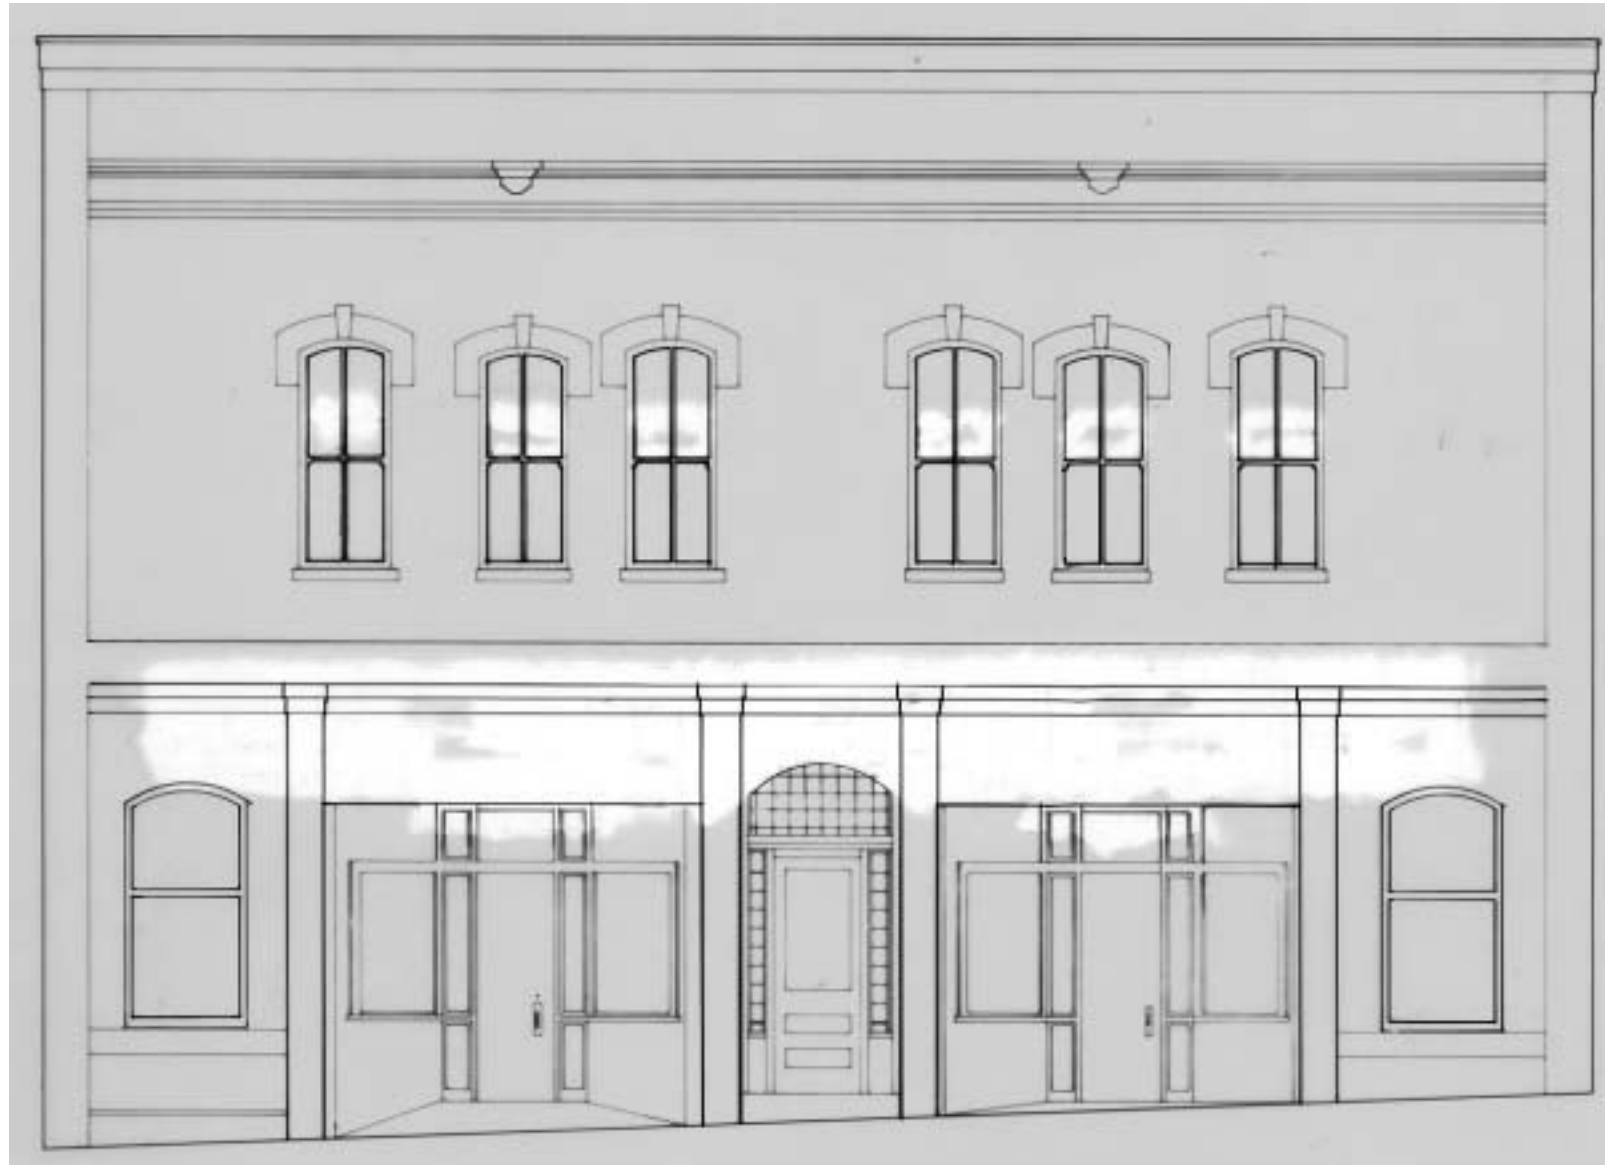
D. Auxiliary components

1. 3-point fabric canopies shaped to fit ground floor structural openings
2. Signage recommended along canopy valences, horizontally projecting from building face, painted or raised lettering on fascia, painted on glass, or neon tubing behind blind fenestration
3. Lighting recommended as part of canopy design

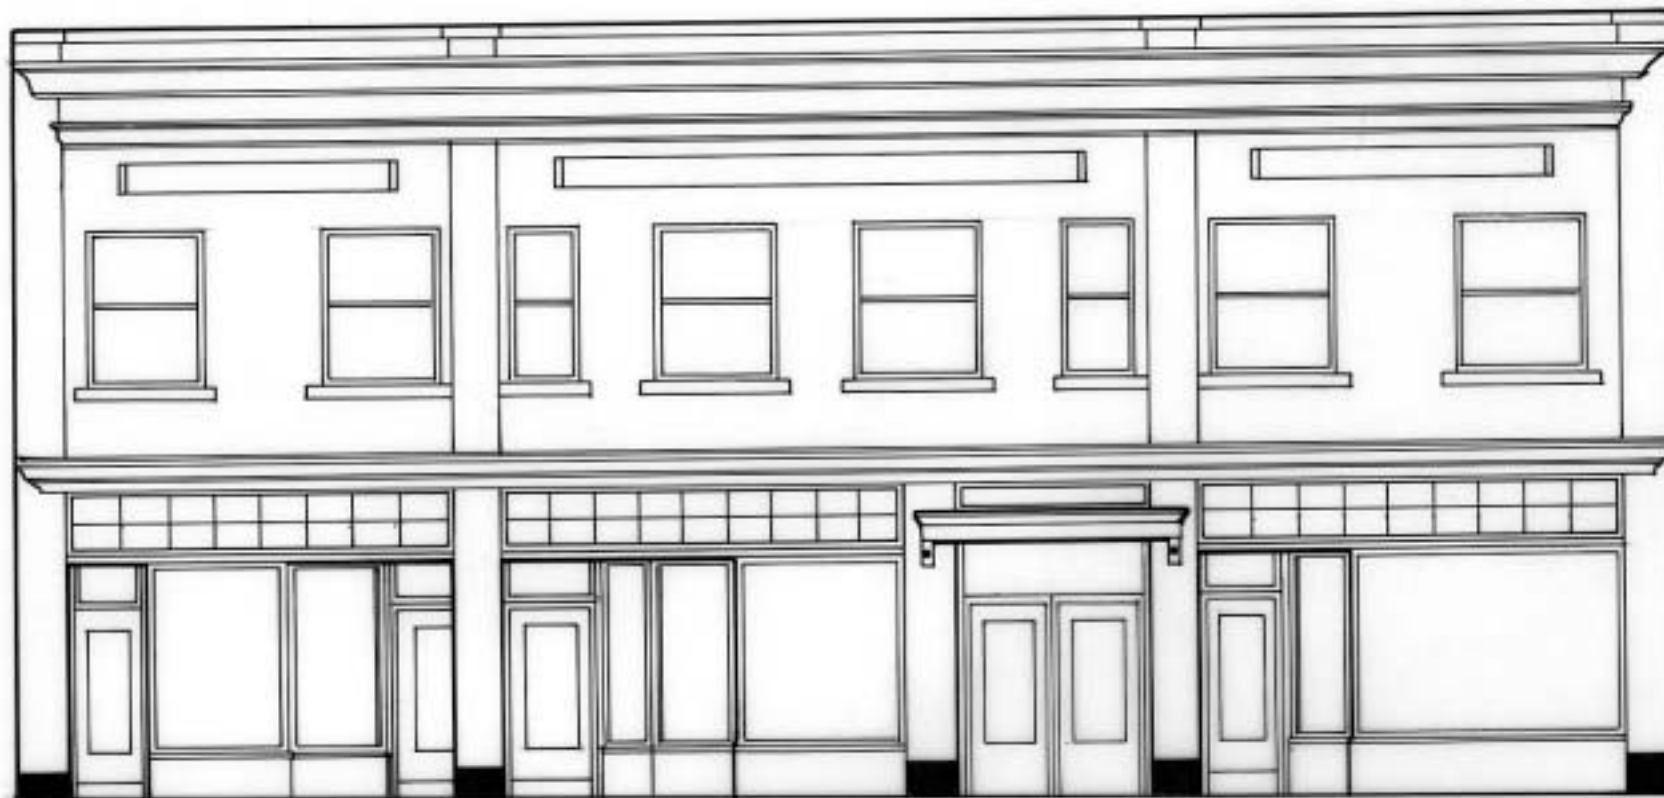
C. Shopfront & fenestration

1. Rebuilding of storefront elements with sympathetic materials
2. Replacement of second storey windows with double-hung wooden sash windows
3. Removal of unsympathetic surfacing materials

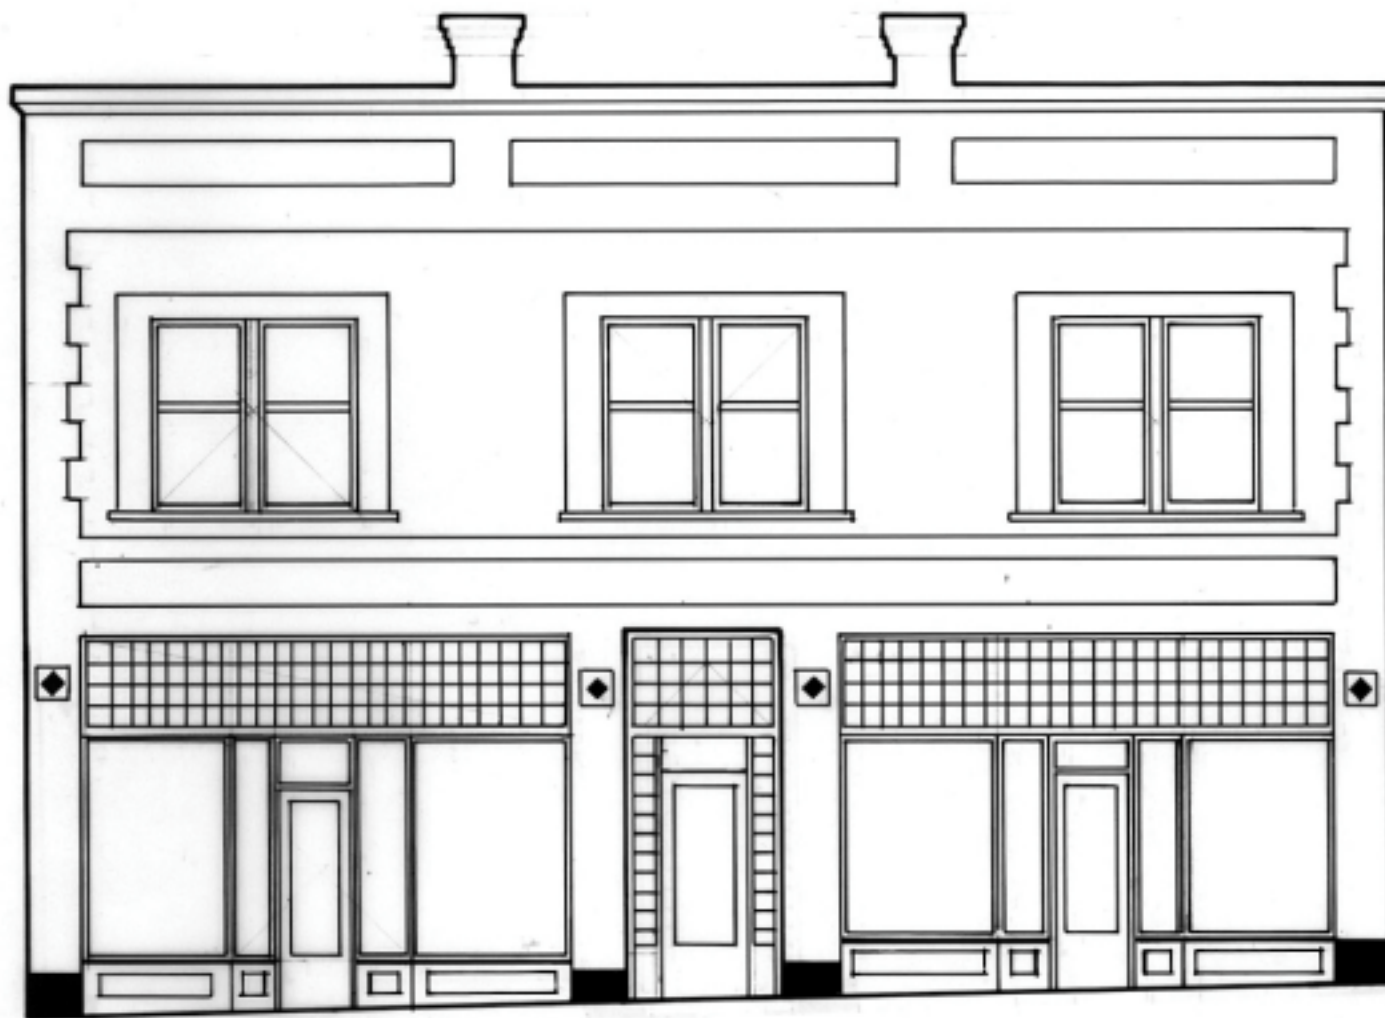
B. Recommended design

1. Removal of second floor windows
2. Removal of ground floor windows and doors and rebuilding of storefront elements
3. Replacement of signage and lighting

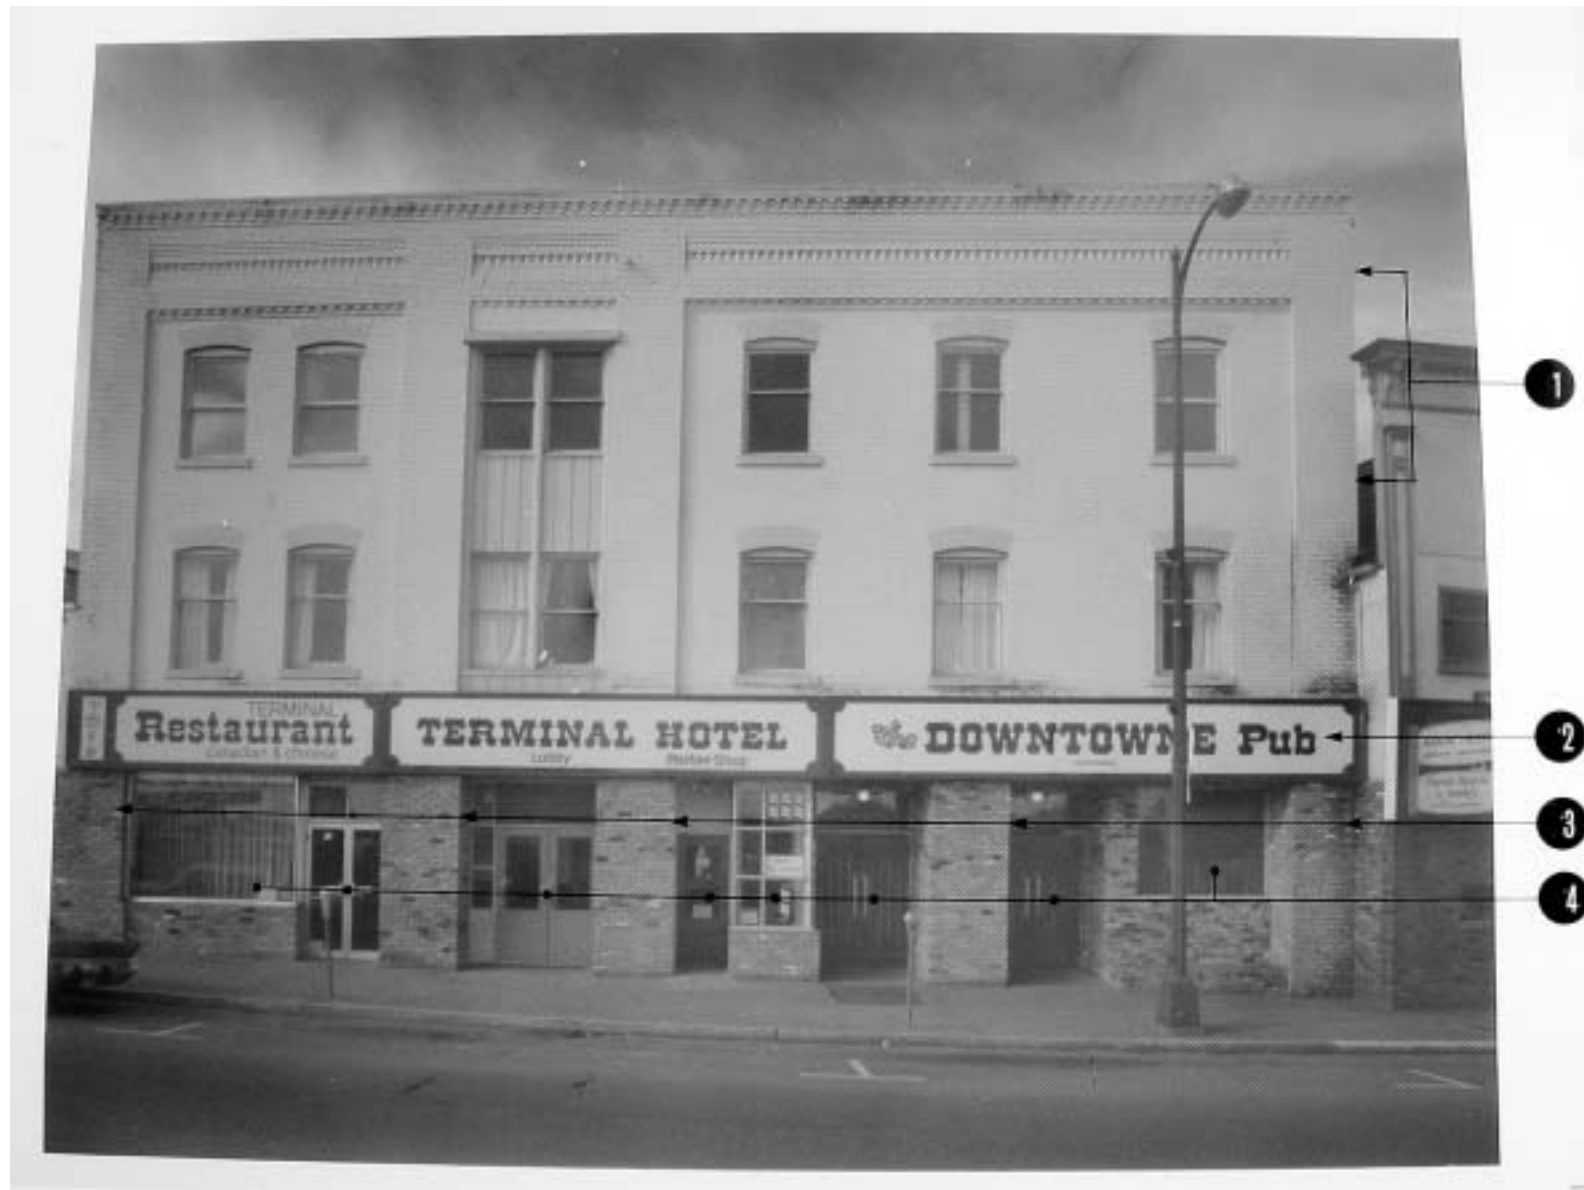
A. Existing condition

This building is in good solid condition and occupies a prominent position on Victoria Crescent. The upper two storeys are intact and offer an opportunity for the additional use of colour to highlight the trim and architectural detailing.

The backlit fluorescent signage is, unfortunately, too large and bright to complement the heritage nature of the building and should be replaced. The ground floor treatment should also be altered to reflect the period nature of the hotel. There has already been upgrading of the hotel, and further modifications could make this building into the show piece of the southern part of the Specified Heritage Area.

It is unfortunate for the structural integrity of the building that the third floor has had to be blocked off. Situations such as this, where areas of a building are shut off, lead to deterioration due to lack of heating and unnoticed leaks. It is hoped that eventually the entire building can be returned to use.

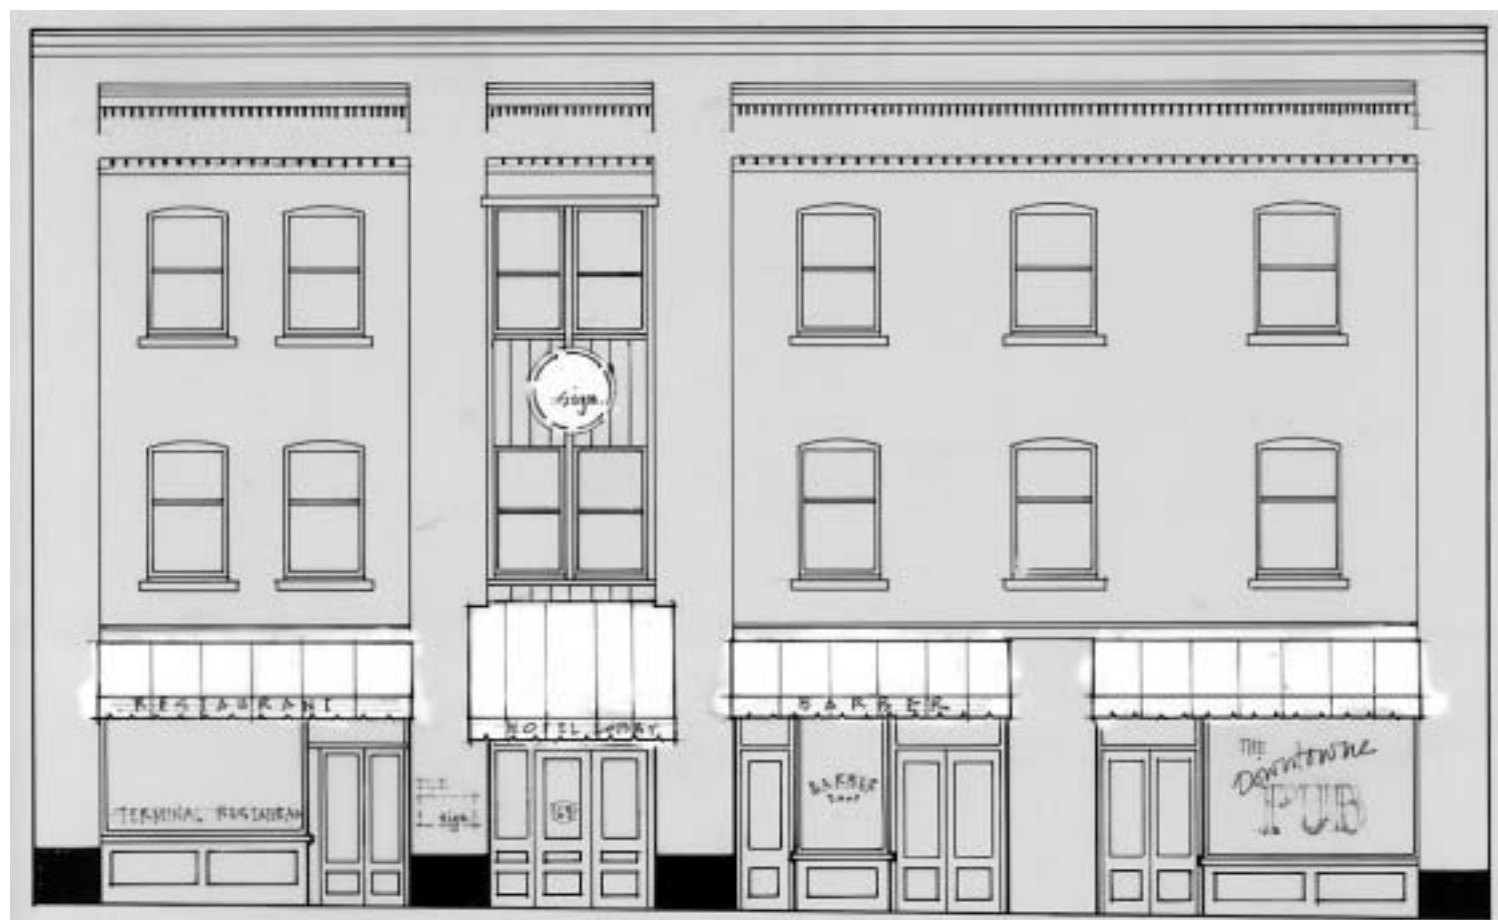
D. Auxiliary components

1. Signage recommended along canopy valence, under canopy, horizontally projecting, painted on glass, or neon tubing
2. 3-point fabric canopies along storefronts shaped to fit structural openings

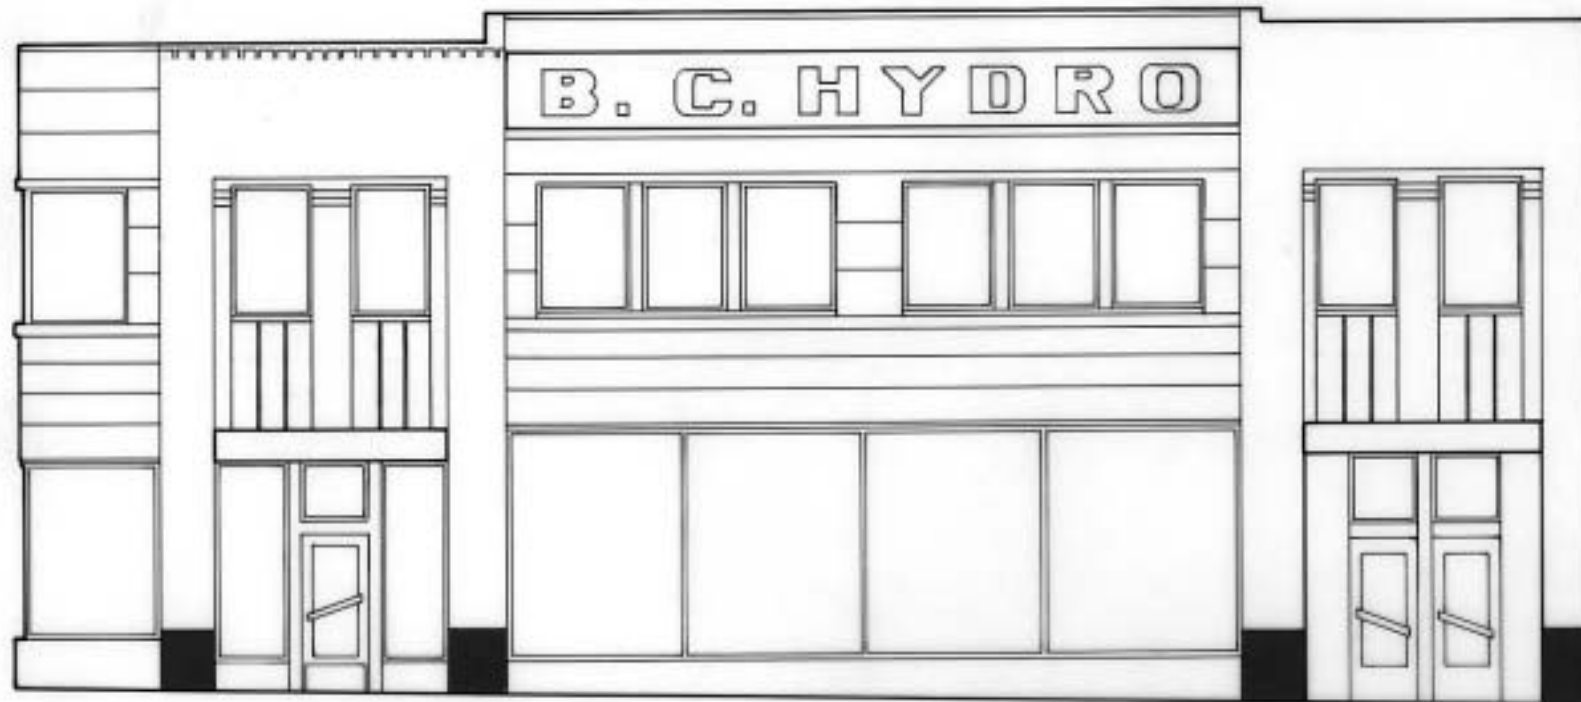
B. Recommended design

- Essentially, all original elements are intact and should at all costs be preserved
- 1. Plastic panels should be removed
- 2. Entire building should be repainted
- 3. Existing awnings, if replaced, should be similar in appearance and placement

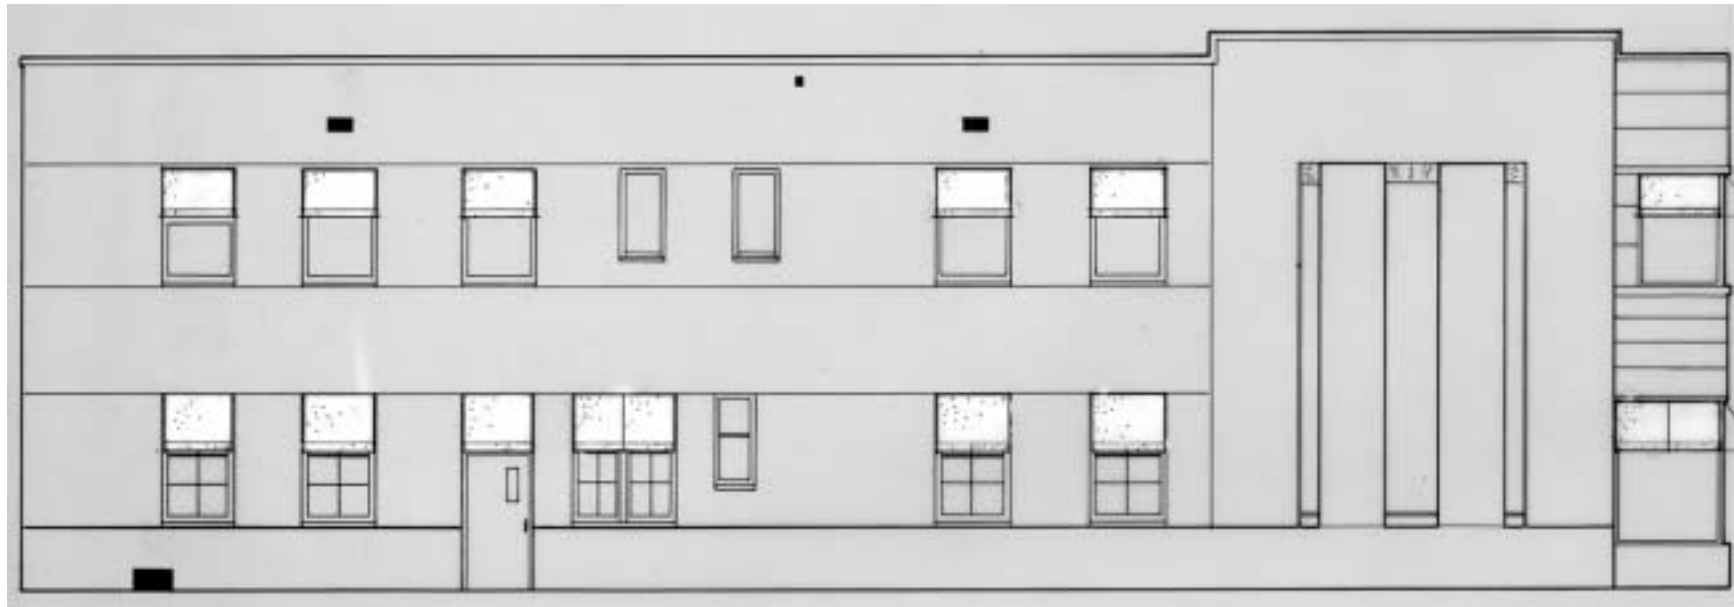
D. Auxiliary components

1. If required, 3-point canopies shaped to fit structural openings should be used
2. If additional signage is required, it should be placed along the canopy valence, under canopy, painted on glass, or neon tubing

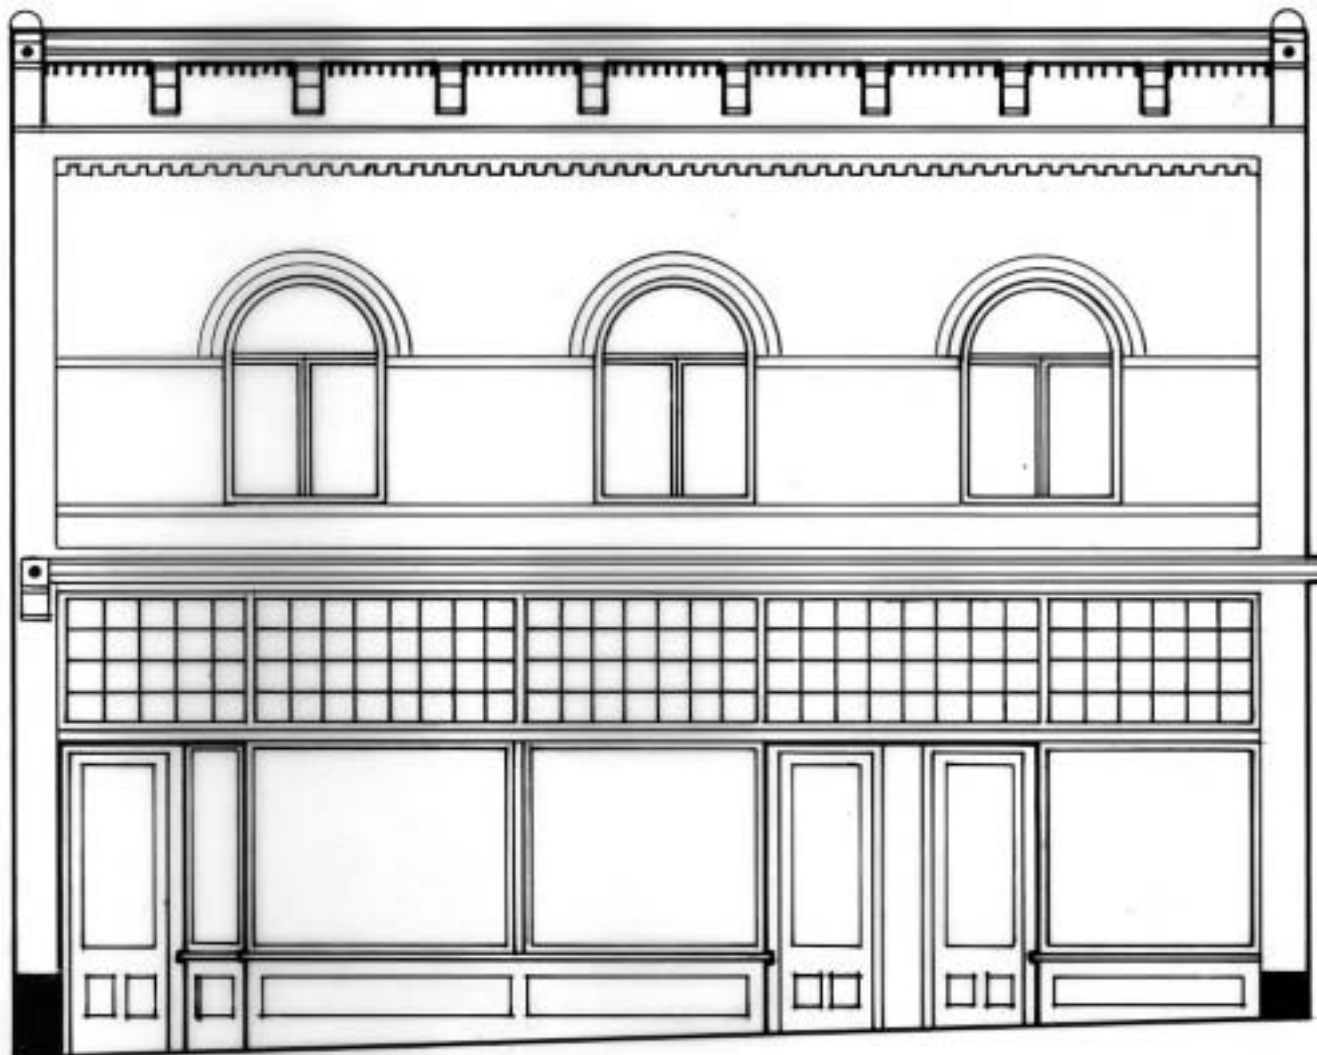
C. Shopfront & fenestration

1. Replacement of aluminum storefront window frames with more sympathetic elements
2. Location and type of entry doors should be more appropriate to the original building (see Rogers Block)

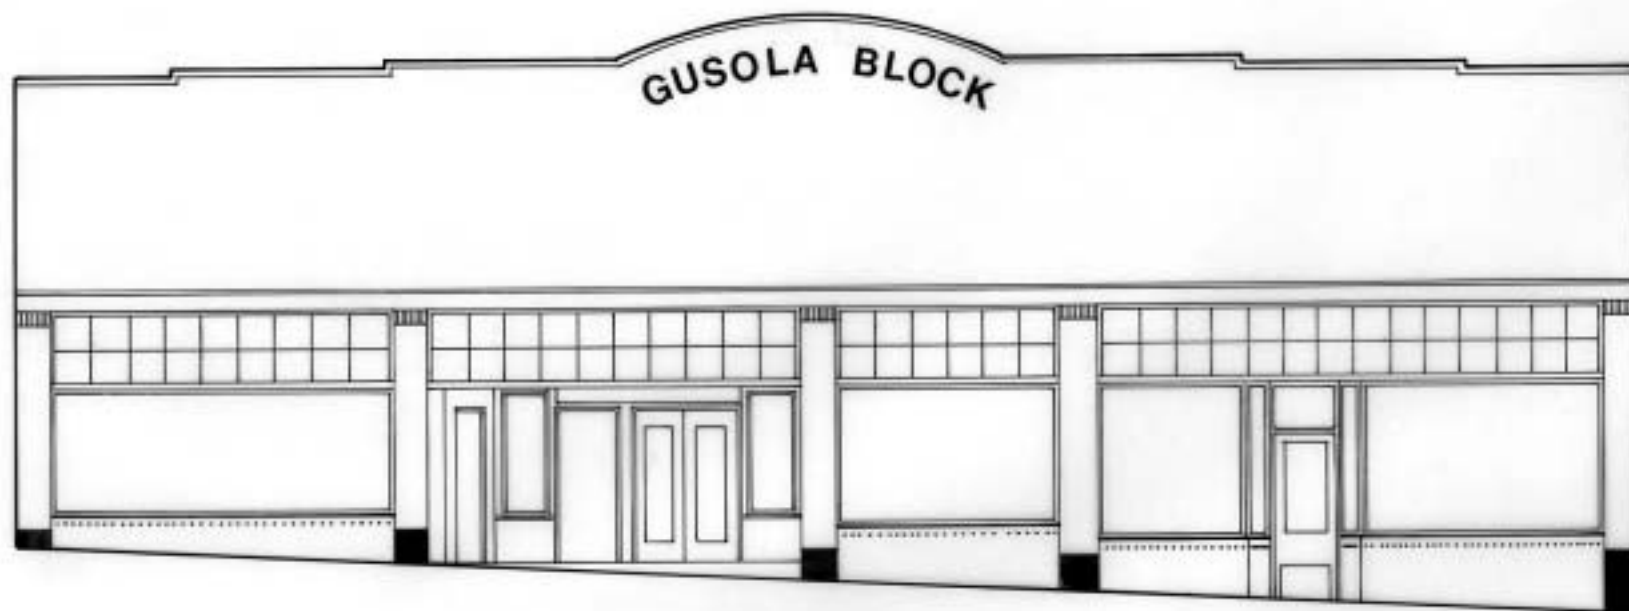
B. Recommended design

1. Rebuilding of most storefront elements. The southernmost storefront should remain intact

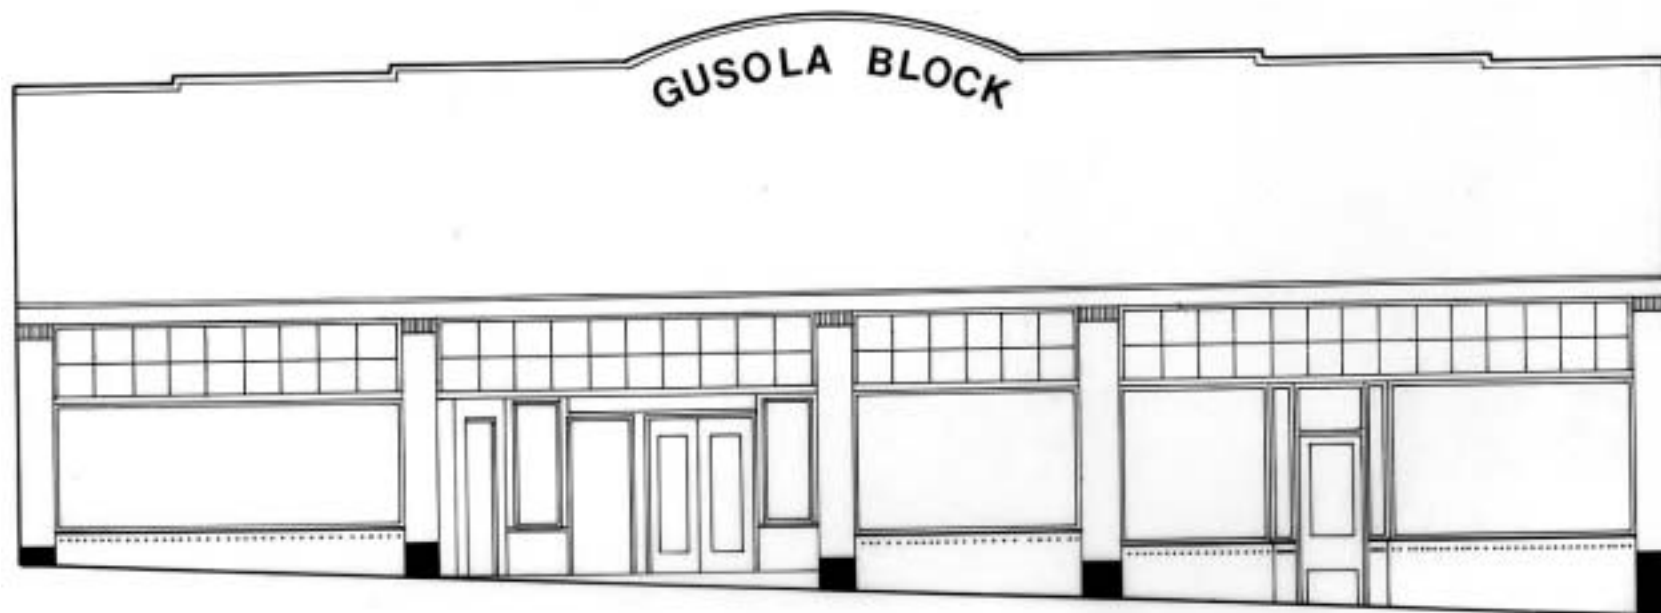
C. Shopfront & fenestration

1. Rebuilding of storefront elements, including windows, doors, and wall surfaces

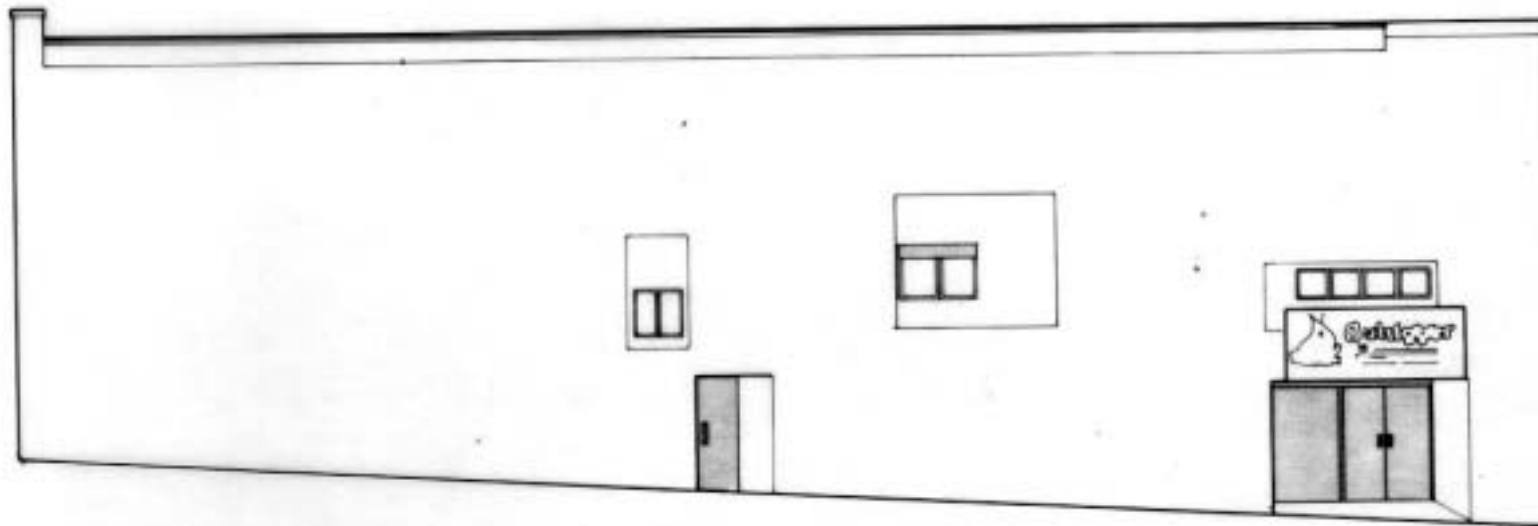
A. Existing condition

UNSUITABLE MODIFICATIONS

2. Entire facade is unsympathetic to heritage nature of the area

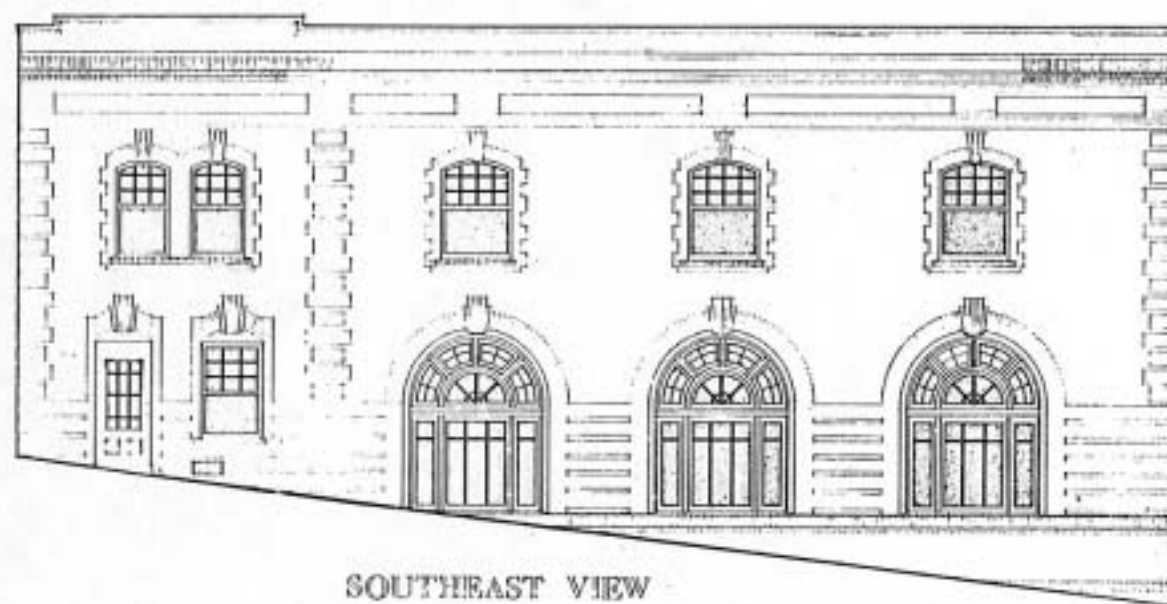
B. Recommended design

As much as is possible, a return to the original appearance is strongly recommended. References should be made to original photographs and the measured drawings that have been prepared

1. Stucco to be removed
2. Second storey entrance to be modified
3. Cornice to be restored

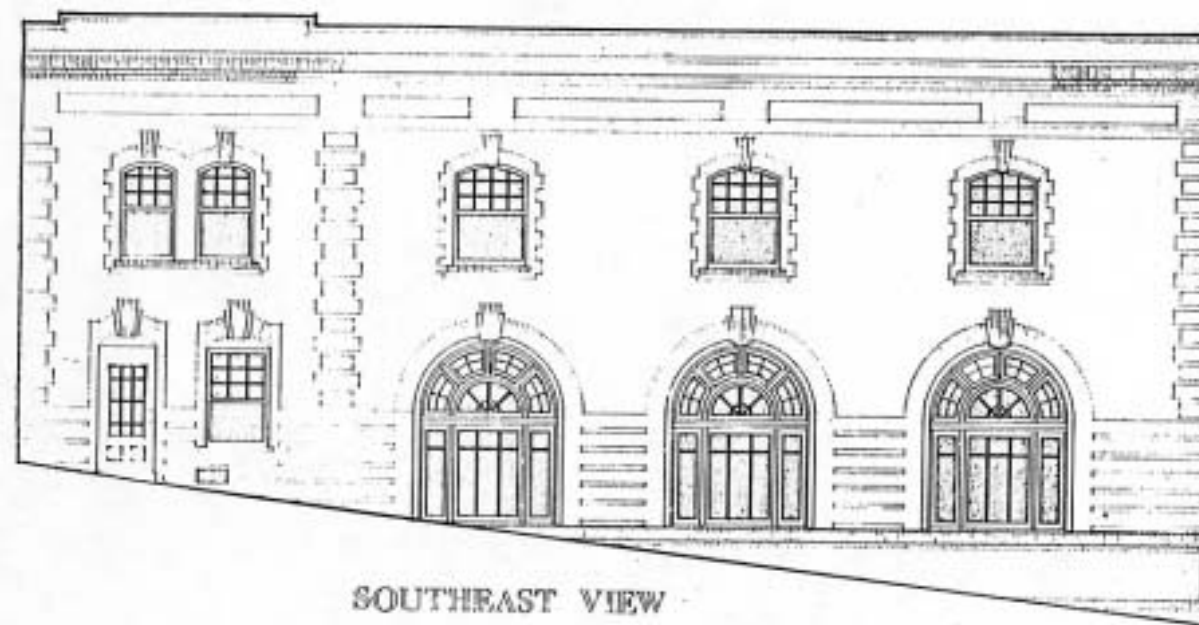
C. Shopfront & fenestration

1. Fenestration to be retained except for main entry doors
2. Second floor entry door to be replaced
