NANAIMO HERITAGE BUILDING DESIGN GUIDELINES

THE FOUNDATION GROUP
#1 – 2629 West Fourth Avenue, Vancouver, B.C., V6K 1 P8
733-4593

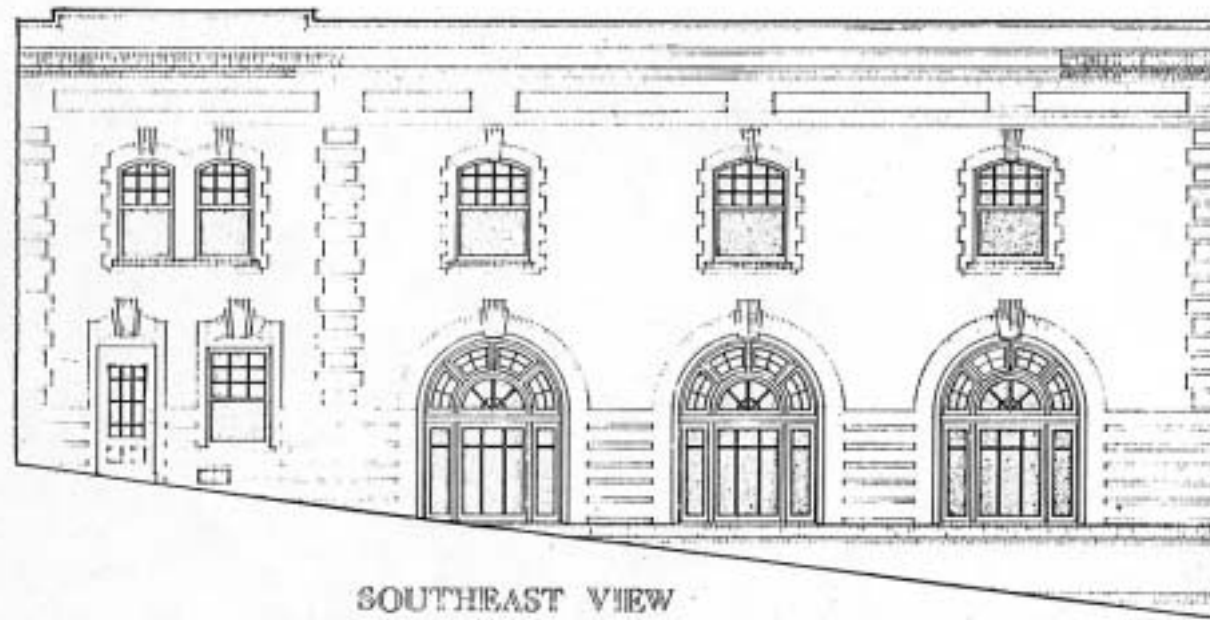
D. Auxiliary components

1. Canopies not recommended except over second floor entry
2. Signage recommended painted on glass or horizontally projecting
3. Spotlighting recommended if the building is restored

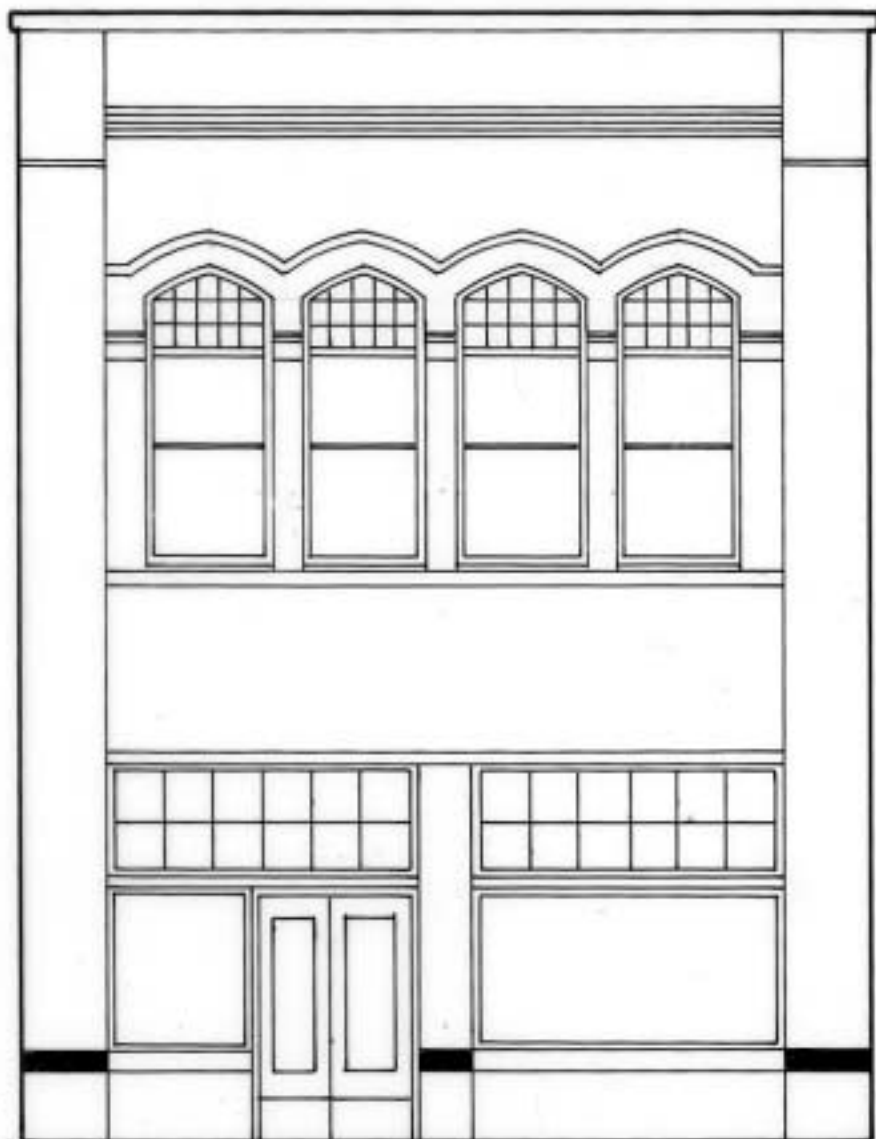
A. Existing condition

1. Leaking roof which endangers structural integrity
2. Damaged flashing

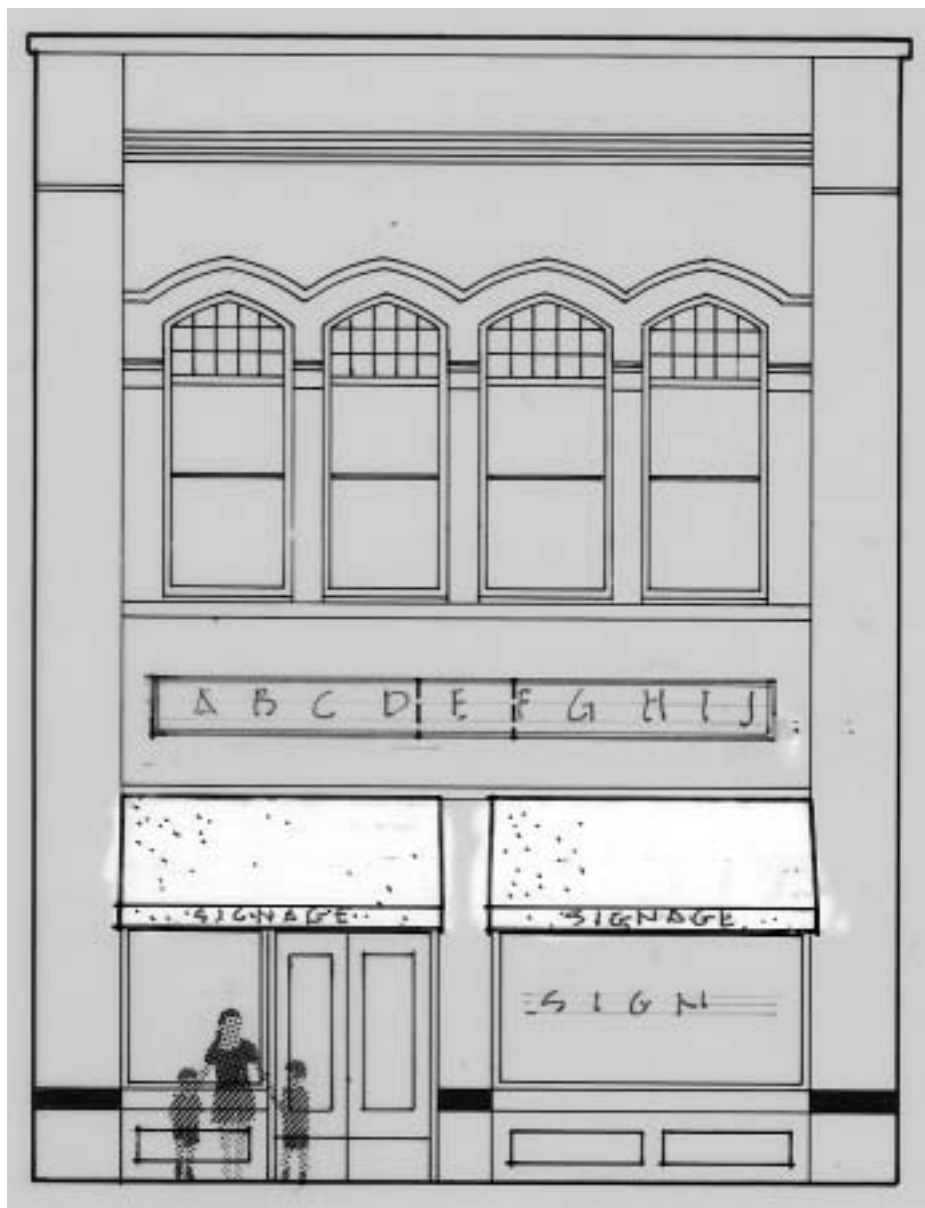
1. Reestablishment of fenestration details
2. Replacement of existing ground floor with sympathetic shopfront elements

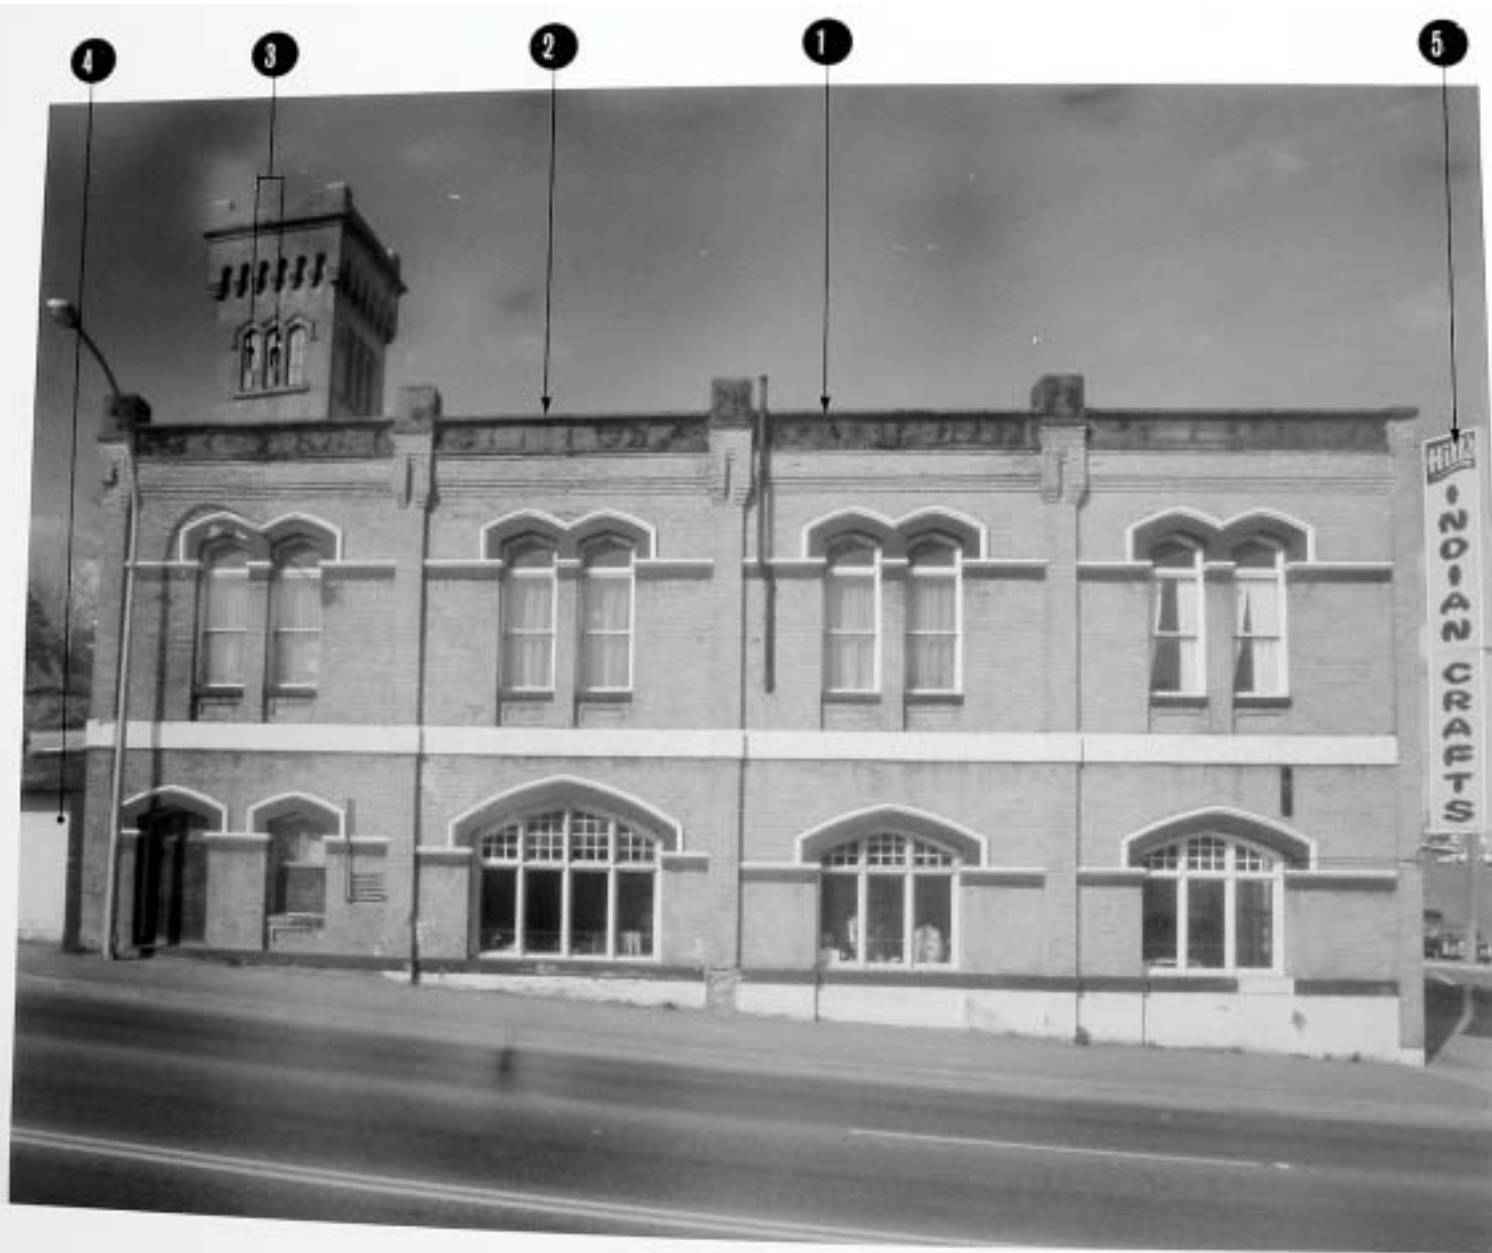
A. Existing condition

1. Leaking roof which endangers structural integrity
2. Damaged flashing
3. Broken windows

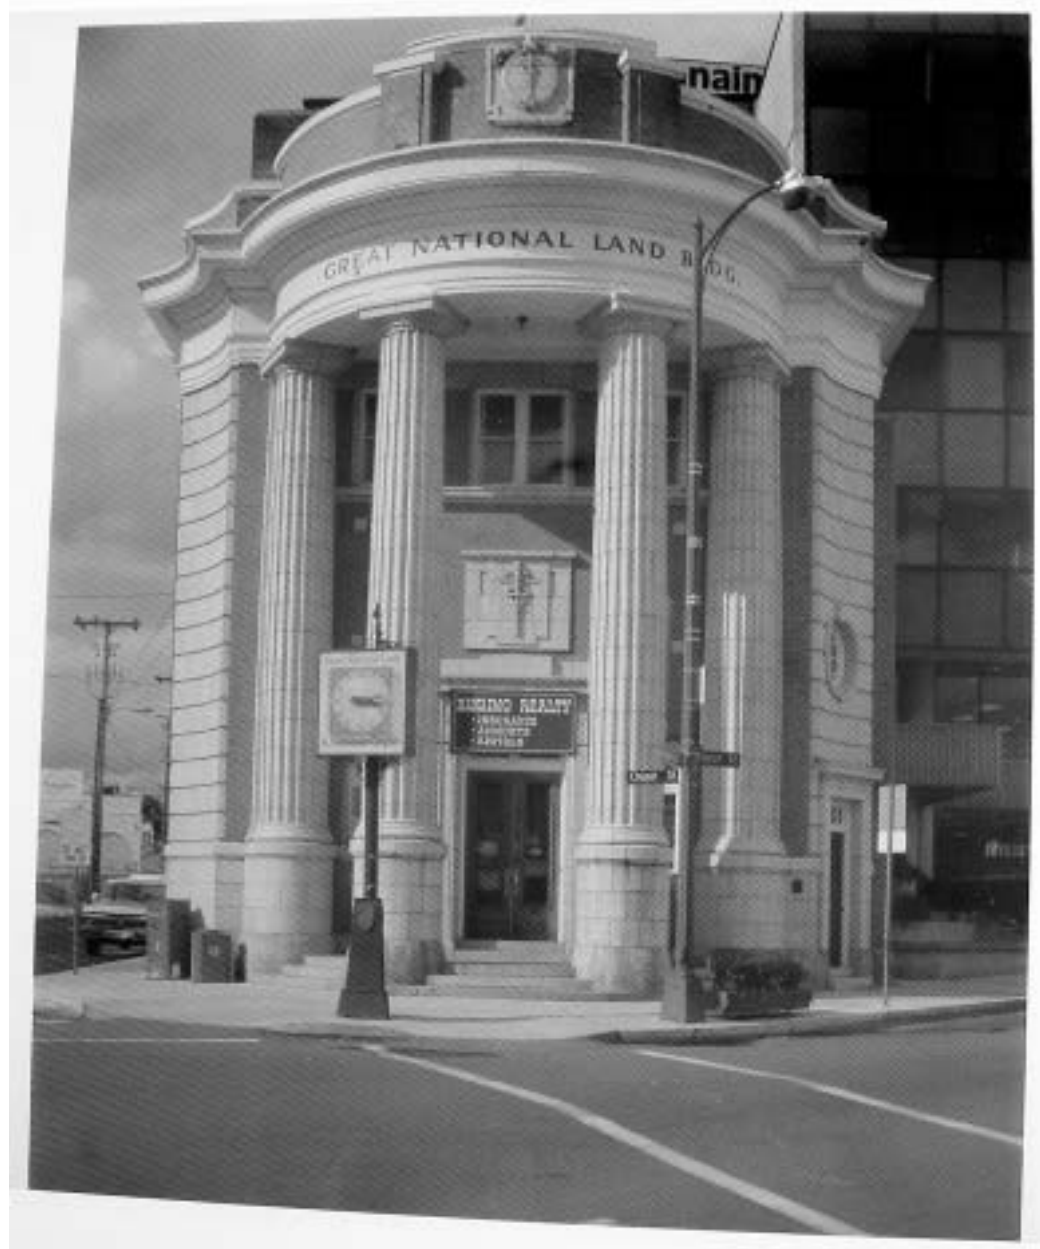
GREAT NATIONAL LAND BUILDING

This building is a downtown landmark and a model of how to keep a historic building in its original exterior condition. The visual appearance has been maintained and, therefore, there are almost no design considerations to be discussed.

Repairs and cleaning should be approached as recommended in the H.A.R.P. Stage II Costing Report. The realty sign should be removed from between the front columns and placed on the face of the building. The main entry should be floodlit to highlight its architectural contribution to the streetscape. Measured drawings have been prepared and are available through the City of Nanaimo. This building is a highly important part of the Specified Heritage Area.

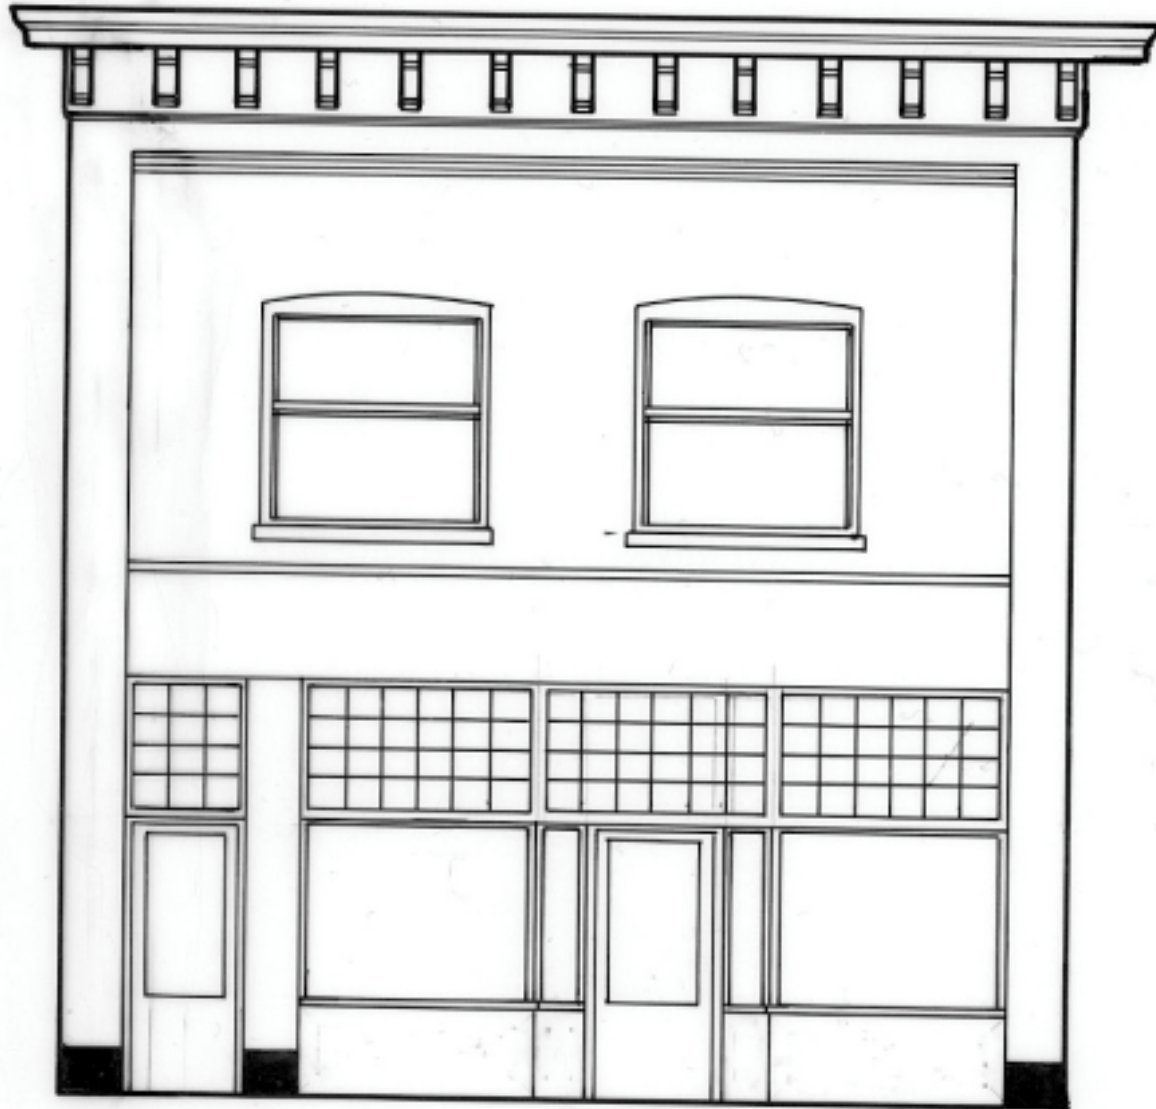
B. Recommended design

1. Replacement of second storey windows
2. Removal of metal canopy and ground floor fascia panel
3. Removal of inappropriate signage
4. Rebuilding of storefront elements
5. Replacement with new signage, canopies, and lighting
6. Remove stucco; repair and patch brickwork

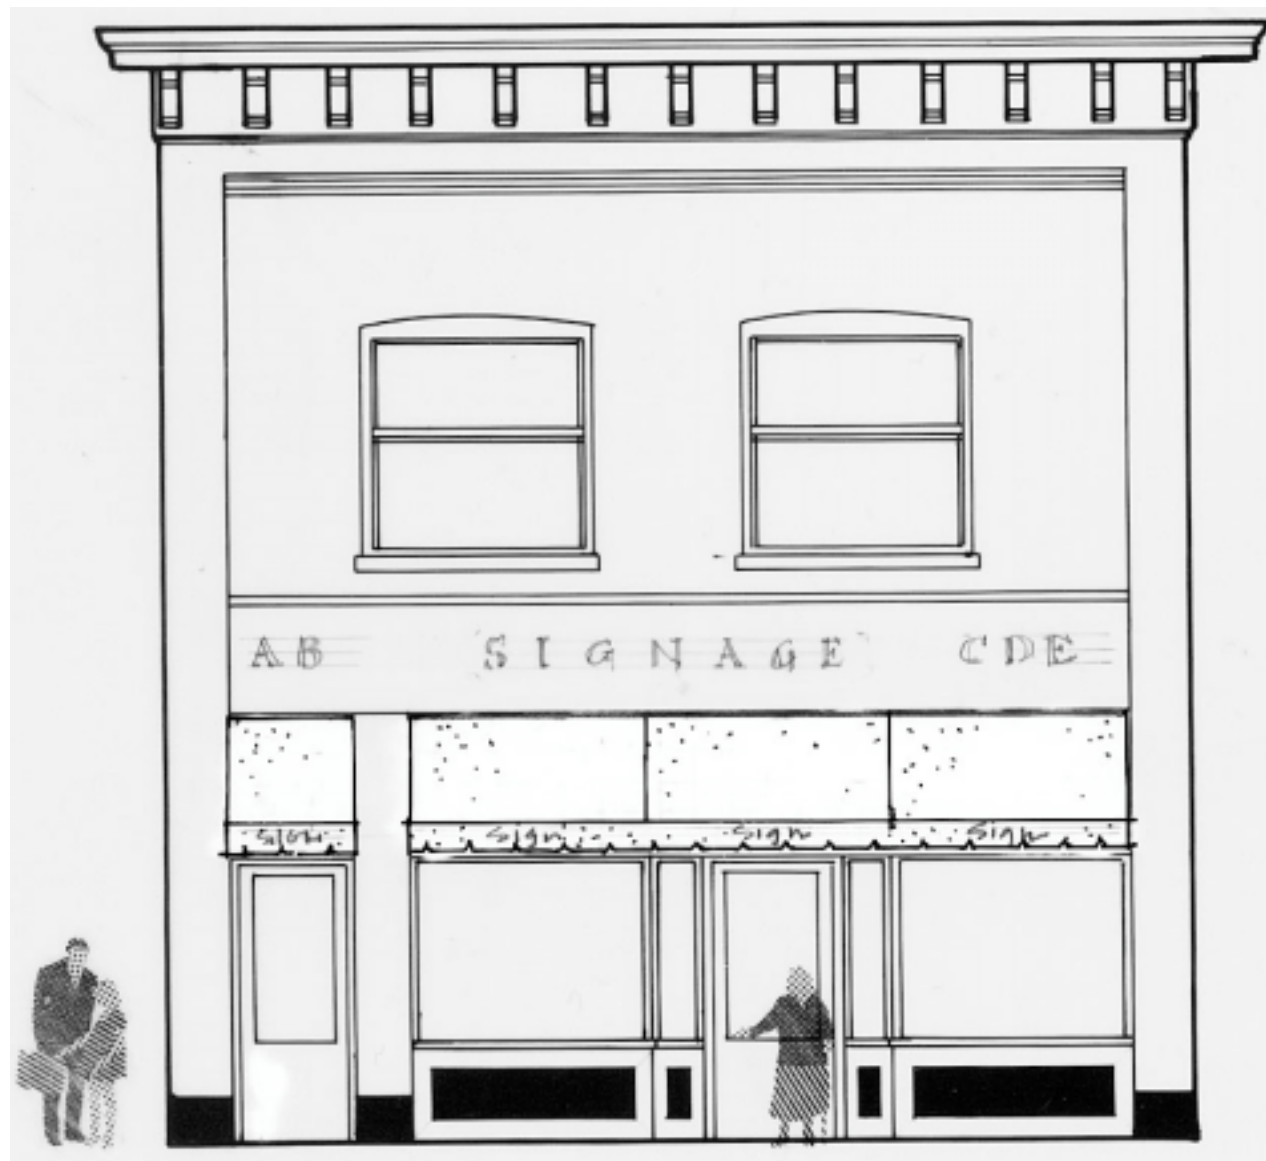
1. Metal canopy replaced with 3-point fabric canopy shaped to fit storefronts
2. Signage recommended along canopy valence, under canopies, or painted on glass
3. Lighting recommended as part of canopy design

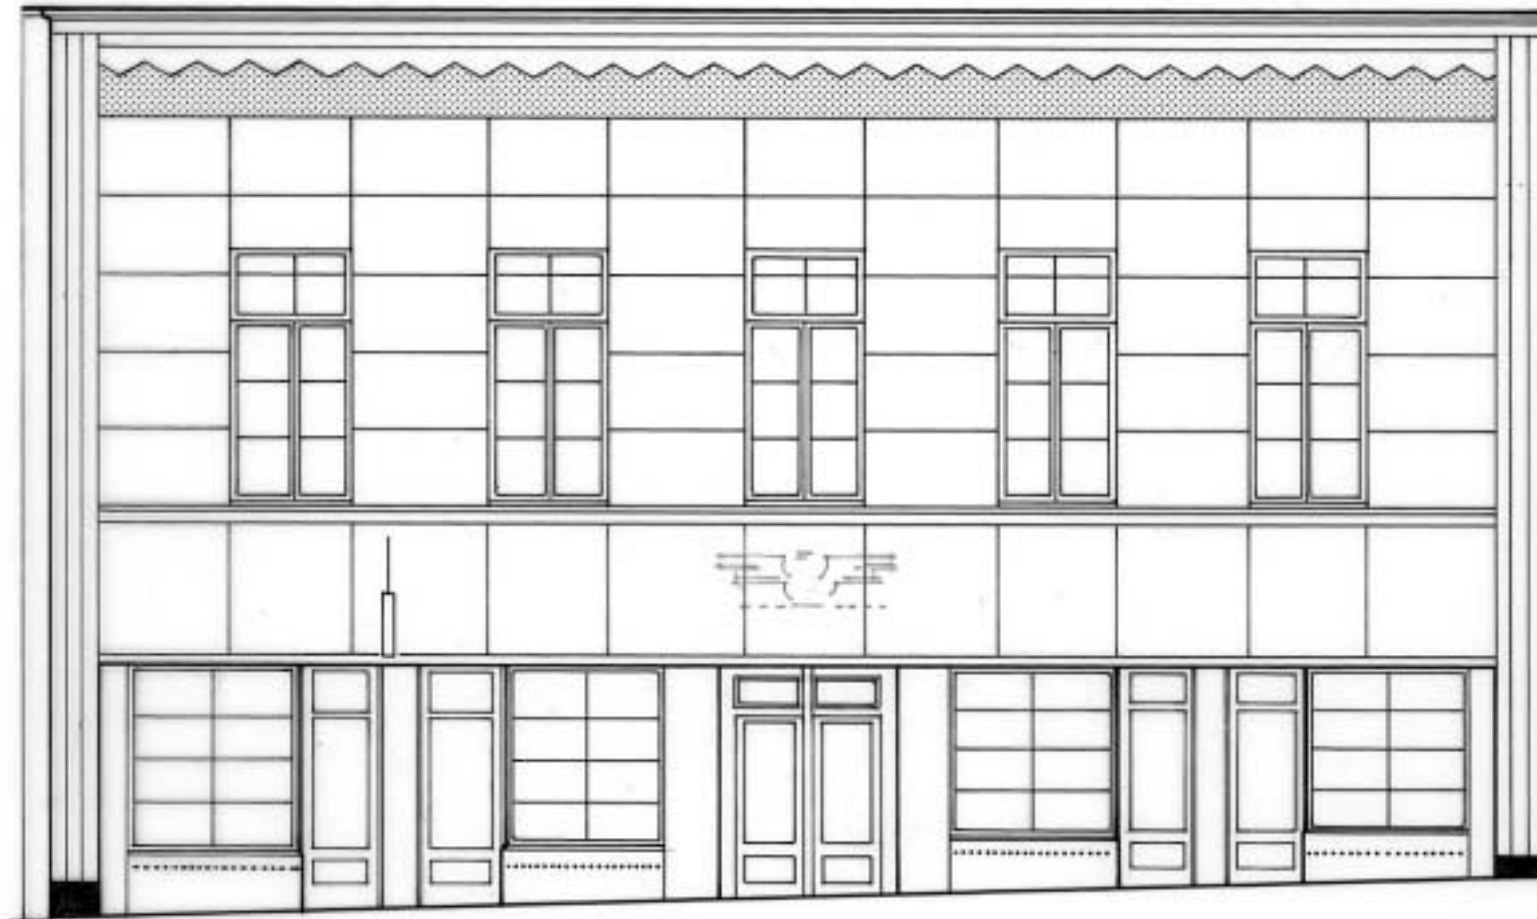
B. Recommended design

1. Removal of existing cloth canopy
2. Replacement of existing main entrance doors
3. Original elements of the building should be preserved at all costs

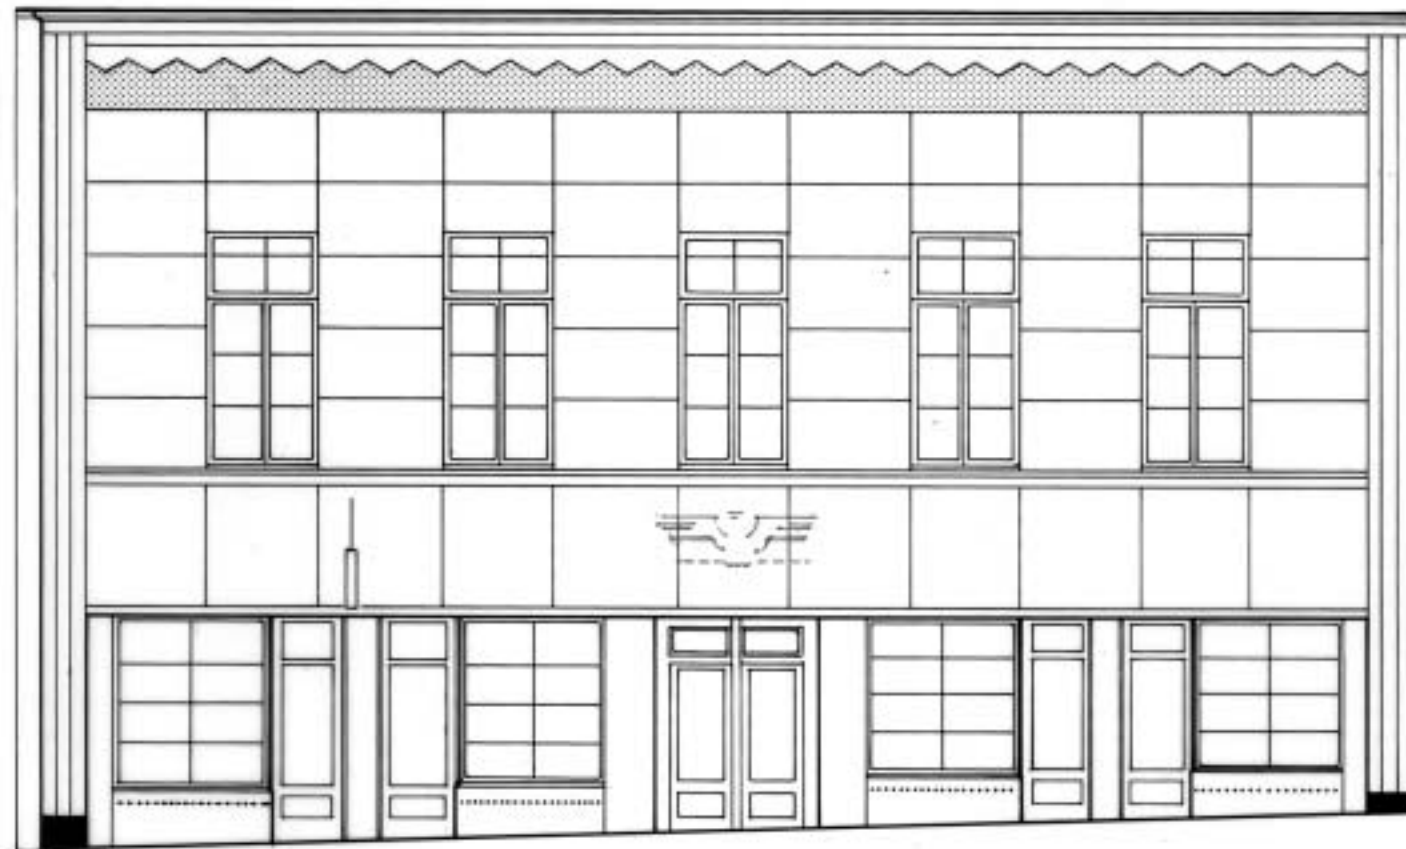
C. Shopfront & fenestration

1. Should be left exactly as is except for main entrance doors

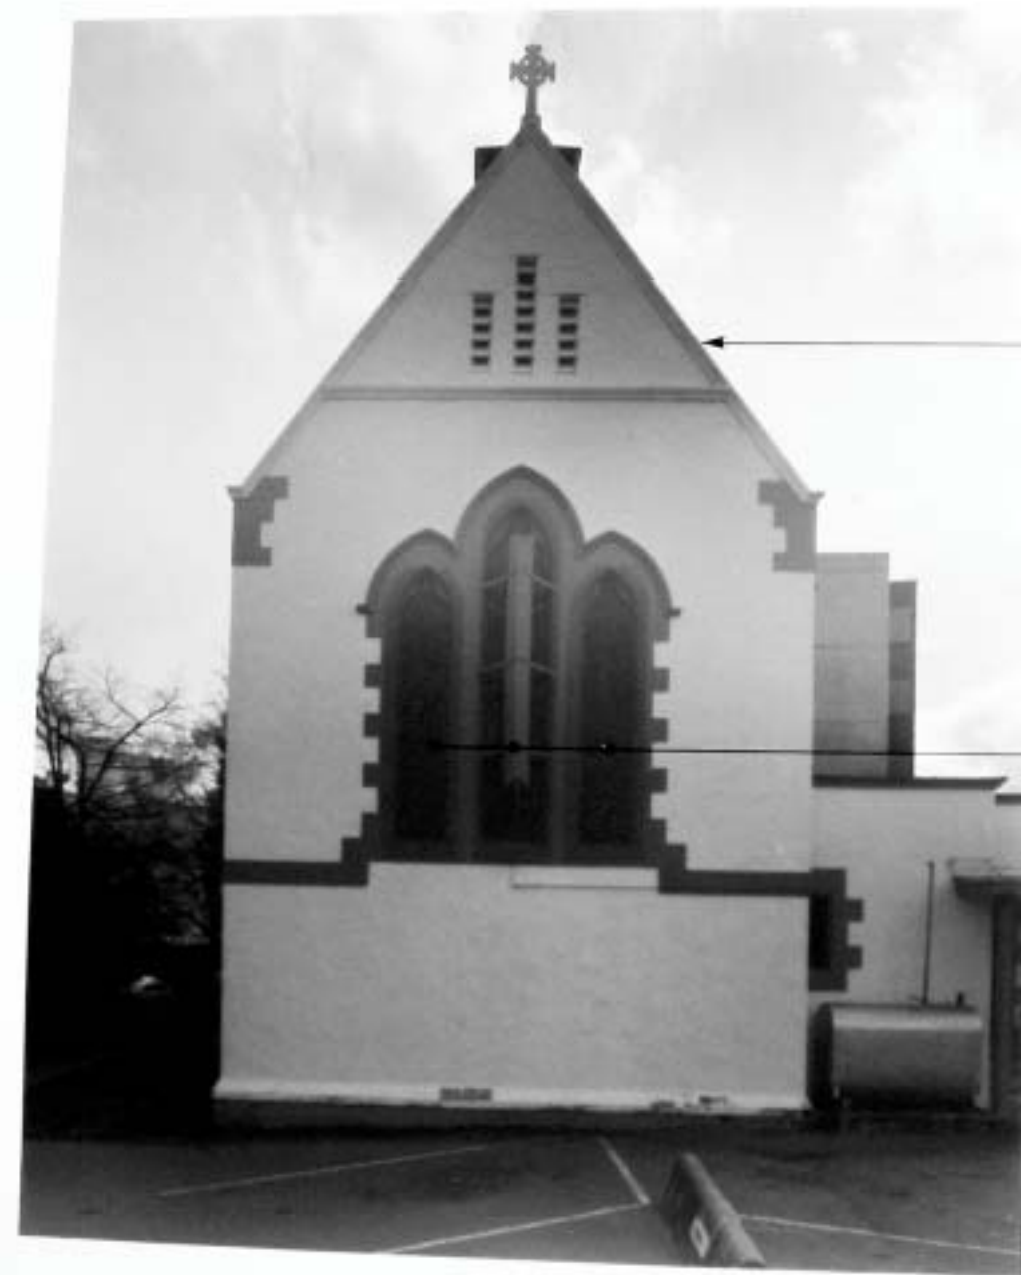
A. Existing condition

1. Leakage along flashing and seepage into walls and interior-- flashing requires attention but slate roof appears to be sound

2. Plexiglass or tempered glass coverings over stained glass windows for breakage protection and additional insulation. Frames to be unobtrusive

The church is in significantly original condition and should be maintained as such. There is some concern as to leakage along the flashing and around the windows, which should be attended to in order to preserve the interior and exterior fabric of the building.

It may be desirable to mount plexiglass or tempered glass panels over the stained glass windows to provide impact protection as well as added insulation. In this case, the framing elements should be dark toned and as unobtrusive as possible. The small-scale bullrush motif fence along Church Street is significant and should be repaired and maintained. Some consideration might be given to improving the appearance of the side buildings from the parking lot through the use of screens or vegetation.

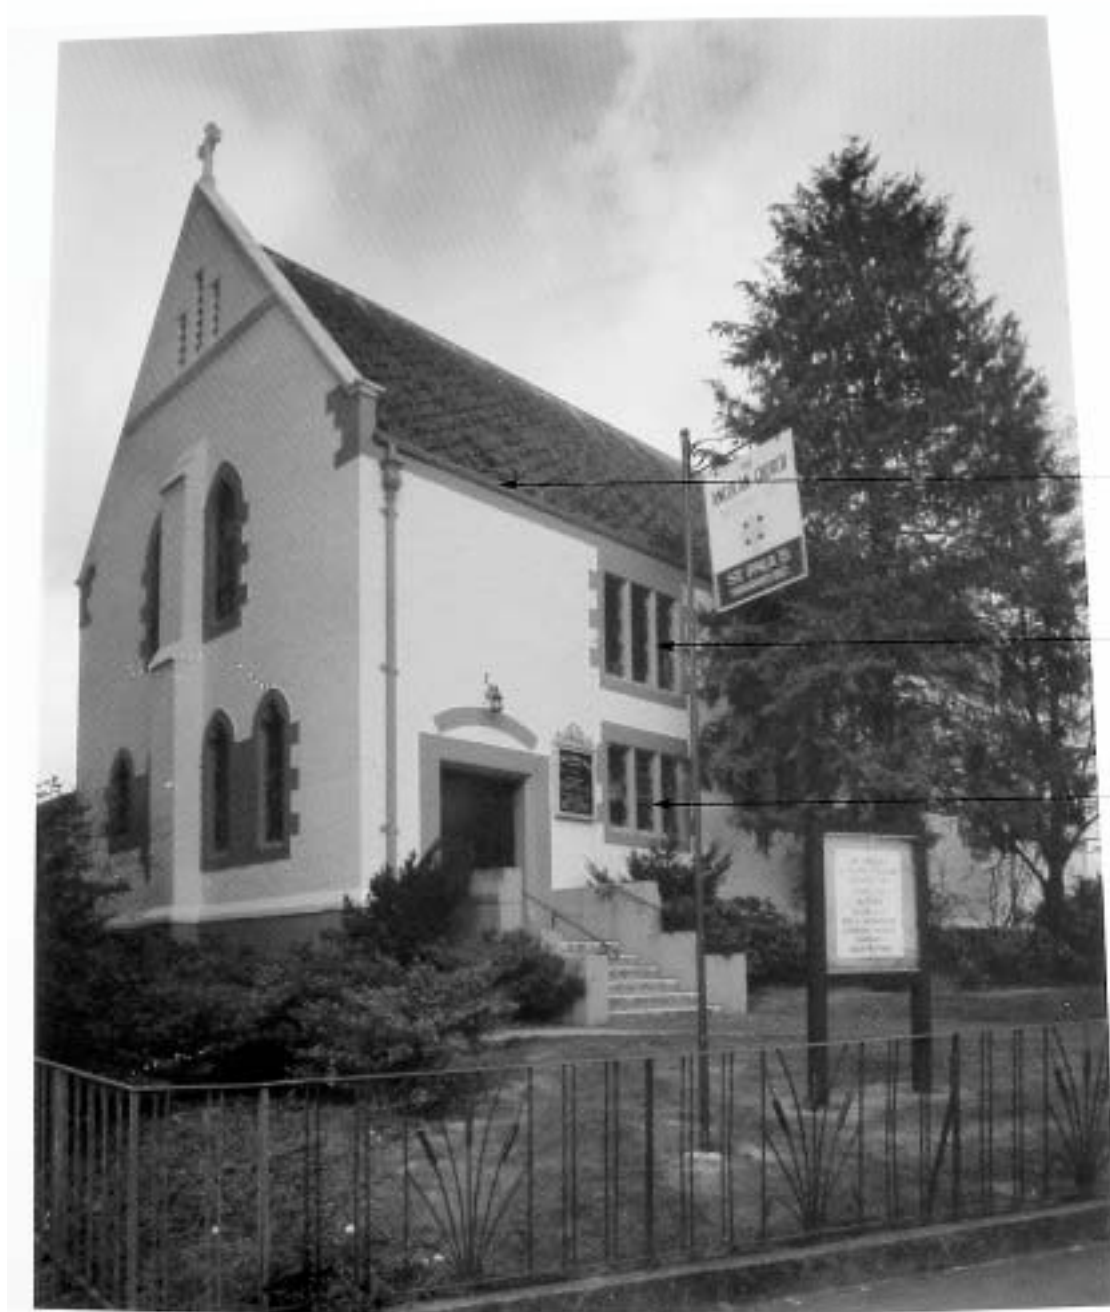
A. Existing condition

1. Leakage along flashing and seepage into walls and interior--flashing requires attention but slate roof appears to be sound

2. Flexiglass or tempered glass coverings over stained glass windows for breakage protection and additional insulation. Frames to be unobtrusive

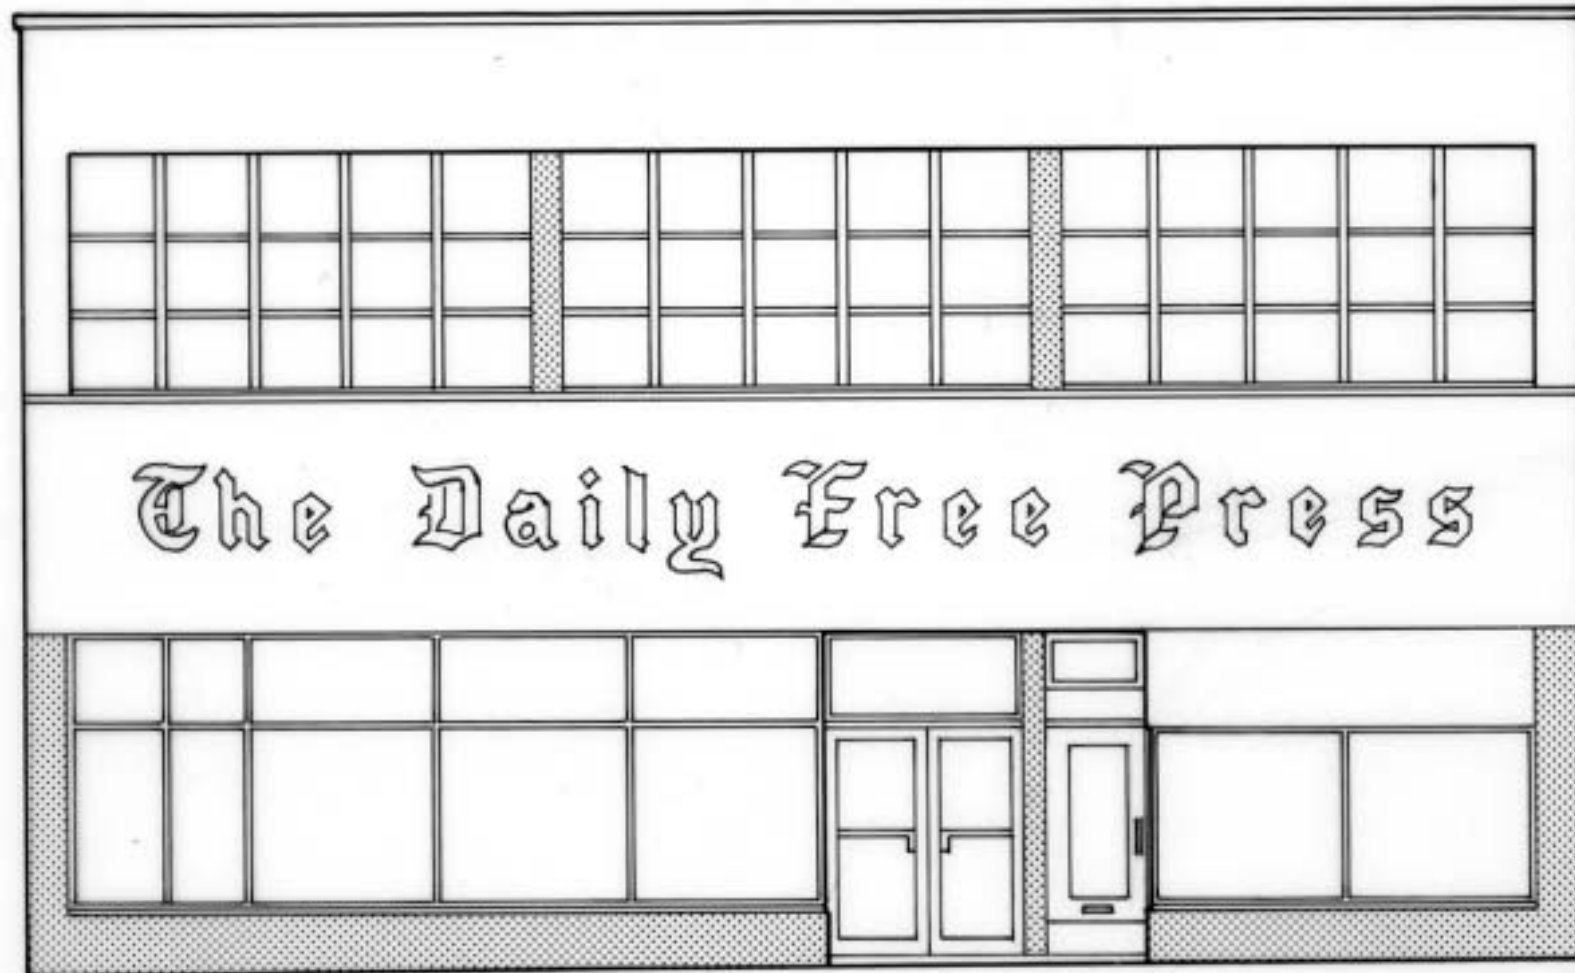
B. Recommended design

Short of an entire rebuilding, it is recommended that the facade be treated only with colour and canopies

It is recommended that the facade be painted in colours sympathetic to the area that will act as a backdrop to the surrounding historic buildings. A brick-coloured body tone is recommended. Canopies may then be in a lighter cream or beige tone. The building is of a rather severe nature, which could be considerably softened through these remedial measures. Interestingly, the Free Press Building forms a significant modern period grouping with the adjacent building, the Modern Café, which is an excellent period facade.

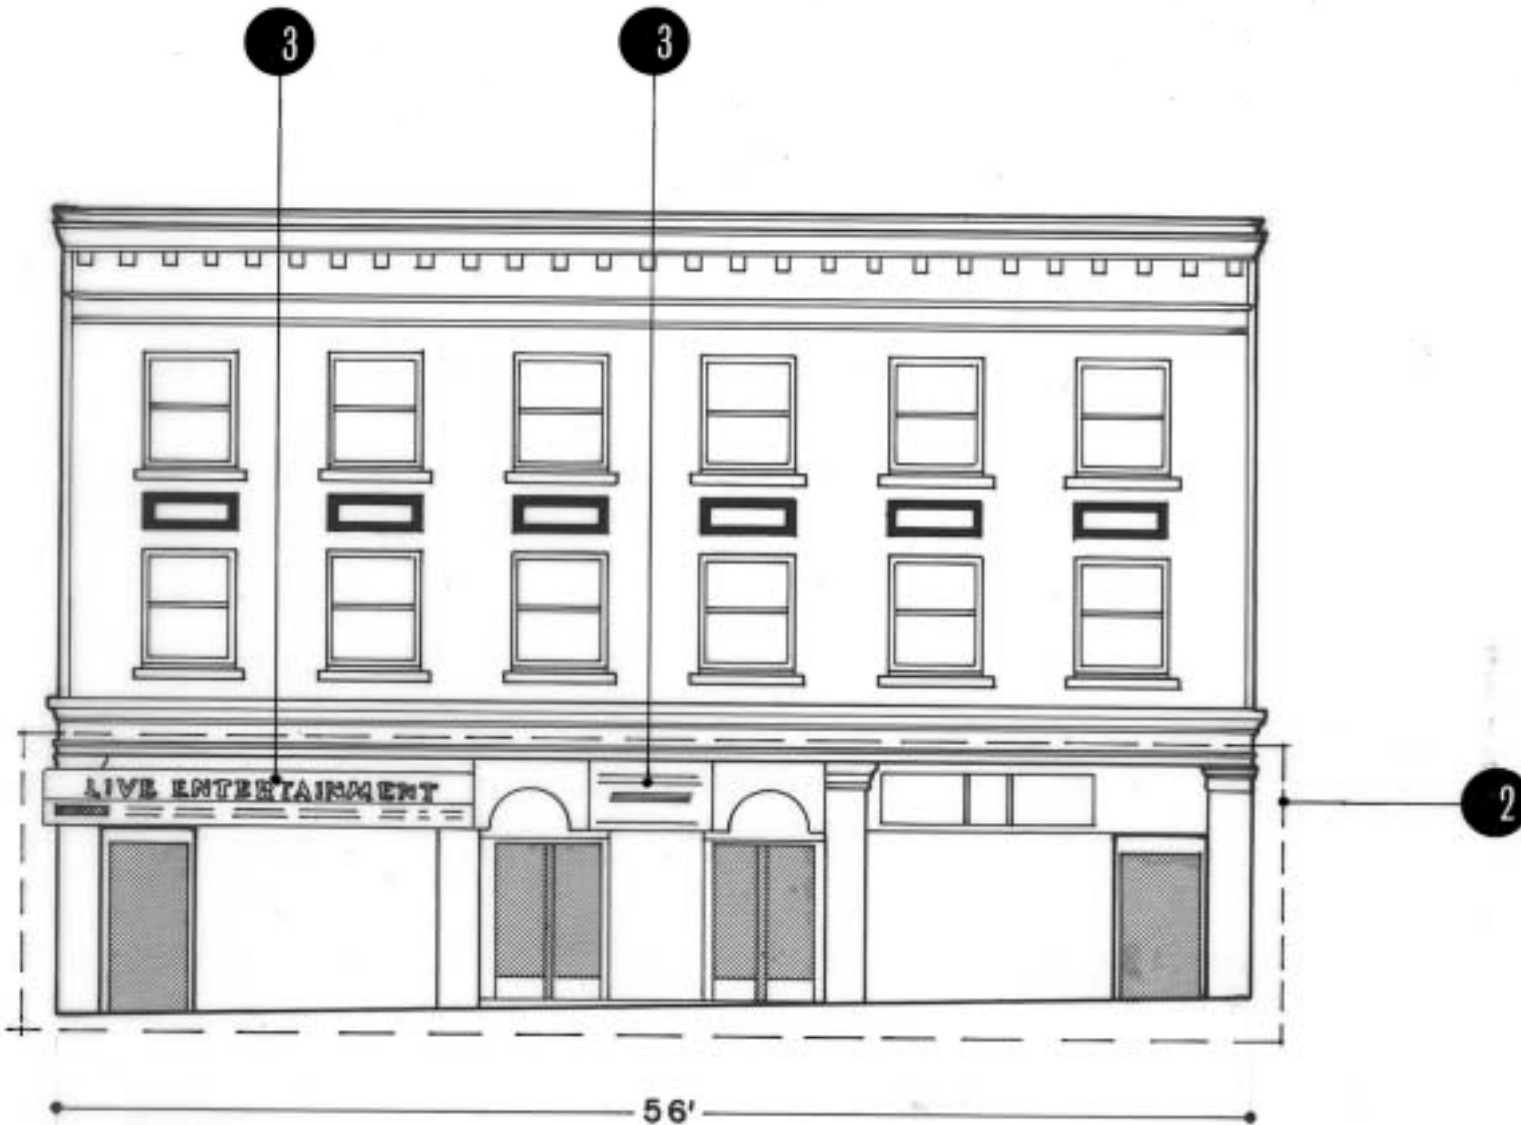
A. Existing condition

2. Ground floor has been unsympathetically altered
3. Inappropriate signage

This building is in good original condition above the ground floor. The street-level components, however, are inappropriate and should be rebuilt.

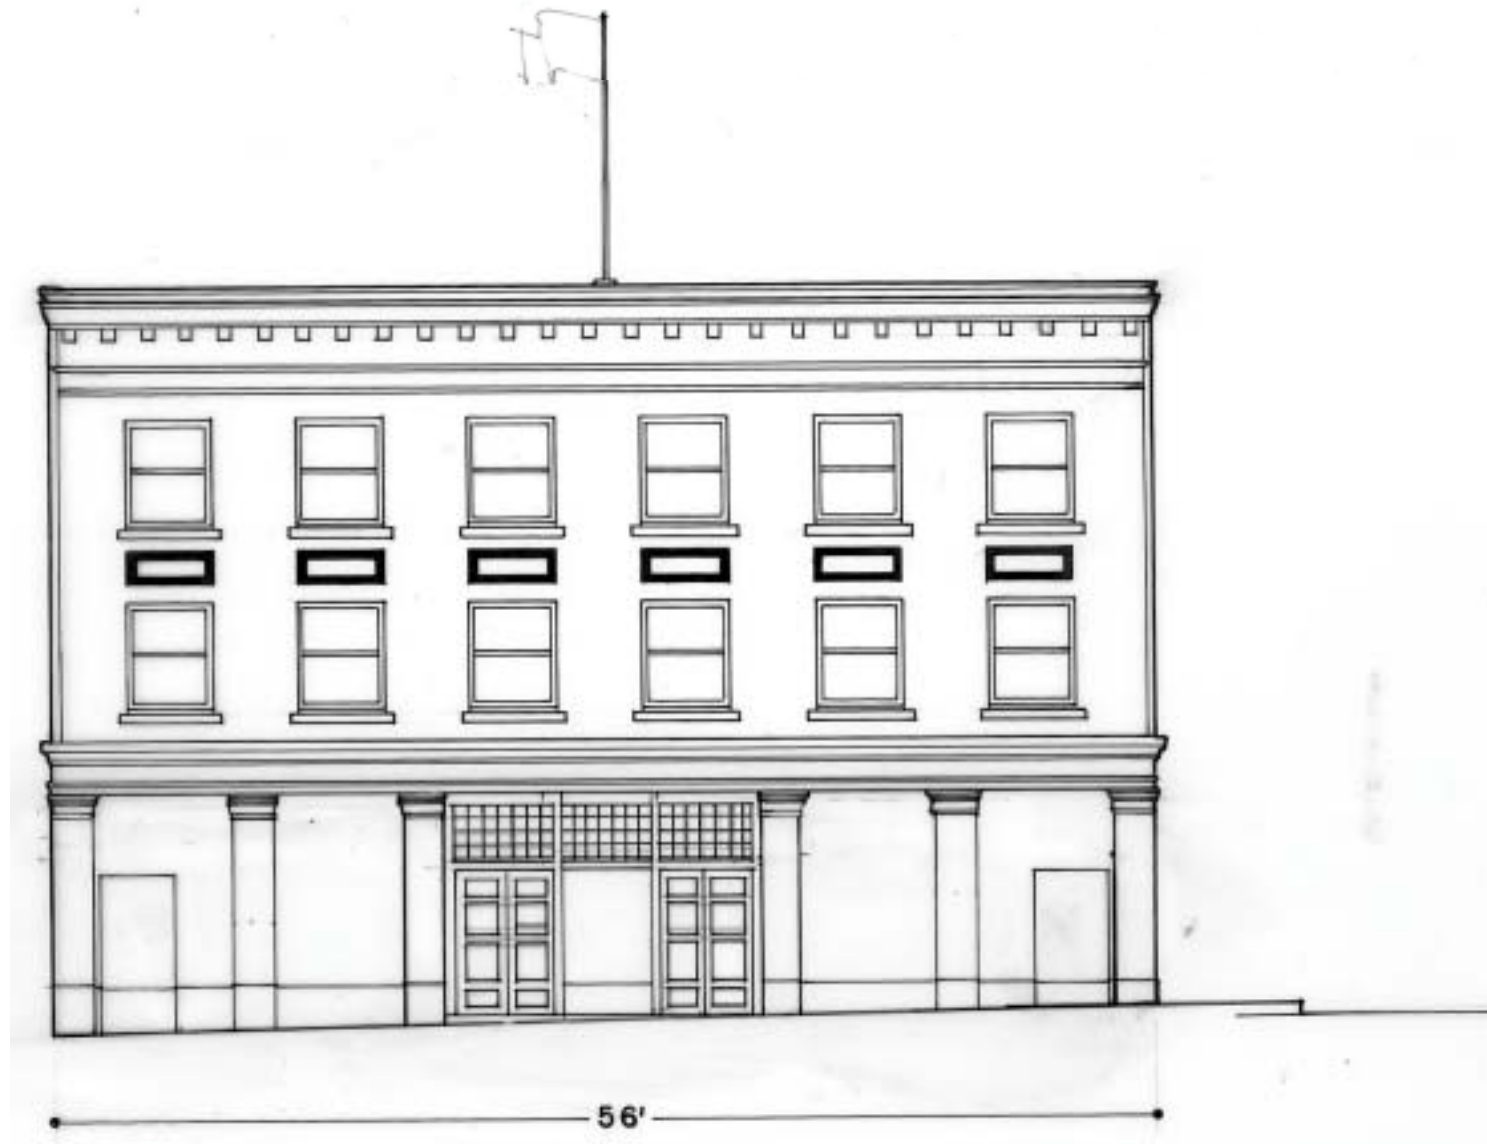
B. Recommended design

1. Ground floor replaced with sympathetic elements
2. Removal of existing signage

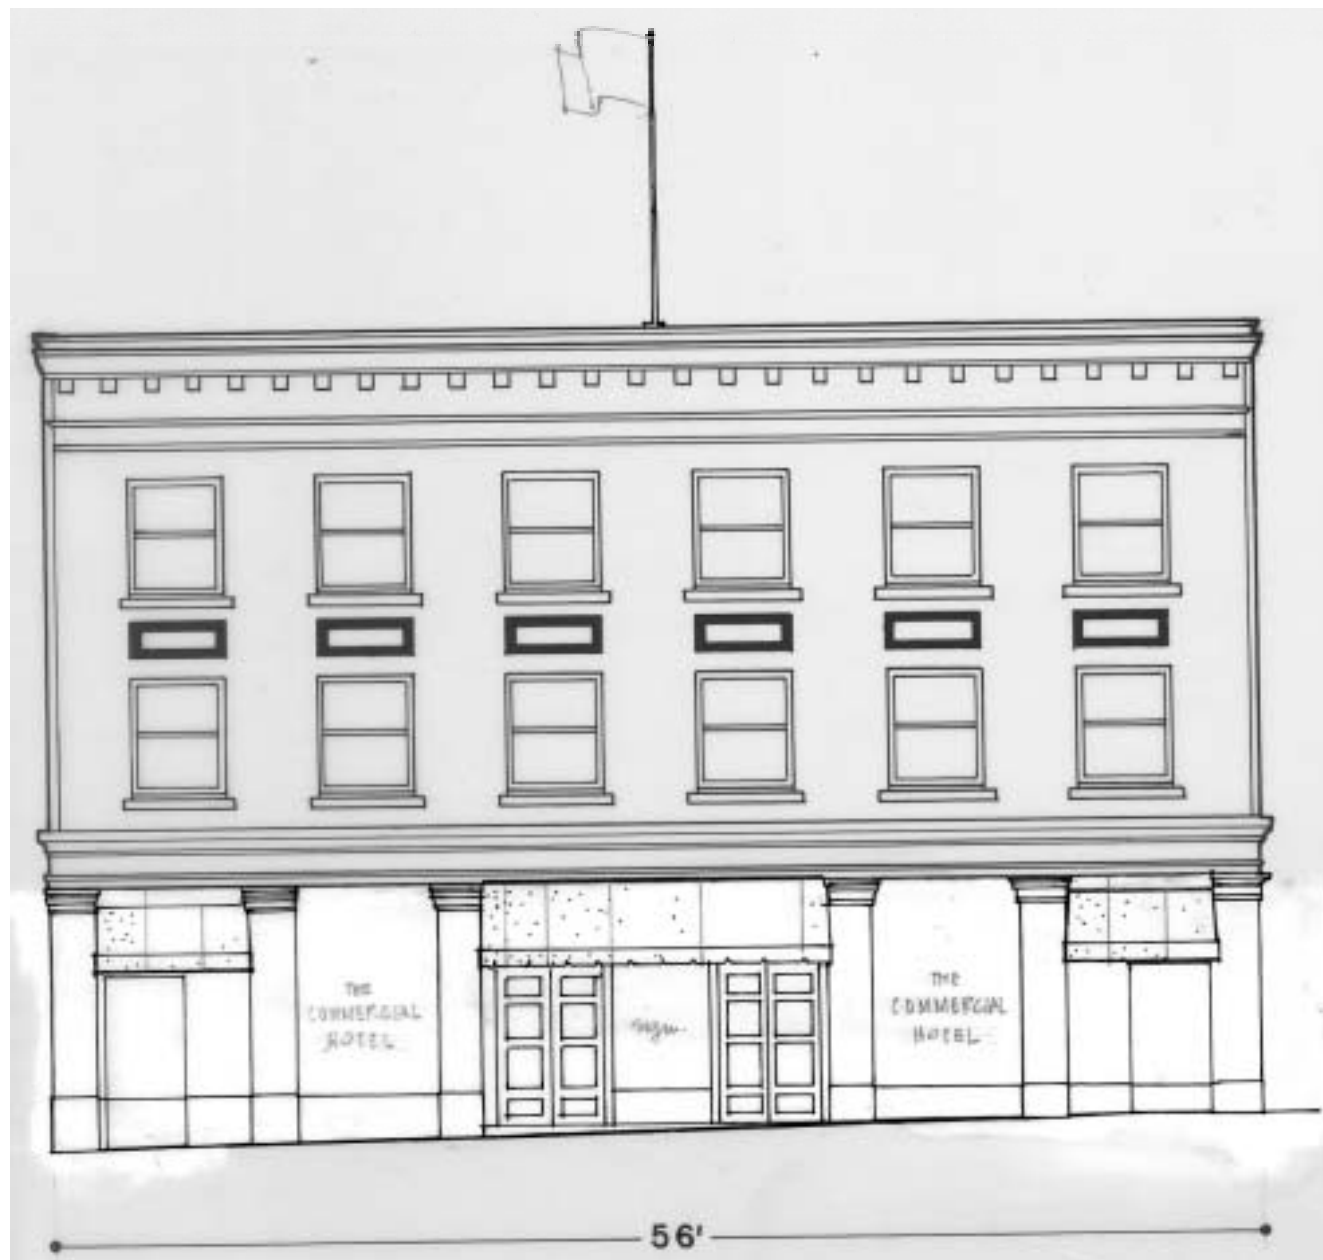
1. 3-point fabric canopies shaped to fit structural openings
2. Signage recommended along canopy valences, under canopies, horizontally projecting or neon tubing
3. Lighting recommended as part of canopy design

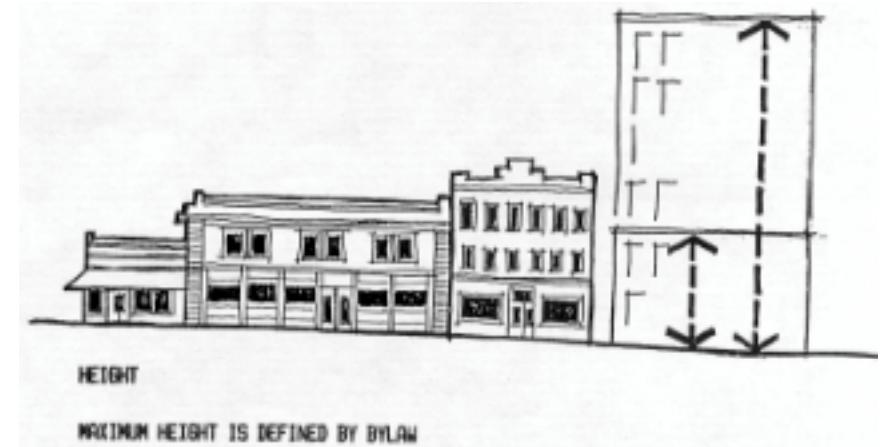
HEIGHT: Should conform to City Zoning Bylaw, Section 28.04 HEIGHT OF BUILDINGS. In addition, the cornice line of adjacent buildings should be respected so that there are no setbacks for the first one, two or three storeys, dependent on context and that storeys above this be set back to minimize their visual impact.

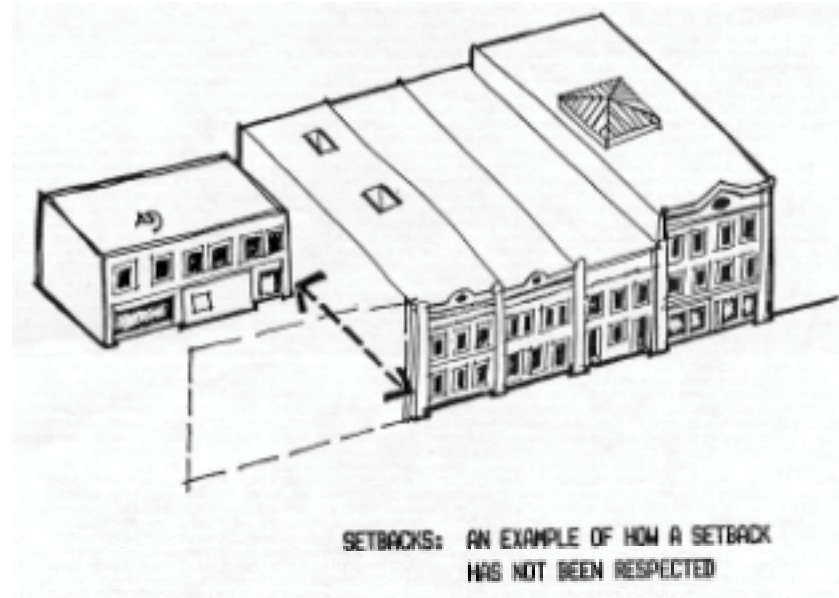
SETBACKS: Should conform to City Zoning Bylaw , Section 28.06. Setbacks of any kind along the street frontage are strongly discouraged.
