Reference No. 1314470516-025-L-Rev0

**COLLIERY DAMS, NANAIMO BC
LOWER DAM – DEVELOPMENT OF DESIGN ALTERNATIVES**

1.0 INTRODUCTION

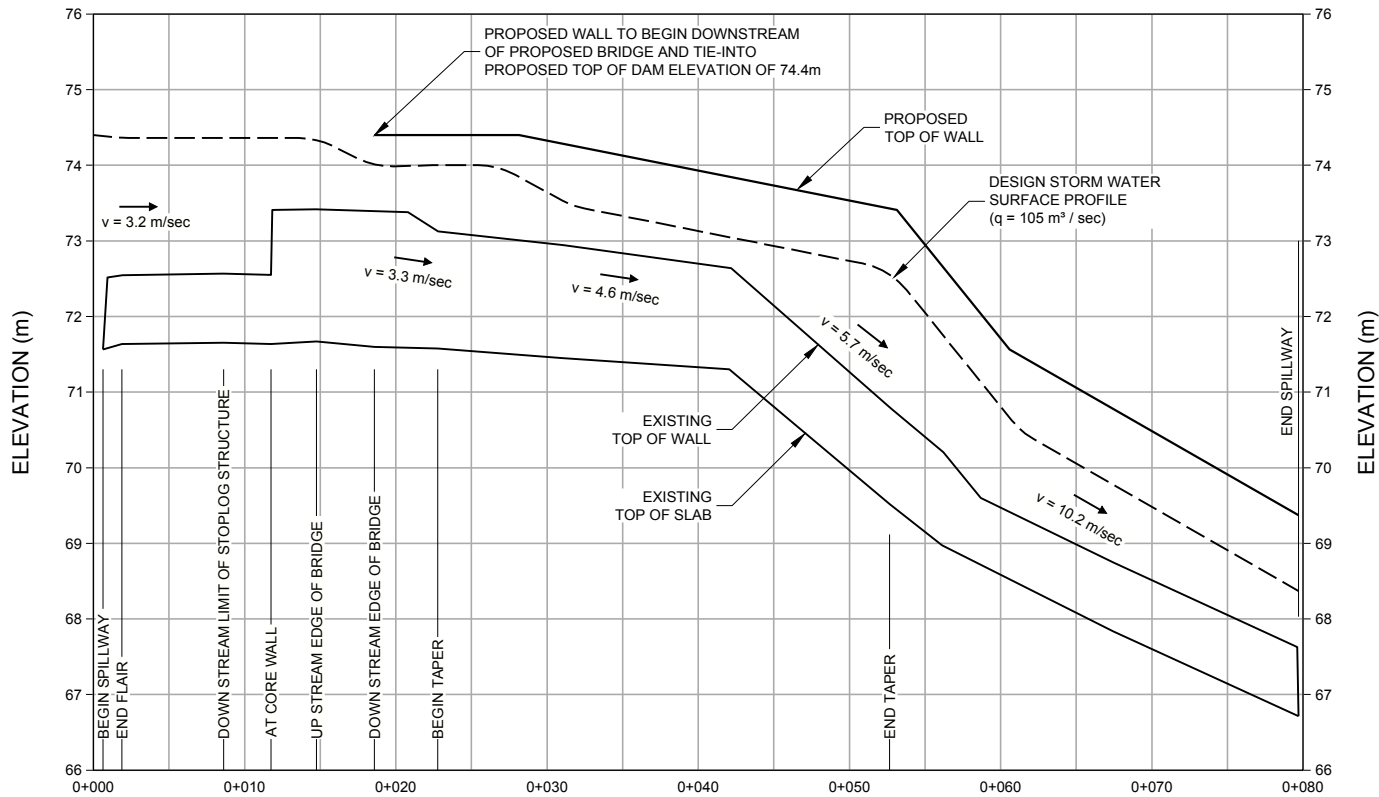
FIGURE
3

- Figure 1: General Arrangement
- Figure 2: Lower Dam Overtopping Protection Option – Conceptual Plan and Profiles
- Figure 3: Lower Dam Overtopping Protection Concept - Existing Spillway Wall Raise

SPILLWAY PLAN
SCALE 1:250

LEFT SPILLWAY WALL (LOOKING DOWNSTREAM)
SCALE V 1:50 H 1:500

RIGHT SPILLWAY WALL (LOOKING DOWNSTREAM)
SCALE V 1:50 H 1:500

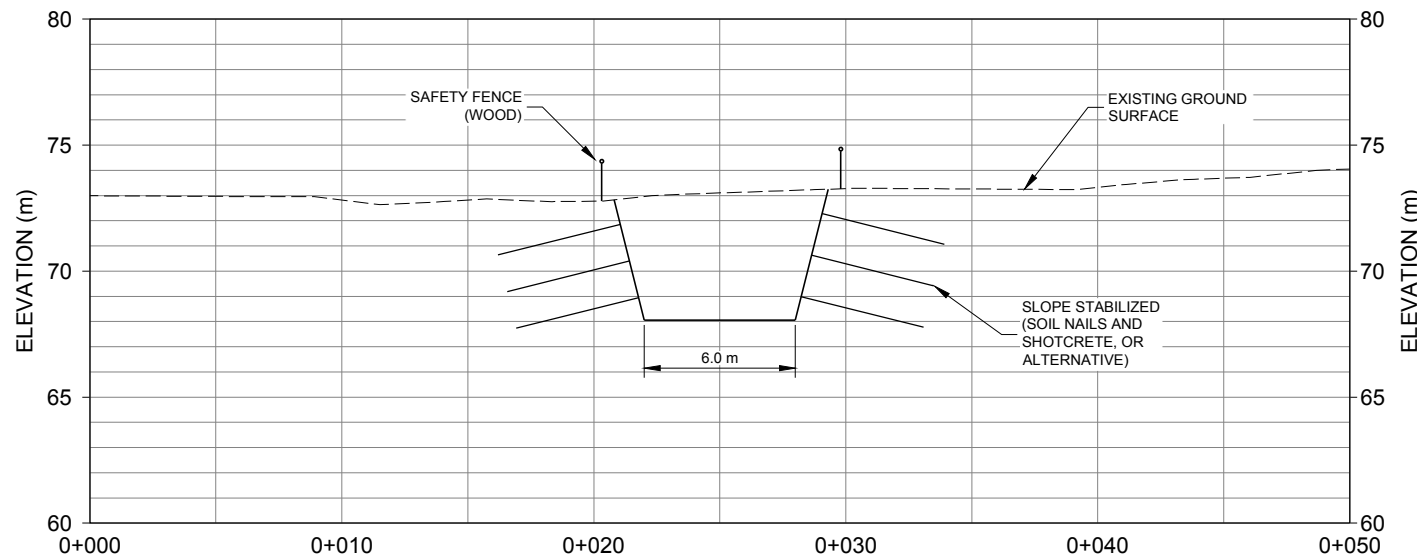
FIGURE
7b

- Figure 7b: Auxiliary Spillway to Harewood Creek Option 1A – Anchored Channel Conceptual Sections
- Figure 8a: Auxiliary Spillway to Harewood Creek Option 2 – Open Channel Conceptual Plan

SECTION A-A'
SCALE 1:300

SECTION B-B'
SCALE 1:300

SECTION C-C'
SCALE 1:300

- **Option 1A (Anchored Channel Option 1A)**—This option is similar to Option 1, however the covered box culvert section is 20 m long and includes a 10 m covered tapered section, as shown on Figure 7a and 7b. Water flows from the weir, through the extended box culvert and into the 6.0 m wide steep, anchor supported open channel before discharging into Harewood Creek. This option has similar advantages to Option 1 with the additional improvement of a 20 m long box culvert downstream of the weir (improved visual characteristics).

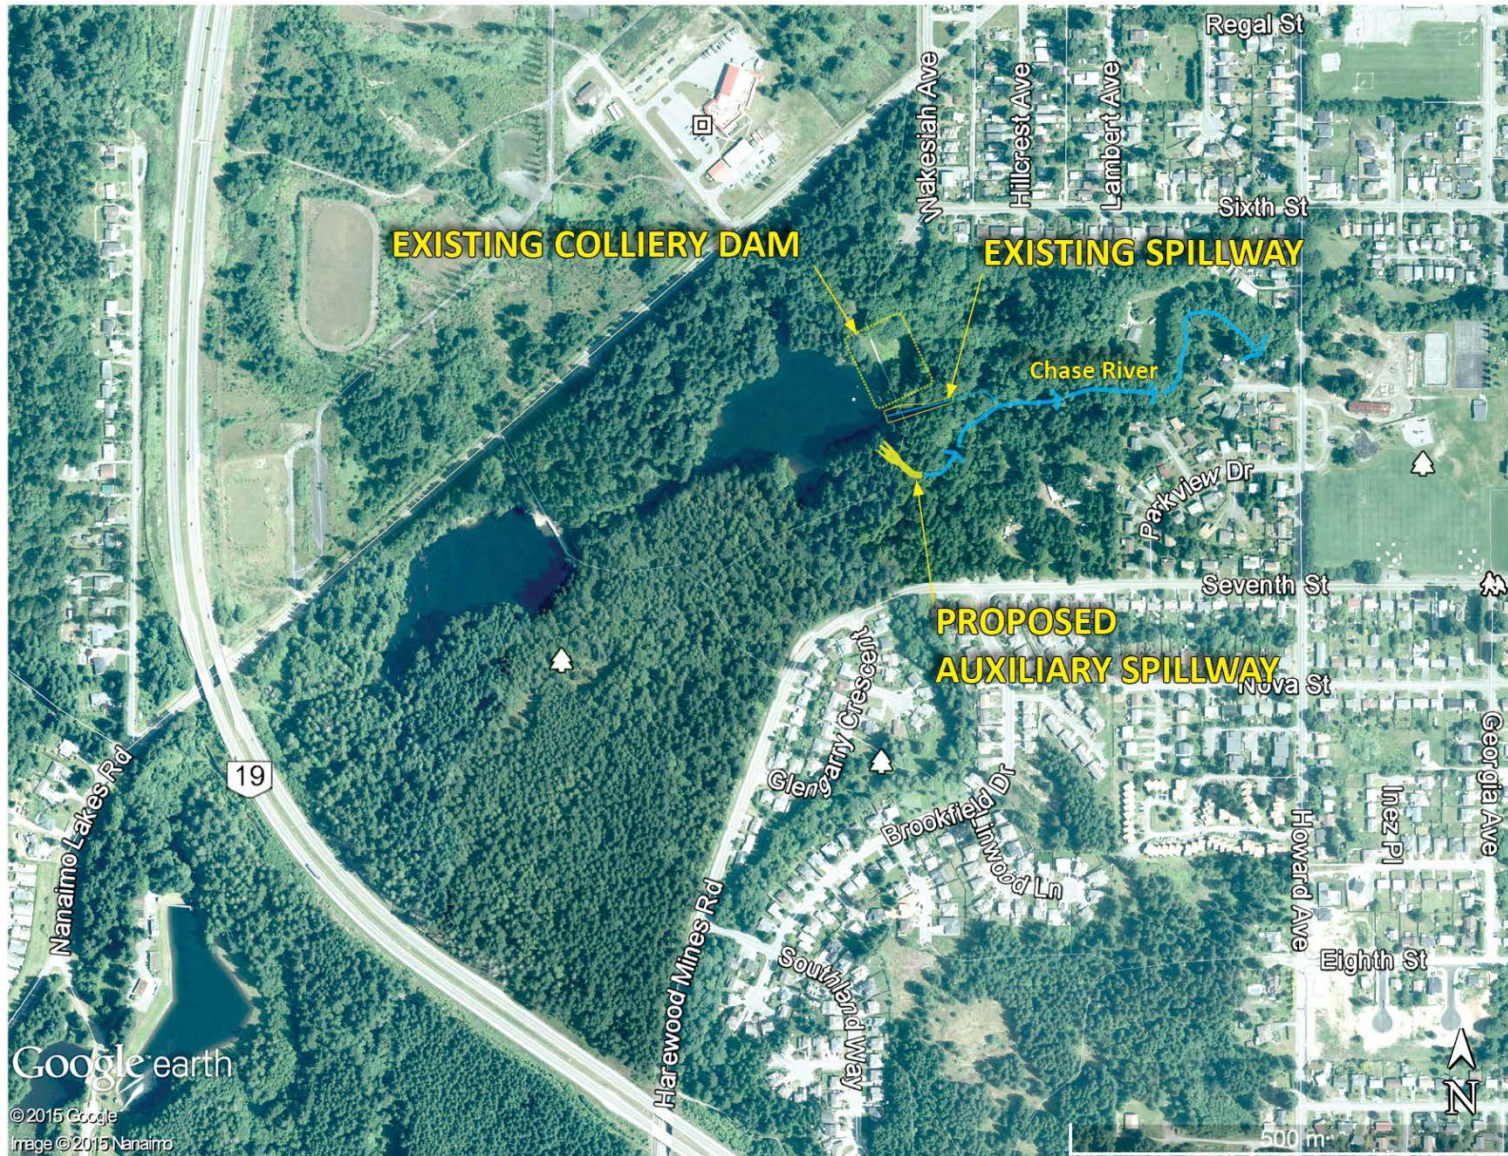
| Figure D-1 | | | |

| TITLE | | Auxiliary Spillway to Harewood Creek Context Plan | |

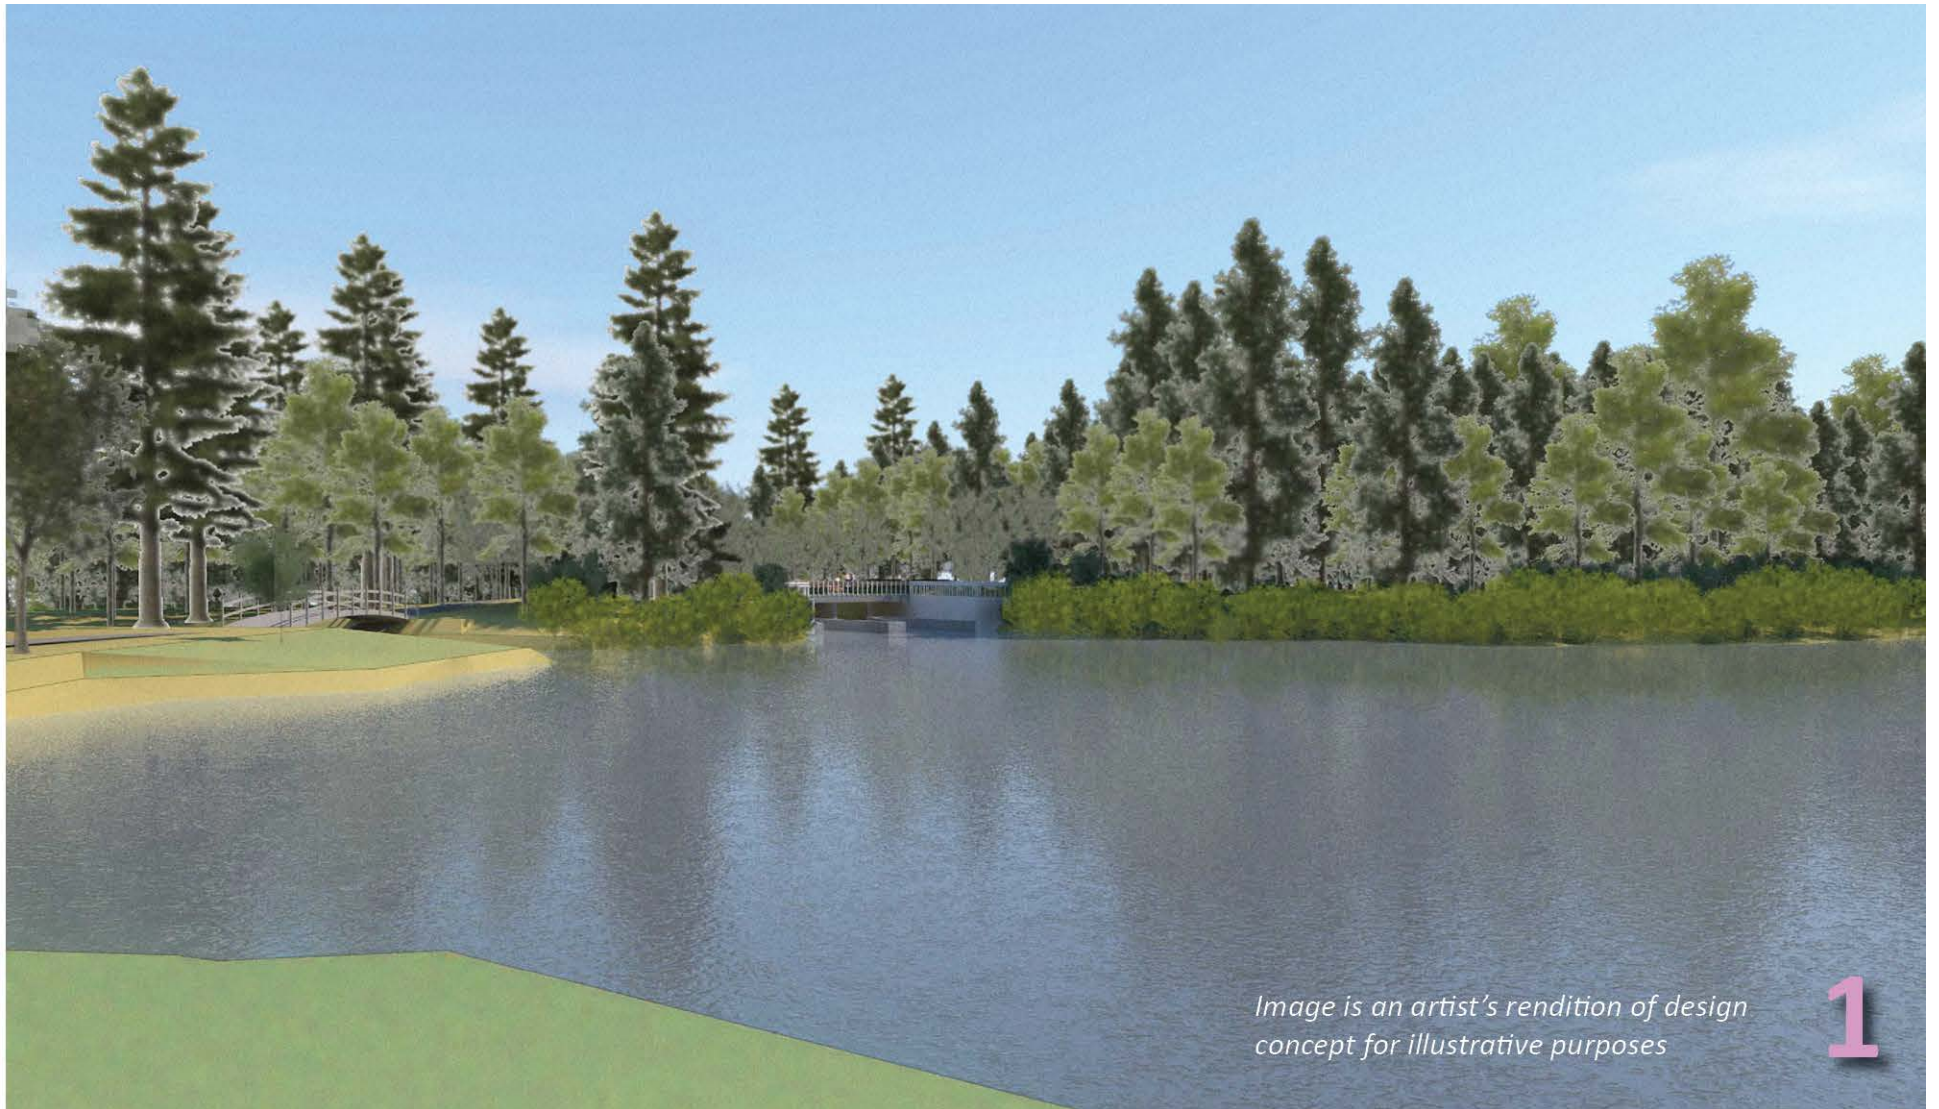
Image is an artist's rendition of design concept for illustrative purposes

View from across the lake

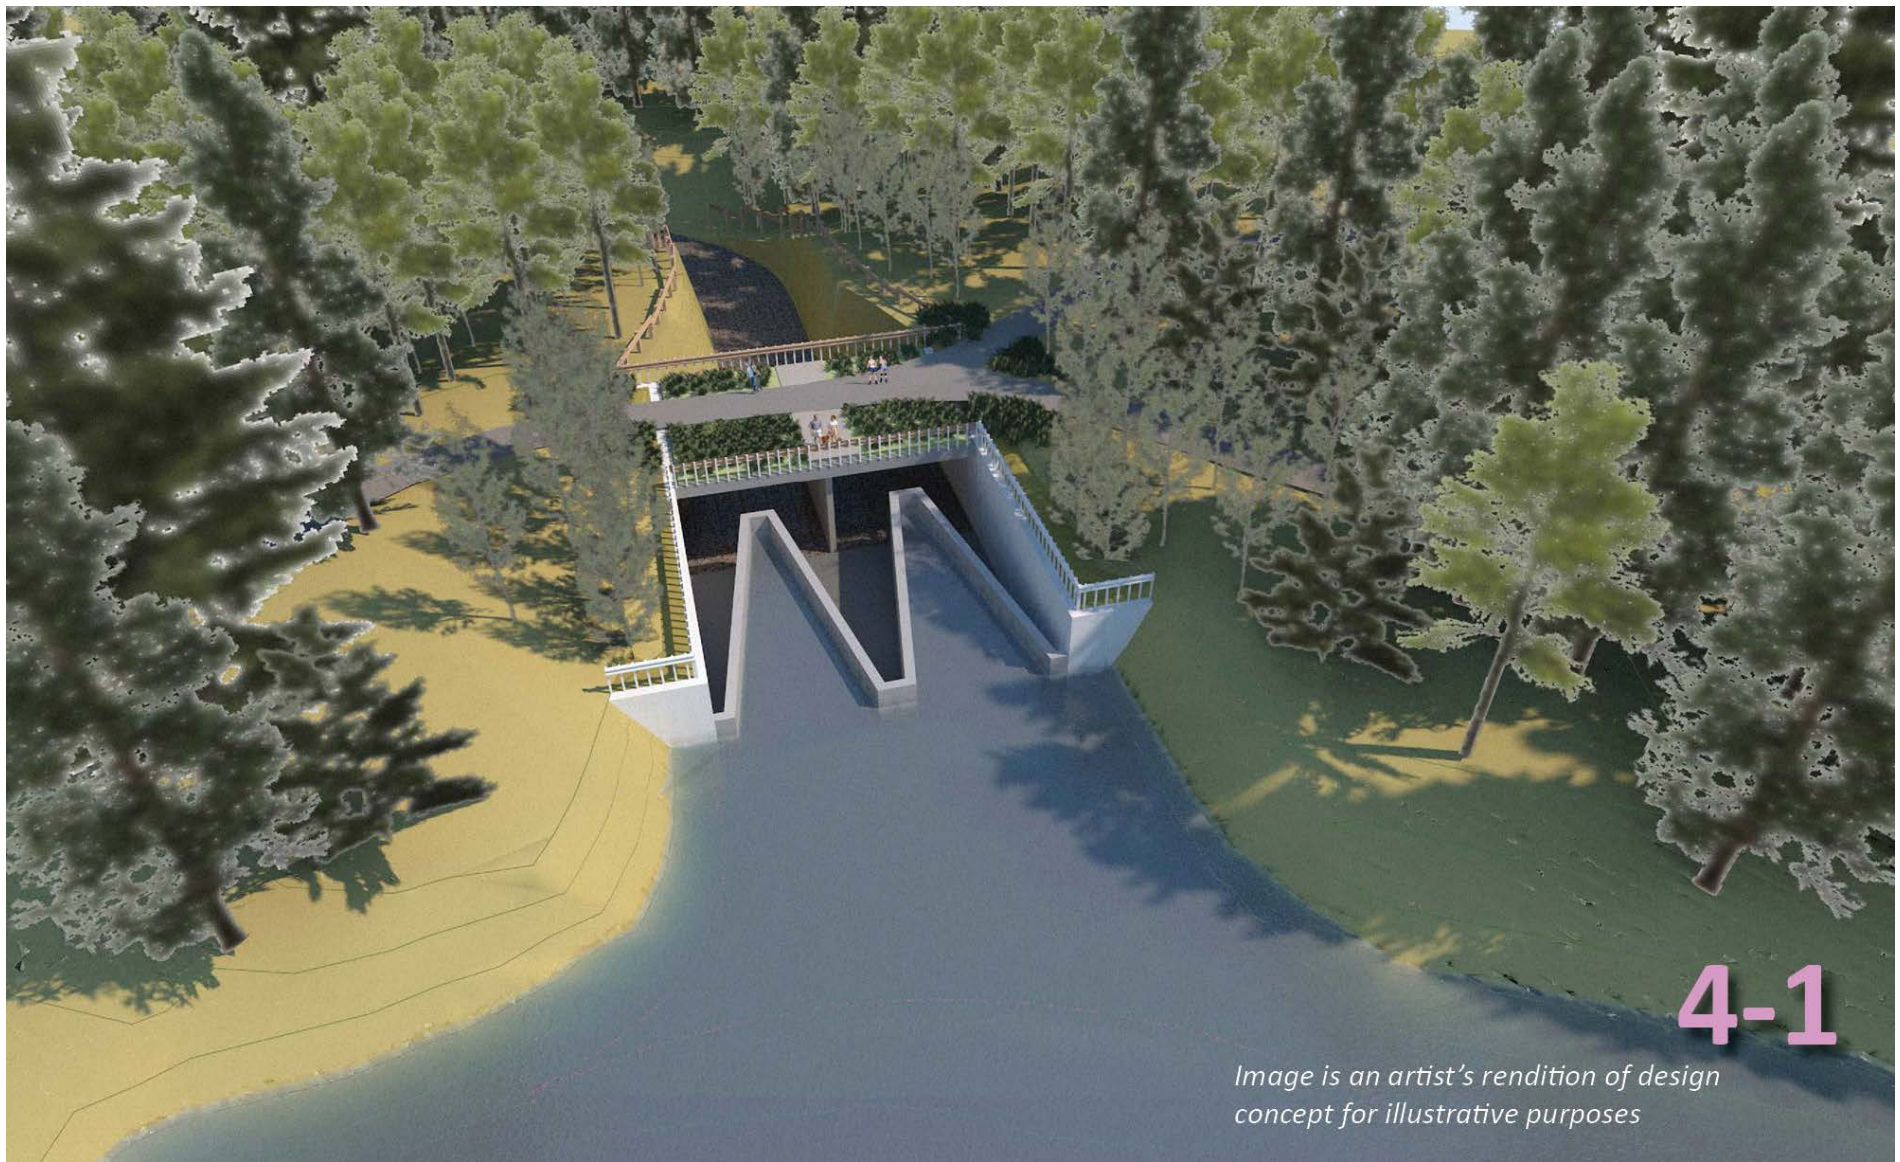
| | REVIEW | BD 03 July 15 | Figure D-5 |

Areal view from the north

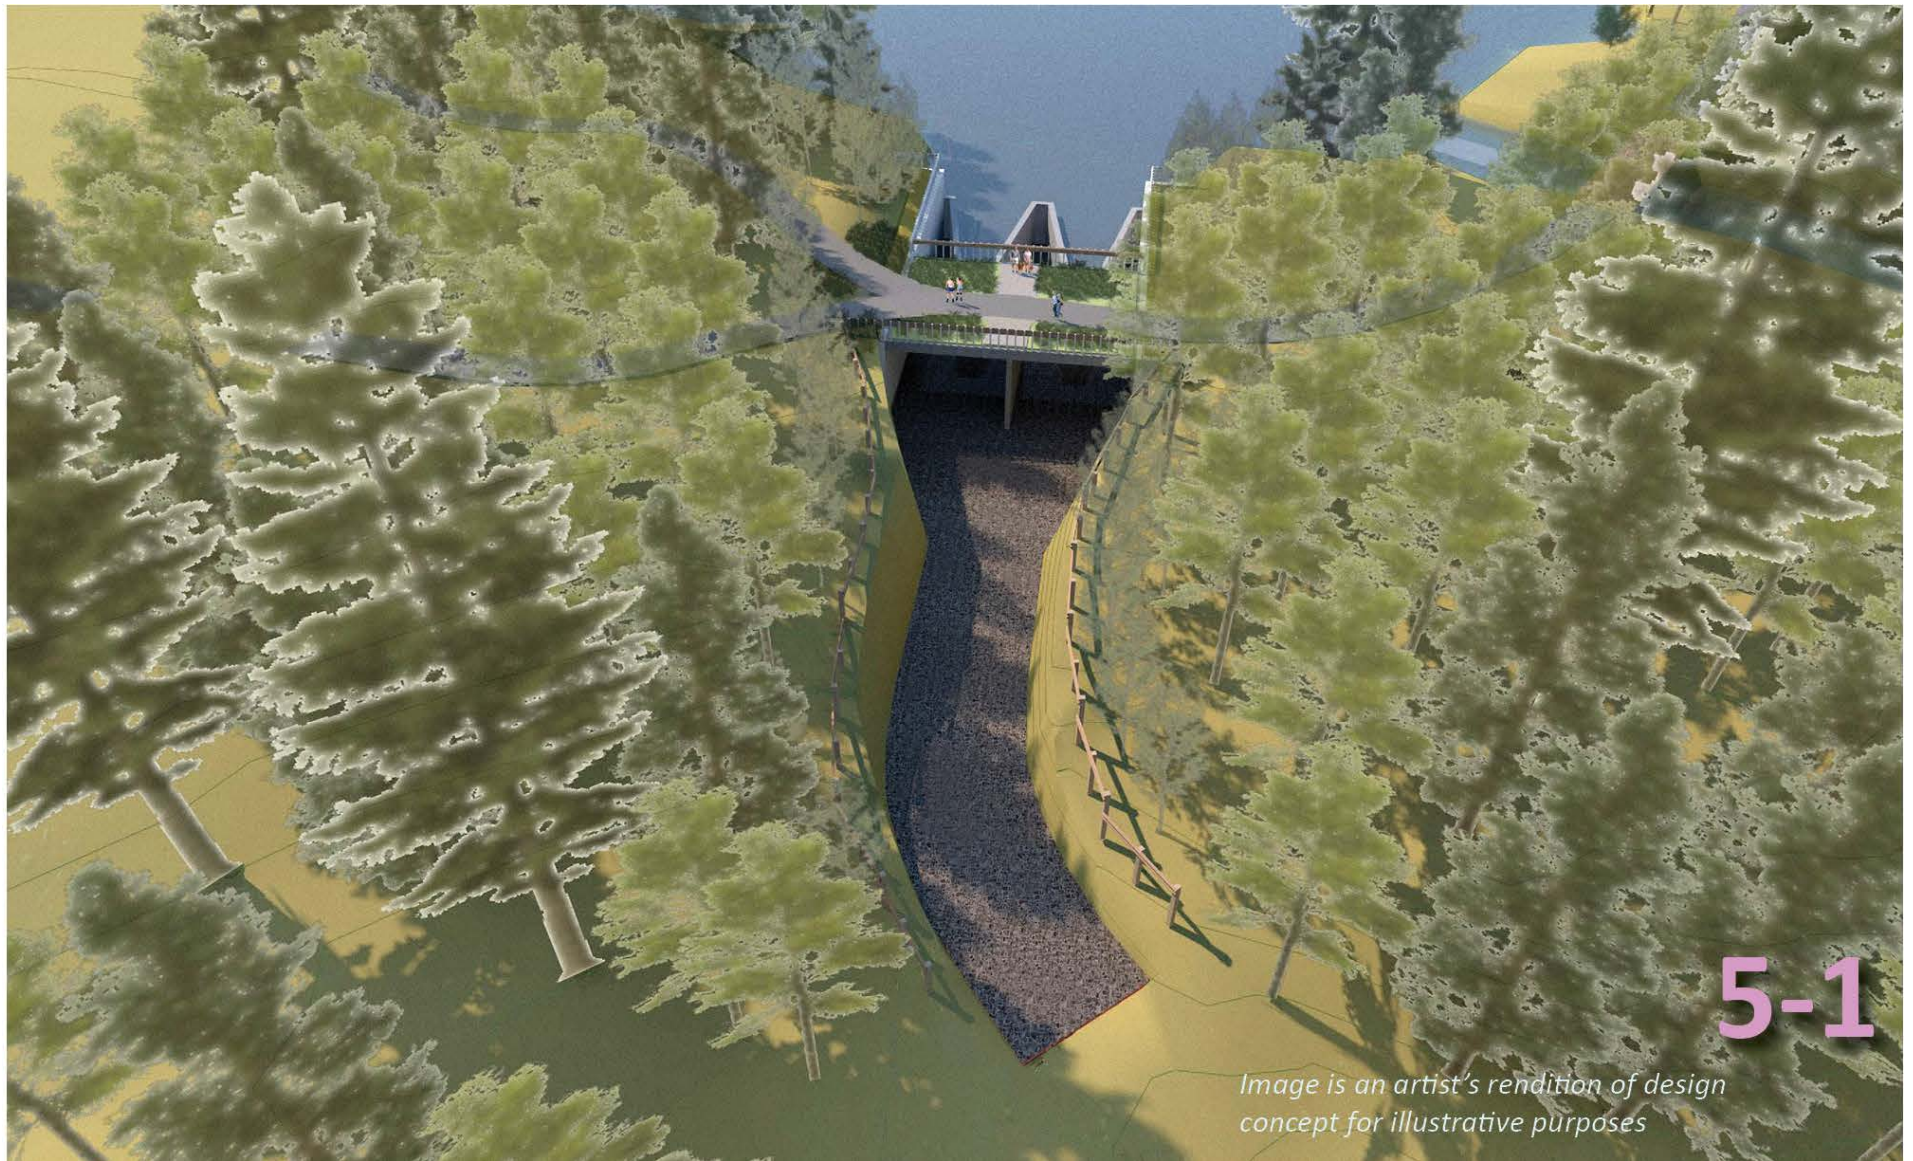
| | REVIEW | BD 03 July 15 | Figure D-6 |

Areal view from the south

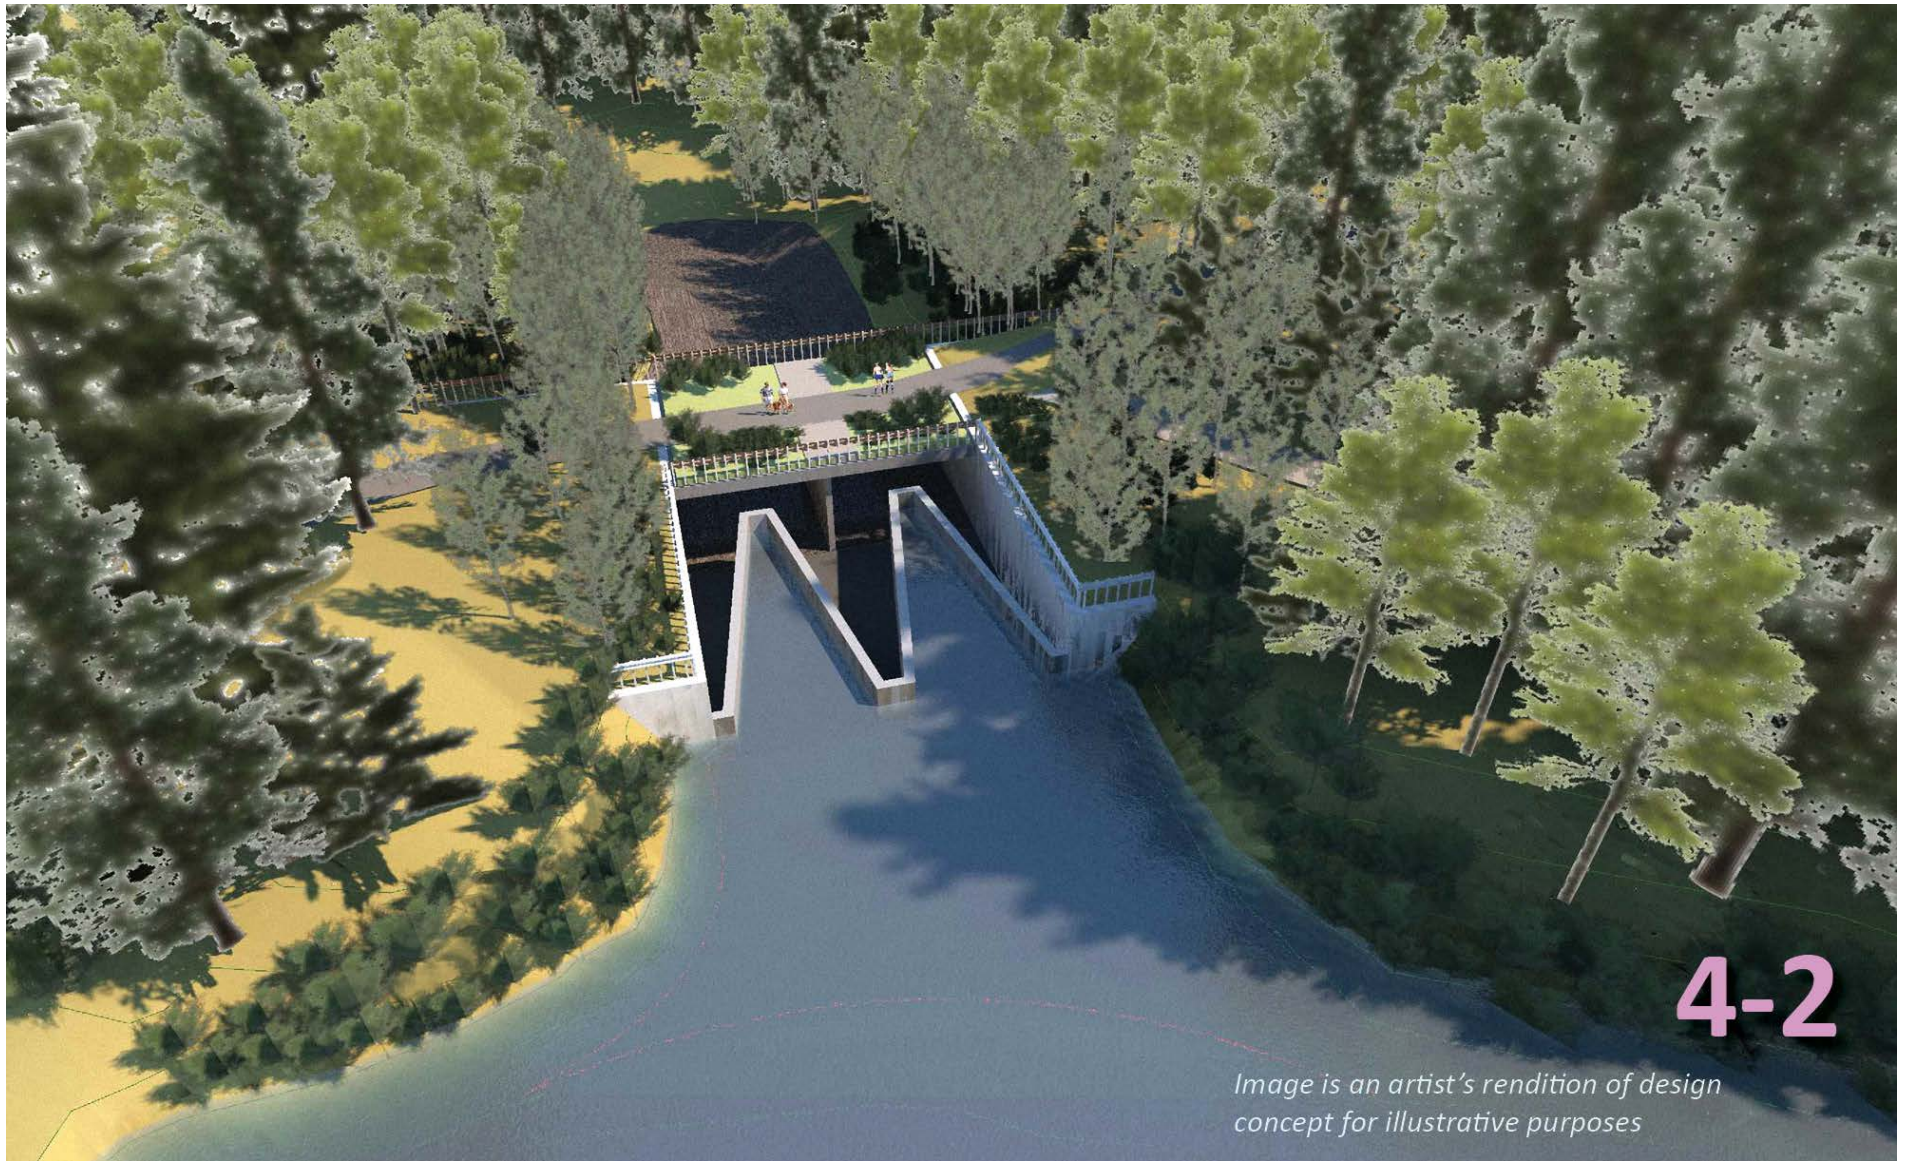
| | REVIEW | BD 03 July 15 | Figure D-7 |

Areal view from the north

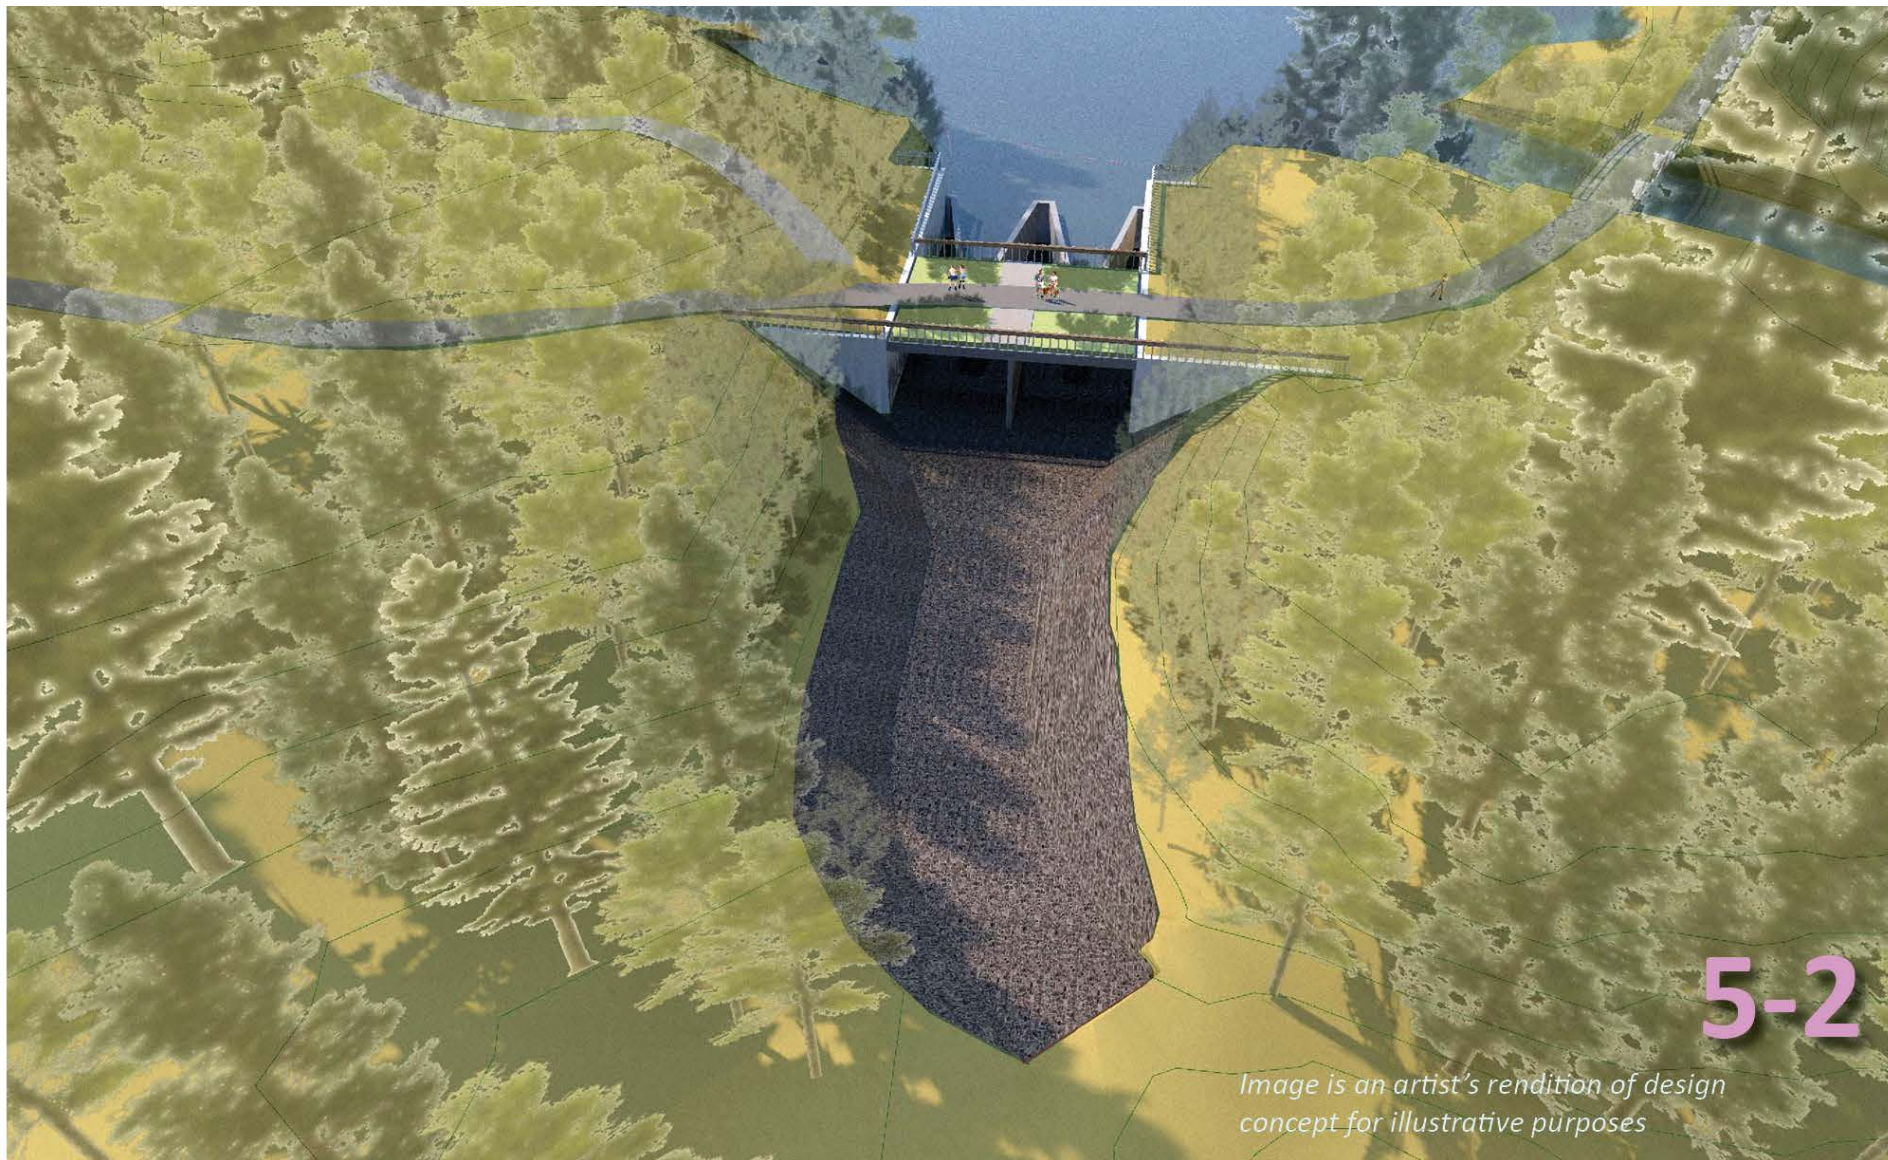
| | REVIEW | BD 03 July 15 | Figure D-8 |

Areal view from the south

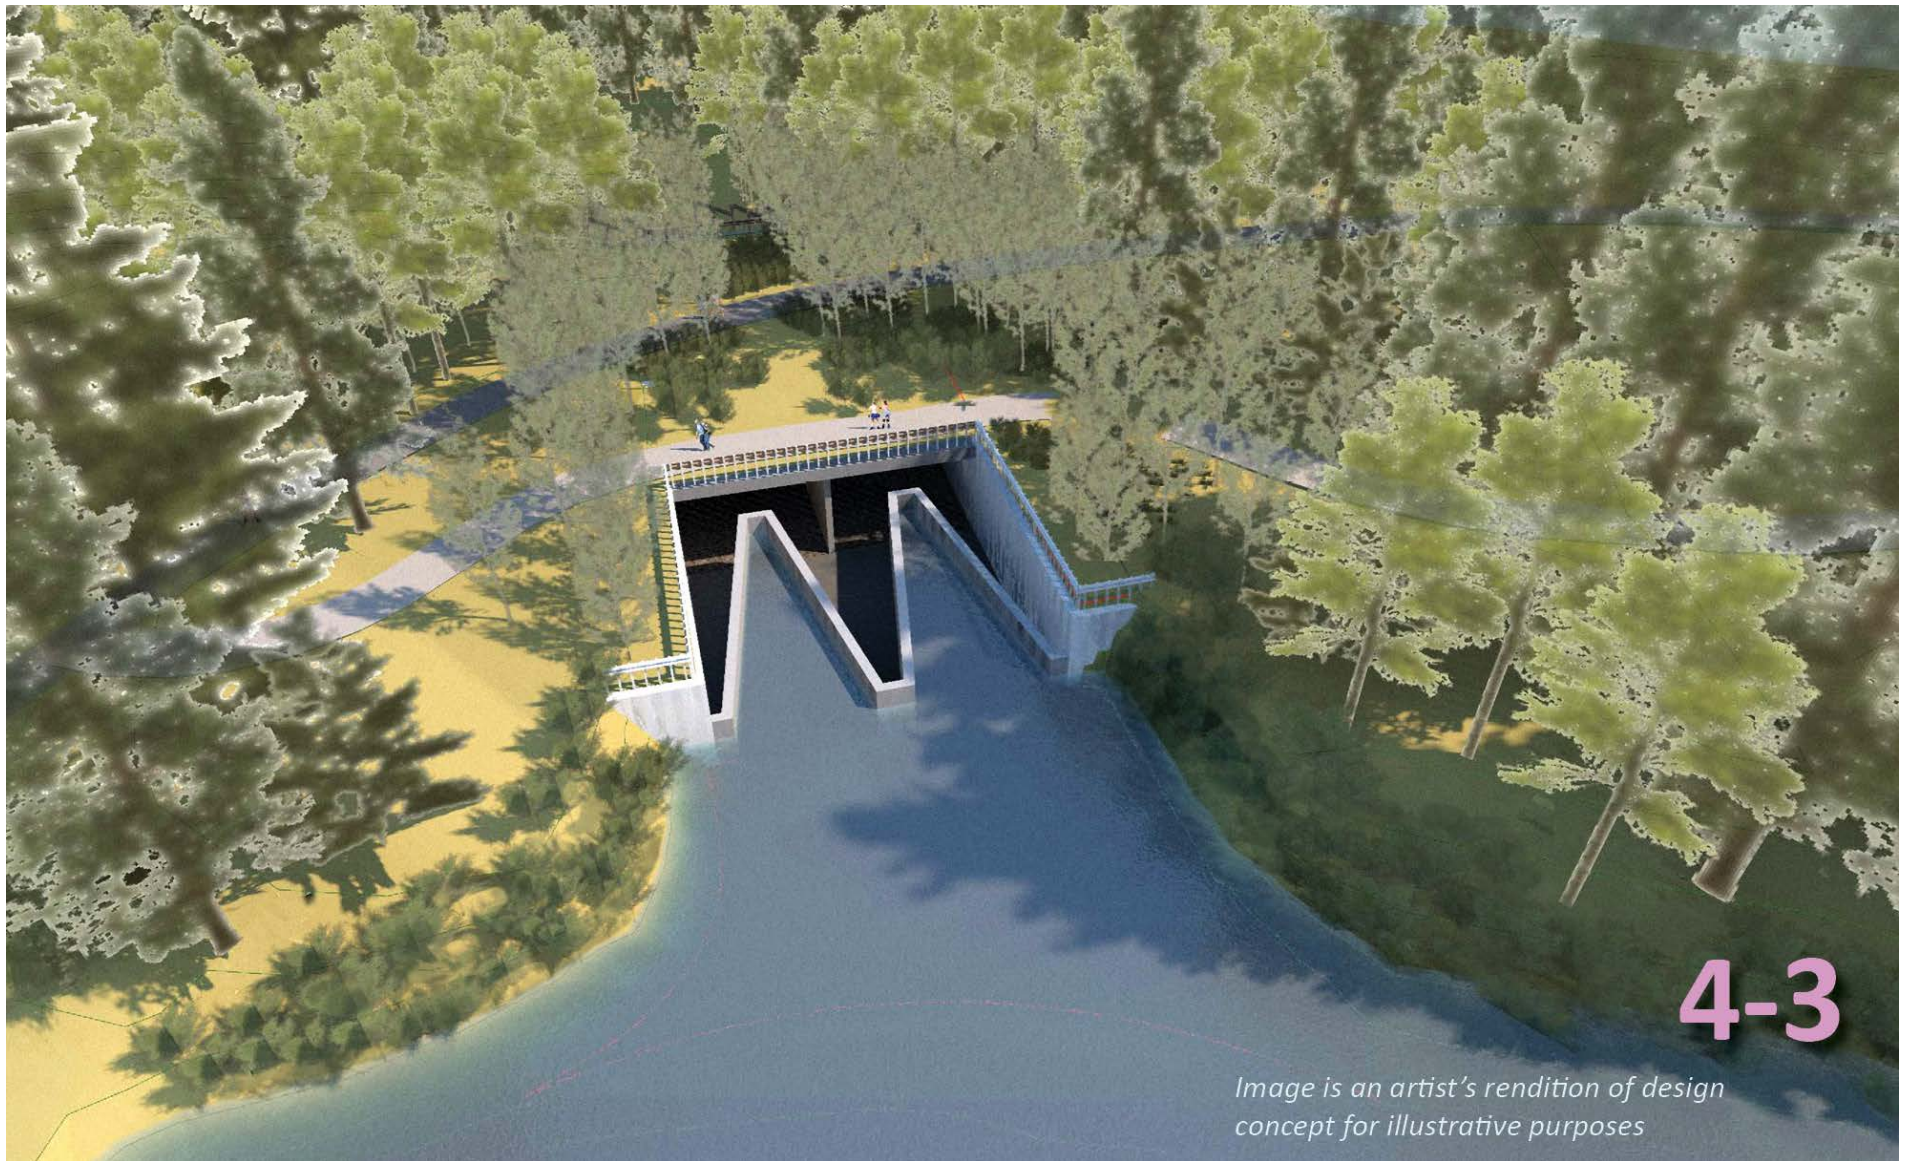
| | REVIEW | BD 03 July 15 | Figure D-9 |

Areal view from the north

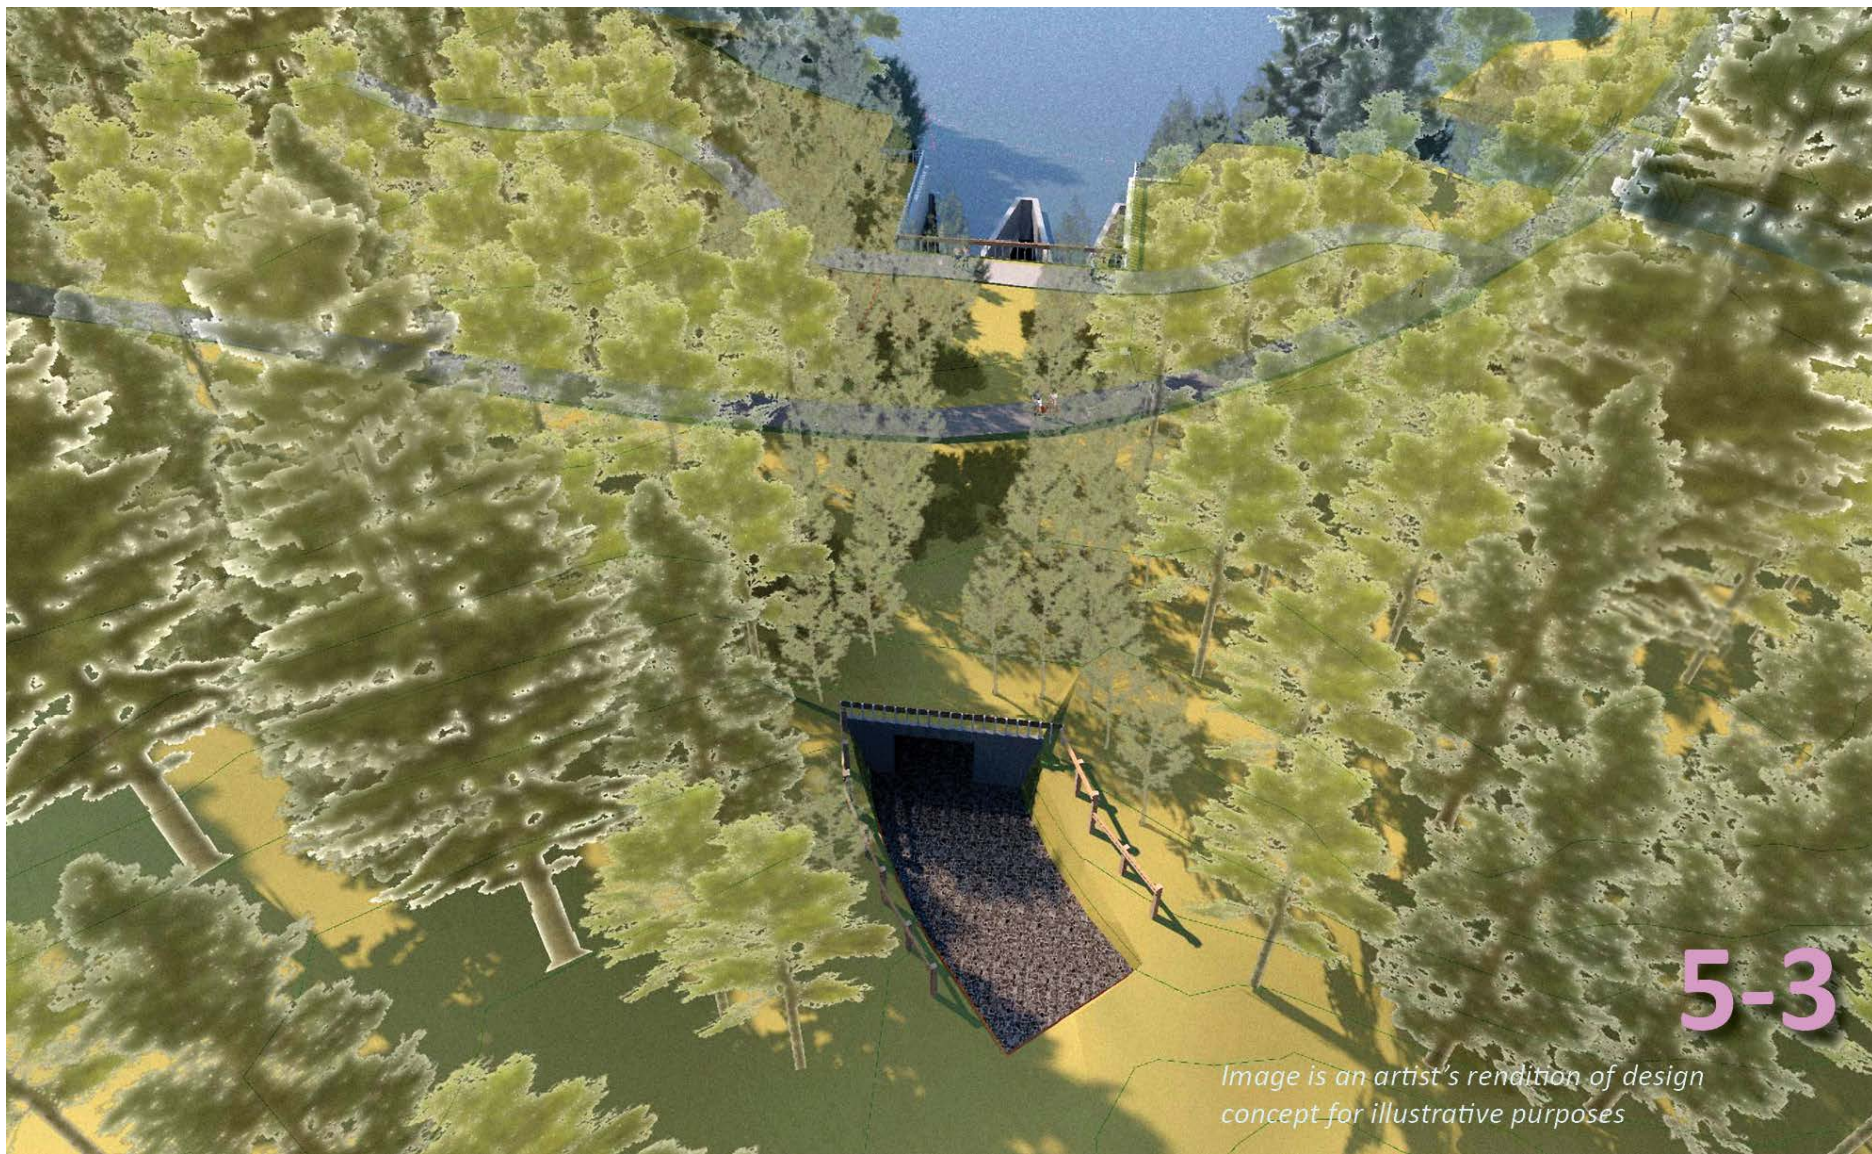
| | REVIEW | BD 03 July 15 | Figure D-10 |

Areal view from the south
