Re-Assessment of Options Middle and Lower Chase Dams Nanaimo, BC

Klohn Crippen Berger (KCB) has been retained by the City of Nanaimo (the City) to assist with engineering and environmental consulting services towards the removal of the Middle and Lower Chase Dams. The removal of the dams was ordered by City Council in October 2012 to address the public safety hazard (e.g. loss of life) posed by the dams to the high school, daycare and residential neighbourhood located a short distance downstream. The hazards are due to the subject dams and their spillways being inadequate to permit the dams to safely impound their reservoirs under the seismic and flood loading conditions established by the British Columbia Water Act – Dam Safety Regulation.

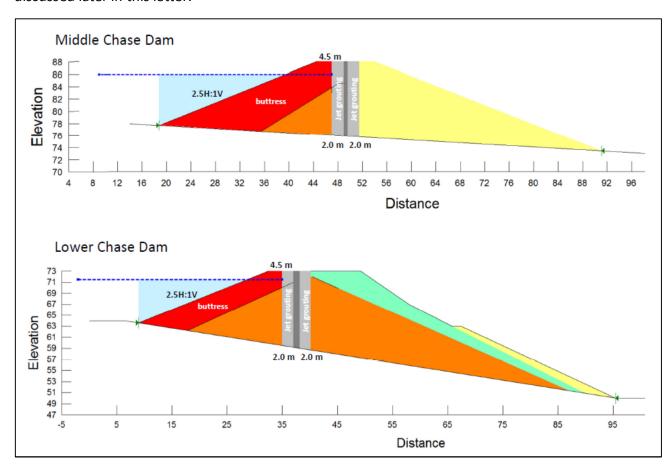
Figure 1: Revised Dam Rehabilitation Cross-Sections (Allow EQ Damage)

The design cross sections for Middle and Lower Dam for the revised design basis is presented in Figure 1. Note that downstream rock fill berms are not shown. The need for these berms will be discussed later in this letter.

The rehabilitation design (jet-grouting and buttressing) and seismic failure analysis were re-run to allow wall cracking and displacements of the concrete walls up to half their width. The deformation limits adopted for the latest assessment of rehabilitation are presented as follows:

- Middle Dam: allowable displacement 300 mm (vs. a maximum of 25mm used in "no damage case"); and
- Lower Dam: allowable displacement 600 mm (vs. a maximum of 25mm used in "no damage case").

Recognizing that the unsupported concrete wall faces on the upstream side of each of the subject dams exacerbates the damage experienced by the dams during a large seismic event, KCB included a rock fill buttress to provide upstream confinement for the concrete wall. A downstream buttress was not included in the analysis and it was demonstrated that from a seismic stability perspective (i.e. stability during, not after, the seismic event), a downstream toe berm was not required. However, the rehabilitation of the dams must be conducted so that the dams continue to safely impound their reservoirs (i.e. do not discharge their reservoirs in an uncontrolled manner) after the seismic event. The need for downstream toe berms will be discussed further in terms of post-seismic event stability later in this letter.

- The Middle Dam concrete walls and jet grouted zones will crack for the both 1:5,000 and 1:10,000 seismic events;
- The 1:5,000 year seismic event (with reservoir lowered by 3.0 m) will result in deformations in the order of 25 mm and 30 mm in upstream and downstream directions respectively;

- The 1:10,000 year seismic event (with reservoir at current elevation) will result in deformations in the order of 132 mm and 68 mm in upstream and downstream directions respectively;
- The seepage rates that result from the calculated deformations and anticipated degree of cracking will be quite high, in the order of several cubic meters per second.

- The Lower Dam concrete walls and jet grouted zones will crack for the both 1:5,000 and 1:10,000 seismic events;
- The 1:5,000 year seismic event (with reservoir lowered by 3.0 m) will result in deformations in the order of 40 mm and 30 mm in upstream and downstream directions respectively;
- The 1:10,000 year seismic event (with reservoir at current elevation) will result in deformations in the order of 135 mm and 70 mm in upstream and downstream directions respectively; and
- The seepage rates that result from the calculated deformations and anticipated degree of cracking will be quite high, in the order of several cubic meters per second.
