THE CITY OF NANAIMO

OPERATION, MAINTENANCE AND SURVEILLANCE (OMS) MANUAL for CHASE RIVER DAMS

- Upper Chase River Dam
- Middle Chase River Dam
- Lower Chase River Dams

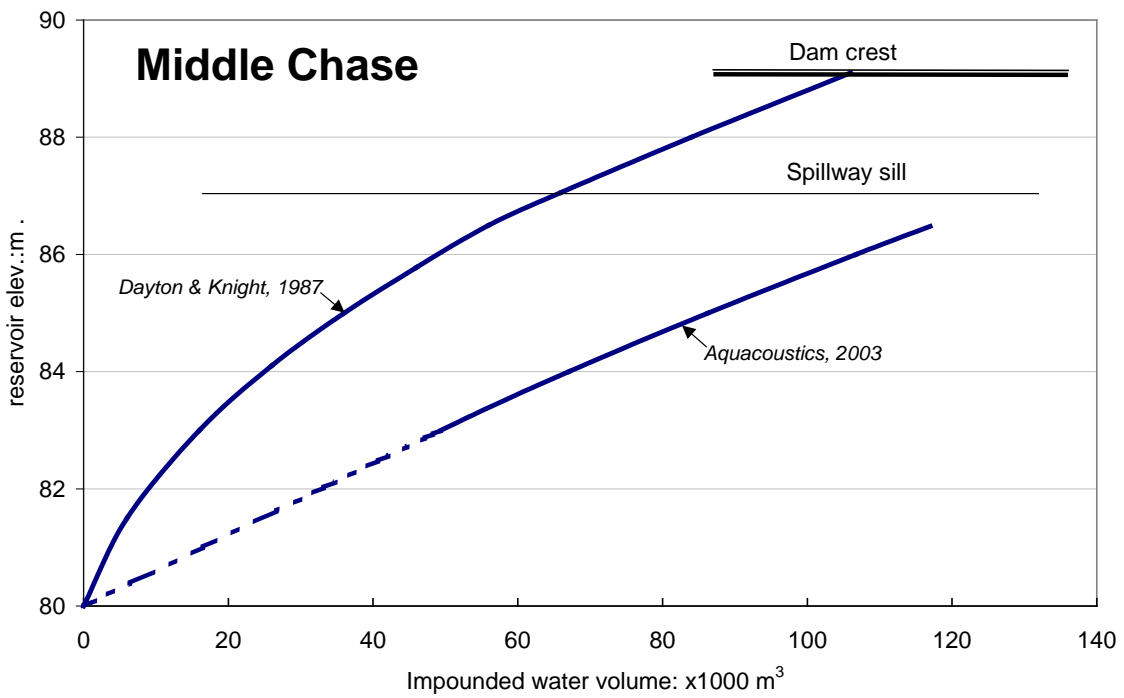
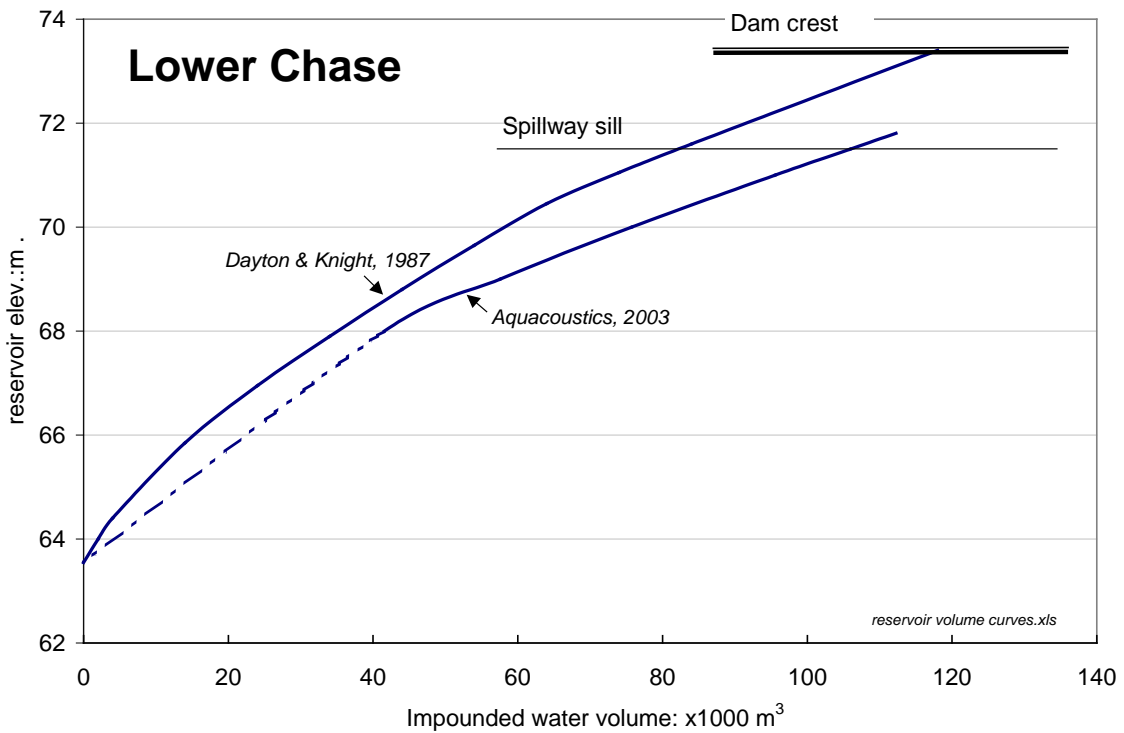
Figure 3: Stored Water Volume versus Reservoir Elevation

Estimated retained water volume versus water level curves were developed for both the Lower and Middle Chase dams some fifteen years ago (Dayton & Knight, 1987). These stored water curves were based on available contour drawings at the time. The estimates of stored water were updated by the recent bathymetric survey (Aquacoustics Remote Technologies, 2003) of the two reservoirs. The computed capacities are shown on Figure 3a and 3b for the Middle and Lower Chase dams respectively. The recent surveys show rather more stored water in the Middle Chase Reservoir than thought in 1987, and comparable storage at Lower Chase. The 2003 estimates are likely the most reliable; the 1987 data is shown for continuity with past documentation of the dams.

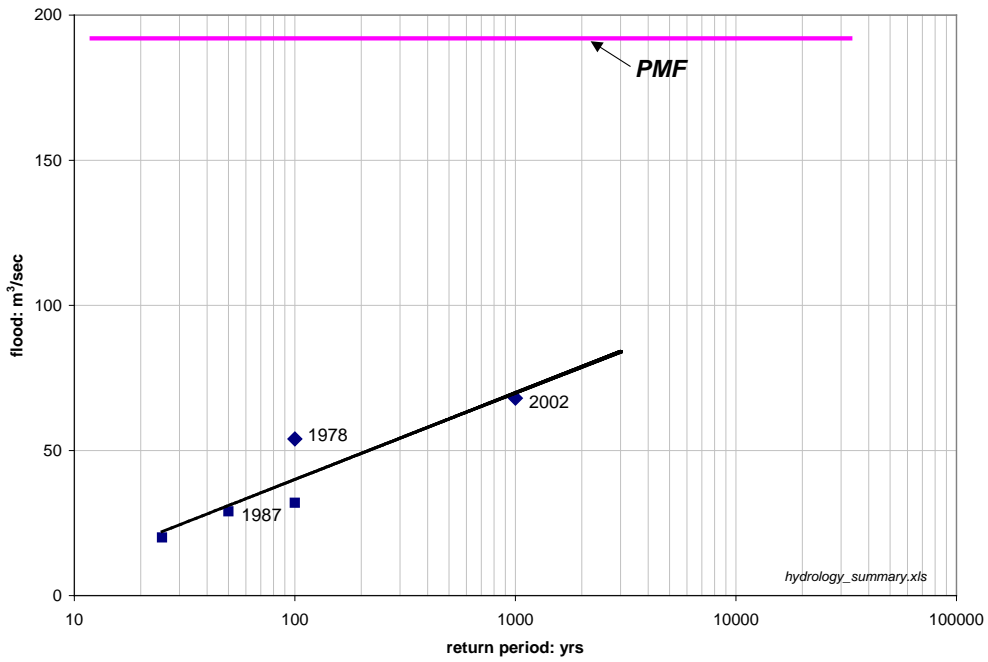
Figure 4: Summary of Studies of Flood Flow versus Return Period at Lower Chase Dam

The results of these studies have been plotted as storm flow versus the associated estimated return period on Figure 4 for the Lower Chase dam. Also shown on this figure is the Probable Maximum Flood (PMF) and which is only quoted by Water Management Consultants. The PMF corresponds to about 230 mm precipitation in 24 hours within the catchment.

There is some difference between the 1978 study and the other two. A trend line has been drawn through the results of these studies, weighted to the 1987/2002 results, to indicate a present best-estimate of how the flood increases with increasing return period. A 3000 year return period event corresponds to about an 80 m³/sec flow at the Lower Chase Dam. The PMF, which is 198 m³/sec, represents markedly in excess of a 10,000 year event (which is quite extreme).

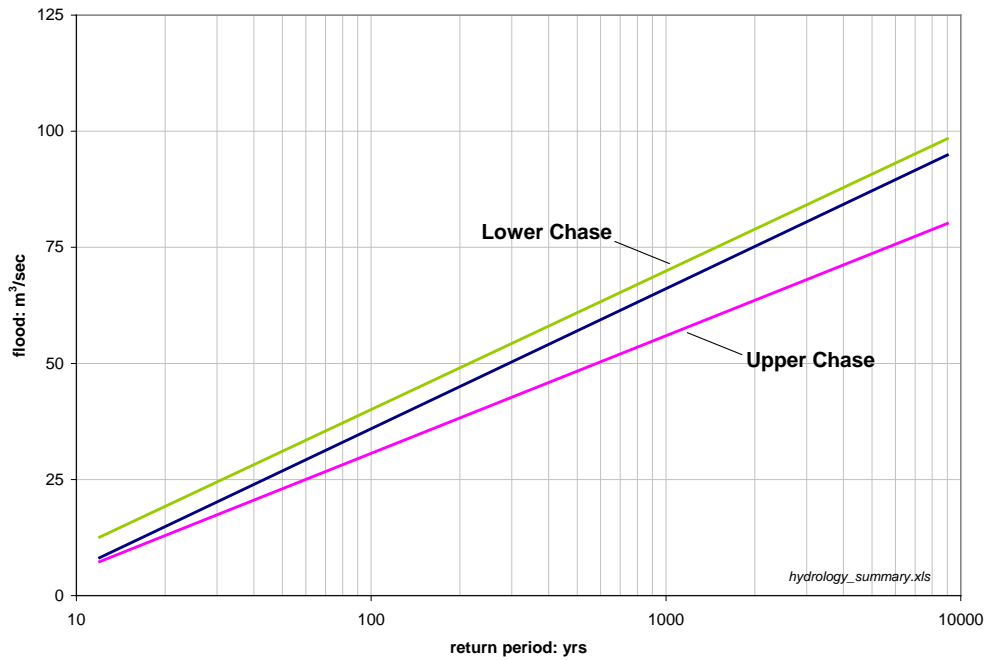
Figure 5: Comparison of Estimated Flood Flows for Chase River Dams

Figure 5 compares the trend lines for flood flow versus return period for all three of the Chase river dams. There is not a great deal of difference from one dam to the next because most of the catchment lies above the Upper Chase dam. There has been no systematic measurement of weir flows over the life of the dams, and thus no measured data to improve the hydrological estimates shown on Figures 3 and 4.

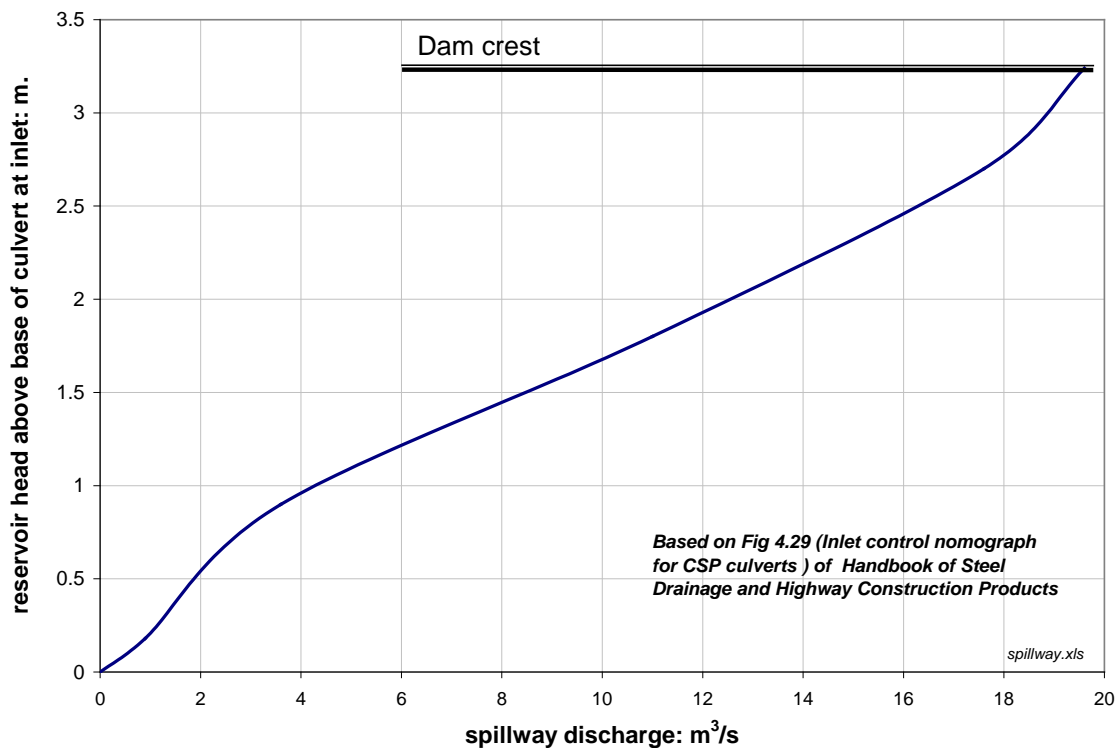
Fig 6: Estimated Hydraulic Performance of Upper Chase Spillway

There are no water depth versus flow capacity curves developed in prior work for the Upper Chase spillway. Figure 6 shows the estimated hydraulic capacity of the Upper Chase spillway as limited inlet conditions to the corrugated steel culverts.

The depth shown on Figure 6 is the depth above the base of the culverts, which is about 0.6m below the base of the upstream concrete channel. There is a short inclined section of the concrete channel immediately upstream of the culverts and, while this accelerates the water at low flows, its effect on the hydraulic capacity of the culverts has not been determined. Thus, Figure 6 is only a first estimate of hydraulic capacity and could usefully be updated by field calibration as storm events present themselves.

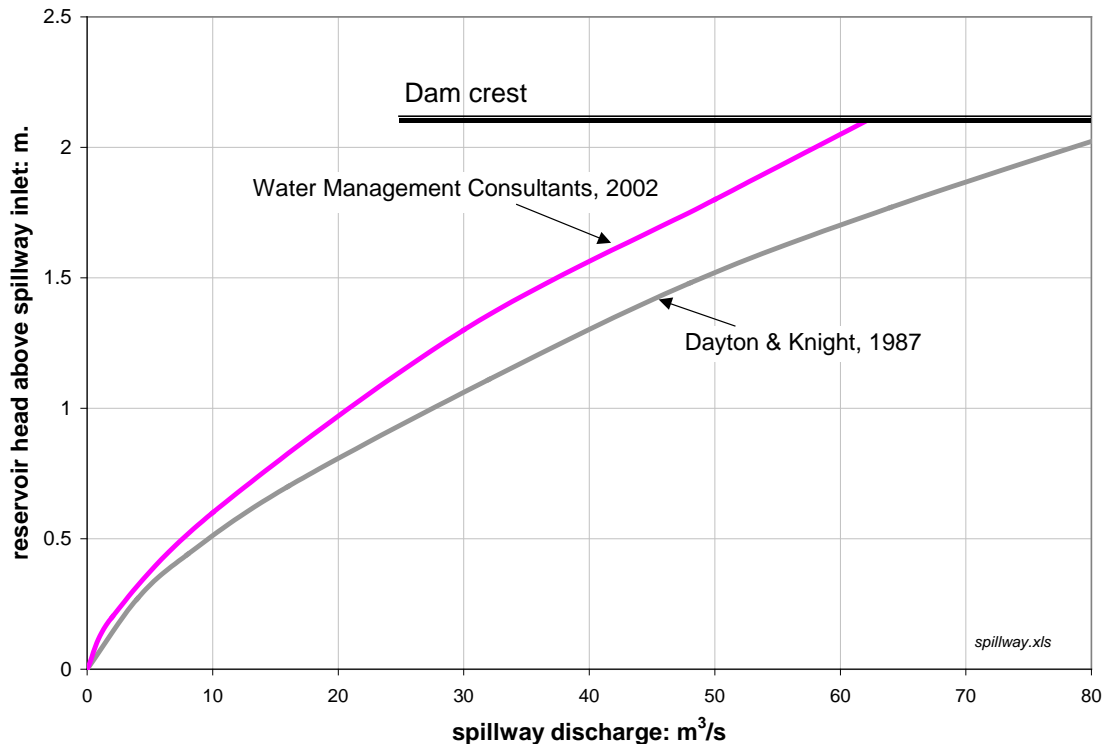
Figure 7: Estimated Hydraulic Performance Curves For Middle Chase Spillway

The capacity of the spillway has been estimated by both Dayton & Knight (1987) as part of developing the then “Data File” and most recently by Water Management Consultants (2002) as part of a study into the Chase River hydrology. The two estimated hydraulic performance curves are shown on Figure 7.

The reason for the difference between the two estimates of the Middle Chase spillway capacity are not known, and there are no known field calibrations to resolve the discrepancy.

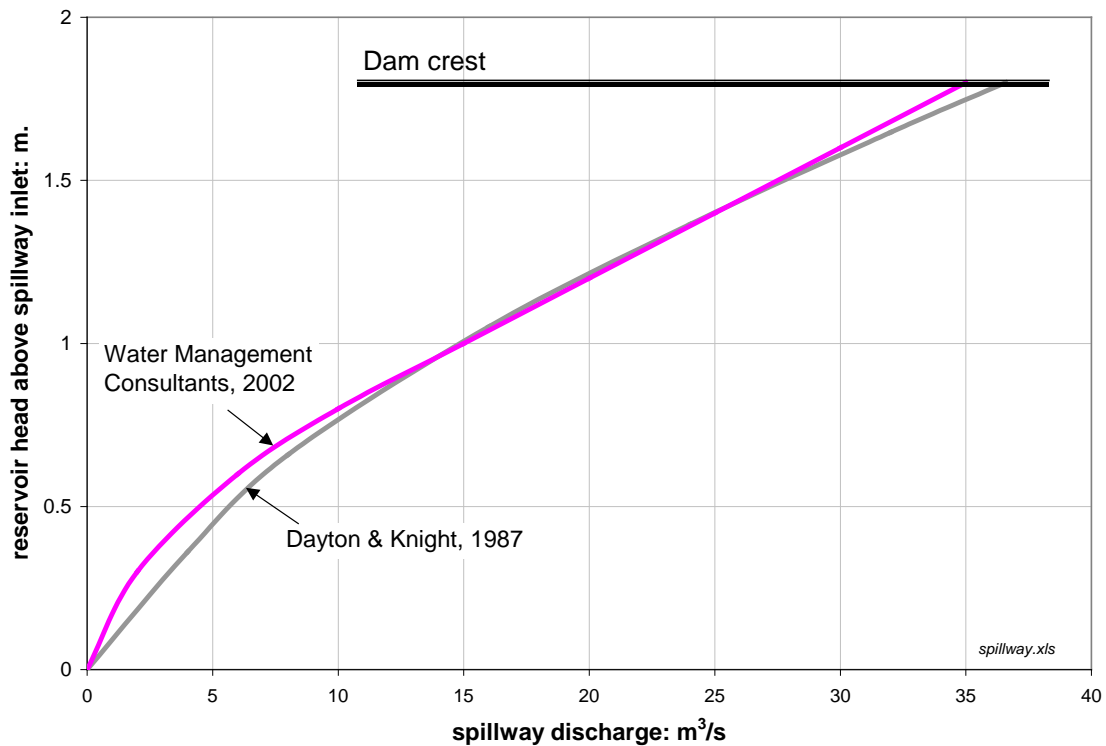
Figure 8: Estimated Hydraulic Performance Curves For Lower Chase Spillway

The capacity of the spillway has been estimated by both Dayton & Knight (1987) as part of developing the then “Data File” and most recently by Water Management Consultants (2002) as part of a study into the Chase River hydrology. Figure 8 compares the two computed performance curves for the spillway. Very similar estimated performance is evident from the two studies.

Broadly, both estimates indicate the spillway can pass 35 m³/sec at the onset of overtopping the crest of the dam. However, Water Management Consultants (2002) note that flows above 25 m³/s would overtop the channel walls downstream of the spillway inlet and might cause some erosion of part of the downstream shell. The estimated capacity of Lower Chase spillway is about half that of the immediately upstream Middle Chase spillway.

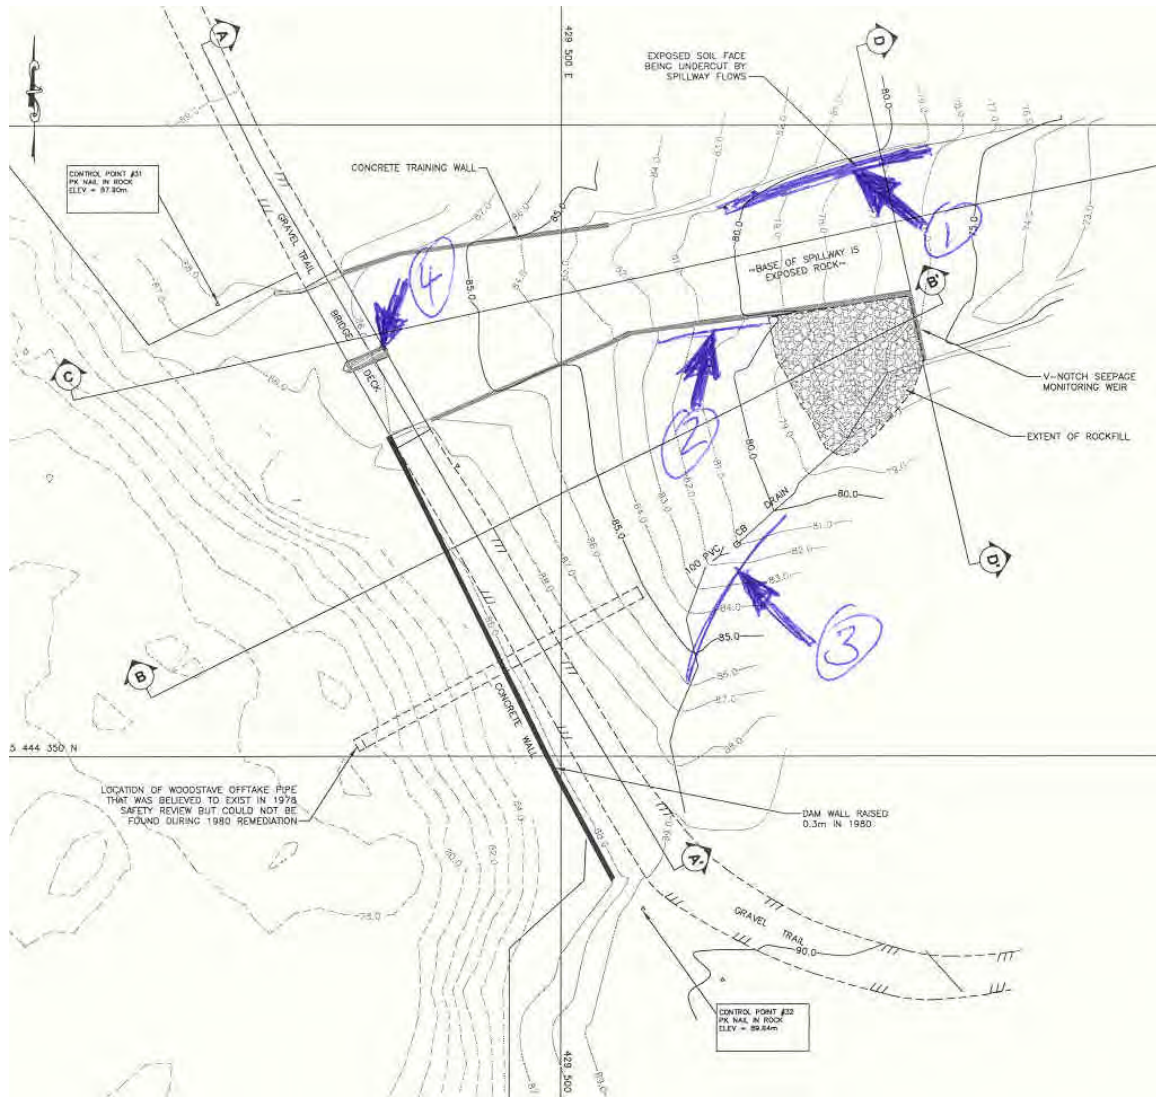
Figure 1: Location of specific inspection items for Middle Chase Dam

INSPECTION ITEMS SPECIFIC TO THIS DAM (see Fig 1 on Page 3 for locations)	
Location 1. Are there any trees that are in danger of toppling into the spillway because of erosion undermining the bank ?	
Location 2. Has the dam slope been eroded by water flowing over the spillway training wall ?	
Location 3. Are there any zones of seepage from the abutment or dam slope ?	
Location 4. Has the concrete supporting the footbridge beam spalled off the pier ?	
<i>If the answer to any of the above questions is "yes" contact Ritchie Fulla</i>
