Reference No. 1314470516-021-L-Rev0

**COLLIERY DAMS, NANAIMO BC
CONSEQUENCE CLASSIFICATION**

APPENDIX B
FLOOD MAPPING

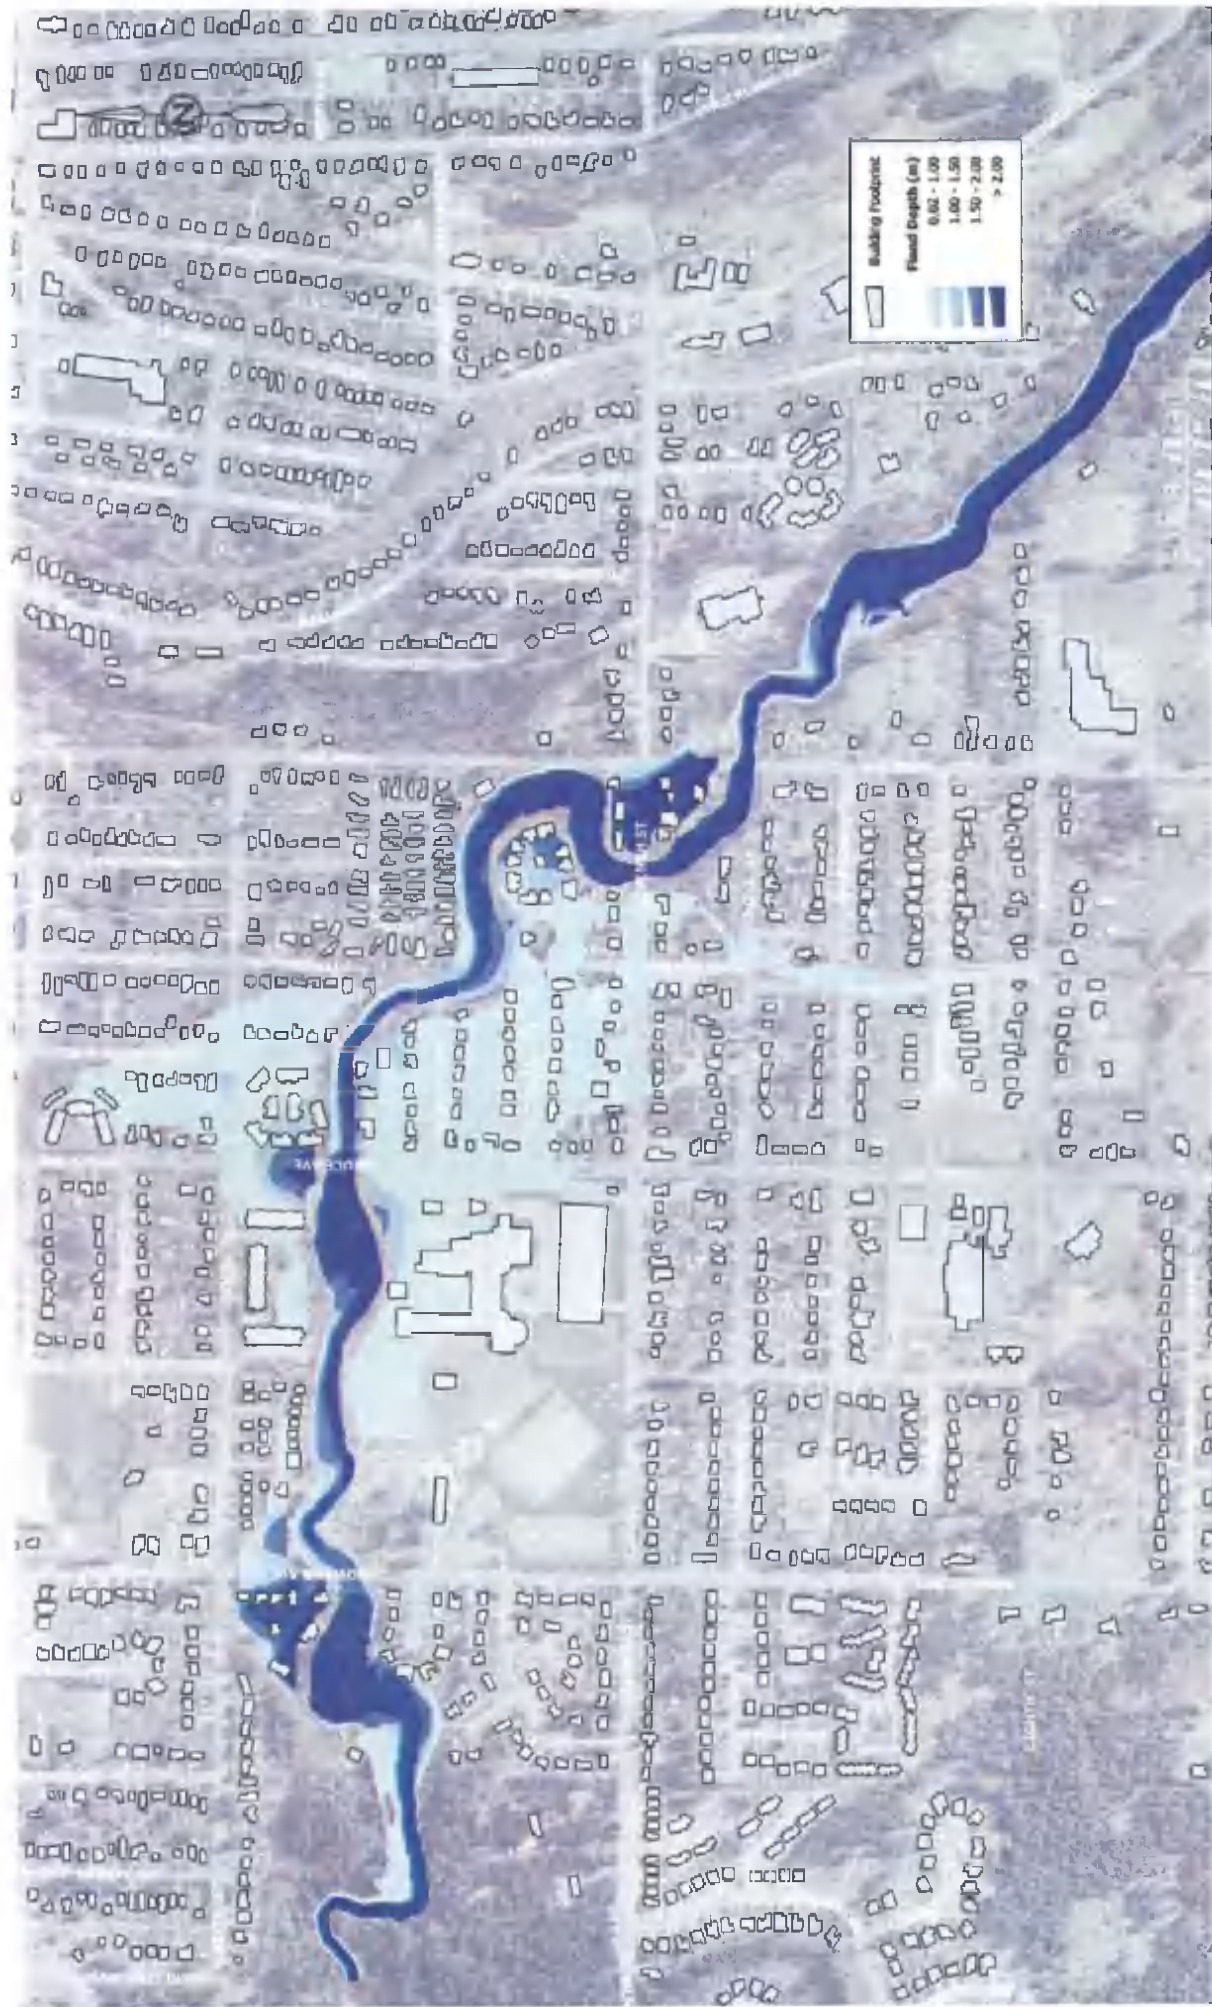
Figure 3

SC3 - Maximum Flooding Depth, Extents and Damages

- For Middle Dam and Lower Dam failure, the most severe downstream *incremental* consequences are represented by Scenario 14 (SC14) which considers a fast beach of the Middle and Lower Dams during a PMF storm event (see Figure 3, Appendix B). For this scenario the incremental expected fatalities are 11. By way of comparison, for the moderate failure of the Middle Dam and Lower Dam in the PMF event (SC13), the incremental expected fatalities reduces to 1.0; and

Based on a review of the descriptions provided in Schedule 1 of the BC Dam Safety Regulations, and the extent of flooding expected for the assumed failure scenarios (Figures 2 and 3, Appendix B), our assessment of the environmental and cultural consequences of the failure of the Middle Dam and Lower Dam are outlined in the following sections.

The extents of flooding for the two dam breach scenarios under consideration are shown on the attached Figures 2 and 3 (Appendix B). These figures illustrate contours of flooding depth. The impacts to Infrastructure and Economics can be summarized as follows:
