2023 Formal Annual Dam Inspections – Recreational Dams

Final Report

H366322-0000-220-230-0005

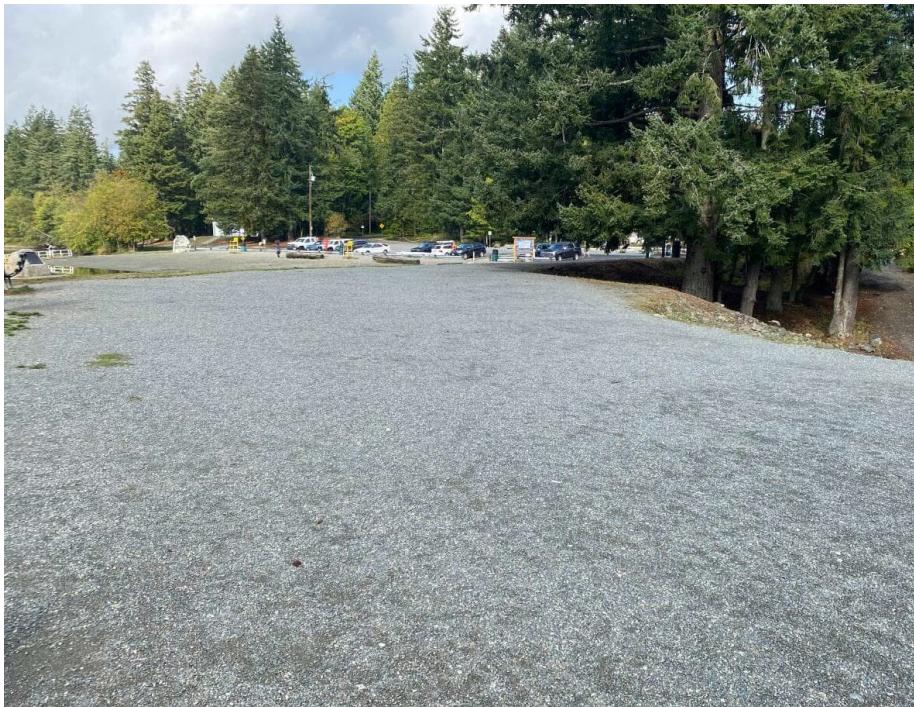
WWL 2: Trees at Crest of Main Dam and Downstream Slope

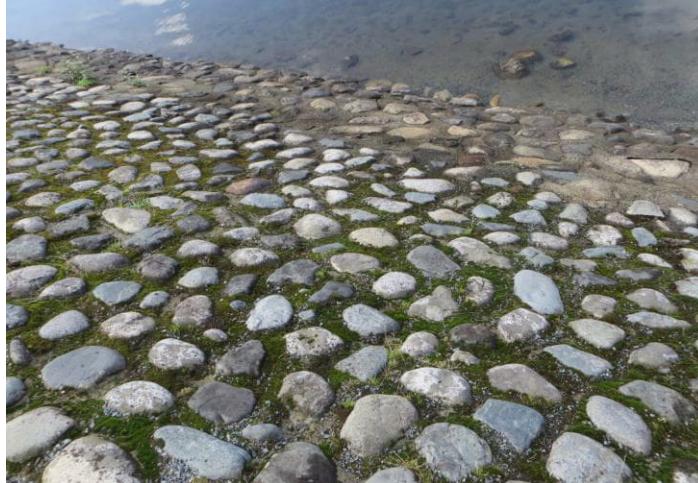
WWL 5: Upstream Stone Face of Main Dam

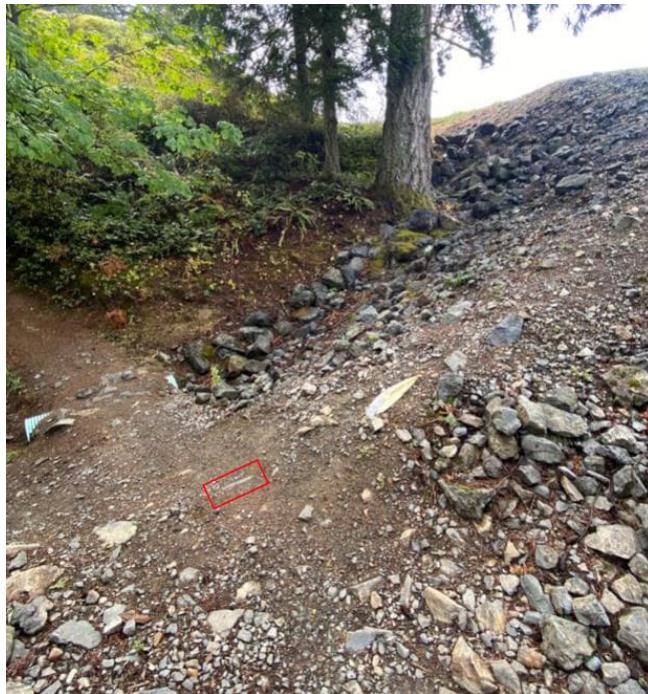
WWL 7: Downstream Face of Main Dam where Part of the Buried Department of Fisheries pipe is Exposed

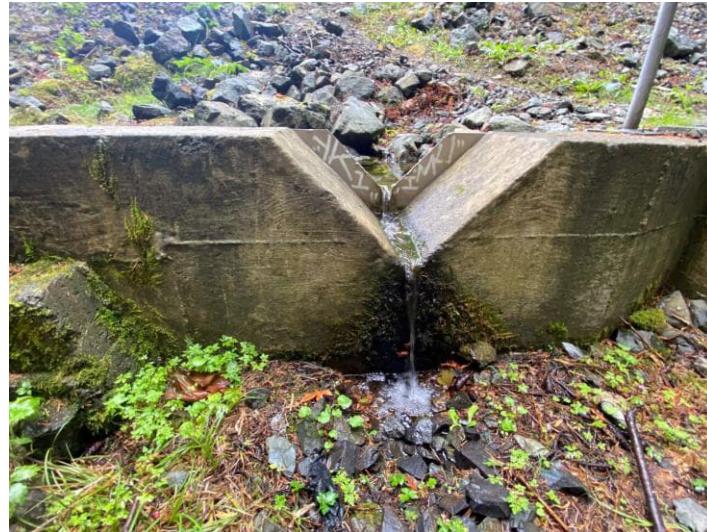
WWL 9: Downstream Seepage Monitoring Weir

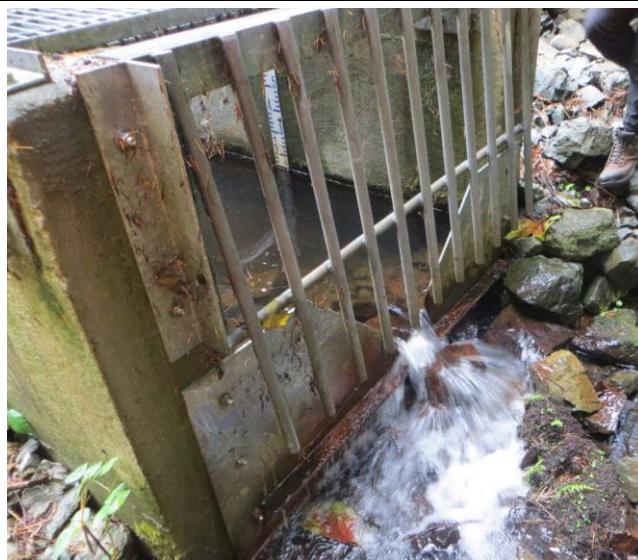
WWL 10: Seepage downstream of the monitoring weir

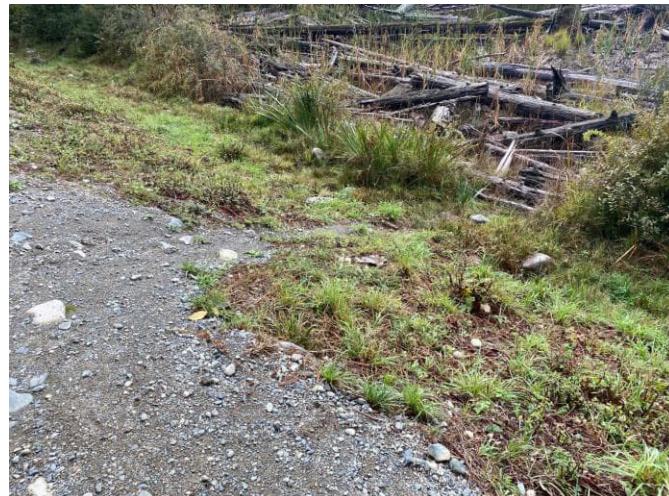
WWL 14: Debris Accumulated at Upstream Toe of Saddle Dam and Light Furrowing on the Upstream Slope

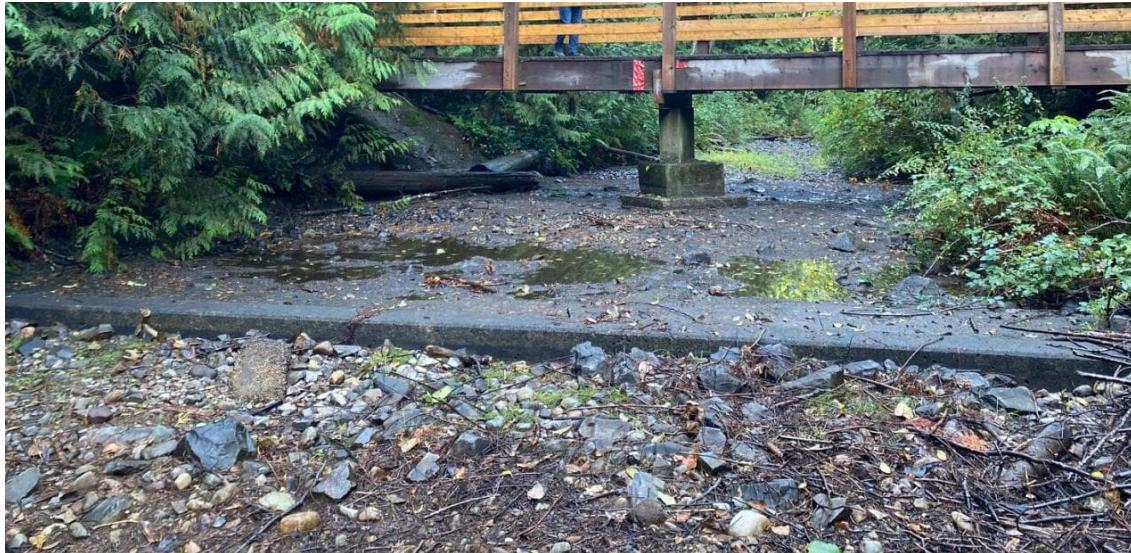
WWL 15: Westwood Lake Outlet Concrete Sill (Outlet Channel)

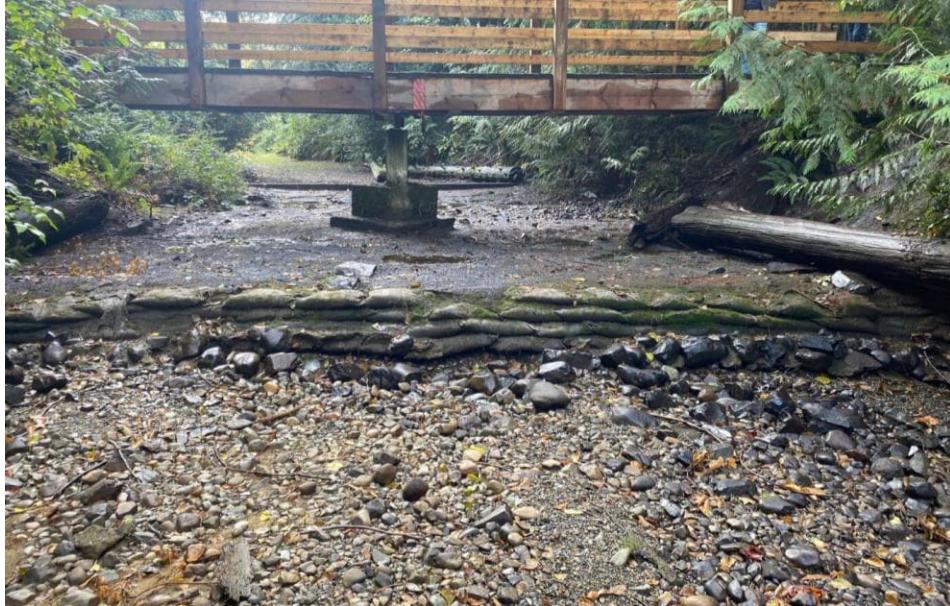
WWL 17: Undermining of the Dam Sacks and Dispersed Riprap at the Downstream Step in the Inlet Channel

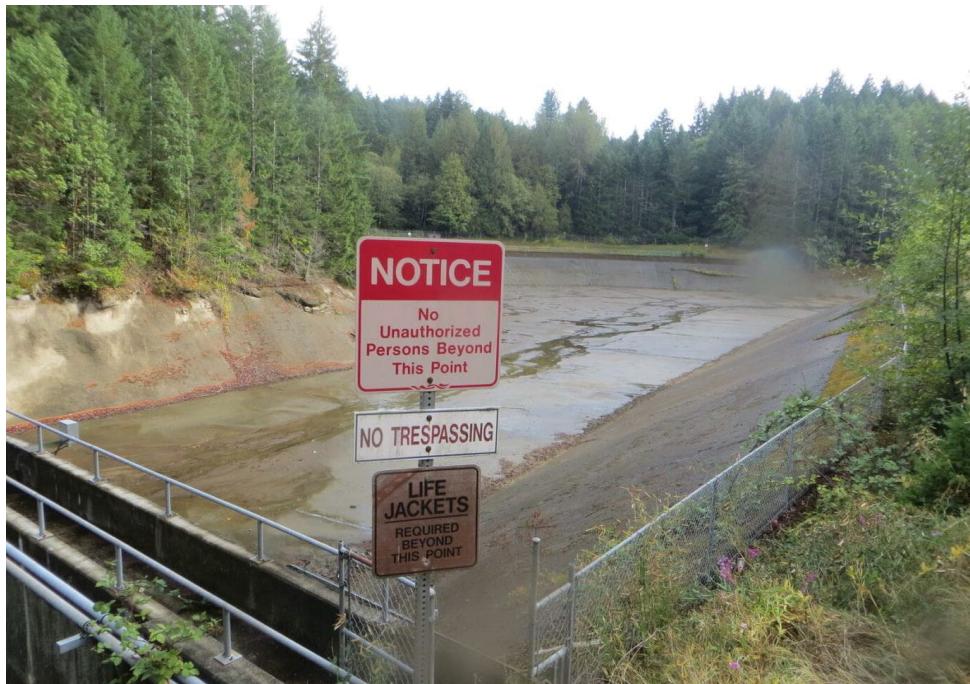
R01 1: Empty Reservoir Looking Upstream from the Dam

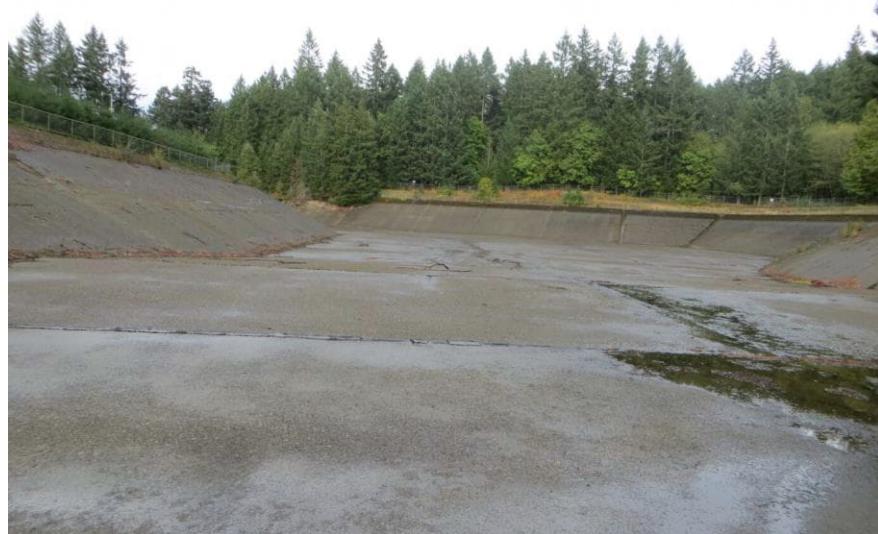
R01 2: Dewatered Reservoir Upstream of the Dam looking Downstream

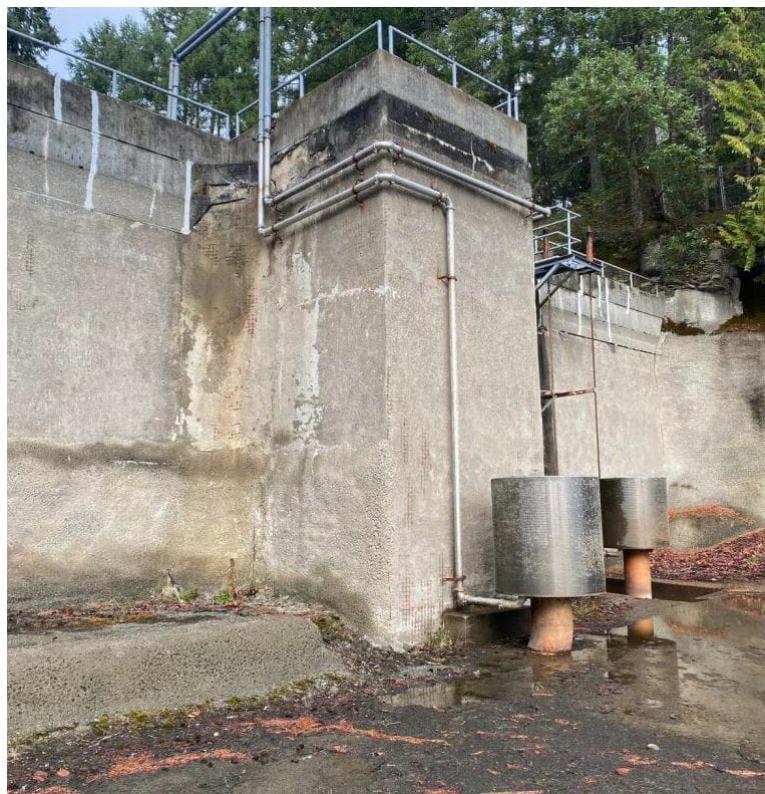
R01 3: Upstream Face of the Dam

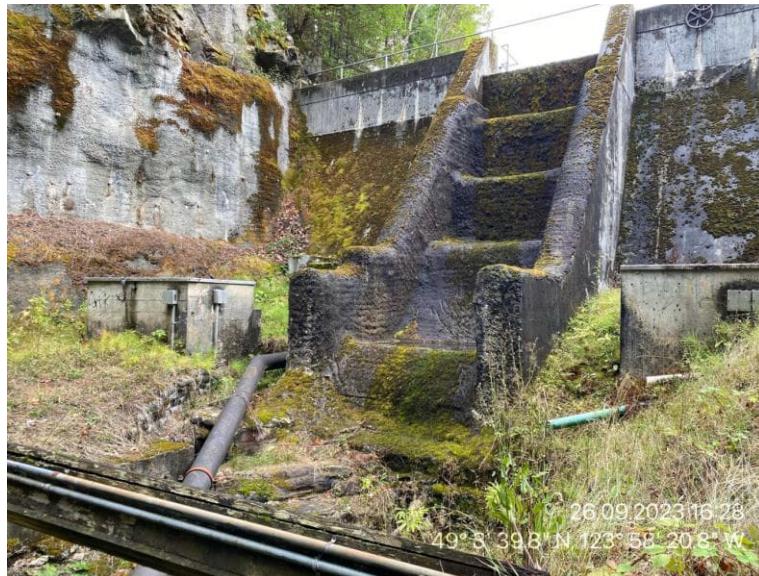
R01 4: Downstream Face and Spillway of the Dam

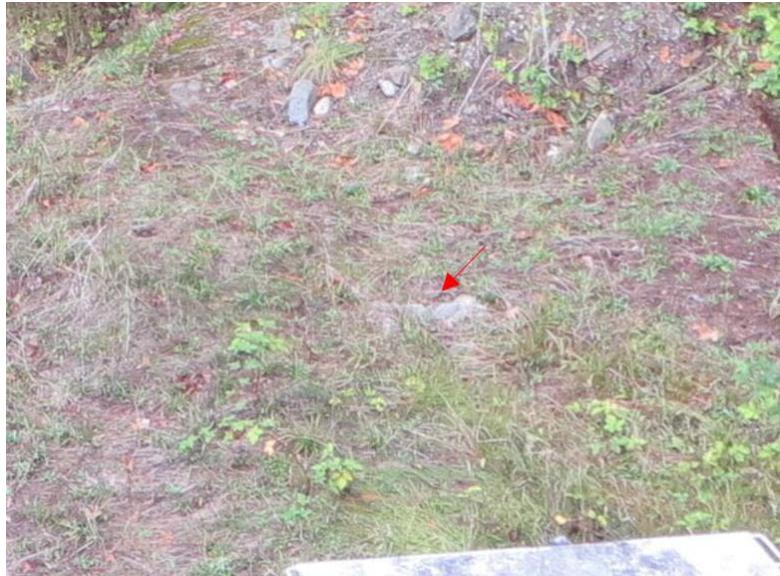
R01 6: 'V' Notch Weir Downstream of Dam

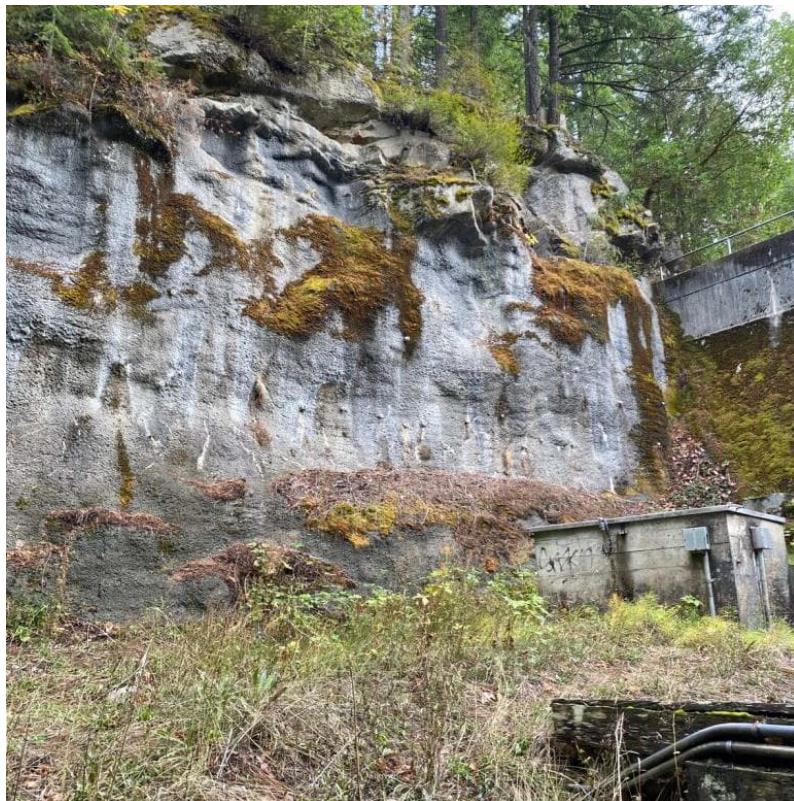
R01 7: Right Abutment Wall Downstream of the Dam (Bedrock, Partially Covered in Shotcrete)

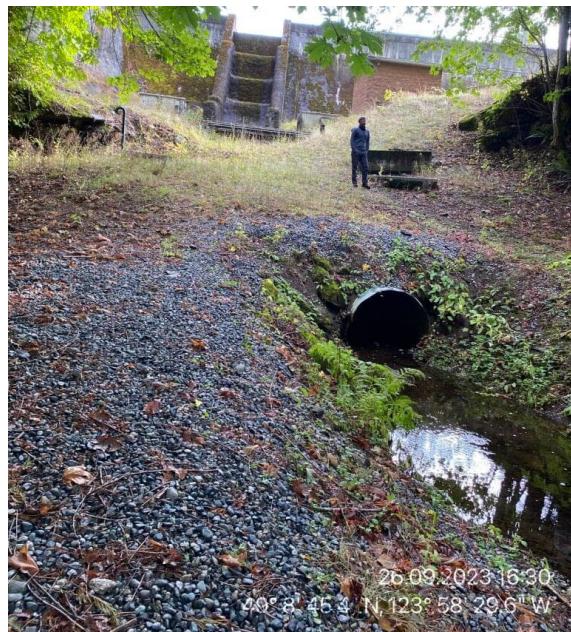
R01 9: Drainage Pipe Downstream of Dam

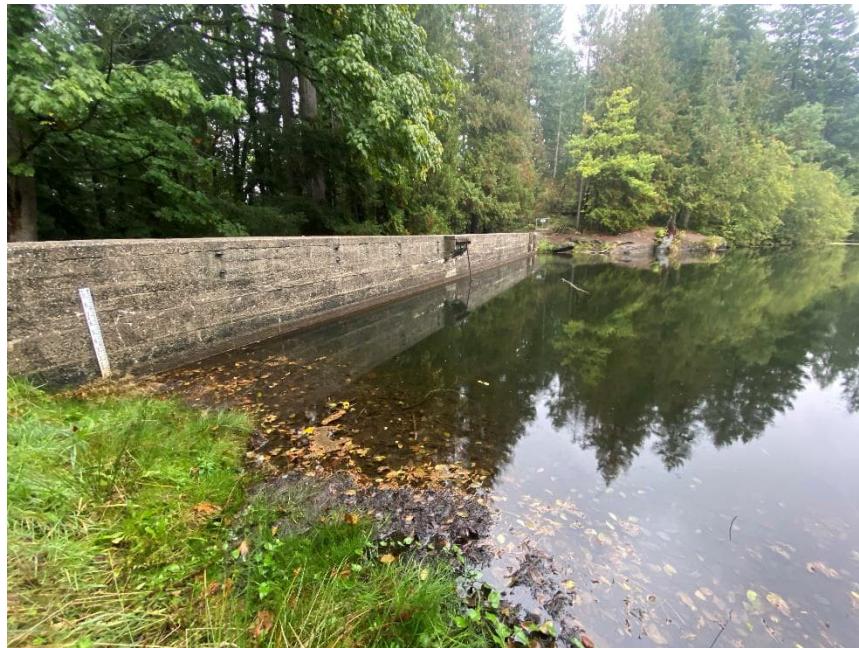
HAW 1: Dam Crest from the Left Abutment

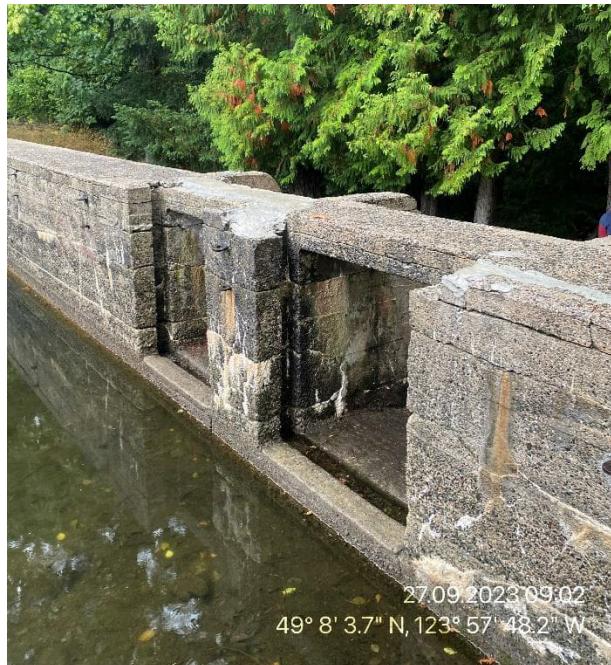
HAW 3: Upstream Face of the Dam and Spillway from Right Abutment

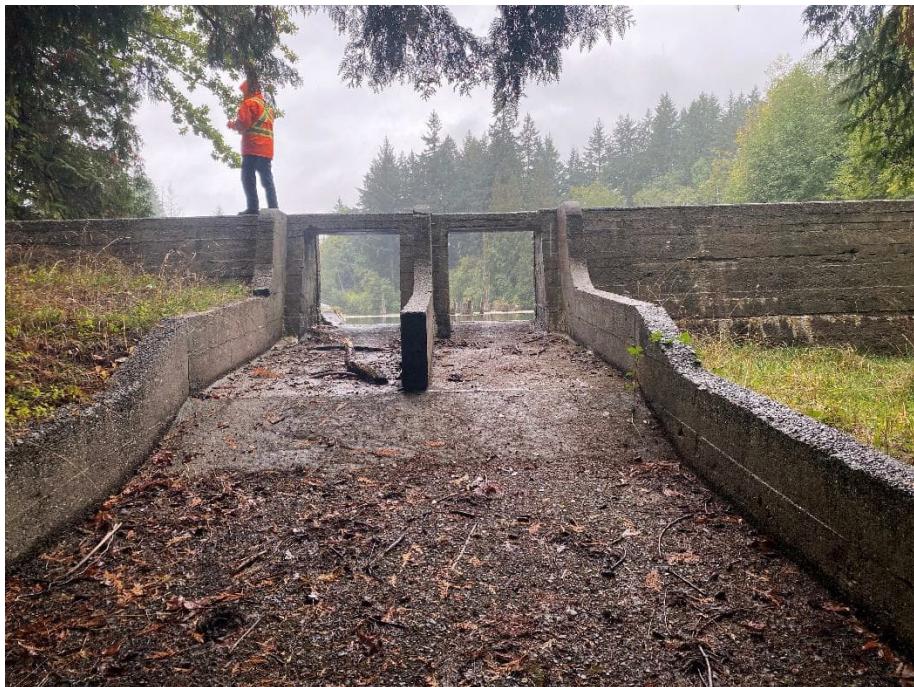
HAW 5: Spillway Chute looking Upstream

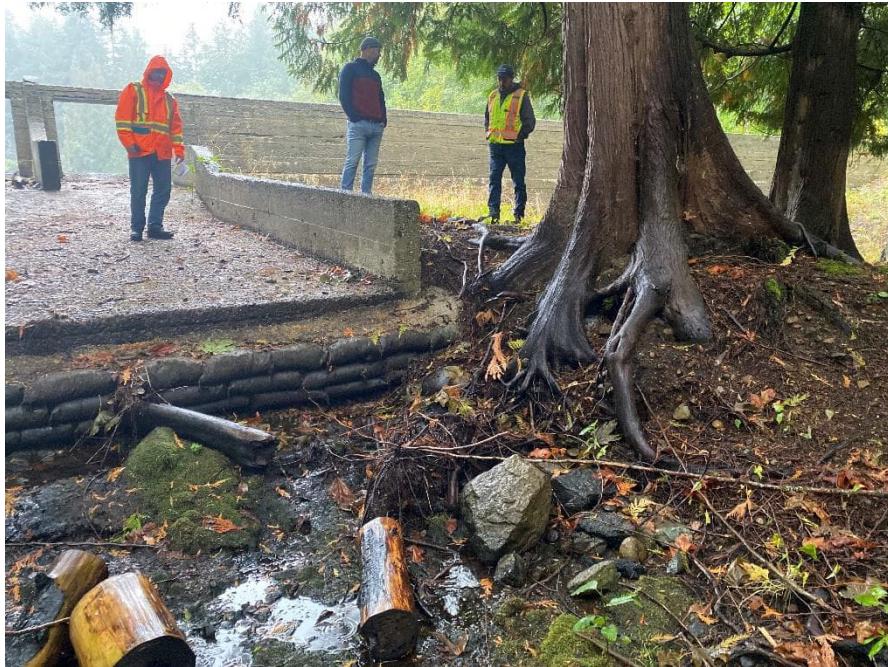
HAW 6: Spillway Slab at Downstream End

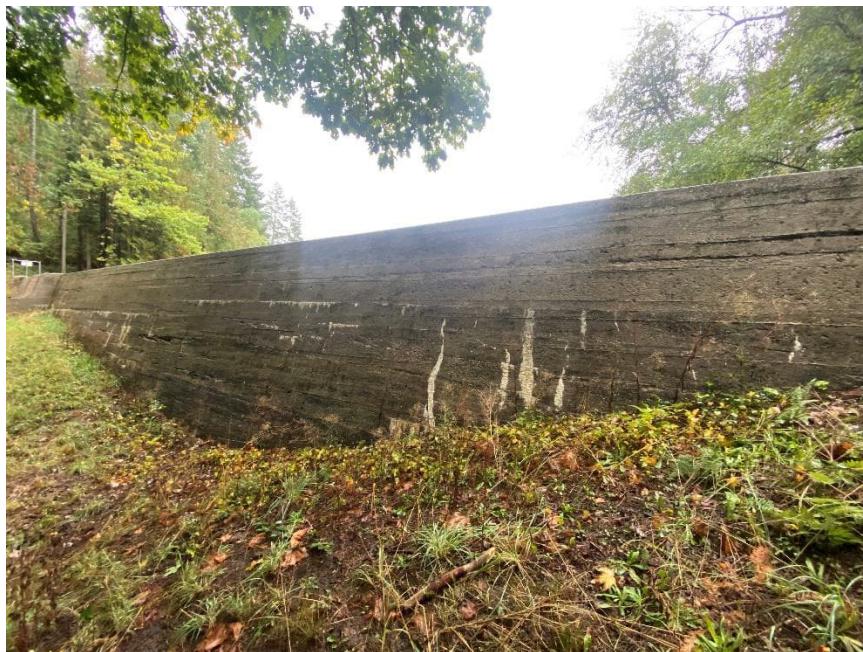
HAW 7: Downstream Side of the Dam

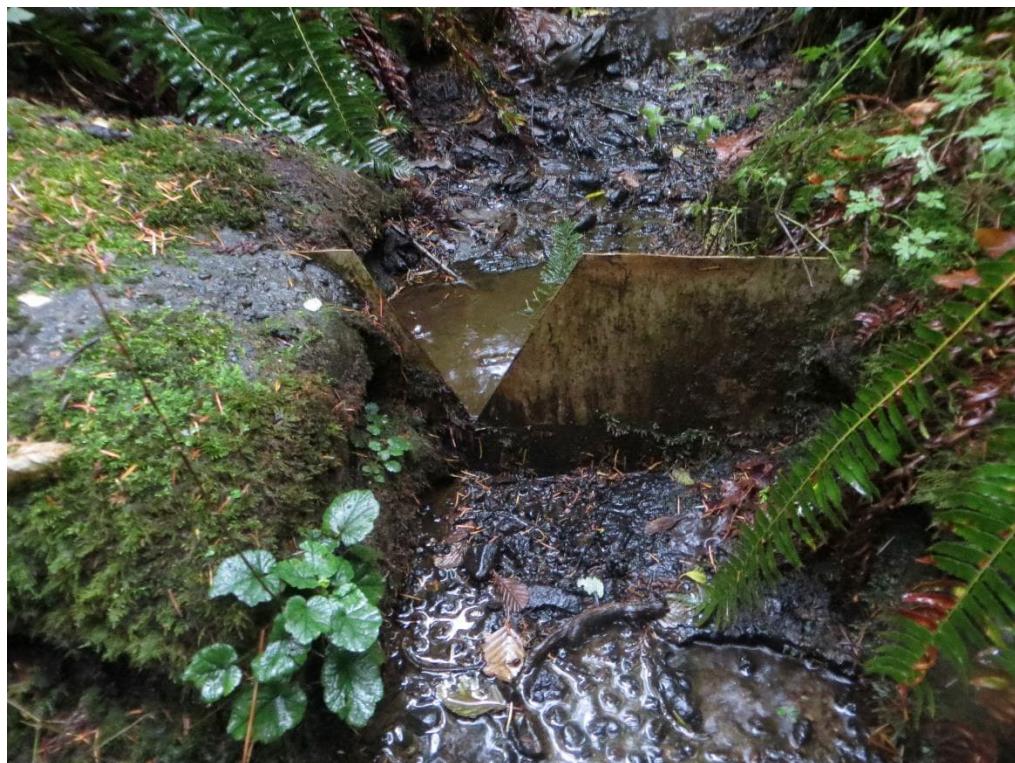
HAW 9: 'V' Notch Weir in Foreground, Stacked Rock Wall Beyond (Looking Upstream)

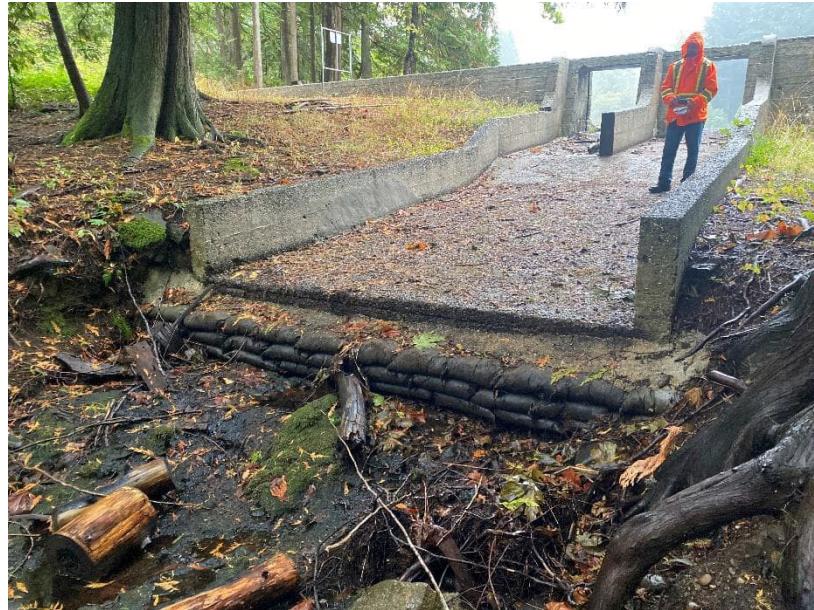
HAW 10: Spillway Chute Concrete Looking Upstream

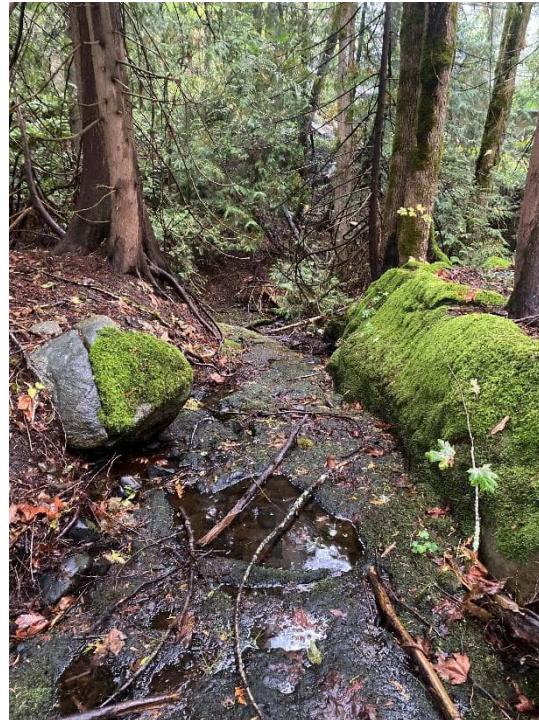
HAW 11: Channel Downstream of Spillway with Minimal Riprap Protection

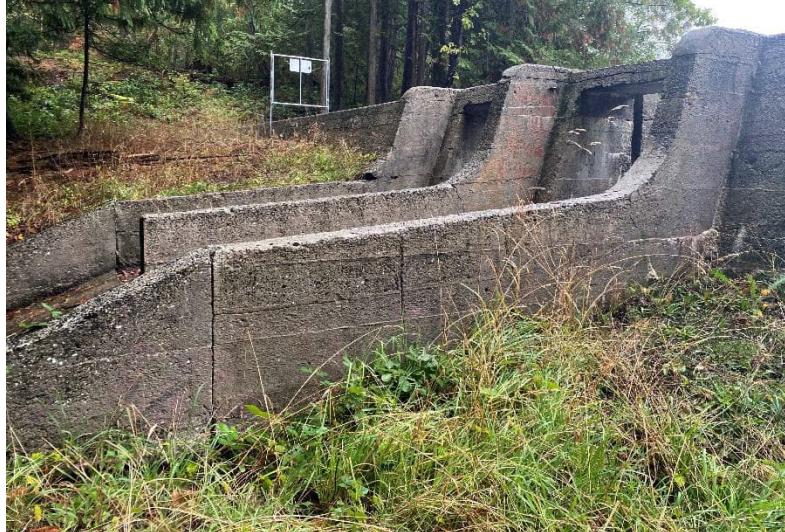
HAW 12: Gap in Joint at Top of Spillway Left Chute Wall

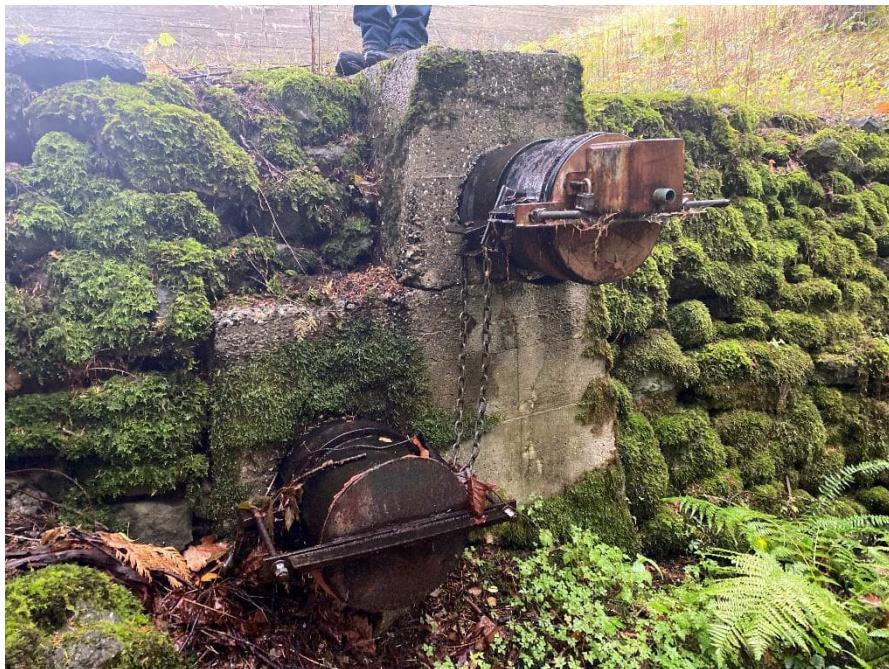
HAW 13: Right Side of Downstream Bench and Stacked Rock Wall

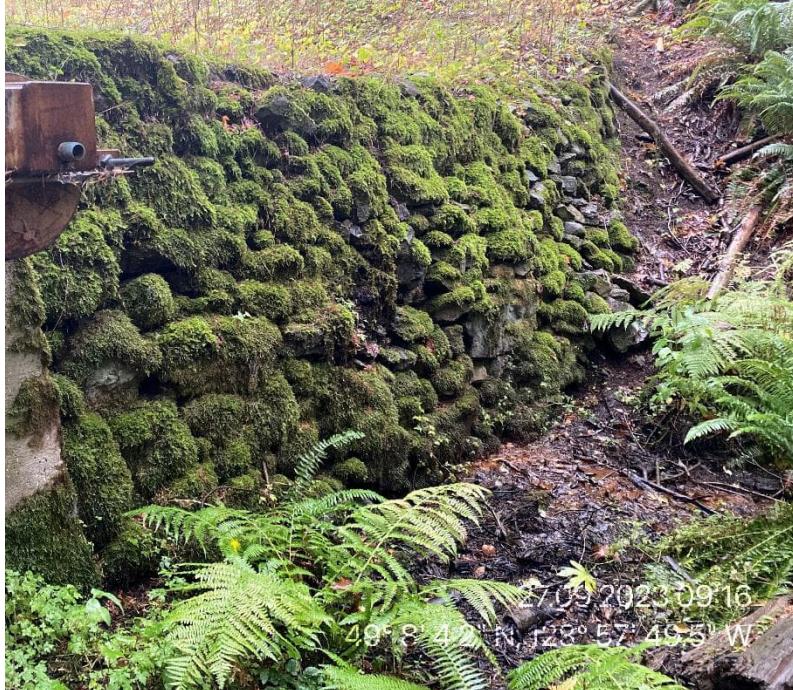
HAW 14: Stacked Rock Wall

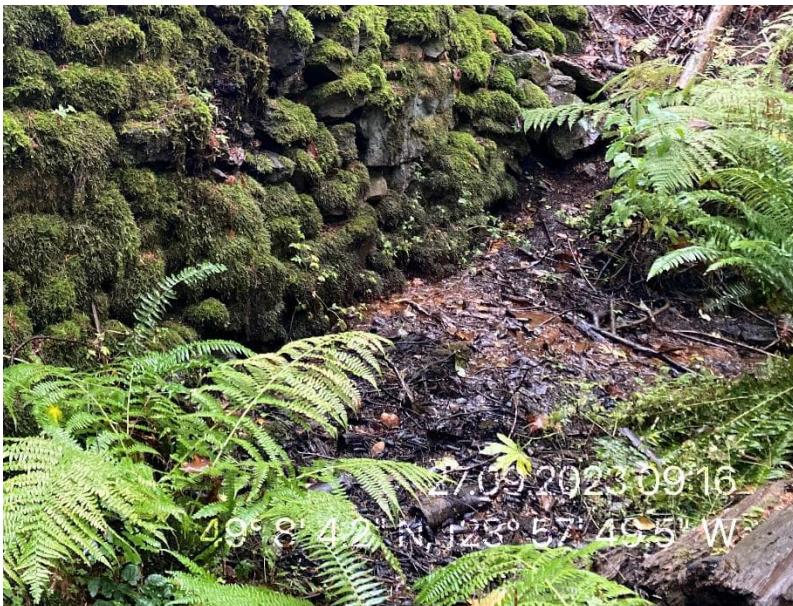
HAW 15: Stacked Rock Wall and Wet, Spongy Area

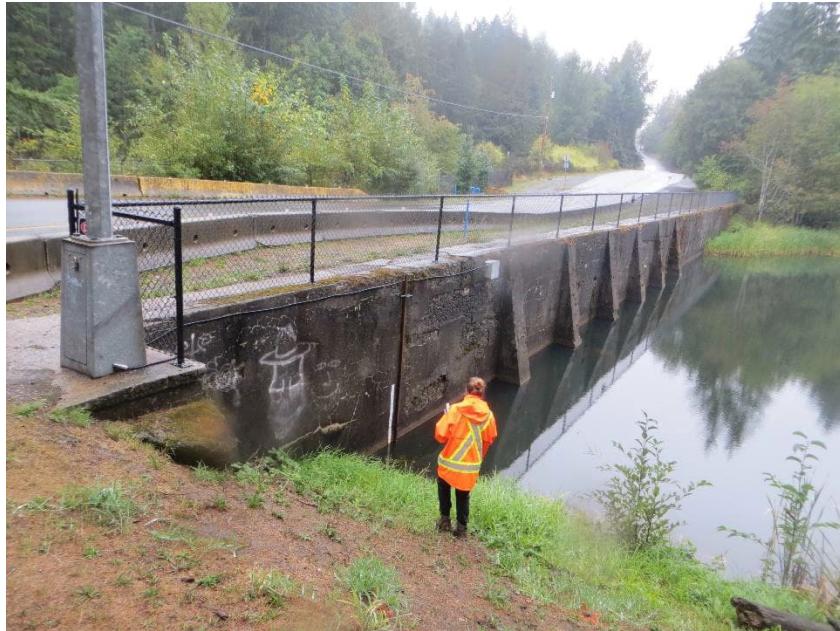
UCR 1: Buttressed Retaining Wall at Upstream Face of the Dam (Looking South)

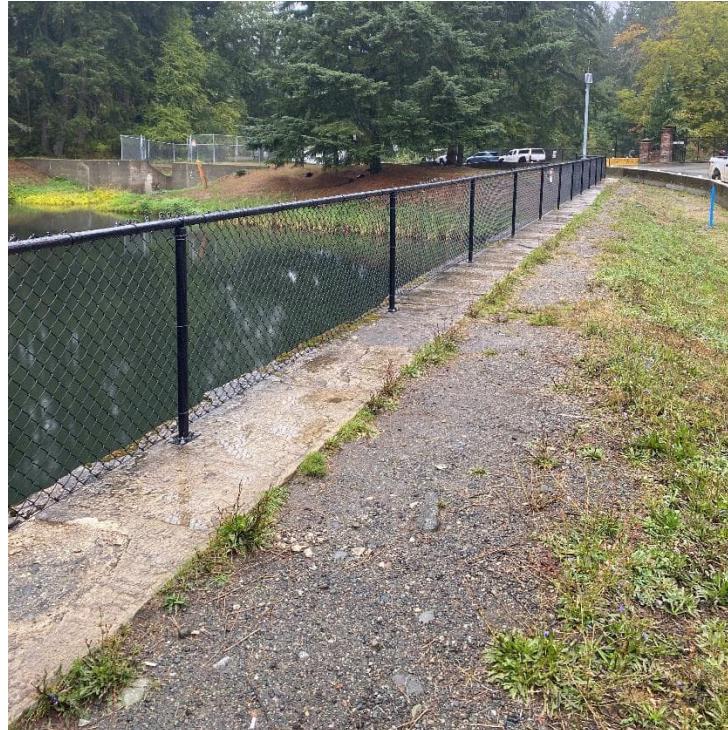
UCR 2: Crest from Right Abutment of Concrete Face of Dam

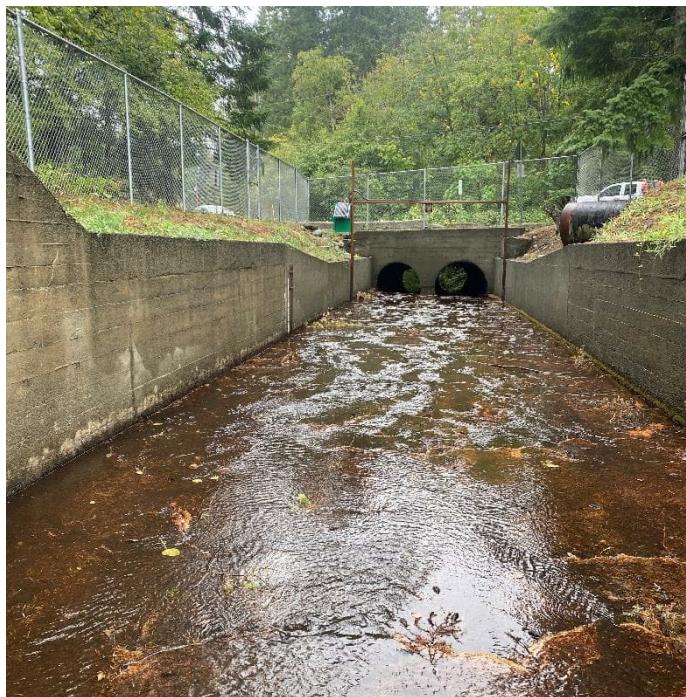
UCR 4: Spillway Structure and FlowDar System (looking Downstream)

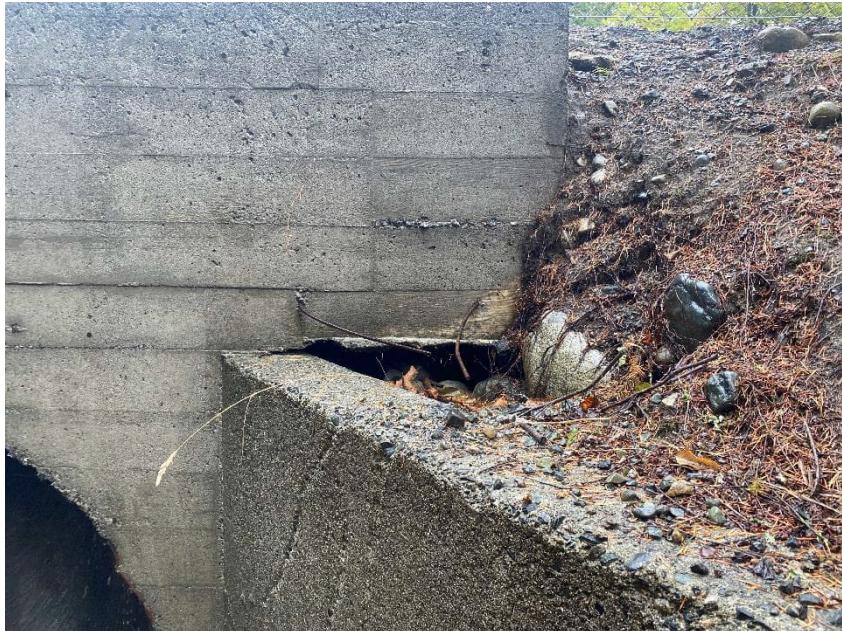
UCR 5: Undermining at the Base of Culvert Headwalls

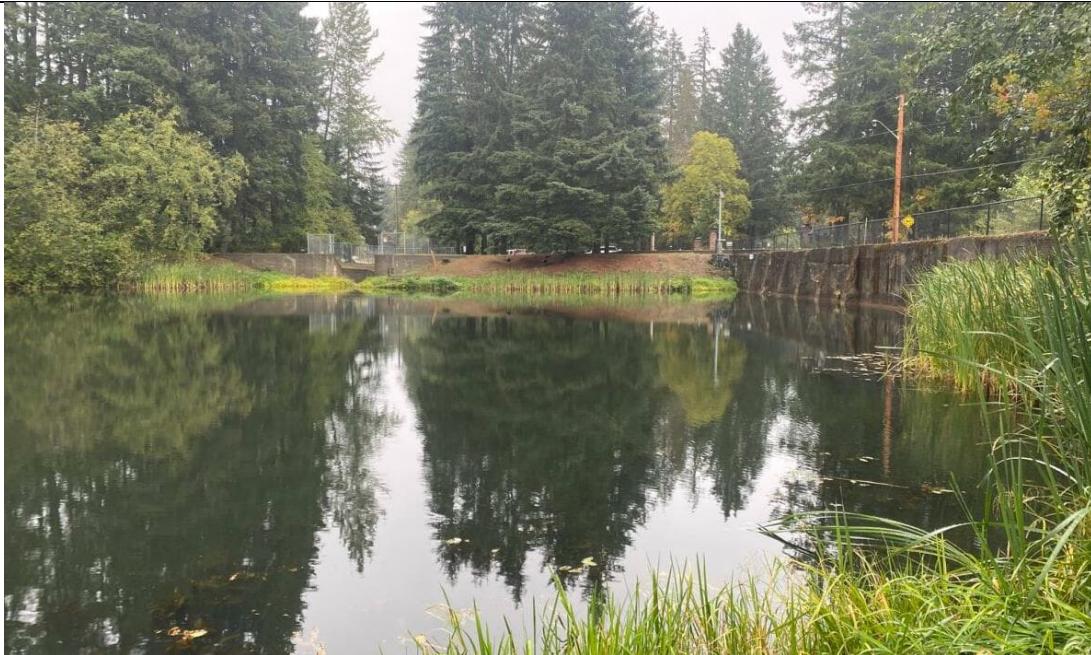
UCR 8: Embankment Dam and Vegetated Shoreline

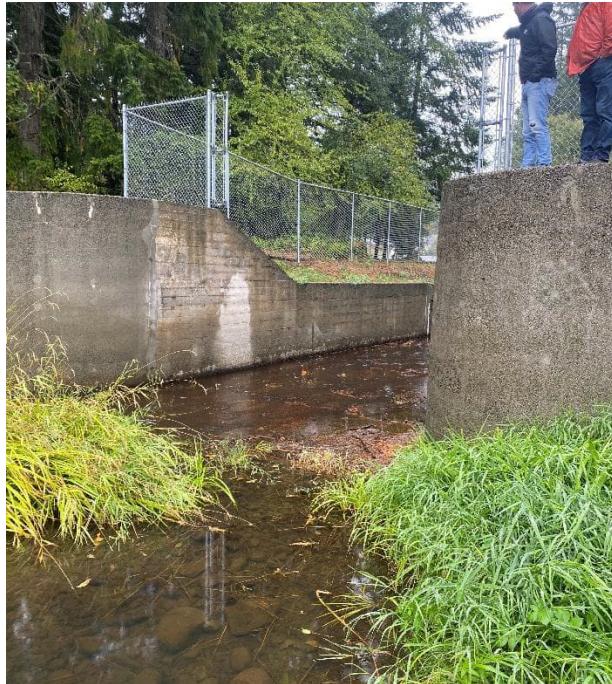
UCR 9: Spillway Wingwalls from Left Abutment

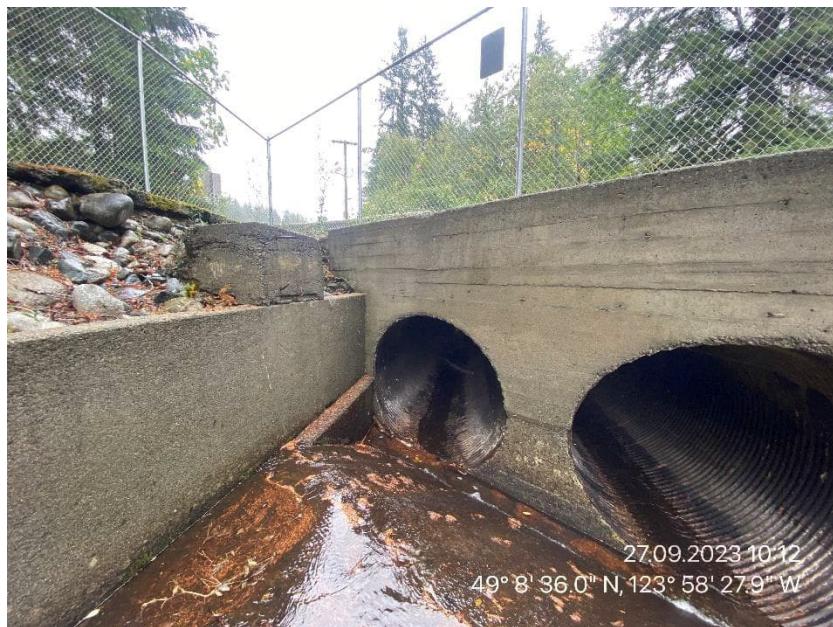
UCR 10: Spillway Wingwalls from Left Abutment

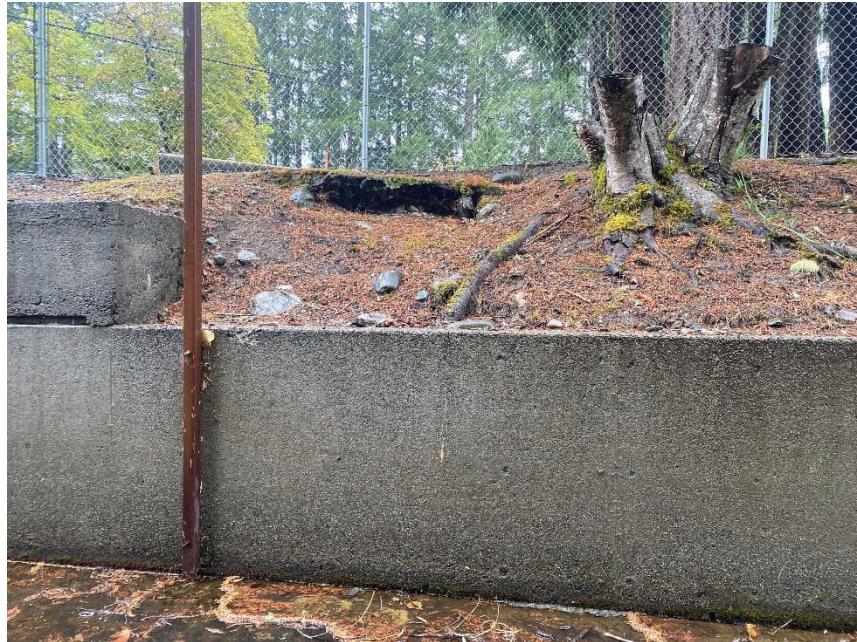
UCR 11: Surface Runoff Erosion Along Wingwall Slopes

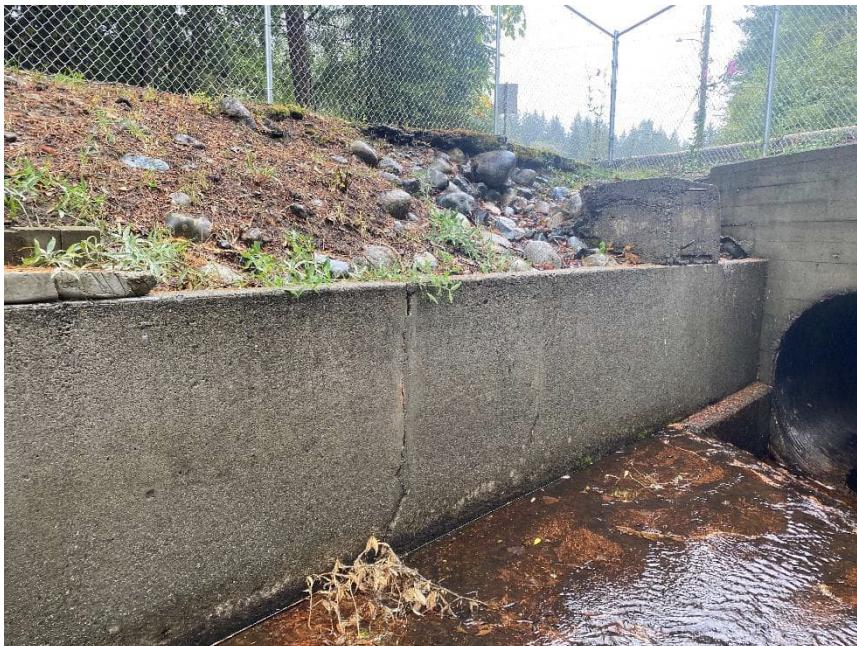
UCR 12: Surface Runoff Erosion Along Wingwall Slopes

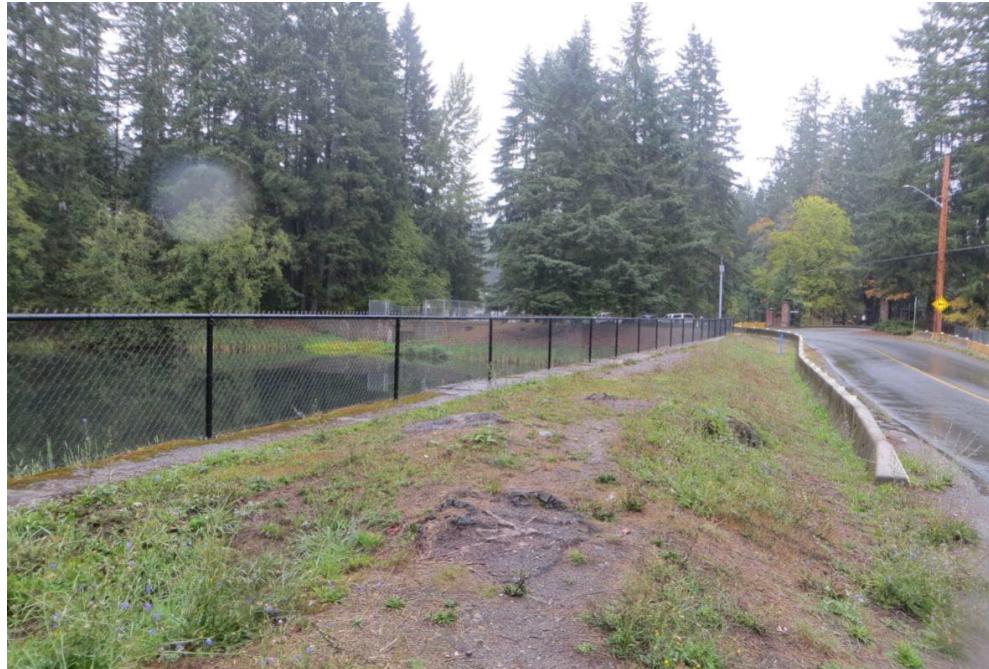
UCR 13: New Fencing Installed Along Buttress Dam

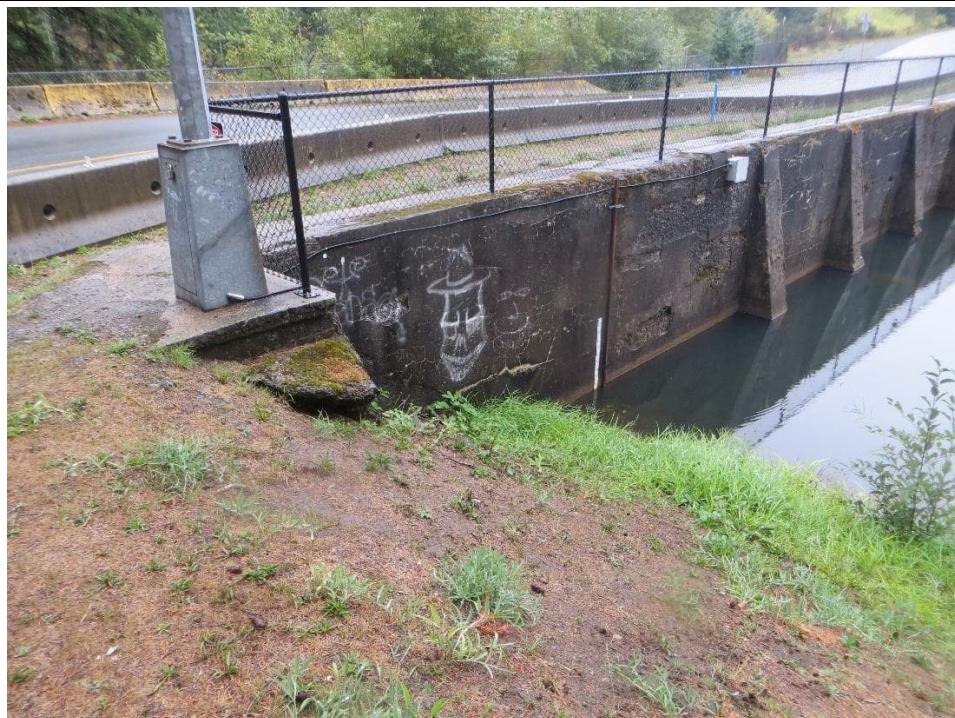
UCR 14: Camera Pole Foundation at Left Abutment

UCR 1.07	Backfill the area of camera pole foundation to prevent further undermining and slope erosion.	N/A	By City staff

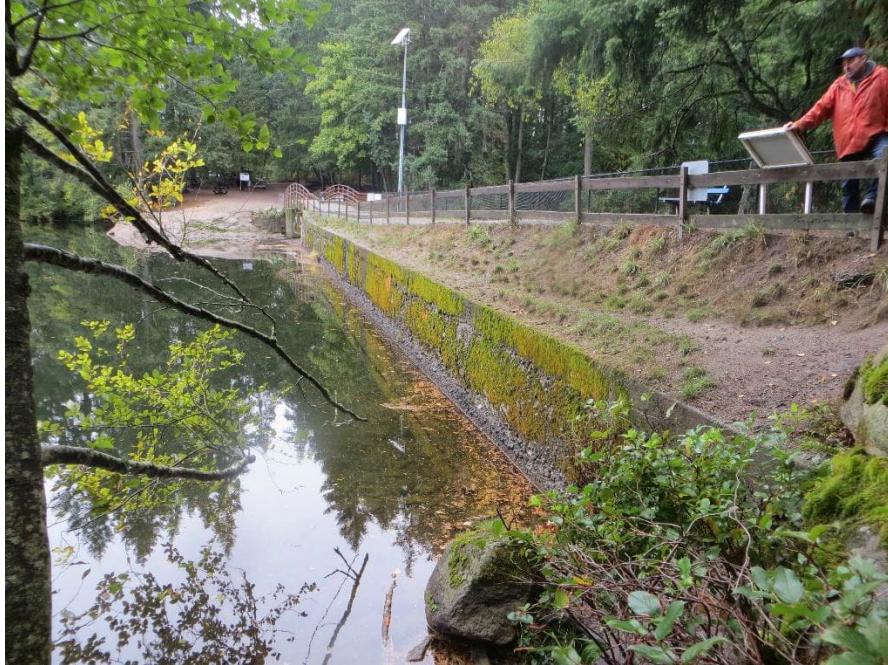
MCR 1: Upstream Wall of the Dam (from Right Abutment)

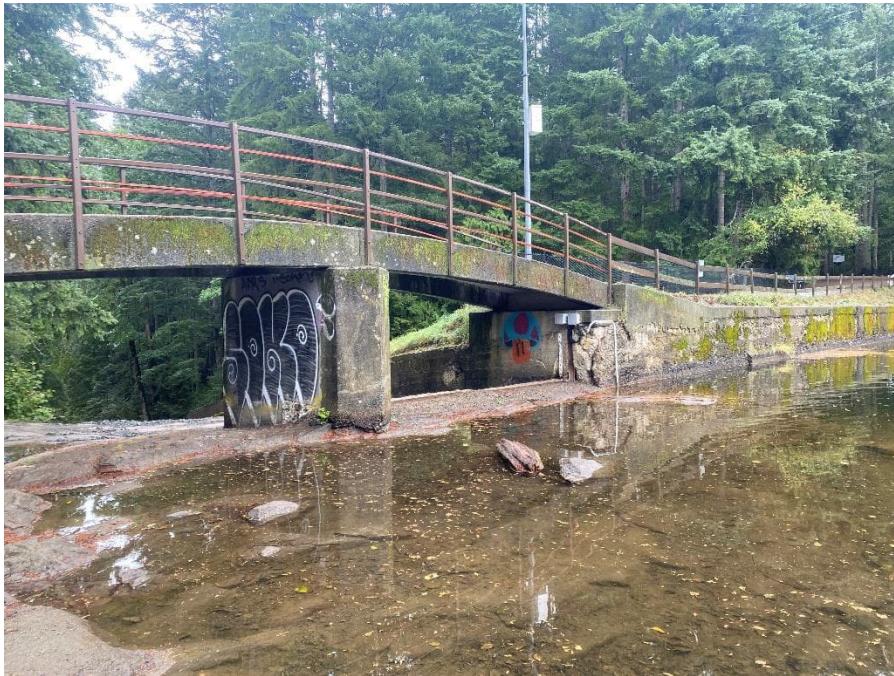
MCR 2: Upstream Wall of the Dam and Spillway

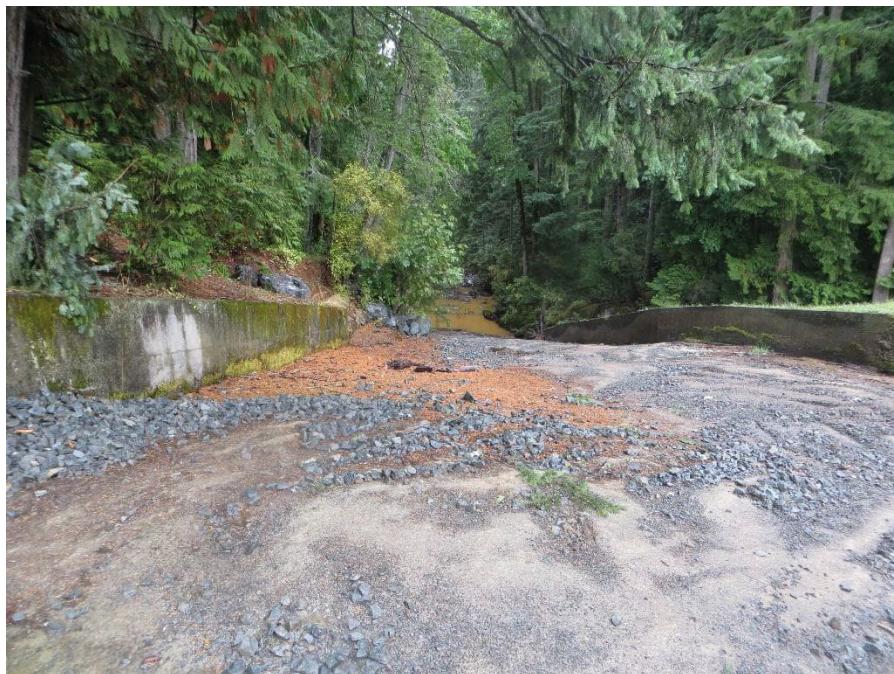
MCR 6: Spillway Chute Slab (Looking Downstream)

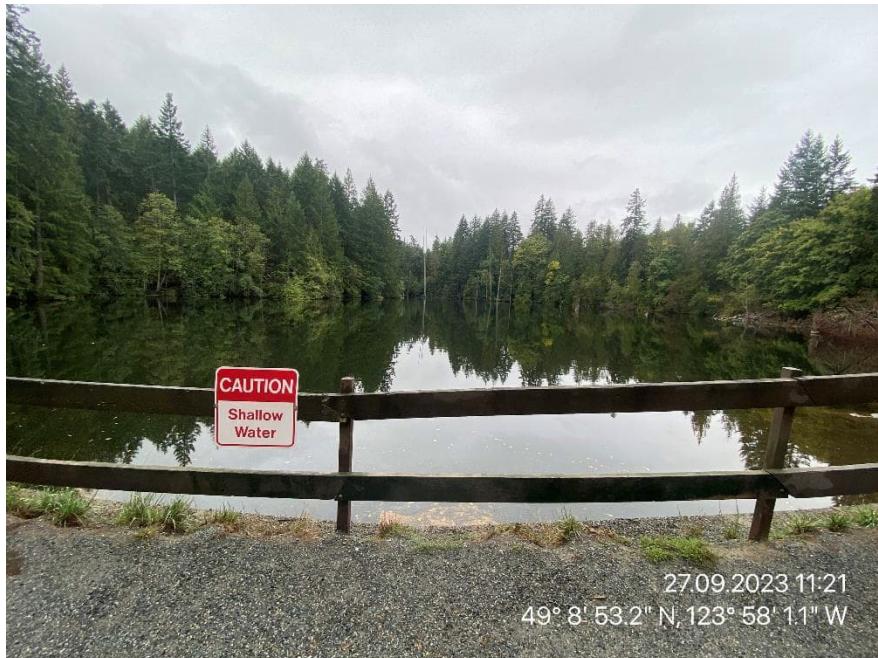
MCR 7: Dam Reservoir.
