2023 Formal Annual Dam Inspections – Recreational Dams

Final Report

H366322-0000-220-230-0005

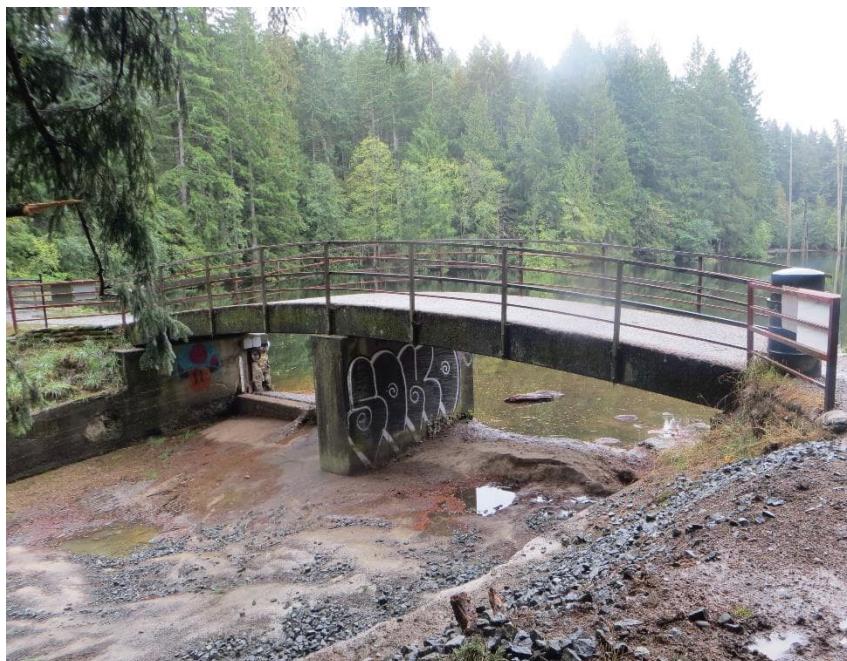
MCR 8: Spillway Chute Structure

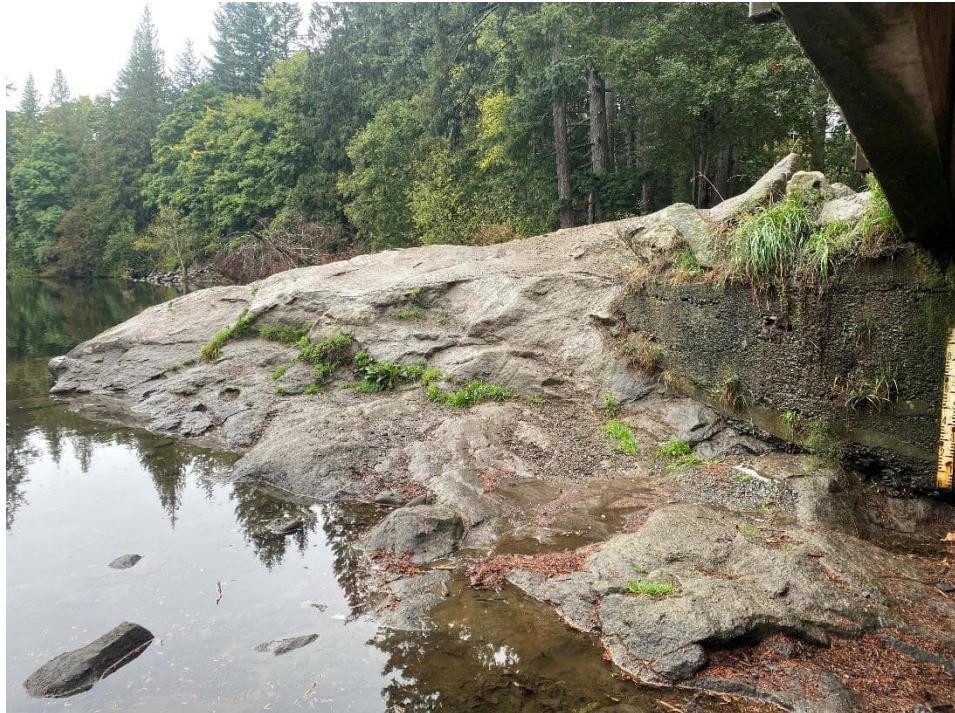
MCR 9: Bedrock at the Left Abutment.

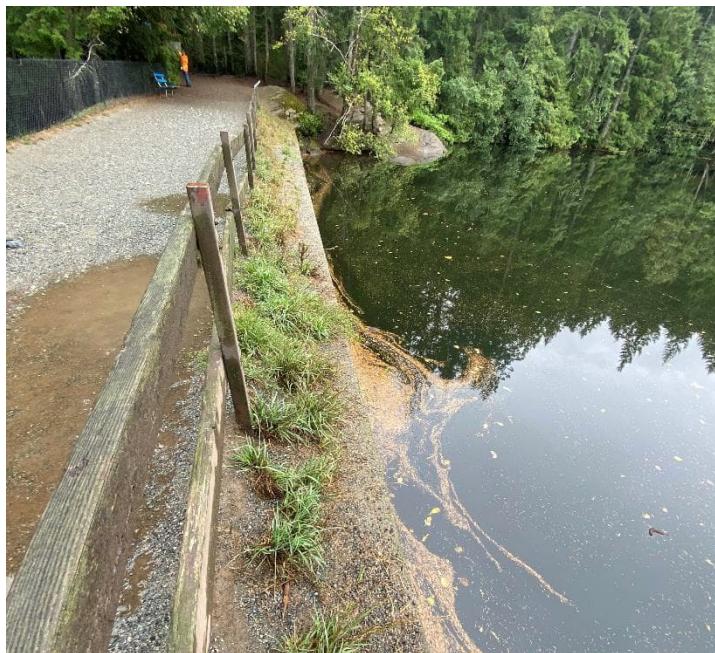
MCR 10: Crest of the Dam (Looking at the Right Abutment)

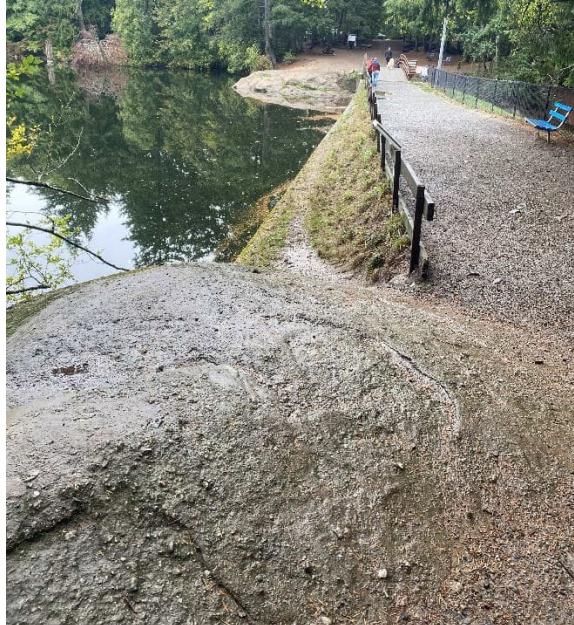
MCR 11: Concrete/Bedrock at the Right Abutment

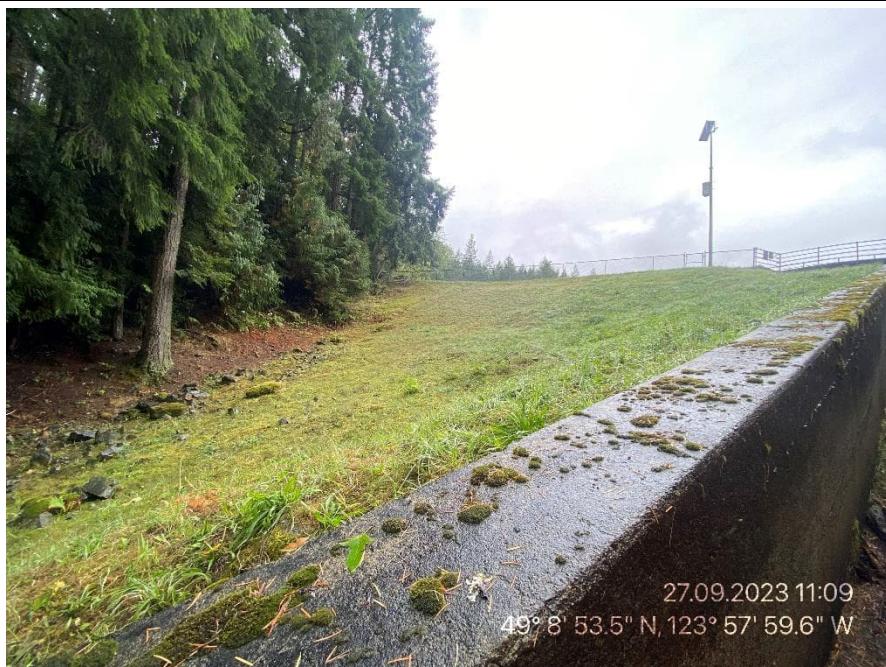
MCR 12: Downstream Face of Dam

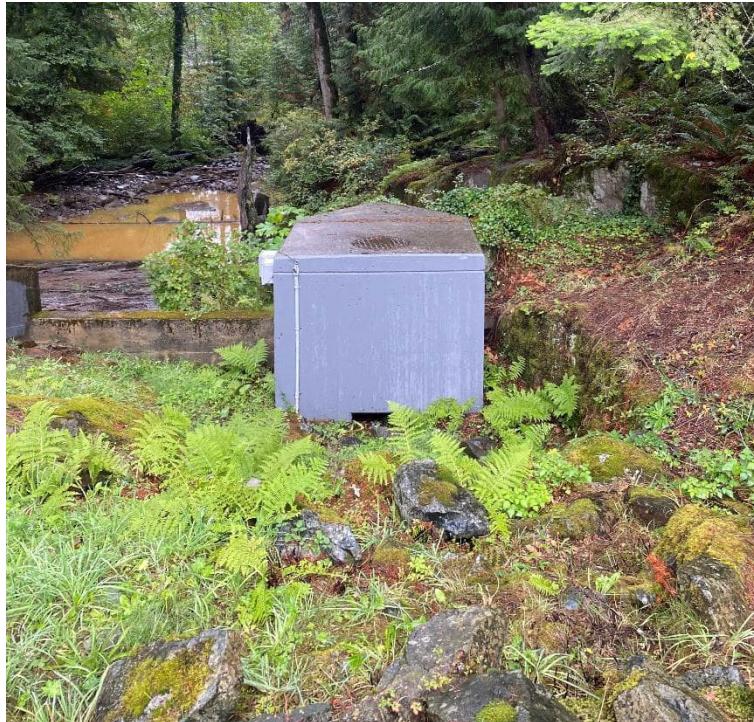
MCR 13: 'V' Notch Weir Housing at Downstream Toe

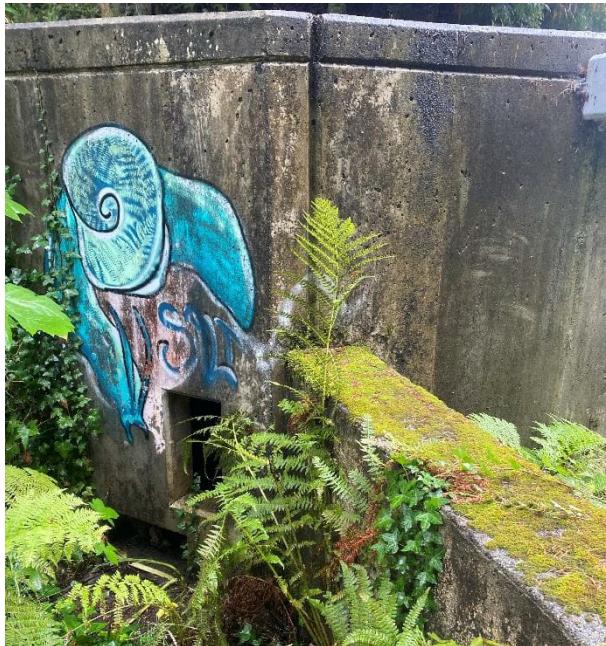
MCR 14: 'V' Notch Weir Concrete Housing (Weir Not Visible)

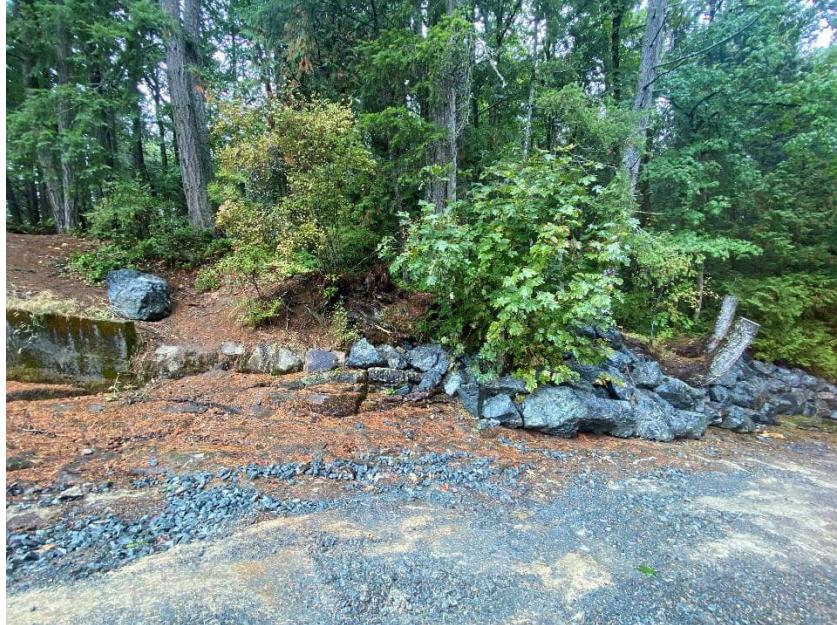
MCR 15: Newly Placed Riprap at the Left Embankment Beyond the Wing Wall

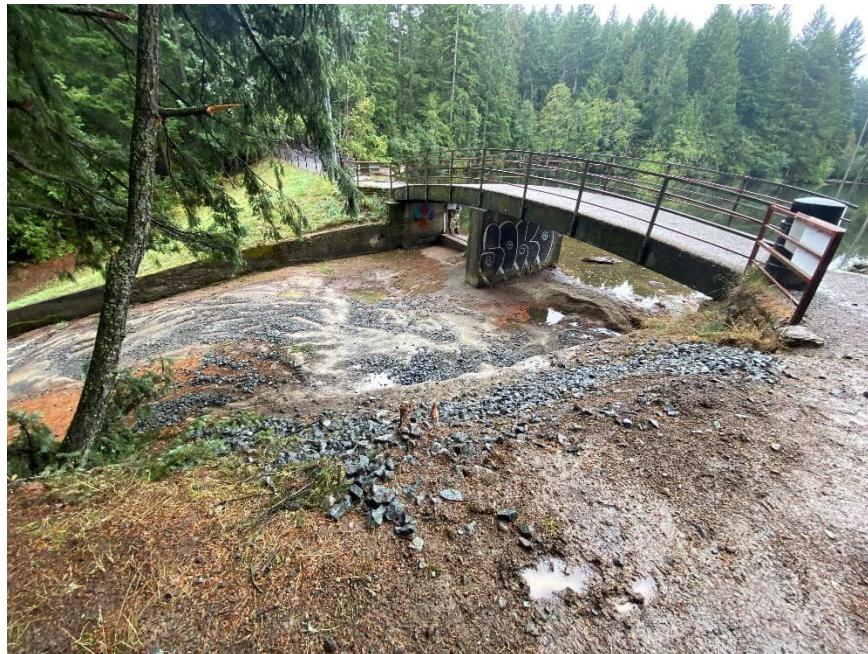
MCR 16: No Fence/Handrail and presence of Cobble cover at Left Side of Spillway

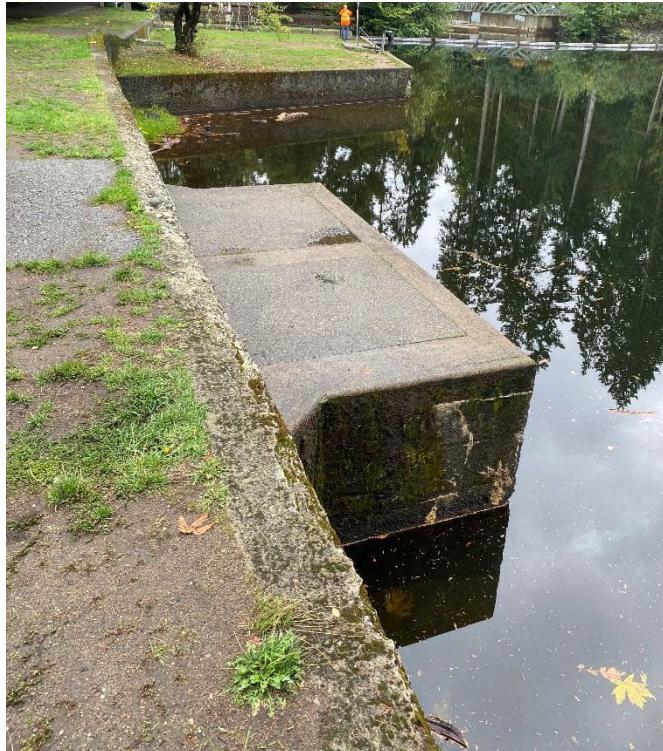
LCR 1: Upstream Face of the Dam with Reservoir (from Left Abutment)

MCR 18: Concrete Crack at Top Corner of Centre Spillway Pier

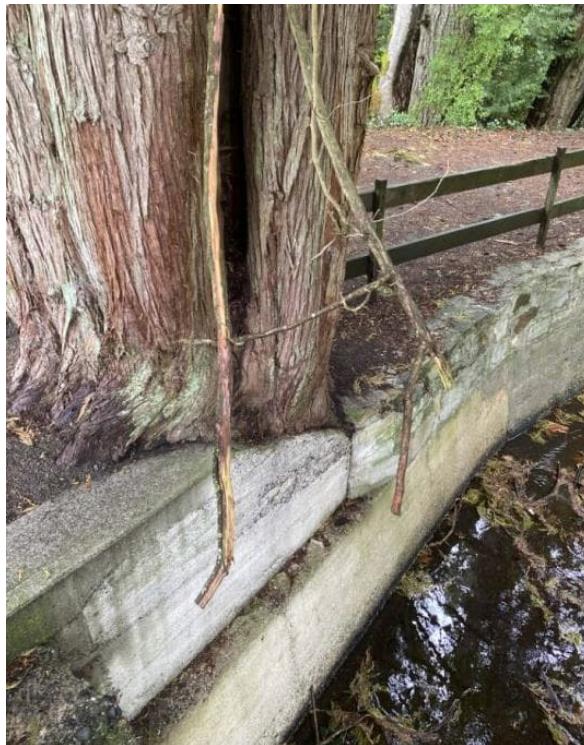
LCR 5: Large Tree Downstream of the spillway Bridge on the Left Abutment

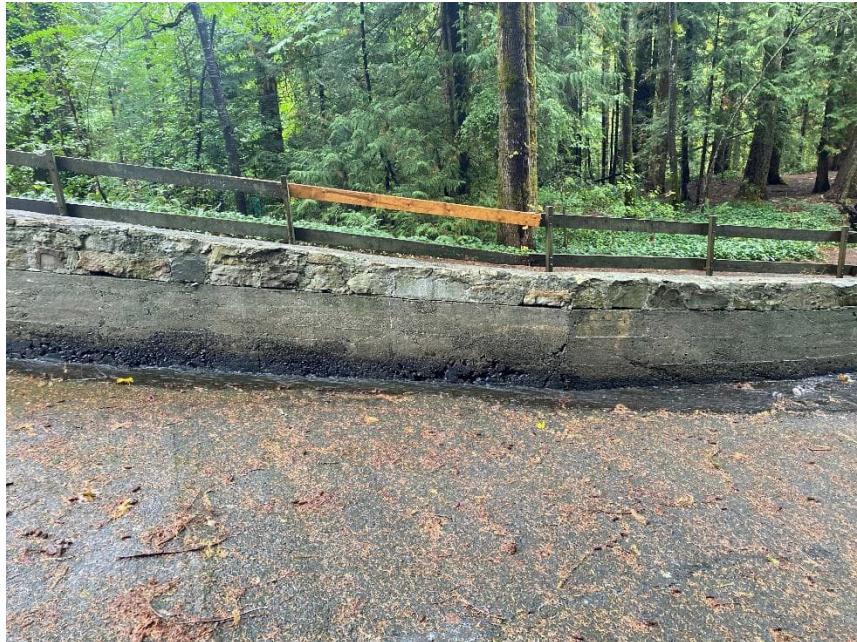
LCR 8: Cracks at Upstream Lower Wall Corner

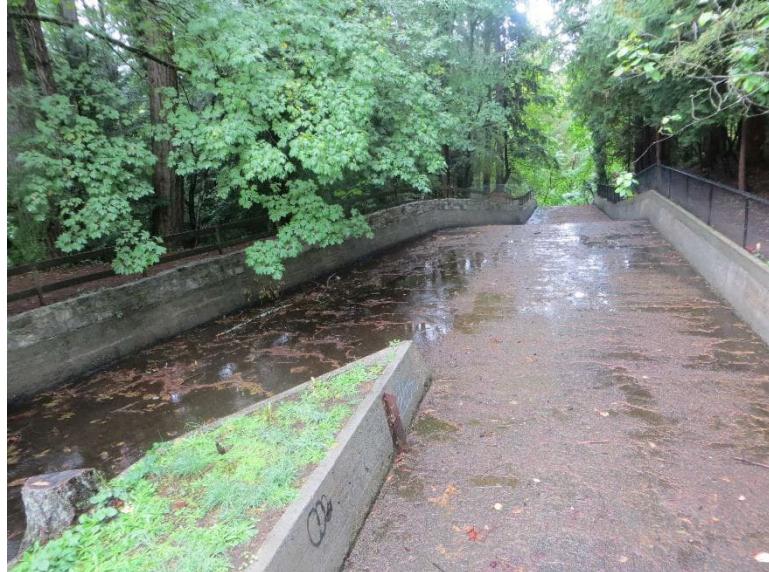
LCR 10: Repair at the Base of Spillway Chute Left Wall

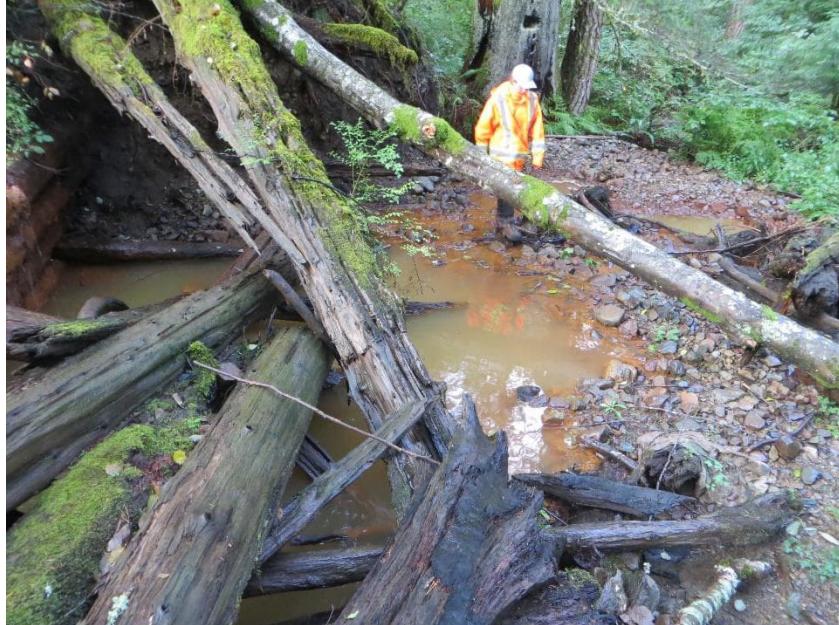
WCL 1: Left Abutment of Dam Showing High Degree of Deterioration

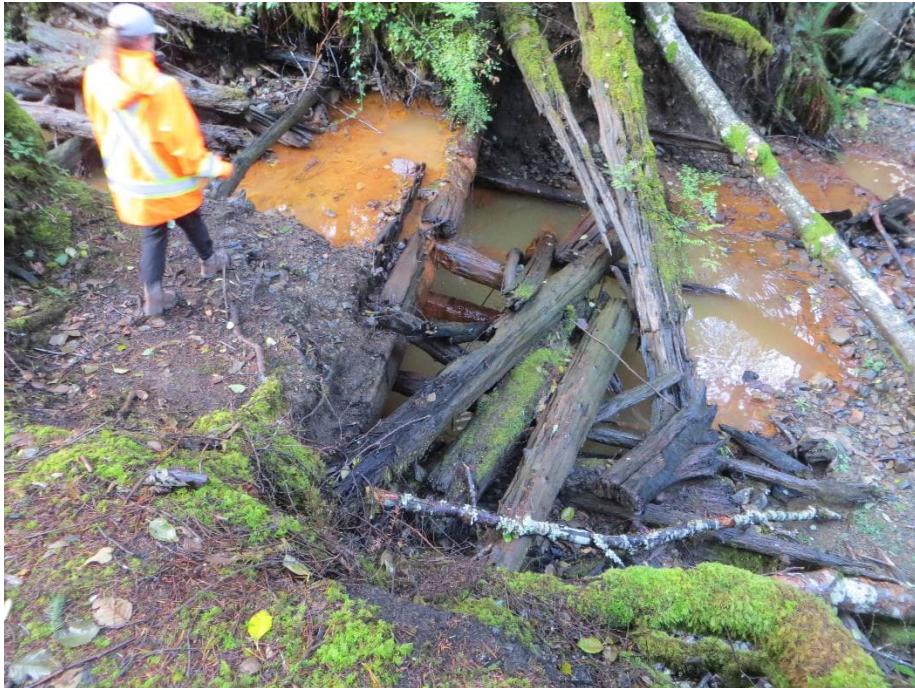
WCL 3: Dam Showing High Degree of Deterioration

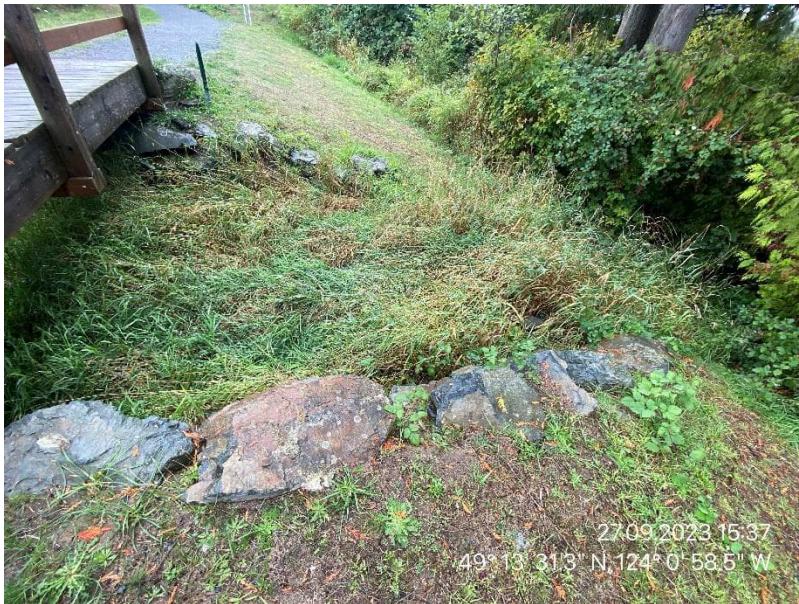
MGC 5: Vegetation on the Downstream and Upstream Face at Right Abutment
