The City of Nanaimo

SEISMIC HAZARD ASSESSMENT MIDDLE AND LOWER CHASE DAMS

N13101249

April 14, 2010

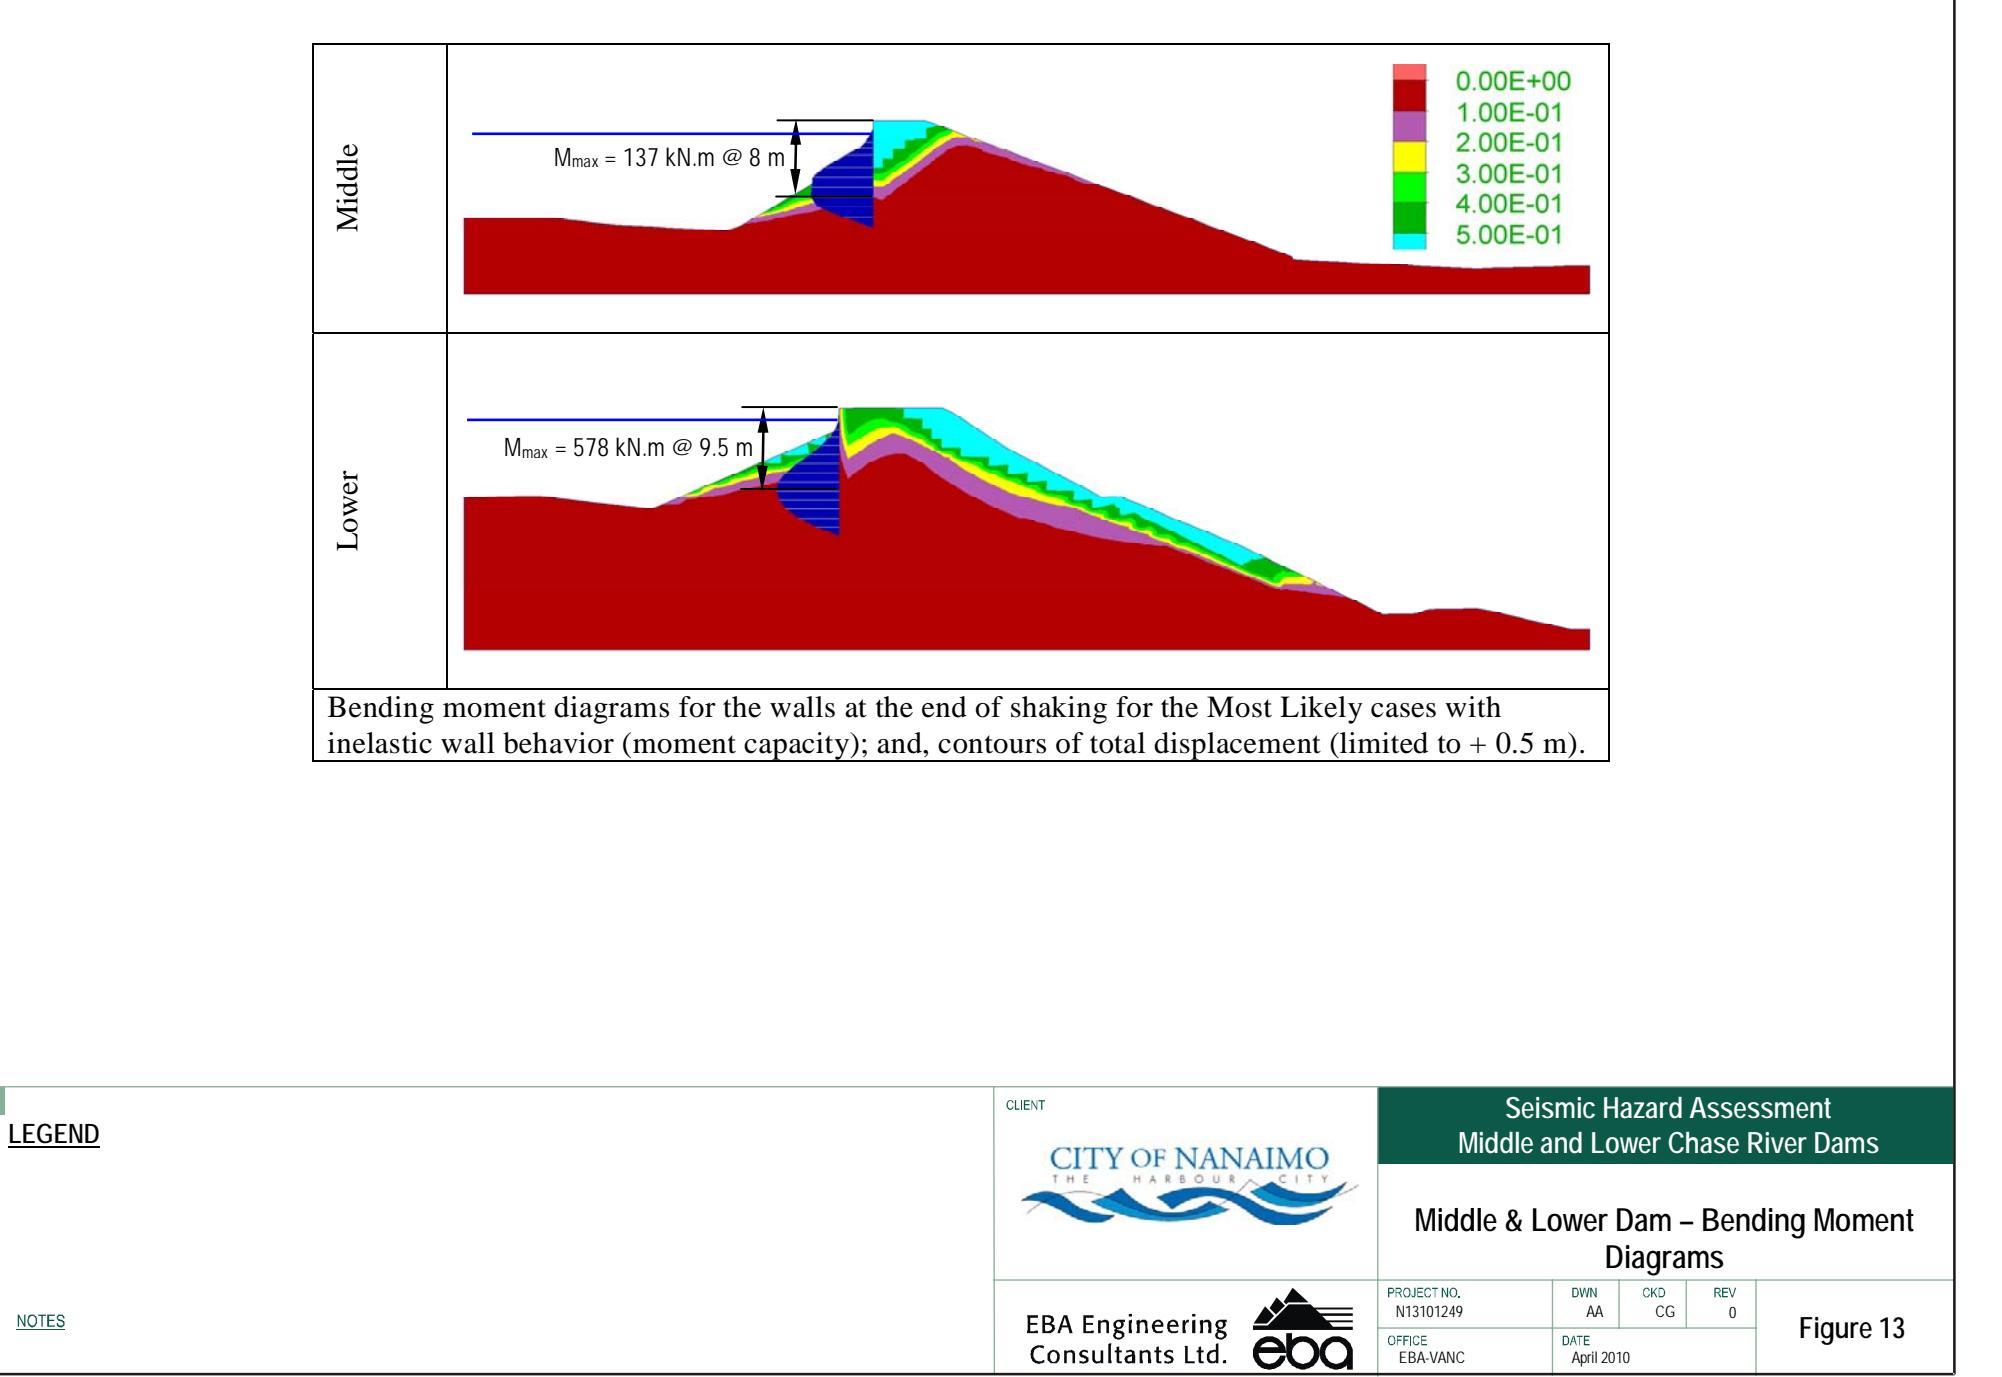
With regard to deflection induced wall cracking, the maximum depth of persistent cracking appears to be approximately 9.5 m below the top of the wall (as shown on Figure 13) which corresponds to the point of maximum bending moment experienced by the wall which corresponds to about 7.0 m below the top of the upstream rock fill, well below normal operating water level. The permanent deflection in an upstream direction means that the portion of the wall will tend to rotate upstream. However, the relatively small magnitude of deflection qualitatively indicates that the degree, extent and magnitude of cracking and corresponding rate of seepage would not be as great as what would occur at Middle Chase Dam. However, it would represent a significant increase in seepage. The downstream slope of the Lower Chase Dam, especially the 1918 railway fill, will experience significant movements during the seismic event, in the order of 1.0 to 2.0 m, due to its loose state. The underlying rock fill will not experience as much deformation, generally less than 0.2 m of horizontal movement. Therefore, the primary effect of downstream slope movement will be distortion of the 1918 fill with crest settlement of over 0.5 m and, more importantly, distortion causing loss of continuity to the 1980 filter zone. The modelled deformations are presented in the deformed mesh shown on Figure 16. Damage to the filter zone will result in loss or reduction in the degree of protection against internal erosion from seepage that is anticipated will be initiated upon cracking of the concrete wall.

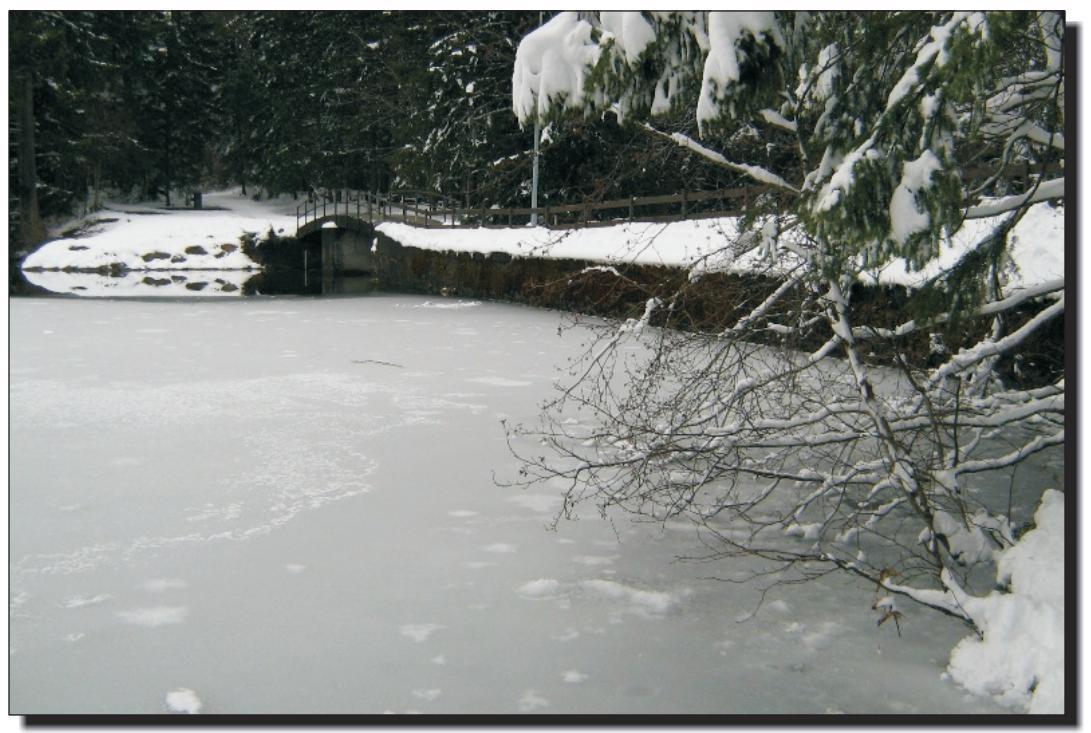
Photo 1 Upstream face of Middle Chase Dam in February 2009

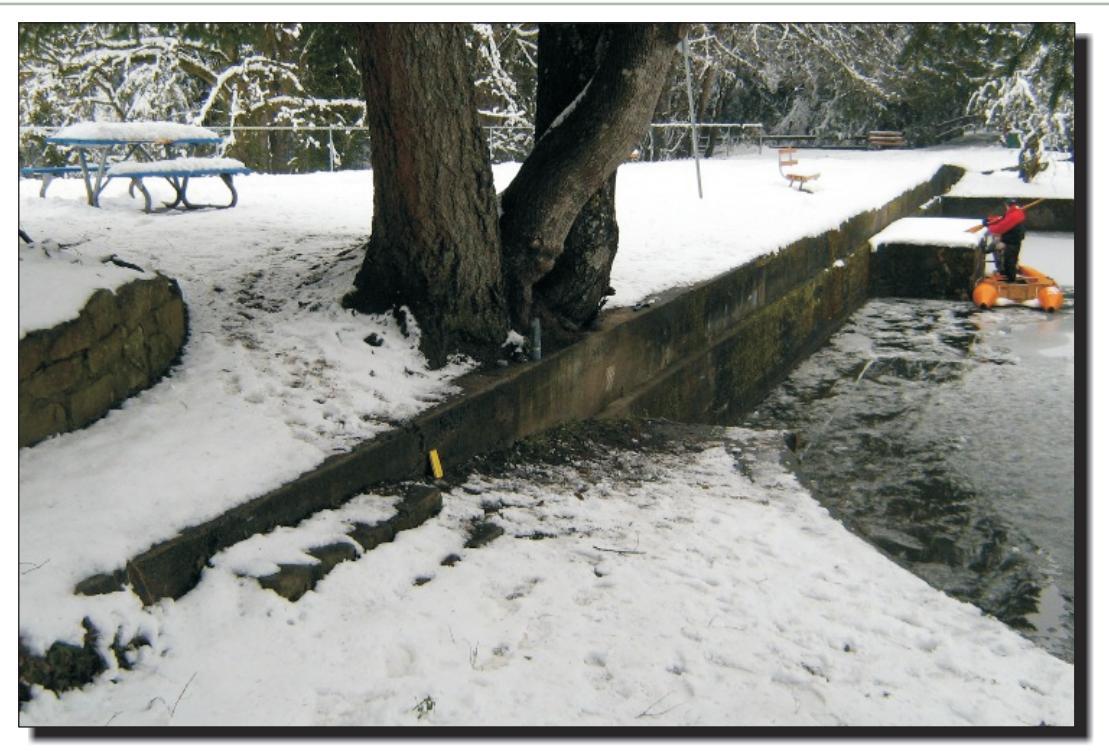
Photo 3 Upstream face of Lower Chase Dam from left abutment in February 2009. Zodiak is being used for rebar survey and Schmidt Hammer testing of concrete strength

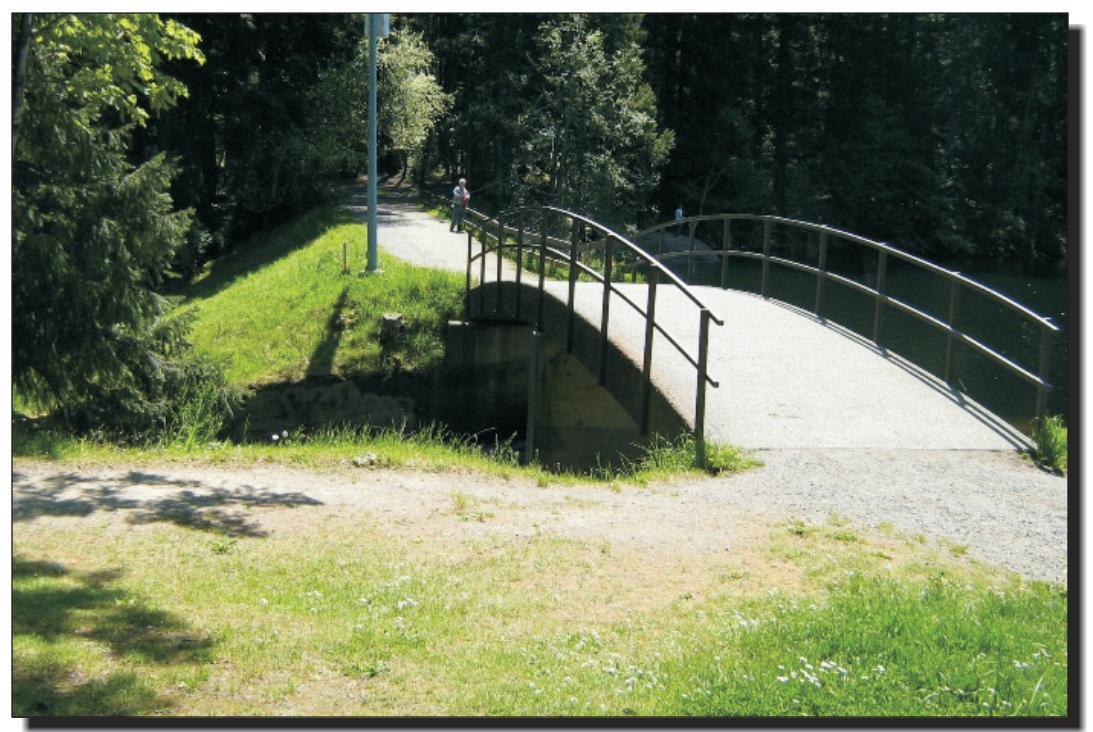
Photo 6 Crest and downstream slope of Middle Chase Dam and bridge over spillway, viewed from left abutment in May 2009

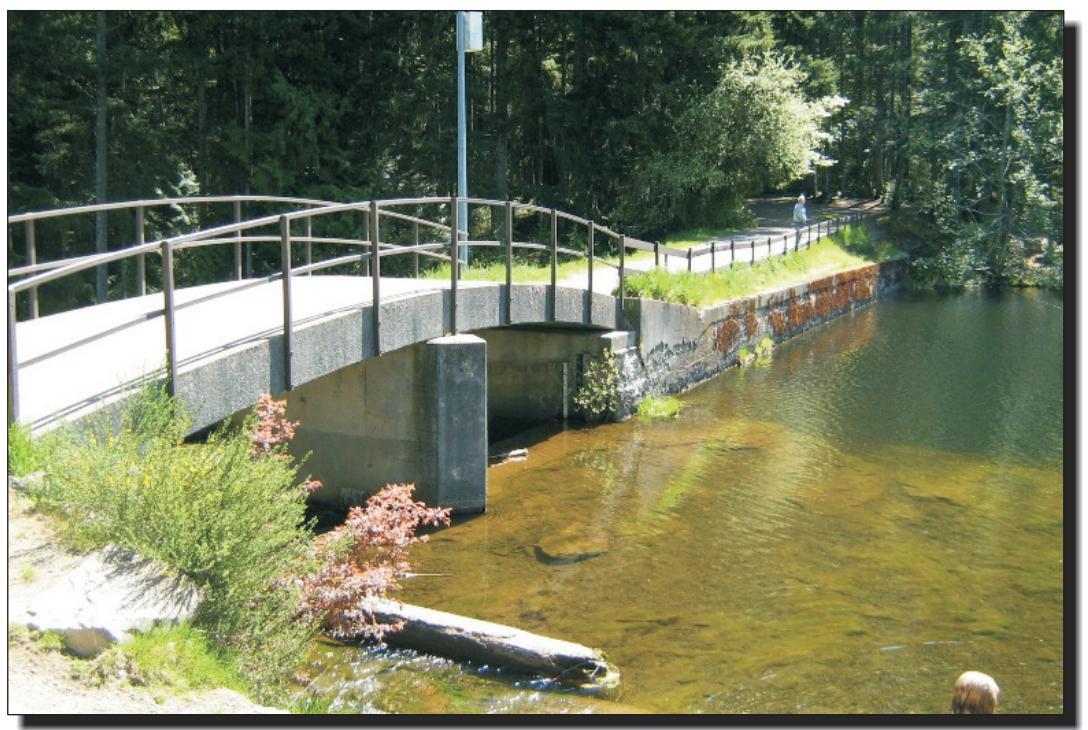
Photo 7 Upstream face of Middle Chase Dam viewed from left abutment in May 2009

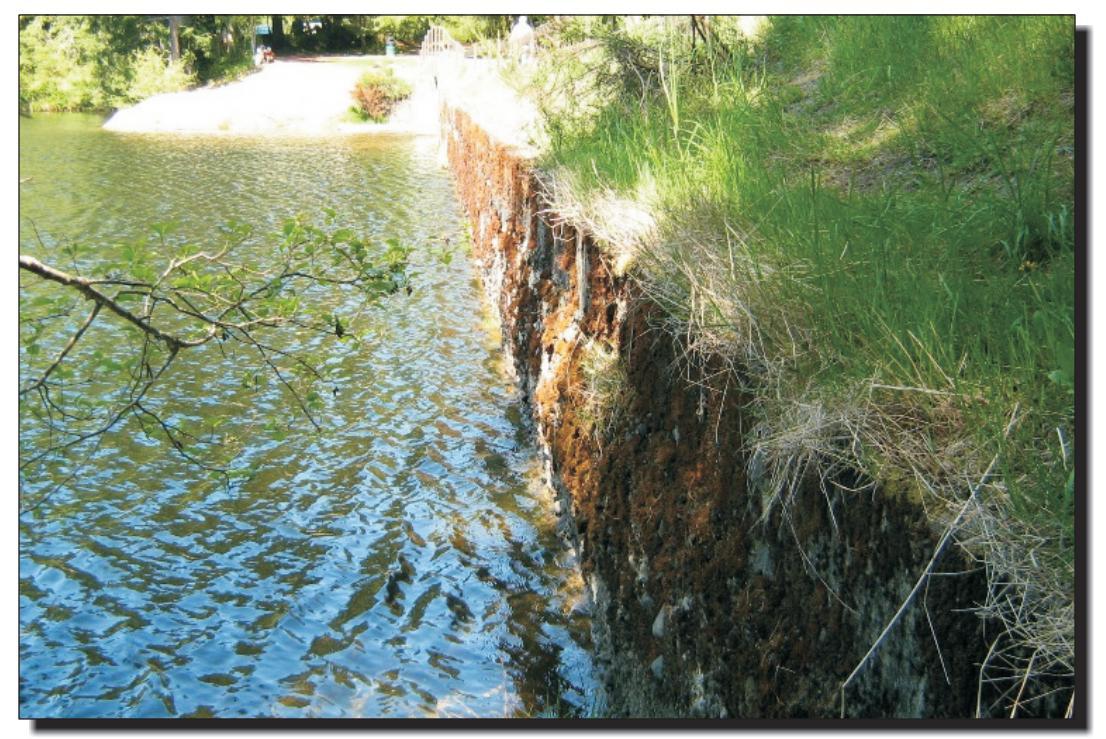
Photo 9 Upstream face of Middle Chase Dam viewed from right abutment.

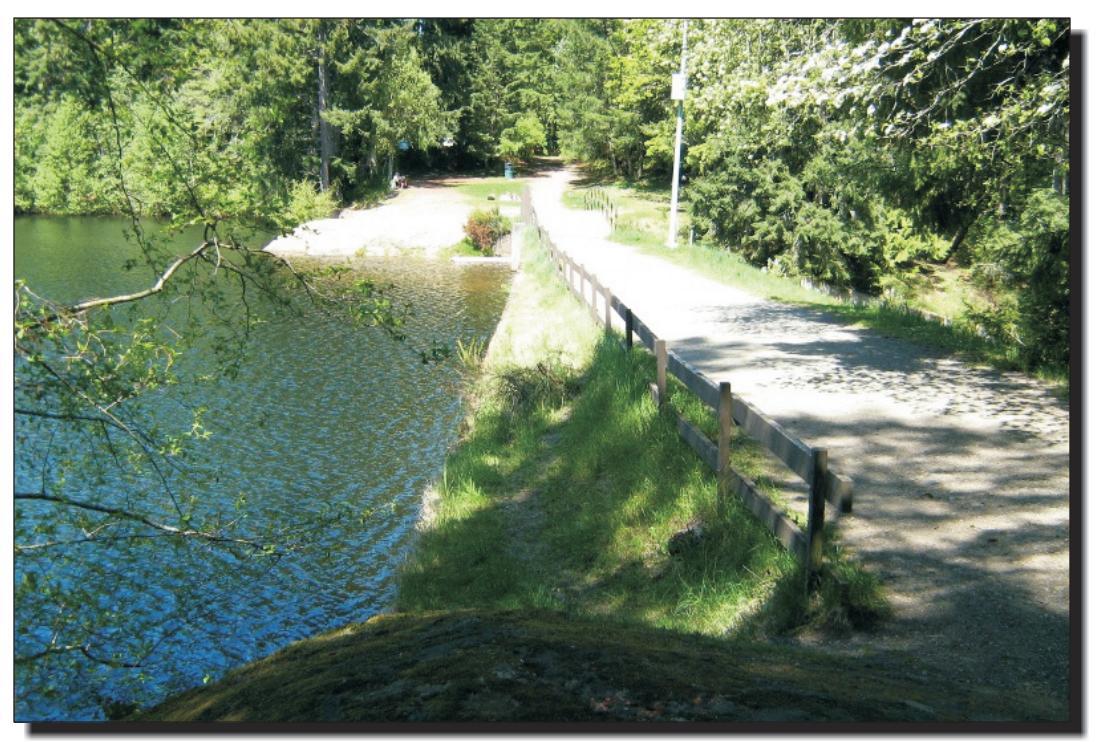
Photo 10 Crest of Middle Chase Dam viewed from right abutment.

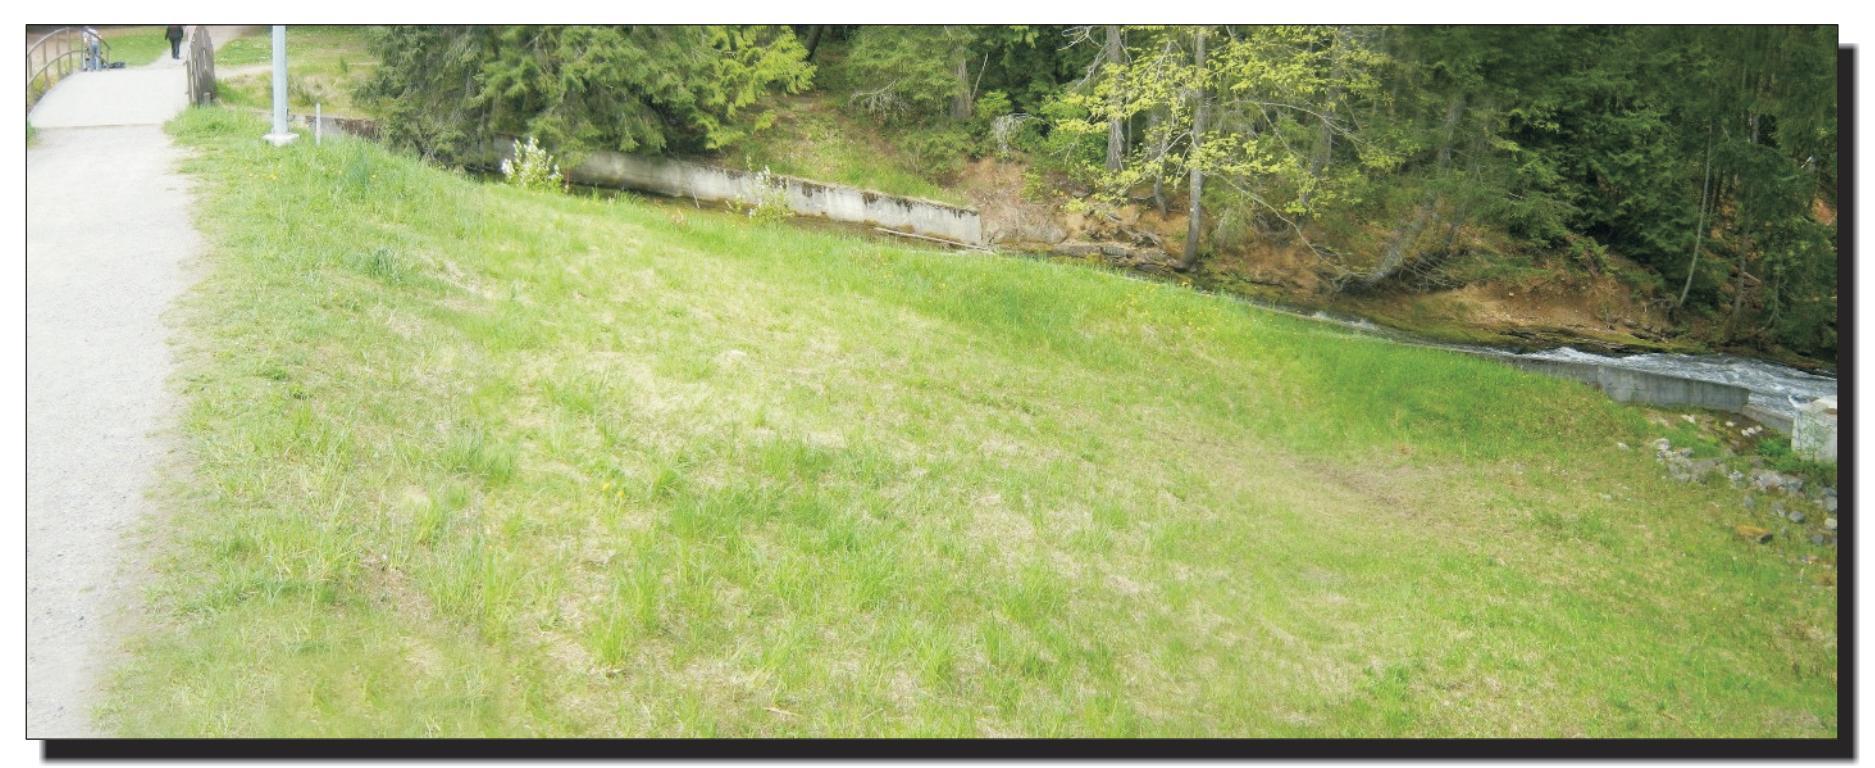
Photo 11 Downstream crest and slope of Middle Chase Dam viewed from crest of dam near right abutment.

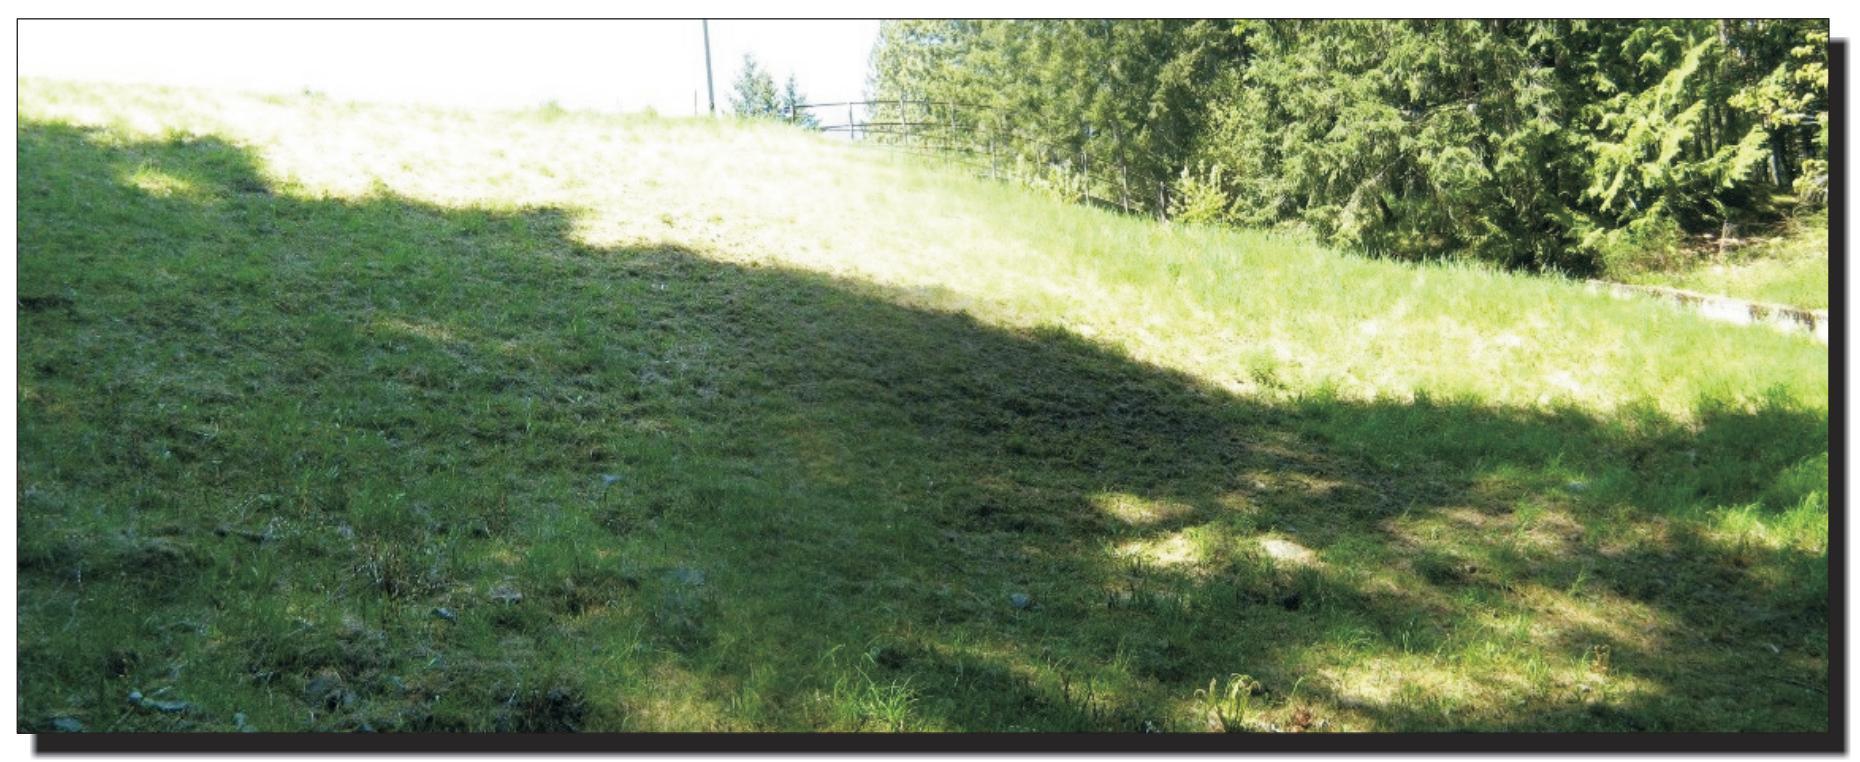
Photo 12 Downstream face of Middle Chase Dam

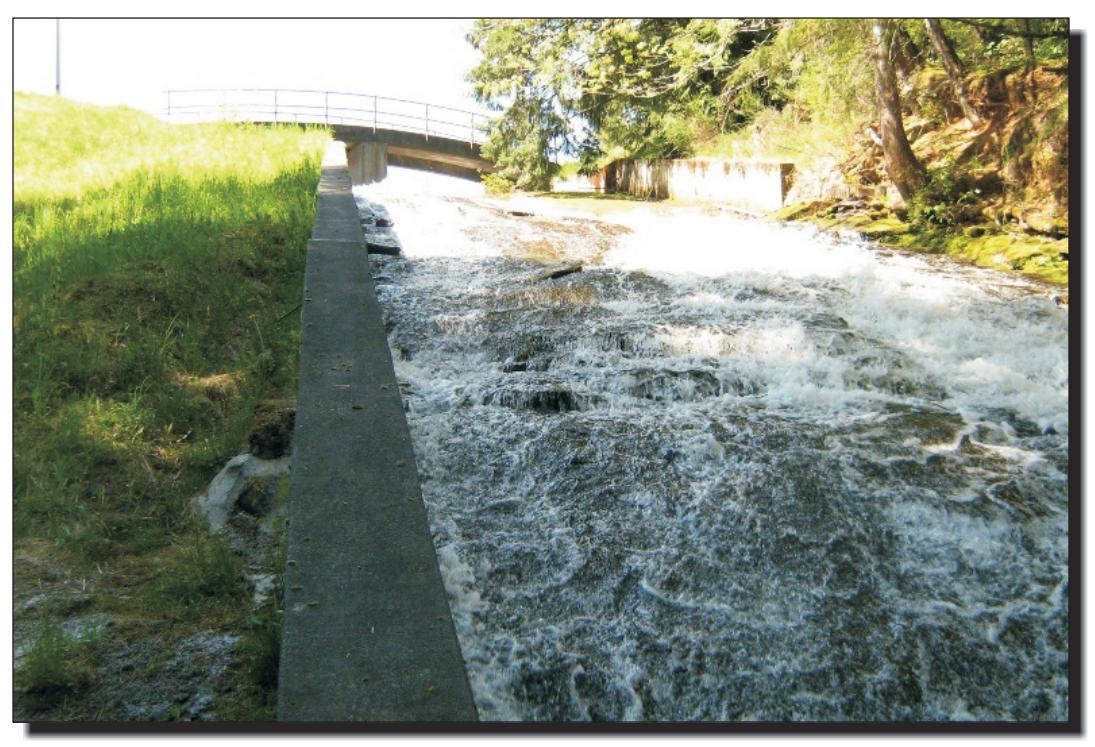
Photo 14 Middle Chase Dam spillway

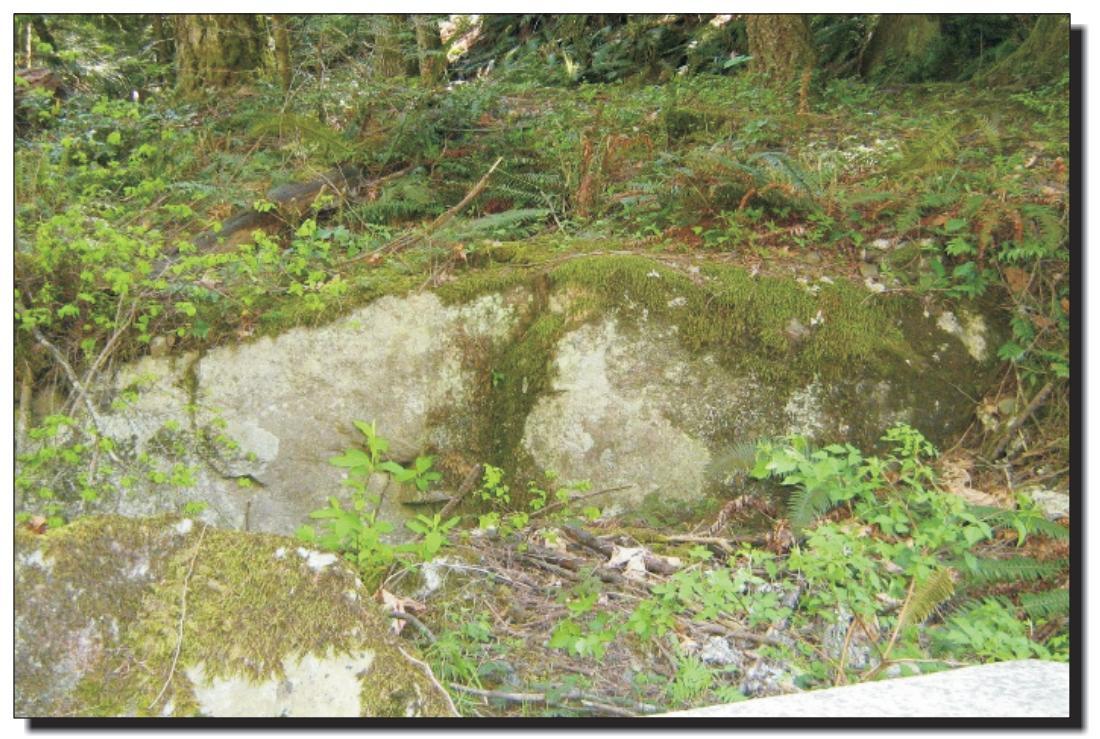
Photo 15 Bedrock is visible at the bottom of the Chase River valley downstream of Middle Chase Dam

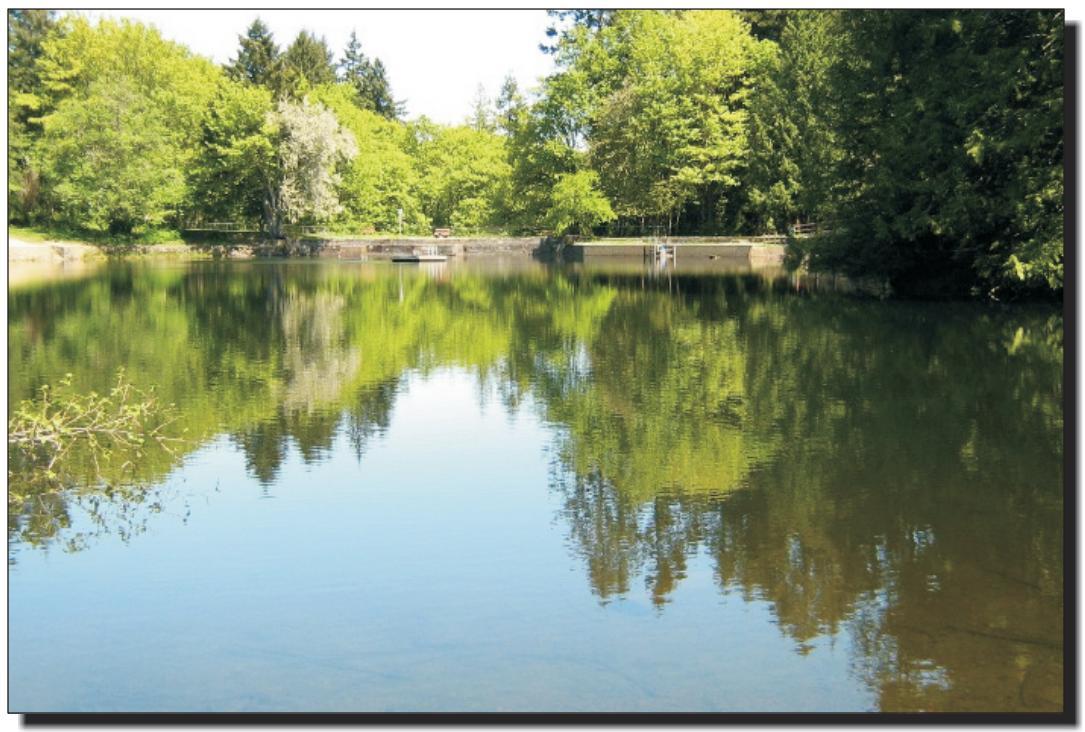
Photo 16 Upstream face of Lower Chase Dam viewed from confluence of Chase River with Lower Chase reservoir

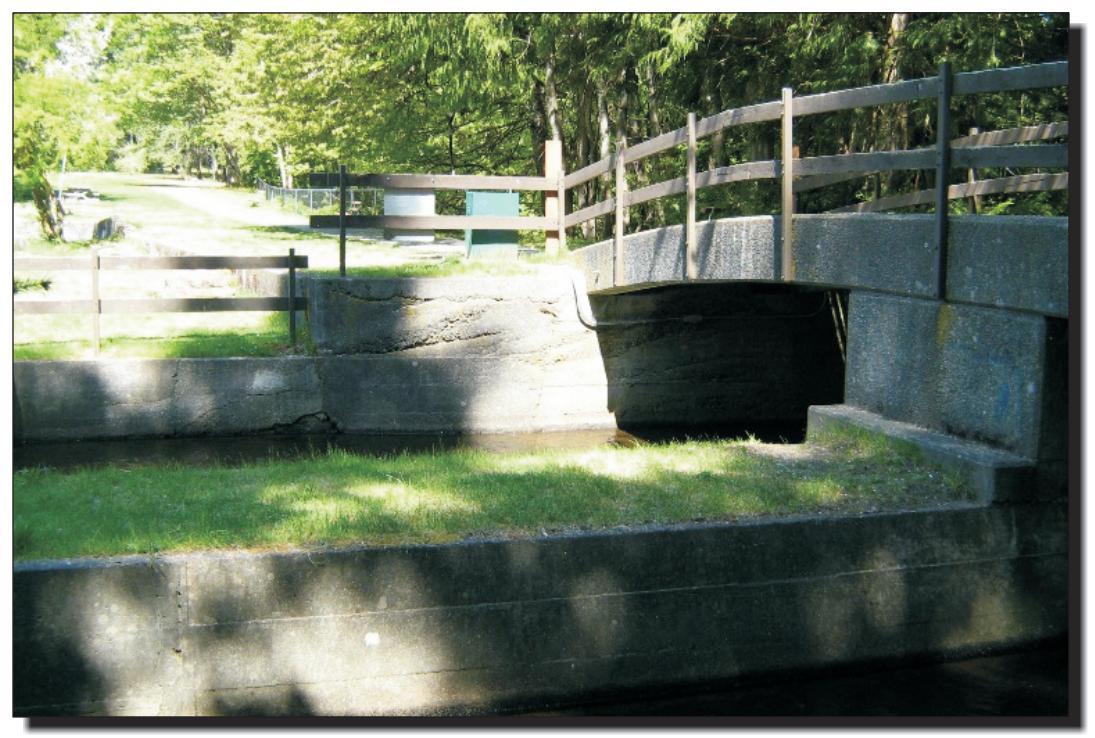
Photo 17 Lower Chase Dam spillway, facing towards left abutment

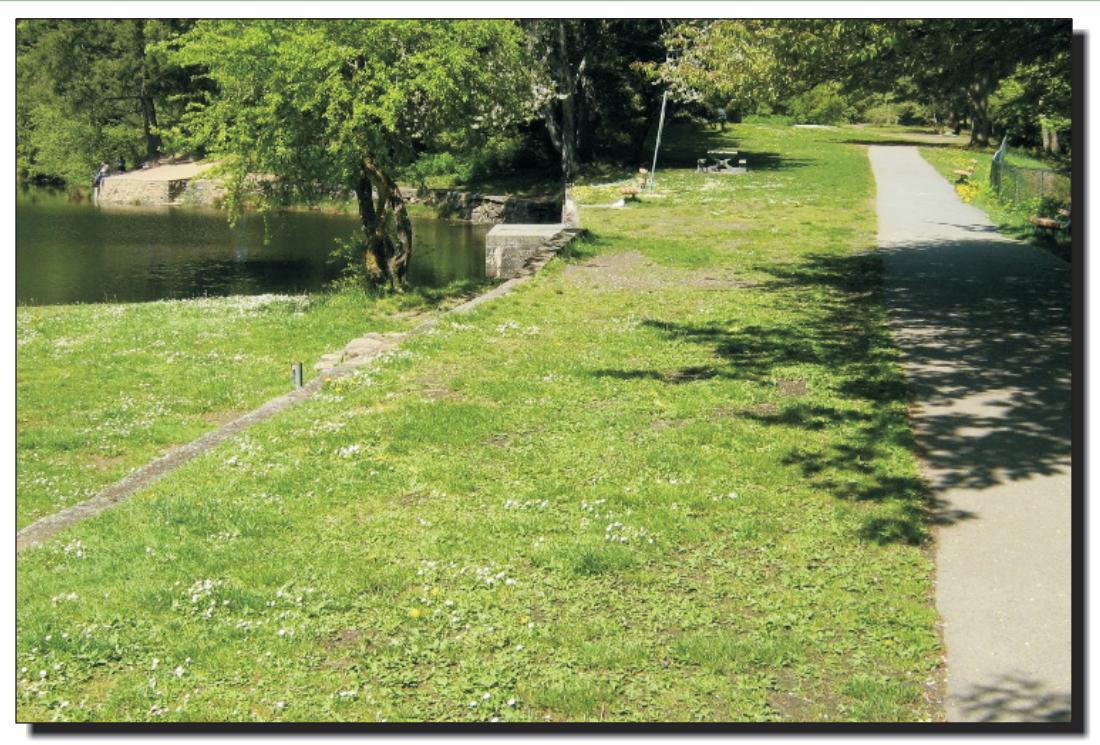
Photo 19 Upstream face and crest of Lower Chase Dam. The photograph is lined up with the original concrete wall. The concrete wall that angles off from the original wall appears to have been constructed at a later date for a different purpose.

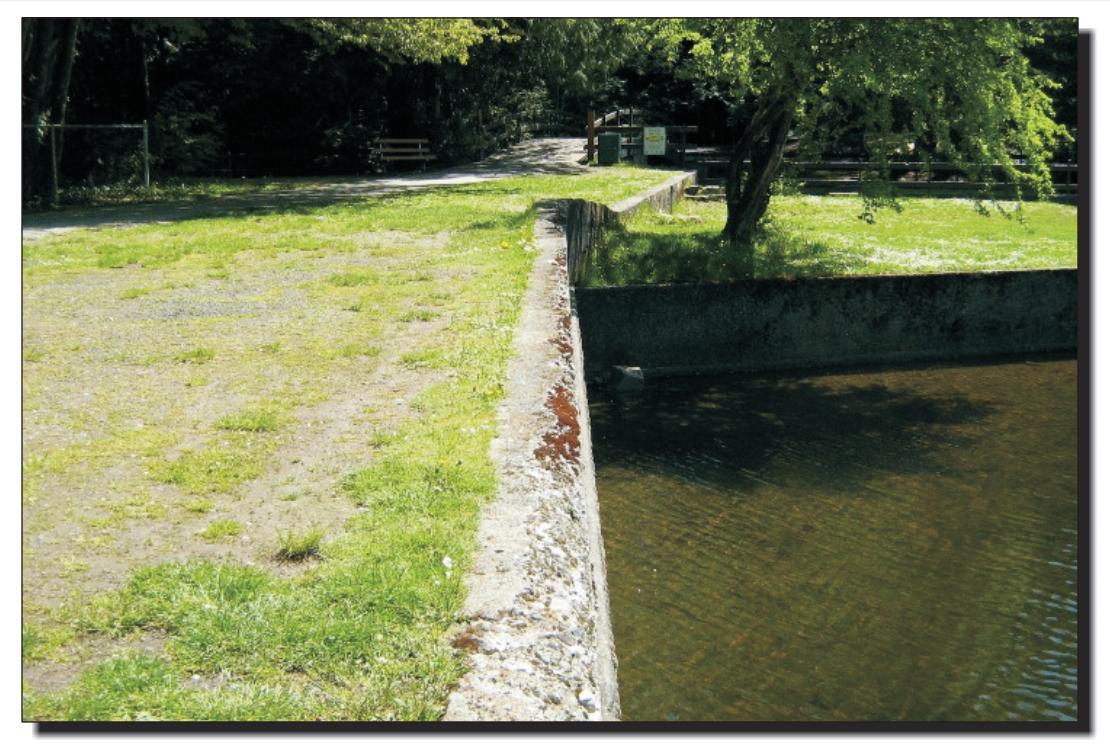
Photo 21

Looking towards right abutment and spillway along the original concrete wall from valve chamber. The concrete wall that angles off from the original wall appears to have been constructed at a later date for a different purpose.

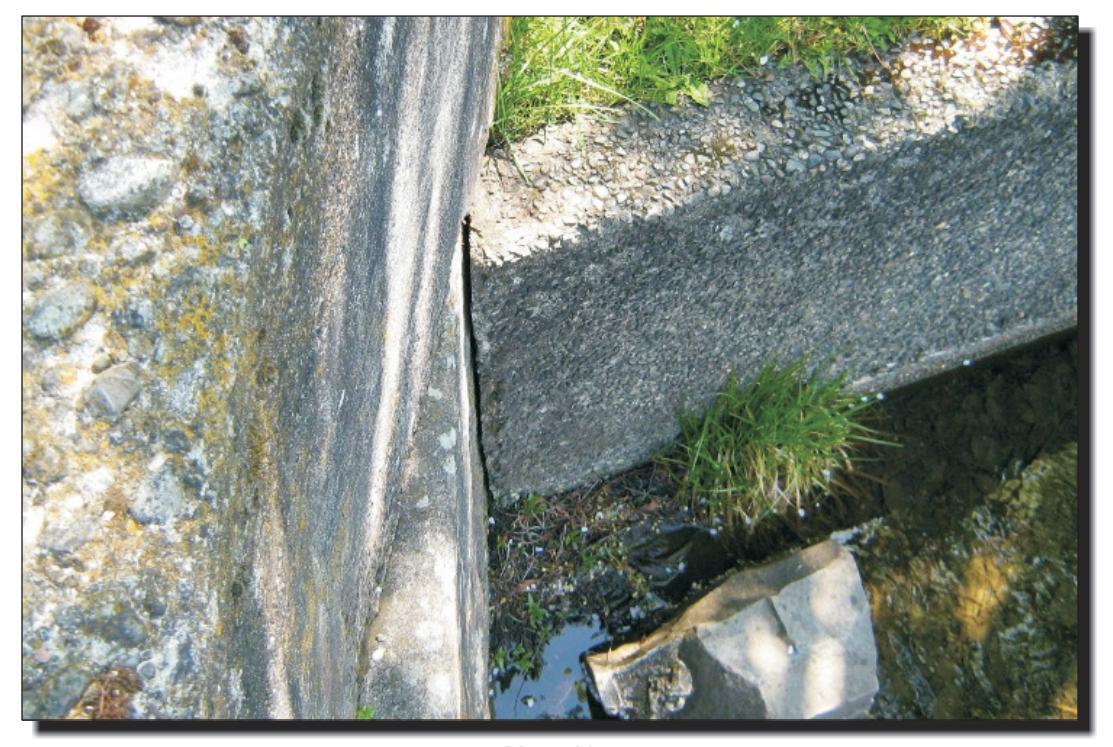
Photo 22 The lower original concrete wall continues to extend in a straight line towards the right abutment. The concrete wall that angles off from the original wall appears to have been constructed at a later date for a different purpose

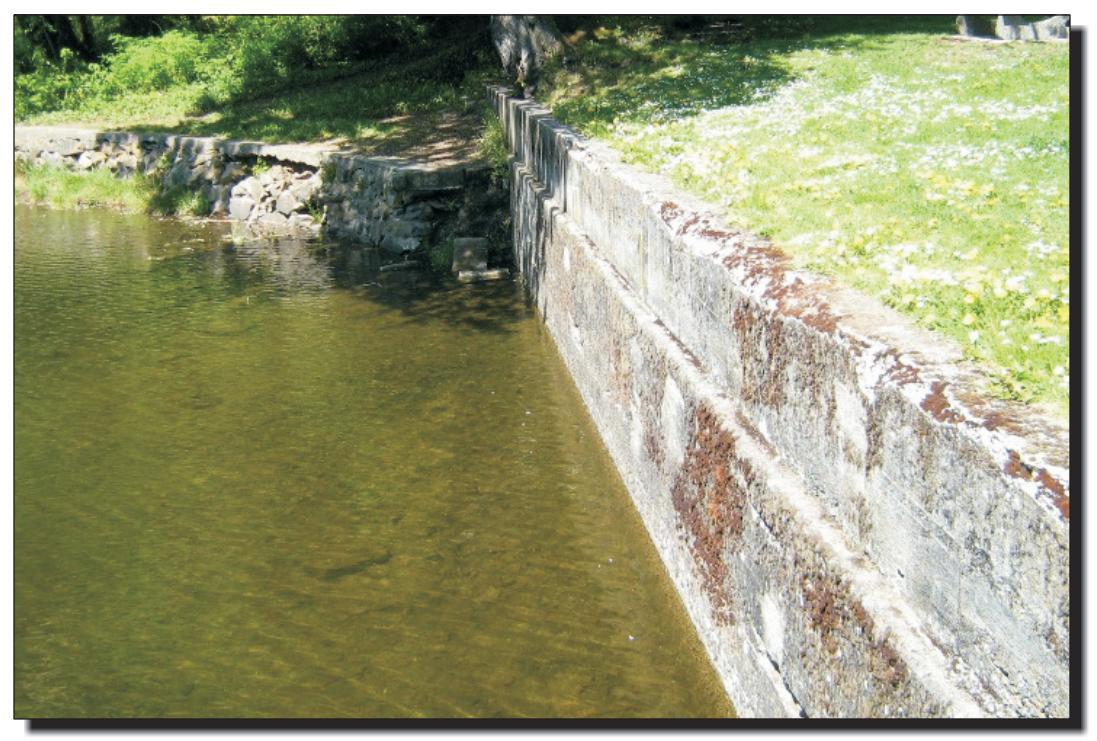
Photo 23

Looking along the upstream face of Lower Chase Dam towards left abutment along the original concrete wall from valve chamber.

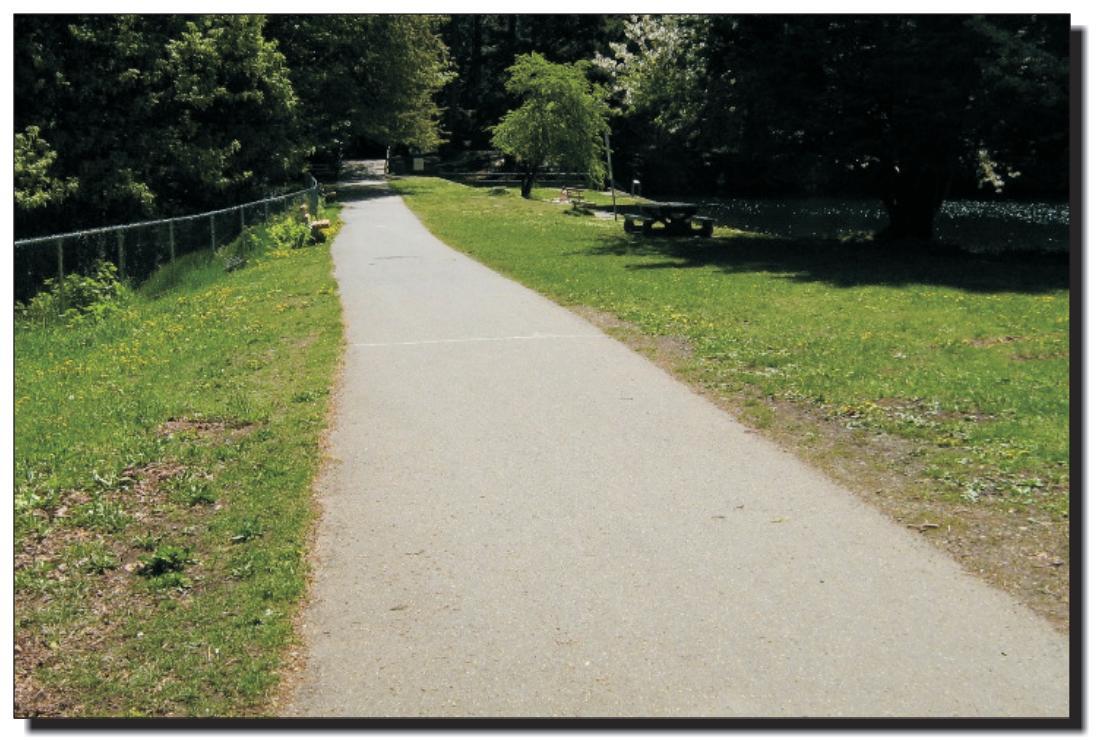
Photo 24 Crest of dam viewed from left abutment

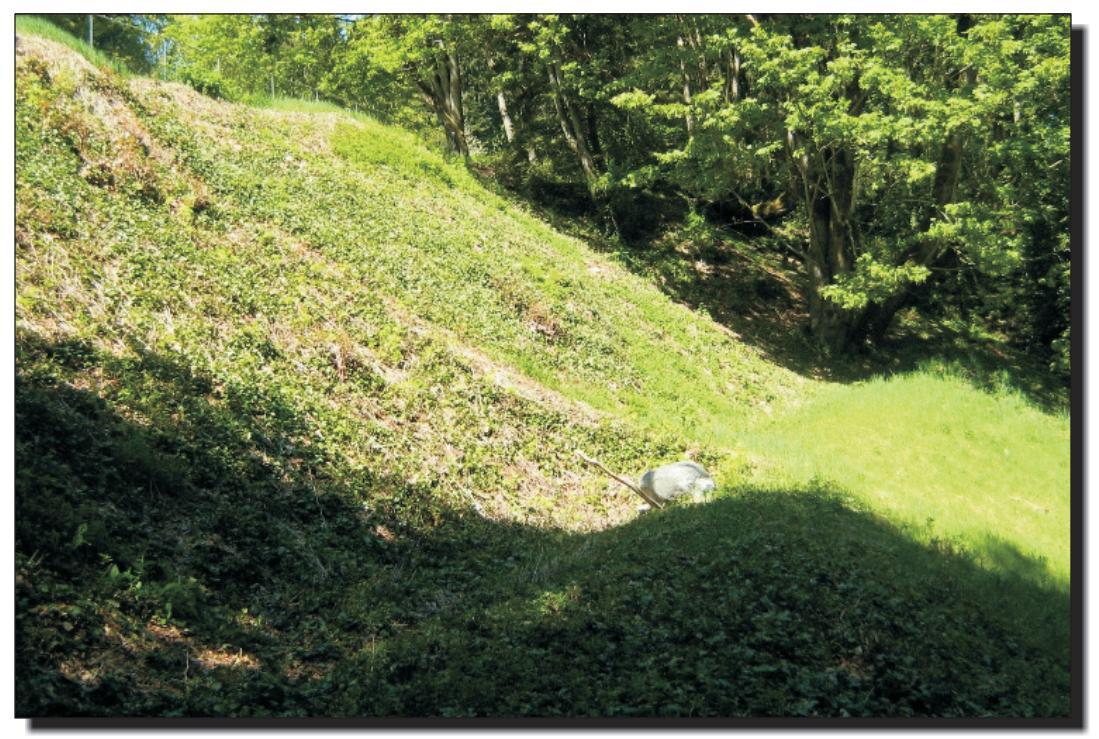
Photo 25 Upper portion of downstream slope and top of toe berm/filter layer viewed from right abutment

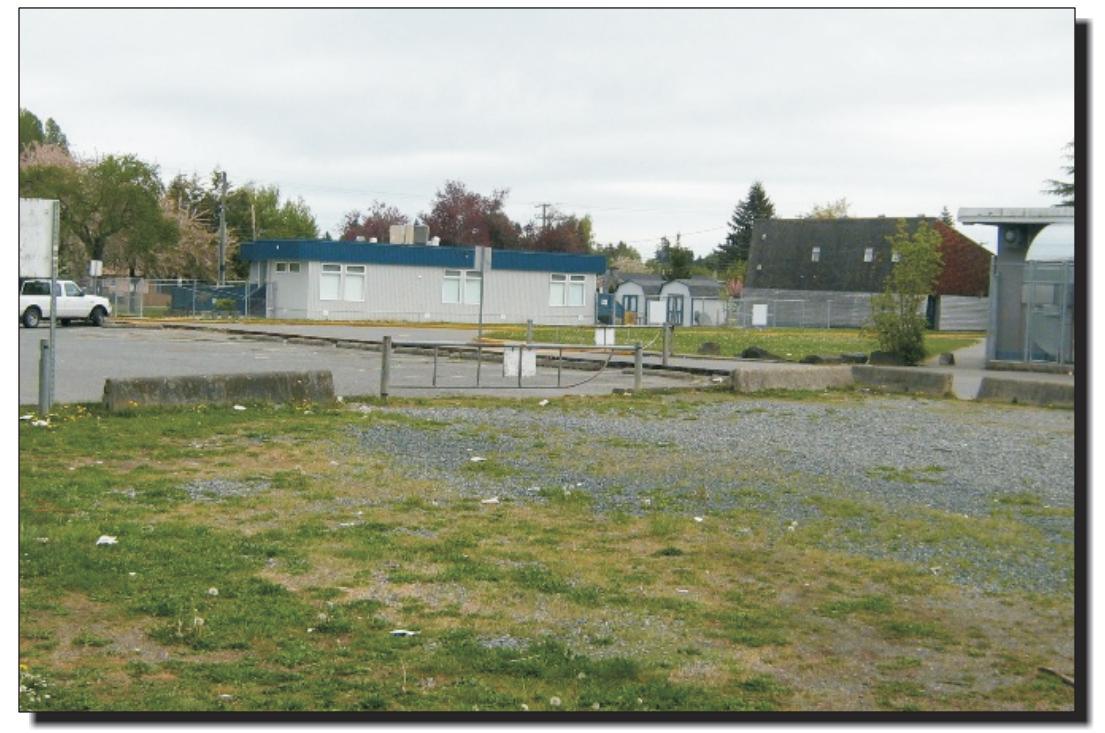
Photo 29 Little Ferns Daycare and Barsby High Scool Buildings located near crest of Chase River channel

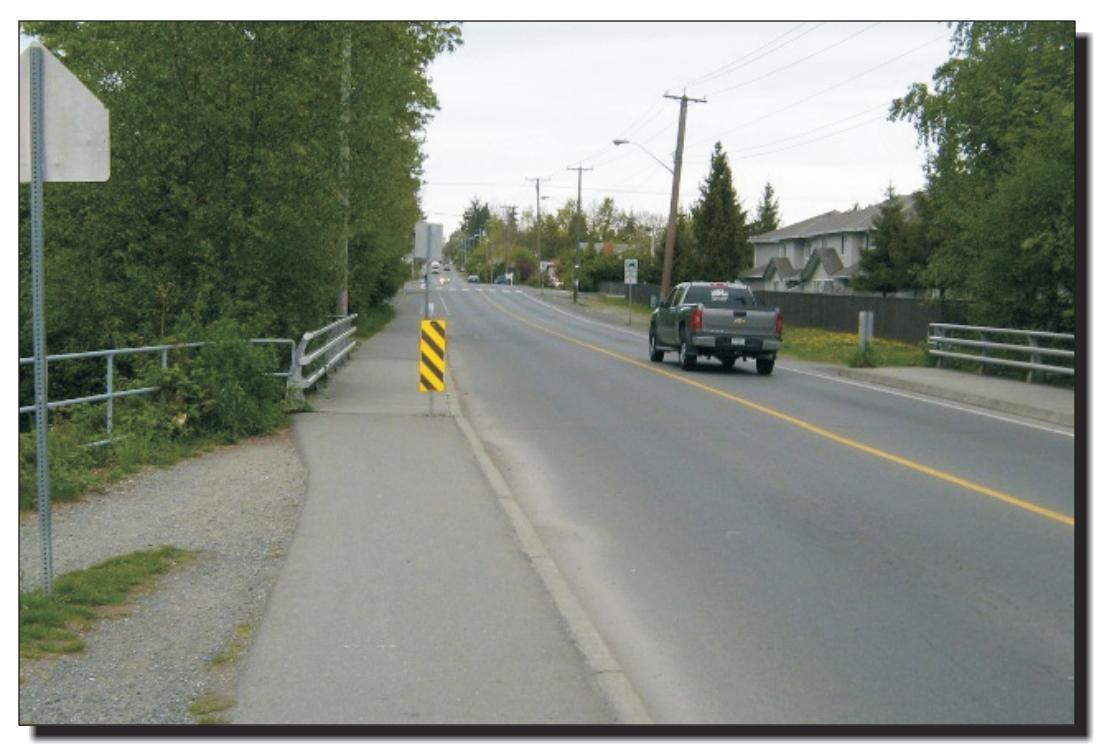
Photo 30 Bruce Avenue crossing of Chase River
